Challenges of Post Earthquake Reconstruction of Heritage Sites

Structural Rehabilitation of Painted Buildings

LANA KRIŽAJ

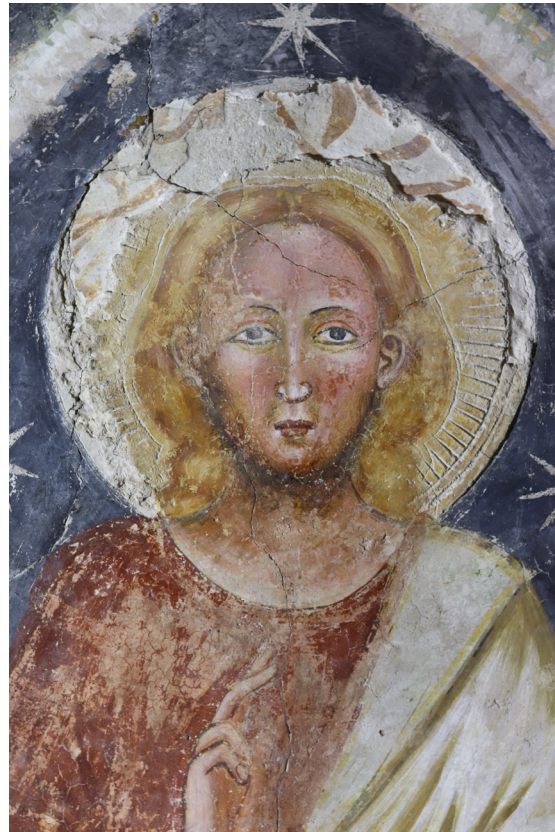
Fig. 1: Presentation of Christ in glory, mid-14th-century wall painting in the Chapel of St. Stephen, damaged by earthquake on 22 March 2022

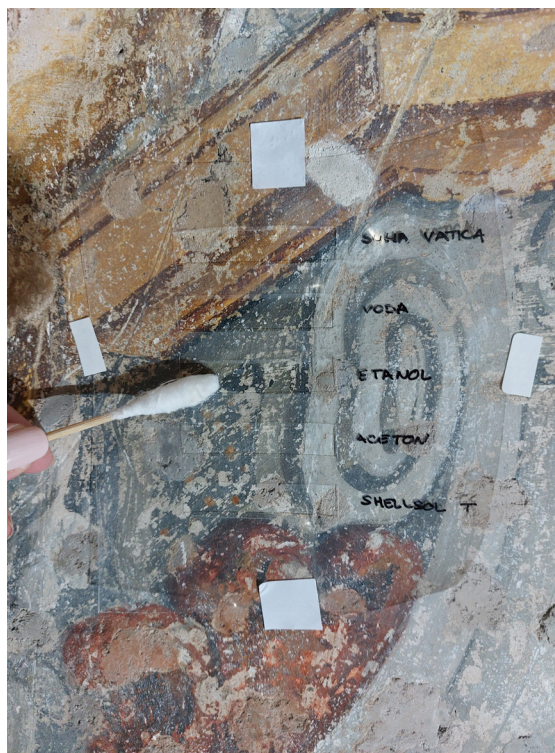
Fig. 2: Binder solubility and stability test being conducted at the Chapel of St. Stephen

The conservation methods used for the wall paintings both in the Chapel of St. Stephen and in the ceremonial hall were the same. First, a preliminary review of the condition of the wall paintings was undertaken. Next, the condition and damage found was documented by thorough photographs of segments that were joined together in panoramic views. Photographs were taken in the visible, ultraviolet and infrared spectrum. Cracks, delaminations, caverns, and salt damage as well as the position of damage to the wall paintings and stone elements have been pencilled into graphic documentation generated by the *Hrvatski restauratorski zavod* in 2005 in order to simplify the process of monitoring of operations at the chapel. Then binder solubility and stability tests were performed on the Gothic, Baroque and wall paintings from the period of historicism where the

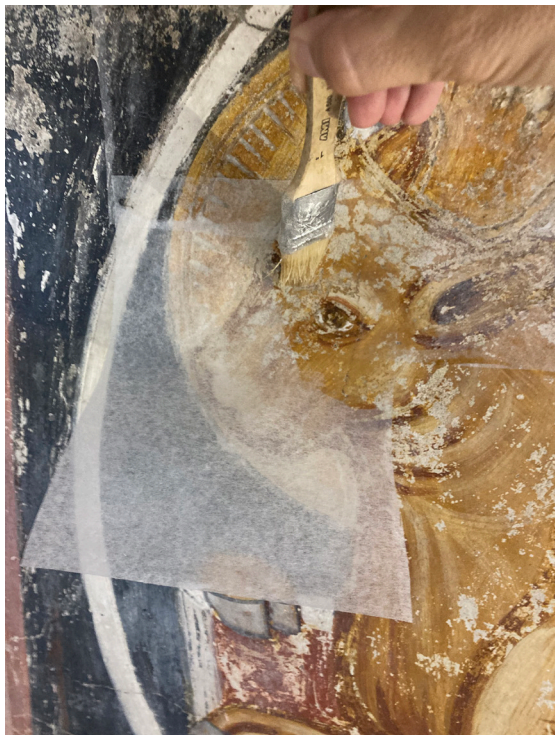
Fig. 3: The process of facing being carried out at the Chapel of St. Stephen

pigment showed mostly stable (Fig. 2). After that, preventive protection of the paintings was initiated using the method called facing (Fig. 3). A layer of 50% cyclododecane in white spirit was applied first directly to the fresco and then a layer of 4% Klucel G in ethanol was applied over segments of Japanese paper (Fig. 4). The cracks and delaminations were also preventively injected and the damaged parts of plaster were protected by edging with lime plaster. Finally, the wall paintings in the Chapel of St. Stephen were secured by a light wooden construction that was separated from the paintings by a thicker sponge and a layer of geotextile.⁷ It was only after these preventive protection measures were implemented that the structural renovation could finally be carried out.

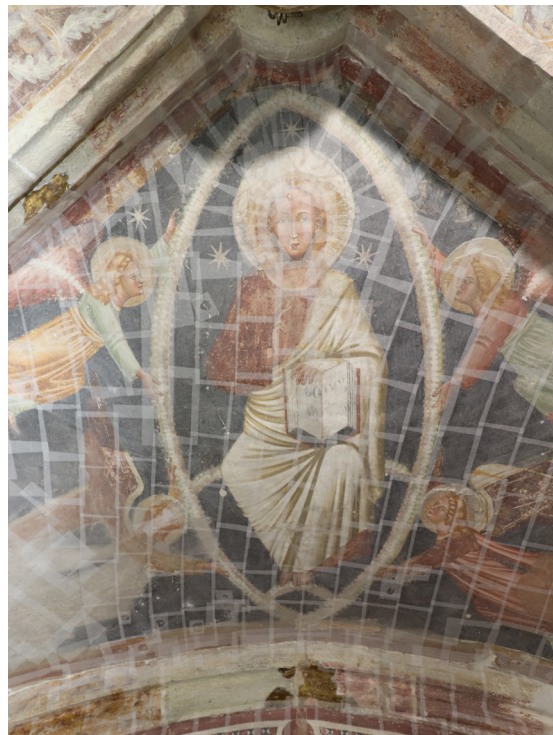
Fig. 4: Presentation of Christ in glory, mid-14th-century wall painting in the Chapel of St. Stephen protected by facing
