KAYSERI SITE ASSESSMENT VISIT

Dates: June 15-21, 2015

The numerical evaluation indicates historical, social and cultural significance, the actual physical conditions and potential risk of the monuments on a scale of 1-5 (1- very low, 2-low, 3-medium, 4-high, 5- very high). Thus, the monuments acquire their place in the final risk array, according to their heritage significance combined with current and potential threats. The monuments ranking higher in the final array are those which require urgent preservation action.

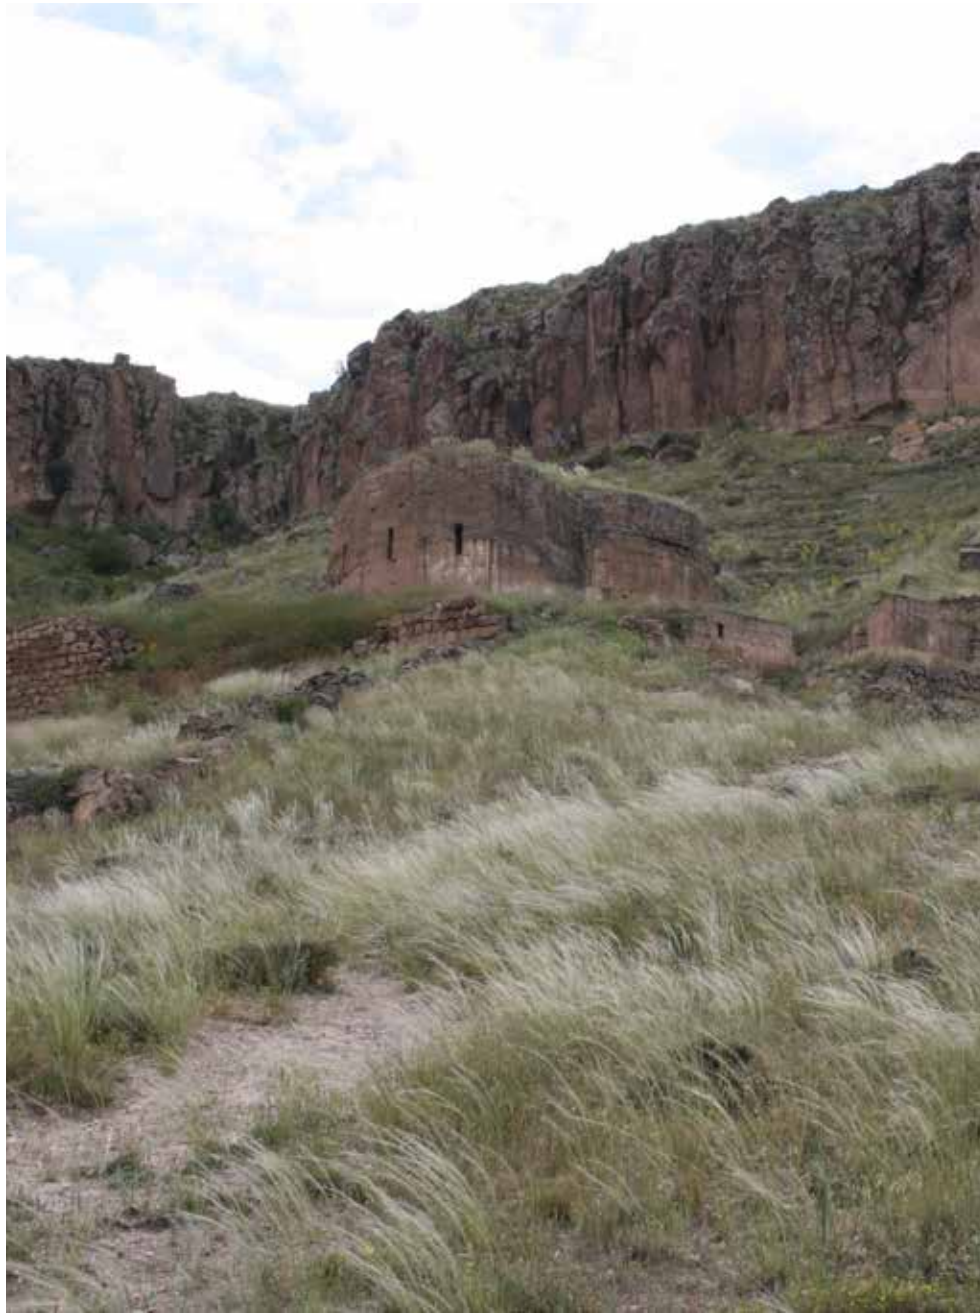
*Church of Saint George
Yeşilhisar county, Başköy neighborhood*

The major problems in the main body of the church are the fact that the dome, part of the apse of the southern wing, and a part of the western exterior walls are missing. These damages have resulted in the accumulation of debris and backfilling in the interior, which has, in turn, concealed the original floor. Furthermore, the support of the structure has been disrupted to such an extent that parts of the building are in danger of imminent collapse. This unfortunate condition is further aggravated by the humidity

caused by rain and snow and the vegetation that has developed in the interior. Building materials have also suffered from significant damage; some stones have disintegrated and others are covered with moss.

The painted decoration of the monument has also suffered significantly and is in part destroyed. Mostly due to high humidity and sudden changes in temperature, many parts have lost their overlay, have fallen, or are on the verge of falling. Significant parts have been discoloured by sunlight entering the structure through the gap of the collapsed dome while other parts of the painting has been covered with dirt, both cases rendering the paintings indiscernible.

The roofing is completely destroyed and the surface is covered with vegetation. The vestibule is also damaged at various points of the masonry. Its walls have been weakened after the collapse of some of its parts, and it is covered with vegetation.

The greatest danger the structure currently faces is complete collapse within the next few years due to high risk nature of unpredictable and unpreventable damage caused by nature and people.

The protection, preservation, and restoration of the building are prerequisites for any future use of the space. Some parts of the structural system may easily be restored. The reconstruction of the missing dome, however, presents serious difficulties due to the lack of information and evidence on its original form. Still, it may be possible to replace the original dome with a light steel construction with stained glass, which would offer shelter and protection for the interior of the building and the painted decorations, while allowing for appropriate ventilation.

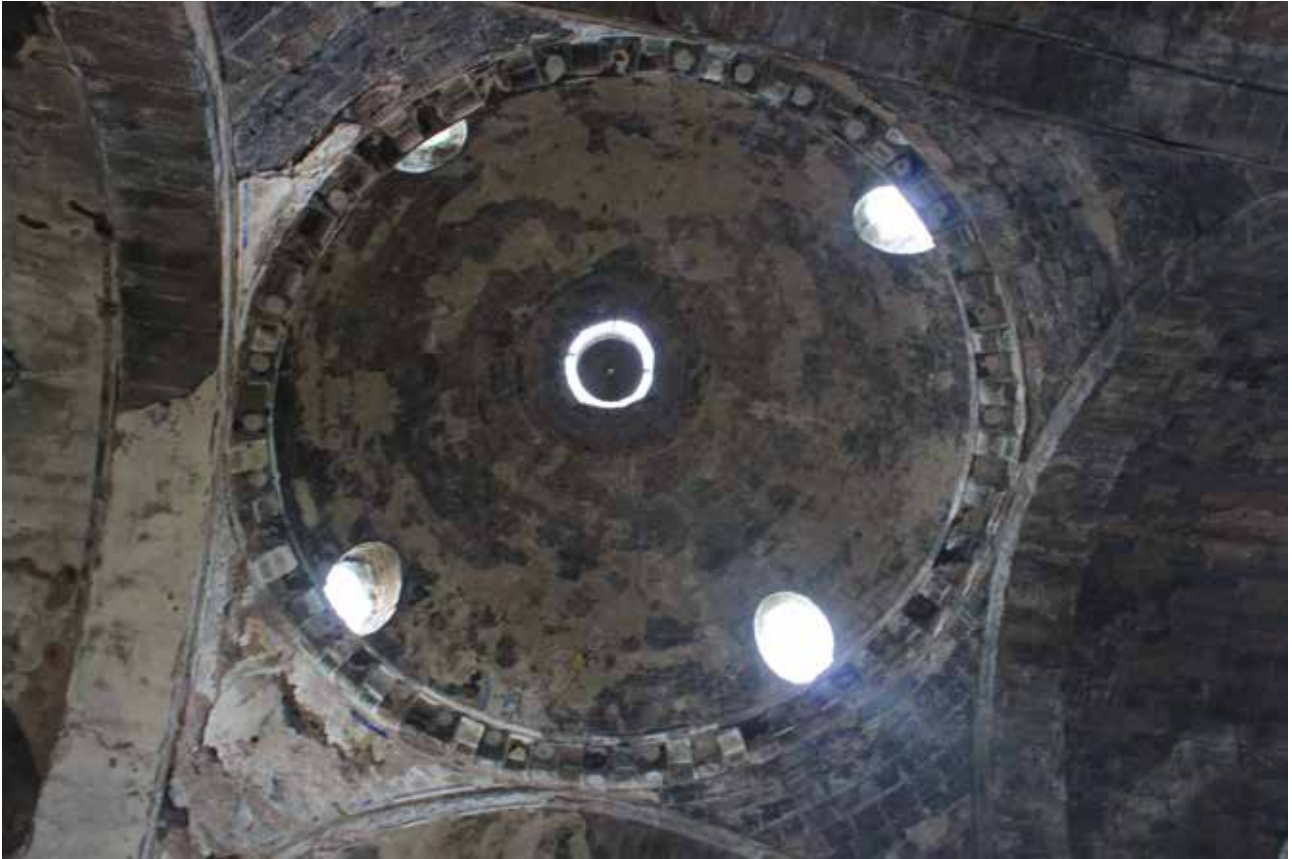
The most serious problems of the nave are located in its western part, which is connected with the gynaecoonitis. The stairs that lead to the upper floor have been almost completely destroyed while the decorative balconies have been drawn into the same fate by the collapse of the gynaecoonitis. The church floor has also suffered significant damage. Its marble tiles have been removed or destroyed during the illegal excavations. At the same time, its structural elements show significant damage due to high humidity and, more importantly, the humidity that descends from the ceiling. As a result, only

few of the plastered or painted surfaces have survived. Even the metal spreaders that remain in situ have been gravely affected by rust.

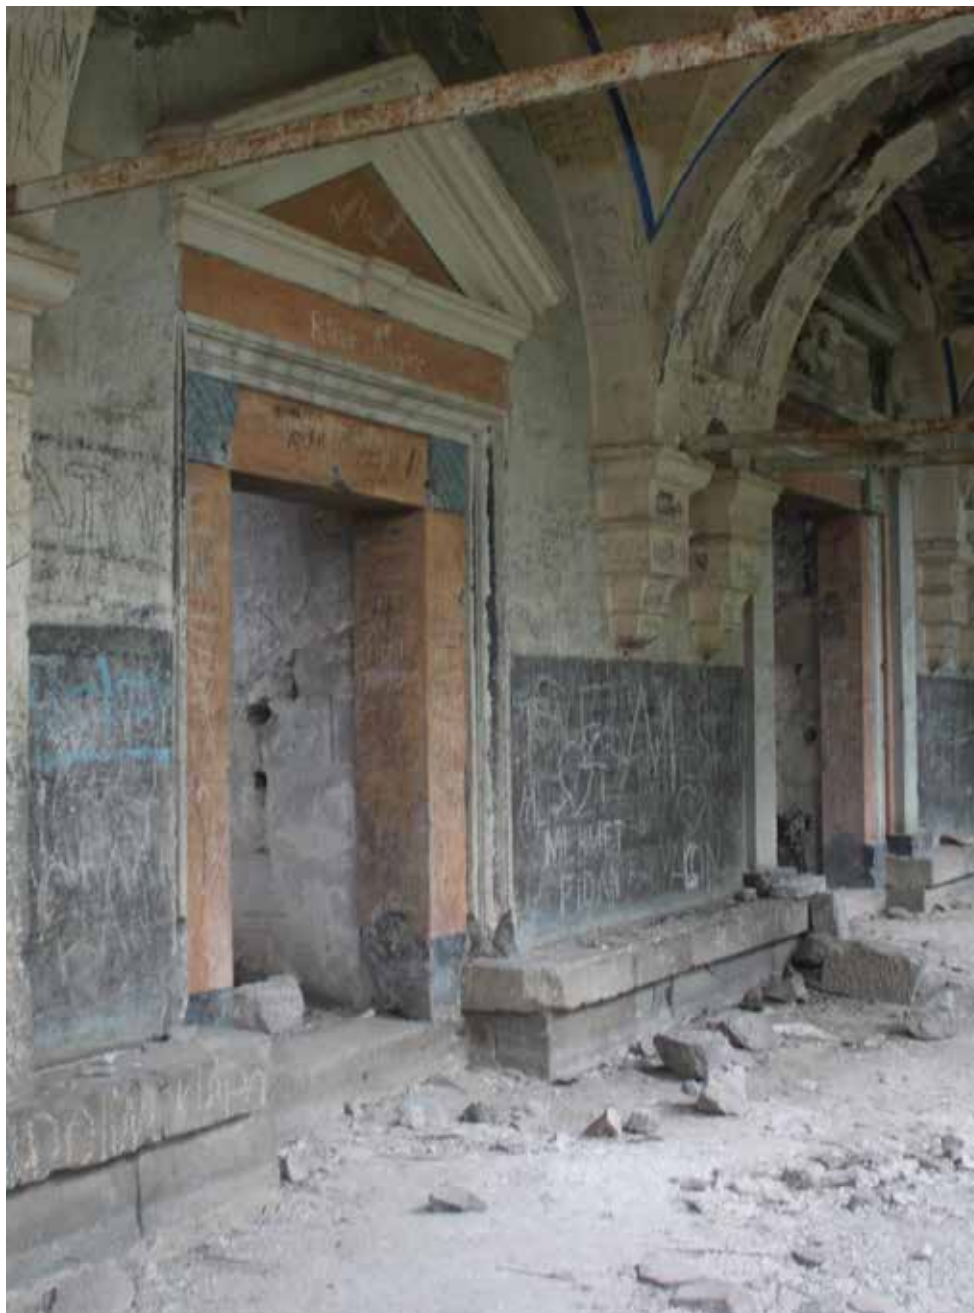
*Church of the Holy Trinity
Talas county, Endürlik neighborhood*

The present condition of the church is not particularly good, despite the fact that it presents no distortions or deformation vis-à-vis the plan: large parts of the gynaecoonitis section have collapsed, causing significant damage to the materials and structural elements of the nave.

Major problems concern the gynaecoonitis, whose southern part has almost completely collapsed, roof and exterior wall on its western part have been damaged, and northern part suffers from decay of the masonry and the roof. The ground floor of the portico is in a somewhat better condition despite the fact that its structural elements have tilted, deviating from the vertical axis, and causing cracks, while its vaults have been split apart from the roof (floor of the gynaecoonitis). Furthermore, all metal spreaders and locks that remain in place and not already destroyed have been negatively affected by rust.

The roof has also suffered significantly: Its slate tiles have been damaged or removed, and vegetation has covered most of its surface. Similar signs of damage are evident on some of the masonry of the exterior wall, where small trees have grown within the structure.

The grave natural and anthropogenic dangers that the monument currently faces, may lead to its complete collapse and destruction in the years to come. The level of risk posed by both natural and anthropogenic causes is very high due to their unpredictability and uncontrollability.

In terms of natural causes, weather conditions (rain, snow, wind, and sunlight), the surrounding vegetation, and earthquakes pose the most serious threats. The lack of fenestration on the windows, the removal of the roof-tiles, and the ruined sections of the gynaecoonitis
