Adana

## ADANA SITE ASSESSMENT VISIT

Dates: October 21-28, 2015

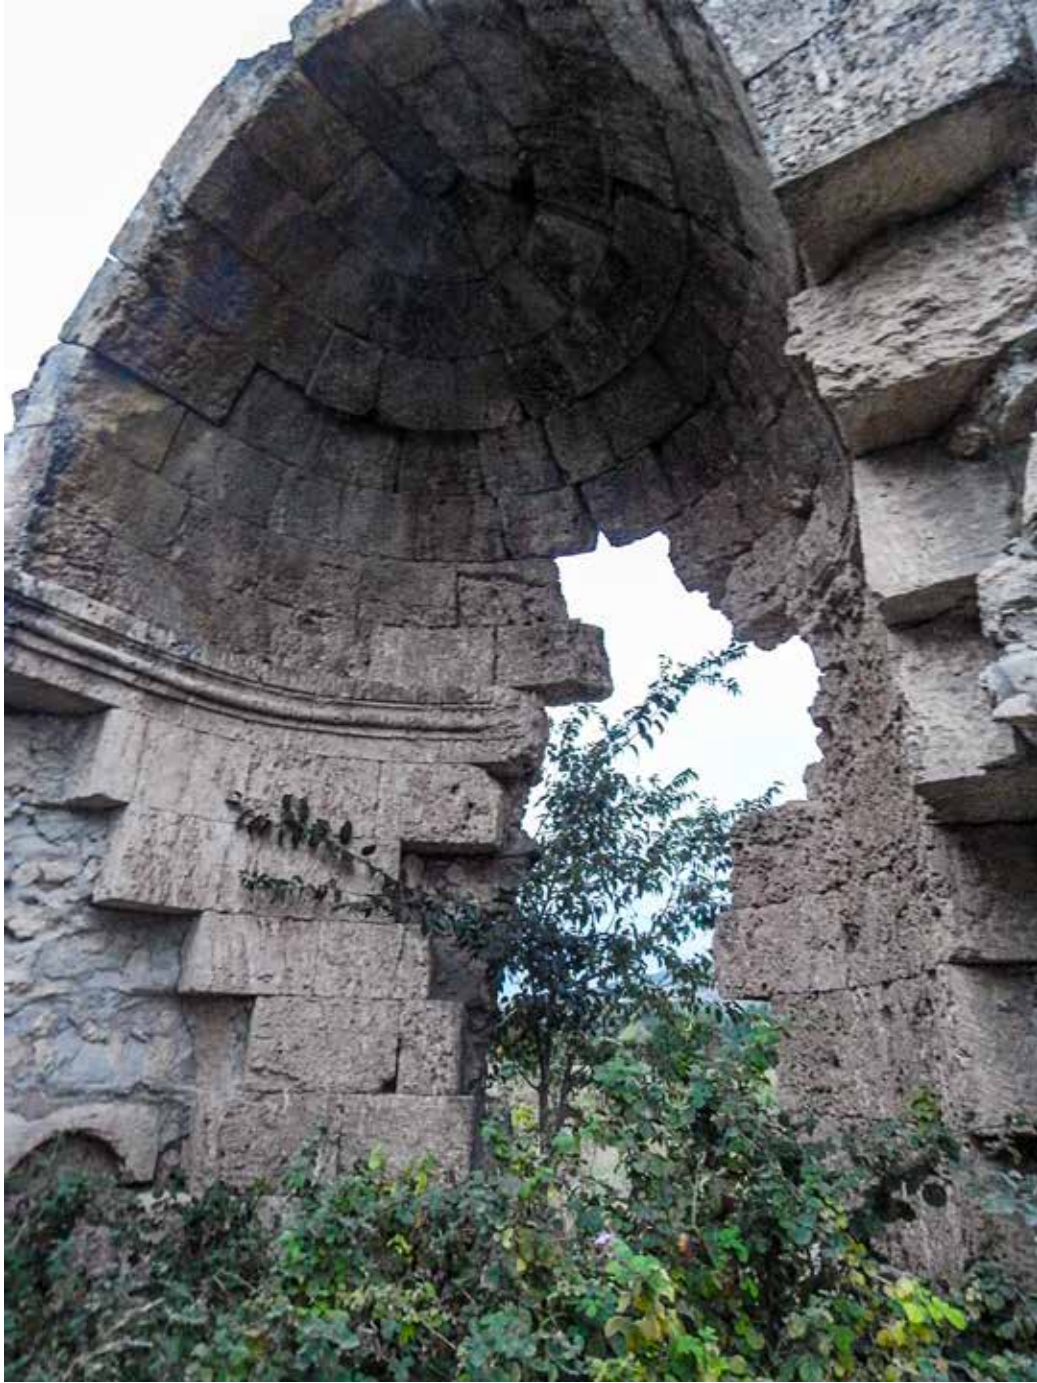
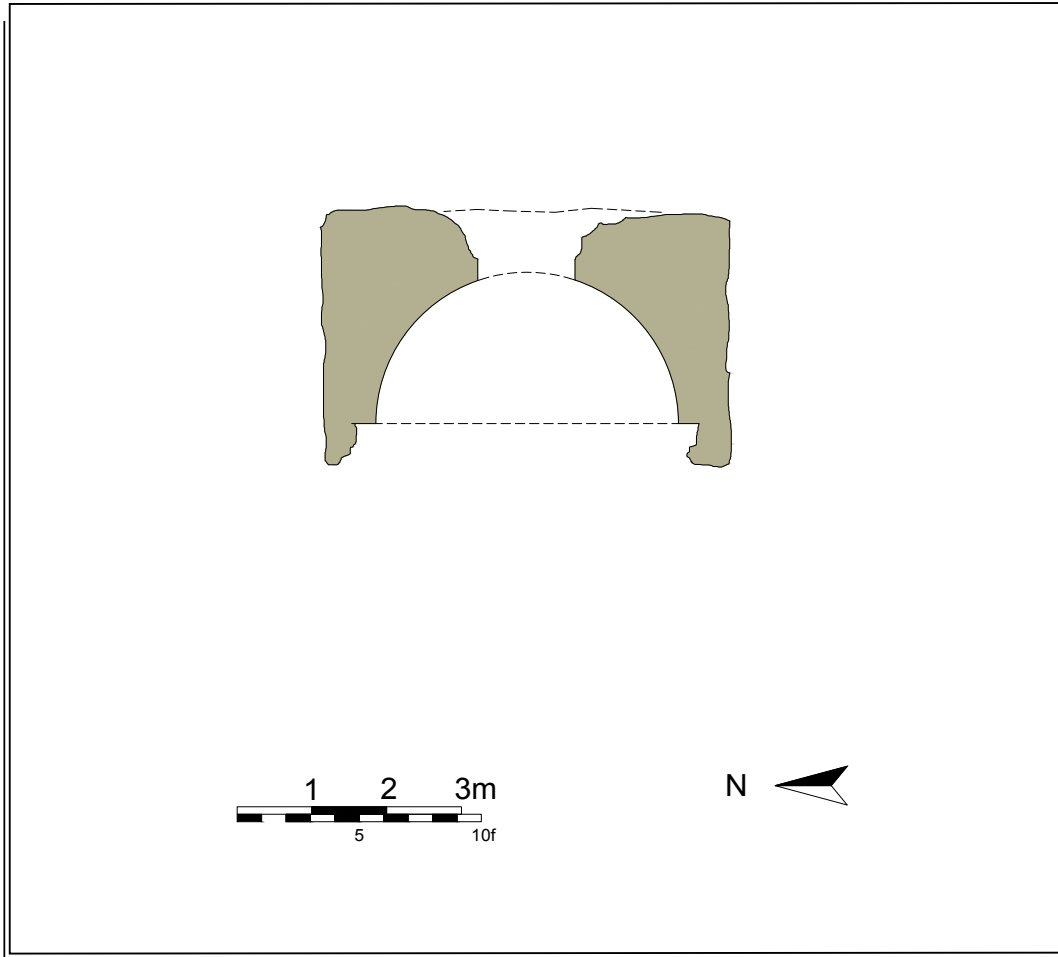
*The Church  
Yüreğir county, Çatalpınar village*

There are large openings in the east wall of the apse, with the structure standing nearly as a partial vault with the majority of its cover stones are removed. Apart from the apse, the main walls and upper roof have not survived and all the remaining architectural texture of the structure is open to natural depredation and vandalism. There are plants growing over the walls, with efflorescence on the vault and material deterioration in sections where the infill is revealed as well as the loss of mortar. As the structure is within a field, there are no visitors other than those who have previous knowledge of it.

Traces of recent repairs with concrete incompatible with the original material are observed.

The large scale of the structure indicates it was an important church. Thus, it is recommended that the building is researched with detailed excavations of its ground. Structurally it requires

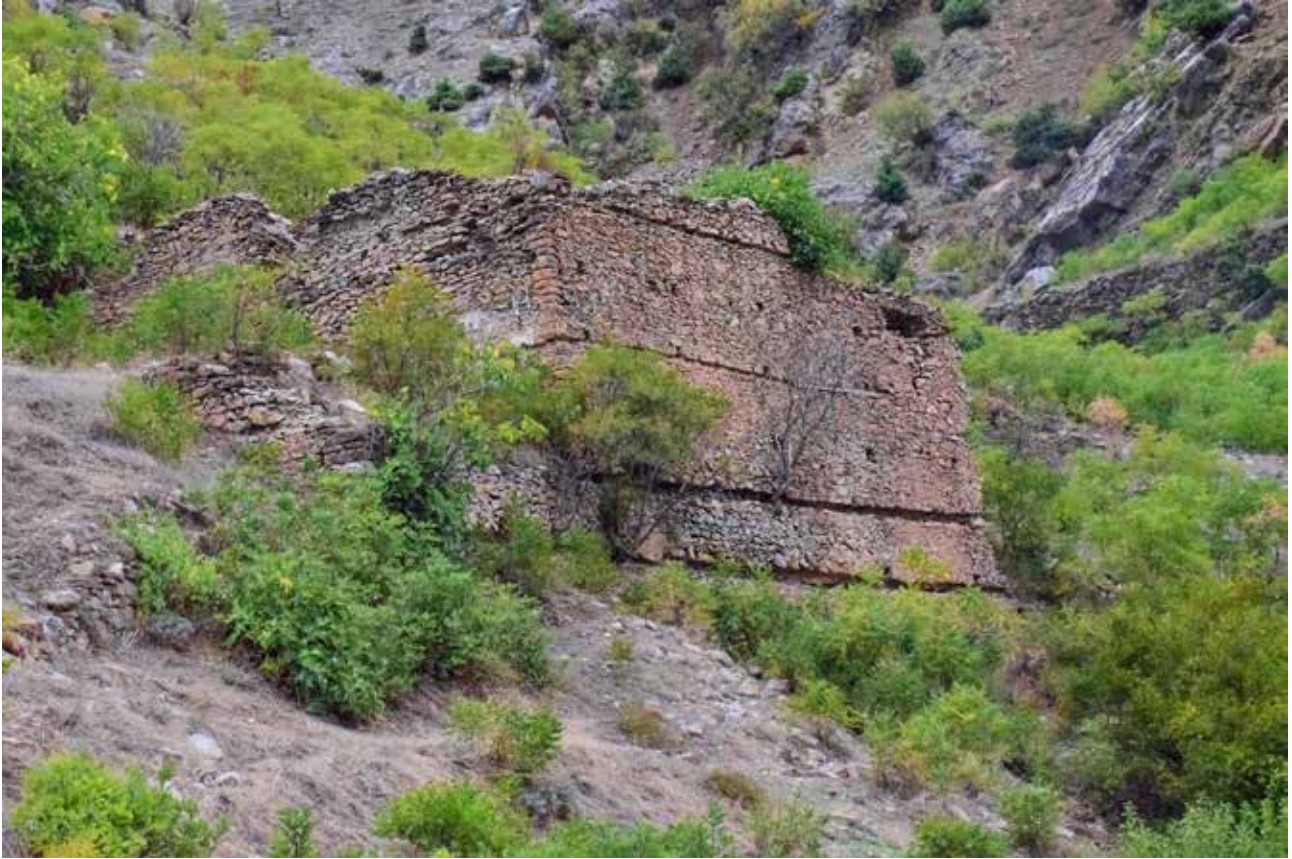
The bathhouse is abandoned, unprotected and unused today. It is about 2 km from the village road and is accessible by foot through the natural surroundings. There is only a signpost on the village road that gives the name and direction of the building, but no further information. It attracts few visitors and none who didn't have previous knowledge of it. The other upper structure and vaults have collapsed, leaving the building open to all kinds of damage from rain and wind. The interior floor of the building has been filled with soil and debris from the collapsing vaults and walls and overgrown trees. There are no doors in the doorways, and other entrances have been broken through the walls, leaving the building open to vandalism. There are indications of vandalism in the building, such as enlarged holes in walls and the removal of all timber tie beams close to ground level. The remaining walls have structural problems ranging from cracks, loss of mortar in joints, surface deterioration of the stones as well as vegetation growth. Some trees have broken through the walls and kept growing, further

damaging what remains of the architectural fabric. There remain no decorative details, inscriptions or ornamentation. The few remains of plastering on the interior of the building are threatened with flaking off, due to direct contact with rain, wind and frost.

The building fabric is in very poor condition, and needs immediate consolidation in order to survive until any detailed conservation project is undertaken.

An archaeological excavation inside the monument and in its surrounding will reveal more information and possibly the foundations of lost parts such as the reservoir. This excavation must naturally be accompanied by a detailed architectural history study. The bathhouse, being an example of a traditional and communal means of living, will be of interest to visitors as a remnant of the historic character of the village. Considering the touristic value, it should also be labelled in the interior with information panel on the different functions of the rooms.

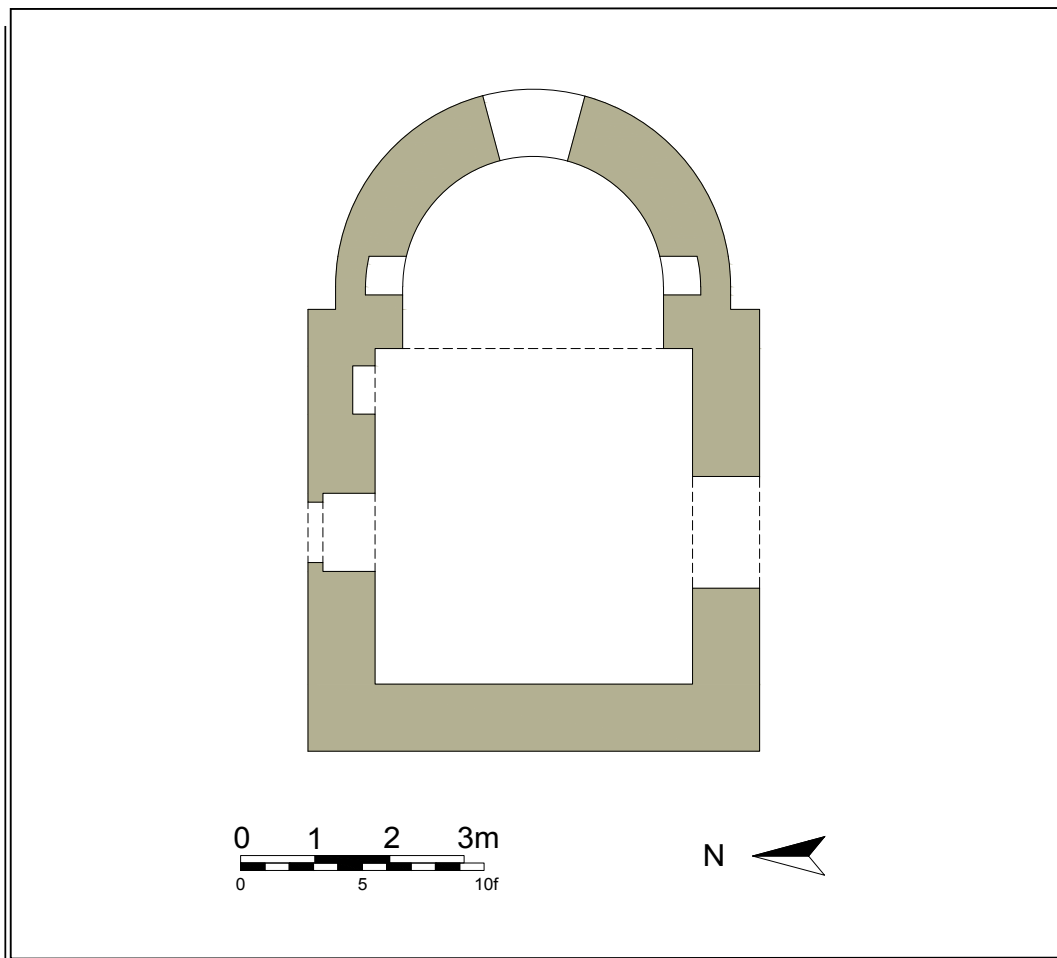
In the interior tall cacti and other plants have grown, with ground filled with bad soil. Due to this fill, the building cannot be entered from the north wall. There are signs on the walls that fires were lit in the interior. The roof is nearly completely demolished and due to water entering, the remaining walls have high degree of efflorescence. There are many cracks in the walls. On the floor of the church is a decorated stone, most probably a baptismal font.

In the last 50-60 years new village houses have been built around it. Reused stones probably taken from the church are observed in these buildings and their garden walls.

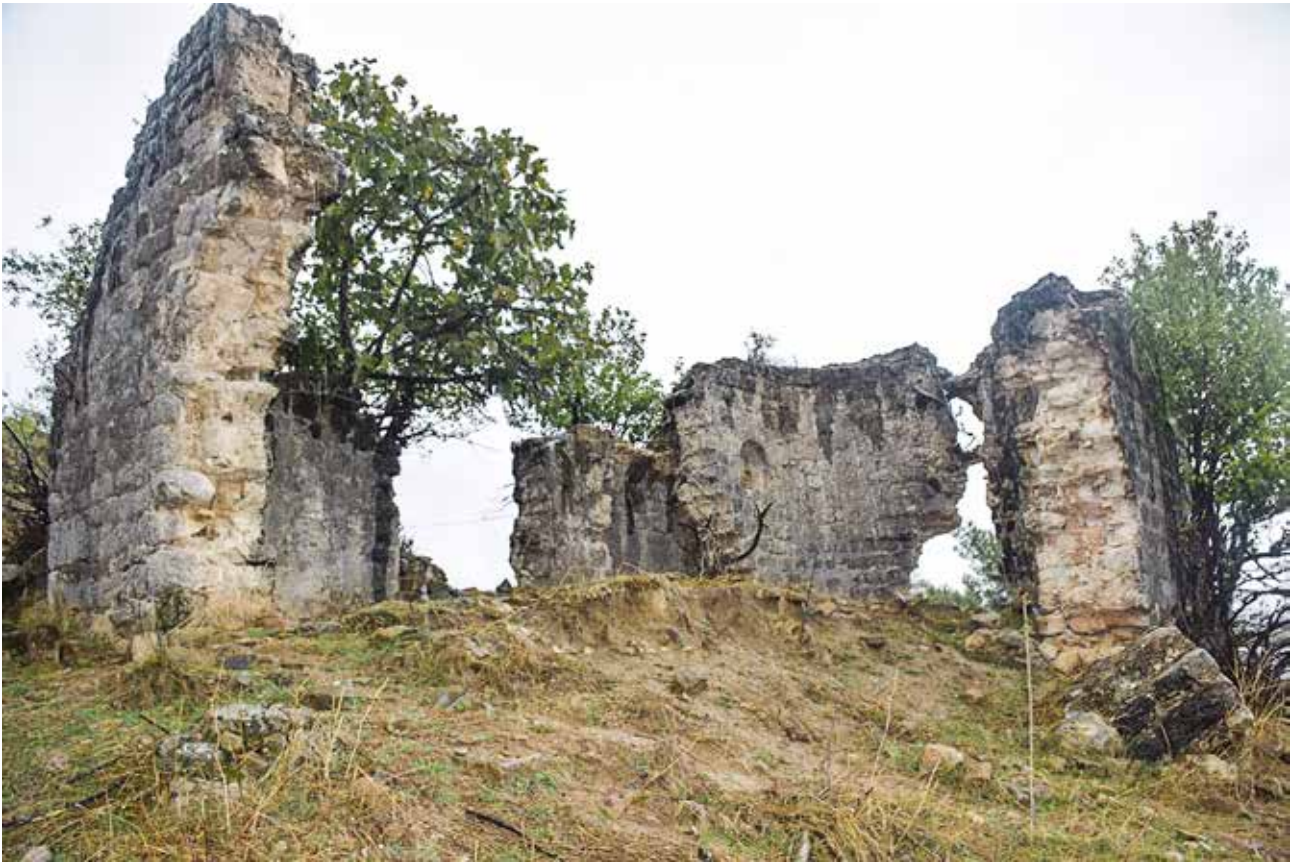
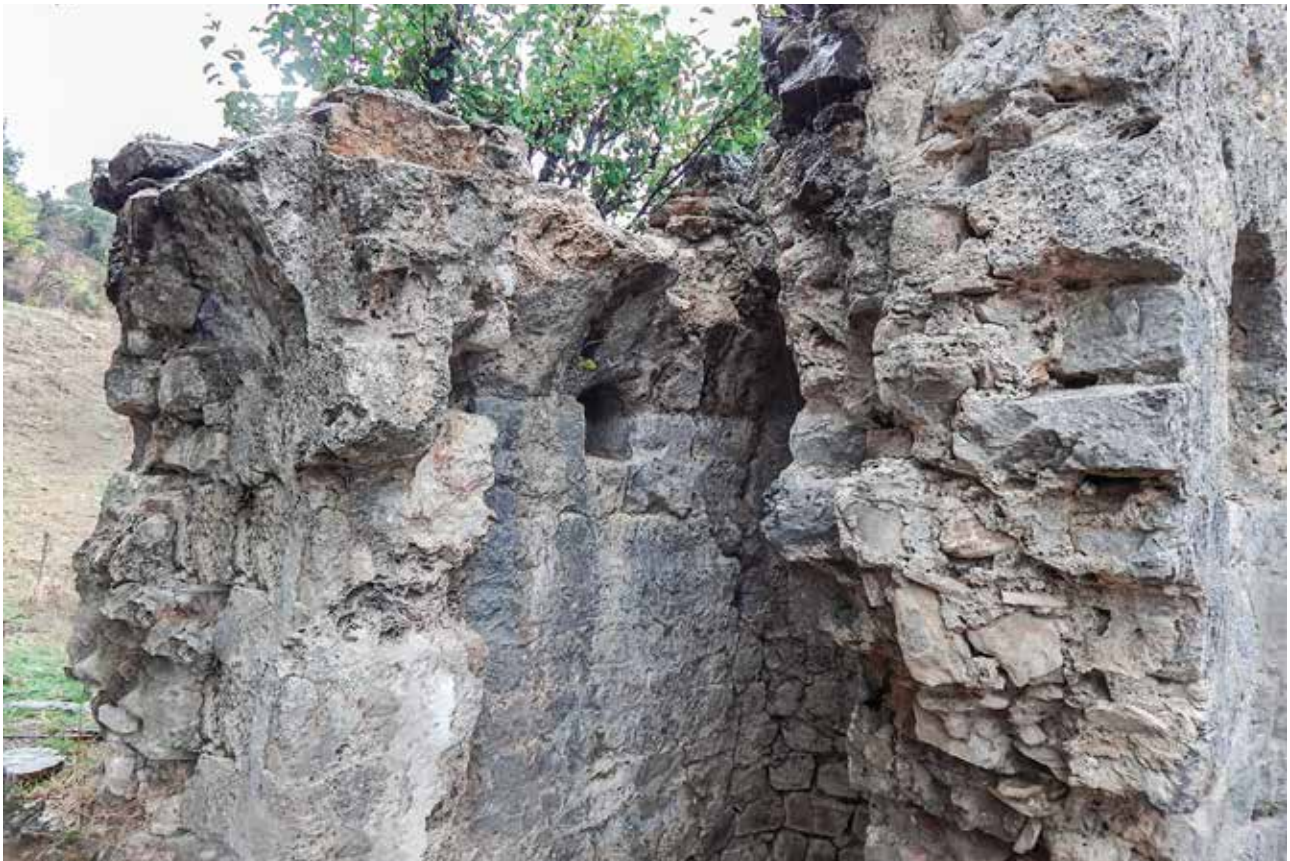
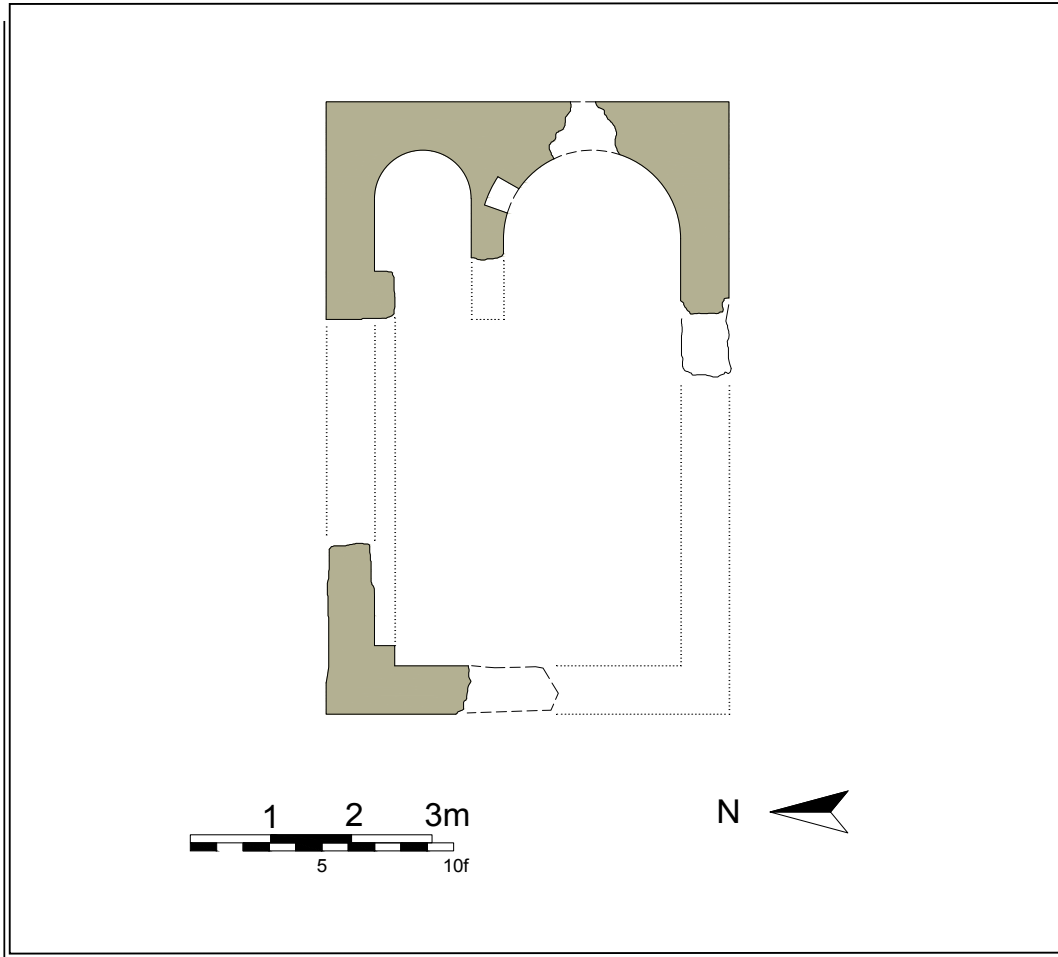
The structure is in ruins, probably the thin loamy soil in the foundations, plant cover, earthquakes and human intervention have caused the structure to be demolished. A large portion of the chapel walls are destroyed, with the eastern section, apse, sacristy, north and northwest walls partially preserved. Only foundations are preserved in some sections of the east and northwest walls and in the south. The stones in the lower rows of the apse dome are preserved, with the upper cover of the structure completely demolished.

The dense plant cover on the walls has opened many cracks; there are vertical and diagonal cracks in the extant walls. The west wall with the main entrance to the church is mainly demolished, with landslides and road construction completely destroying the south wall. Stones from the missing sections are not observed in the area; probably villagers have taken them away for use in other structures.

The church requires emergency reinforcement as it is in ruins. Research is needed to determine the original layout of the church. Further, to obtain information about the whole church, internal and external excavations should be completed. The plant cover surrounding the structure should be cleared, reinforcement projects should be prepared and work related to preservation and landscaping is recommended. If no precautions are taken, the remaining walls will not stand for long.

It may be necessary to reinforce with steel construction to counteract the effect of earthquakes. It is necessary to clear the plants covering the walls, fill cracks, restore mortar in the walls and protect from rain and snow damage.

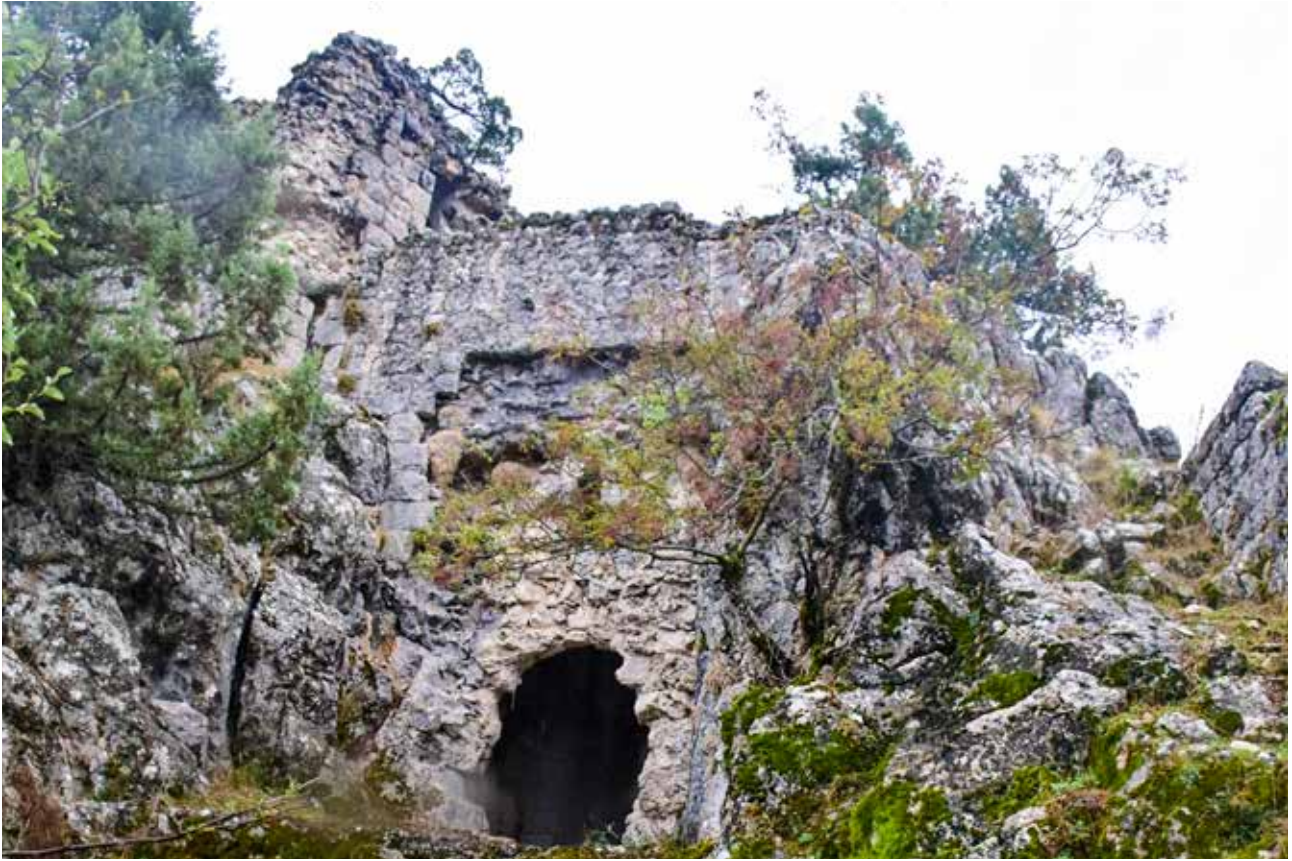
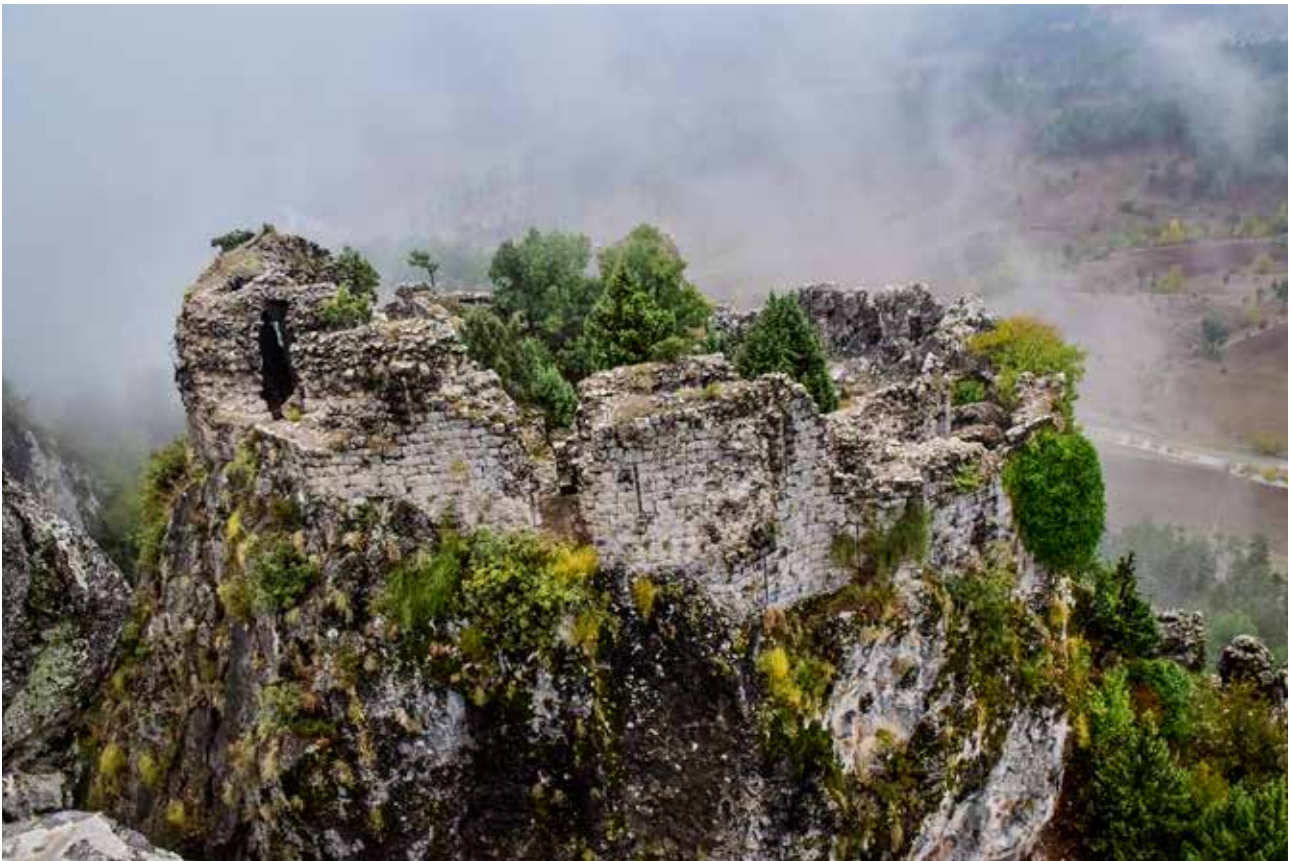
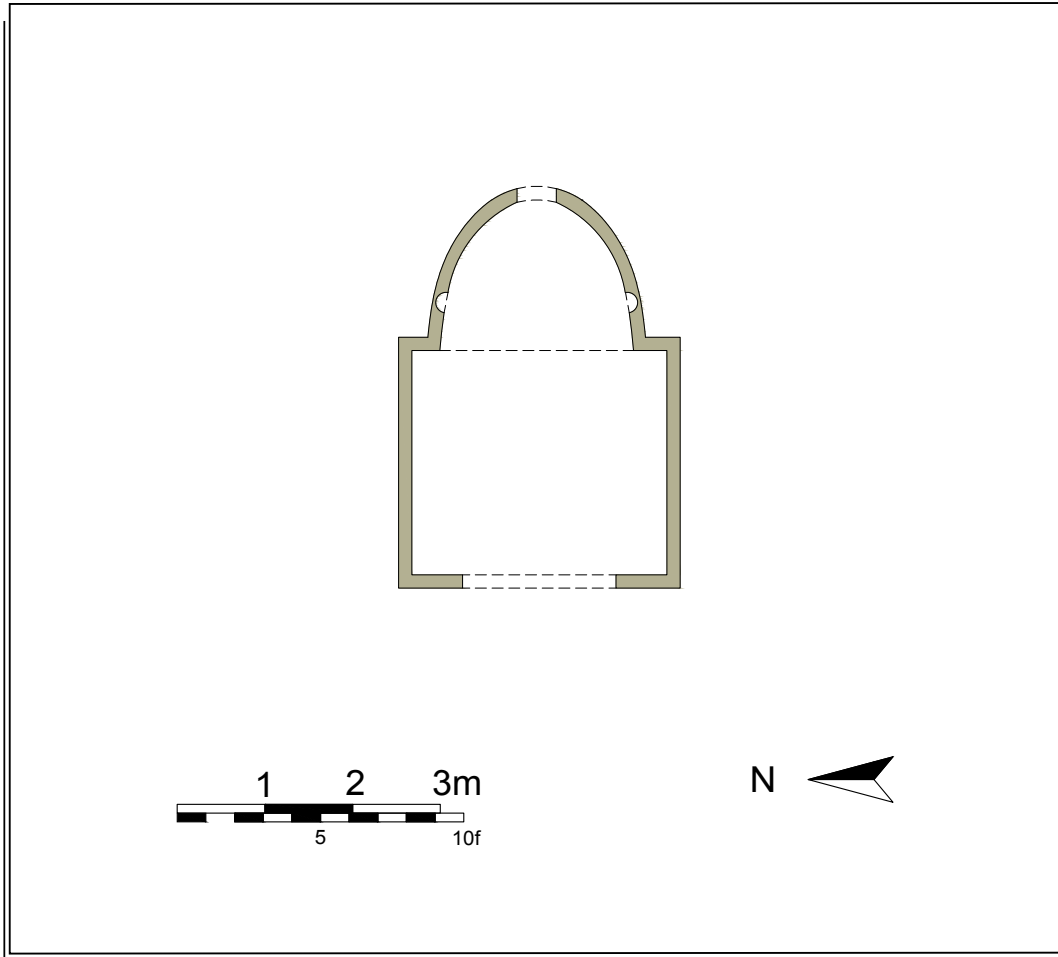
The fortress and chapel are in ruins. Access is difficult and dangerous. The upper sections of the walls and the wooden floor covering of their adjoining buildings are damaged. The causes of the damage are natural water and plant cover. There is no information panel and no preservation has yet been undertaken.

The main walls of the fortress are open to the natural conditions and are at risk of decomposition due to the effects of water and plant roots among the stones.

Clearing plant cover from the body and upper surfaces of the walls, repointing with original material and also general clearing of the ground level and filling of cavities in the foundations of the walls with compatible material will be beneficial.

It is recommended that the plant cover that damages the structure be cleared from the ground level and from the architectural elements; and archaeological excavations be completed to determine the characteristics

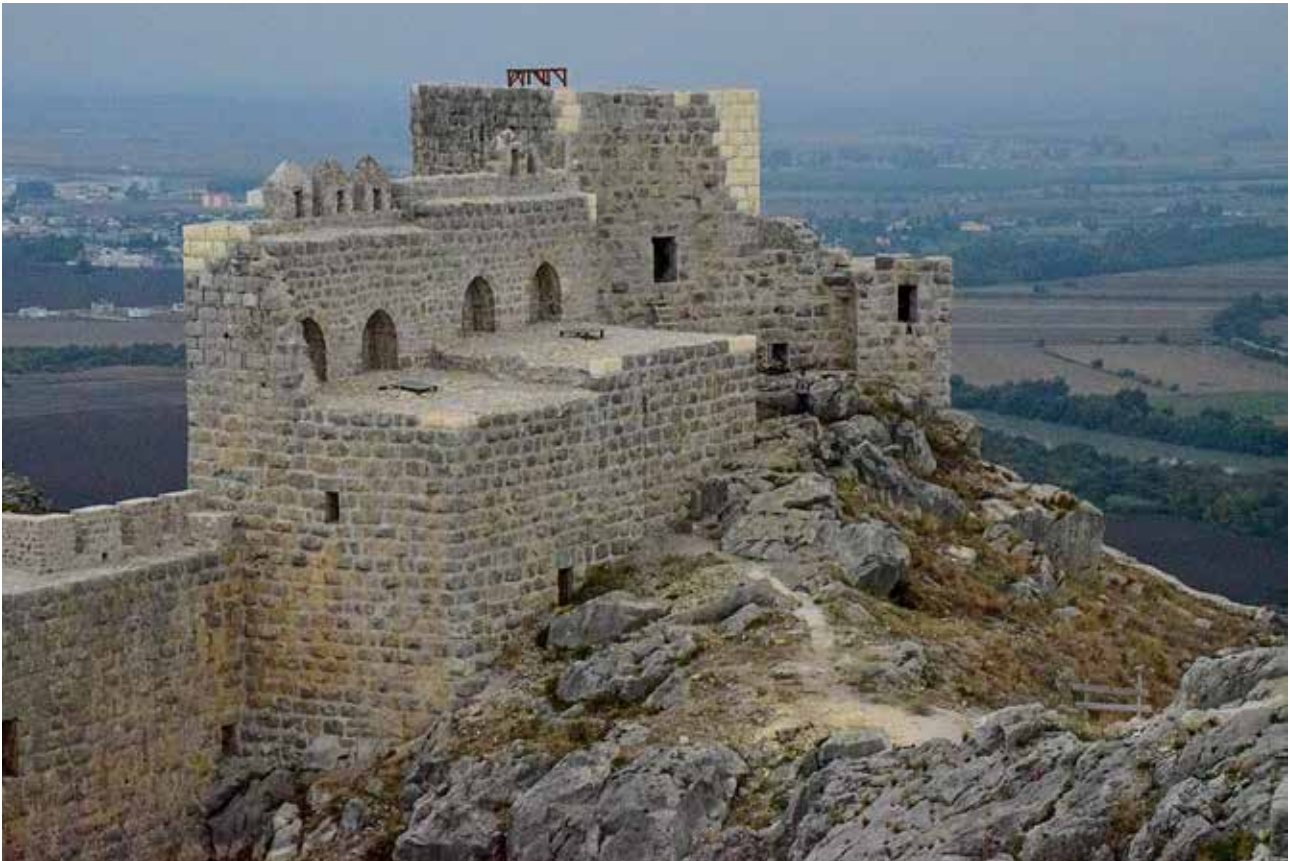
of the adjoining structures damaged. There is no plaster on the outer walls. Generally the mortar of the main walls has lost its properties due to being open to the effects of water. There is vertical separation observed in some walls.

The sanctuary is in demolished ruins. The southwest walls and vaulted roof are

demolished. The walls in the remaining sections contain vertical and diagonal cracks. The pieces of the demolished building are found near the chapel. The cause of the destruction is probably earthquakes or explosions.

The writings and inscriptions are destroyed. The lion figure in the coat of arms of the Armenian Kingdom of Cilicia above the arch of the entrance gate has been damaged with the cross motif above the lintel scratched.

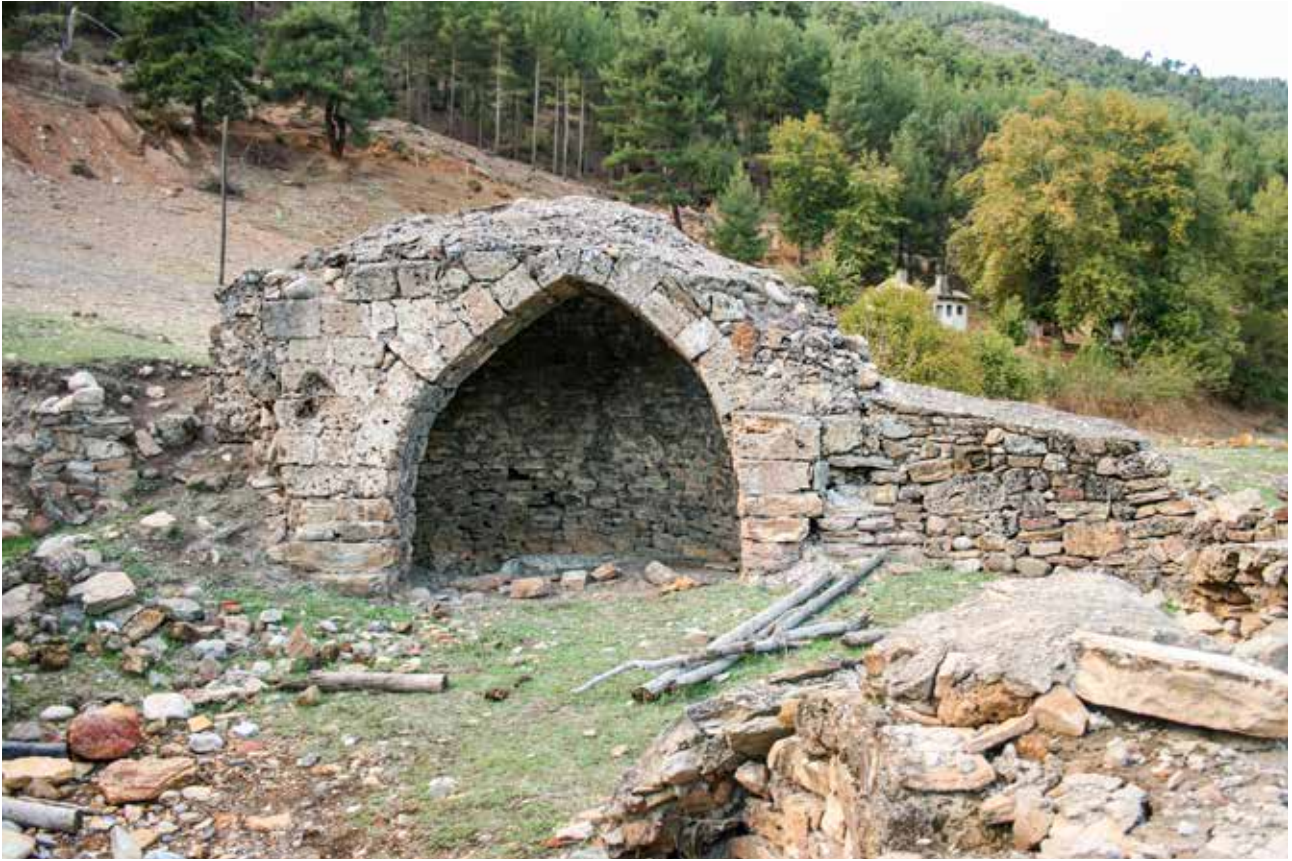
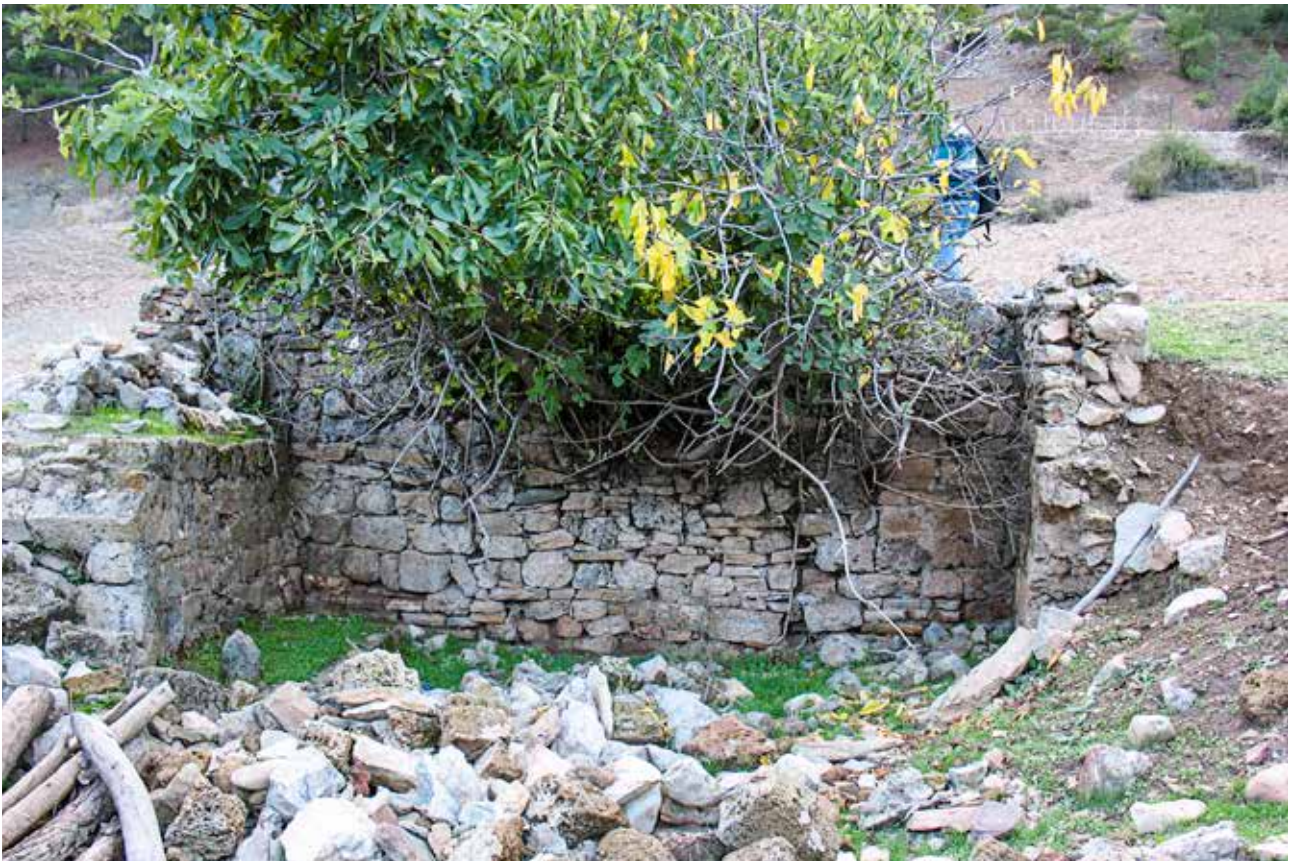
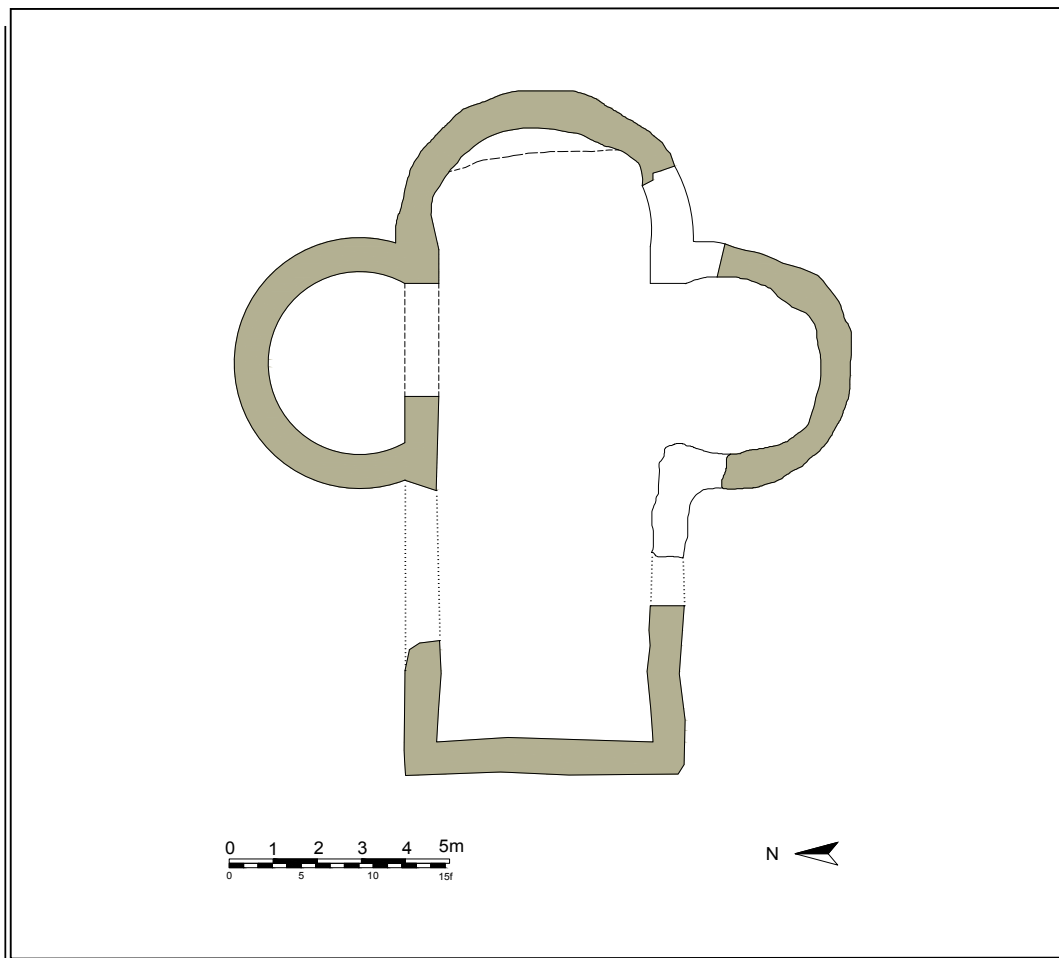
Most of the sections of the church are currently demolished with the entire walls only preserved to a height of 1.5-2 m; whereas, the west and north walls are in better condition. Plants have grown over the north wall. There is erosion on all facing stones of the walls. The upper structure is completely demolished.

The church and its surrounding can be cleared after excavations and its original form can be identified. As there is not sufficient information on its original form, it is recommended that the remains of the church should be reinforced and preserved instead of restoring the building. Additionally, direction and information panels can be placed in the area.

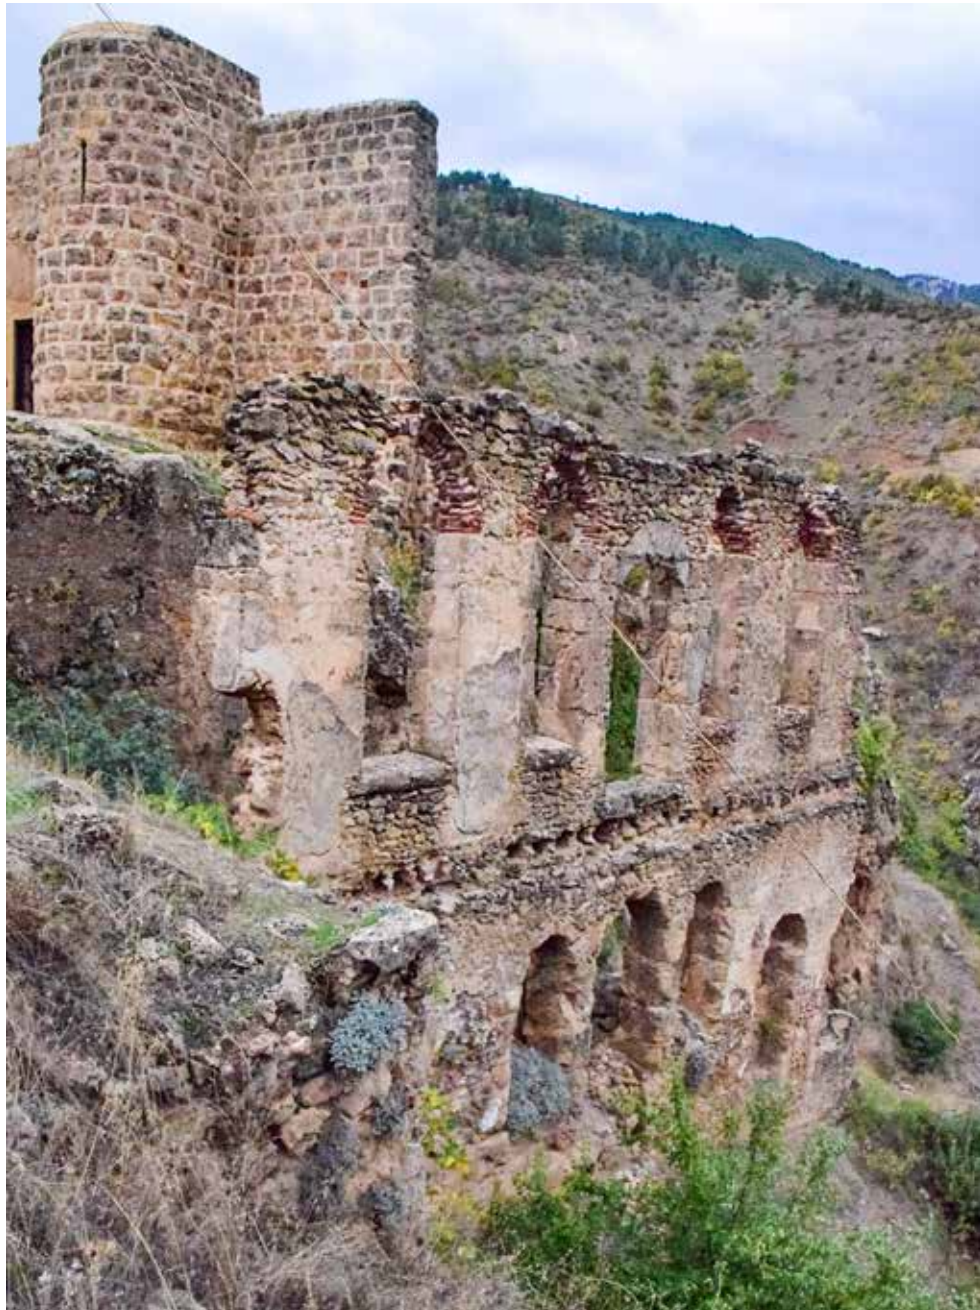
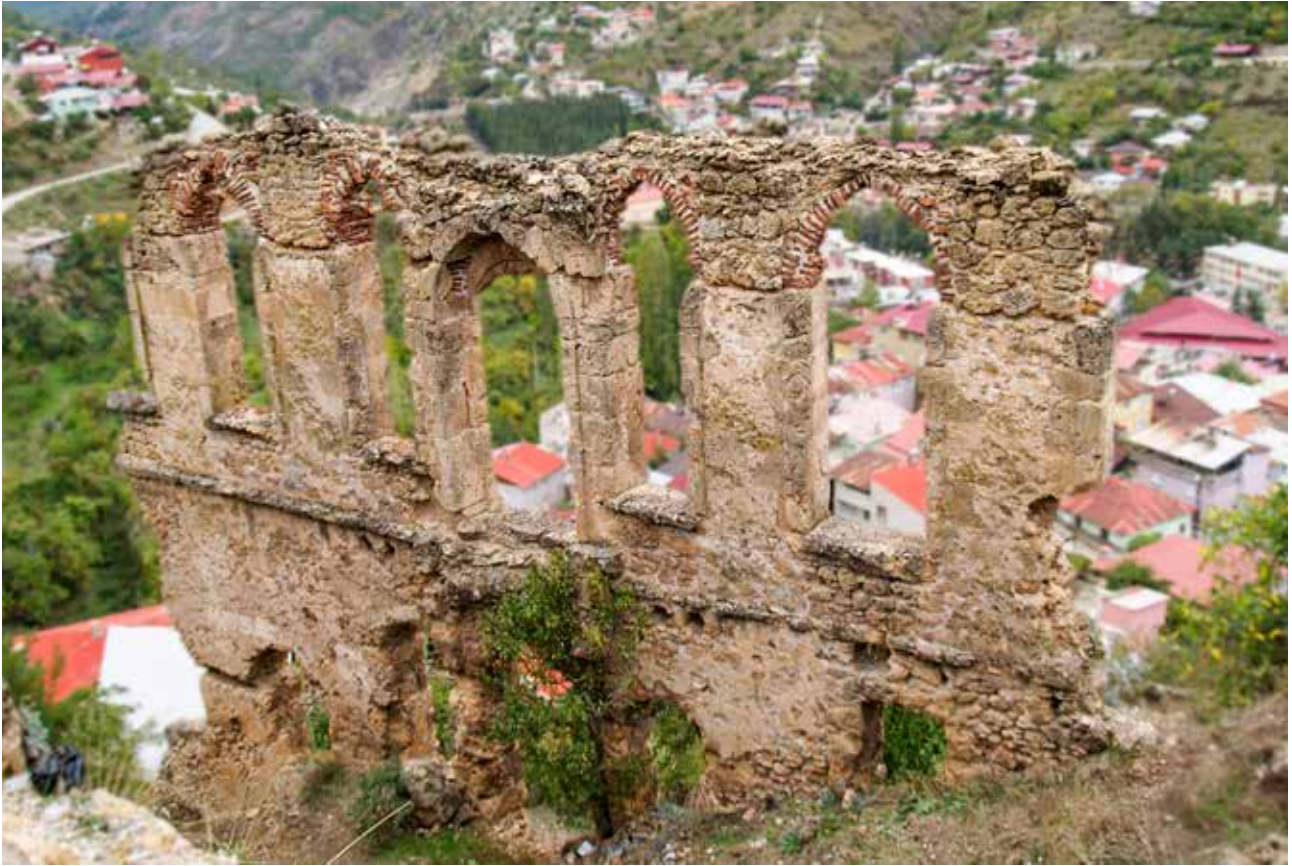
Only one heavily ruined wall of the building stands today at the western slope of the citadel. The plan of the building cannot be read at its current state. It is abandoned and unprotected. There is no signpost from the village road or information panel on the site. It attracts few

visitors and none who didn't have any previous knowledge of it. However its proximity to the Saimbeyli Fortress naturally makes the building visible and accessible for the visitors to the fortress.

The remaining wall has structural problems including being unsupported from both sides, having cracks, loss of mortar joints, surface deterioration in the stones as well as vegetation growth. The remaining plastering on the interior of the building are threatened with flaking off, due to direct contact with rain, wind and frost.
