Adana

## ADANA SITE ASSESSMENT VISIT

Dates: October 21-28, 2015

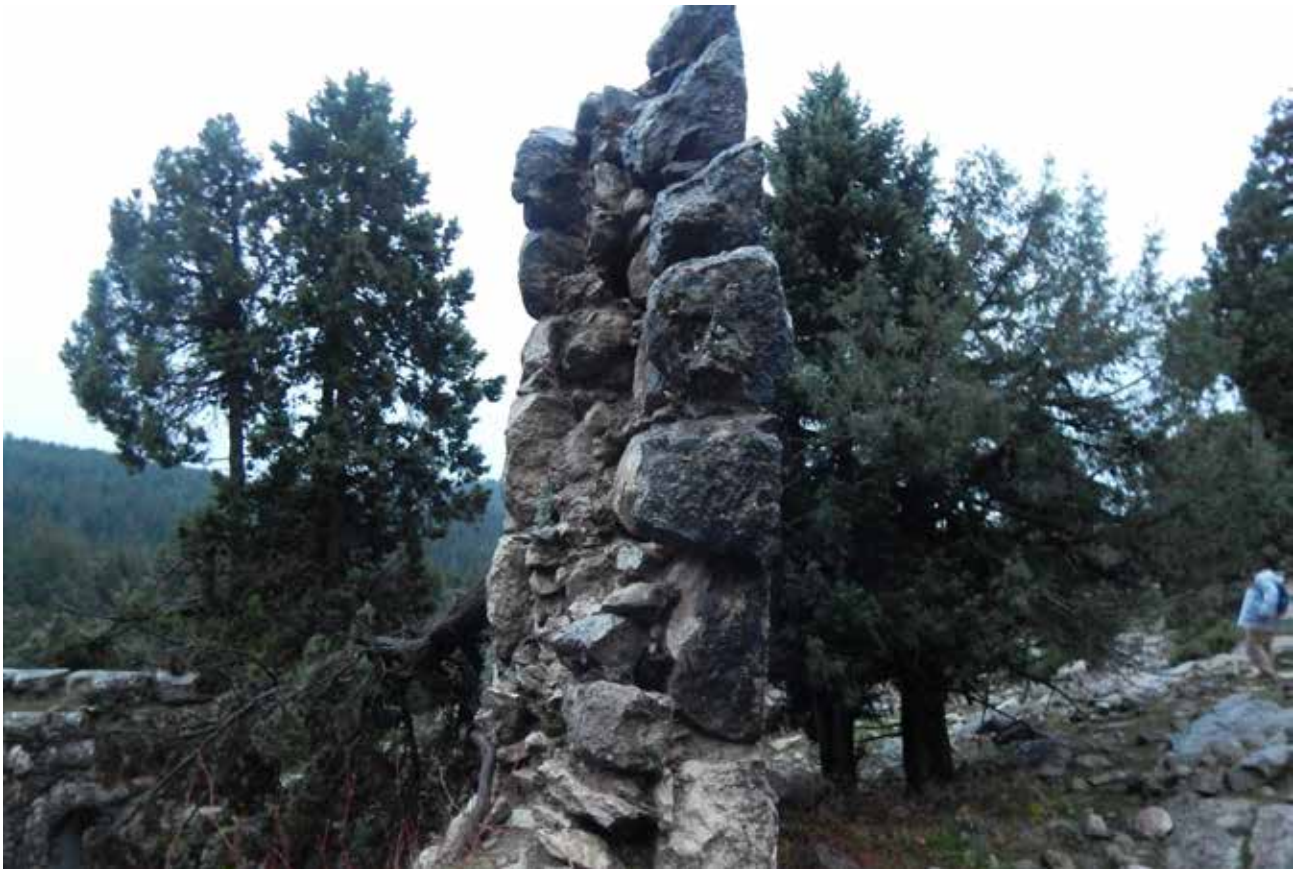
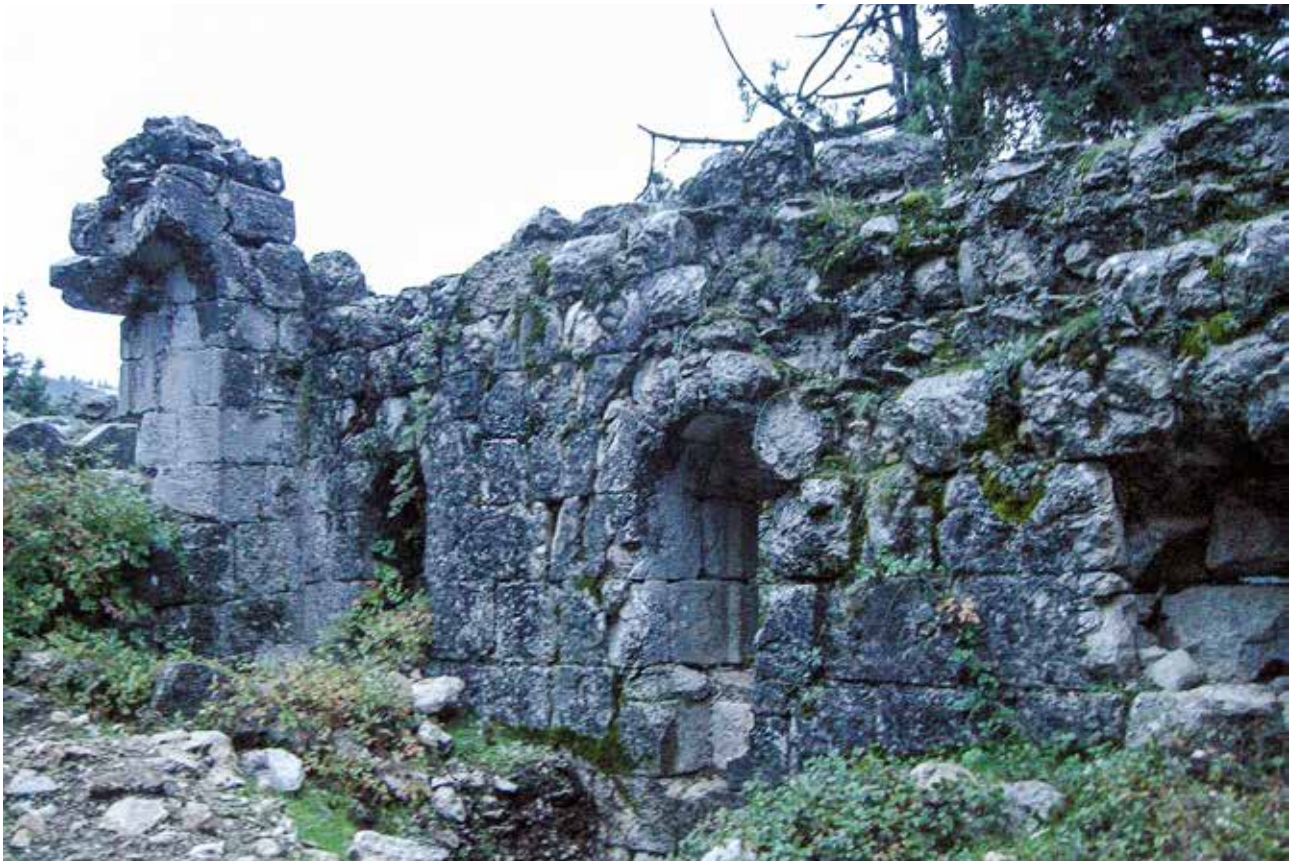
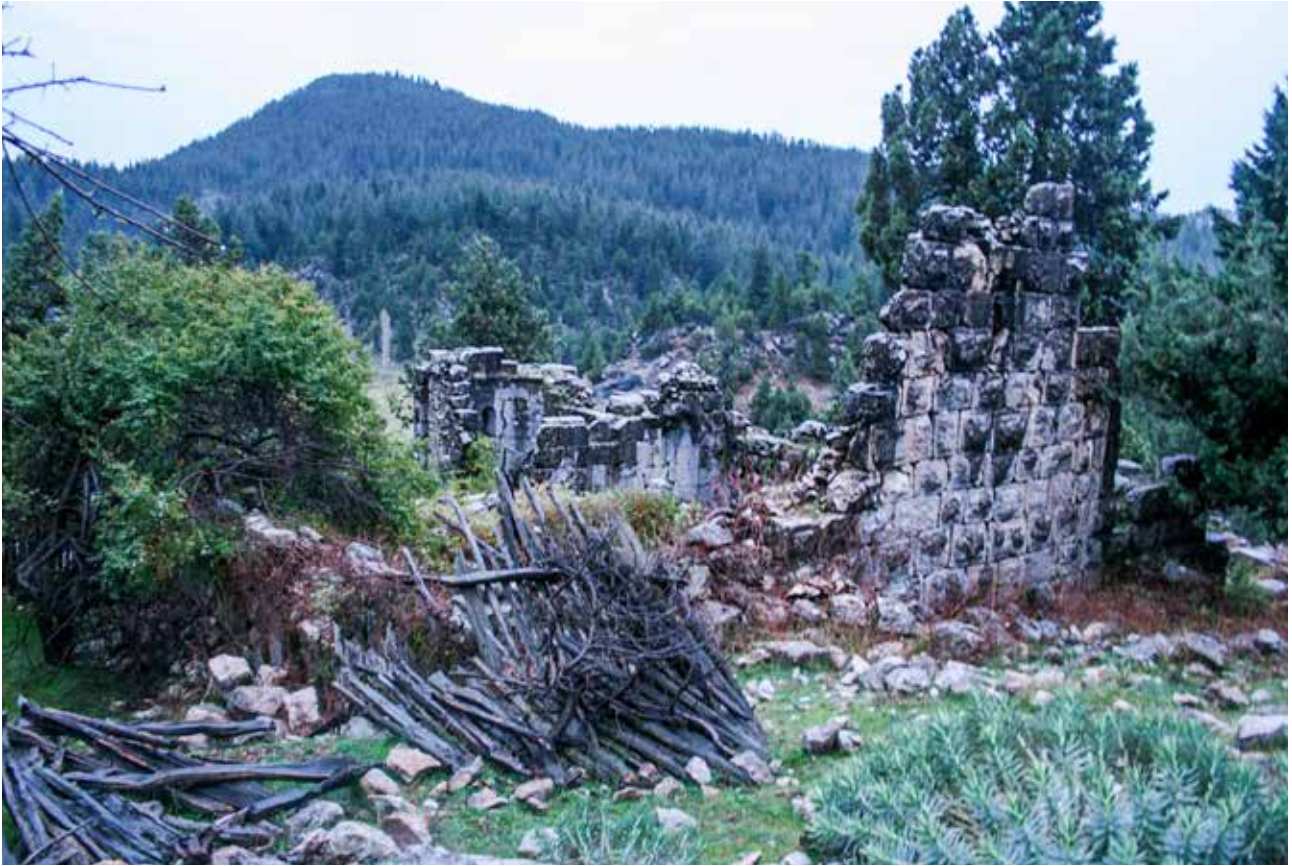
The first floor of the large hall is still standing, apart from the center of the east wall. The second floor is only preserved in the center of the west wall. As the completely ruined church is in a forestry area at present, with difficult access, it is difficult to carry out documentation and accurate measuring and identify architectural characteristics.

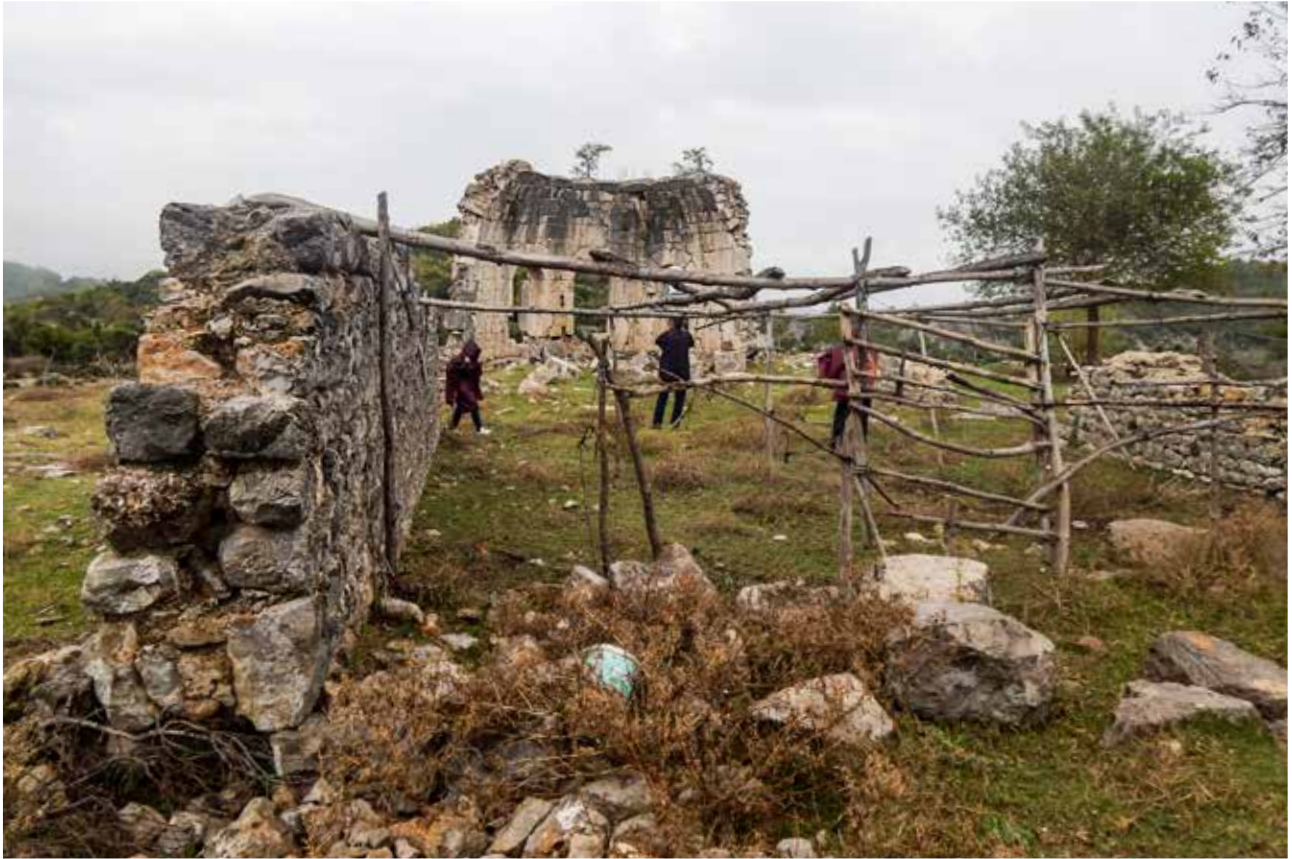
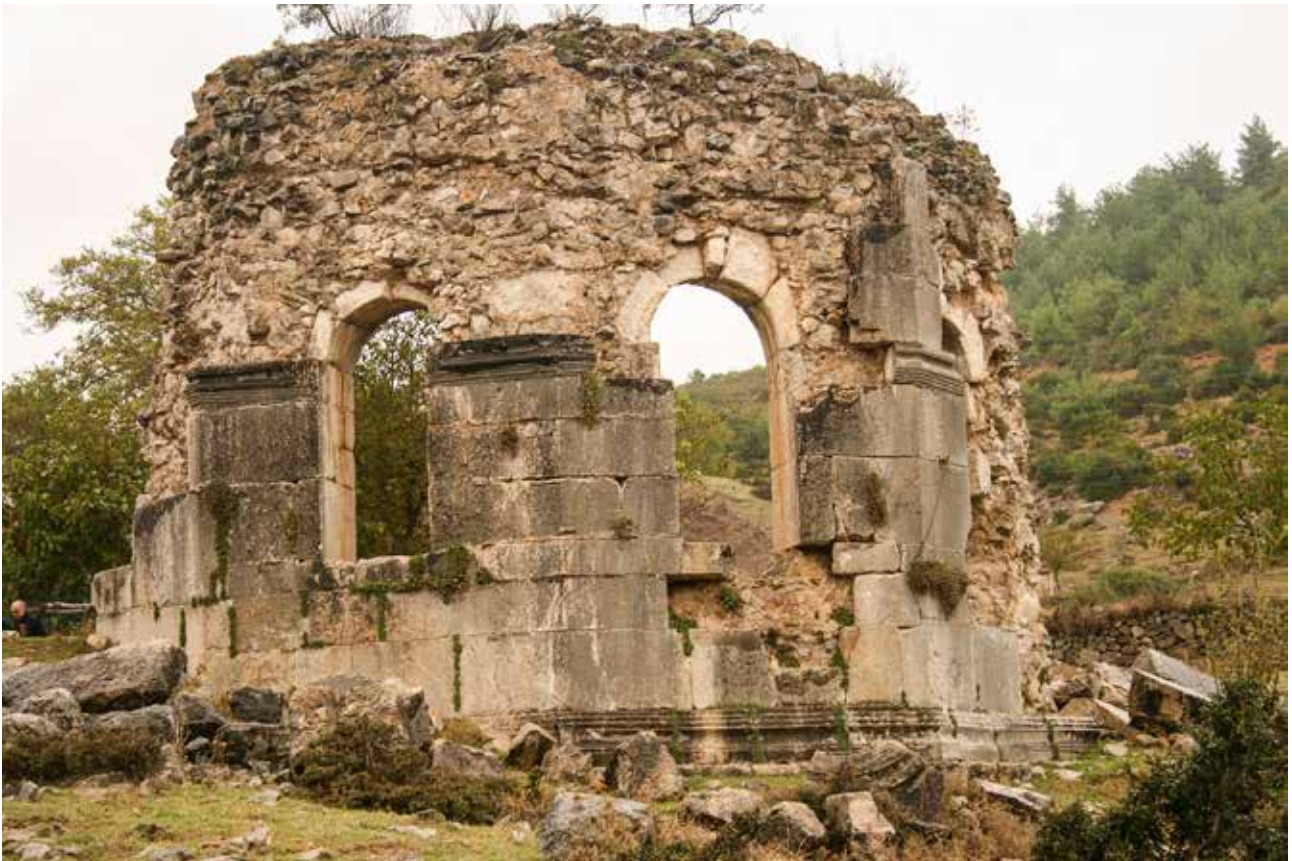
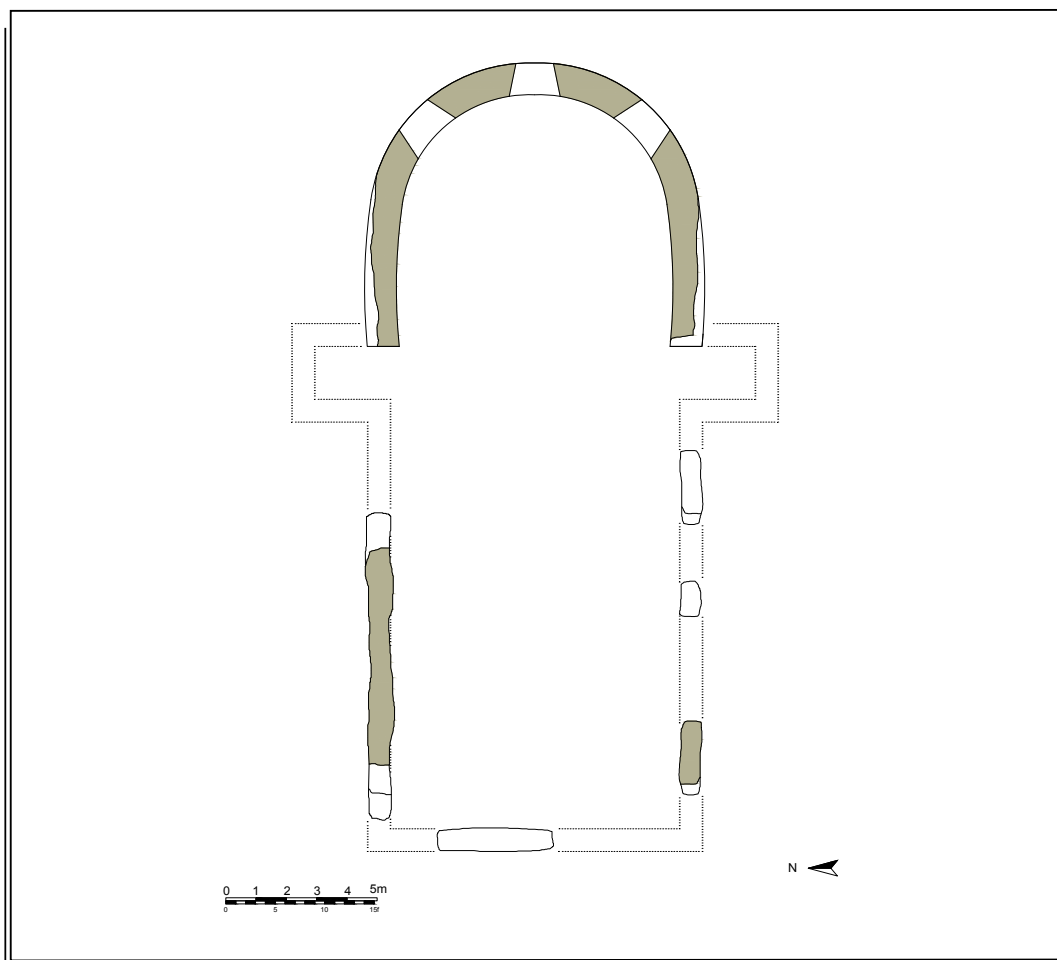
The western façade is completely demolished. The stone cladding of the western, northern and southern façade of the main walls of the structure has fallen off, and only a few remnants are visible.
