Izmir

## IZMIR SITE ASSESSMENT VISIT

Dates: January 21-24, 2016

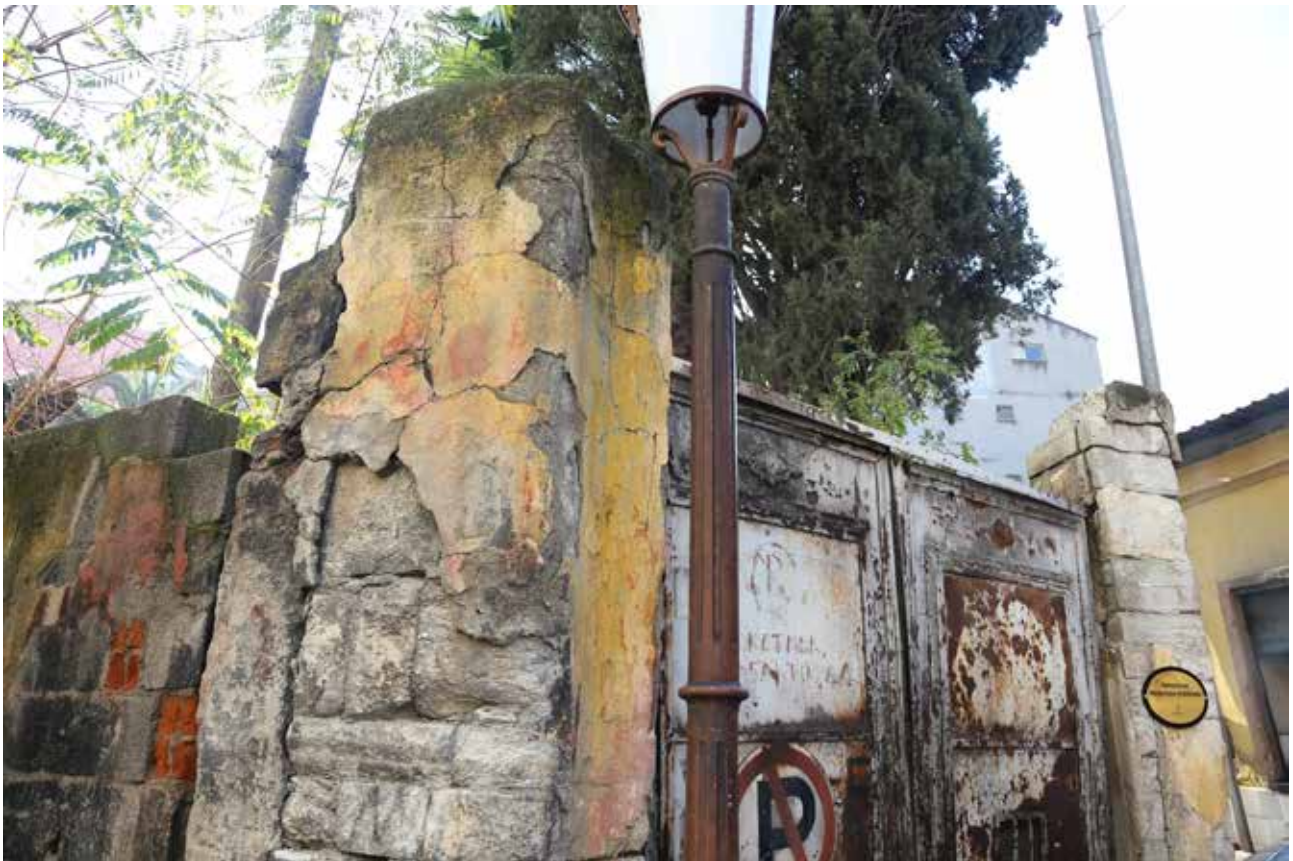
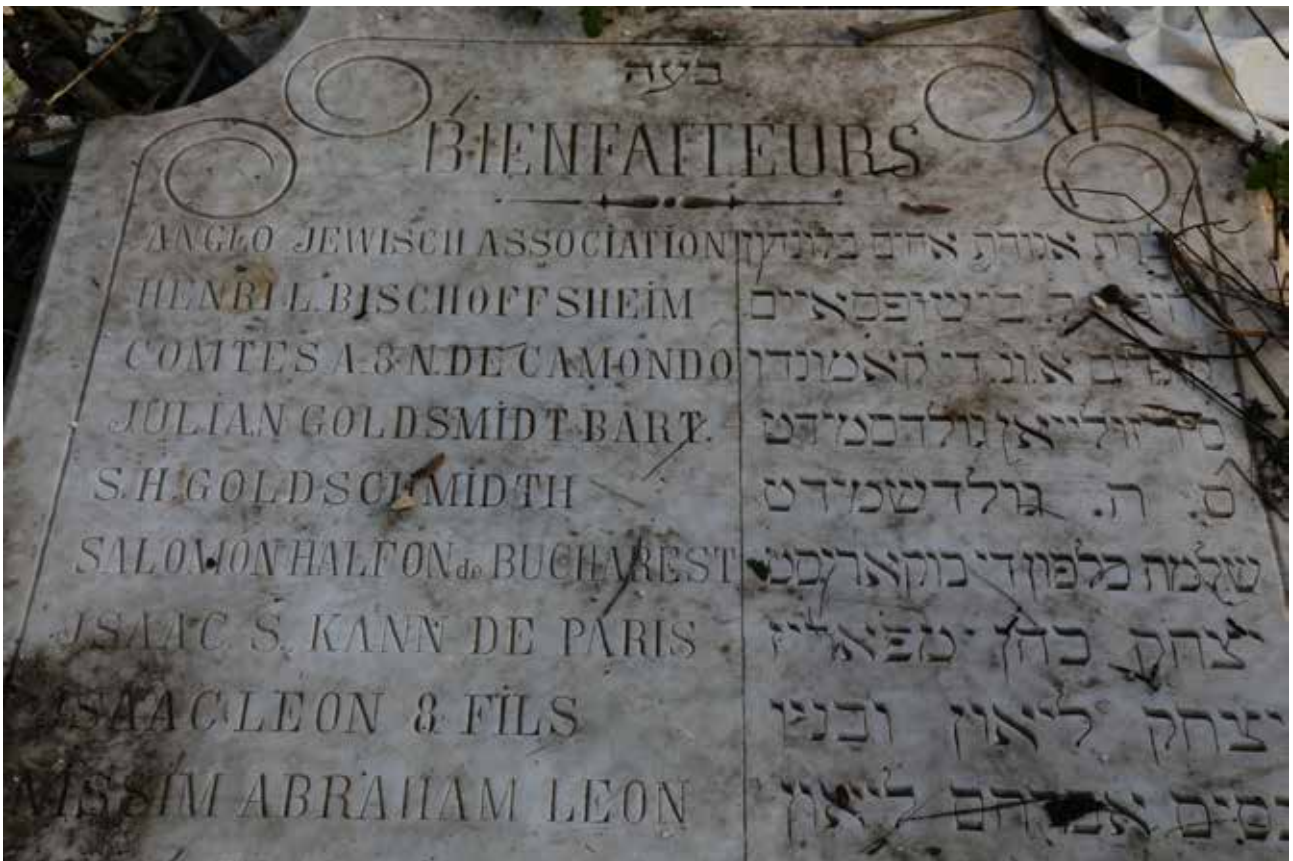
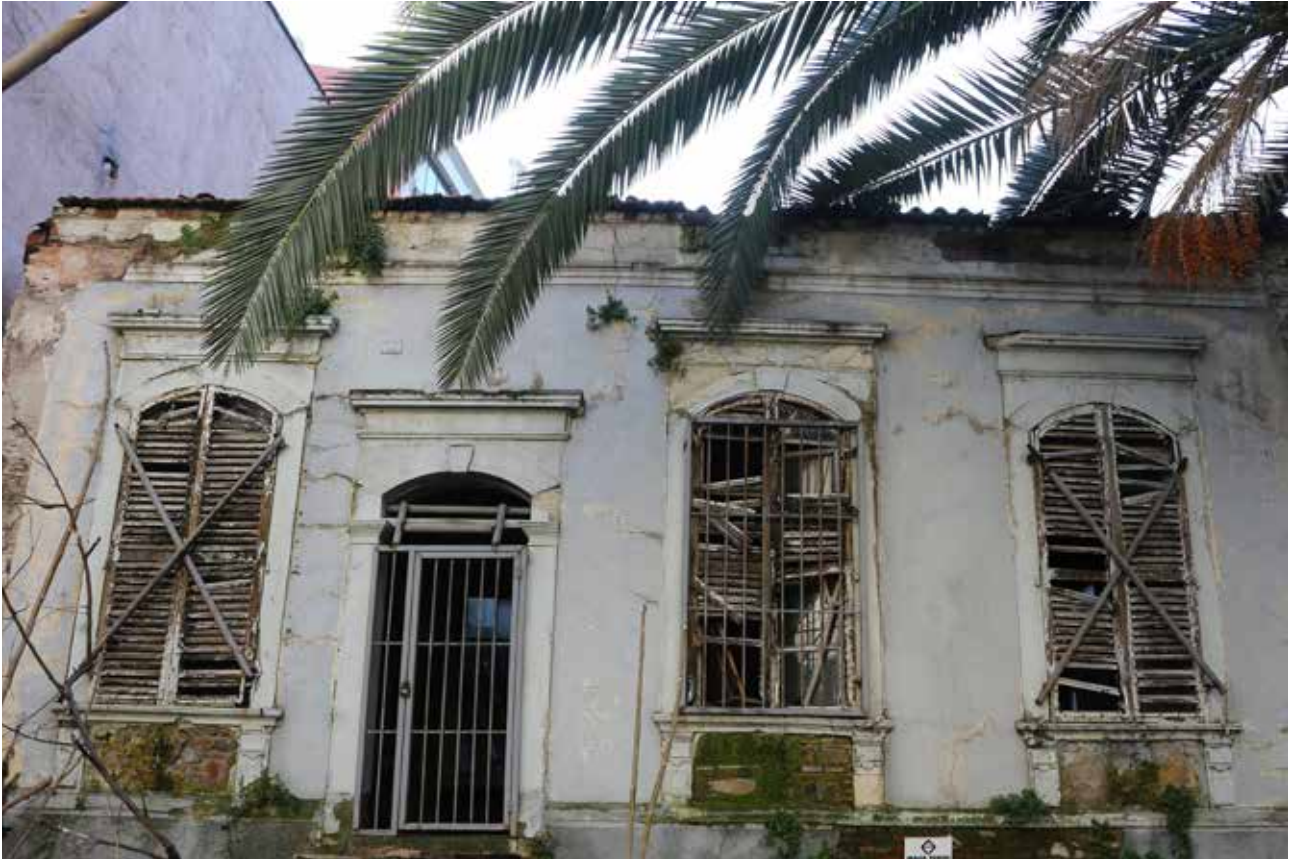
The yard is filled with wooden debris of the collapsed sections of the structure including the roof framing. The entire flooring connecting the main entrance to the areas behind has collapsed making it impossible to walk inside. The masonry parts of the external walls have collapsed in certain places and profiled roof moldings are partially preserved. The structure has preserved its original characteristics and is ready for surveying and recording studies.

The structure is under clear risk of being lost and of looting of available construction material due to both structural situation and being exposed to the elements. The lot on which the building stands is surrounded by encircling walls, but is easily accessed through a sheet metal door and walls contain holes at places. As the roof of the building has completely collapsed and nearly the whole internal space is open, it is exposed to wind and rain damage.

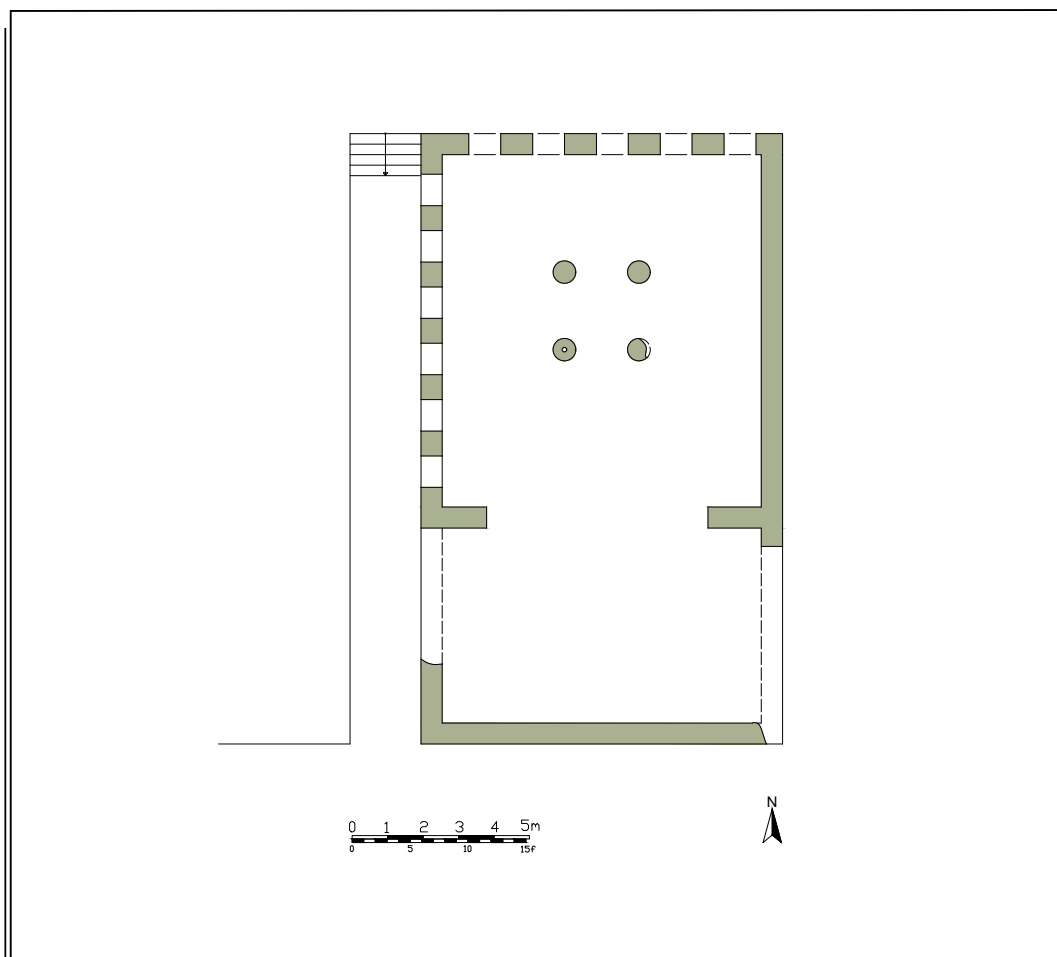
The walls along the slope on the south, north and west façades of the building are still standing with two vaulted cellar chambers at their lower levels. The cellar in the west has semi-circular brick arch, while the cellar in the east has a semi-circular arch of fine-cut stone. Though not accessible, the dimensions of the inner space of the cellars can be identified using

a torch. Additionally, on the north wall, there are four windows with still visible semi-circular arches.

The site, has been within a residential area throughout history, is today like a slum area which has allowed for the rapid deterioration of the structure. The structure should be cleared of rubble and other debris, to reveal the level of synagogue's original floor. This debris has caused a large heap over years, severely damaging the building. It is appropriate to secure the site, clean the structure and place an information panel explaining the history and significance of the synagogue.

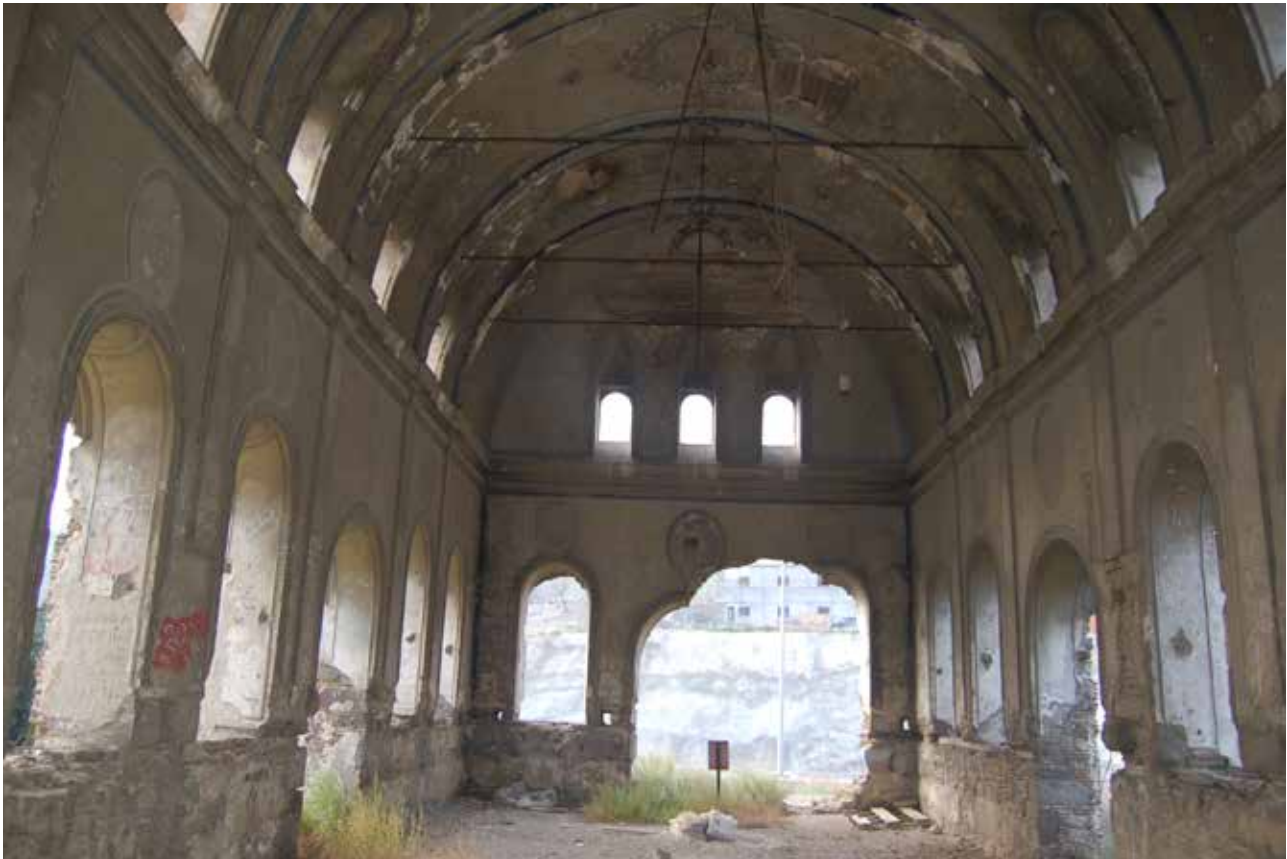
*Church of Prophet Elijah  
Konak county, Aziziye neighborhood*

The structure is entirely abandoned today. The major alteration the church suffered is the complete disappearance of the narthex and parcellions, while the naos stands with its walls and the interior decoration in a comparatively good condition. The original flooring has disappeared and is presently covered with dirt, and the roofing is partly inlaid with earth and turf, as is the former conical roof of the apse. Many of the iron trusses spanning the supporting arches of the barrel vault are lost: five of them entirely missing in the lower row, and one in the upper row; the loss endangers the vault's

structural solidity. The western façade (the former narthex wall) is partly demolished due to the collapse of the entrance and the window opening to its left; only part of the rectangular molding survives. Doors and windows are wide open and original joinery has been destroyed. Material deterioration is more pronounced than the structural problems of the building.

Given the 2011 architectural restoration study, a detailed structural consolidation project should be carried out. Until a restoration project addressing both the architectural and structural problems of the building is put into effect, immediate rescue measures are necessary to protect the structure from further damage of its elements. Excavation works

should be conducted to survey and document the traces of the lost parts –the narthex and the parecclesions– and consolidation works necessary for their maintenance should be undertaken.

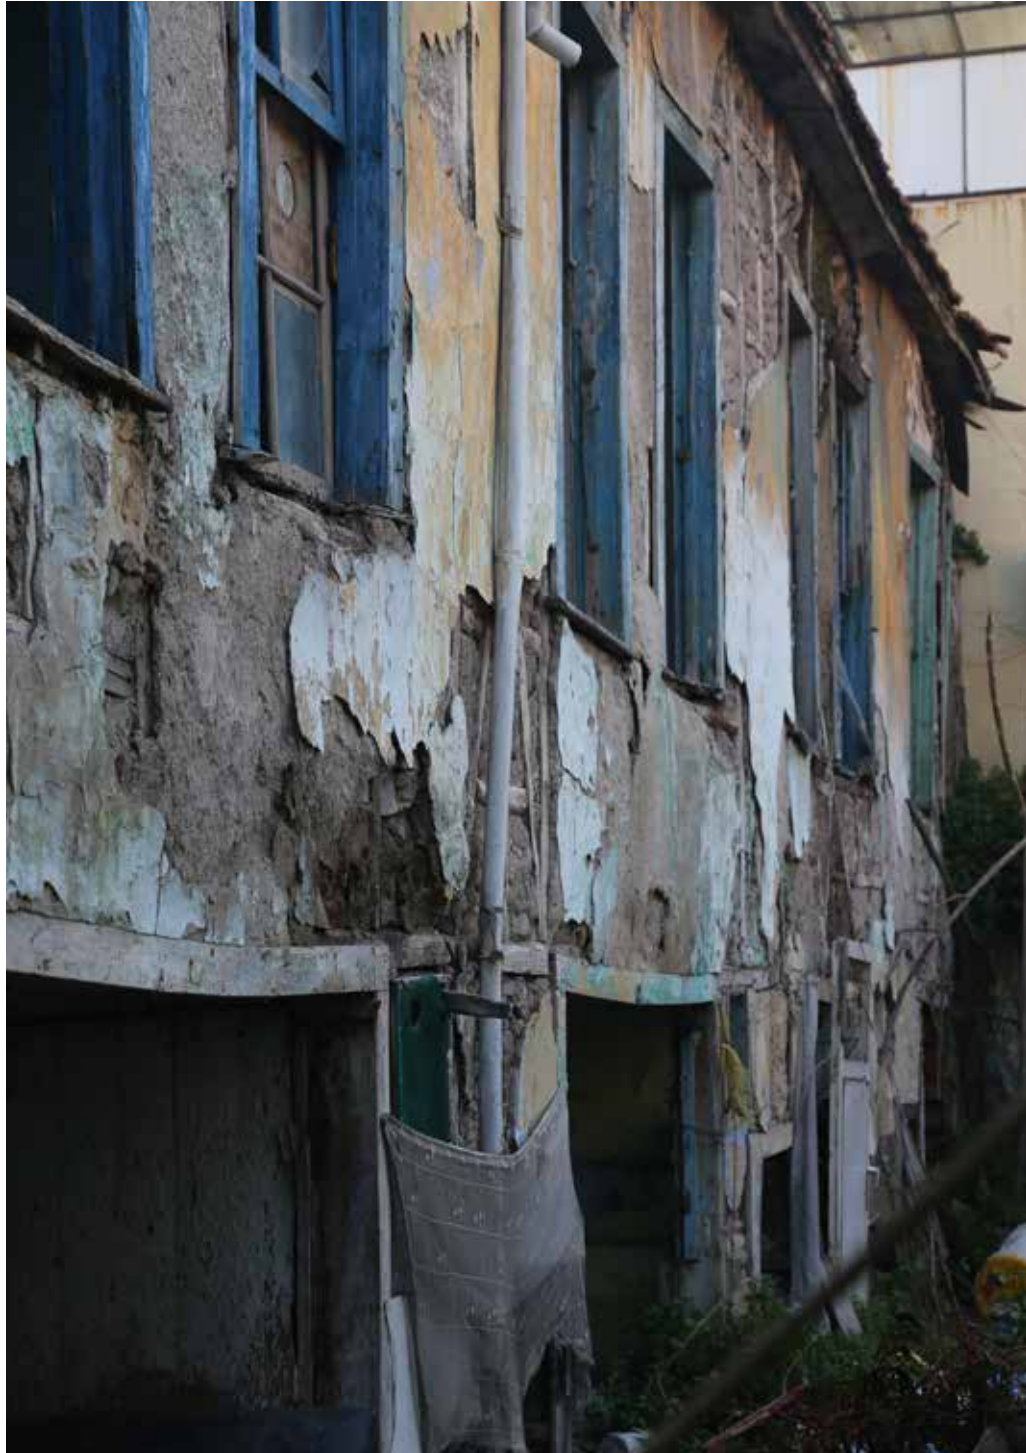
*Cortijo structure no.3  
iç Sokak*

of new development allow a structure with a height up to 6.80 m on the lot. Hence, this very significant and unique example of “organic development” type cortijo in Izmir will be demolished and replaced by a

new building with different form and function in the light of the new rules foreseen by the conservation development plan.
