Niğde

NIĞDE SITE ASSESSMENT VISIT

Dates: August 23-28, 2016

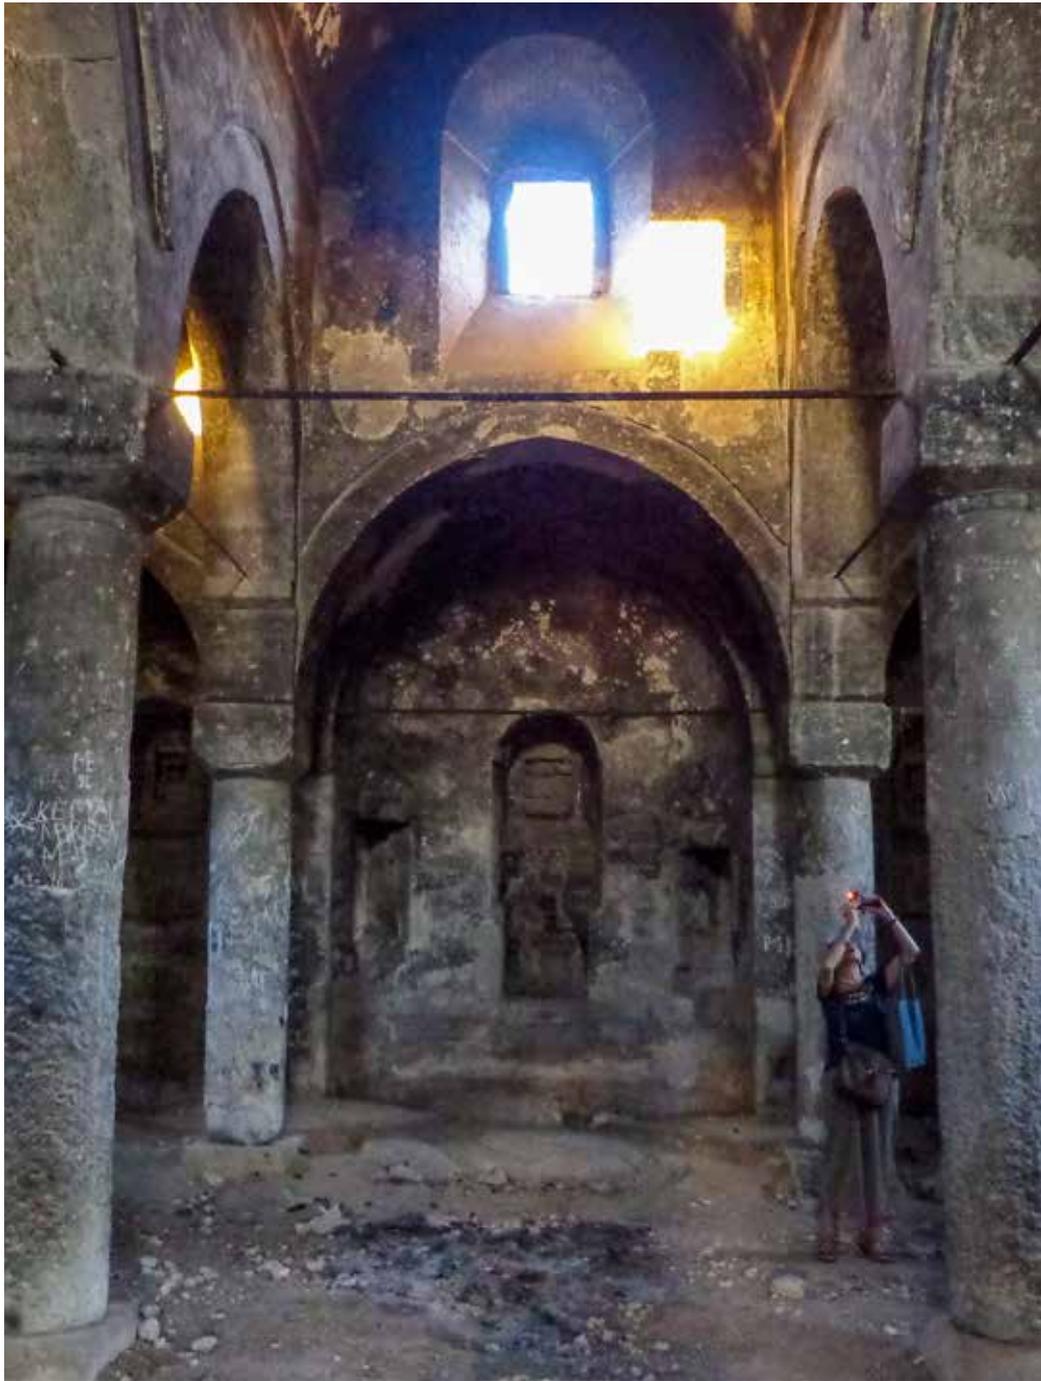
*Church of Saint George
Niğde Central county, Yeşilova village*

Vandalism is seen on the exterior façade as spray paint and as incisions on the frescos that have survived on the walls and columns in the interior. As with the window bars on the ground level, the tension rods between the columns have been cut out and stolen. Additionally, indications that fires have been lit are visible from soot on the interior walls and ceiling.

There is degradation of the stones on the external façade, occasional breakage of roof moldings and plant growth.

Due to the loss of parts of the roof, water has entered the structure and caused efflorescence in the vaults. Due to damp, all structural elements have been badly damaged; with plaster loss and disintegration of the frescos.

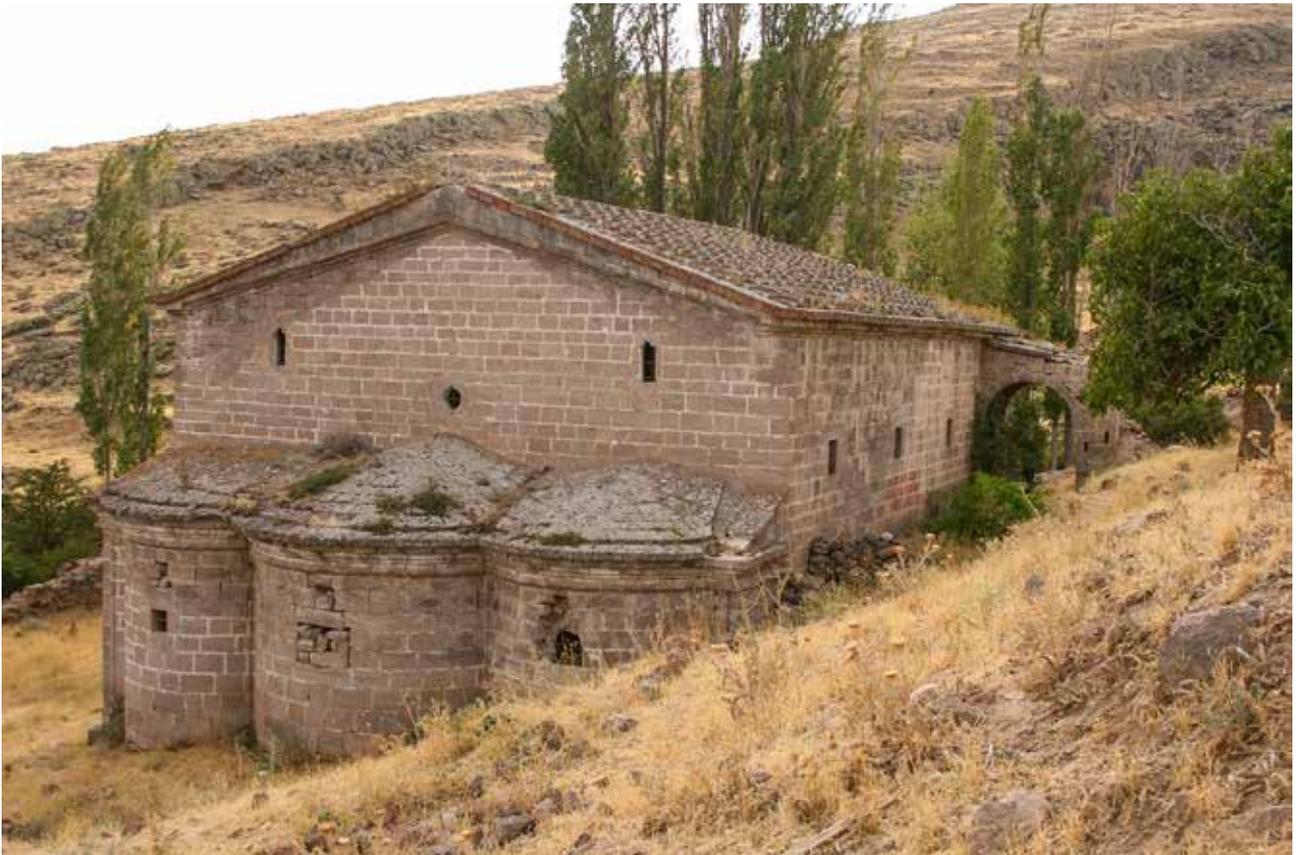
*Church of Saint Nicholas
Niğde Central county, Küçükköy village*

The northern and southern walls have lost parts of their mortar in the upper levels and this problem is even more pronounced on the southern façade. There are fractures in the gallery floor, and later interventions made with cement are observed. In addition to fractures in the plaster, there have also been interventions using cement to the parts where mortar has fallen off. Moreover, a unit south of the narthex has been closed off with concrete blocks and an additional room thus created later. A portion of the stone facing on the roof is missing and this has left the structure open to forces that degrade it.

The window opening in the apse has been closed with rubble stone, yet the window openings in

The simplest and most urgent precaution required for this structure in a poor and neglected state is to control entrance to the building. The structure has no door and people can easily enter and damage it, which will lead to this relatively preserved structure becoming a ruin in a very short time. In addition to this primary precaution, a comprehensive restoration project should be prepared and the problems mentioned above must be resolved.

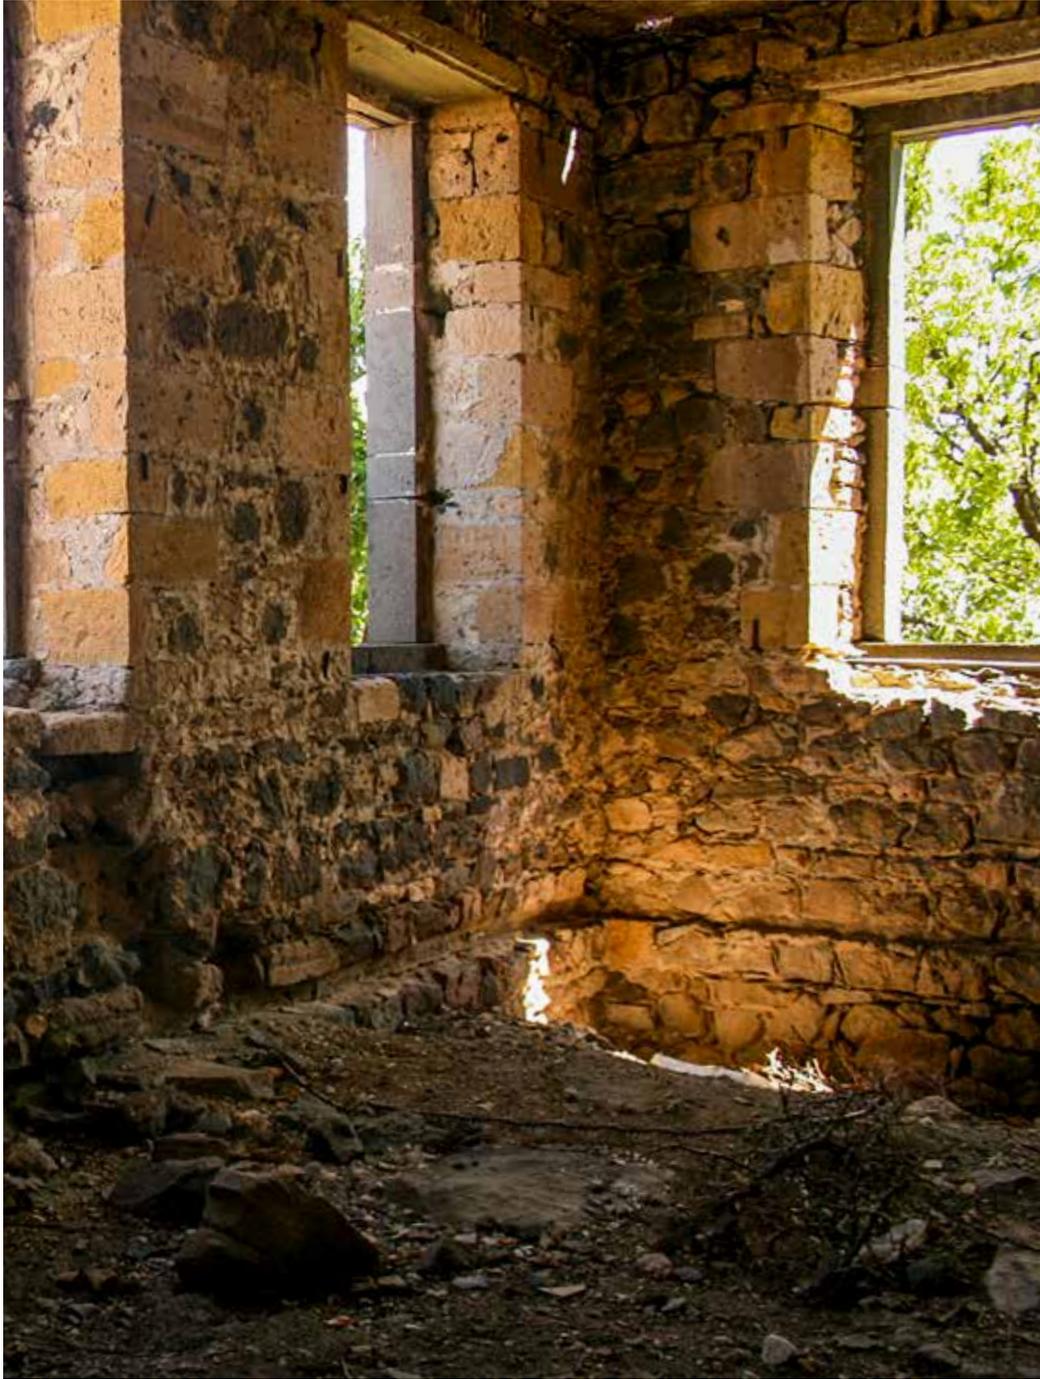
*The Greek School
Nigde Central county, Ballı village*

The roof of the building is in very poor condition and requires an emergency intervention. The lack of glass in the windows means that rainwater can easily enter the building. Some openings in the southern façade have been filled in with concrete blocks. The northern façade is packed with soil, and this load of soil poses structural risks to the building. The plaster has begun to peel. There is no flooring or wall plaster in the east wing.

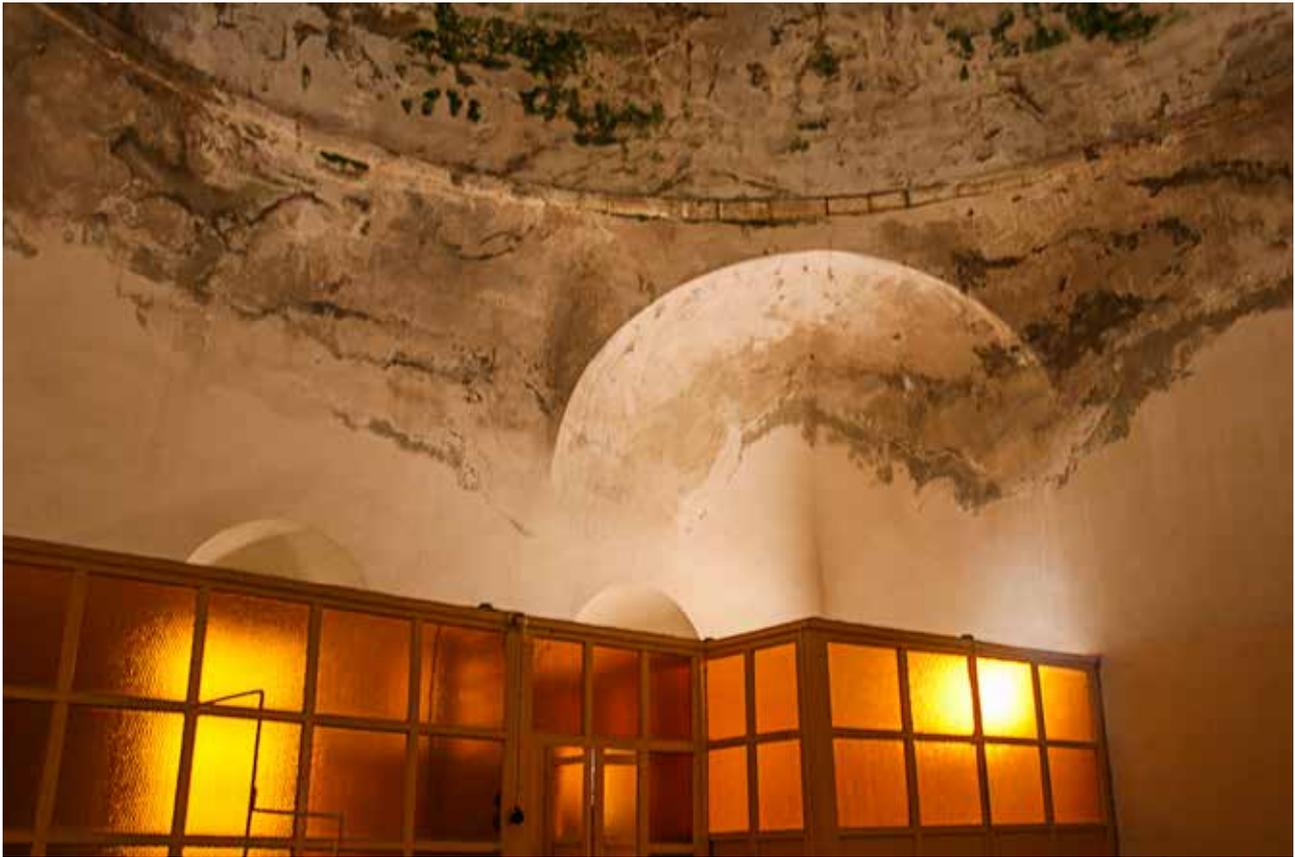
Because of the cement plaster, the main construction material, which is stone, cannot breathe. This has led to widespread efflorescence, moss growth, and falling plaster in the interior. Mortar has been lost in the dome and cracks may be observed. As the cement has

not quite adhered to the stone, plaster has fallen off the exterior (especially the roof) with plant growth beginning on the dome. Graffiti can be seen on the external façade. Additionally a large satellite dish has been added to the roof of the hamam recently, adding weight to the roof and disrupting the integrity of the original structure. As there has been no glass in the small skylights for a long time, rainwater entering the building has caused dampness related problems. During renovations that took place probably within the last 50 years, electrical lines, as well as heating systems and radiators, have been added upon the plaster on the walls.

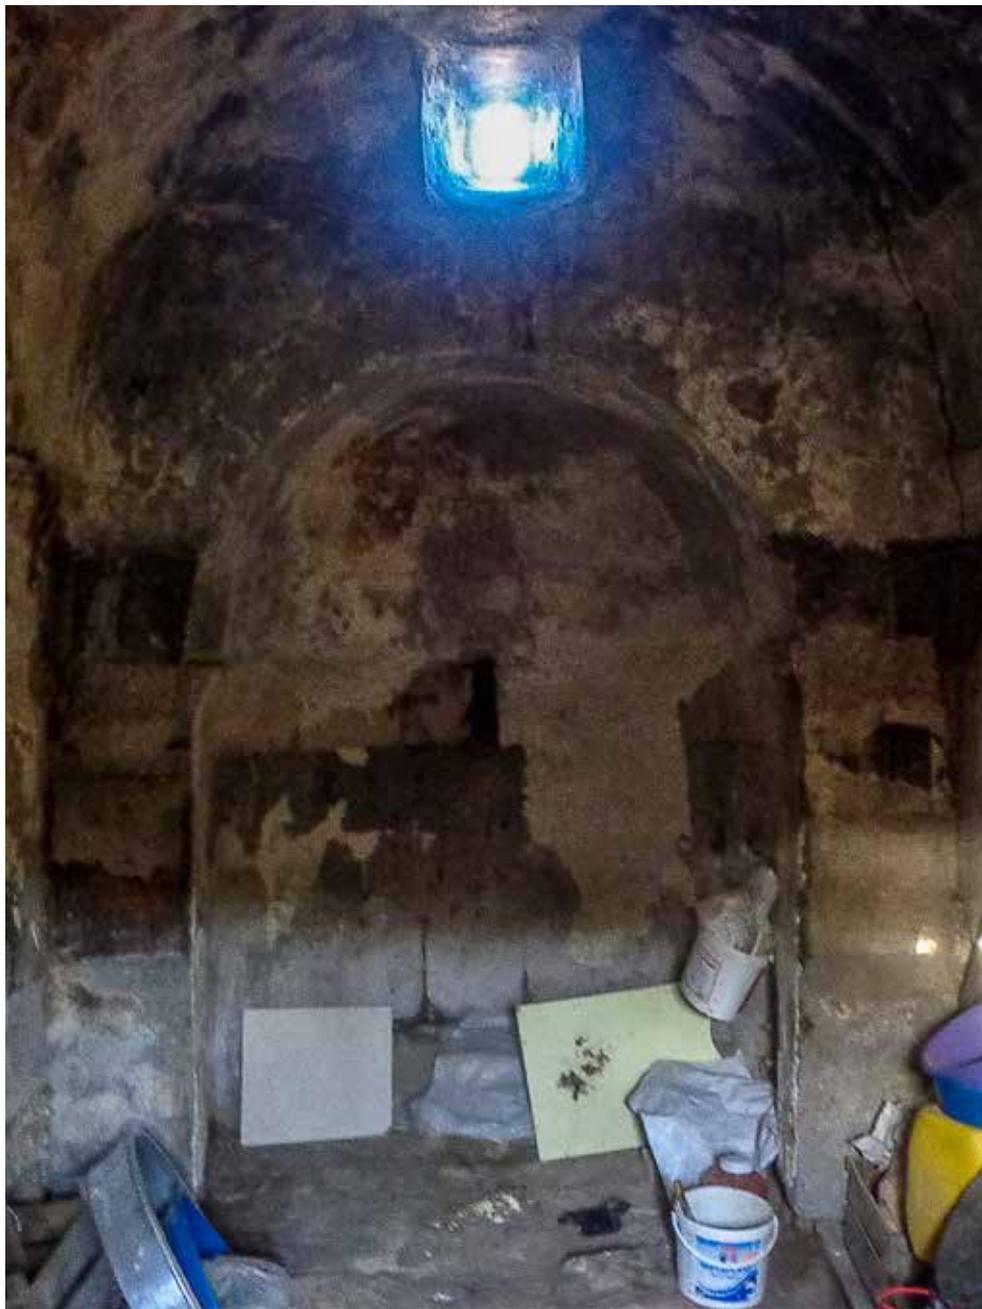
*The Chapel
Niğde Central county, Uluğağaç village, Köyiçi locale*

is an earthen floor. Inadequate interventions in terms of support and filling have been made recently in attempting to reinforce the structure (e.g., fractures have been filled in with rubble). Holes have been opened (probably by treasure hunters) in the interior and exterior facing of the church in hopes of reaching within the walls. Due to the erosion and rotting of the stones,

the surfaces have degraded with hairline and structural fractures visible in the walls. Nearly all the stone in the interior has been exposed to dampness, with chemical degradation present (efflorescence, mold). Again due to this reason, the majority of the plaster has fallen off with the very few remaining frescos in poor condition. Additionally, plaster in the interior has been

incised and vandalized. Recently the interior was painted white; however, due both to dampness and the use of paint unsuitable to the original plaster or stone it has begun to flake.
