Bursa

BURSA SITE ASSESSMENT VISIT

Dates: September 28 - October 2, 2016

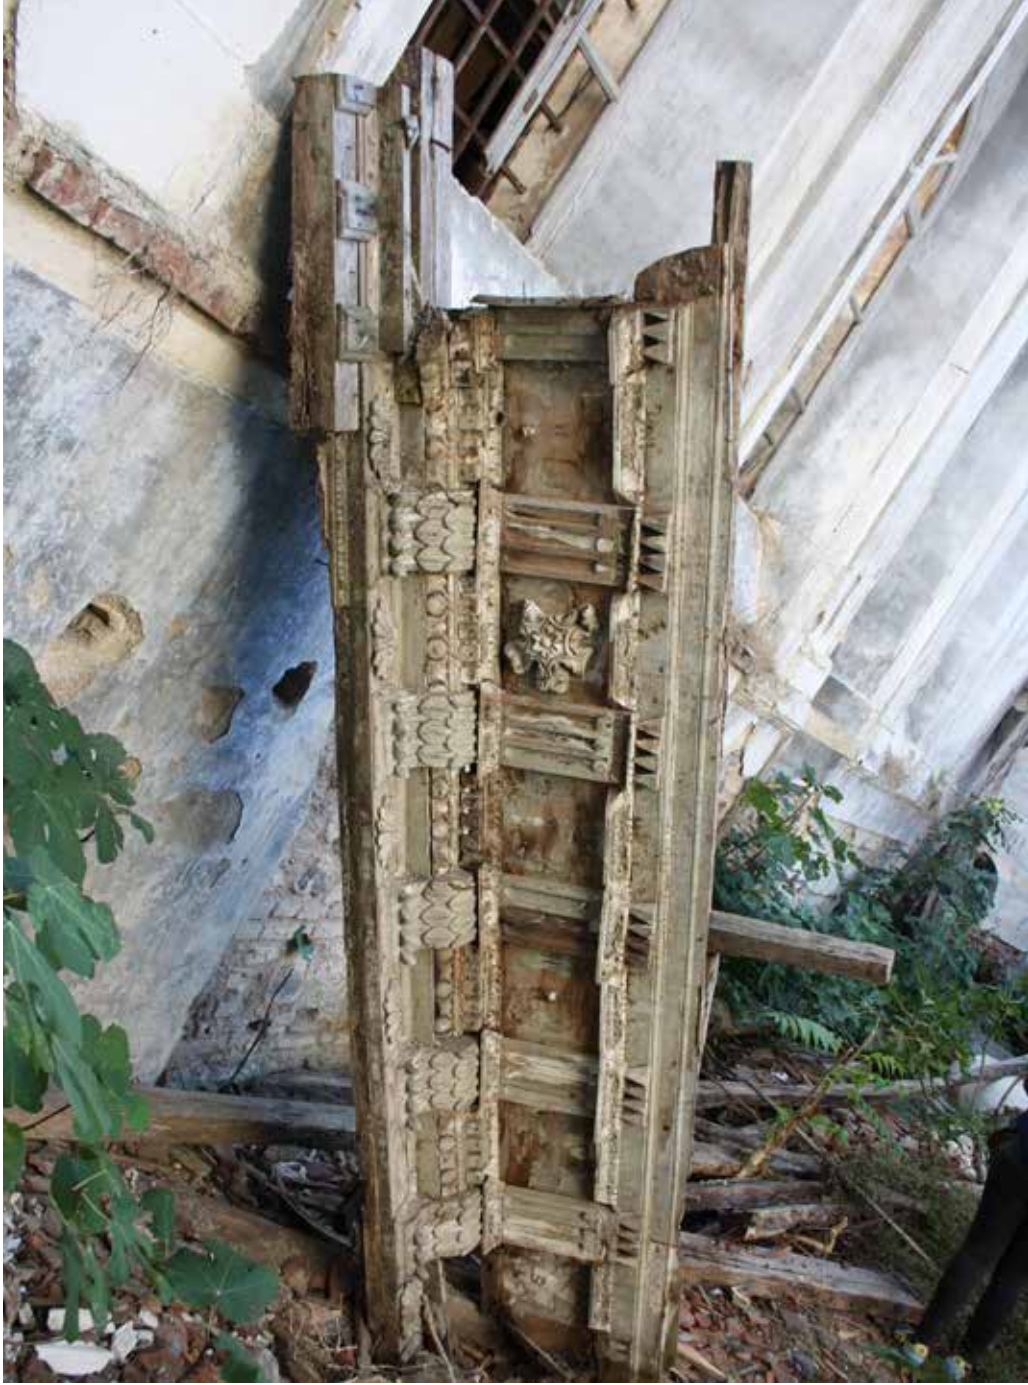
*Church of Saint Paraskevi
Mudanya county, Dereköy village, Köyiçi locale*

The plaster from the ceiling of the narthex has fallen off, rendering the laths visible. The steps within the stair towers have collapsed. The eastern wall/railings of the gallery floor are also destroyed. Currently only a very small amount of some parts of the iconostasis remains. According to what the mukhtar (village headman) said in 1986, tourists dismantled and took it away and the remainder was destroyed. Photographs taken in 1986 show that the liturgical elements and fabric of the church was in much better condition then, than it currently is (Otügen et al., 1986, 472, 708-710). There is no lock on the door, there is graffiti both painted and incised on the façades.

This rapidly-deteriorating structure requires immediate protection. As the roof has collapsed, the internal walls are open to the forces of nature and are being damaged. Plaster and stucco details are flaking and falling off, the frescos are fading and main walls are weakening. The wooden liturgical elements on the naos floor are open to the effects of all kinds of weather conditions and human depredation, and are rapidly deteriorating.

A restoration project should be prepared, the additional structure leaning against the southern apsidiole should be removed, and environmental work and landscaping carried out. While awaiting restoration, the church should have a temporary protective roof put in place, and uncontrolled entry through its doorways and windows must be prevented. Its history should be researched in detail and an information panel and directional signs placed in the near surroundings. It is recommended that the structure be given a cultural function open to the public.

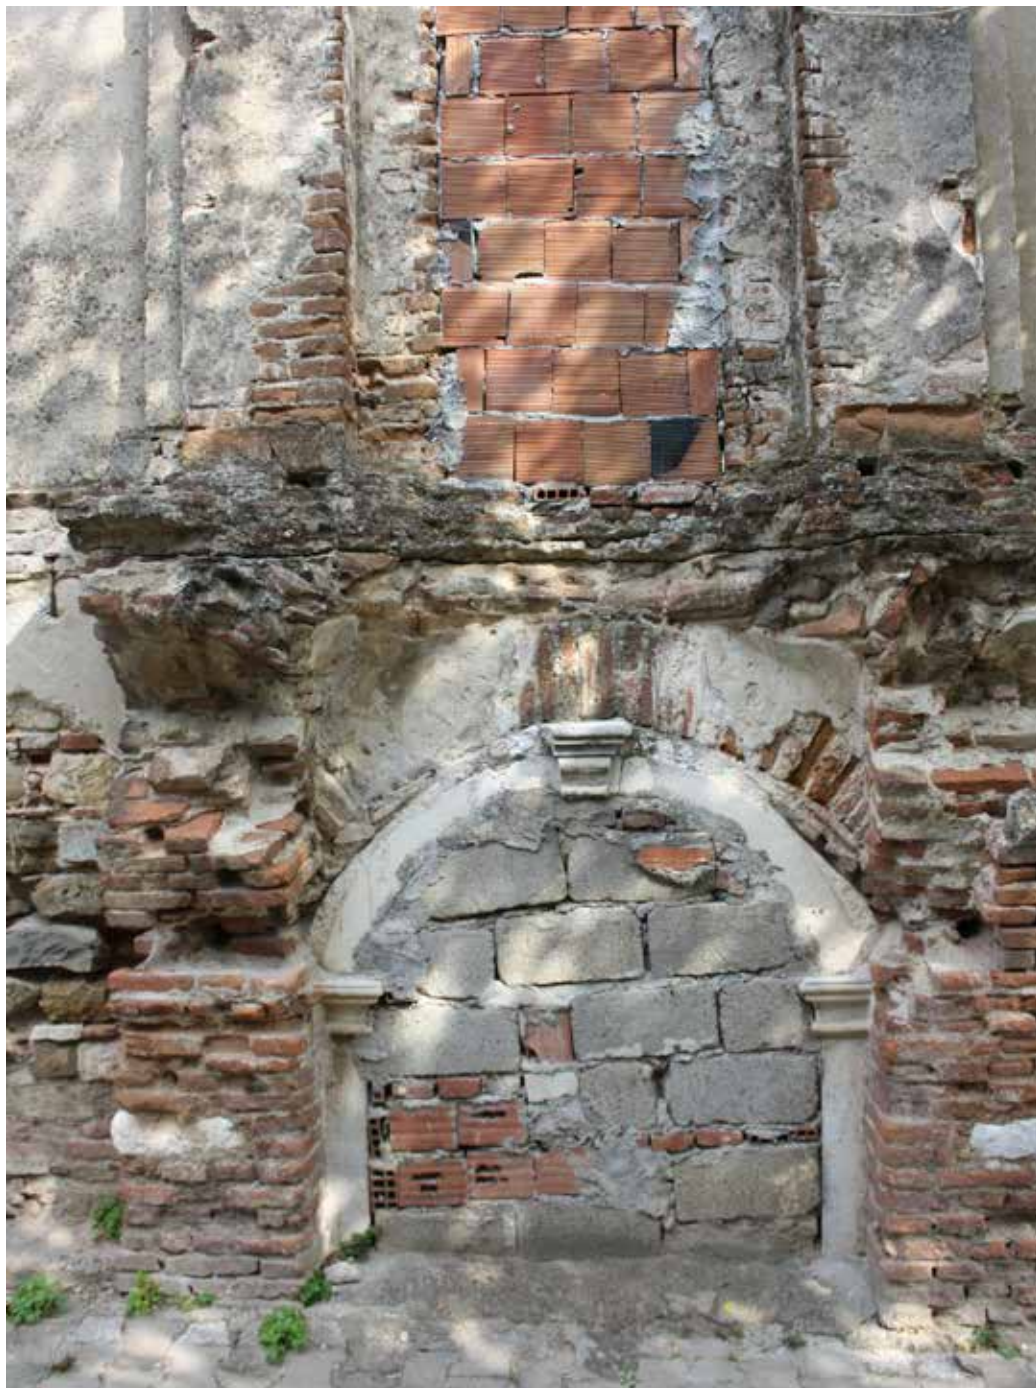
*Church of Panagia Pantovasilissa
Mudanya county, Tiriye town*

On the exterior, the separation of a large part of the main apse wall in the eastern façade of the building is news of severe damage that may be caused in the future by earthquakes to come. The arch rising towards the south from the pier in the western wall of the southern façade has collapsed. Internally, the roof of the narthex has collapsed, as a result of which the wall paintings are exposed to weather conditions. All main walls and the roof contain visible fractures, due to which even heavy rain may cause significant damage. The plant cover on the roof is weakening the structure. The wooden scaffolding put in place of a collapsed column in the southwest of the naos does not provide sufficient support. The structural stability of the structure is in danger and emergency precautions must be taken.

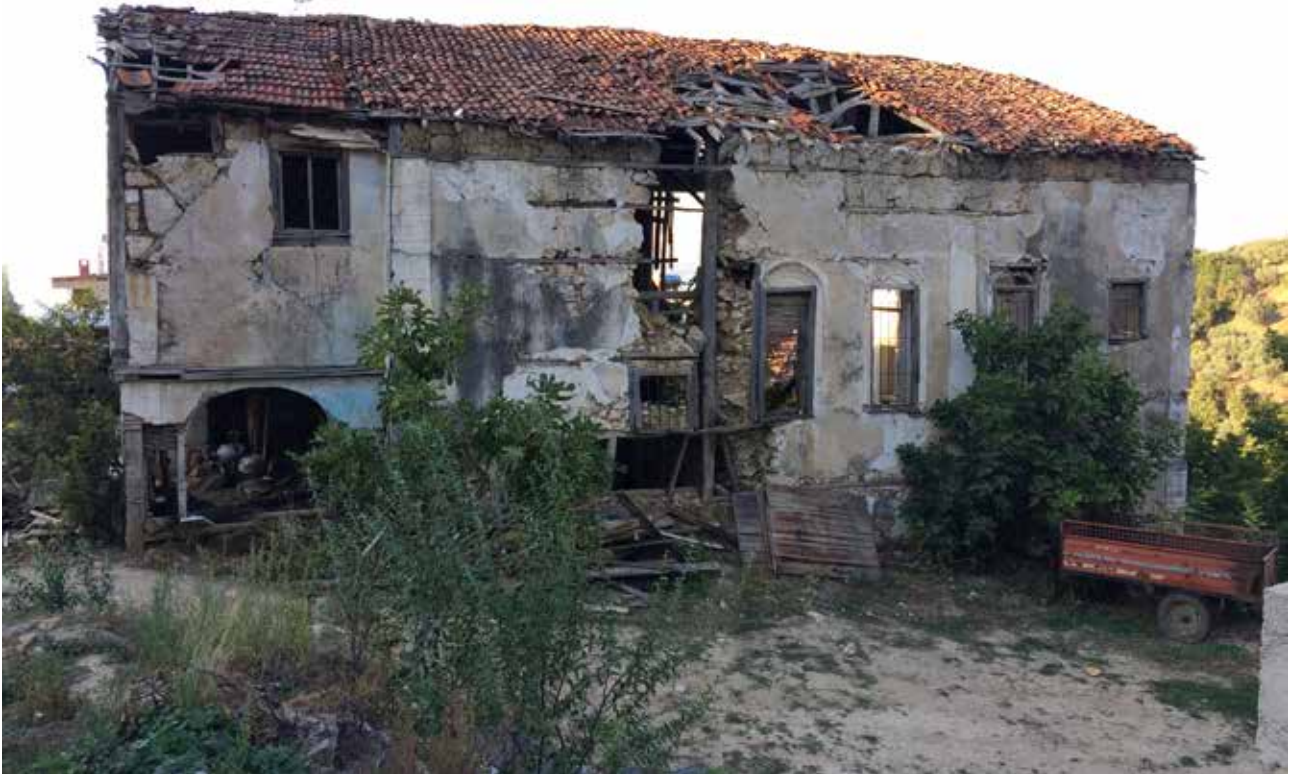
The roof of the structure is partially destroyed or damaged. This situation has left the structure defenseless against the effects of nature and has increased its rate of destruction. Currently a large section of the southern wall has collapsed, and because it is also missing its roof this destruction will continue. Cracks observed around what may be the doorway in the northern wall may cause parts of the wall on the upper level to collapse. On the eastern wall of the sub-foundation level of the apse, there are holes which may lead to the collapse of larger parts in the future. The roof of the apse is largely destroyed resulting in increasing damage to the dome.

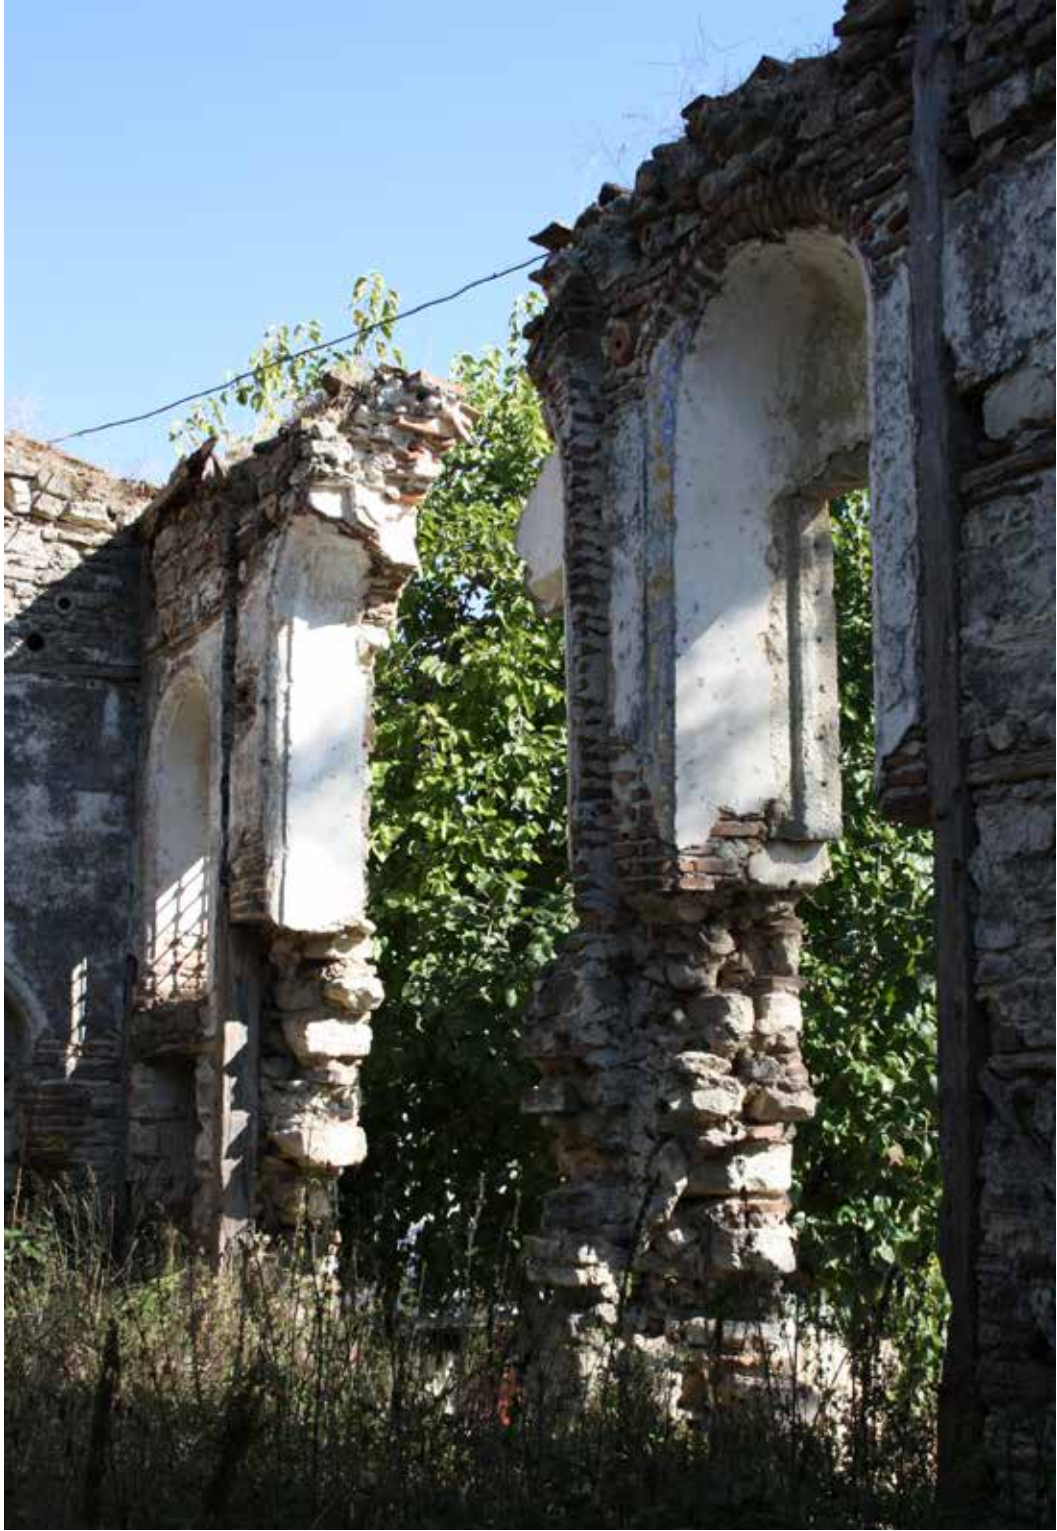
*Church of Saint George
Karacabey county, Çamlıca neighborhood*

The Church of Saint George in Çamlıca village has been abandoned and left to fall into ruin, along with other old houses in the village. The roof of the building has collapsed with the interior partially filled up. The main walls have cracked and partially collapsed. The structure is becoming more ruined each and every day due to both natural factors and vandalism. Nearly all the plaster has fallen off, with advanced disintegration of all building fabric. The wood in the southern wall is in relatively better condition, while there are only empty cavities in the other walls. The eastern façade is adjacent to a private lot and cannot be seen by visitors. North of the apse, the owners of this private lot have built an oven on the upper level, with a toilet on the lower level. The damaged sections of the southern façade negatively affect the stability of the structure, and this poses a threat to people using the lower channel and roads, in the case of its collapse.

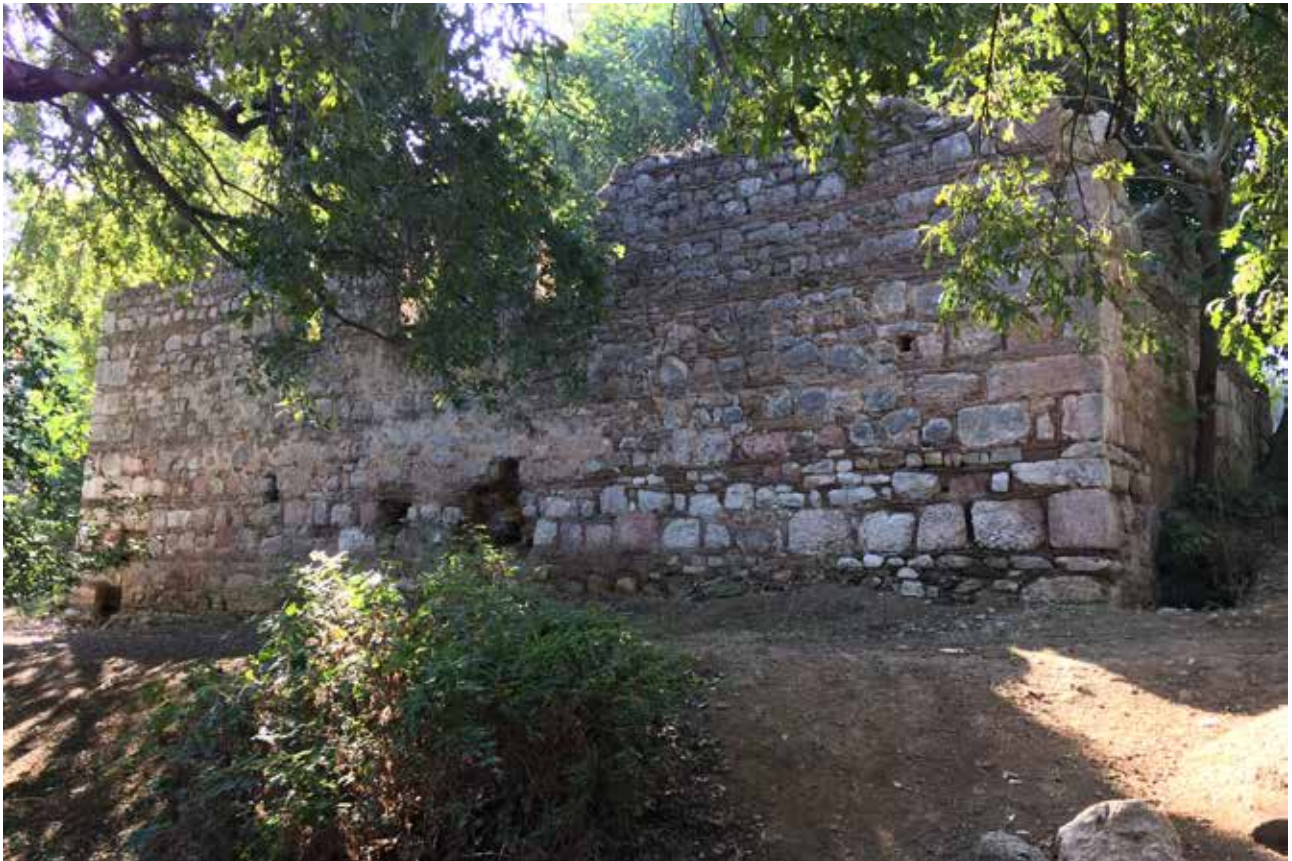
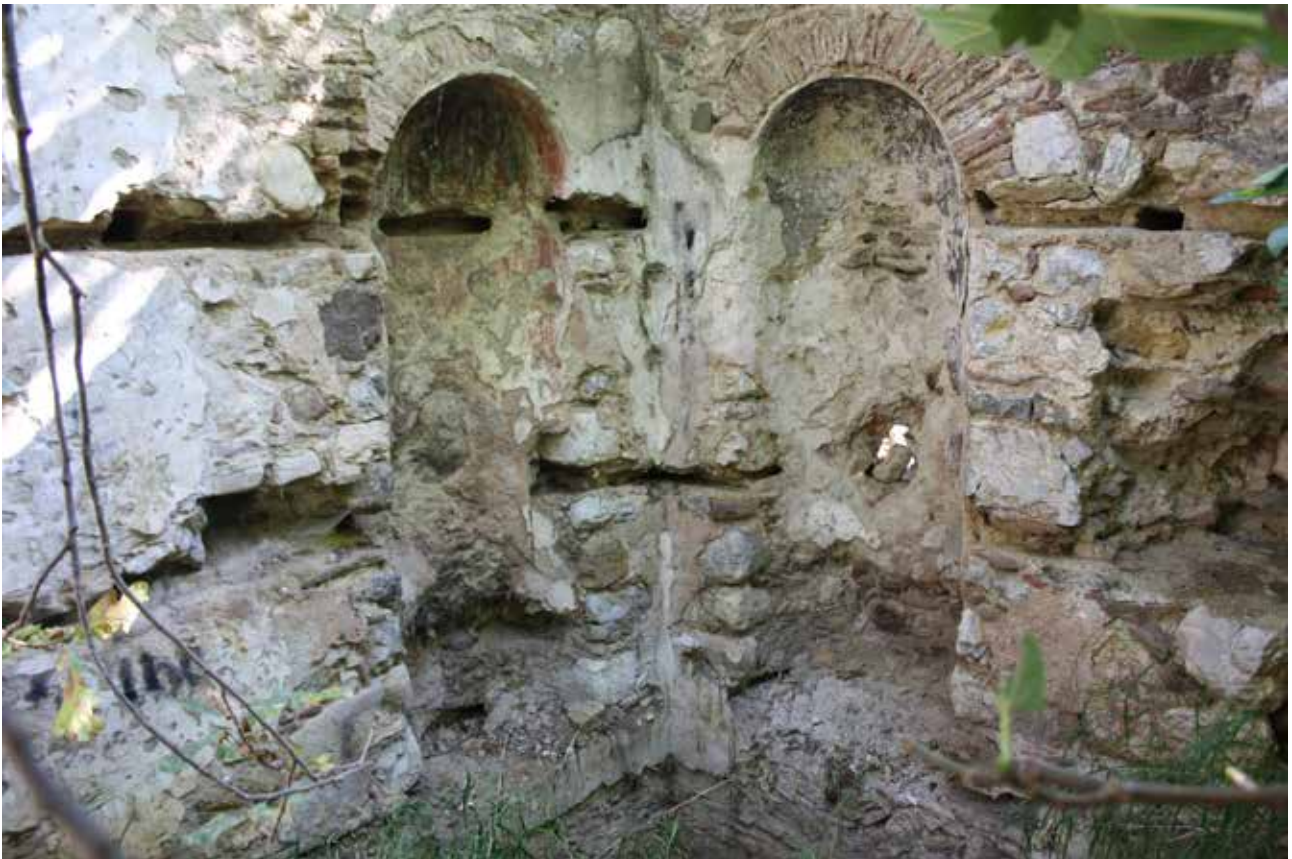
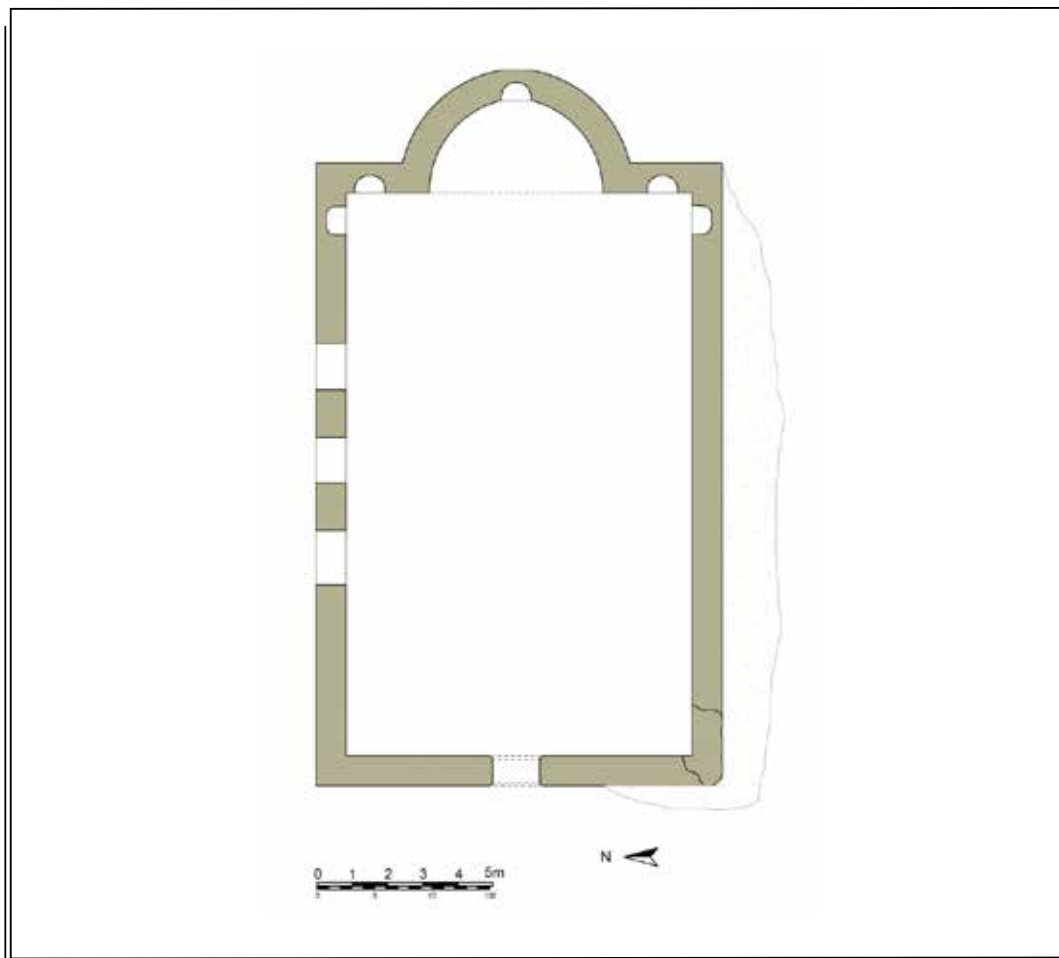
The structure is neglected and in ruins. Currently no detail relating to the internal organization of the structure is discernible. Trees are growing inside, outside and on the southern wall of the space. There are numerous pits dug by treasure hunters' pits and serious destruction is observed. Rubble has been dumped inside the structure and there are holes in the walls. There is no trace

of the roof, with the walls collapsed down to the level of the window arches. The southern wall is acutely destroyed. The structure has been badly damaged by vandalism.

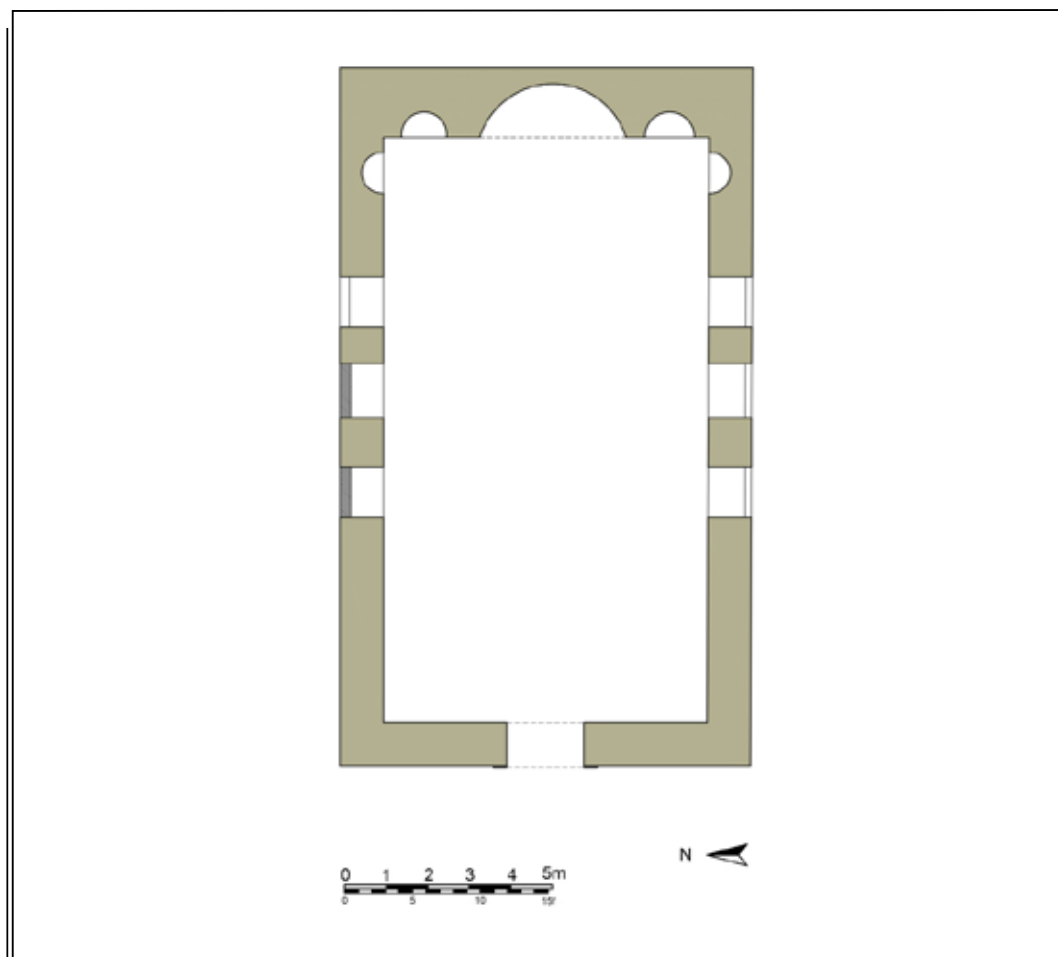
The church is within a garden that is private property, partly surrounded by barbed wire. Additional sections have been built in the interior, as the church was used as a house in the 1950s. After being used as a house for 15-20 years, the church was abandoned with no further maintenance (Yıldız, 2014, 32). During its use as a house, a wall was added in an east-west direction almost right on the axis. Sections were added with brick-filled wooden frame system and adobe brick during this process. These sections, as well as the hearth of the house and flooring are currently in ruins.

The entrance door of the church was filled in and closed off, with the marble jamb broken and very little of it remaining. On the southern side of the original door, the wall was broken to create a later entrance. The apse projection was completely demolished, with the opening filled in with rubble stone and space for a door and two windows left open in this fill. Currently the brick arch of the apse is observed from the eastern external façade. Mortar pointing using inappropriate material has been attempted the eastern and southern façades.

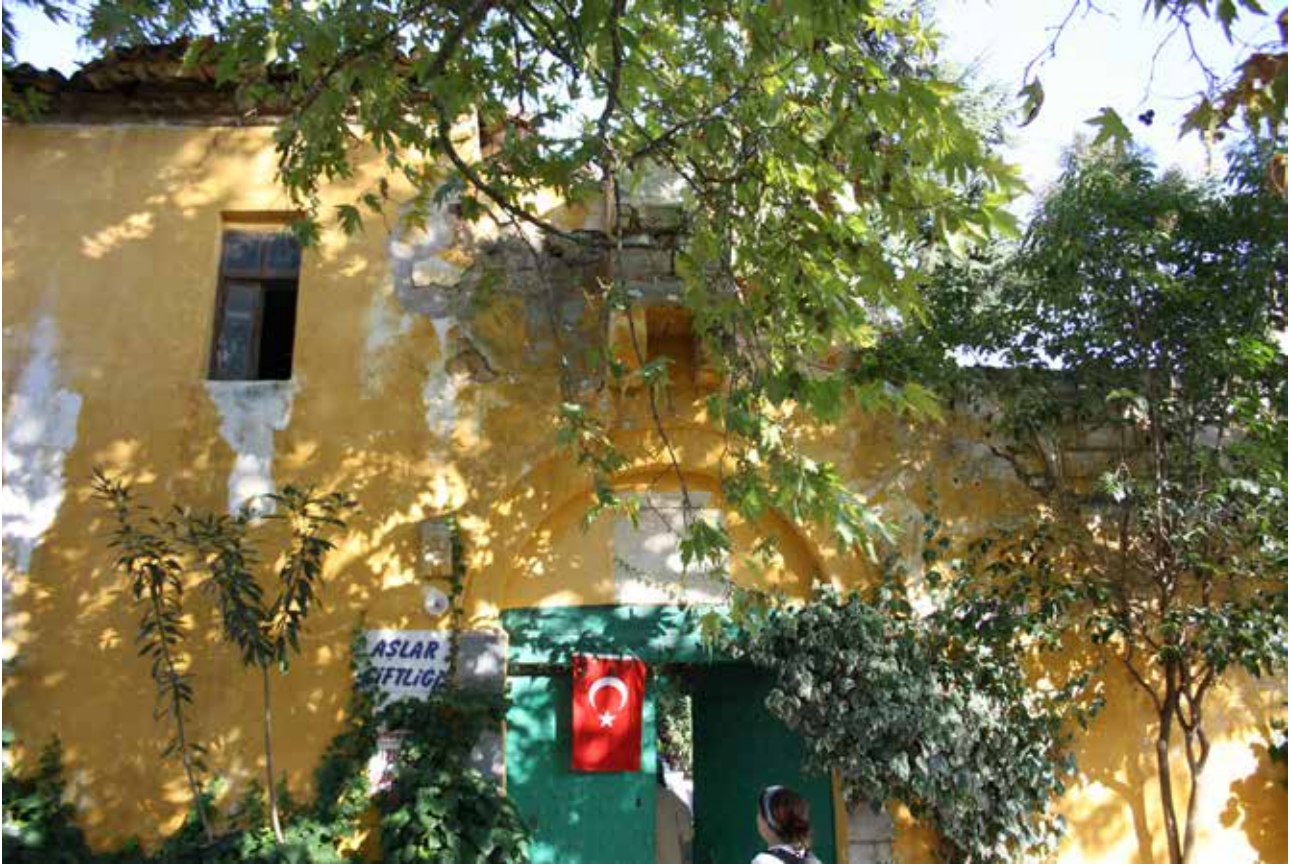
The wall has no capstone, so rainwater enters it causing damage. At the same time, there are pieces of historical columns lying in the farm garden. On one wall within the farm there is a Turkish-English information panel prepared by the municipality containing many spelling mistakes and missing information.
