Kayseri
Adana
Izmir
Elazığ
Niğde
Bursa

Assessment Report of Architectural Cultural Heritage

April 2018

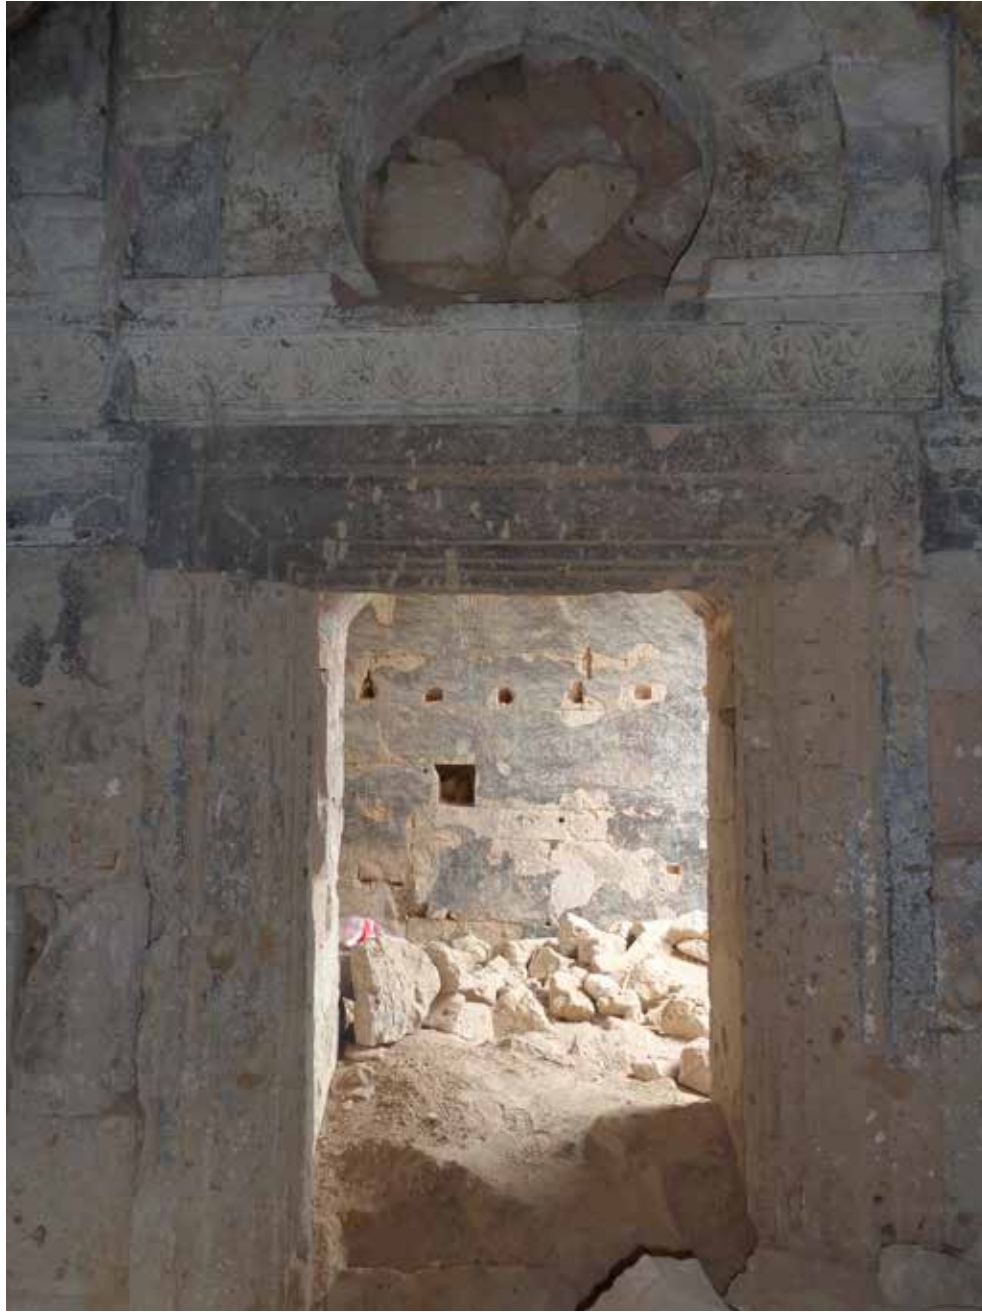
*Church of Saint George
Yeşilhisar county, Başköy neighborhood*

The major problems in the main body of the church are the fact that the dome, part of the apse of the southern wing, and a part of the western exterior walls are missing. These damages have resulted in the accumulation of debris and backfilling in the interior, which has, in turn, concealed the original floor. Furthermore, the support of the structure has been disrupted to such an extent that parts of the building are in danger of imminent collapse. This unfortunate condition is further aggravated by the humidity

caused by rain and snow and the vegetation that has developed in the interior. Building materials have also suffered from significant damage; some stones have disintegrated and others are covered with moss.

The painted decoration of the monument has also suffered significantly and is in part destroyed. Mostly due to high humidity and sudden changes in temperature, many parts have lost their overlay, have fallen, or are on the verge of falling. Significant parts have been discoloured by sunlight entering the structure through the gap of the collapsed dome while other parts of the painting has been covered with dirt, both cases rendering the paintings indiscernible.

The roofing is completely destroyed and the surface is covered with vegetation. The vestibule is also damaged at various points of the masonry. Its walls have been weakened after the collapse of some of its parts, and it is covered with vegetation.

The greatest danger the structure currently faces is complete collapse within the next few years due to high risk nature of unpredictable and unpreventable damage caused by nature and people.

Weather conditions (rain, snow, winds and sunlight), vegetation developing around the monument, and earthquakes constitute the most serious natural threats. The parts of the roof that have collapsed leave the structure unprotected against rain and snow, and contribute to the problem of humidity and

erosion of the building blocks and the painted decoration. The vegetation growing on the roof further weakens the structure, exacerbating the accumulation of incoming rain water in the interior of the building. Any seismic activity will have detrimental effects on such a weak building and could cause additional cracks and, possibly, further collapse.

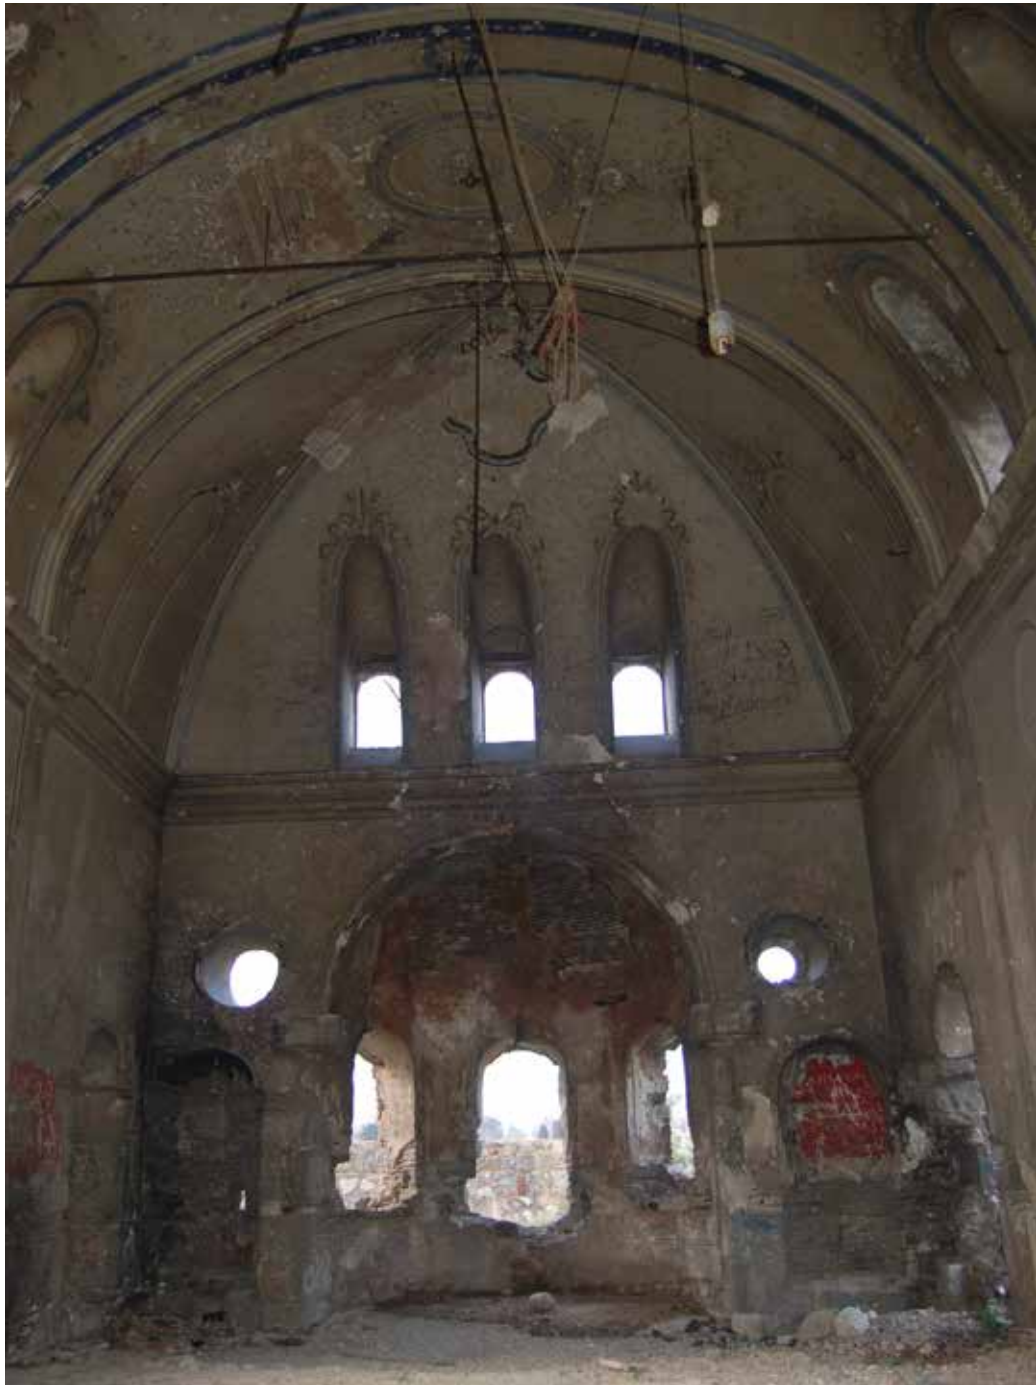
*Church of Prophet Elijah
Konak county, Aziziye neighborhood*

structural solidity. The western façade (the former narthex wall) is partly demolished due to the collapse of the entrance and the window opening to its left; only part of the rectangular molding survives. Doors and windows are wide open and original joinery has been destroyed. Material deterioration is more pronounced than the structural problems of the building.

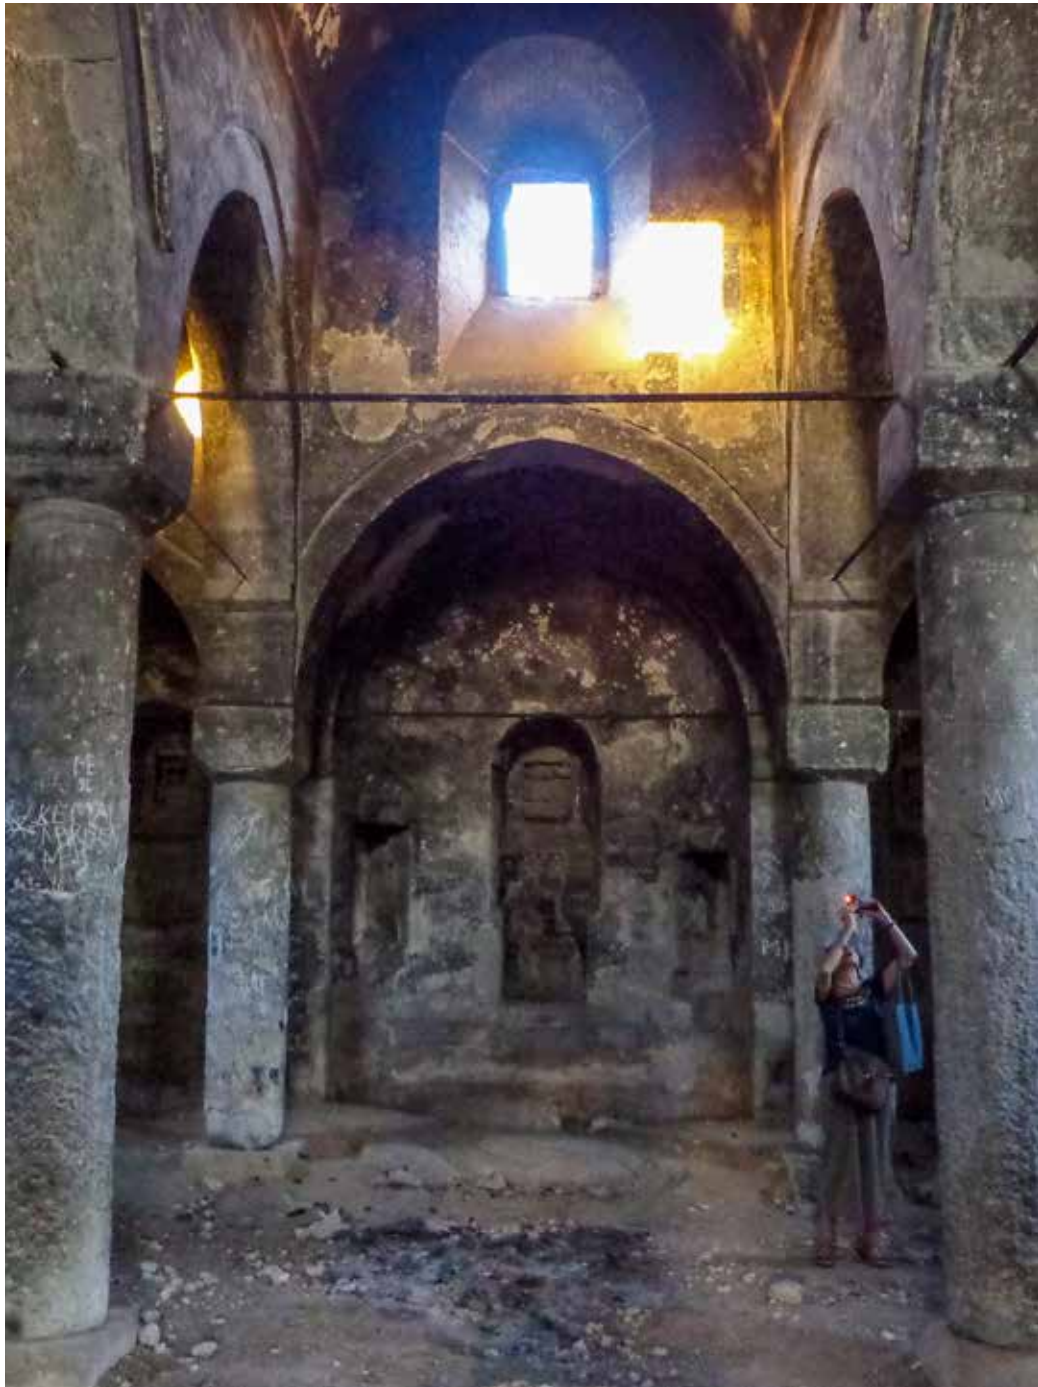
*Church of Saint George
Niğde Central county, Yeşilova village*

Vandalism is seen on the exterior façade as spray paint and as incisions on the frescos that have survived on the walls and columns in the interior. As with the window bars on the ground level, the tension rods between the columns have been cut out and stolen. Additionally, indications that fires have been lit are visible from soot on the interior walls and ceiling.

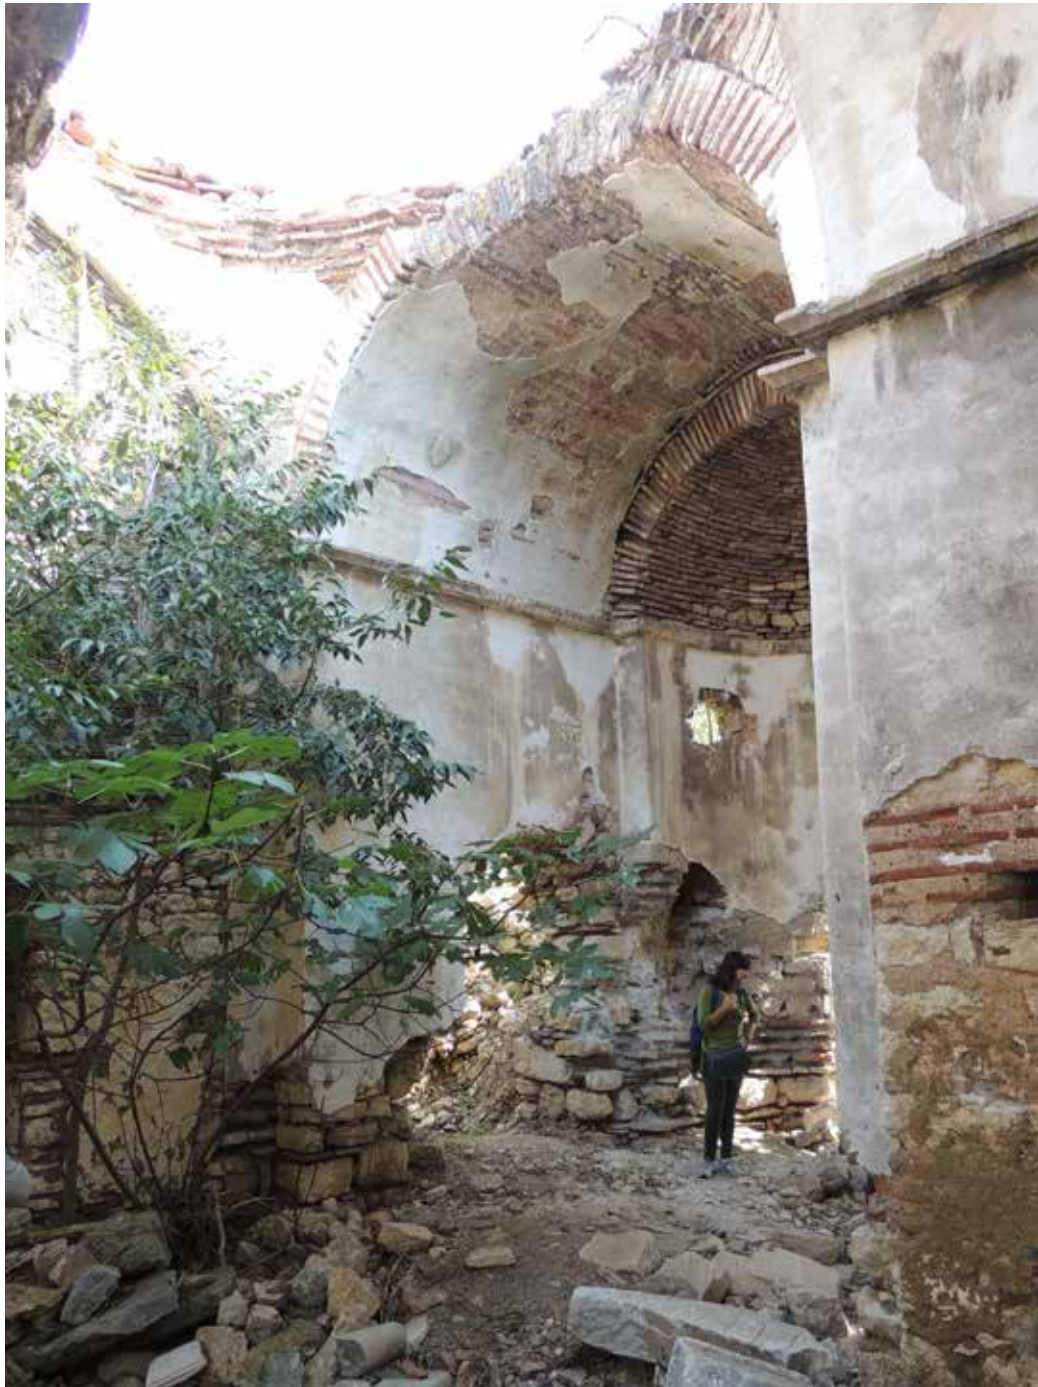
*Monastery of Saint Constantine
Nilüfer county, Gölyazı neighborhood, Mutlu/Manastır Island*

found. In the 20th century an additional floor with wooden support was added within the northern arm of the cross. The floor is covered with rubble, soil and collapsed material. The roofs of the corner rooms and narthex and a large portion of the walls have collapsed. The dome has collapsed; however, the semi-domes above the apses are still standing.

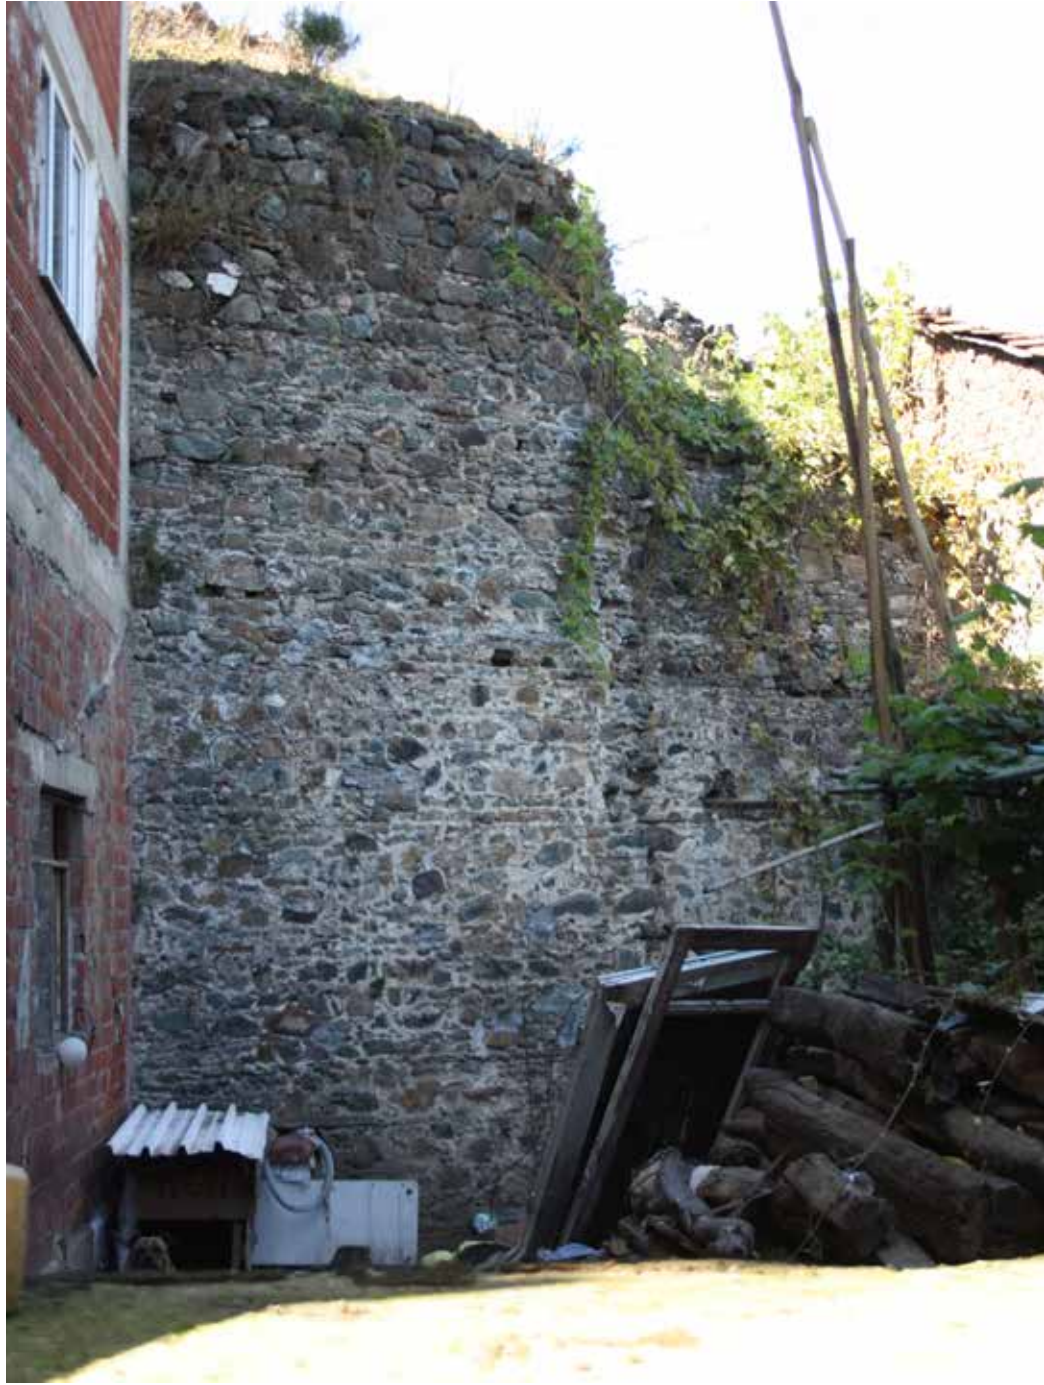
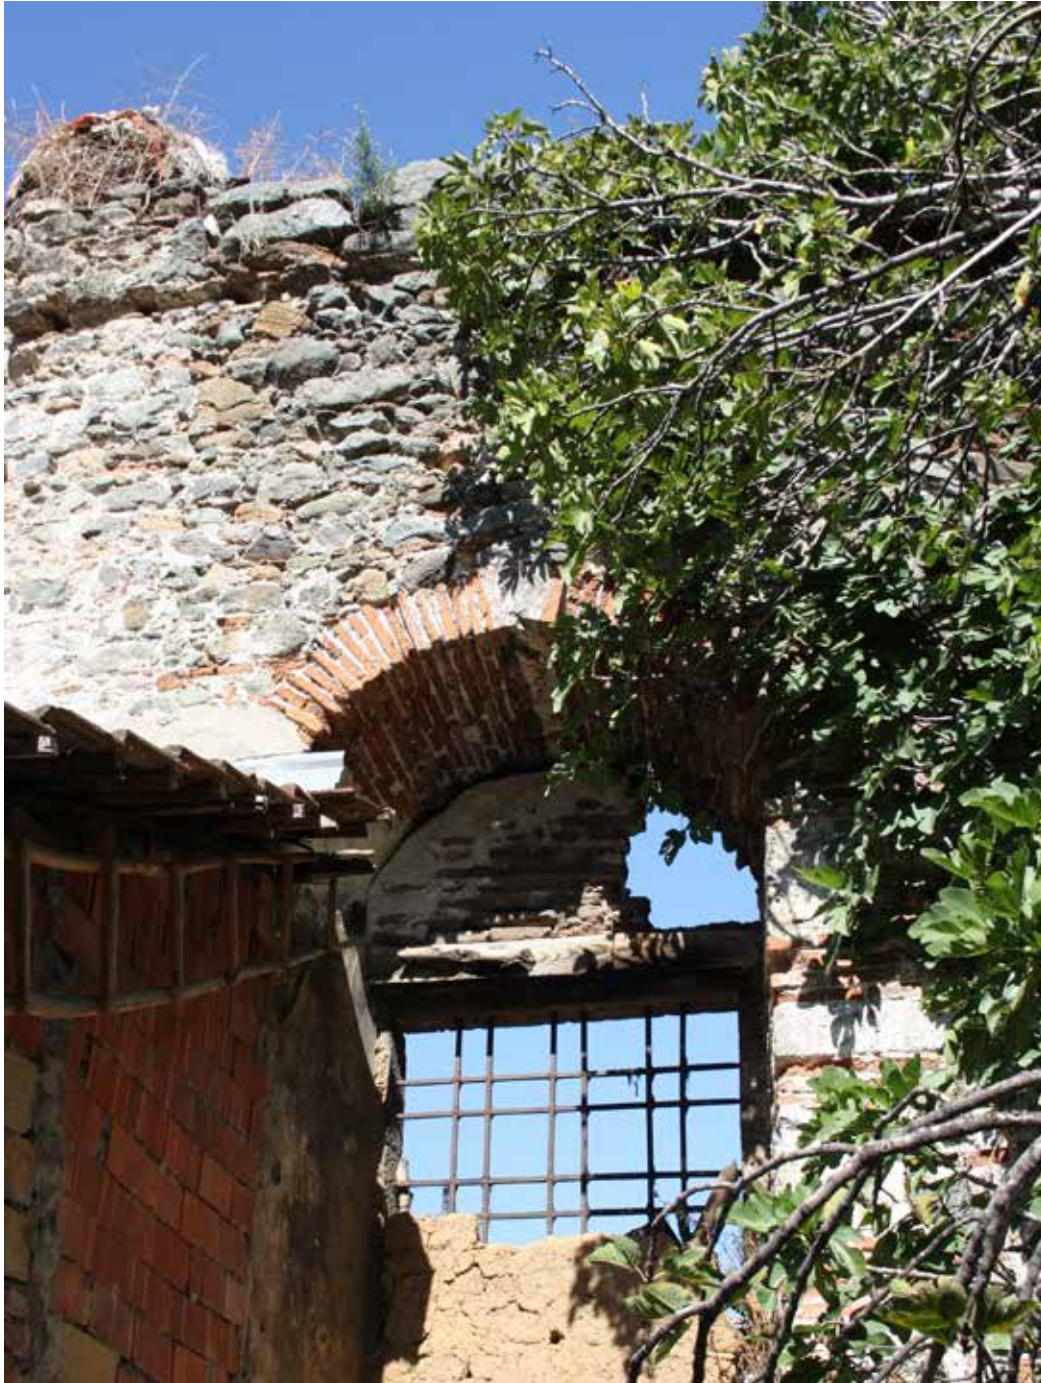
*Church of Saint George
Orhangazi county, Yenigürle neighborhood, Köyiçi locale*

while being in a weak structural condition. The destruction caused by the illegal structures built within the church is also quite serious. Initially, rehabilitation studies must be conducted to

remove all the later structures from within and around the church, and those living inside it should be moved to a better environment. The necessary survey, restitution and preservation projects should be prepared, and the parts
