Conservation of Cultural Heritage and Documentation Techniques

Bursa Forestry Museum (Saatçi Ali Pavilion) Conservation Problems and Suggestions

Oğuz YEKE, Faruk Saraç Vocational School of Design, Architectural Restoration Program, Turkey

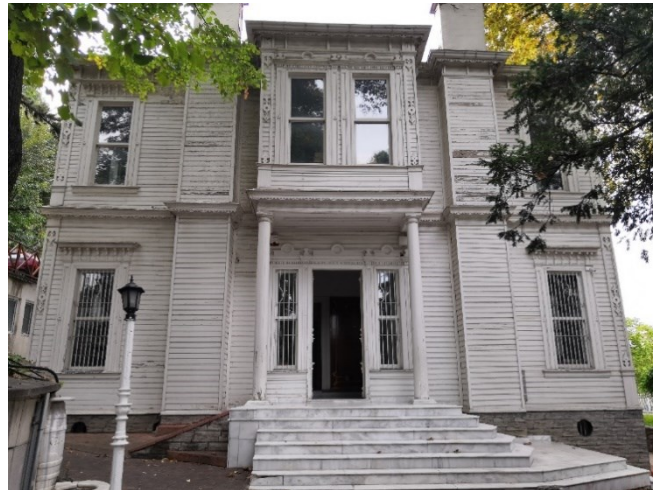
There was no structural damage and serious damage. There are paint spills and joint opening in the exterior cladding. Wooden windows and doors have paint spills. Time-related wear and moisture have been observed on the floor beams in the basement ceiling. There are many layers of paint on

the walls of the building and they are poured from place to place. Gypsum plaster made on ornaments on the wall caused great damage to these embellishments. The ceiling coverings in the structure and the decorations made in the painting technique on the canvas are original and damages such as contamination and rupture have been observed to a great extent. On the first floor there are unauthentic wooden elements on the walls and ceilings of the rooms in the southeast. It is considered that roof carriers generally do not have structural damages. Corrosion and buckling were observed in the zinc coating on the windowsills of the building facade. Zinc rain downpipes of the structure have been replaced by unauthentic material in some places.

Fig. 2. Southeastern Façade of the Building and the Main Entrance, Bursa, Turkey (© Oğuz Yeke).

Stone imitation pavements surrounding the facade at the level of the basement of the building should be removed and covered with plaster as determined from the old photographs. After the decaying and needing parts of the zinc surfaces on the upper cornice of the facade and windowsills and the wooden parts that are underneath are determined, they should be treated with protective varnish. The existing lodging structure will be preserved by cleaning the arched chimney from the original fire brick located in the basement. During the survey, the ornaments on the wall, traces of which were found during research scraps, should be designed and renewed during the application.

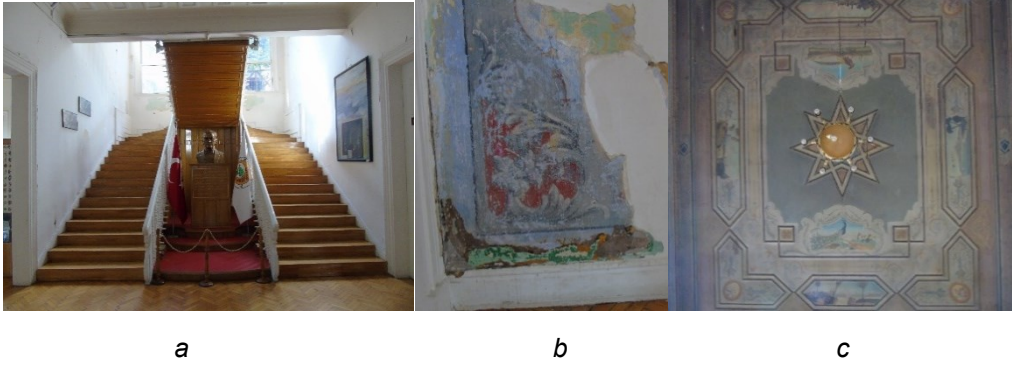
Fig. 3. Forestry Museum inner walls and ceiling ornaments. a) Stair Hall; b) Ornament in Stair Hall Wall; c) Room Ceiling Detail (© Oğuz Yeke).

After examining the building survey, deteriorations affecting the structure, unauthentic additions and situations that need to be intervened were identified and protection recommendations were made. Repairs in line with these recommendations should be done in a way that will cause minimal damage to the original tissue, attention should be paid to the construction technique and materials, and restoration application should be done without changing the internal order of the structure (Ahunbay, 2004). The existing wooden elements in the structure should be painted with paint scraps, and if there are rotting parts, they should be renewed in their original details and materials. The unauthentic coating on the roof should be removed and the necessary reinforcements should be applied. Necessary arrangements should be made in the creeks and ridge on the roof and the existing roof tiles should be replaced with the traditional Spanish tiles. The wooden shutters on the guillotine windows, which were determined from the old photographs, should be rebuilt with original detail and material and replaced. The original wooden flooring should be repaired. The original ceilings in all spaces should be scraped away from paint and decaying and repairing elements should be identified. After the inspection, protective natural wood varnish should be applied and re-painted and replaced.
