Yeni Hammam: History in Graffiti

Catalogue of images found in plaster layers in an Ottoman bathhouse in Plovdiv

Nina TOLEVA-NOWAK, University of Architecture, Civil Engineering and Geodesy, Bulgaria

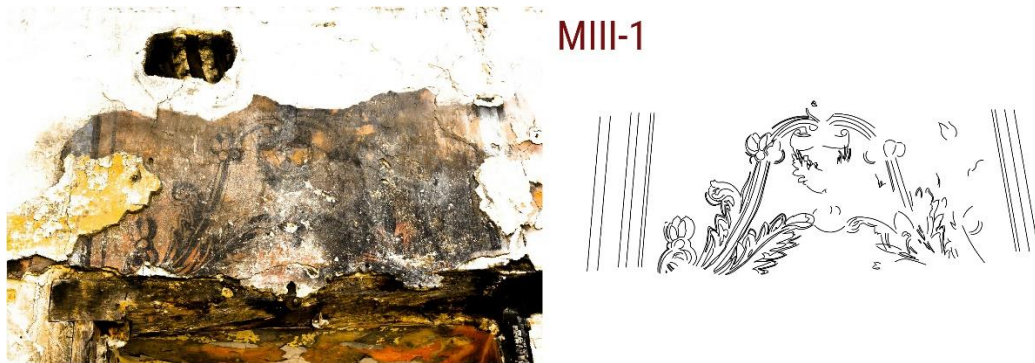
Fig. 4. Early Revival murals (© Nina Toleva-Nowak).

Third period (1818 – 2nd third of the 19th century): After several earthquakes in the first third of the 19th century, the urban landscape of Plovdiv was heavily damaged. One of the most devastating earthquakes was the one from 1818 and it most probably led to the demolition of the original masonry dome and the need of quick construction of new wooden one, which can be spotted on later photos from 1892. The plaster layer is characterized by saturated, dark colors, executed entirely in the spirit of the frescoes from the early Bulgarian Revival (which are heavily influenced by the Western Baroque) – lavish hand-painted ornamentation with the rhythmic demarcation of the mural panels (traced throughout the height of the dressing room), reinforced with black ribbons and lines in Turkish blue and ultramarine. These murals are severely damaged and can be traced only in a few fragments (Fig. 4). The author is currently working on a restoration project based on the documented elements.

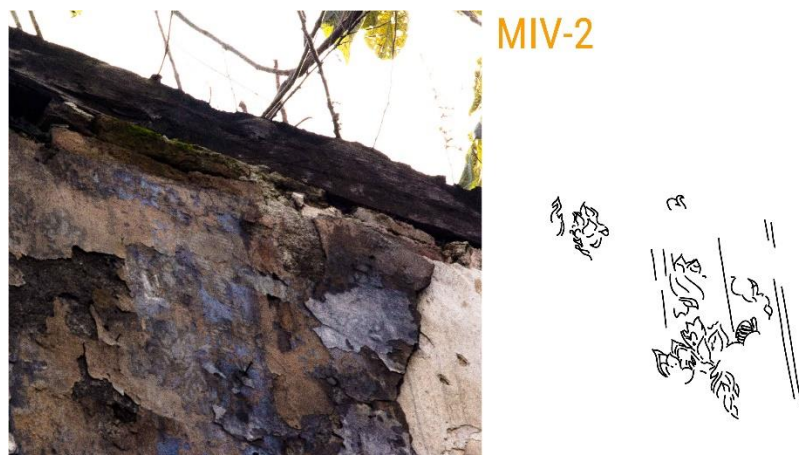
Fig. 5. Late Revival murals (© Nina Toleva-Nowak) remnants of column with decoration.

Fourth period (2nd third of the 19th century – 1928): The next plaster layer is characterized by bright, colorful chromatics (white, Turkish blue, yellow, black) and remnants of painted architectural elements – columns, railings, vases. The style of the murals is typical for the Mature Revival (the second third of the 19th century). Unlike the previous plaster layer, here the ornamentation develops in height – the preserved fragments are at the level of the second floor, around the windows. Given the classical proportions of the painted columns (Fig. 5), and given the growing population of the city and the need for more infrastructure, probably in this period a wooden gallery in the locker room appeared, forming a second floor. Its presence is documented in the photographs archived in National Institute of Immovable Cultural Heritage during survey from 1980s. The window openings on the second level were probably drilled in the stone wall during that period. Unfortunately, this plaster layer is heavily damaged and its reconstruction is becoming more and more challenging.
