Structured Light Scanning as a Monitoring Method to Investigate Dimensional Changes Due to Climatic Changes on Cultural Heritage

Kristina HOLL, Otto Friedrich University of Bamberg, Germany

Abstract: For a long-term preservation of cultural heritage items, stable climate conditions are necessary. As indoor temperatures will rise in the future due to climate change, chemical reactions take place much more quickly. At the same time, however, relative humidity decreases, which can cause damage, especially in the case of objects consisting of organic composite materials. As reactions to changes in climate depend very much on surrounding circumstances, on past climate patterns, and on the preservation history of an object (conservation treatments, changes in location, etc.), it is generally difficult to forecast future damage to cultural heritage objects that might be caused by climate change. Comparable damage patterns can be found on cultural heritage items which have been subjected to unfavourable climatic conditions over a longer period. This is usually due to excessive use, e.g., numerous events or the incorrect operation of cultural heritage items. This usually leads to inapprop

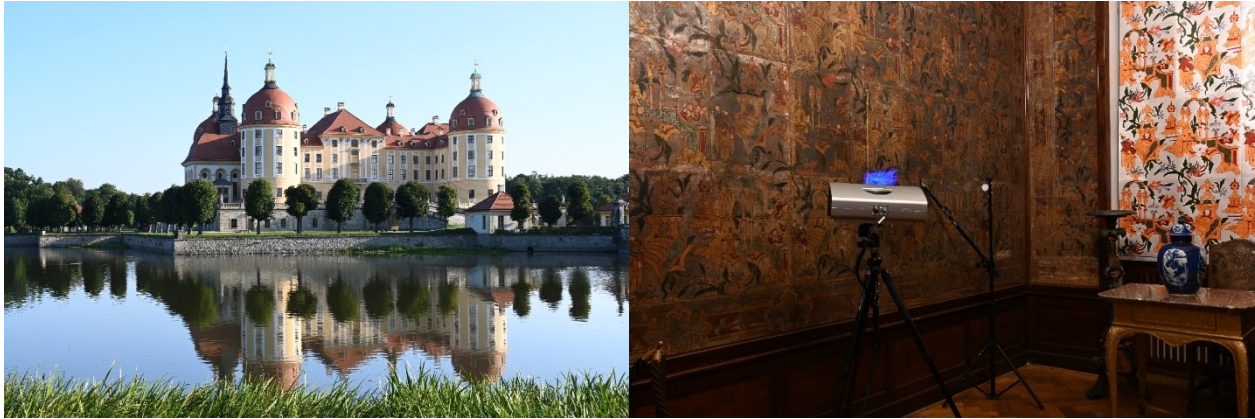
Fig. 1. Left: Castle Moritzburg from the 18th century is situated in Saxony 15 km north of Dresden. Right: The Chinese Room inside the castle is an example of one of 11 rooms showing original leather panels. The examination of the historic surface was conducted by structured light scanner combined with precise microclimate monitoring (© Kristina Holl).

The hunting lodge of Moritz of Saxony from 1542, which was converted into a baroque palace under August the Strong in the 18th century, displays the world’s largest collection of baroque gilt leather panels, see Figure 1. Eleven of the original 60 rooms in the palace still feature embossed, punched, and painted calfskin or goatskin panels, which are being continuously restored, see Schulze (1997) and Schulze (1998). As leather is an organic material that reacts very quickly and strongly to climatic changes, the leather panels in Moritzburg Castle suffer from high temperatures above 24 °C and a decreasing humidity down to under 30% RH. Typical damages are deformations, cracks as well as losses in the original substance. Especially leather panels which have been mounted in the past were fixed with nails and therefore are restrained. As a result, the reaction to fluctuations in temperature and relative humidity propagates especially around seams and mountings. For the examination with the SLS already damaged surfaces were chosen for investigation. Figure 2 shows the result of the SLS of the reference area in the Chinese room combined with an orthogonal colour photography, which was laid below to improve the localisation.

The measurements have been conducted with a COMET L3D 5M structured light scanner by Steinbichler Optotechnik (now Carl Zeiss Optotechnik) (Figure 1, right). With this method, it is possible to scan areas of varying sizes by changing the lenses. Using a 250 mm lens, an area of $260 \times 215 \times 140$ mm can be examined, and with a 75 mm lens, the area is $74 \times 62 \times 45$ mm. The distance between two measured points also depends on the lens: the smaller the image section, the higher the resolution (250-mm-lens: $100 \mu\text{m}$ distance, 75-mm-lens: $30 \mu\text{m}$). Using the Comet Plus 9.63 software, several scans are combined into a single data file. The scans were carried out in rows with a vertical and horizontal overlap of more than 50% between every single scan. The redundant data reduces the matching errors between the individual scans and guarantees a higher geometrical accuracy for each monitoring area (Figure 2, 3 right), see Drewello et al. (2011).
