Quarry Marks and Carving Lines on Marble Elements in the Monuments of Roman Athens: Hadrian's Library

Adalberto Ottati

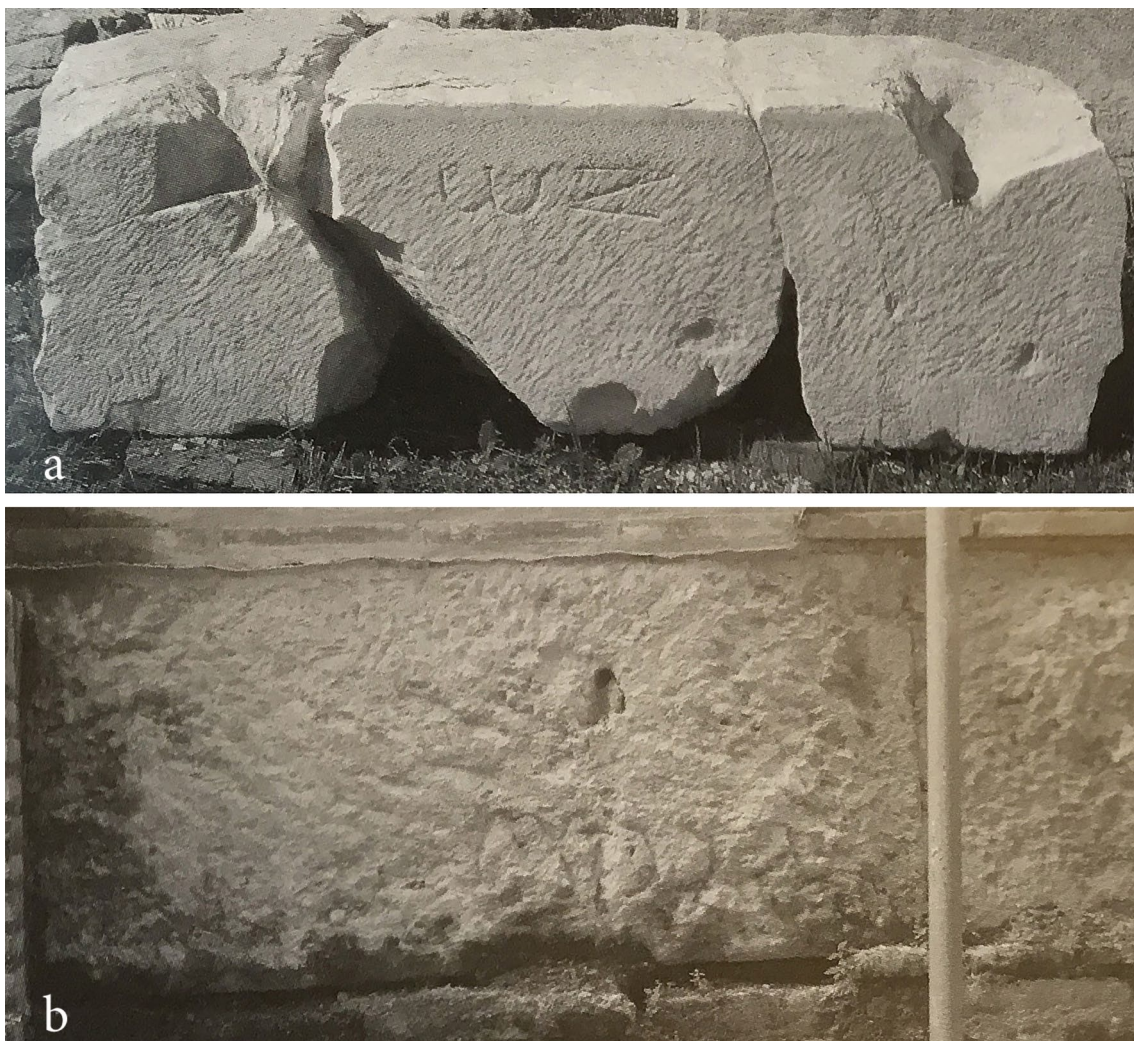
With regard to marks on blocks, the letters and numerals were engraved on blocks of Pentelic marble and Poros stone to indicate their classification and destination during quarrying and transportation to the building site.⁵ It is extremely interesting to note that both the Latin and Greek numerical and alphabetical systems were used to number the marble elements of the monument.⁶ Examples have been found on the ashlars of the first rows (ΙΛΑΓ), as well as on the upper part of the southern wall (ωΖ: fig. 2a). The Latin numerical system was used to number the Poros blocks in the hidden parts and the building foundations on the southern section of the western wall and on the eastern wall (XXXIII, IXX, MDD etc. fig. 2b).⁷

Fig. 2: Athens, Hadrian's Library, quarry marks on blocks; a: Greek quarry mark; b: Latin numerals.

The fact that the stone surface was left rough-hewn has led to the hypothesis that the marks were made during the early quarrying stages.

Notae lapicidarum of this type and their variants are quite common. The mark "ωΖ" has been found, for example, in the Hagia Sophia in Constantinople. Despite the chronological diversity, the comparison is important in terms of the large number of masons' marks in the Hagia Sophia. A. Paribeni's study highlighted the morphological and typological aspects of the *marmorarii* marks and a privileged link with certain types of architectural elements. This led the scholar to believe that the execution of the Hagia Sophia marbles was based on solid planning and standardised working procedures.⁸

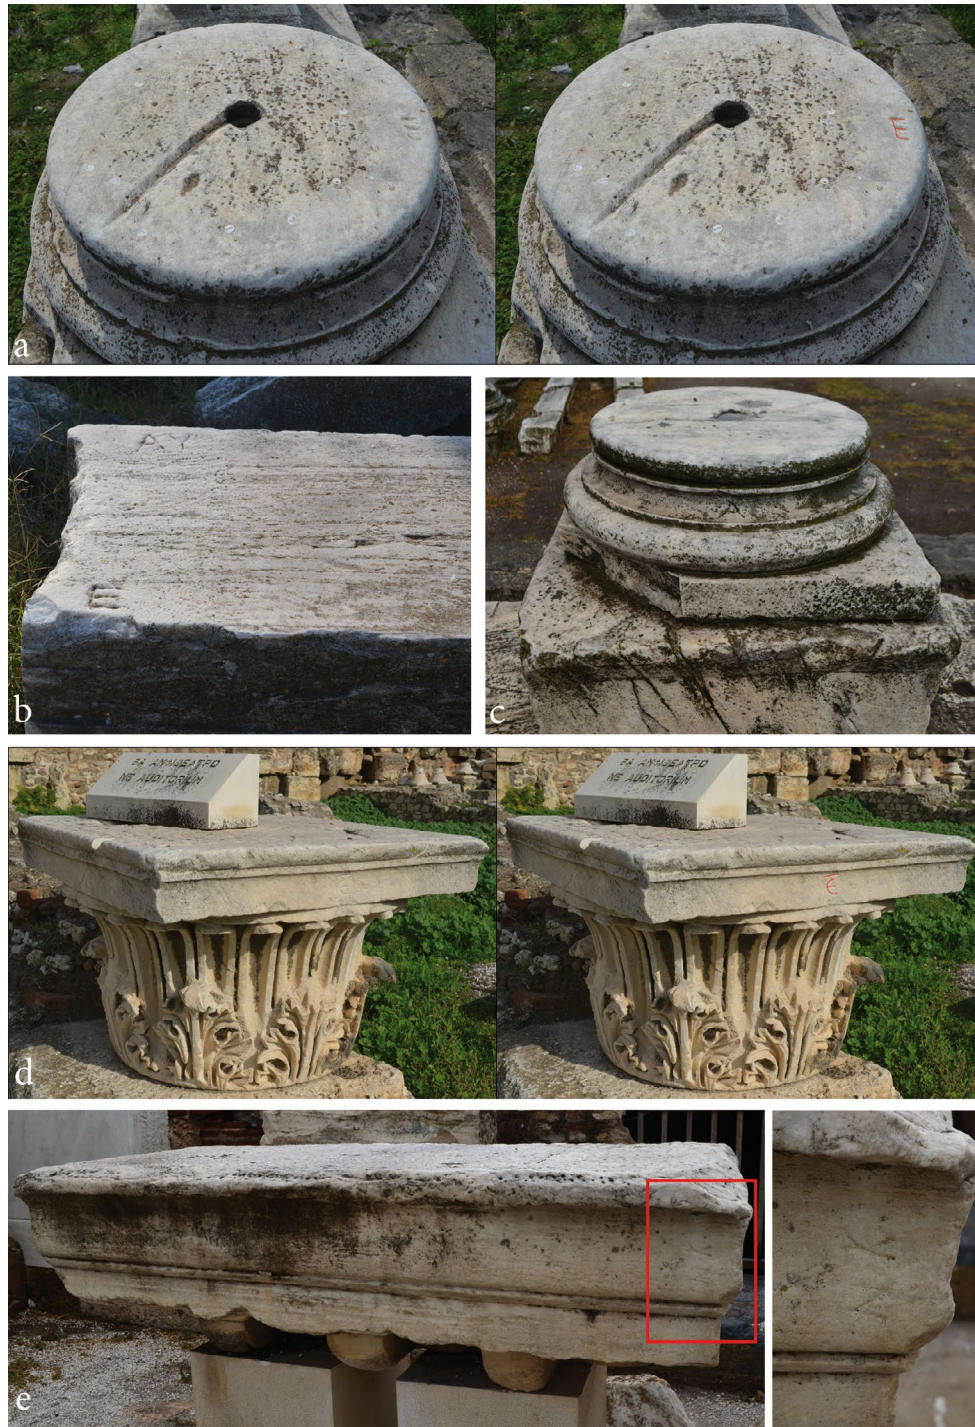
Marks can also be seen on different architectural elements at Hadrian's Library. For example, an "E" is engraved on the flat top surface of two Pentelic marble attic bases (fig. 1, n. 1; fig. 3a). Also in this case, the mark is placed not to be seen and is probably a system for identifying the workshop or to facilitate the counting of and subsequently payment for the products. An example of this is the marks on the basin supports found in the shipwreck of Punta Scifo that were being transported from the Docimium quarries.⁹

One of the two bases engraved on the top surface with the "E" also has an "A" on the back (fig. 1, n. 2; fig. 3c), engraved on the scotia, in this case presumably to assist with its assembly.

Another mark that could be interpreted as numeral useful for the assembly process is on the band below the abacus of a small Asian Minor-style capital¹⁰ dated to the Hadrianic period¹¹ and perhaps belonging to the building's decoration¹² (fig. 1, n. 3; fig. 3d). It is an "C" with a superimposed horizontal line.¹³

Marks of this type have also been found on a cornice placed outside the propylaeum: "NK" on the *cyma recta* (fig. 1, n. 4; fig. 3e).

Fig. 3: Athens; a: Hadrian's Library, east portico, mark on a base; b: Roman Agora, marks on a block in Pentelic marble; c: Hadrian's Library, east portico, mark on a base; d: Hadrian's Library, northern Auditorium, capital with mark; e: Hadrian's Library, mark on a cornice.

Comparisons of this kind are widespread. Examples can also be found in some pieces in the nearby Roman Agora, where the coexistence of several marks can be interpreted as evidence of the different working phases, from extraction at the quarry to delivery at the construction site and the final use and assembly of the materials (fig. 3b).

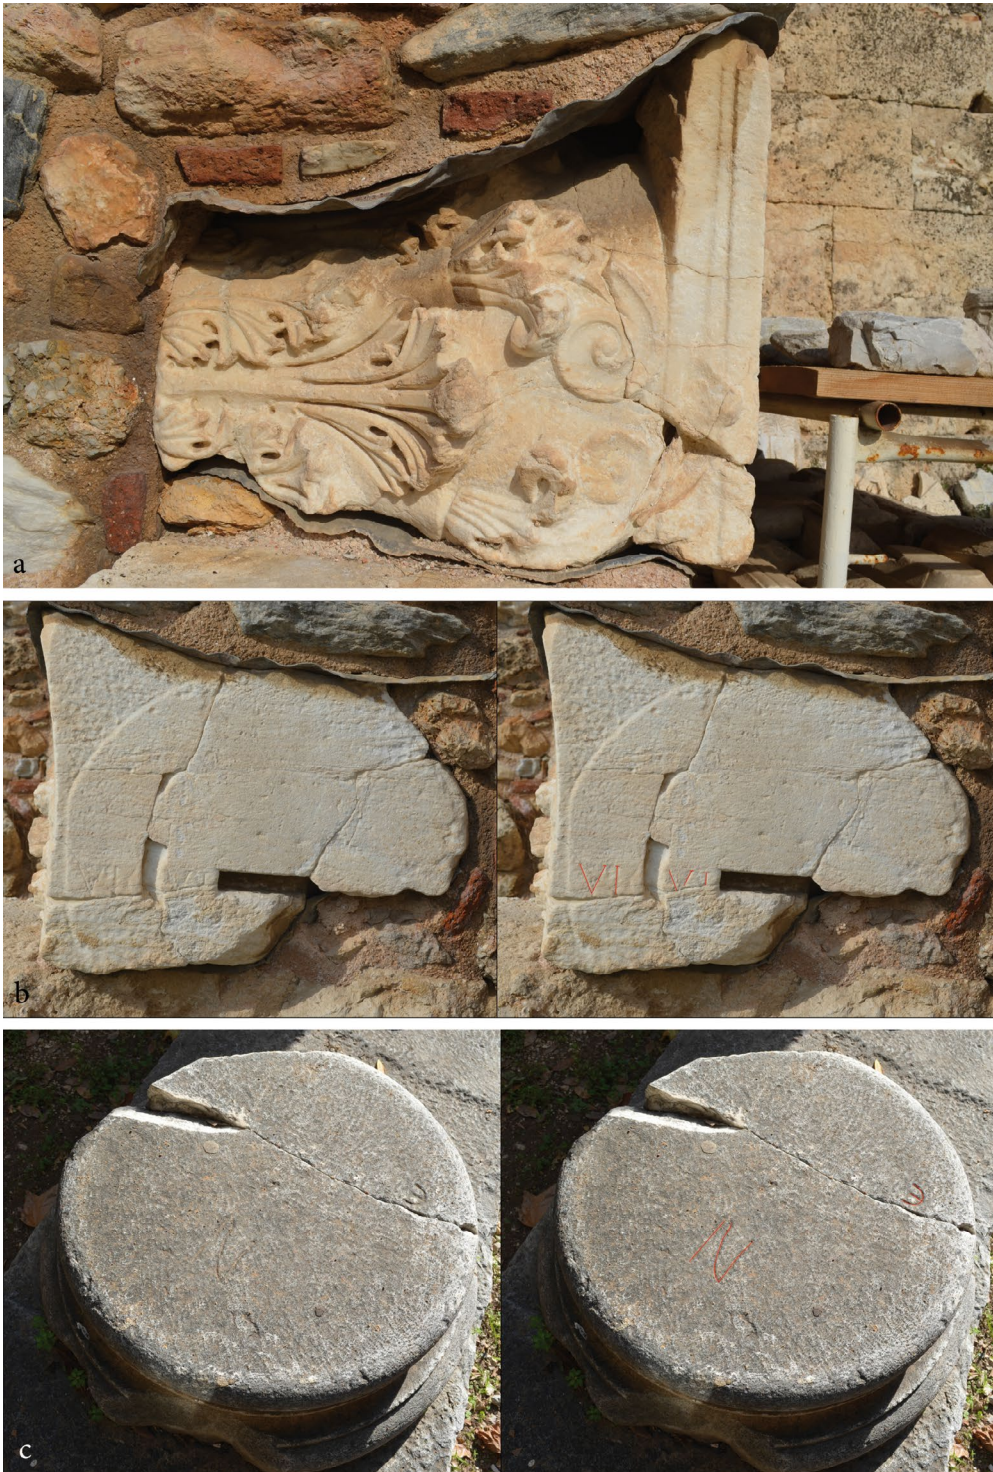
Fig. 4: Athen; a-b: Hadrian's Library, northern side, capital reused in a medieval wall, front and top surface with marks; c: Agia Aikaterini, base of portico with marks.

in modern times (fig. 1, n. 5). On a circular *scamillus* worked on the capital's top surface there are two marks identified as the same Latin number, "VI" (fig. 4b). An explanation of the presence of these numerals is quite obvious, since they are located at the sides of an ancient fracture line and were thus useful for maintaining a link between the two parts of the capital, which had been broken in ancient times, during storage, transportation or use.

It should be noted that a similar numeral (in this case IV), although in a more cursive form, is found on a base reused in the portico of Agia Aikaterini, near Hadrian's Gate. In this case the base is also broken and recomposed (fig 4c). On one fragment we see the Latin numeral and on the other the Greek letter "Ε". The two marks, presumably not contemporaneous, could be indicative of two different uses: the Greek letter would fall into the category of quarry and workshop marks, while the Latin one may have referred to its assembly or reassembly.

Ruling out a modern origin for these numerals which seems unlikely to say the least, it can be noted that also in this case the use of Latin numerals could testify to the collaboration between Greek and Roman workers and uses, which has already been observed for the numerals found on blocks (*supra*).

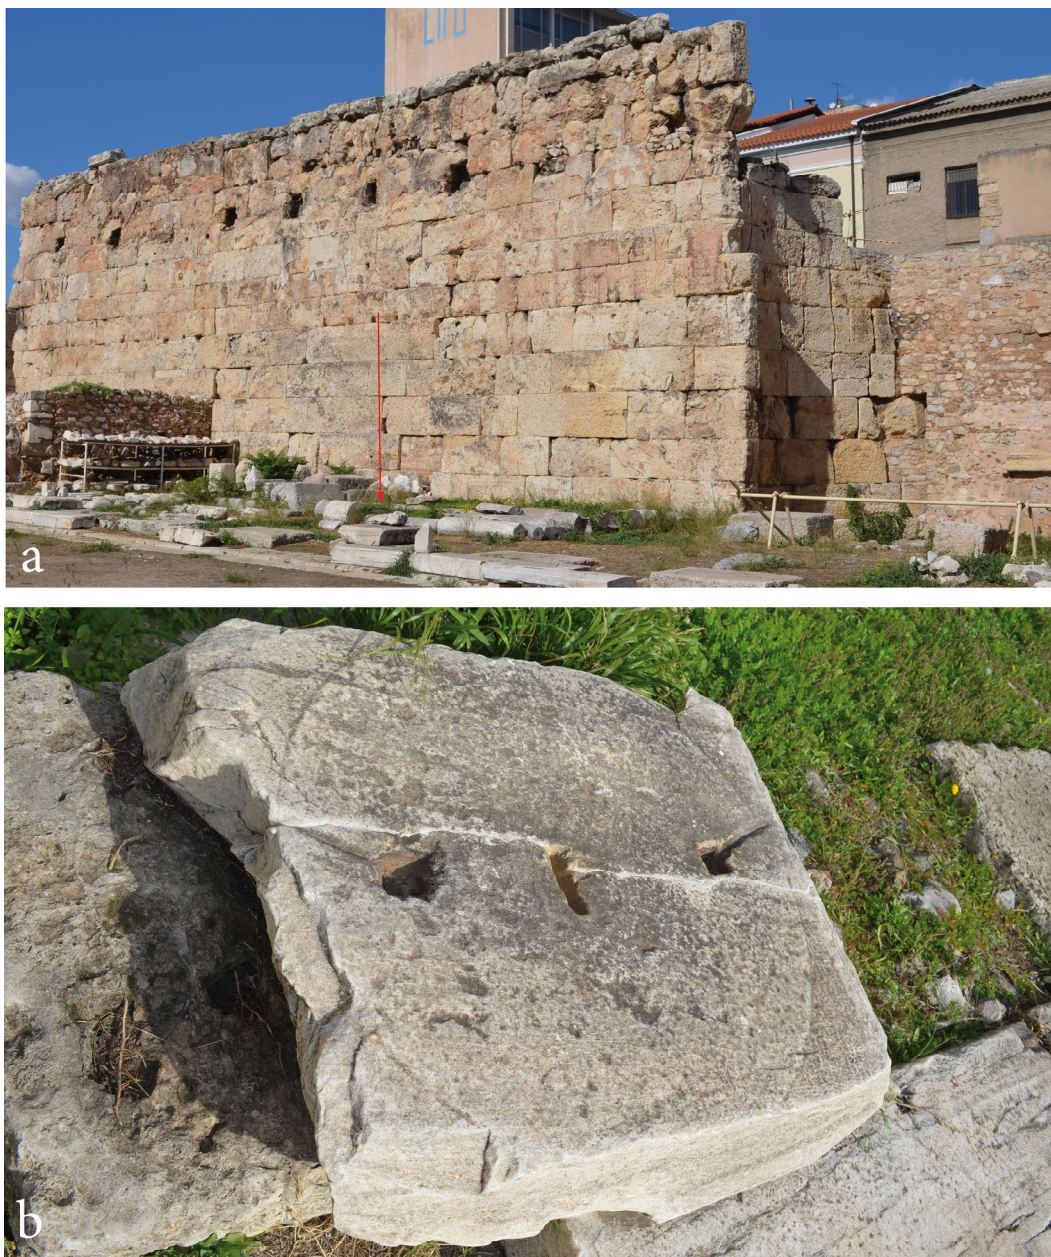
Fig. 5: Athens, Hadrian's Library, northern portico; a: position of one of the surviving stylobate slabs; b: slab of the stylobate with a circular carving.

- The first is on the northern side of the complex (fig. 1, n. 6; fig. 5a). The upper surface presents a circular shape carved with the skilful use of a tooth chisel (fig. 5b).

The system of marking the outline of the upper piece on the lower section is certainly not exceptional in the Greek world.¹⁶ It is not even surprising that the circular incision was used, presumably, for placing the attic bases, therefore with quadrangular plinth. It should be noted that in the propylaeum of Hadrian's Library we find the same use of engraving the stylobate with a circumference on which to place attic bases, an example of which is preserved on the first western column. The presence of the circumference marked on the marble slab of the stylobate may have been used not only to place the elements, but also to manage the building materials at the construction site, which would have arrived in a semi-worked state from the quarries,¹⁷ or, in some cases, for supplying the pieces that had to be of the appropriate size. The dialogue between the quarries and construction site would have been constant in order to ensure that the materials ordered corresponded to the building plan and the frequent changes that would have been made during its course.¹⁸ As pointed out by Y. Tigginaga, this connection is demonstrated by the construction techniques used at Hadrian's Library aimed at producing prefabricated elements that would have improved adherence to the original plan and the speed of execution.¹⁹

Briefly explained, on the northern stylobate there is a carving line that seems to be arranged for a circular element (fig. 5b), probably a base, while on the eastern

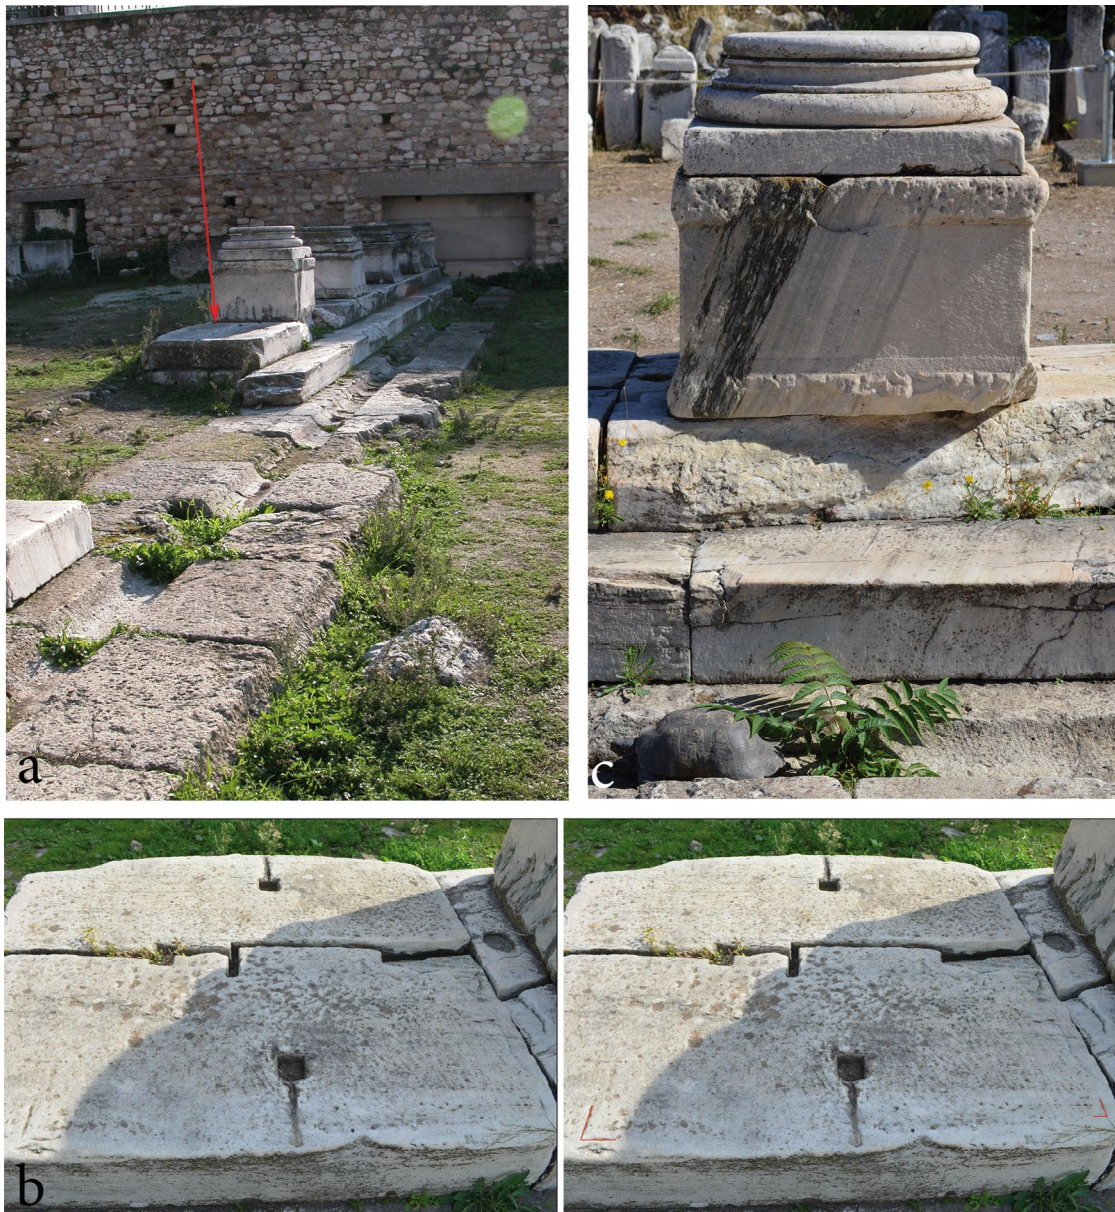
The carving line is located next to the fifth pedestal to the south and therefore does not correspond to the current positioning of the pedestals (fig. 6a).

The stylobate slab, in this case worked in two different blocks, due to a clear act of restoration, does not have any circular-shaped incisions, but signs that delineate the corners of an area on which a square base had to be positioned (fig. 6b). Parallels with incisions marking the positions of pieces are widespread and different examples have been found in Greece and the area of Asia Minor, starting with Hadrian's Library itself. These signs are on the pedestals of the cipollino marble colonnade of the facade.

Fig. 6: Athens, Hadrian's Library, western portico; a: position of one of the stylobate slabs with angular carving lines; b: the stylobate slab with engraved the angles for the placement of square-based object; c: a plinth preserved *in situ*.

stylobate there are engraved lines attributable to the positioning of a square base on a slab formed by re-used elements (fig. 6b). Finally there are pedestals in positions that do not correspond to these incised lines (fig. 6c). While the pedestals are attributed to Herculus' restoration (*infra*),²¹ the difference between the carving lines on the northern stylobate and those on the eastern one remains unexplained and even

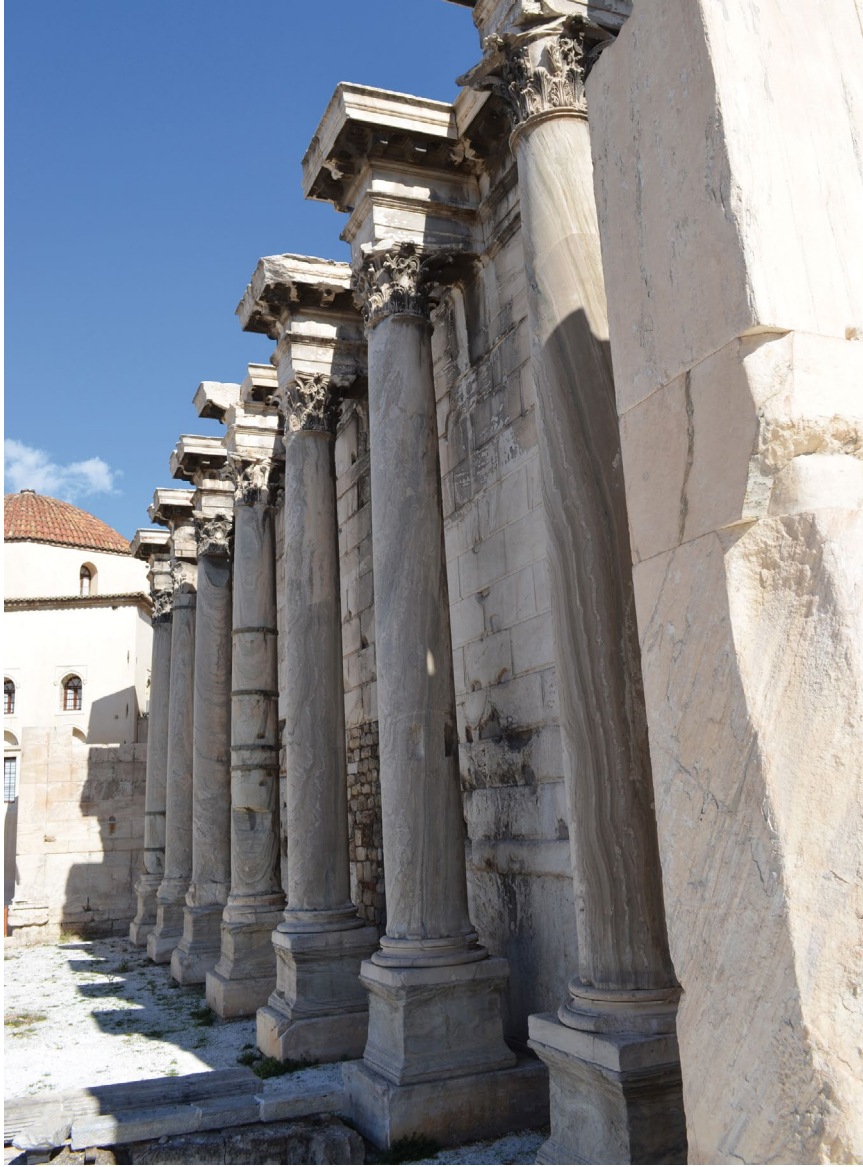
Fig. 7: Athens, Hadrian's Library, western colonnade outside the enclosure with Cipollino marble pedestals.

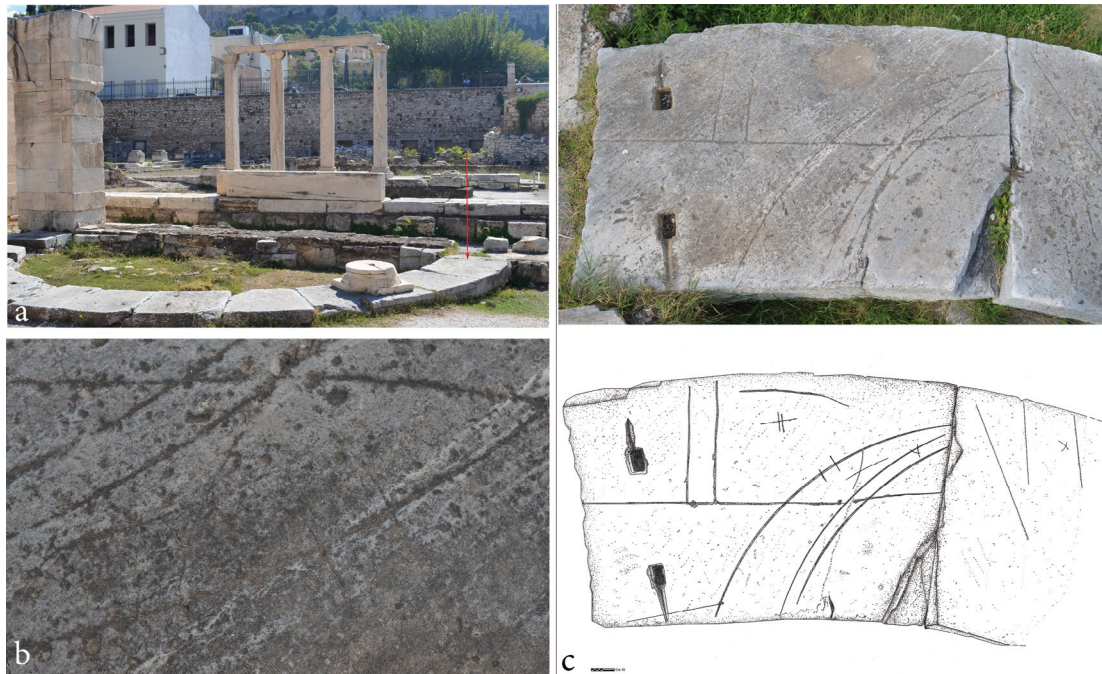
At a site that was extensively rebuilt over the time, such as that of Hadrian's Library,³² it is obviously very difficult to establish the chronology and original building context of many of the marble elements. An extremely interesting case is undoubtedly that of a carving line on a block of Imezio marble used as stylobate for the curved colonnade of one of the ambulatories on the northern side of Eudocia's Basilica (fig. 1, n. 8; fig. 8a).³³

The carving line presents a series of curves calculated with a compass (fig. 8b) that were used for the design of a curved element (fig. 8c). Given its reuse as stylobate of the colonnaded apse of the first phase of Eudocia's Basilica (5th century)³⁴ and the incompleteness of the carving line, which must have continued on adjoining blocks, it can be assumed that it is older than the basilica and belonged to a Roman monument, perhaps Hadrian's Library.

Fig. 8: Athens, Hadrian's Library, northern ambulatory of Eudocia's Basilica; a: position of the stylobate slab with carving line for the creation of a curved element; b: particular; c: stylobate slab with carving line for the creation of a curved element and drawing of the engravings on the slab.

It is currently difficult to try and imagine the three-dimensional manifestation of the engraved signs. They could be part of a plan for an apse or the elevation of an arch or a vaulted structure. However, geometric research clearly shows it to be part of the design of the monument, either part of a planimetry or an architectural element.

The case of the carving line for the construction of a curved element on a foundation block of Eudocia's Basilica is also of great interest, as it shows us a portion of an extremely complex planning process.
