Documenting and visualizing deterioration of monuments on a 3D environment

Projection of 2D documentation drawings on a 3D SfM model

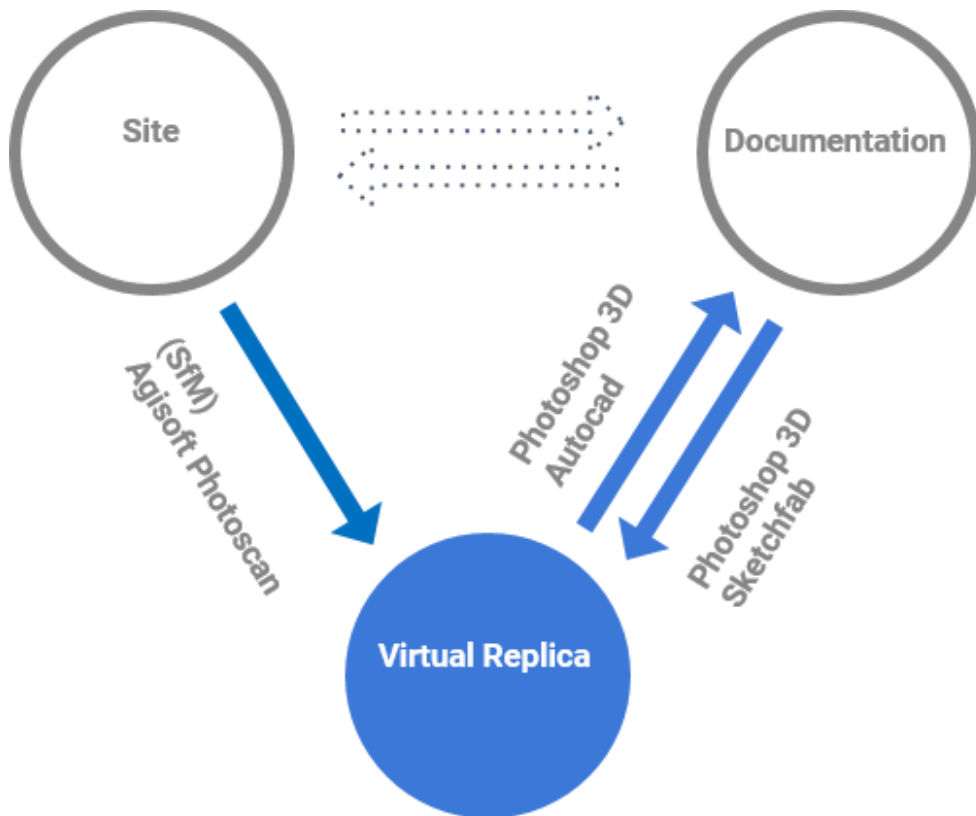
Fig. 1b. Case Study Workflow.

In this paper, the above workflow it is implemented (Fig. 1b) using:

1. Structure for Motion (SfM) method and Agisoft Photoscan software for the creation of Virtual Replica
2. Autodesk Autocad for vector documentation
3. Adobe Photoshop and Photoshop 3D for raster documentation
4. Adobe Photoshop 3D for incorporation of raster and vector documentation
5. Sketchfab as online viewer

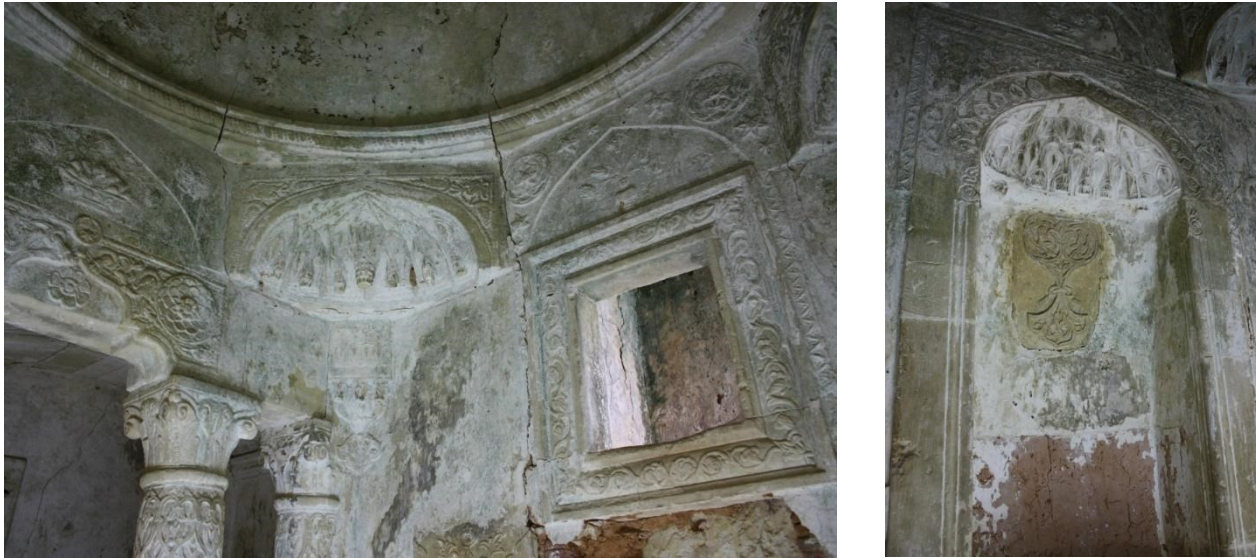
Fig. 2., Fig. 3. Decorative and Morphological Elements.

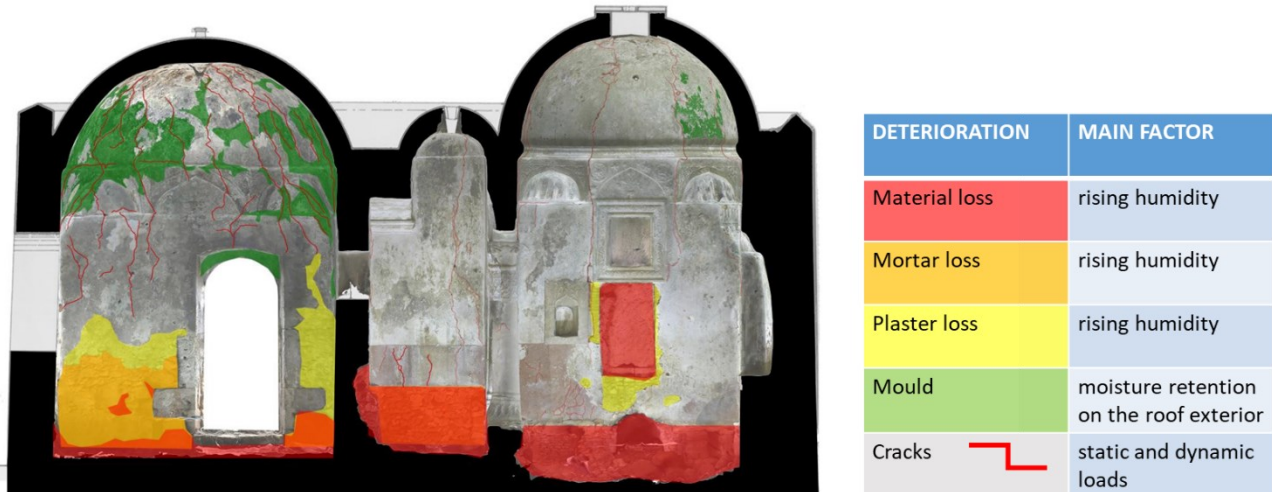
The building due to long-term abandonment presents considerable damage, with a significant crack in the intermediate semicircular dome. At the same time, rising moisture and covering much of its outer envelope with vegetation and soil are constant aggravating factors (Fig. 4).

Fig. 4. Section -Main Deteriorations.

Constructively, the particular hammam is made of a semi-carved stone masonry, it has a number of damages and deteriorations, and needs immediate restoration. Its construction was quite complex due to the configuration and maintenance of the optimum indoor temperature and humidity conditions for the operation of the hammam. The different mortars and coatings used per room relative to the operation of each space have brought different types of deterioration.

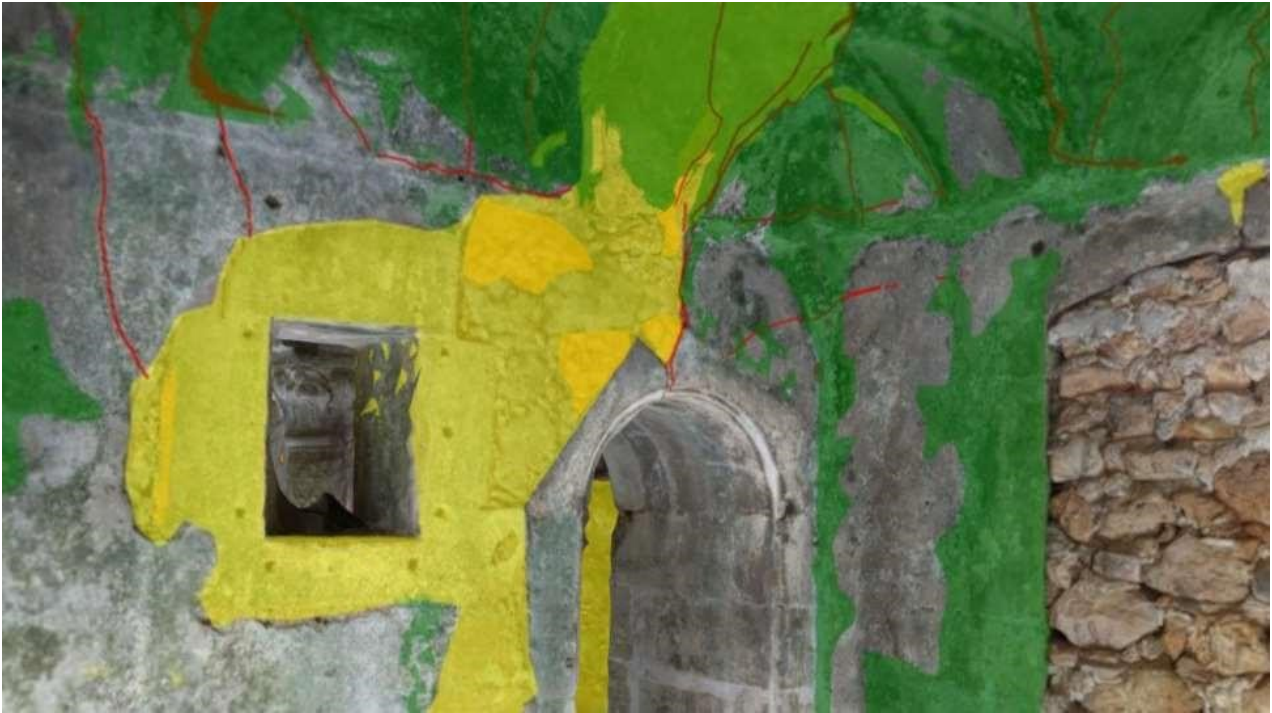
Fig. 7. The final result in the Photoshop 3D environment.

The same procedure can be followed for every different deterioration. The final result (Fig. 7), which includes all the deteriorations, is one .psd file for the 3D model and one (.psb) file relevant to textures with all deteriorations on layers. Inside the Photoshop 3D environment, one can browse the model and observe all the desired deteriorations by turning on/off the layers from the texture file (.psb).

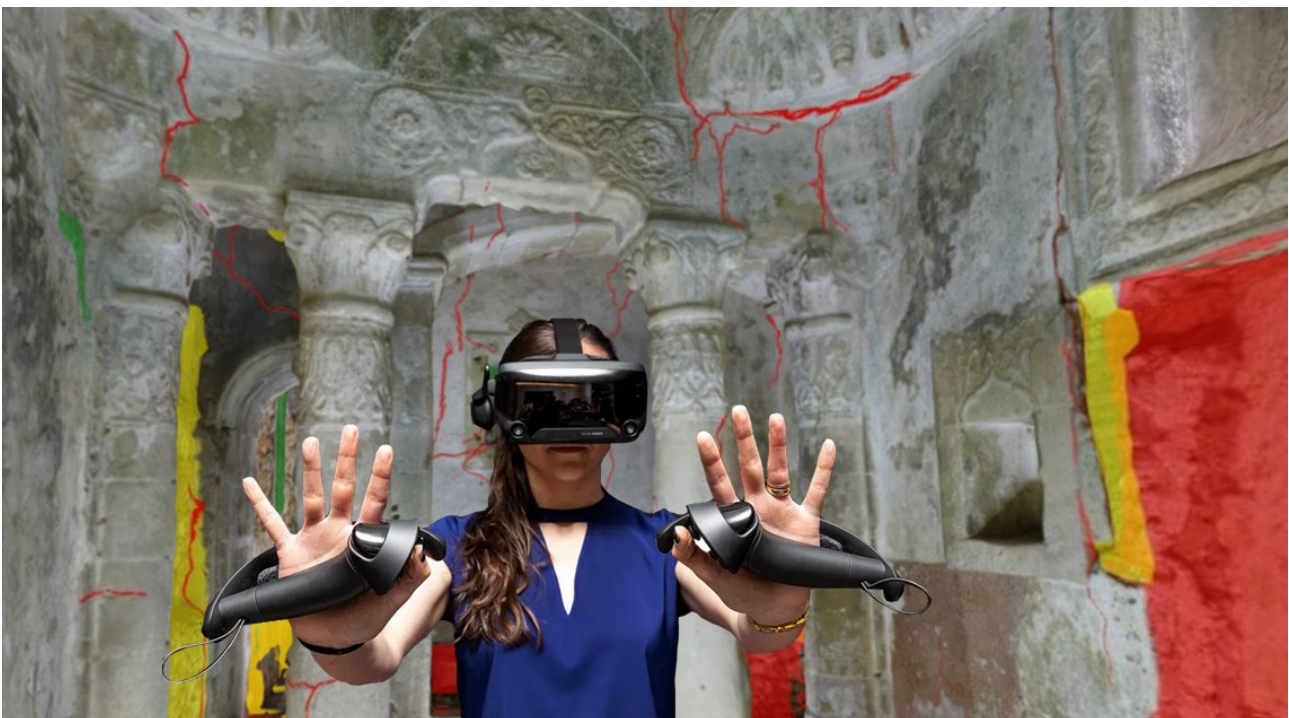
Fig. 8. Future Work

- incorporate in the suggested workflow the 3DHOP (3D Heritage Online Presenter) framework for the creation of interactive Web presentations of high-resolution 3D models.
- examine the success of incorporating of remote sensing documentation in 3D model
- be recording and analyzing directly on the 3D model using VR technologies such as VIVE (Fig. 8) as well as recording and analyzing in situ using AR technologies.
