Structure from Motion as a tool for documenting barge wrecks in the event of looting by treasure divers and threats from a newly immigrated species, the quagga mussel.

Michaela REINFELD¹, Römisch-Germanische Kommission (RGK), Germany Bernhard FRITSCH², Exzellenzcluster Topoi, Germany

Keywords: transport barges—Structure from Motion—monitoring—looting—quagga mussel

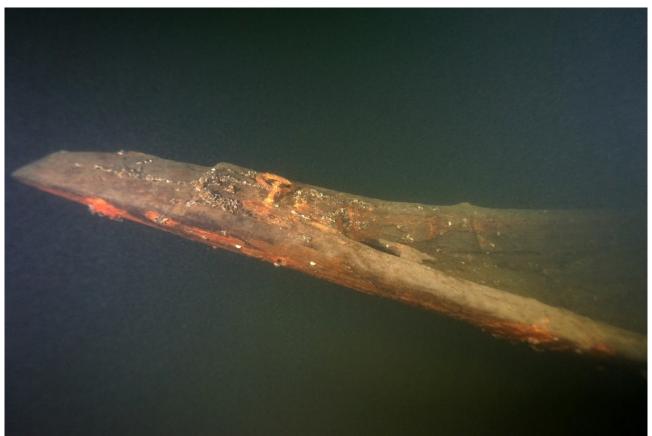
Fig. 3. Raised stem, to which an additional Kaffenspitze was attached (© Kai Dietterle).

The wooden transport barges were built mainly from pine or spruce, with oak used for particularly stressed components. Depending on the conditions of the water, the barges could be sailed, hauled or punted. They were flat-bottomed and the stem and stern were both curved upwards and bent inwards, whereby the typical ends were formed. This shape facilitated landing on the shore. In addition, the high stem was an important aid in navigation (Fig. 3). From the stern, the skipper navigated his barge with a huge rudder, and the aid of a tip attached to the bow, the so-called "Kaffenspitze", served as a bearing when he could no longer see the barge's actual bow due to the high stacked cargo. In addition, a massive mast step that could hold a mast more than 20 m high was located in the front third of the boat. The skipper and his family were housed in a simply furnished cabin in the stern (Fig. 4) (Polandt and Menzel, 1989, pp. 53f, 58; Teubert, 191, p. 272, Sohn, 2013, pp. 36–54). The cabins of the Kaffenkähne are often no longer preserved. They were either destroyed during the accident that led to the vessel sinking, or by treasure divers in search of valuable objects.
