# Pathology detection for HBIM application on a Byzantine church in Axos village in Crete, Greece

In this paper a research case of documentation of structural pathology for HBIM implementation on the byzantine church St. Ioannis Prodromos in Crete, Greece is presented, analysing the process of historical analysis, data capture using laser scanning and photogrammetric tools and documentation, proposing a method for pathology diagnosis and classification to be used in an HBIM application in the future.

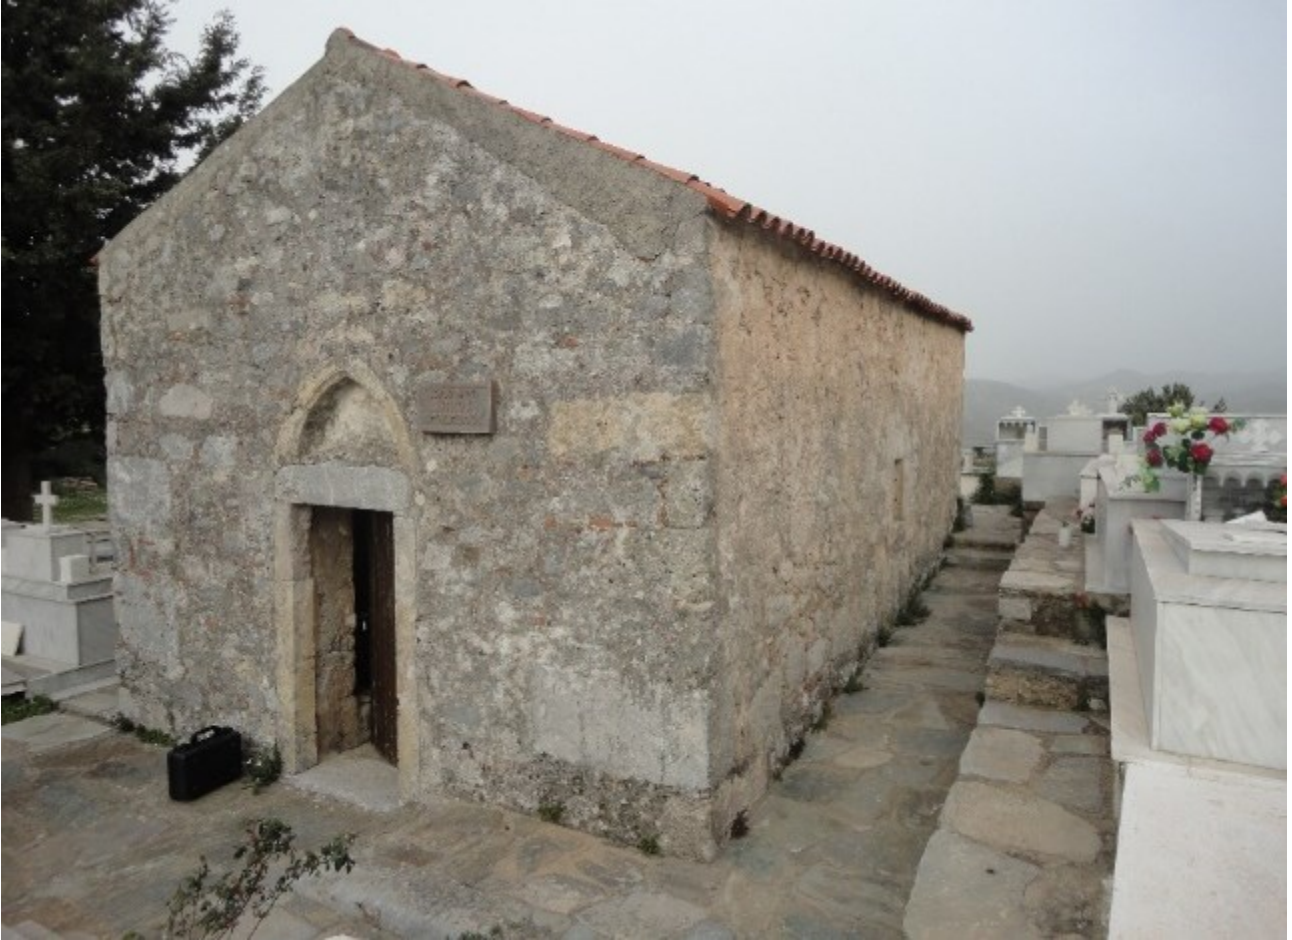
Fig. 1. SouthWestern view of St Ioannis Prodromos in Axos, Crete.

St. Ioannis Prodromos is a single-aisle arched church with two internal stone arcs for additional structural support and a duo-pitched roof with byzantine tiles which is not the original, since the roof of the temple was replaced in the '90s (Fig. 1). The width of the church externally is 5.15 m and its length, up to the arch of the sanctuary, is 8.90 m and with the arch is 10 m (Fig. 1). The width of its interior is 3,62 m. Sanctuary's arch was built on the remains of an older church, which today is preserved at the level of its foundation, 0.20 m over the ground surface. One of the most interesting aspects of this church is a byzantine tile (sleeper), which can be found at the right and left side of the sanctuary's arch at a height of 2.46 m, which has been placed inside the stone structure and was used as a sink, for the elimination of water and moisture, trapped between the roof and the masonry.

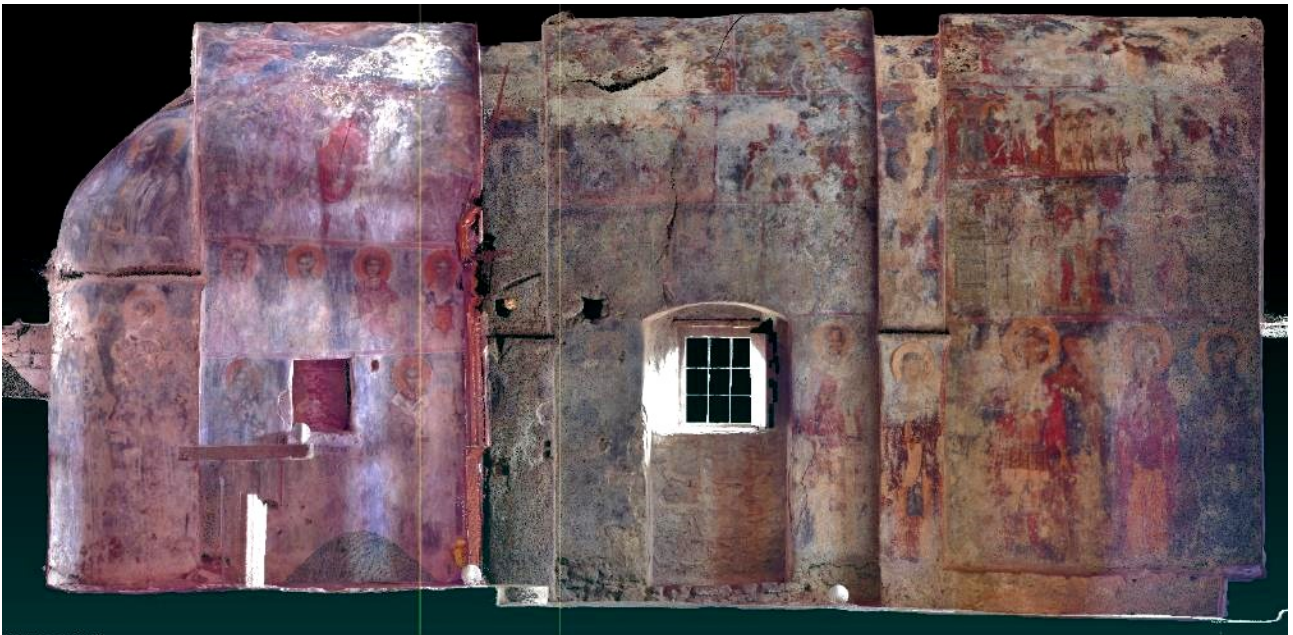
*Fig. 4. Orthophoto of the north facade of St Ioannis Prodromos Church in Axos.*

Pathology diagnosis for structural engineers demanded the highest possible level of accuracy regarding cracks, differences in the shape of structural elements, severe humidity issues that affect stability, etc. Therefore, a methodology using digital processing of selected orthophotos was followed. This technique was chosen as the best applicable one since the whole church was covered with frescos inside, making existing cracks difficult to mark and notice. This phenomenon was worsened by the high level of humidity which had created large blackish areas on the facades. Digital processing including removal of the RGB filters and controlling of orthophotos' level of intensity was carried out in all interior surfaces, making frescos disappear and cracks appear clearly on the walls and arches (Fig. 4, Fig. 5). Architectural designs of pathology were finally made in AutoCAD using Bentley Point Tools for numerous sections, because the highest possible level of accuracy was

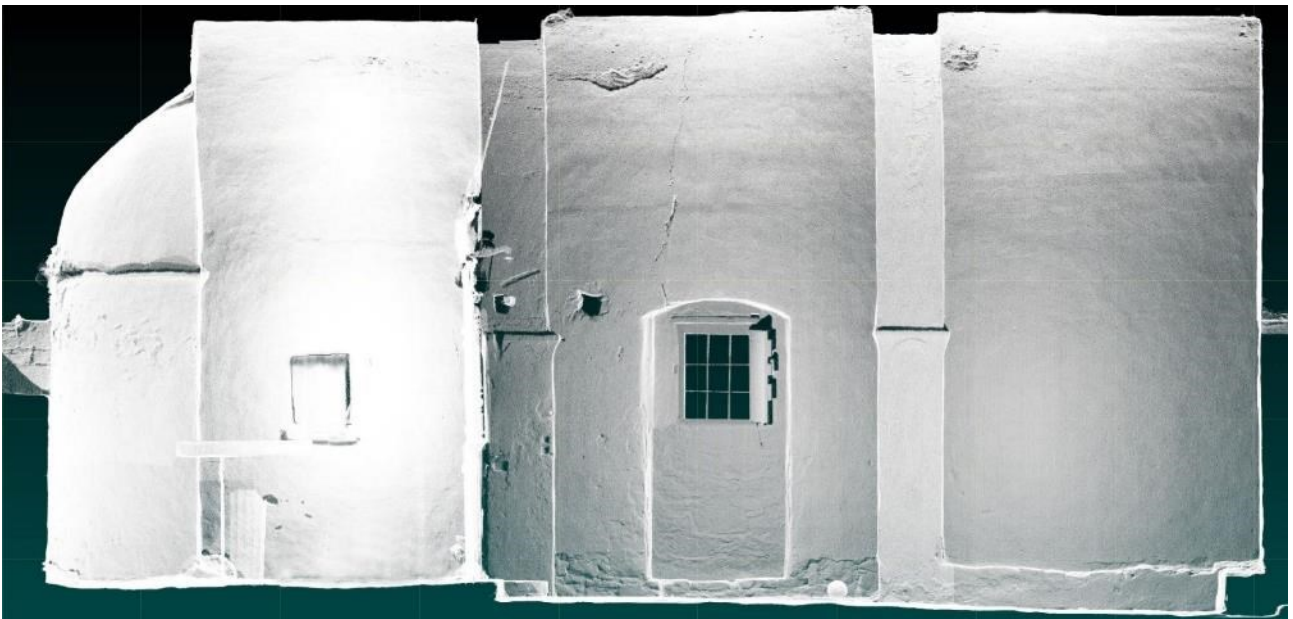
*Fig. 5. Orthophoto of the north facade of St Ioannis Prodromos Church in Axos, without RGB filters, used for crack detection.*

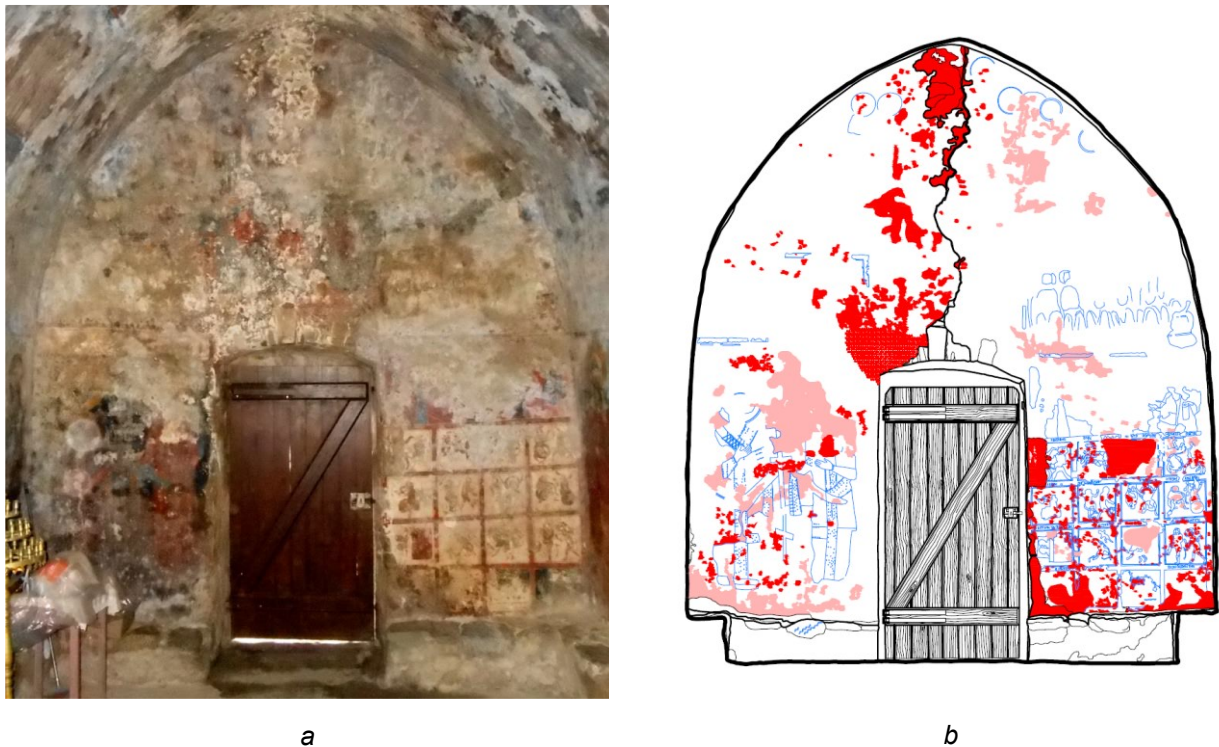
Fig. 6. West internal façade a) Orthophoto b) AutoCAD drawing with pathology mapping.

the restorers, a more specialised approach was followed, that required detailed drawings for the frescoes of each façade, where pathology issues were documented in full detail (Fig. 6).

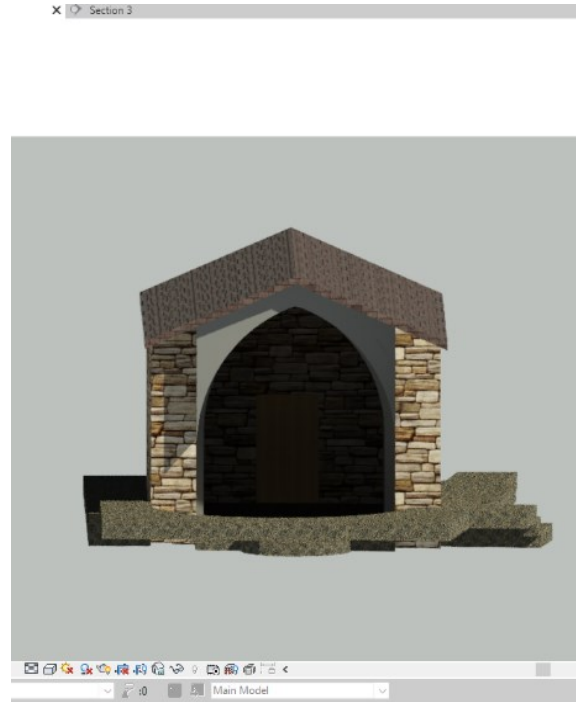
Fig. 8. Model of St Ioannis in Revit 2021 Architecture. a) 3D SE view b) Cross section c) Photorealistic NW view d) Cross section where different material is shown.

In a second phase of the project, a model in Revit 2021 Architecture was created, using all existing designs and information (Fig. 8a, b). Wall and floor architectural elements were used for the creation of masonry, vault structures and grounding area, while the materials of the Revit 2021 library were used (Fig. 8c, d), awaiting the analysis of the mechanical characteristics for further expansion of the attributes. The filling material between the vault and tiles was modelled as well, adding to the constructional accuracy of the model. All information regarding pathology, photos, pathology designs, etc, are added as pictures linked to each façade, while the excel database is being combined to the Revit model.

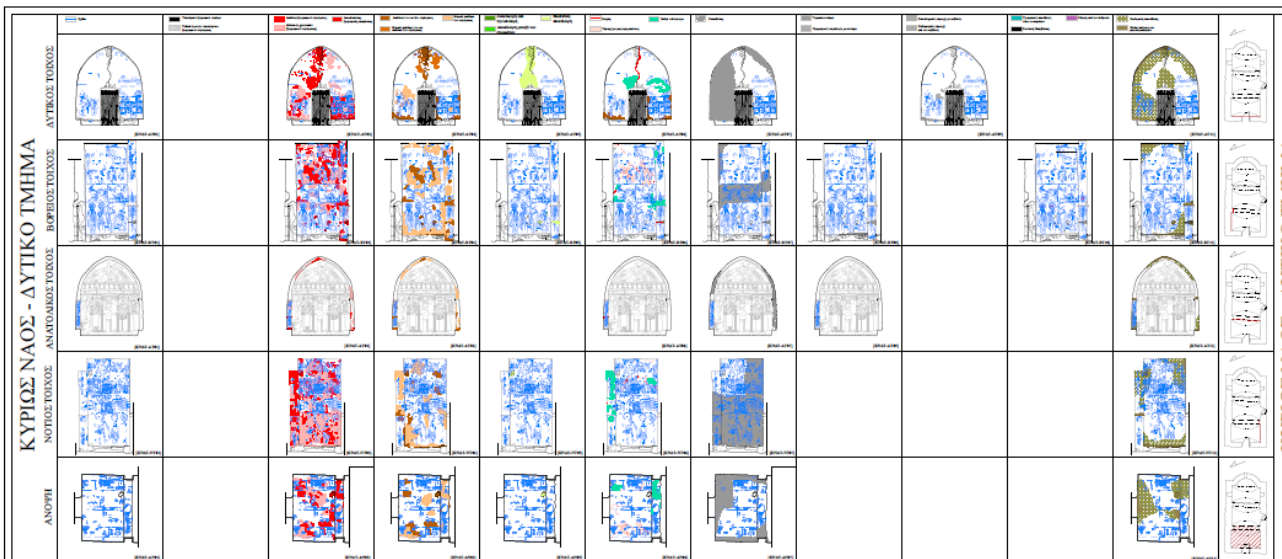
Fig. 10. Frescoes pathology documentation.

Non-structural (aesthetic) problems focused on frescoes, where façades were separated in frames for every form, linked to a list with the name of the Saint or the Christian expression that can be further expanded using semantics regarding orthodox icon themes. Pathology was classified in 16 categories, regarding only the problematic areas and including issues like micro cracking, missing colours, biological damage, etc (Fig. 10). It is important to note that in this case a close collaboration with experienced conservators was necessary, for a full and thorough documentation, that could save both time and money in the restoration process.
