## Digital survey as a diagnostic tool

### A model for the tower of the Castle of Cerretaccio

Ambra MARAMAI, Università degli Studi di Firenze Scuola di Architettura, Italy

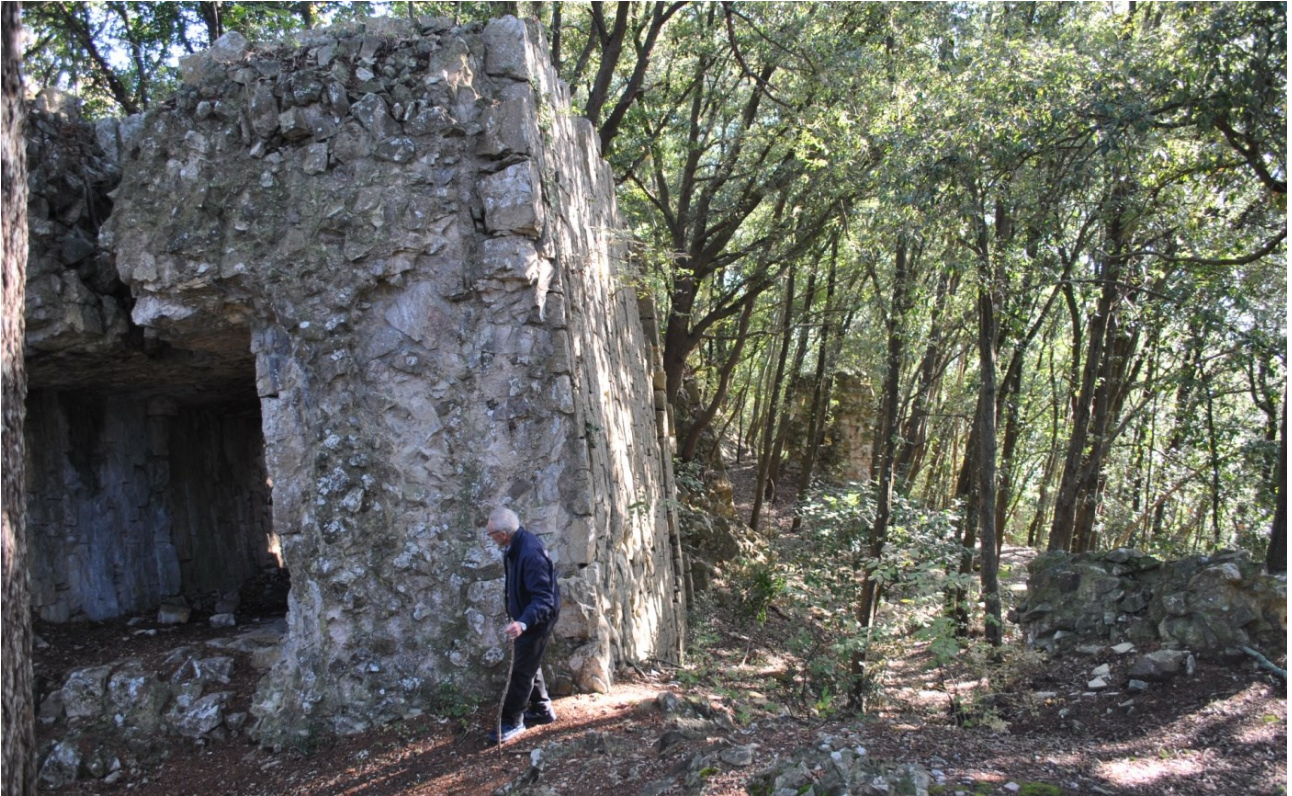
*Fig. 1. Tower section. (© A. Maramai)*

This is one of the most evident cases in which the digital survey and therefore the production of a 3D model could become not only a representative tool but rather an essential diagnostic tool. By implementing a backward procedure, starting from the various fragments of the tower lying on the ground and going to reassemble them, up to virtually reconstruct (or physically using a scale model) the original model of the tower, it will be possible to highlight any deficiencies consistent in the foundations, fractures that can be traced back to the seismic action or to the war activity or possibly aspects never taken into consideration.

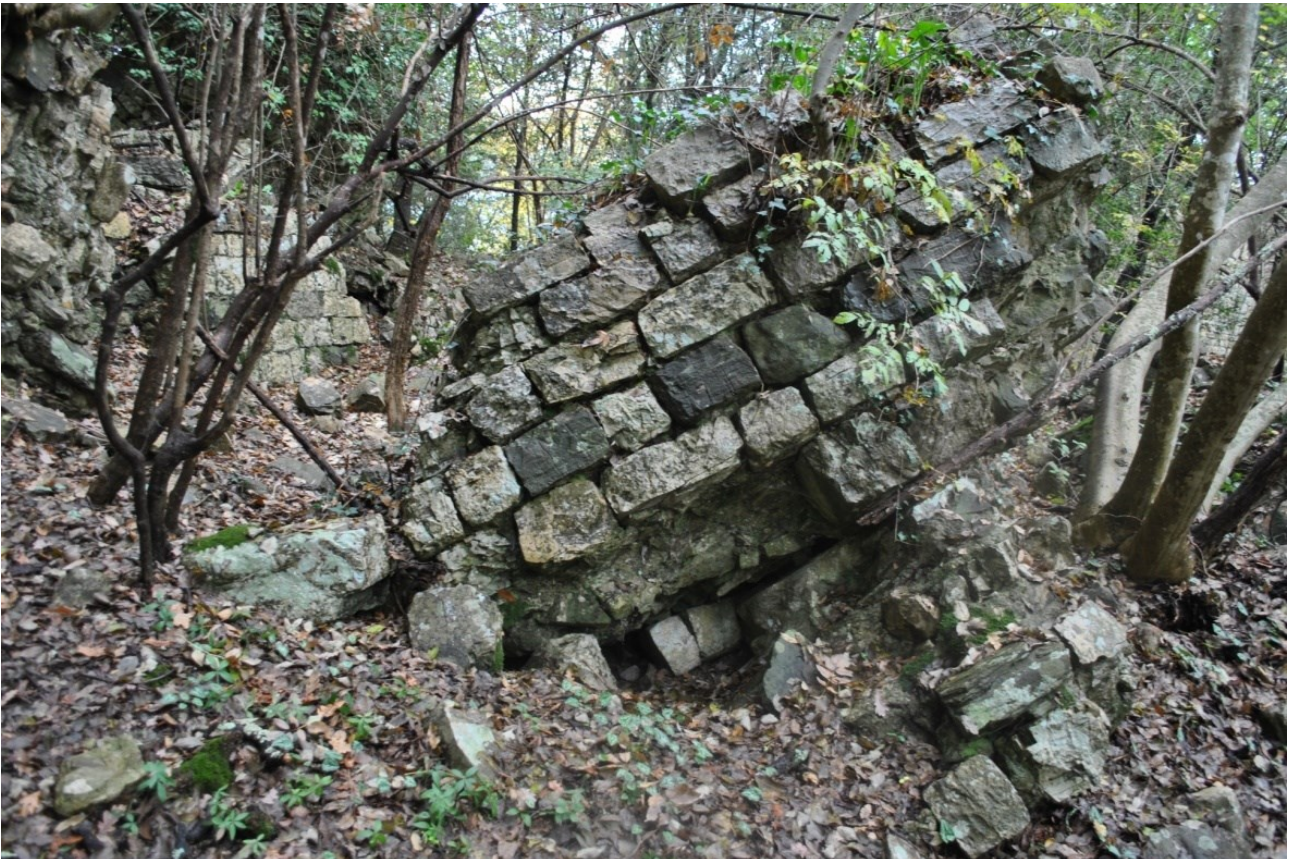
*Fig. 2. Some fragments of the tower. (© A. Maramai)*

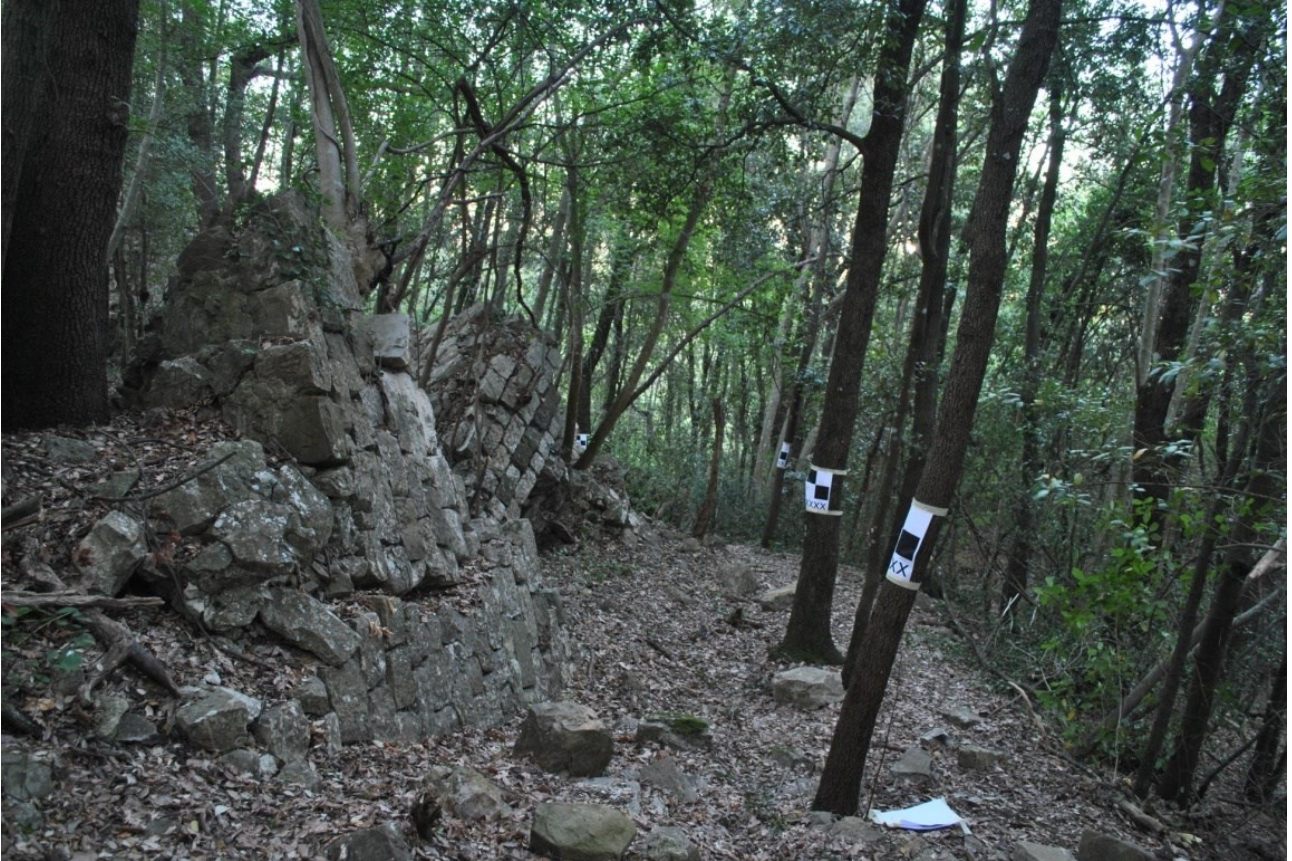
*Fig. 3. Digital survey campaign. (© A. Maramai)*
