Patterns of Post-Earthquake Domestic Architecture in Bam County (Southeastern Iran), an Archaeological Study

LEILA PAPOLI-YAZDI* & OMRAN GARAZHIAN**

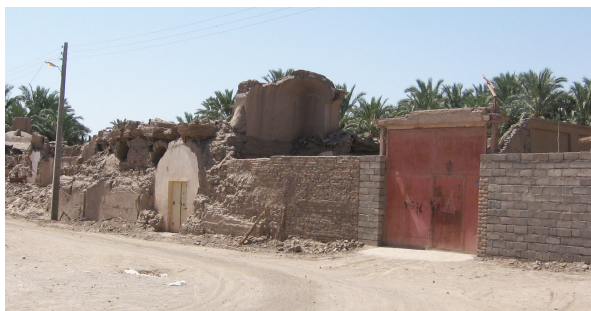
Before the earthquake Bam was famous as one of the unique mud brick cities of Iran. In its historical districts, clay and mud bricks are the main building materials, the roofs are arched, and 30–60 cm thick walls support the weight of the roofs. Decorative features in such buildings include partitions between, or among, roof arches (Fig. 1).

Fig. 1. Traditional houses, Bam city.
Photo: L. Papoli-Yazdi.

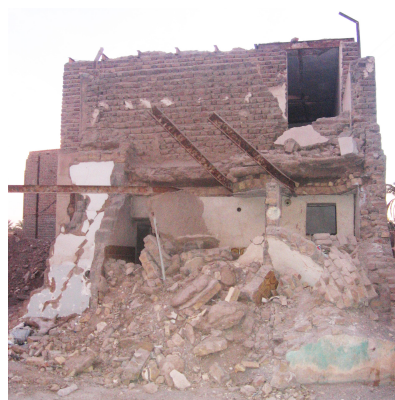
In modern districts of the city, the buildings are unlike the traditional ones, which were mostly surrounded by palm gardens. Most of the buildings in this style are constructed of bricks, clay, and lime mortar for the walls, and soil and chalk for the roofs. Wooden beams and girders are used to construct flat roofs, and the walls carry the load of the roofs without having any organic relation with the roof. These buildings are mostly decorated with chalk layers, and tiles are used in specific parts like the kitchen and toilet (Fig. 2).

Fig. 2. Transitional style of houses, Bam.
Photo: L. Papoli-Yazdi.

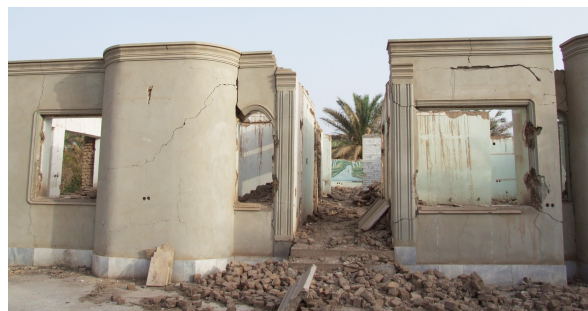
Most of the buildings in this style are constructed of bricks, cement, girders, and block posts. Roofs are flat and the building has a framework that transmits the roof's load to the walls. The major parameter of this style is having a framework. Buildings are decorated on the exterior with ornamental 3 cm bricks and cement, and on the interior by arches and paintings on chalk layers (Fig. 3).

Fig. 3. Modern buildings, Bam.
Photo: M. Dezhankhooy.

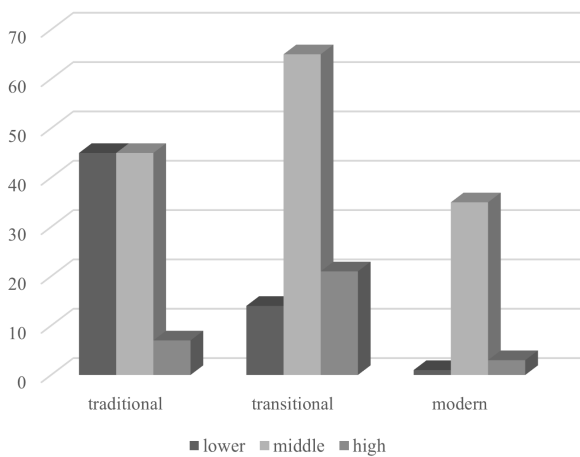
Based on the studied cases in Bam, about 45% of the traditional buildings belong to low-income people/families, 47% to those of middle-income status, and 7% to high-income residents. This means that most of the residents in traditional-style buildings are from those with middle- and low-income status. For the transitional style buildings, 14% of the residents are of low-income status, 65% belong to those of middle-income status, and 21% to high-income status residents. This demonstrates, that for transitionally styled houses the majority belong to those of middle-income status. Following the positive correlation pattern between income status and the modernity of building style, 64% of the residents in modern-style buildings were of high-income status, and 35% were of the middle-income group. In our study it was observed that modern-style buildings were never inhabited/owned by low-income status people (**Fig. 5**).

Fig. 5. Number of each construction style according to different economic statuses.

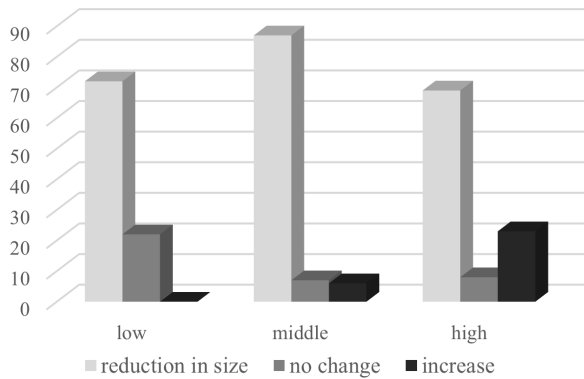
The size in 72% of low-income status buildings decreased, while in 27% of cases there was no change in building size. There was no increase in size with regards to the buildings of this socioeconomic group. For the middle-income group, in 87.5% of cases there was a reduction in building size, in 5% of cases there was an increase in size, and in 7% of cases there was no change in size. For the high-income group, in 69% of cases there was a reduction in size, 23% demonstrated

an increase in size, and in 7.6% of cases there was no change in size. Generally, we can say that a decrease in building size was the most frequently observed size change. Size increases, when they occurred, were mostly in high-income households, as they have more capital to finance an increase in building size. Furthermore, high-income households experienced fewer changes in the size of their domestic spaces (**Fig. 7**).

Fig. 7. Changes in building extents of different economic status compared with pre-earthquake ones.
