KAYSERI SITE ASSESSMENT VISIT

Dates: June 15-21, 2015

The numerical evaluation indicates historical, social and cultural significance, the actual physical conditions and potential risk of the monuments on a scale of 1-5 (1- very low, 2-low, 3-medium, 4-high, 5- very high). Thus, the monuments acquire their place in the final risk array, according to their heritage significance combined with current and potential threats. The monuments ranking higher in the final array are those which require urgent preservation action.

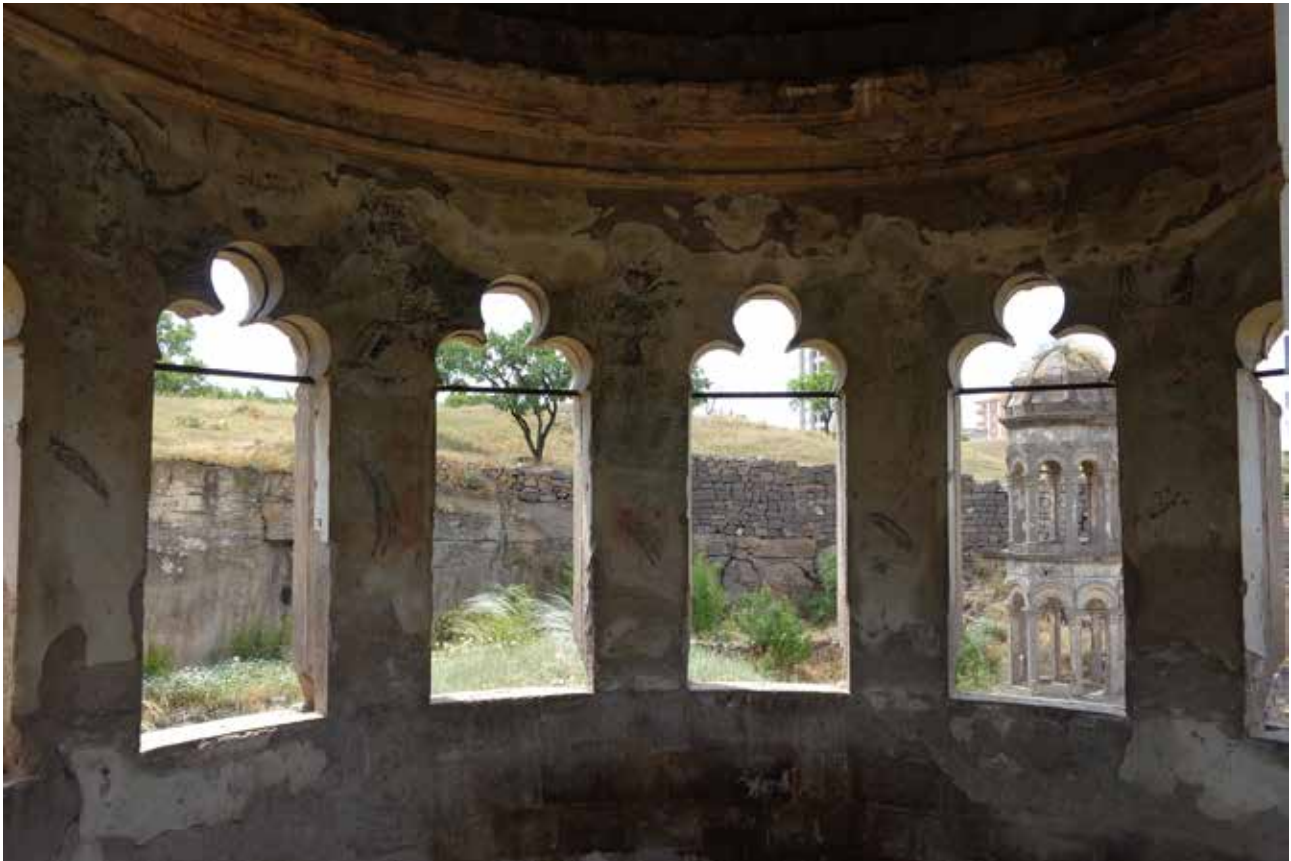
In the area of the nave, a large number of windows have been filled with rubble and the marble floor-tiles have been removed, while the few surviving metal spreaders have suffered from oxidation. All structural elements have received significant damage from high humidity, which has damaged the plaster and the wall paintings. Stone roof tiles have been damaged or removed and vegetation growth is apparent on the surface. The dome is still standing (a rare instance among the churches in the area) but has suffered heavy damages: the binding mortar has eroded which pits the dome under the risk of imminent collapse.

The church occupies a prominent position on an artificial plateau on the outskirts of the settlement and virtually abuts a high rock. It may be accessed by vehicle from the main road of the village until a certain point after which the visitor must proceed on foot along a cobbled path. The ground around the building is covered with large stones that remain in situ since the time the temple was built, thus defining the outer limits of its courtyard.

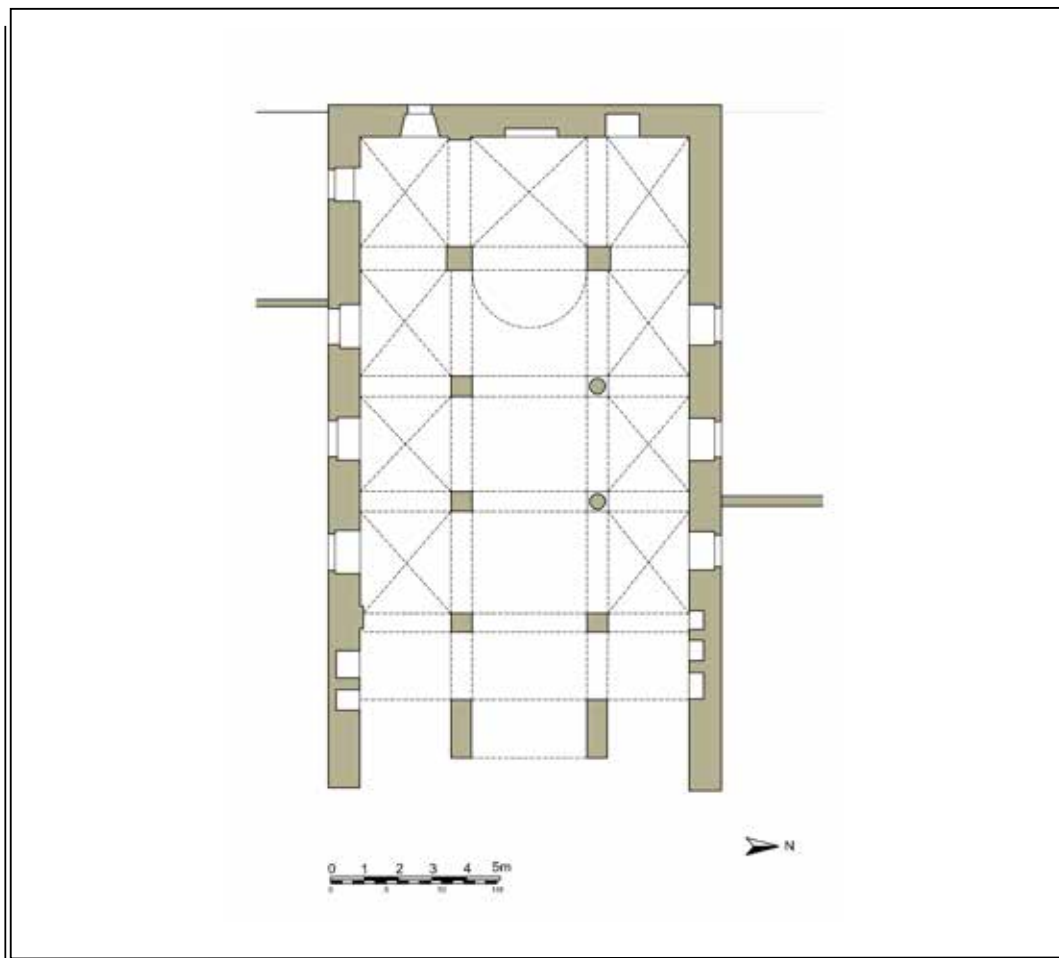
it was used as a factory, which also changed the structure's relationship with its environment. Today, there are additional spaces on the south end of the structure. The entrance is through the courtyard built with the additional walls. The east wall of the building is destroyed to open a new entrance. The original entrance to the structure (through the west wall) is closed, with the apse (on the east wall) destroyed to make way for the new entrance. The gallery story is removed. Stone blocks are later additions supporting the columns and a concrete area into the interior. It is possible that these additions accommodated a crane and a horizontal transportation system for the factory. The floor is covered with cement. A reinforced-concrete water tank was placed on the roof during this period. Vaults and arches are whitewashed. Religious frescoes appear on the vaults, but only few of them have survived as the plaster has fallen off.

Additional structures, new walls, and added masses have brought along structural issues as well. Drainage problems in the roof lead the plaster to fall off, and thus has damaged the frescoes. Joints and the roof have vegetation growth. Iron spreaders are rusting while the concrete mass on the roof weighs down on the structure.

Given its structural conditions and exposure to human and natural damage, the structure is currently under risk. Urgent intervention is required especially to prevent the collapse of the apse and the vaults. As the structure is inside

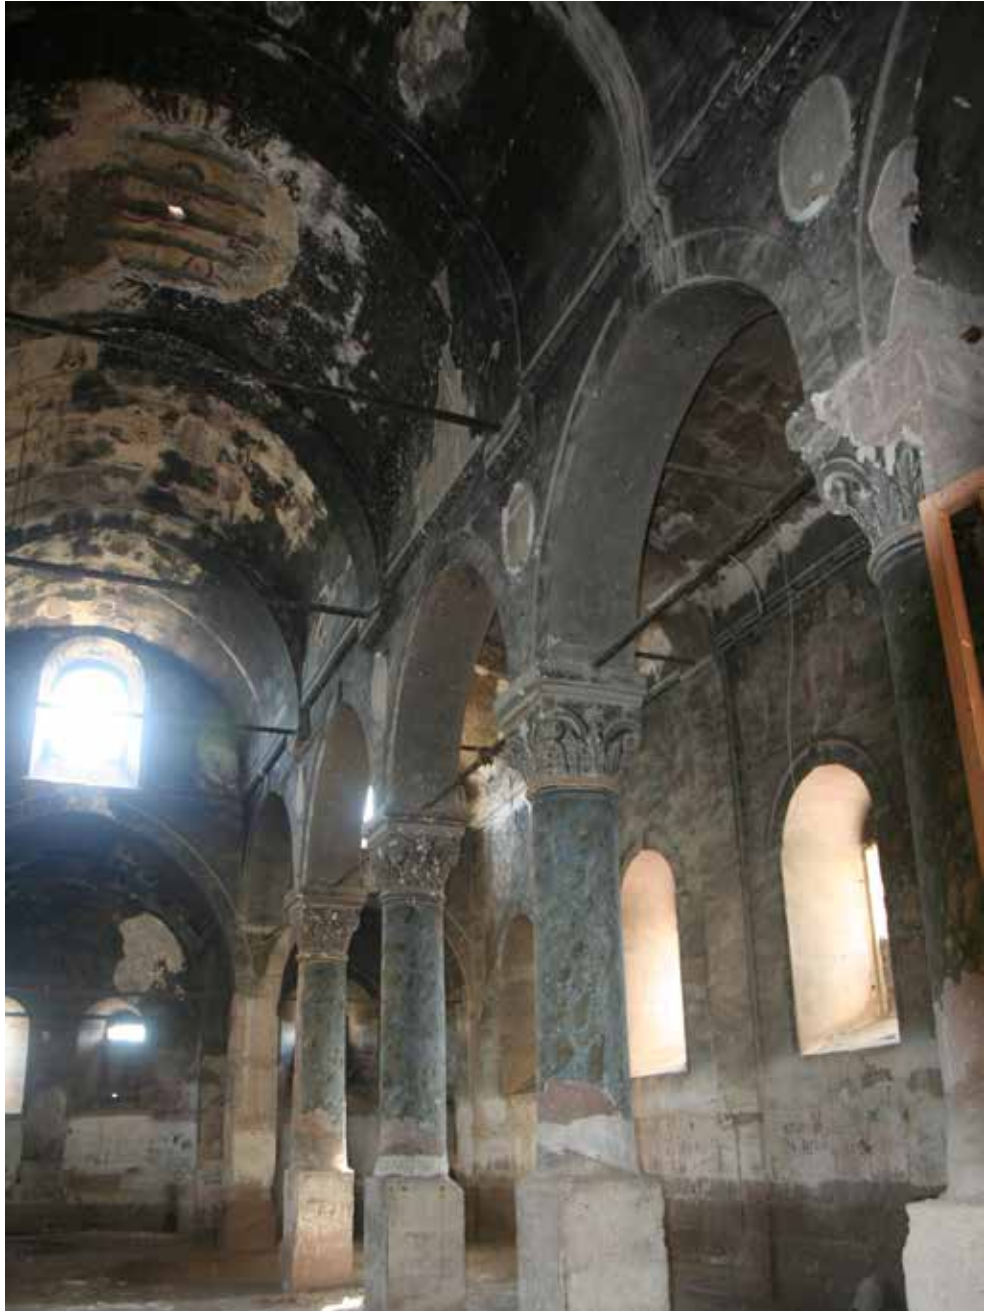
*Church of Saint Demetrios
Incesu county, Yeni Cami neighborhood*

The destroyed and exposed arches of the narthex and the gallery are walled with rubble and uneven stones and the resulting spaces are provided with new entrances. Some windows are also filled in. Most of the stone cladding of the roof has fallen off, with the molding broken in some places. The roofing is covered with vegetation. The floor of the interior is unrecognizable due to treasure hunters' excavations. Window grills are dismantled. There are visible cracks on the

apse and the columns. The frescoes and the floor are damaged. No trace of the bell tower survives.

The plan and the spatial features of the building are entirely recognizable. Research has been conducted, but no excavation or a far-reaching iconographic study has been done so far. The biggest threat to the structure today is its exposure to human damage. Deteriorated, neglected, and vulnerable to earthquake, it requires immediate structural intervention. Excavations in the vicinity could provide the

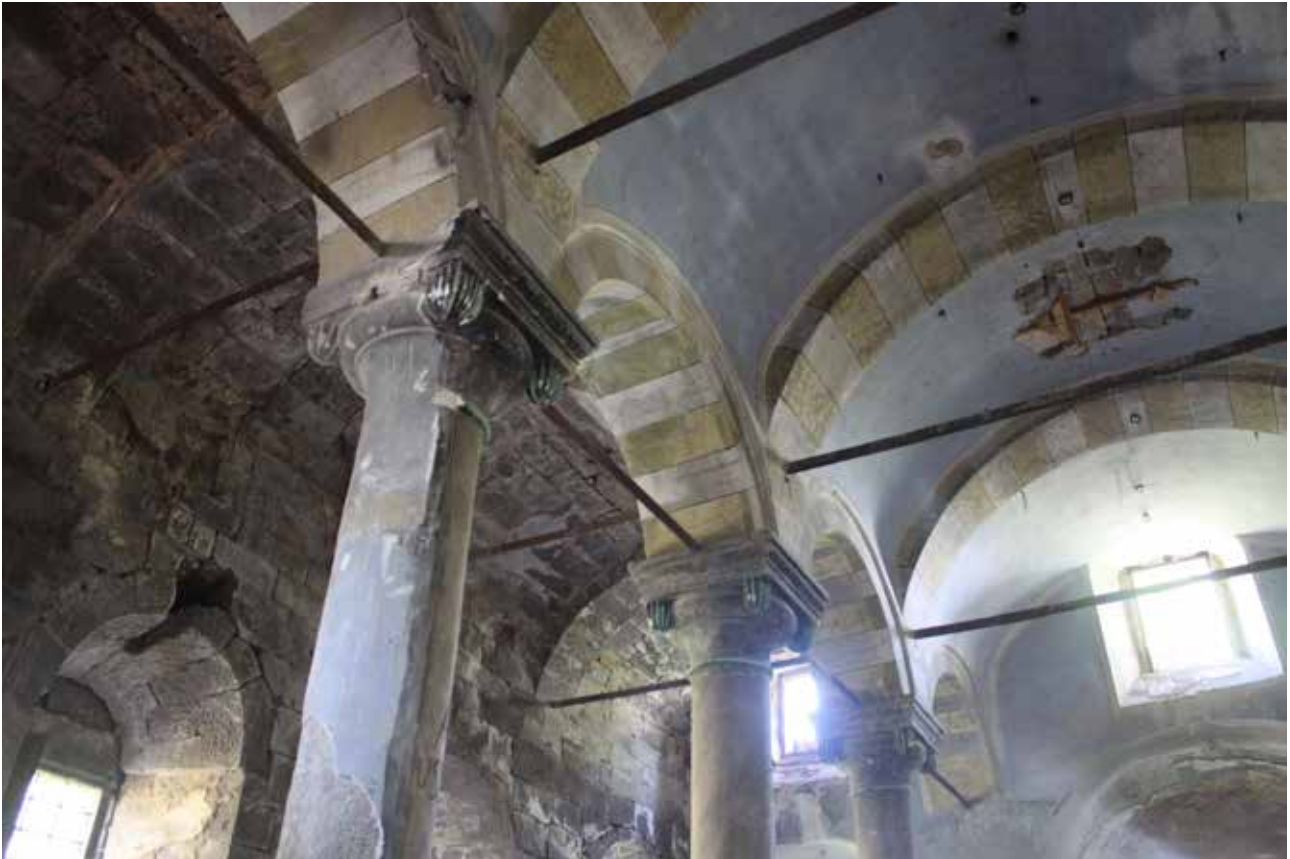
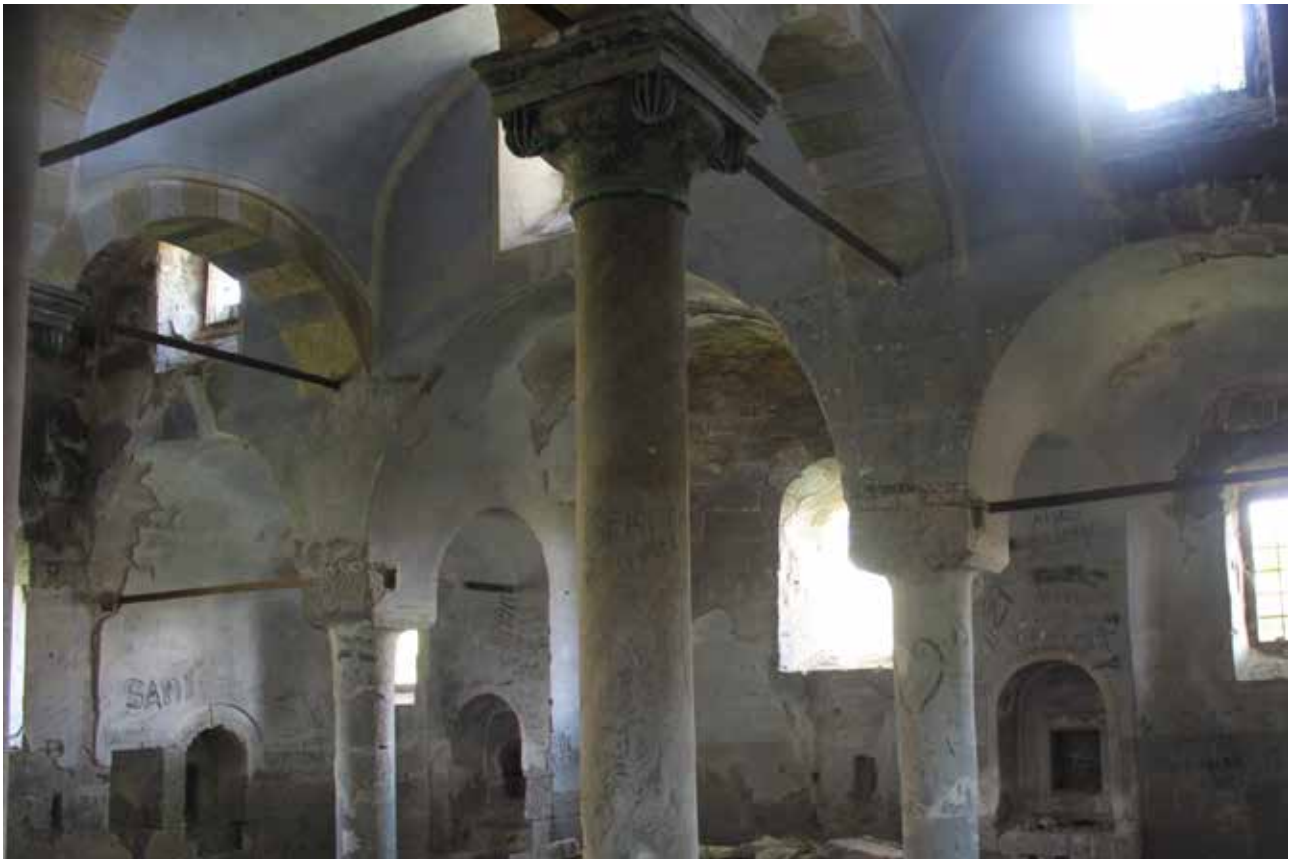
The plan and the spatial features of the structure are entirely recognizable. The main walls, apse, narthex, and the roofing are still standing. The narthex on the west is walled and its arches are filled but it is still observable from the façade. The window on the west wall of the south nave is walled in. The upper part of the bell tower is destroyed while the interior floor is unrecognizable due to treasure hunting excavations. Interior paint and coating have flaked off the walls, spreaders and window grills are rusting, and some window frames are removed. Molding and cornices are broken in certain parts on the façades. Incrustation causes damage on the columns of the portico while vegetation growth on the roof affects deformation.

The biggest current threat to the already neglected structure is exposure to human damage. Vulnerable to earthquake, it requires immediate protection and structural intervention. Excavations in the vicinity could provide the required information on its original site.

The structure also needs cleaning, protection, and a sign. Awareness raising activities can be done about the structure and its cultural significance for locals. Along with the Surp Toros Church that belongs to Armenians, another ethnic group in the village, the structure can serve as an alternative tourist destination.

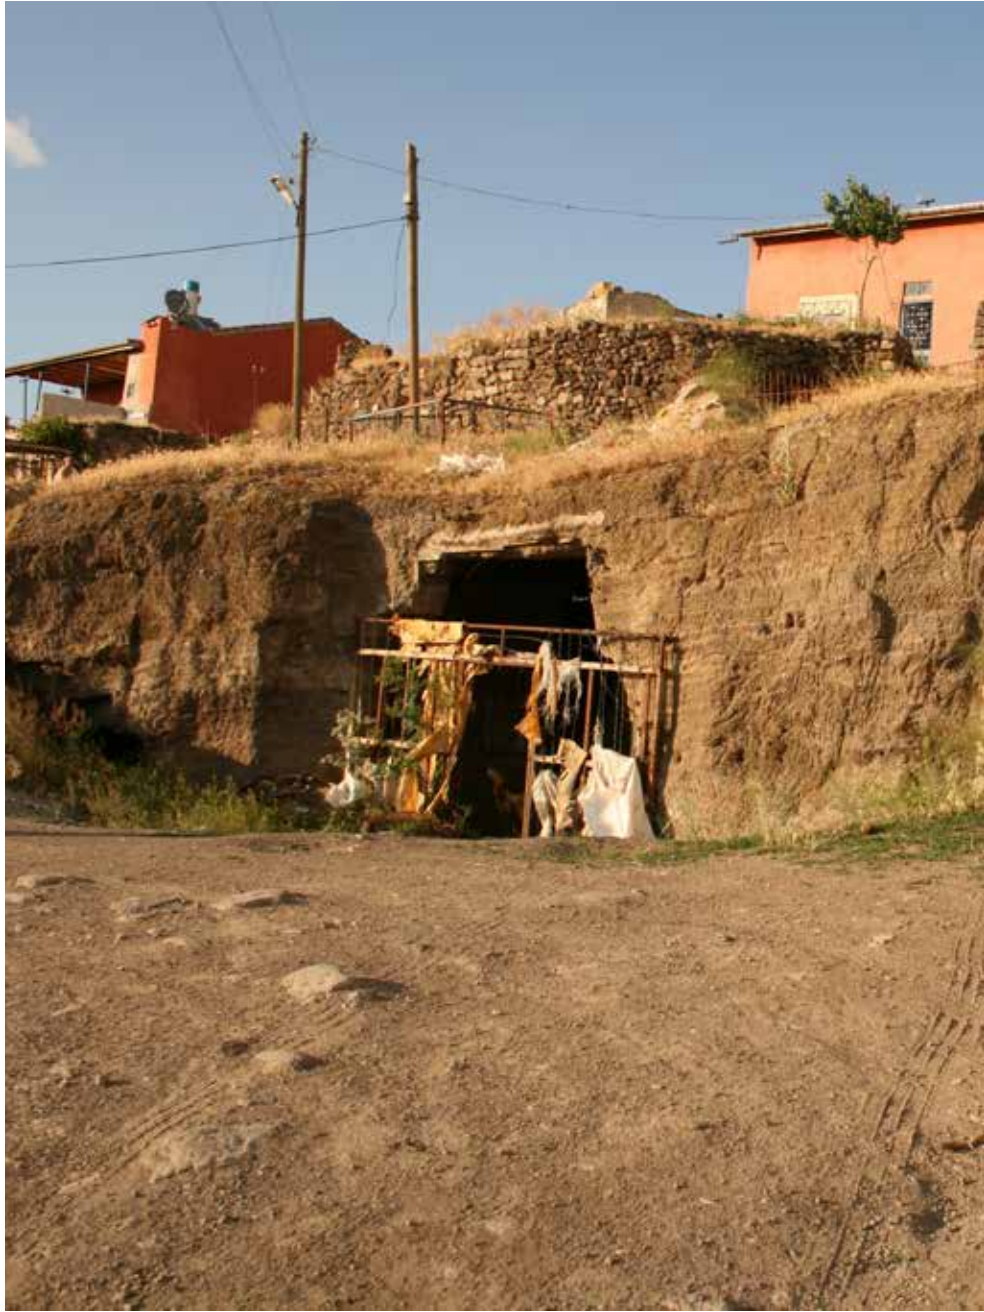
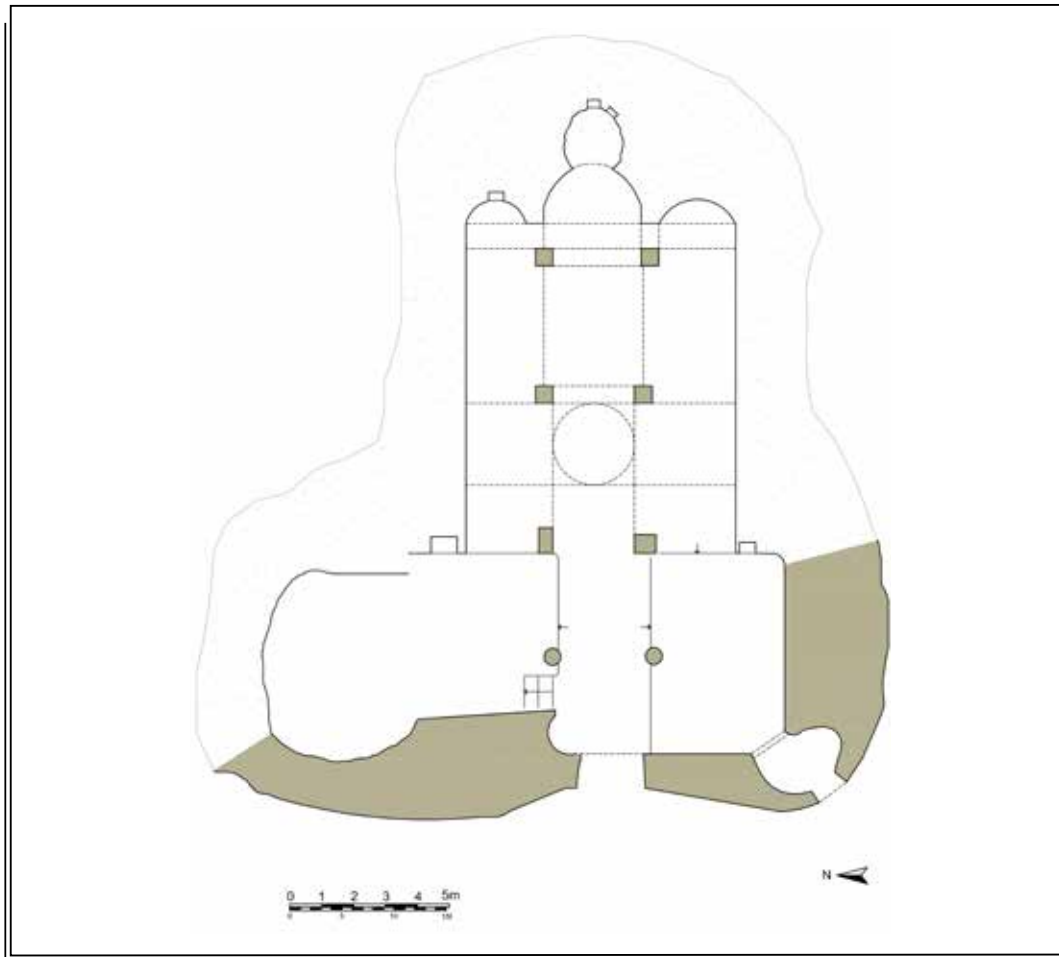
*Church of the Holy Mother of God
Develi county, Bahçebaşı neighborhood*

Once used as a stable, the church is currently abandoned. The original plan of the rock-carved structure is intact, but has suffered from human intervention and natural damage over time. All of the interior columns are cut, and the plaster is damaged. Frescoes are almost entirely lost. Colored angel figures on the pendentives and wall-painted motifs on the interior wall of the apse are visible.

Due to its structural condition and vulnerability to anthropogenic and natural damage, the church is under risk and unrecognizable from outside. The building is exposed to vandalism in addition to the effects of the wind and rain through the two openings in the roof. With all its columns cut, the structure is vulnerable to earthquake, left neglected, and in bad condition. It needs urgent structural intervention and preservation. Excavations must be carried out in its vicinity to obtain more information about

its original levels. The openings on the roof and door must be covered to prevent further damage to the interior. A fine example of a cave church, the structure can be restored to serve faith tourism purposes. It needs cleaning, preservation, and a sign.

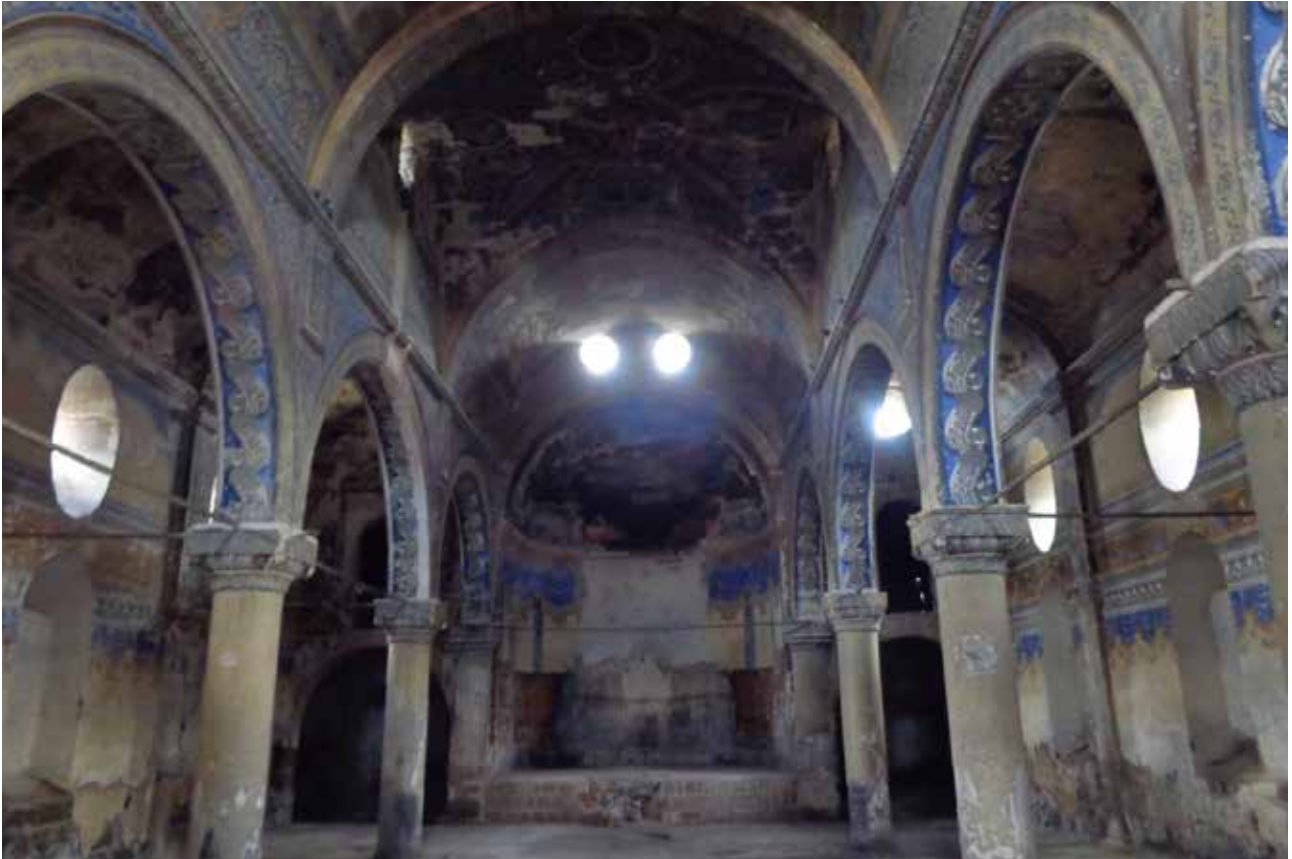
The bell tower standing at the junction of four Armenian neighborhoods in Tomarza and the courtyard that most probably surrounded the tower have disappeared. On the severely damaged east façade are doors opening to the bema and the area in the south (diaconicon) opening to the naos. These doors on the damaged east façade along with all of the upper and lower windows are filled in. The outer layer of the double wall of the apse is destroyed, revealing the rubble filling of the wall.

The west façade has completely lost its original form, with the narthex and the gallery destroyed and the arches filled in with rubble. The only remaining traces are those of the gallery in north and south corners. The original main gate of the west façade is replaced by an iron gate rising inside the west wall which serves as the current entrance to the structure, directly leading to the naos. Vaulted elements in the

corners presumably served as stairs in their original form, but are now filled in with rubble. The doors opening to the bema and diaconicon on the east side are filled in as well. The only surviving traces of upper balconies supported by these side areas are of the floor. The floor of the entire structure has been covered with cement. Wood laths are nailed around the oval windows. Some of the iron spreaders are cut out. Whitewashed surfaces on the east façade must be remains of the stores abutting the walls of the church. Although the church is less damaged and pillaged compared to other churches in the region, the hole in the apse floor suggests illegal excavation.

Cracks and fractures in the roofing stones have caused humidity inside the structure. The apse and vaults have efflorescence and plaster falling from the surfaces. Vegetation on the roof has corroded the molding of the eaves and caused

cracks and fractures. Plaster falling off the columns and walls might be due to neglectful, improper use of the structure after it lost its function as a church. While no structural damage has been identified, the collapsed outer layer of the double walls will cause harm on the structure over time.

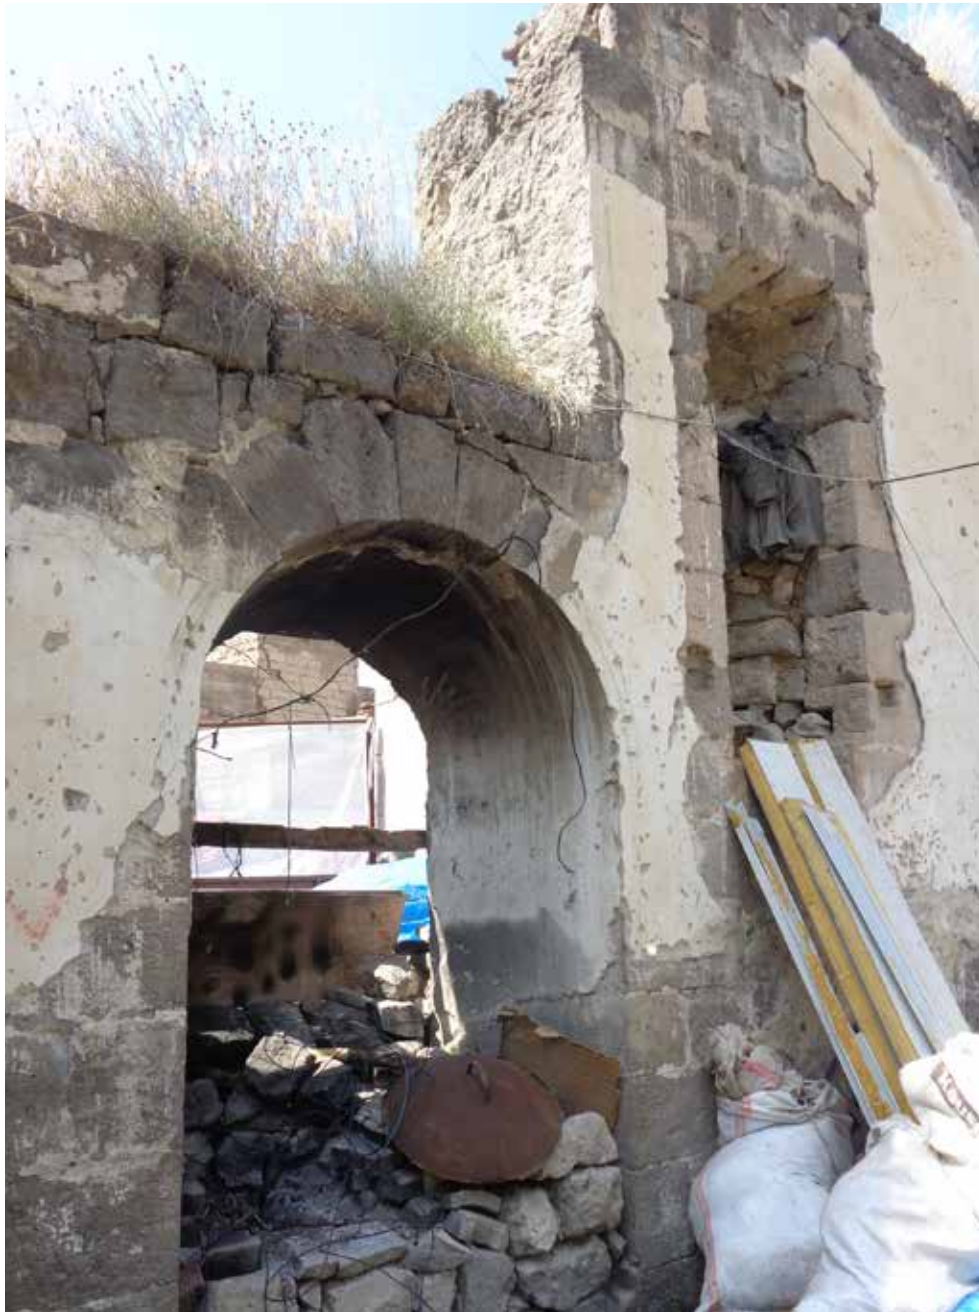
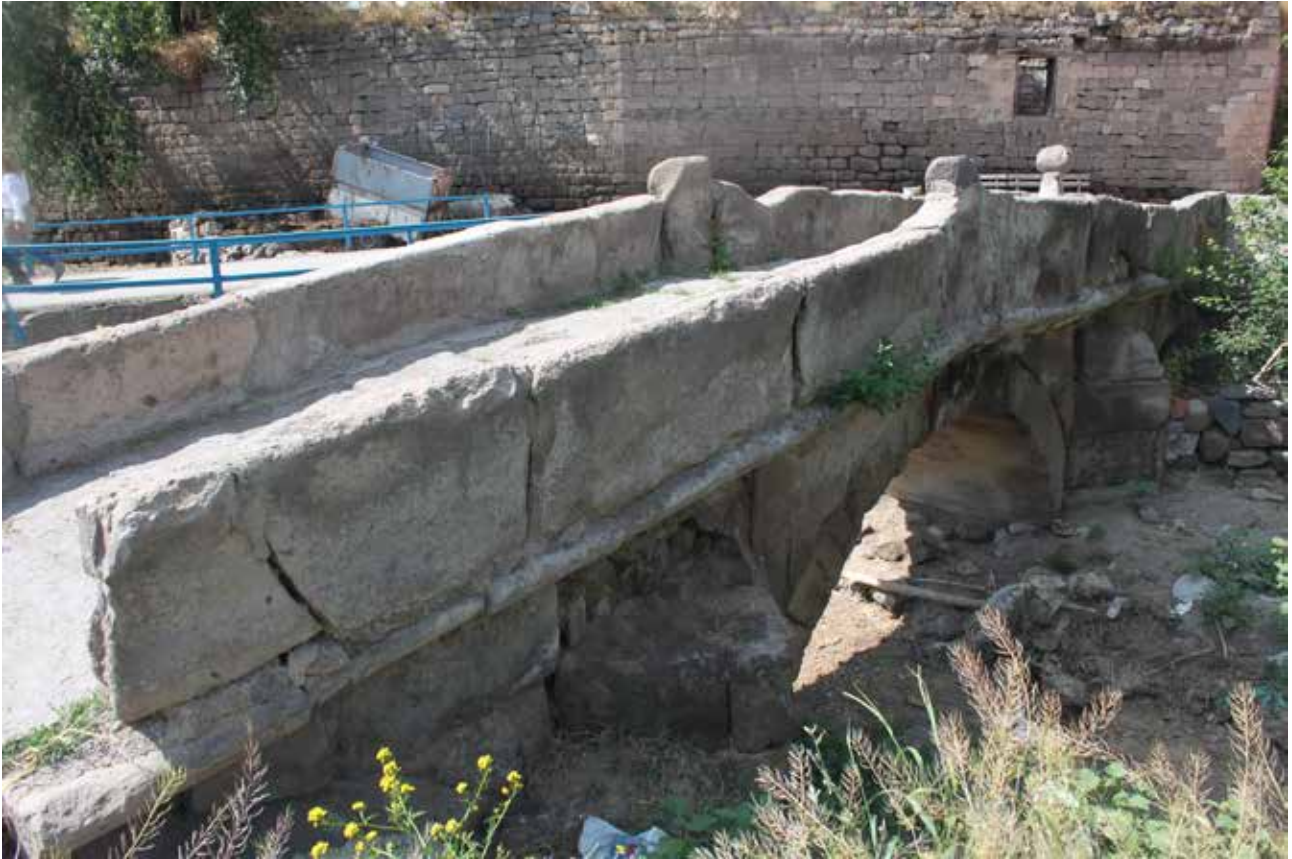
*Church of Saint Stephan
Melikgazi county, Germir neighborhood*

Parts of the walls, interior columns, and spaces of the church have not survived. Today it serves as a stable with a house appended to it on the

west and south walls. The walls of the apse and the west wall are still standing. The entrance to the structure is through the northwest wall since the narthex is currently a part of a residence. As is evident from the inner inlays of the arch, the upper story of the narthex is later walled up with rubble, leaving small window openings in the middle and on the sides.

Although the plan of the structure is hard to map out due to alterations over time, the partly standing exterior walls and traces on the interior surfaces give an idea about the plan. The roof of the structure did not survive, hence the building remains uncovered, with plaster remnants on the original surfaces vulnerable to natural and human damage.

The only Armenian church in Germir built in the second half of the 19th century (Ilter, 1989, 1676) is in large part in ruins with most of its features destroyed. Similar to many surrounding buildings, it is left to neglect and external damage. Its use as a dwelling has left most of its original features in poor condition. The church is vulnerable to earthquake and needs urgent structural intervention and protection. The structure should be considered as part of a rehabilitation and restoration project that

should pay attention not to cause any damage to the surviving walls and that can attribute new functions to the church. The area needs to be cleaned out, protected, and marked by a sign. As long as the remaining walls of the structure are kept safe, the building can be reconstructed as a multi-purpose hall or preserved in its current state for touristic purposes.

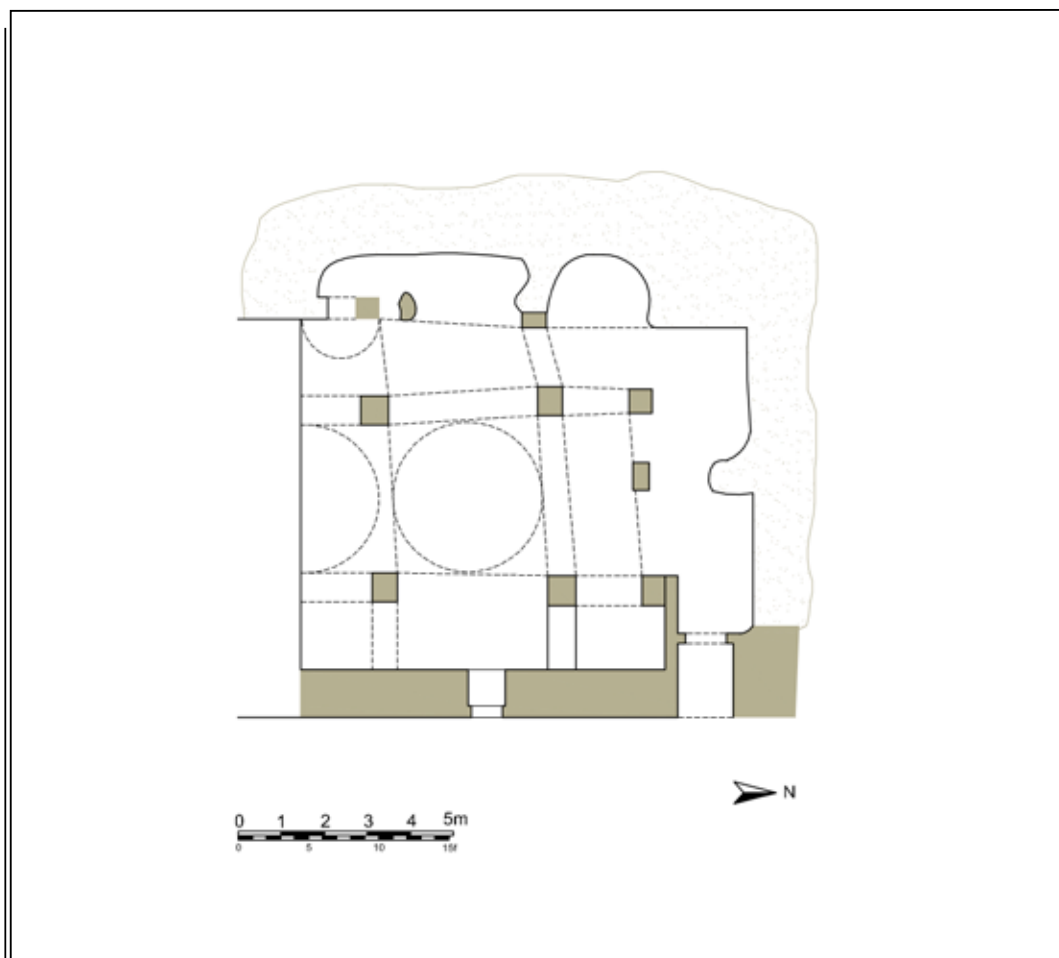
The structure is currently in ruins, and its original entrance, which is closed, lies underneath the road level. Ashlar facing on the exterior of the north and east parts of the drum has fallen off, and the rubble infill has scattered around. The structure is used as a stable and warehouse, and the unlocked door add to the threat, to which the structure is exposed due to this recent use.

The plan of the structure is largely in place, but has suffered from anthropogenic damage. Although the spatial layout and volumetric connections are not clearly recognizable, the plan is clear.

The structure has also suffered from humidity in the interior, efflorescence, stratification, and biological damage. The plaster has fallen off. Only a very small number of colors and patterns of the remaining frescoes are discernible. The roof has moss growth. Stones have fallen off from the drum.

The biggest current threat to the structure is exposure to human damage. Neglected and vulnerable to earthquake, it requires immediate structural intervention. More information needs to be acquired on the original ground levels by way of excavations in its vicinity. The structure also needs cleaning, preservation, and a sign.

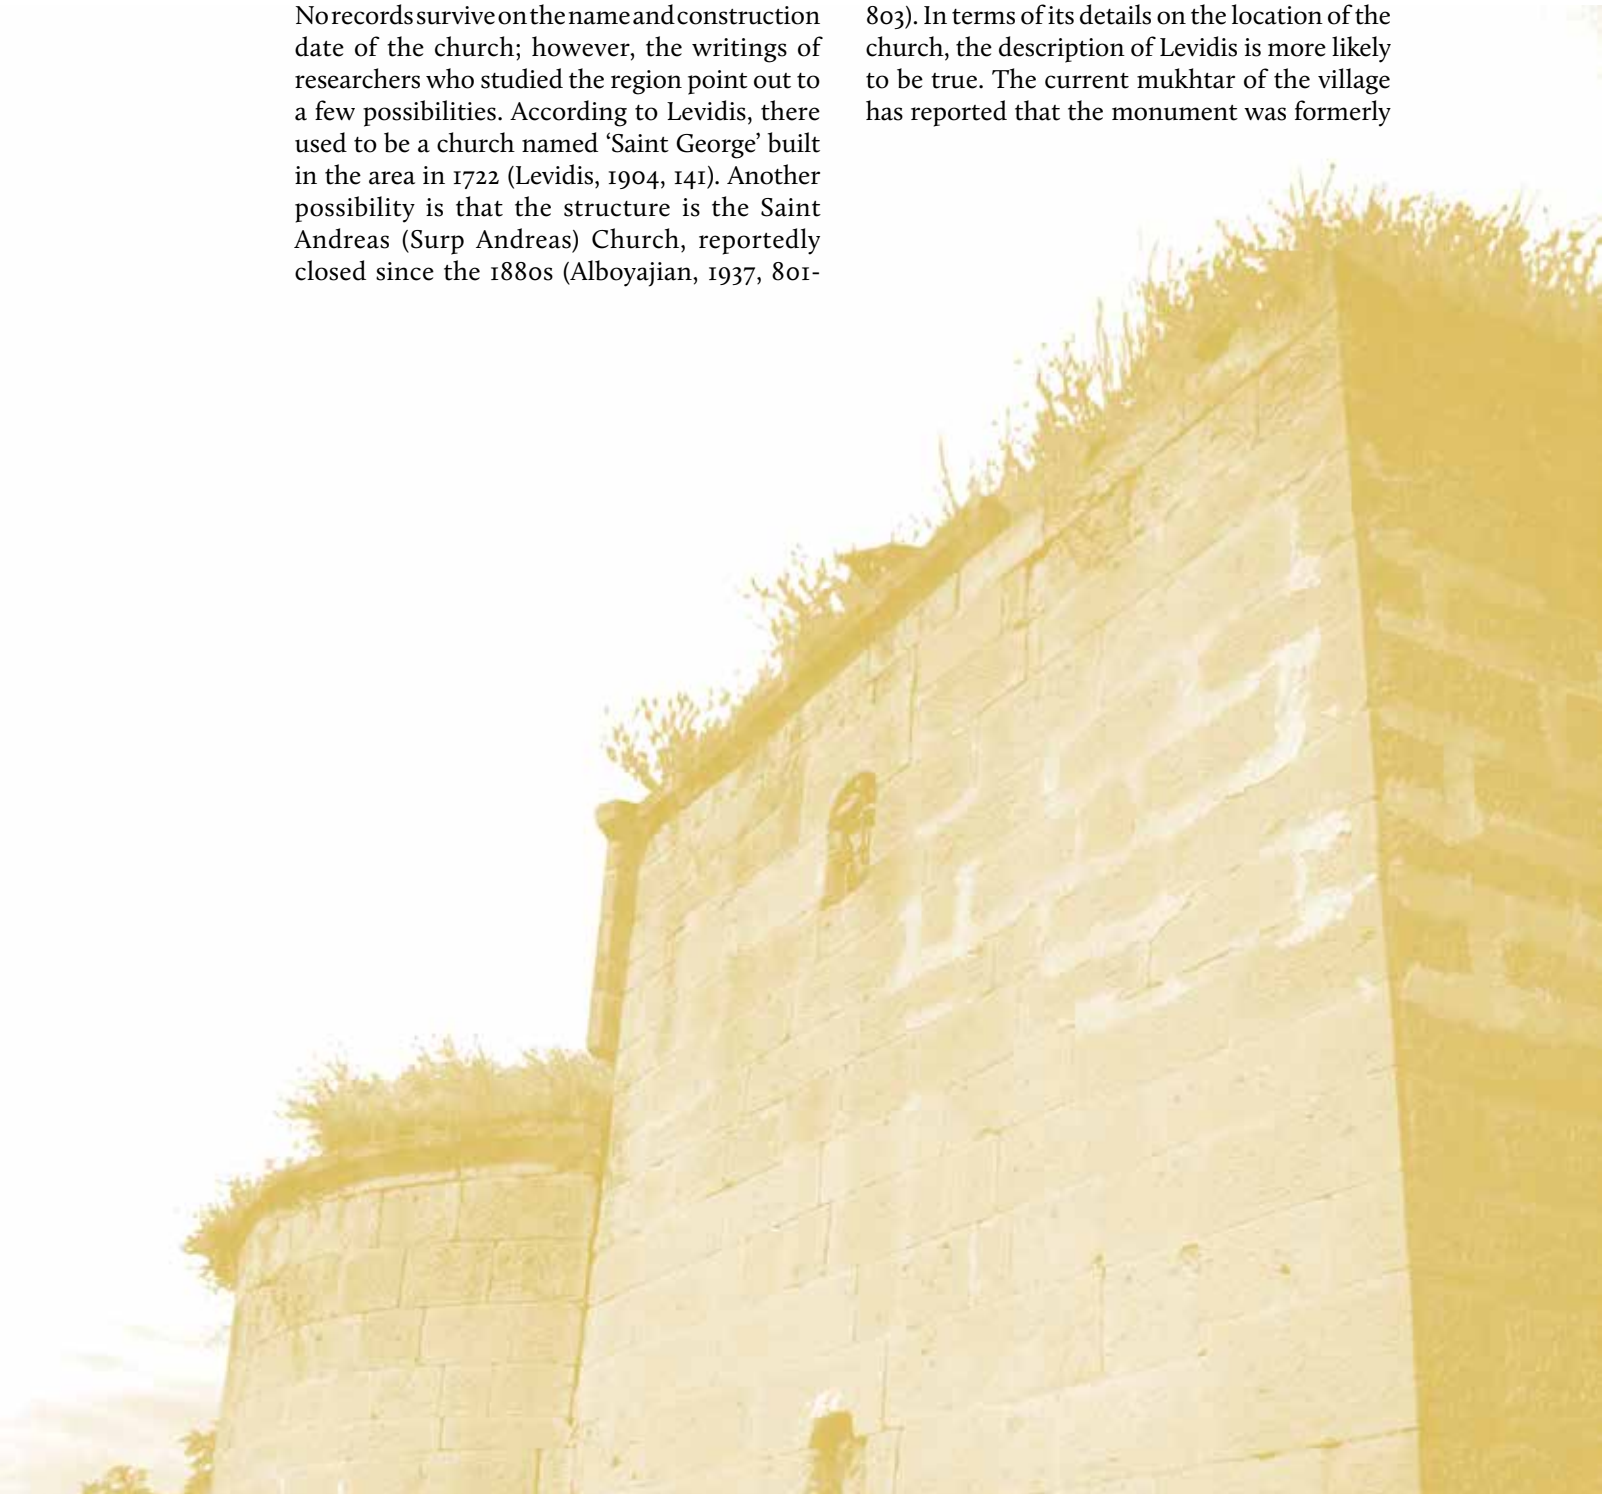
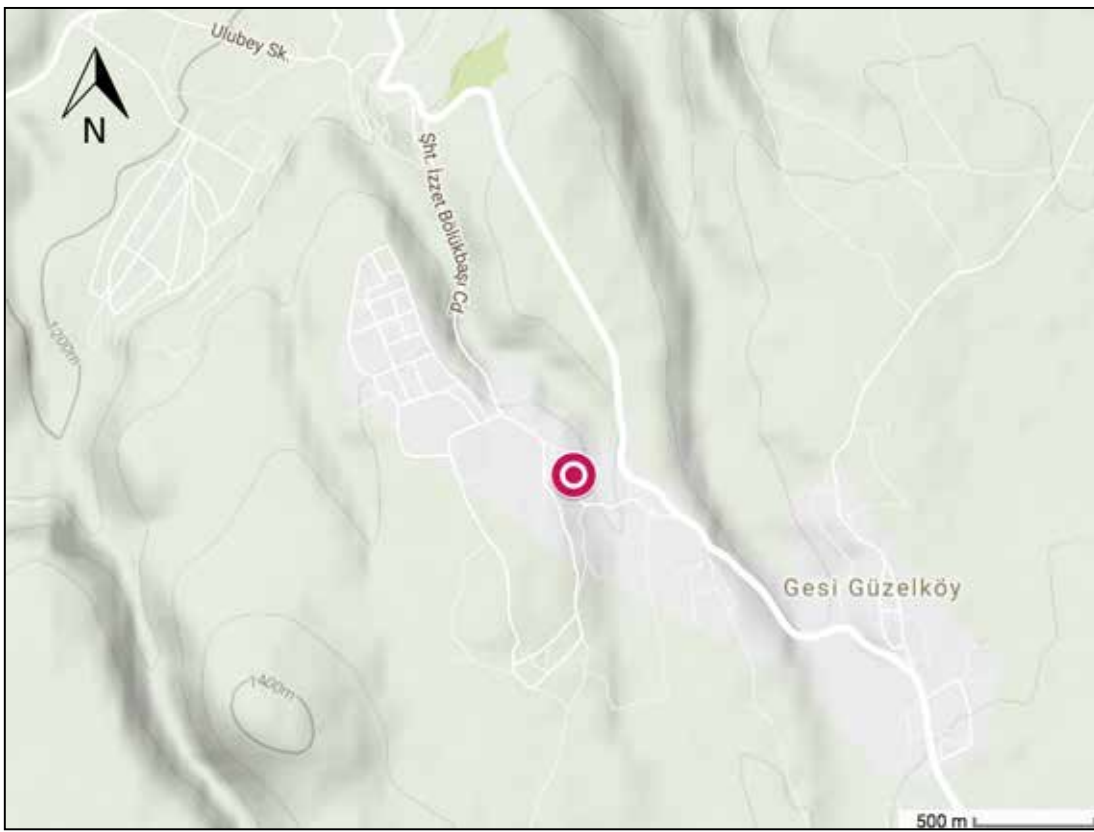
Dense vegetation growth weakens the roofing, with humidity damaging the vaults. Upper side of the walls also have efflorescence. Plasters flake off the walls and vaults, which are further damaged with soot due to fires lit inside. Some parts of the beveled cornice are broken while ashlar on the exteriors are missing in some places.

The main damage to the structure are the cracks presumed to have emerged during the earthquake in 1835, which completely destroyed some of the churches in the region. These cracks are further deepened with ground subsidence resulting from the sloping site on which the church is built. There are severe cracks on west and east sides, below and above the north wall, and the northwest and southeast corners of the middle nave vault. There are traces of efforts to fill in some of the cracks with concrete.

Although the main walls and roofing of the structure survive, the deep cracks on the walls and the roofing have extended over time. The cracks and missing stones of the structure call for an urgent consolidation. This small, typical village church with a clear plan and predictable spatial characteristics will be further damaged if left to neglect. There is no sign. The gate, which protects the interior against vandalism, is kept locked, but this measure is not enough.

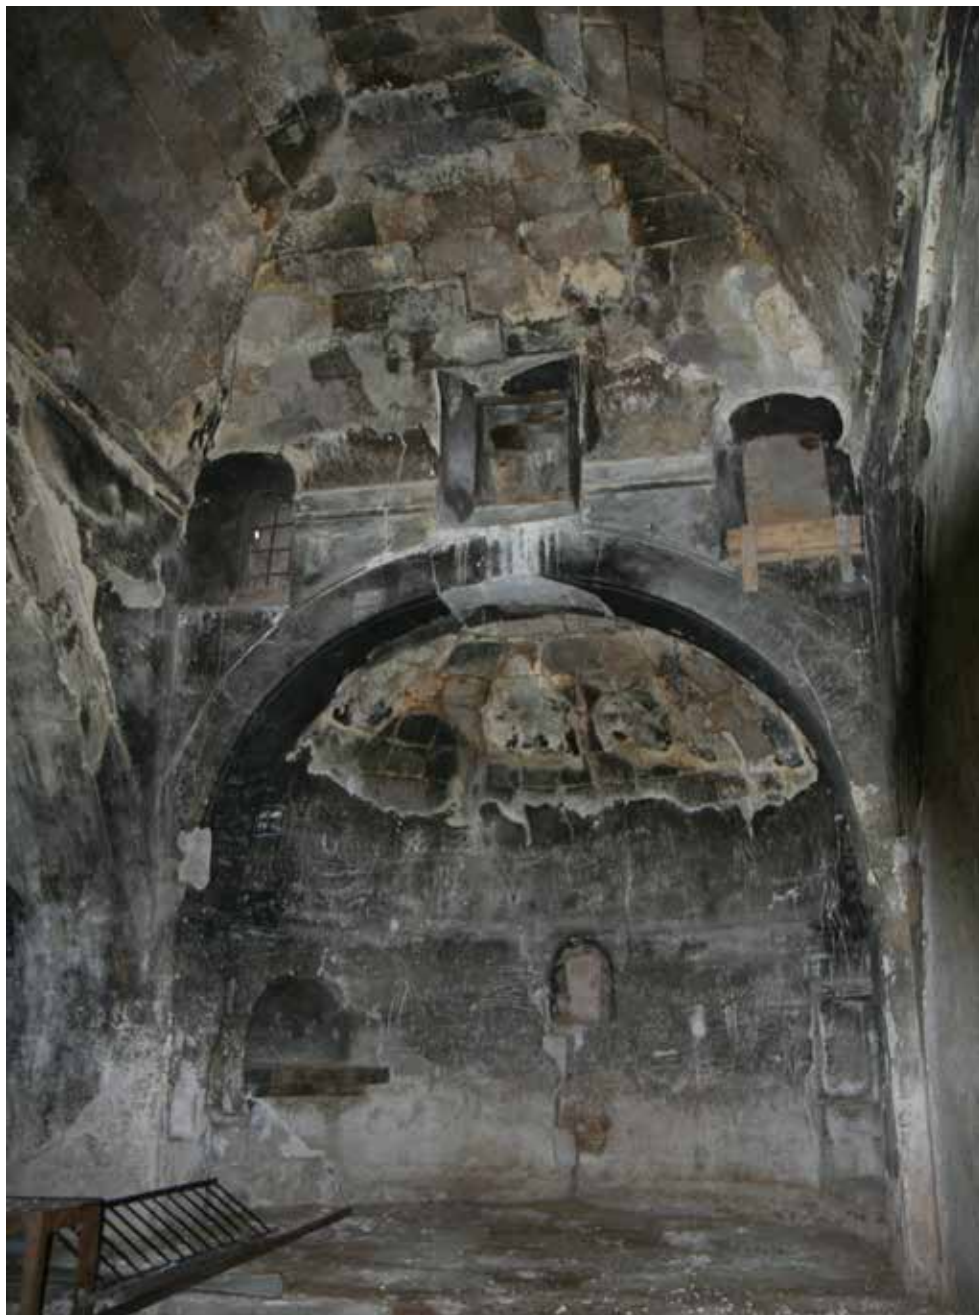
*Church of Saint George
Melikgazi county, Gesi Kayabağ neighborhood*

The original form of the structure is severely damaged. The only surviving traces are from the walls and the joints of the gallery. There is a wall in the arch span separating the side and middle naves to the south of the naos, with the side nave serving as a separate room. Ekin reports that the wall was built in 1940s to host weddings (Ekin, 2005, 90). The windows on the east and south sides of the church are filled in. A reinforced concrete flower pot is found on the outer side of the south wall.
