Adana

## ADANA SITE ASSESSMENT VISIT

Dates: October 21-28, 2015

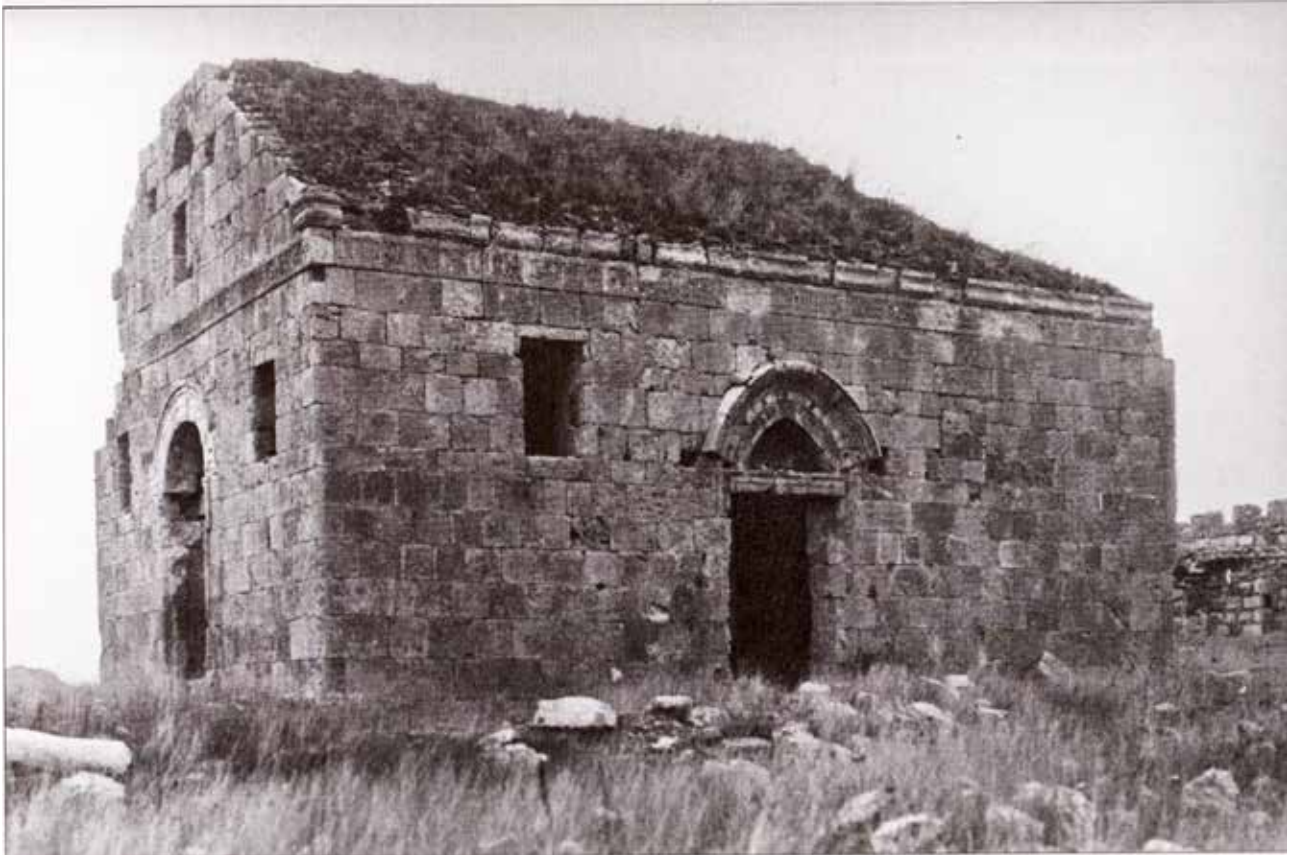
*Church of Saint Zoravarats  
(Kevorkian, 2012, 296)*

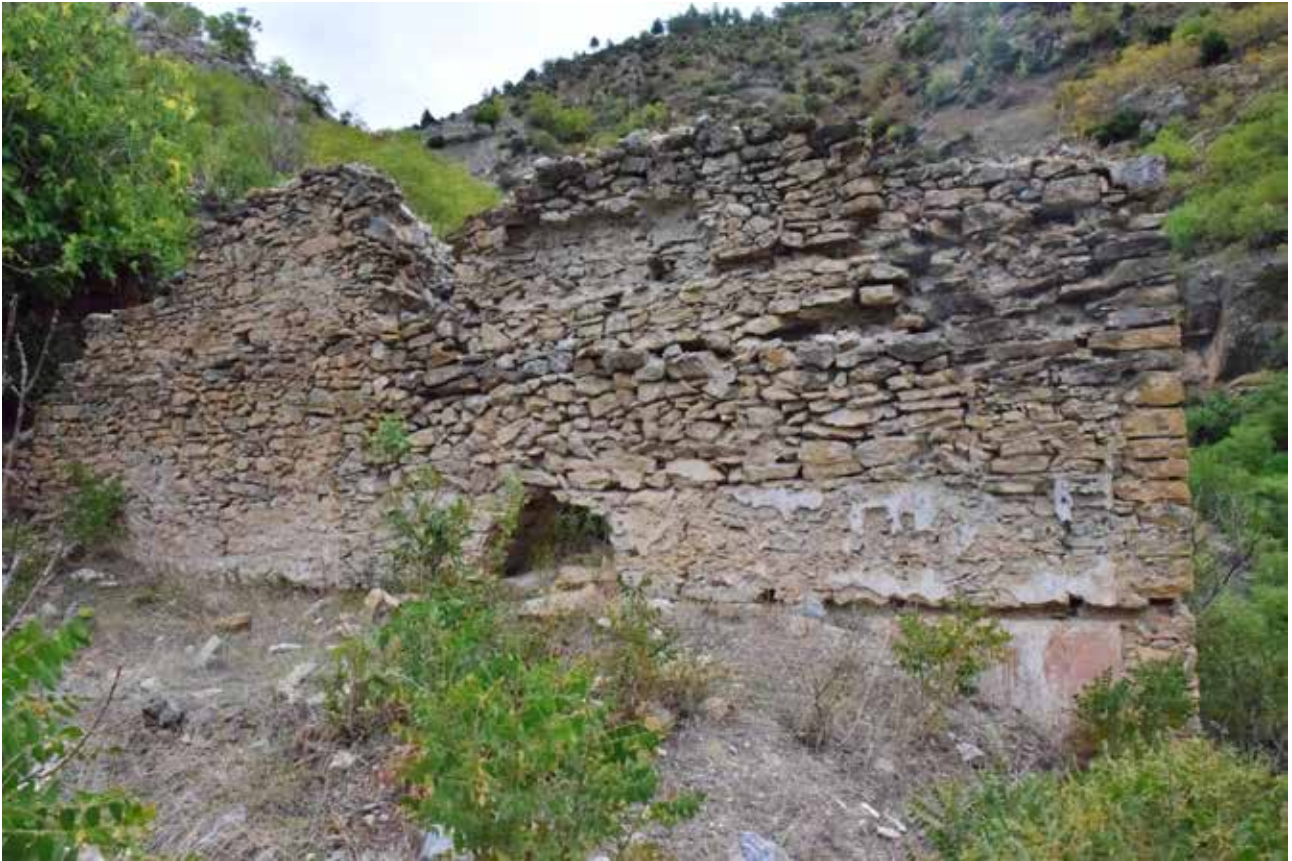
The bathhouse is abandoned, unprotected and unused today. It is about 2 km from the village road and is accessible by foot through the natural surroundings. There is only a signpost on the village road that gives the name and direction of the building, but no further information. It attracts few visitors and none who didn't have previous knowledge of it. The other upper structure and vaults have collapsed, leaving the building open to all kinds of damage from rain and wind. The interior floor of the building has been filled with soil and debris from the collapsing vaults and walls and overgrown trees. There are no doors in the doorways, and other entrances have been broken through the walls, leaving the building open to vandalism. There are indications of vandalism in the building, such as enlarged holes in walls and the removal of all timber tie beams close to ground level. The remaining walls have structural problems ranging from cracks, loss of mortar in joints, surface deterioration of the stones as well as vegetation growth. Some trees have broken through the walls and kept growing, further

damaging what remains of the architectural fabric. There remain no decorative details, inscriptions or ornamentation. The few remains of plastering on the interior of the building are threatened with flaking off, due to direct contact with rain, wind and frost.

The building fabric is in very poor condition, and needs immediate consolidation in order to survive until any detailed conservation project is undertaken.

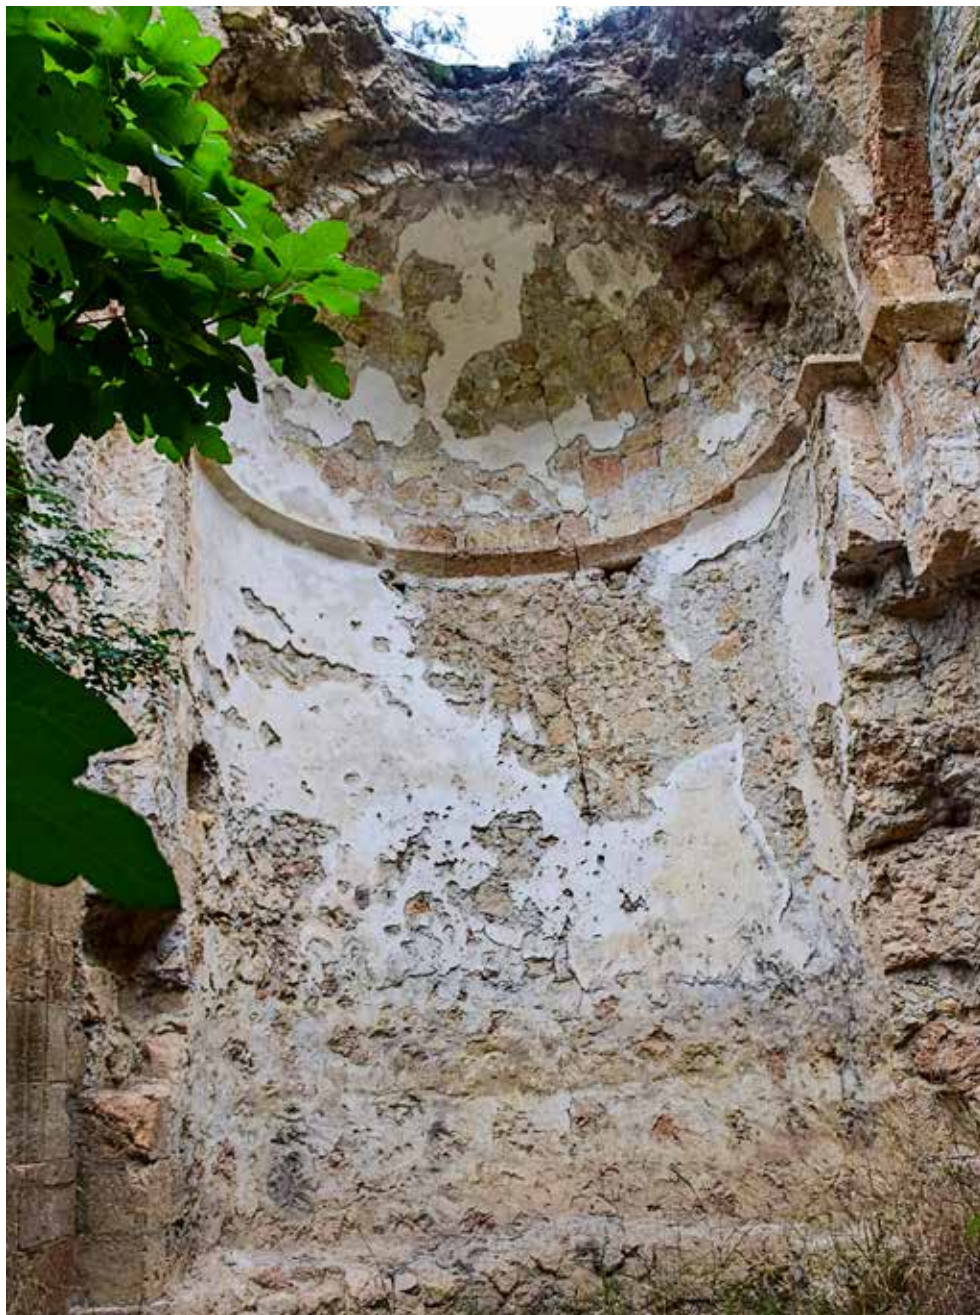
*Etchmiadzin Chapel of Sis Monastery  
Kozan county, Yarımoğlu neighborhood*

Currently, the most original texture remains in the Etchmiadzin Chapel. The apse wall and south walls are partially standing. Though rare, plaster and paint remains are encountered in the apse and nave walls. To the east of the Etchmiadzin Chapel, a crypt was revealed after the illegal excavations by treasure hunters. The large-scale foundation stones of Church of Gregory the Illuminator are visible beyond the demolished north wall of the chapel. Apart from the south wall of the chapel, the stone cladding from the rest of the walls have been removed. There is a vertical crack in the wall of the apse. The surfaces of the stones have been deteriorated in many areas.

Sis Monastery comprises unique remains reflecting an important period of the Armenian Kingdom of Cilicia and its culture. It is recommended that the remains of the monastery to be protected as an open air museum. By this way, a forgotten cultural asset of the region's past can be preserved for the future.

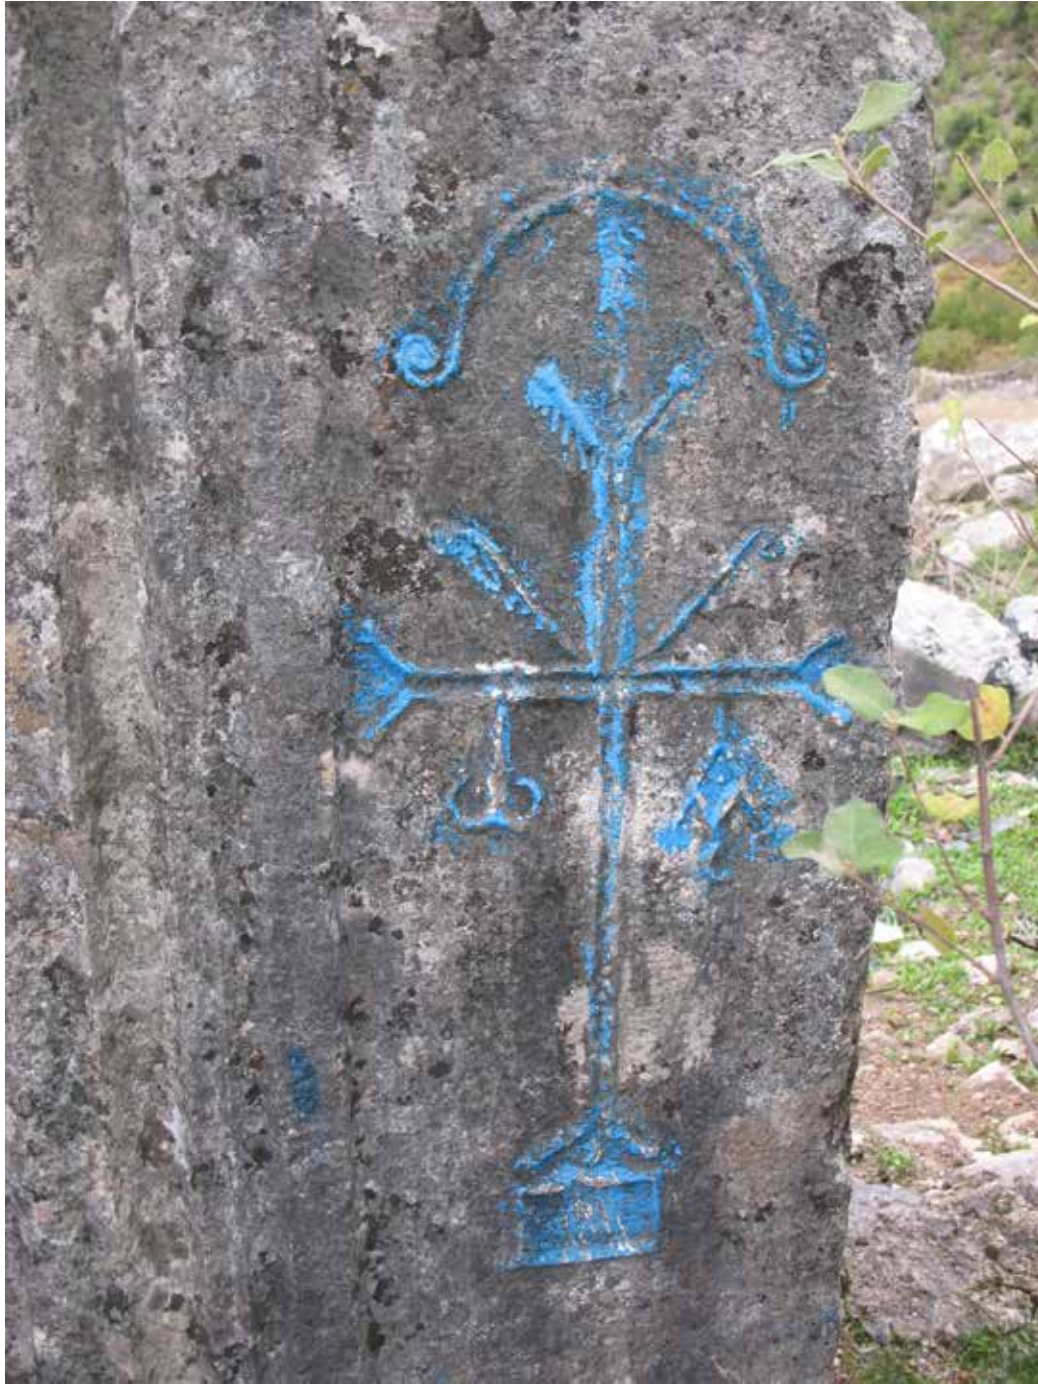
*Kara Church  
Saimbeyli county, Cumhuriye neighborhood, Çınarlı locale*

The advanced degree of vegetation growth, earthquake danger and human intervention may cause the church to be demolished. It is recommended that vegetation growth near the walls of the structure be cleared, and archaeological excavation of the site, architectural and archaeological documentation of the structure and fragments, engineering and material research, historic and archival research should be conducted along with reinforcement of the structure and the preparation of preservation and landscaping projects.

To preserve what survives, firstly general clearing of the site should be completed, stones fallen from walls and arches should be replaced, mortar repointed, walls cleared of plants and missing walls and arches and cavities in the floor be filled with original material.

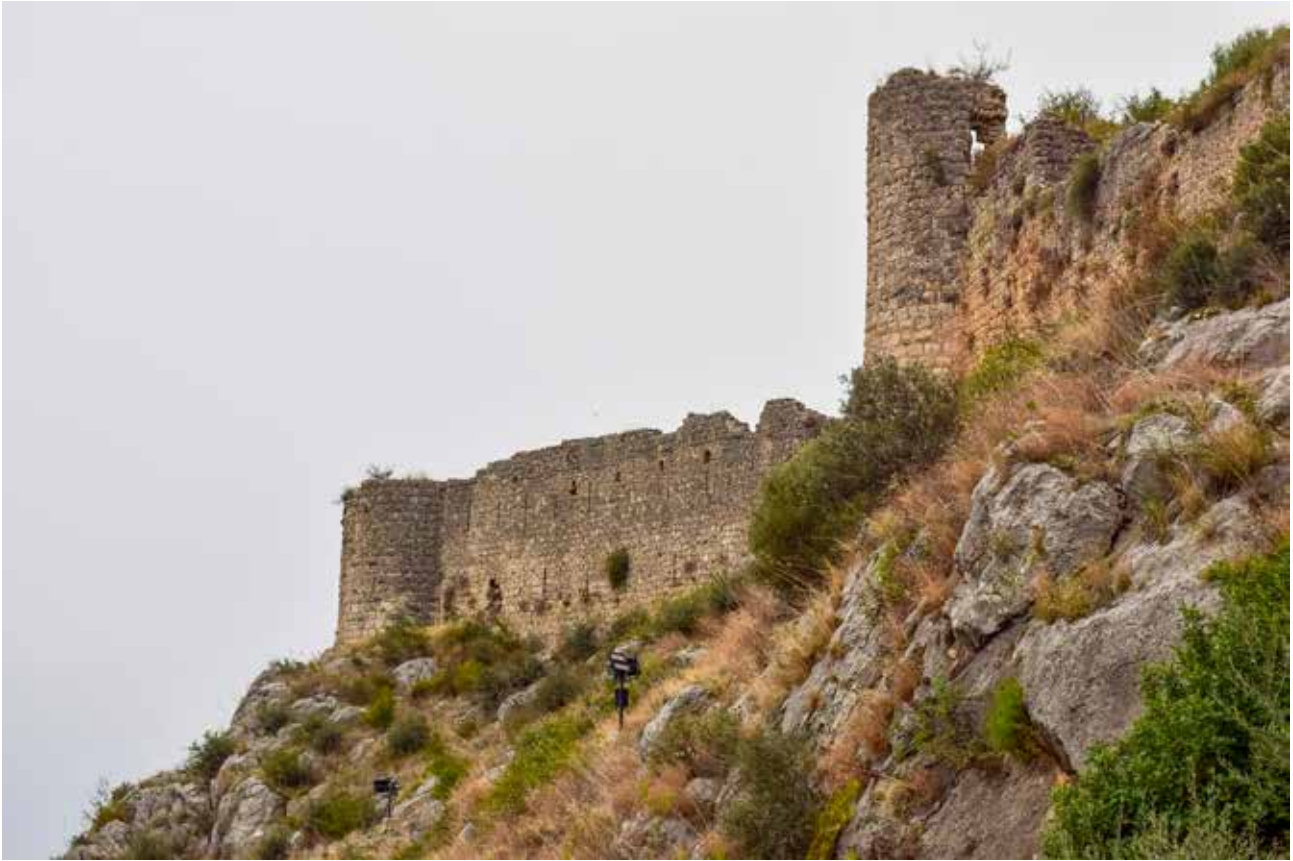
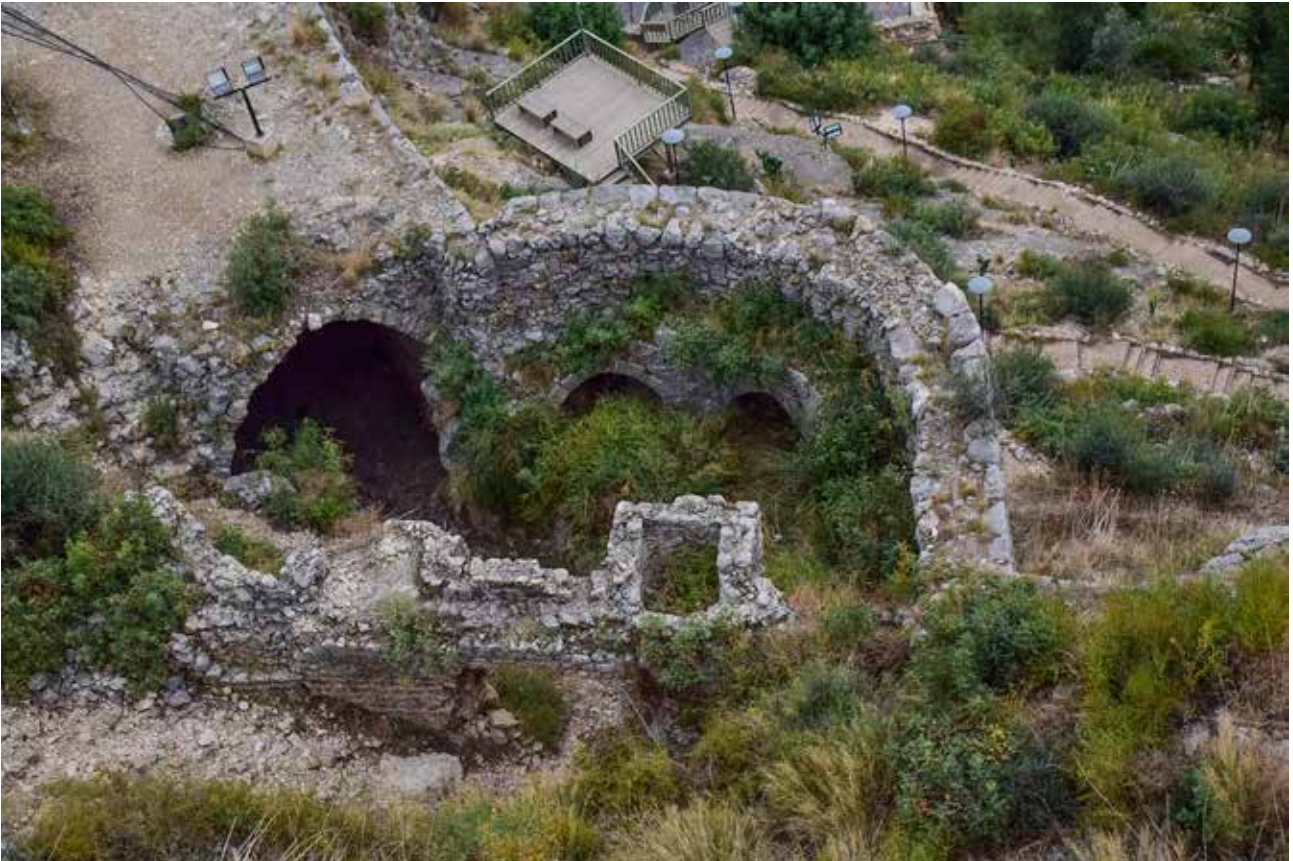
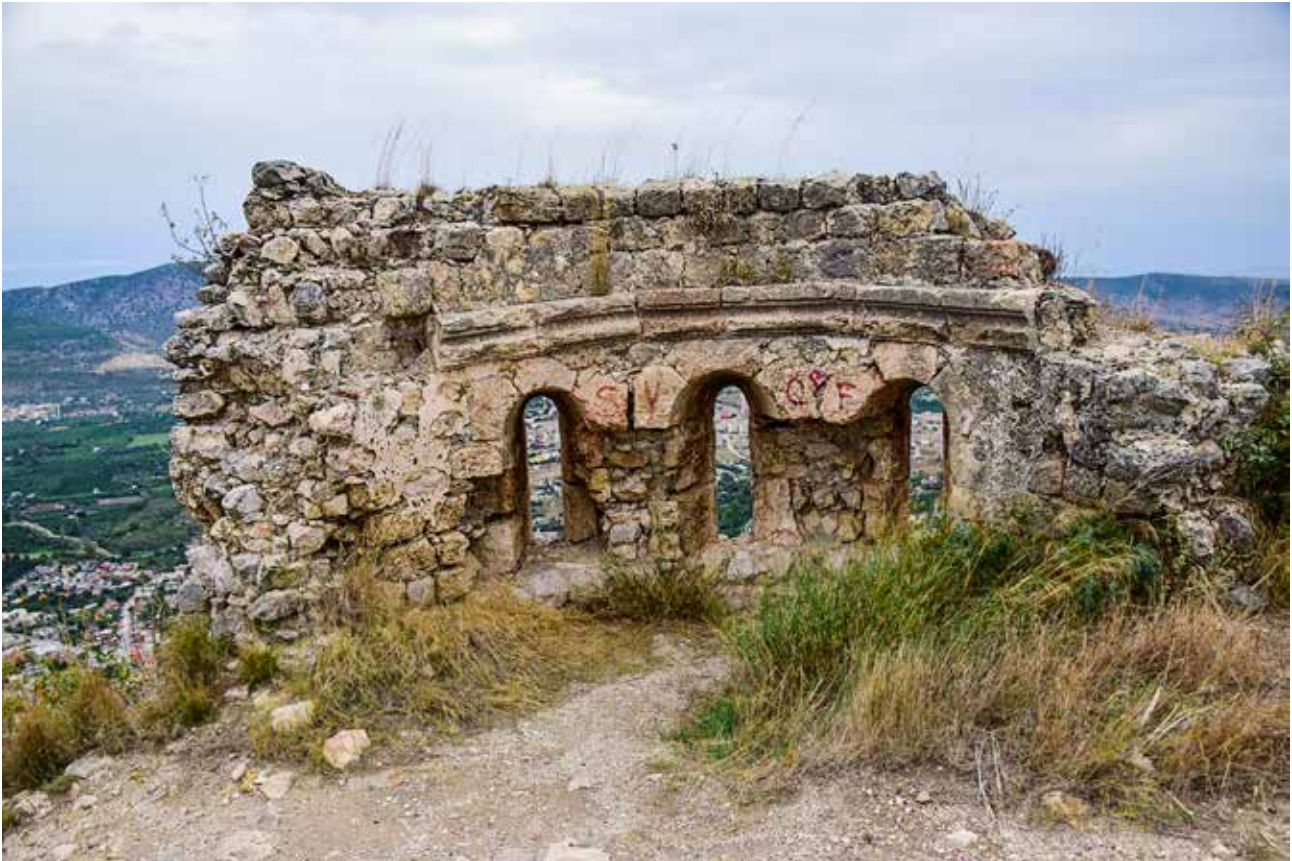
other structures are ruined to the extent of seismically risky condition and need serious strengthening and preservation.

If the fortress and its surroundings (the very historical town) are not preserved, it cannot resist the rainwater, weather, time, and other destructions.

the notable structures as well as the internal areas of the fortress need to be excavated; the buildings must be strengthened and partially restored. For the determination of the height and spatial-volumetric compositions of the walls, additional excavation and survey works should be implemented.

The slopes of the rocks and the bottom need to be excavated, and the survived religious and residential buildings need to be partially restored. The defensive and public buildings and structures as well as those to be revealed after excavations (wall, tower, gates, stairs, church, palace, armoury, prison, well, residential houses, etc.) must be strengthened and preserved. The necessary works ensuring the protection of the defensive and public buildings from earthquake, tempest, rainwater, as well as providing the drainage system must be implemented.

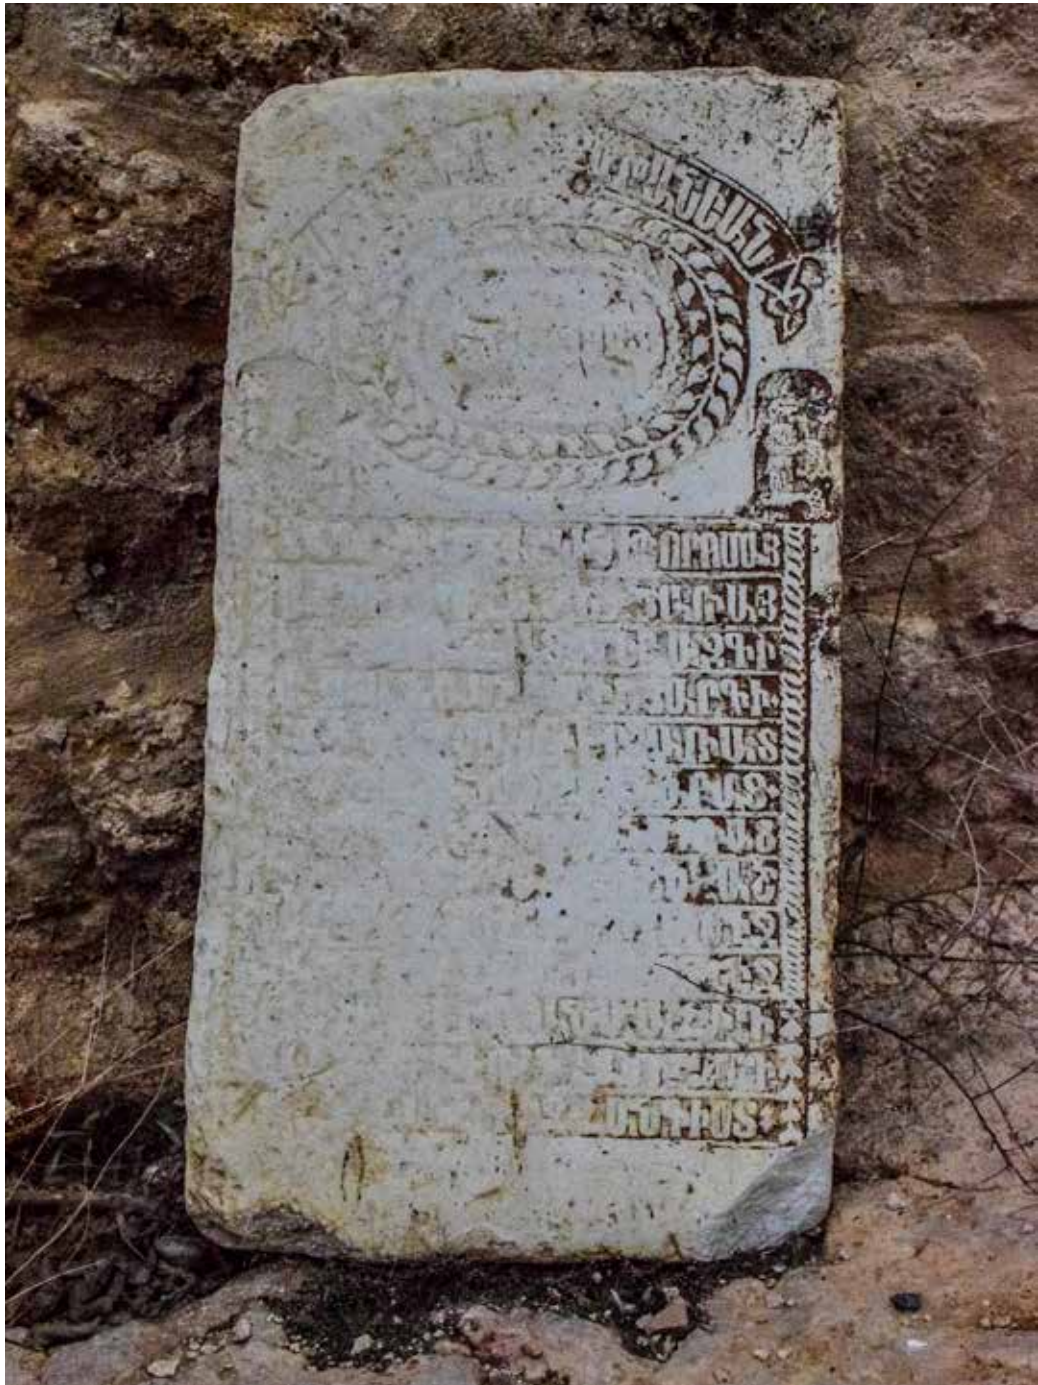
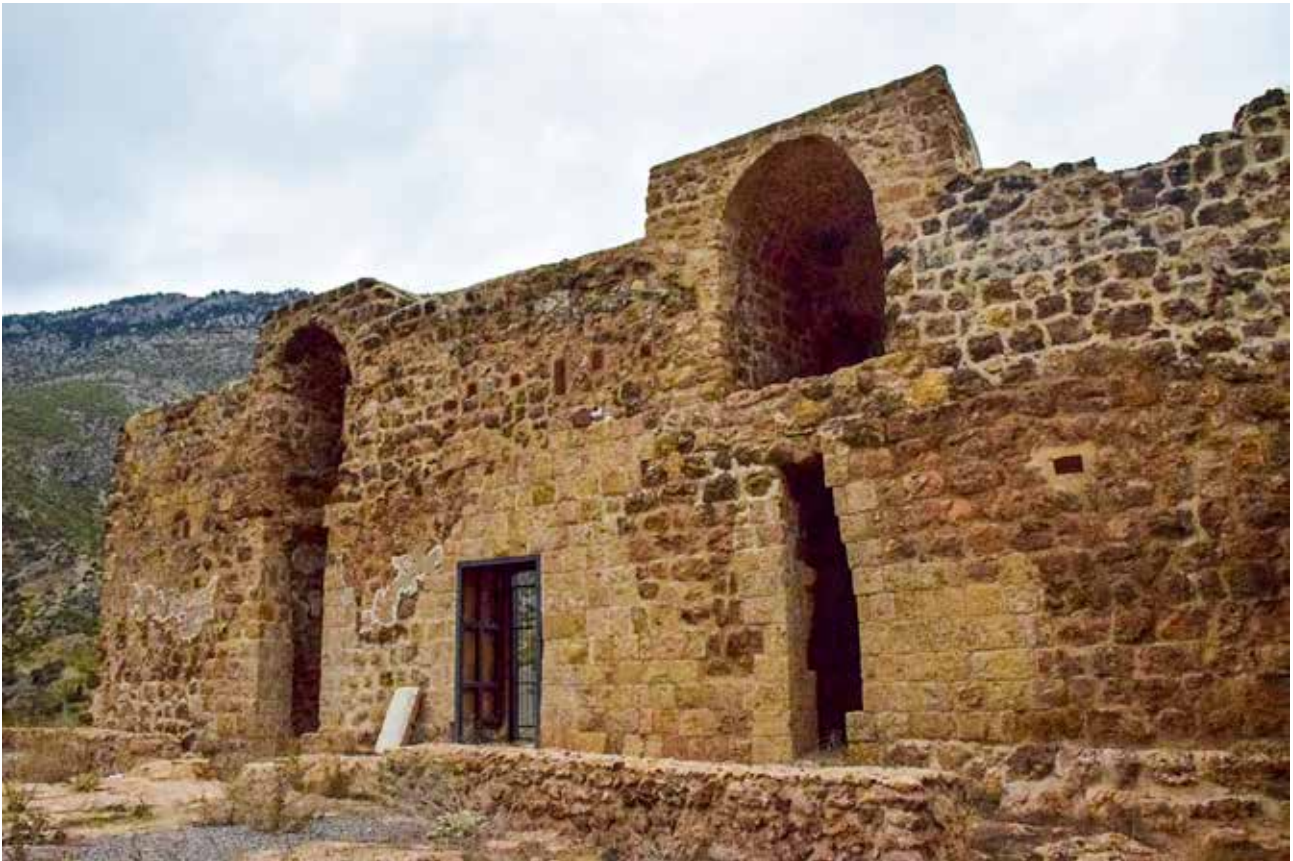
Saimbeyli Fortress  
Saimbeyli county, Islam neighborhood

In 2006, prior to the restoration project being initiated, it was reported that many stones of the monument were taken by villagers to be used as infill for the foundations of new homes they were building (NTVMSNBC, 2005). Also, the existence of a mine close by may have further destabilized the building due to vibrations.

The main entrance as well as the majority of the fortress is lost and there remain only two bastions today, which have been strengthened as well as their missing sections rebuilt using a lighter-coloured stone. Also, salvaged stones have been reinstated using pointing mortar a
