Niğde

NIĞDE SITE ASSESSMENT VISIT

Dates: August 23-28, 2016

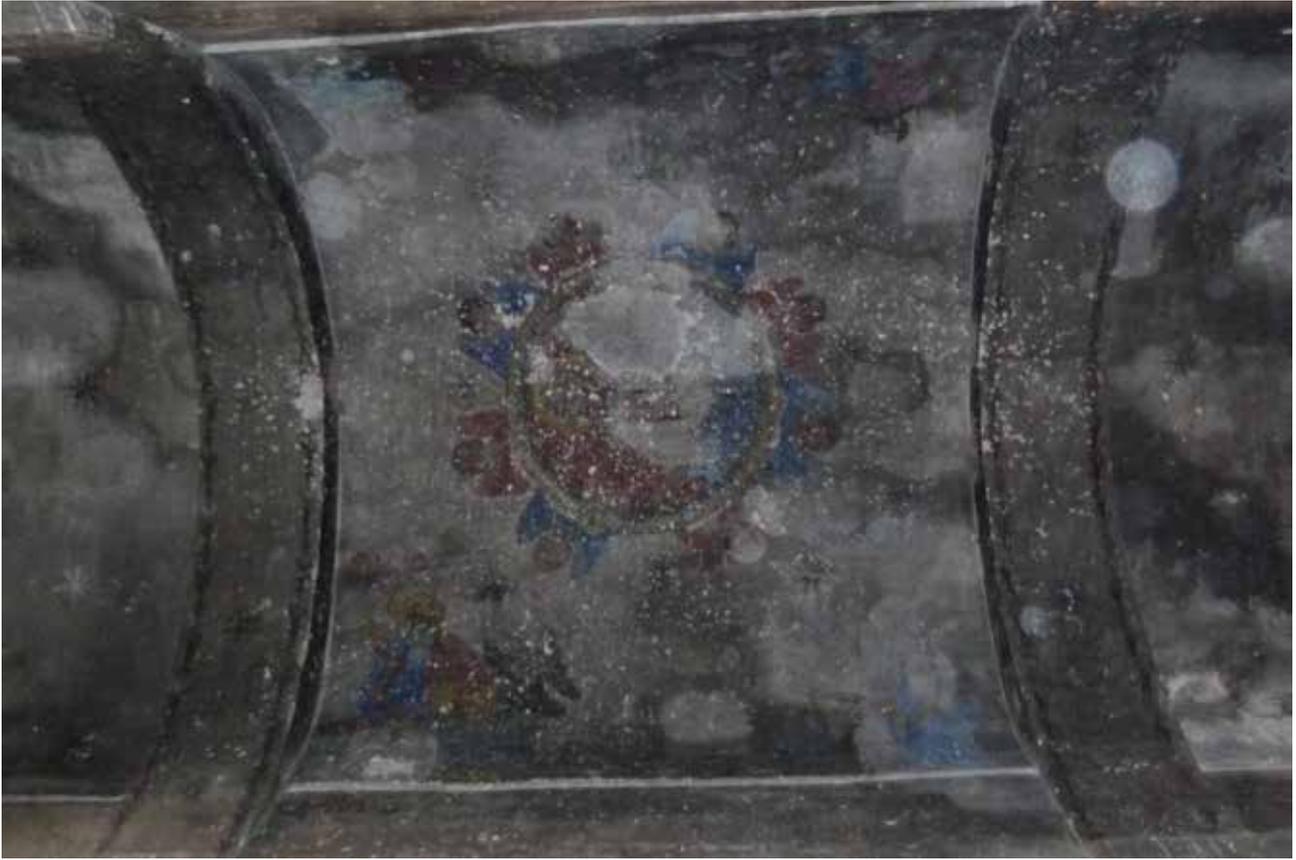
There is degradation of the stones on the external façade, occasional breakage of roof moldings and plant growth.

Due to the loss of parts of the roof, water has entered the structure and caused efflorescence in the vaults. Due to damp, all structural elements have been badly damaged; with plaster loss and disintegration of the frescos.

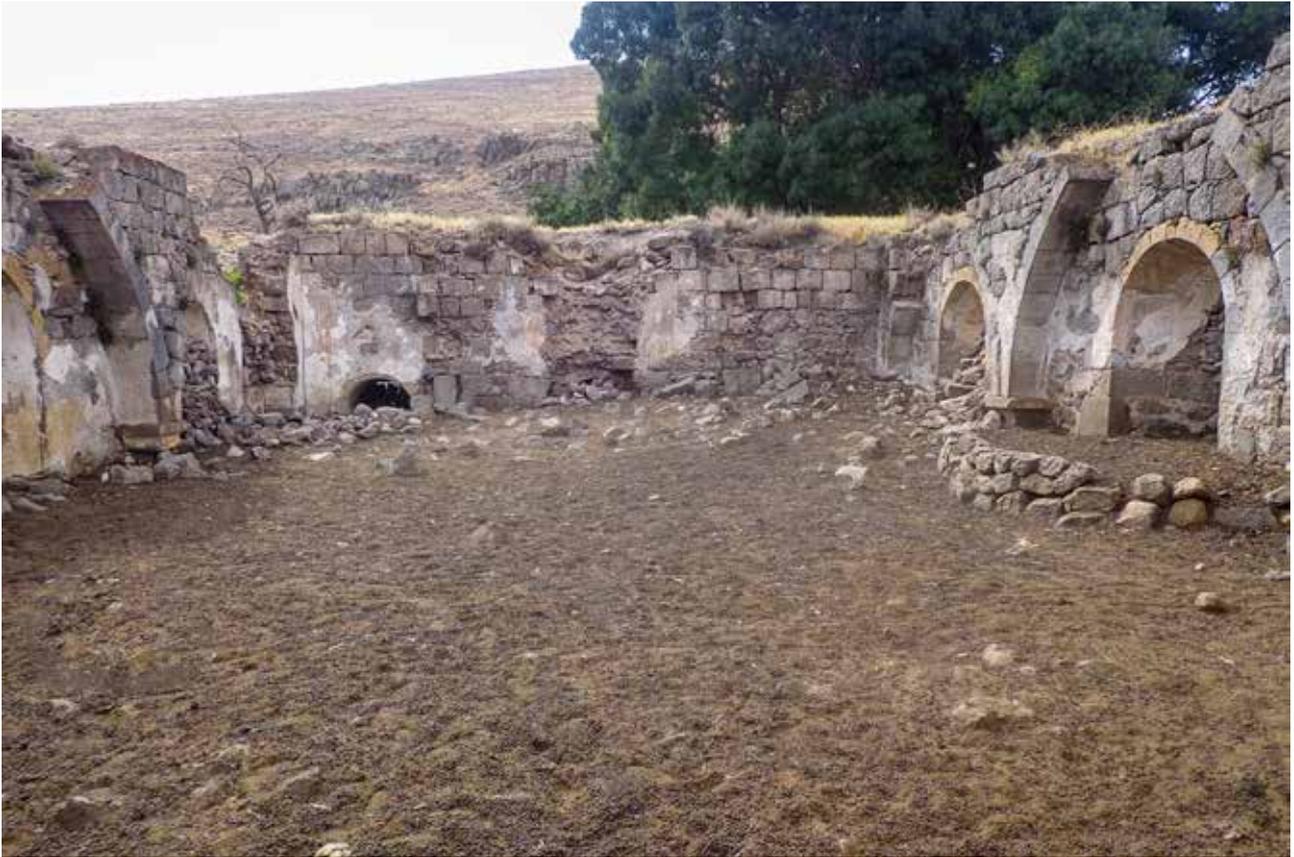
There are only remains of the outer walls of the structure and the original main entrance has collapsed. Some of the walls hint at the original plan of the church; its spatial characteristics are, however, unknown. Though the church has reached the present with its entrance portico and four outer walls, it is in a ruined state. The north and south corners of the external

narthex west of the church have been damaged. The three doors providing entrance into the church from this external narthex has been filled in and closed, and the floor has also filled up so that entry is through a window in the northeastern façade. The church is filled with at least two meters of soil and animal manure so that the floor covering and traces of columns separating the naves and carrying the ceiling

are not visible. There are very large structural problems as may be seen in the façades of the church. Intense destruction is observable in the main walls of the structure. The ceiling of the naos and the roof are completely lost and the upper portion of the main walls has collapsed. The plaster on the walls has fallen off, mortar has been lost and there is plant growth on the remaining architectural fabric.

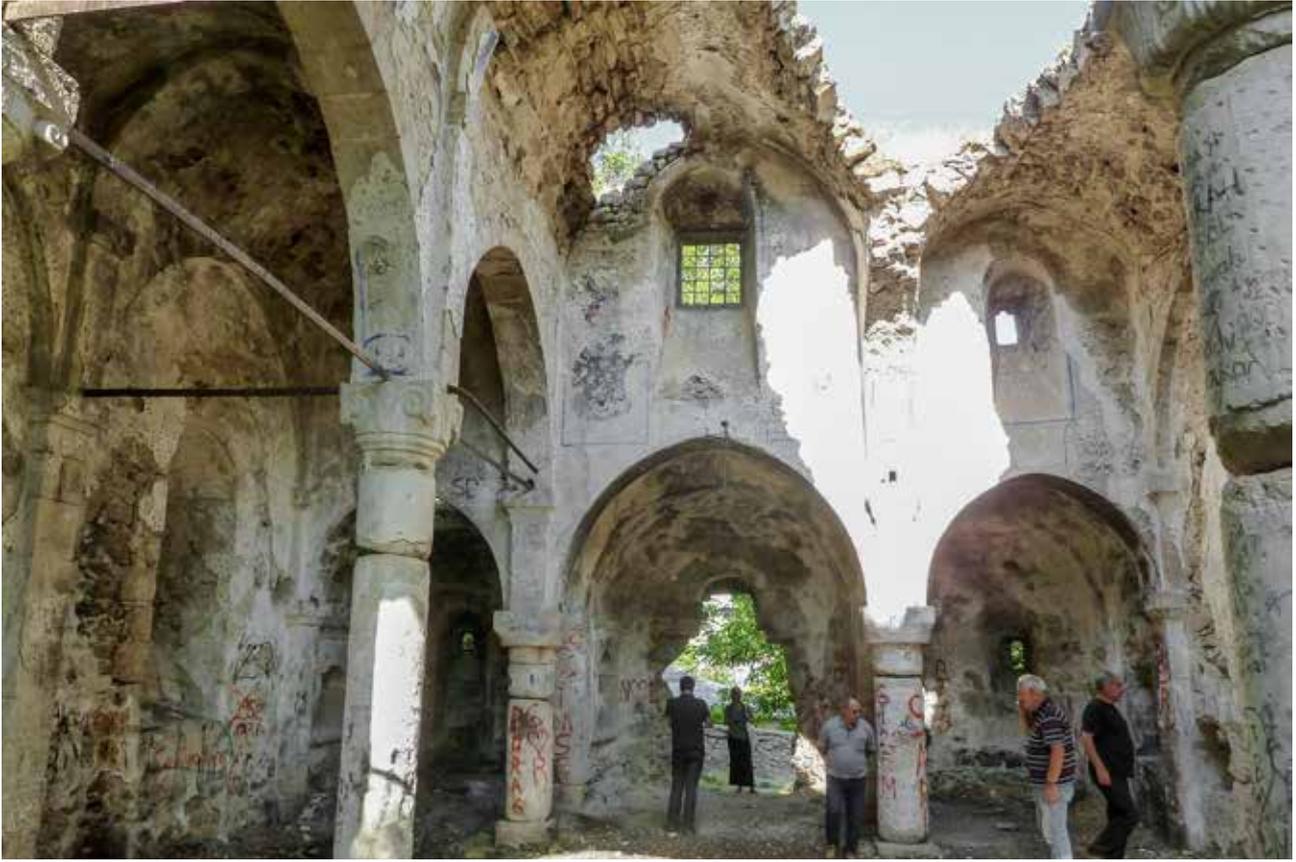
The linking rings and lead in the columns, which are connected by arches and standing on square pedestals, have been removed. As a result, the column and capital in the central axis of the nave on the southern side have fallen into the structure. The ceiling supported by the column that has collapsed has also fallen in. The ceiling is partially destroyed in the southern aisle and central nave, while the ceiling of the northern apse has been damaged. Only the eave moldings on the south and north have not been lost.

In general, the roof of the structure is covered with soil and plants. Though access is easy, as trees and gardens surround the structure, it is difficult to notice from the outside. There is no information panel and no visitors.

The roof of the structure has partly collapsed and as the gabled roof has been destroyed, the structure is open to the impact of wind and rain. The soil accumulation on the western and northern façades has caused even more dampness on the external walls and structural damage. The removal of metal accents on the pillars has negatively affected the structural integrity of the building. The current barrel vaults supported by the columns are in danger of collapsing at any moment. With no environmental protection, the structure is open to destruction through human intervention.

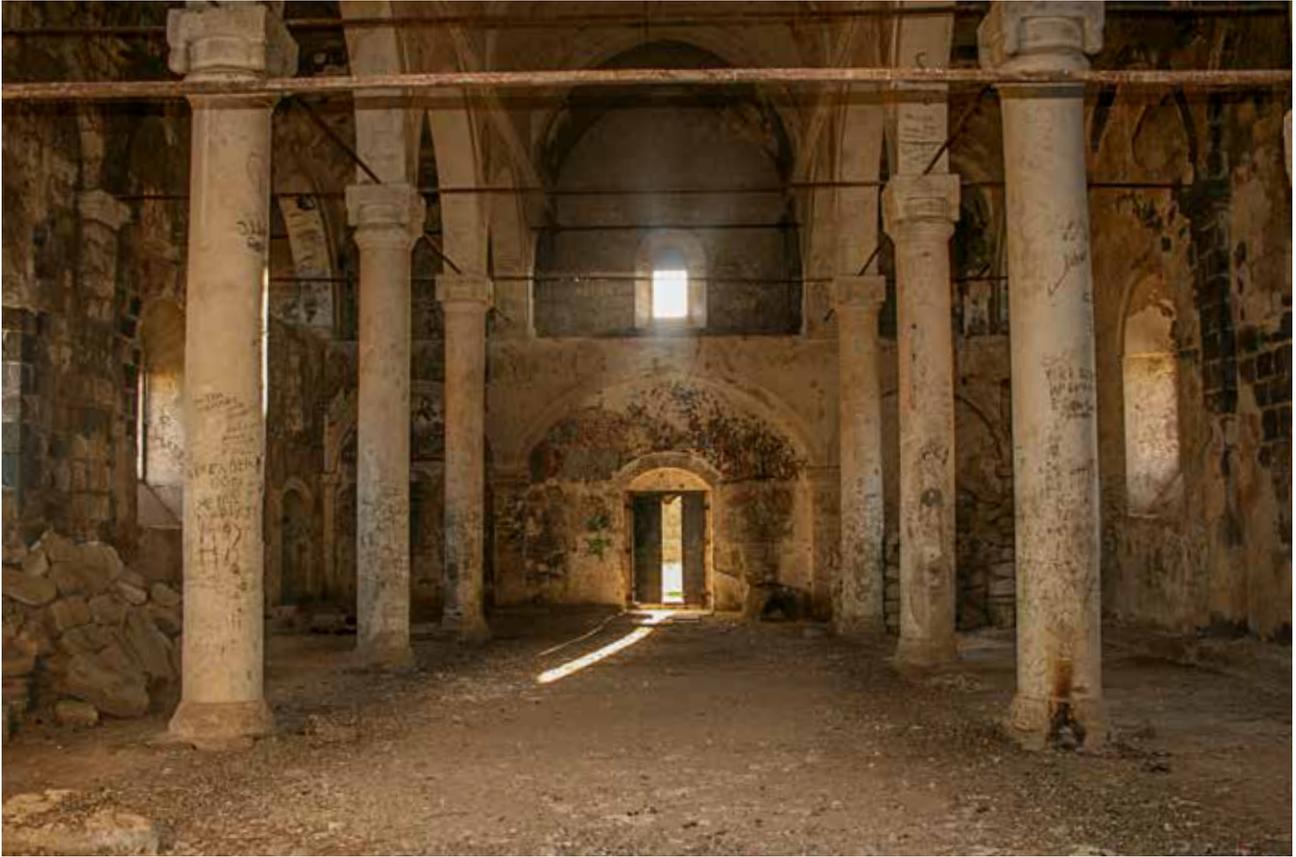
Currently, Church of Saint Macrina survives in a decrepit and neglected state. Due to the impact of the passage of time and of environmental as well as human factors, great destruction and degradation has occurred. All wooden window fittings within the structure have been carved out, and the stone flooring in the central nave and side aisles has been taken out and stacked inside. A niche for a mihrab has been created in the southern side of the nave wall, and some windows have been covered up with bricks. The main altar stone in the center of the bema has been knocked over. Apart from the northern aisle and narthex door, all original doors have been replaced with iron doors. The lower parapet stones and wooden parapets of the gallery floor and the stone and wooden stairs providing access to this floor have been removed. The iron bars in the windows, cramp irons and tie bars have been removed. The stone columns within the structure have been painted over. There is serious destruction in the sepulchre chapel as well.

Within the courtyard, the water wells have all been filled up and closed. Due to the soft soil upon which the structure is built, there are horizontal

and vertical structural cracks in the vaults and main walls. There is a general loss of materials in many places, abrasions, deformation, as well as corrosion and bending in the iron fittings. Within the interior, large sections of plaster have fallen off; plant growth is visible as well as efflorescence. There are problems related to dampness and the destruction of frescos has taken place due to these intense factors. However, it is still possible to discern the subject matter of compositions that have survived up to this day (Songur, 2016a, 43-45).

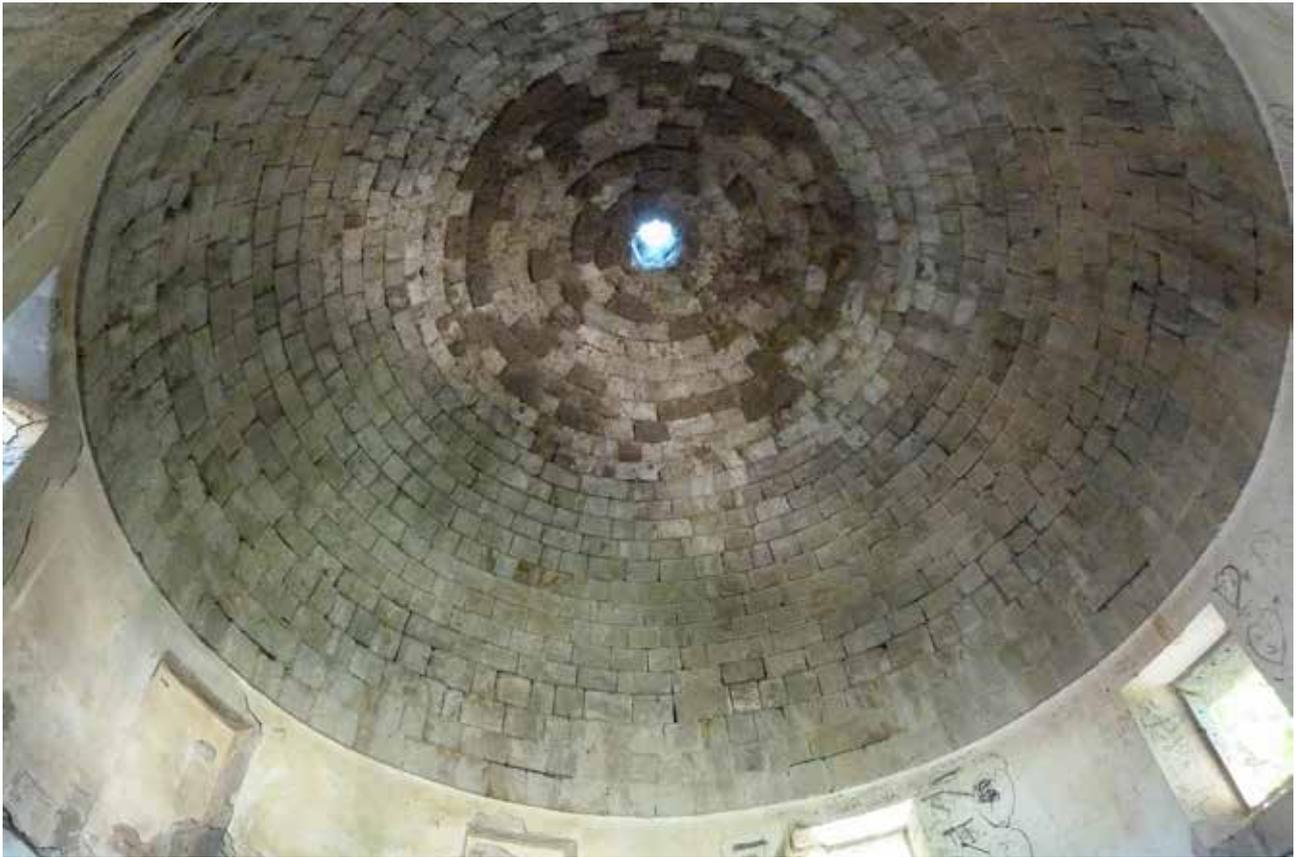
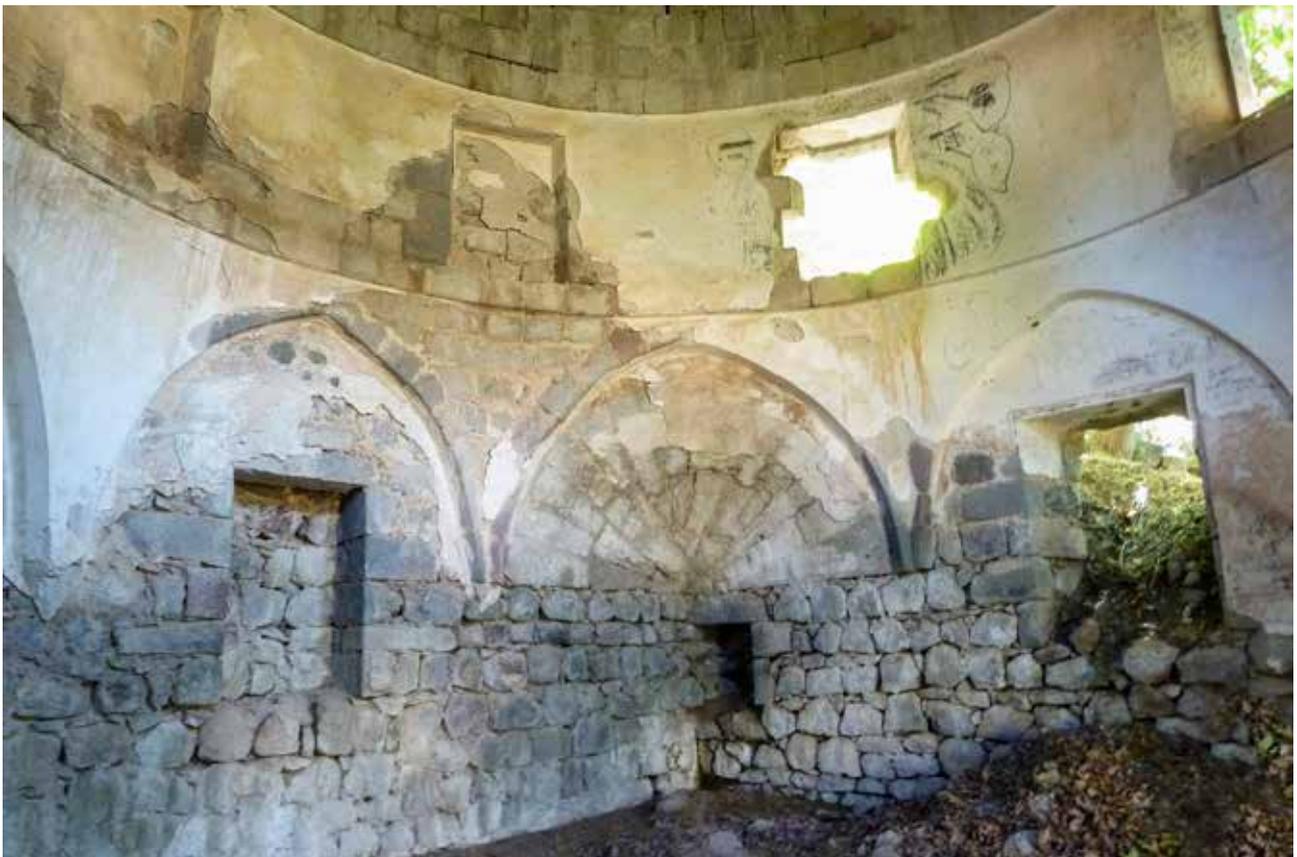
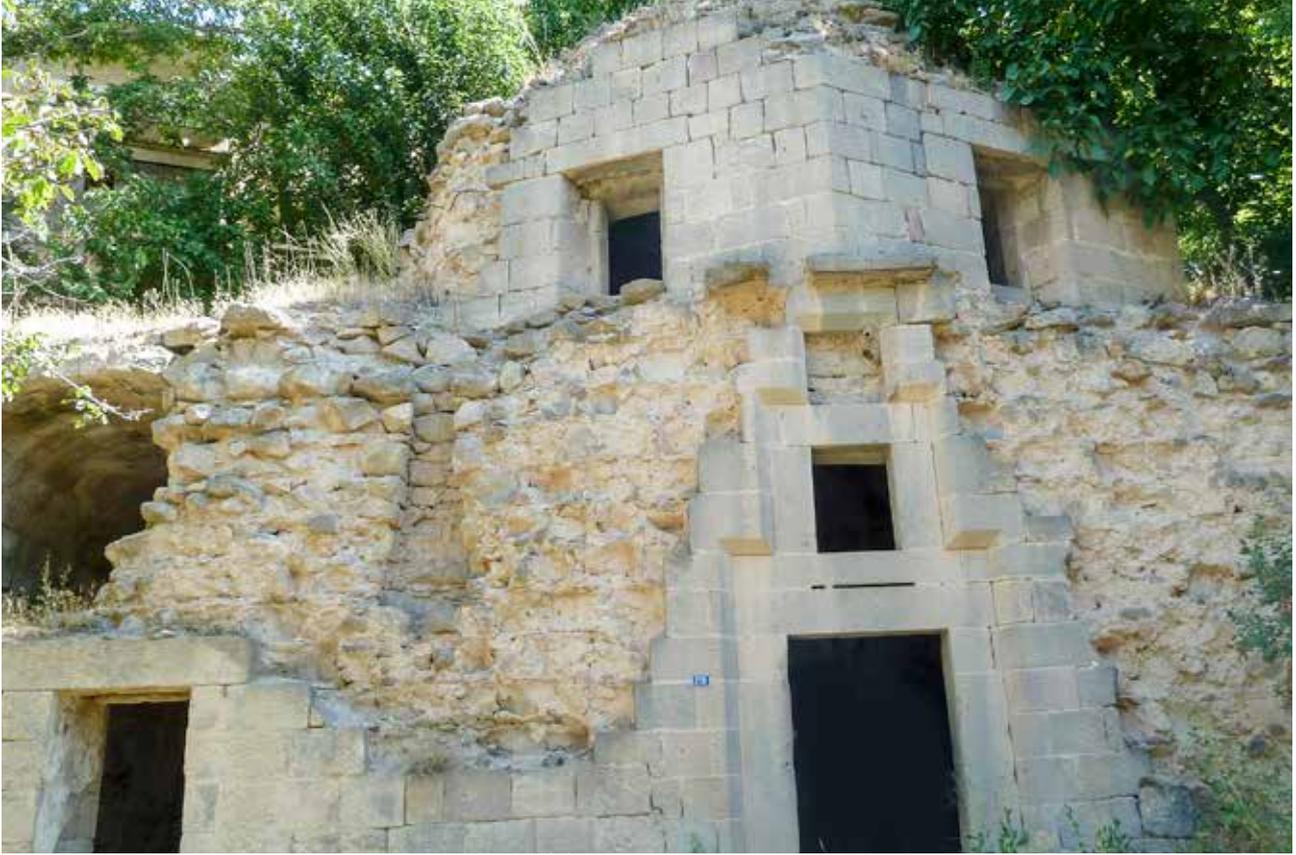
An example of 19th century Ottoman hamam architecture, Yeşilburç Hamam is currently not used and is in ruins. The facing and flooring stones of the structure have been removed and used in other constructions in the village, with the furnace, chimneys, and drains exposed as a result, and the hamam brought to its current ruined state (Ozkarıcı, 2013, 48).

There are severe fractures in the structure and plants have begun to grow on the roof. The dome stones have been removed or have collapsed so that the interior is filled with soil. Nearly all of the plaster has been removed. Almost none of the elements of the hamam, such as basins and massage stones remain.

The structure is in a poor and unmaintained state with almost no measures for its preservation. It is structurally in bad state, extremely open to human depredation and vandalism. It is also unprotected against the forces of nature.

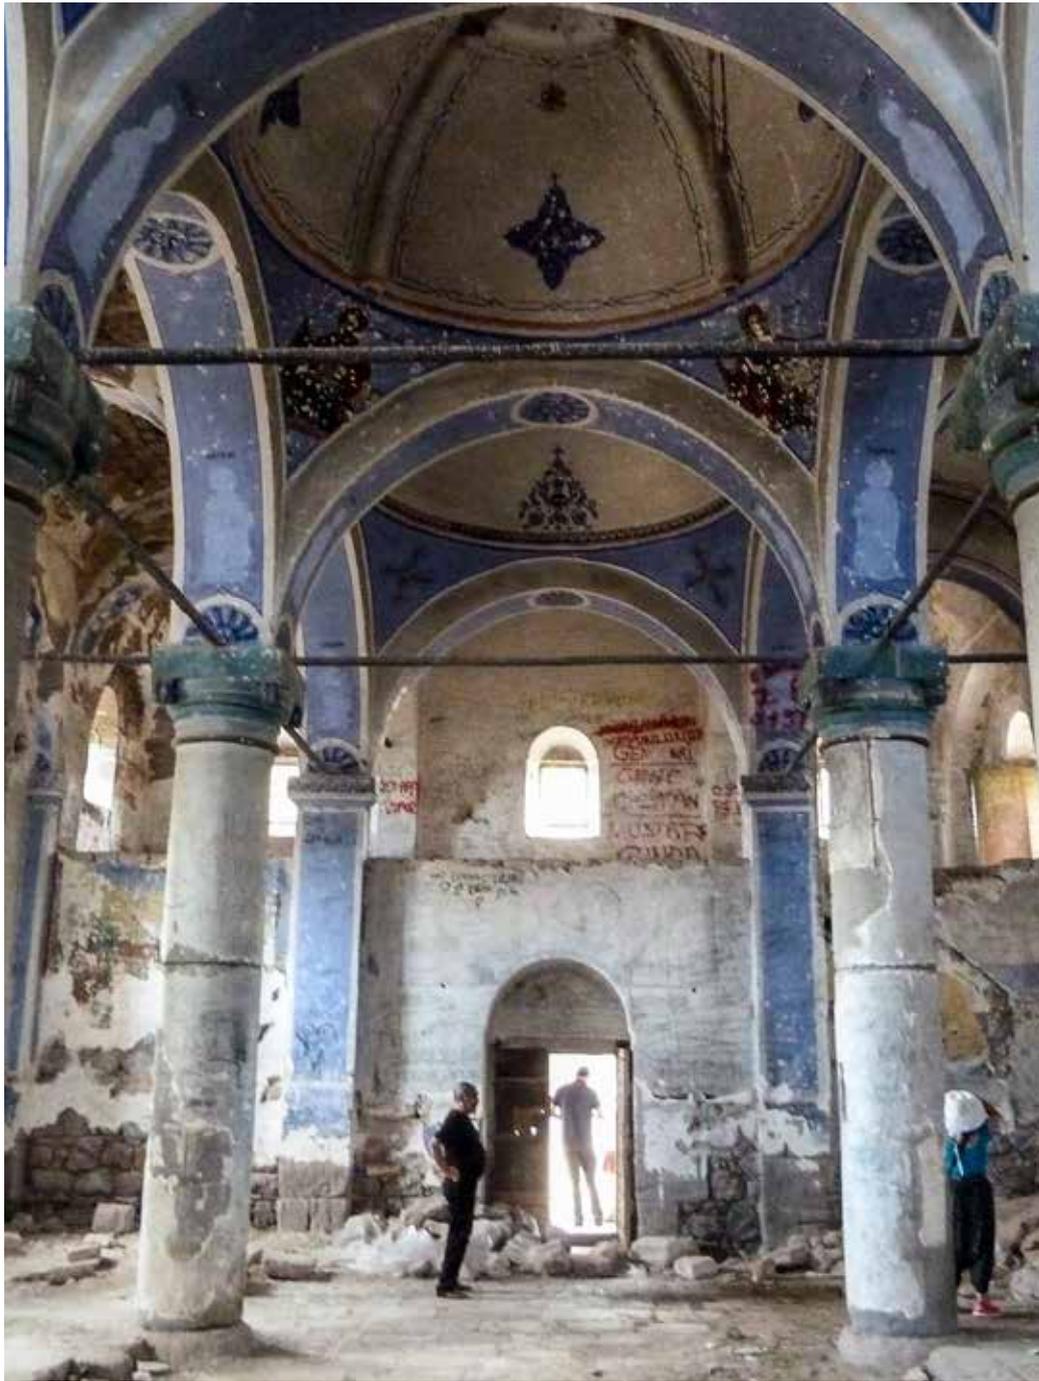
the diaconicon and prothesis remain (although the bars have been removed from the window in the diaconicon). The niches here have been destroyed. The plaster on the columns has peeled. The majority of frescos on the ceiling and walls remain; however, these frescos and decorations are at risk of being lost to vandalism. Of the saint figures on the arches in the central nave which were painted with blue paint, only

the silhouettes are now visible. Additionally, the tie bars in the between arches are largely present, though some have been removed. During field research, it was mentioned that locals used the structure as a mosque at one point; however, there are no traces of such use within the structure (there is no mihrab and the figures of the saints remain).

The simplest and most urgent precaution required for this structure in a poor and neglected state is to control entrance to the building. The structure has no door and people can easily enter and damage it, which will lead to this relatively preserved structure becoming a ruin in a very short time. In addition to this primary precaution, a comprehensive restoration project should be prepared and the problems mentioned above must be resolved.

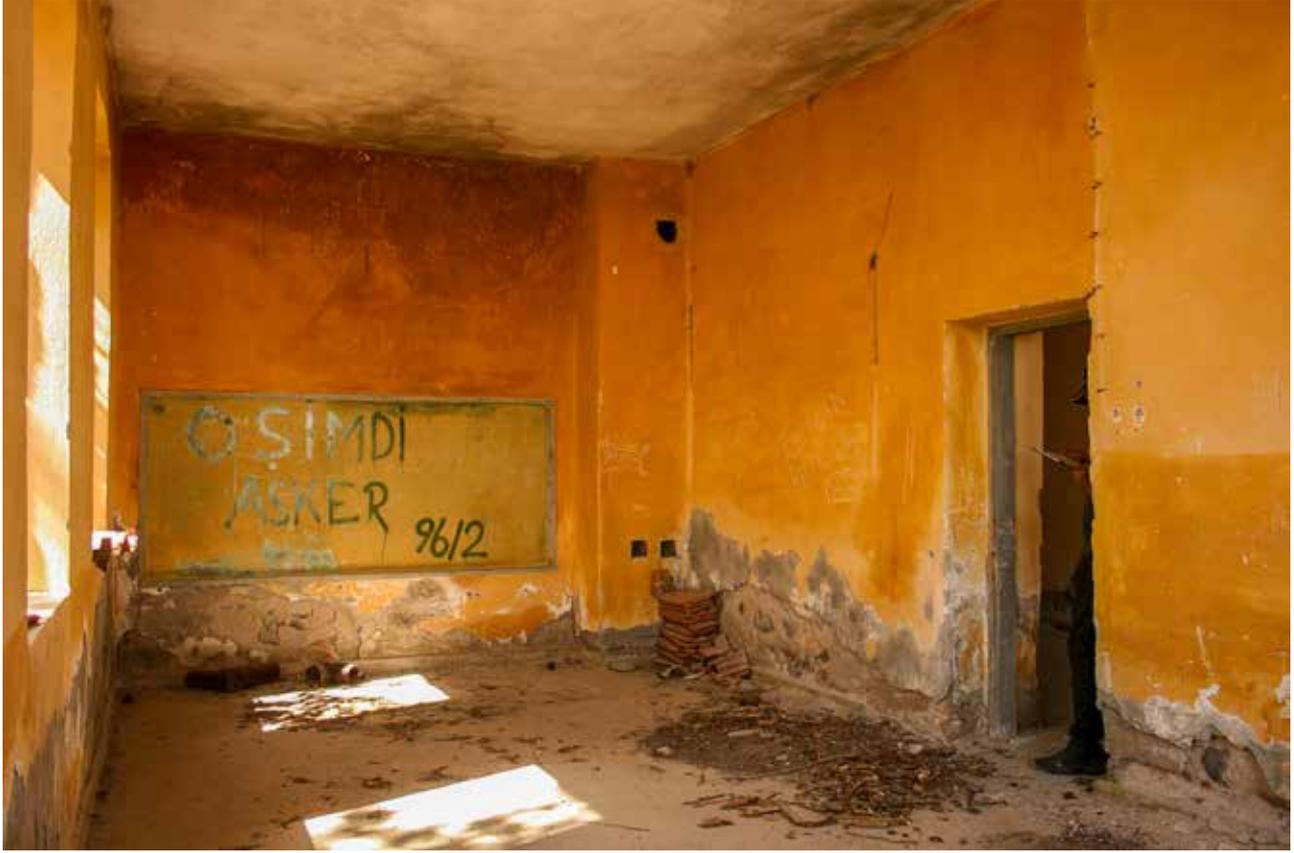
*The Greek School
Nigde Central county, Ballı village*

The roof of the building is in very poor condition and requires an emergency intervention. The lack of glass in the windows means that rainwater can easily enter the building. Some openings in the southern façade have been filled in with concrete blocks. The northern façade is packed with soil, and this load of soil poses structural risks to the building. The plaster has begun to peel. There is no flooring or wall plaster in the east wing.

The school and church should immediately be registered as historic buildings by Nevşehir Directorate of the Regional Board for Conservation of Cultural Assets. The structure should be assessed along with the church. As stated in analysis reports for other structures in Niğde, taking action with regards to this single structure will not be sufficient for the development of Ballı village; there is need for a regional strategy. The Ballı village school and church are valuable structures that can be used as an important parts of this strategy.

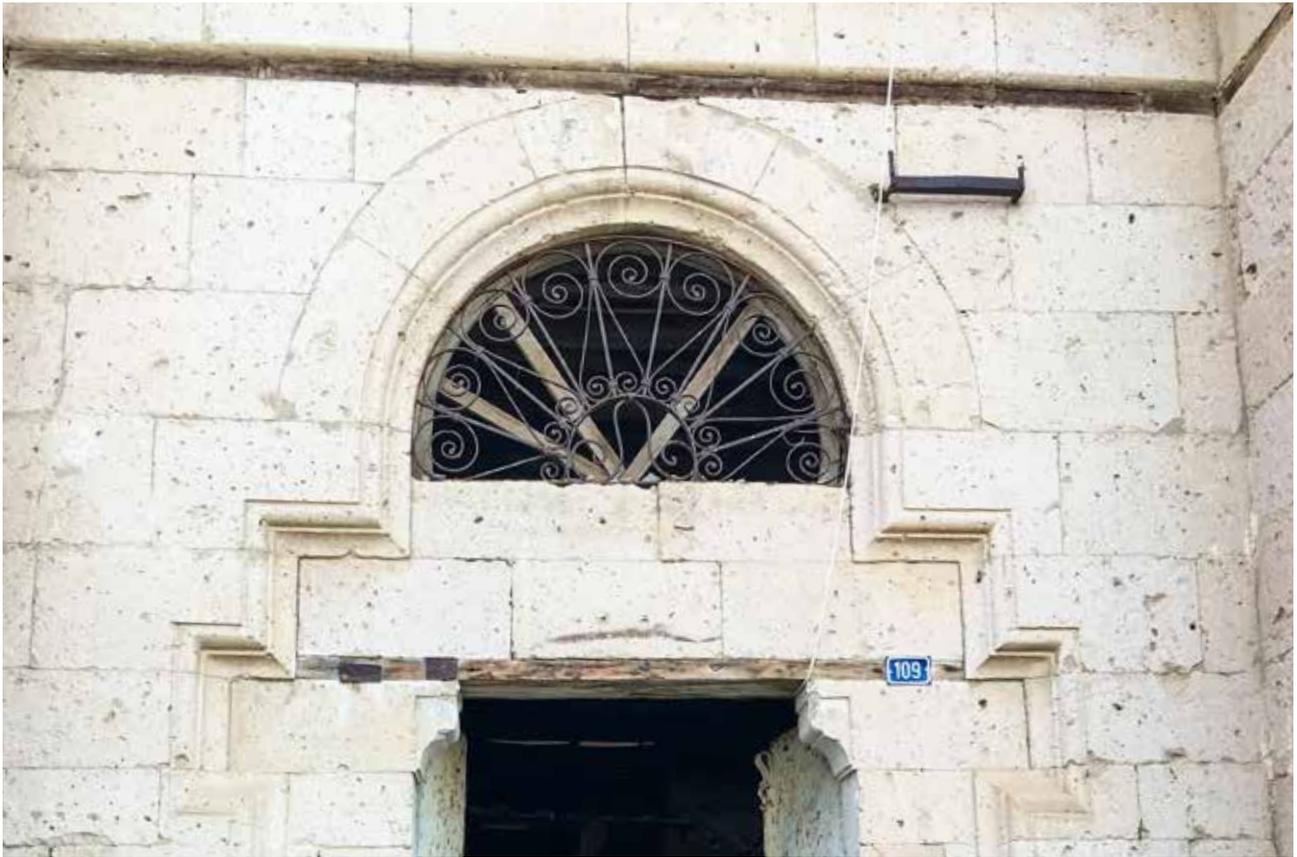
*The Greek School
Niğde Central county, Uluğaç village, Köyönü locale*

In the first floor hall, the flooring to the northeast has been partly destroyed. The original stone main wall between the two northern rooms on this floor has been removed and a wall has been built from concrete blocks. All the wooden flooring in the first floor rooms has been renewed, and the ceilings replaced using plywood. Some of the doors and shelves of some of the built-in closets are missing.

A large portion of the clay roof tiles of the structure have been destroyed and lost. As a result of this, the wooden eave plates, the wooden roof construction and first floor ceiling cover have suffered serious loss of material and rotting. The chimneys on the roof have partly collapsed or are sagging. Due to the general water problem in the roof and lack of glass in the windows, a large portion of the plastered surfaces within the structure are peeling and falling apart, with hairline fractures in the main walls.

The facing on the façades, especially the molding stones, have suffered deformation, efflorescence and erosion due to dampness. The stone shapes beside the main doorway are destroyed and deformed. The wooden beams in the façades are rotting and have started losing their integrity. There is corrosion, bending and deterioration in the window bars.

The wooden staircase used to access the upper level is rotting and losing its ability to carry weight. The railings on the upper floor gallery are no longer in place. All of the wooden doors and windows have lost parts of their material, are rotting and infested with termites. Fires lit inside and outside the structure have created soot and caused color changes on the stones.

As the beams for the annex were installed by the removal of part of the main wall, this has damaged the structural balance. Due to sinking and deviations in the structure, the vault surfaces and main walls contain structural and hairline fractures.

In addition to the effects of wind and rain, the walls are completely open to vandalism and contain hairline and structural fractures. Accessing the upper floor is risky, with danger of breakage or collapse in the wooden flooring. At the same time, the ongoing degradation of the wooden roof is a serious problem. The entrance should be locked immediately to prevent vandalism. Then the necessary efforts for preservation and repair must be carried out. When compared with other structures in the region (as the outer facing has not been destroyed), it will not be difficult to renovate this structure.

The landscaping of the building's garden should be completed, with the courtyard walls repaired and put back together. It is necessary to place road signs and an information panel about history of the school and Uluğağaç with maps of other historical structures in the area.

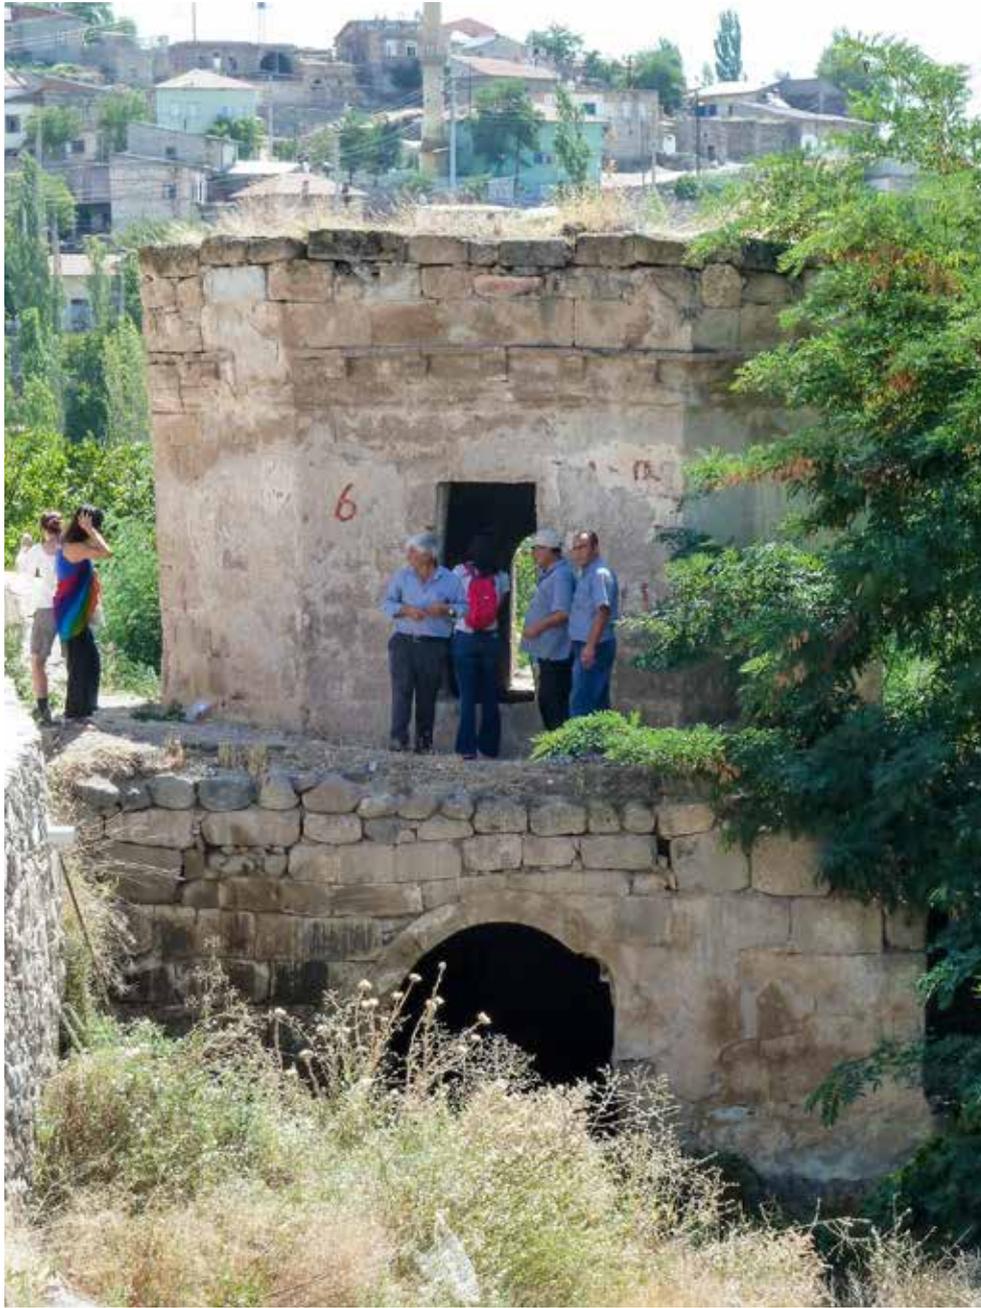
*Sivri Church
Altunhisar county, Yeşilyurt village*

The building is in relatively good state, with no major damage. The original entrance of the church on the southern wall is covered by the thick layer of dirt and rubble, filling the interior. For the same reason the original height of the church (today measuring 9.82 m) cannot be properly established. Sparse traces of the original frescos survive on the interior surfaces. Two of the three apse openings are closed off with rubble, and the damaged and enlarged windowsill on western wall is currently used as the entrance to the structure.

The use of the drum as a masjid in the 18th century has caused notable alterations to the original church, which are obvious in its present state: in the interior, a niche was created as a mihrab on the northern side of the dome, on top of which there is the sacred inscription "La ilahe illallah Muhammede Resulullah". The western window of the drum was enlarged as a door allowing access to the prayer space. On the exterior, the roofing of the church was flattened, and the upper stone courses in the apse and the drum were repaired with rubble. A Muslim tombstone was used as construction material in doing this. An inscription incised on the block outside the western window of the naos, "Hijra 1185" (corresponding to the year 1771) gives probable the date of these interventions (Pekak, 2008, 101).

Though registered as a historic building in 1999, no conservation action has been undertaken so far, and the church is left to abandon, exposed to weather conditions and unprotected from vandalism.

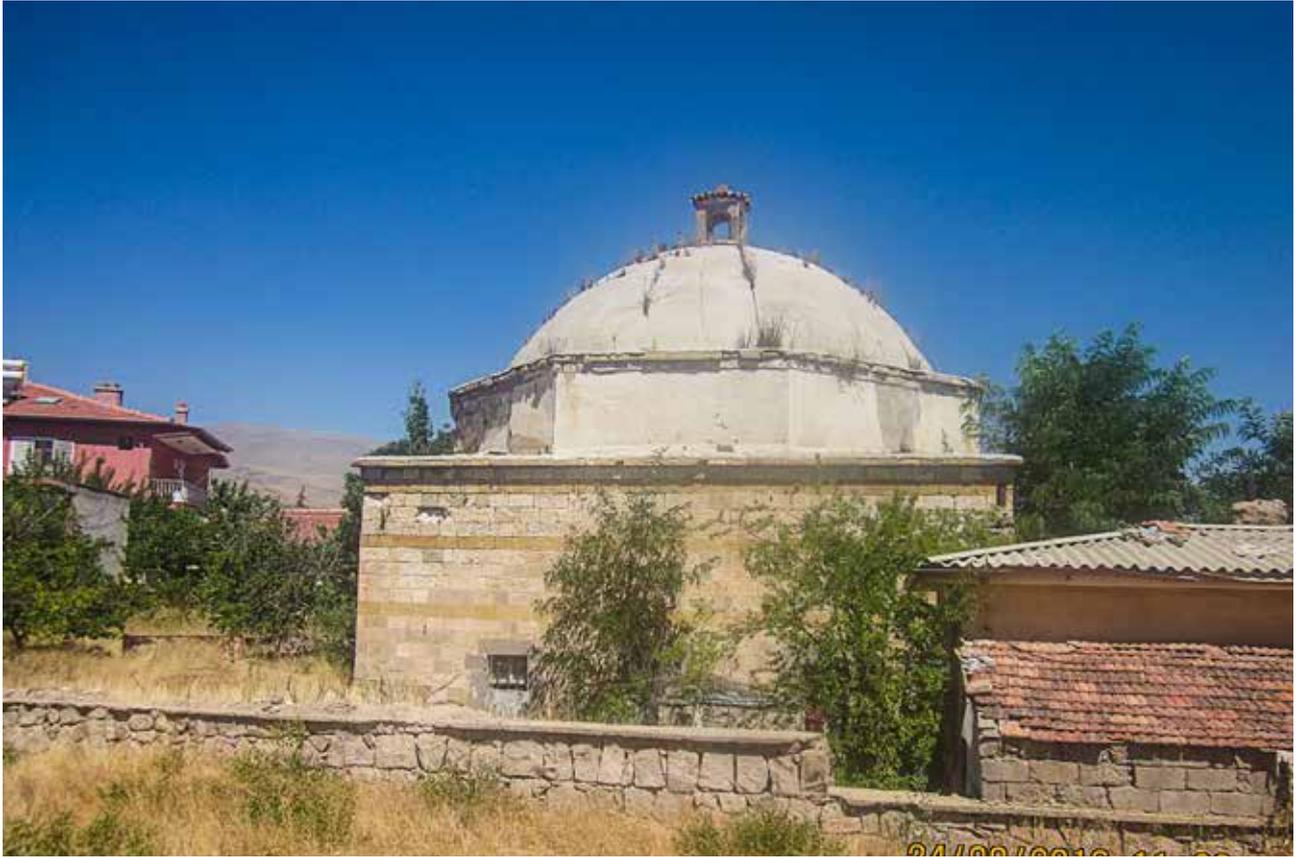
*The Public Bath
Niğde Central county, Fertek neighborhood*

The hamam is currently moderately intact; however, since unsuitable additions and repairs were later made and it has been abandoned for nearly 15 years, structural degradation has taken place due to lack of protection and maintenance. At the same time, the interior houses the unused benches of the village and the hamam is partly used as a depot. As the door is not locked, entrance to the hamam is unchecked.

Because of the cement plaster, the main construction material, which is stone, cannot breathe. This has led to widespread efflorescence, moss growth, and falling plaster in the interior. Mortar has been lost in the dome and cracks may be observed. As the cement has

not quite adhered to the stone, plaster has fallen off the exterior (especially the roof) with plant growth beginning on the dome. Graffiti can be seen on the external façade. Additionally a large satellite dish has been added to the roof of the hamam recently, adding weight to the roof and disrupting the integrity of the original structure. As there has been no glass in the small skylights for a long time, rainwater entering the building has caused dampness related problems. During renovations that took place probably within the last 50 years, electrical lines, as well as heating systems and radiators, have been added upon the plaster on the walls.

All of the later reinforced concrete additions, the plaster, plumbing and the satellite dish must be removed. Reinforcement and protective actions should be undertaken. Visually, the interior must be furnished so as not to disrupt the original texture, and infrastructure must be installed in order to provide for the daily needs of the hamam. It is recommended the hamam be made functional again based on a management model including the locals living in the village. Having this chance of fulfilling its original function, an information plaque should also be added to Fertek Hamam explaining the history of the structure. It must be emphasized that it historically met one of the basic needs of the village, but at the same time is a common heritage with important social aspects.

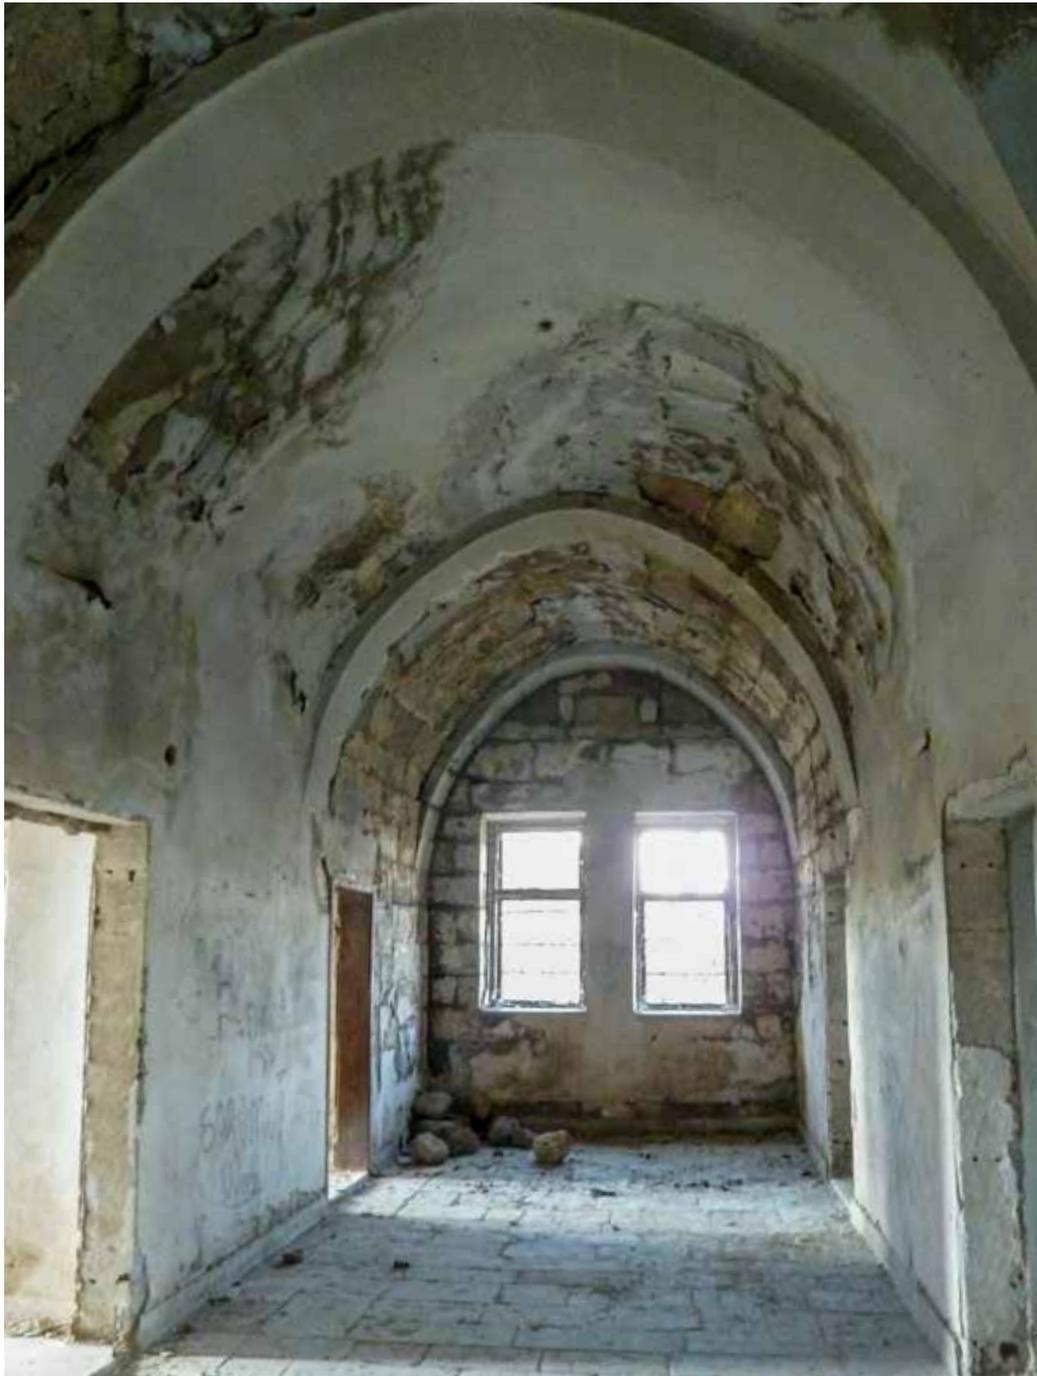
*The Greek School
Niğde Central county, Hasaköy neighborhood, Köyiçi locale*

Abandoned since 1979, the Hasaköy Greek School has reached today in a seriously ruined state. Though the external façades do not look badly damaged, degradation and interventions are visible in the interior. Toilets were built at the end of the south arm of the cross-plan corridor, at this time the lower window in the southern façade was also closed off, the stairs to the roof were removed and a reinforced cement ceiling was built. An additional room was created by adding a wall, east of the western entrance to the corridors. The terrazzo covering on the stone classroom floors was laid down later on, and the stone walls were plastered and painted. The plaster on the walls of the interior later flaked off and the cut stone wall is partially visible. The entrance doors and wooden window frames were changed, and the wooden doors and window bars were removed. Currently only some of the wooden frames of the doors and windows remain. Three arms of the cross-shaped window over the western entrance were filled in and closed off. Cement in the stone steps leading to the entrance doors is clearly visible, and parts of the staircase in the west have been removed. A concrete fountain has been built in the courtyard towards the wall, and the western garden entrance has been removed. The roof which used to be soil consists of pebble stones today.

The use of wrong material and its faulty application on the roof have led to the seepage of water through the main walls. Due to this dampness, the mortar between the stones has cracked open, there is deterioration in the surfaces and deformation in the parapet, parts of the surfaces of the vaults in the interior have fallen off, cracked and separated, and yellowed. There is sagging in the chimneys of the roof. The material comprising the external facing and moldings is partly lost; deformation and dampness has led to mold and dirt on these surfaces. The remaining portions of the wooden elements have begun to rot, with corrosion and deformation in the iron bars and doors. Some of the cramp irons have been removed, with corrosion in the remaining iron sections.

To stop this degradation, outlined in detail in Songur's report (Songur, 2016, 47-48), the restoration project that has been prepared must be approved and immediately put in motion. This school, a witness to history and carrying architectural value, should be restored, and a multifunctional new and historical educational facility opened for the village. At the same time, this structure may become a regionally important cultural center, bringing about quite significant development locally. In addition to serving the village, this may be an important source of motivation for visits by the grandchildren of people who migrated to Greece and a source of tourism for Hasaköy, along with the rest of its cultural and architectural heritage.
