Niğde

NIĞDE SITE ASSESSMENT VISIT

Dates: August 23-28, 2016

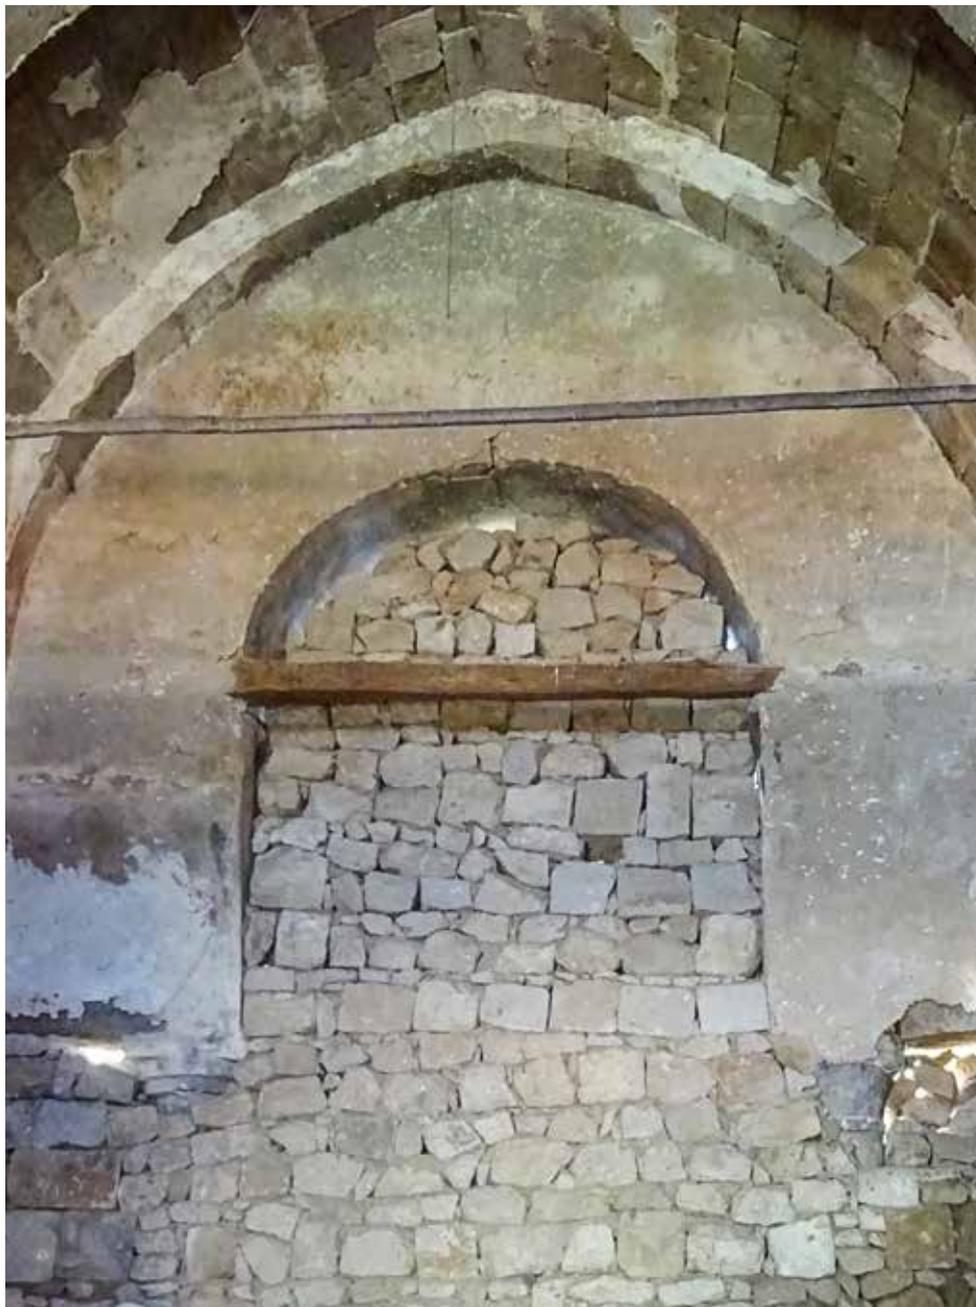
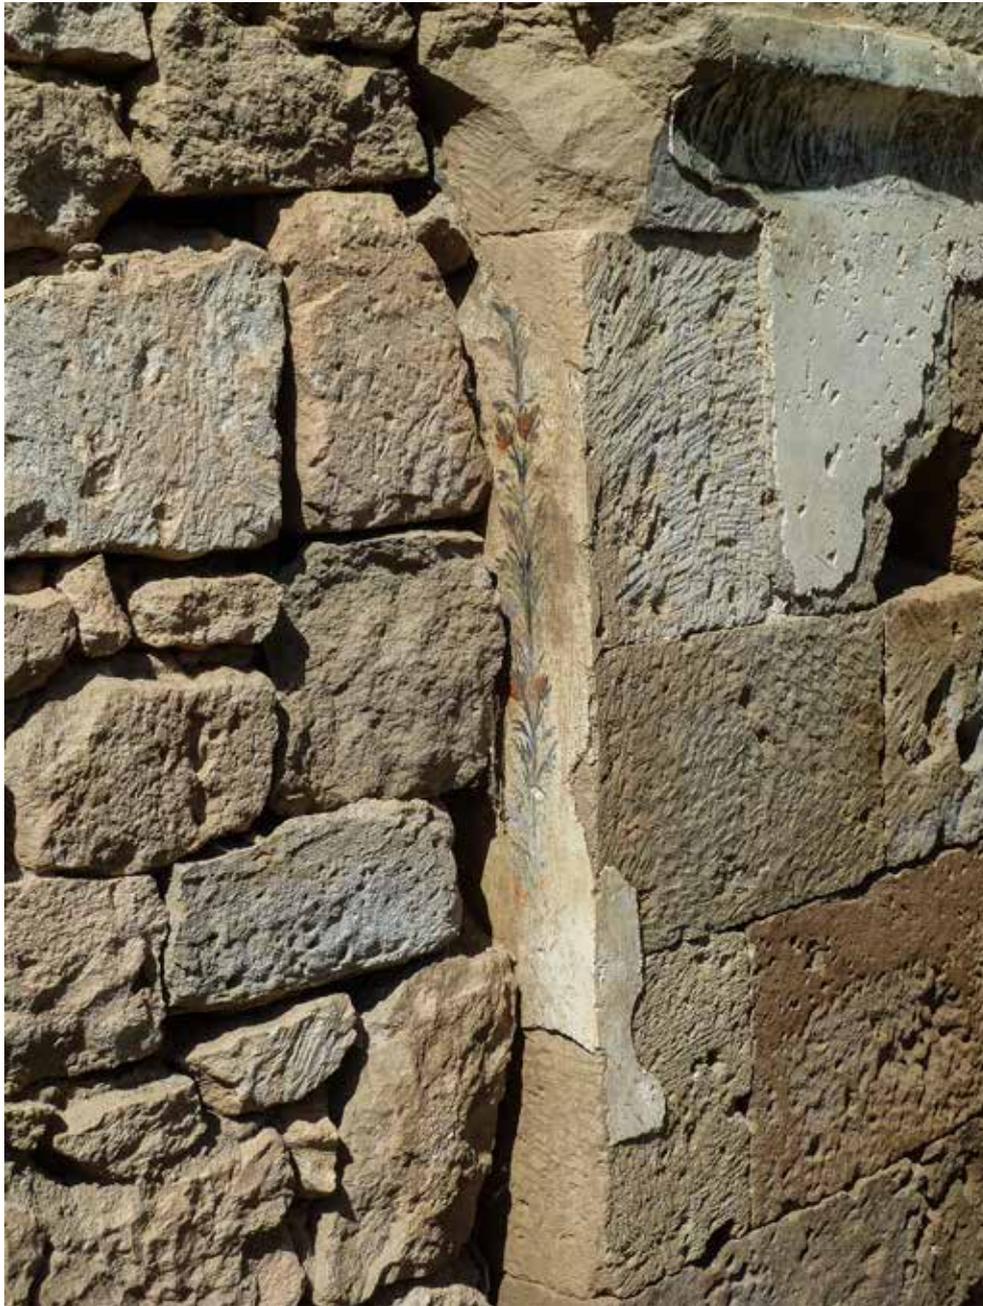
*Church of Saint Pachomius
Niğde Central county, Dikilitaş village*

the northern and southern sides of the building. The major alteration that the church has suffered is the complete disappearance of the bema along with its dome and apse (or apses), while the naos and its walls are in a comparatively better condition. The side where there are missing parts is currently covered by rubblework. On the interior, only the upper horseshoe-shaped part of the wall separating the naos from the bema survives, framed by an embedded arch and supported by two columns, all of which are hardly discernible among the rubble. The surviving parts of the dome and of the supporting arches below it have been left totally unprotected. This eastern side of the building is buried, all the way up to the top of the bema columns. The floor of the naos has become filled with earth, with no trace left of the original flooring.

The edifice is important in terms of Greek Orthodox church architecture, as it is one of the few surviving freestanding churches from the 18th century in the region, and it is a noteworthy one for the particular decoration of its western façade as well as for the masonry of the ambo. Though it has been registered as a historical monument, no action for its conservation has been undertaken, and the church is entirely abandoned today, unprotected from weather conditions and vandalism, especially on its exposed eastern side. Half of it is buried under earth on its northern side and even more so on its eastern side.

Excavation activities must be carried out in order to survey the foundations of the missing eastern part of the church and discover the possible remains of the cemetery that is said to have surrounded the church. A special study is necessary to establish the size and form of the bema, dome and apse, in order to confirm or refute the theory that the church used to be a domed one, and specify whether the estimated construction date is indeed correct. A careful survey should also be undertaken in order to identify the rough walls and stone structures around the building.

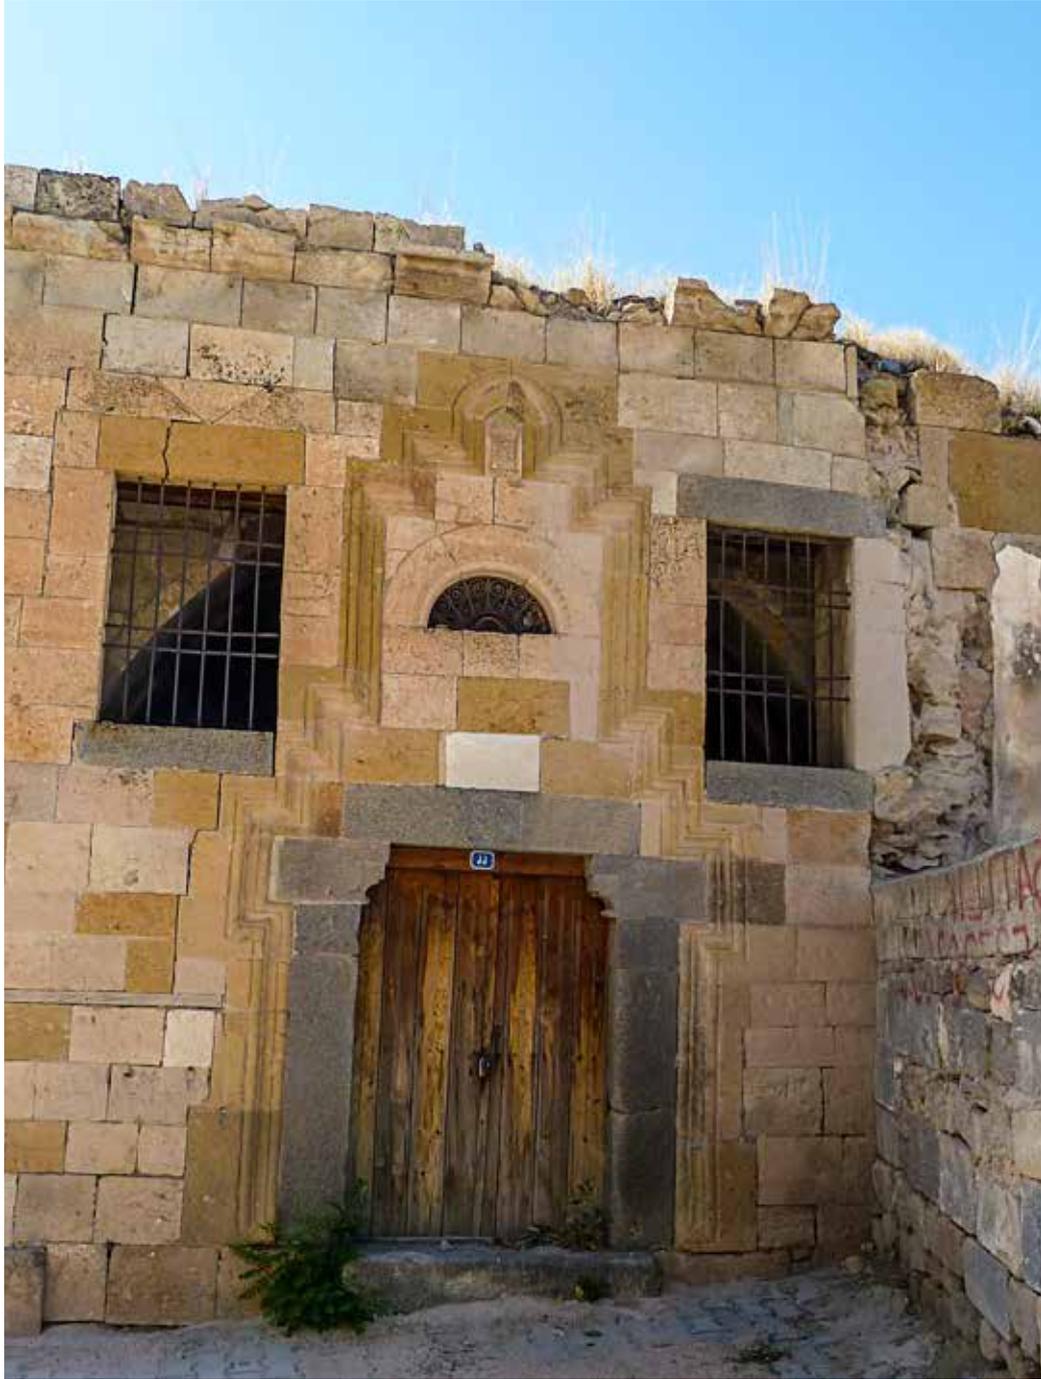
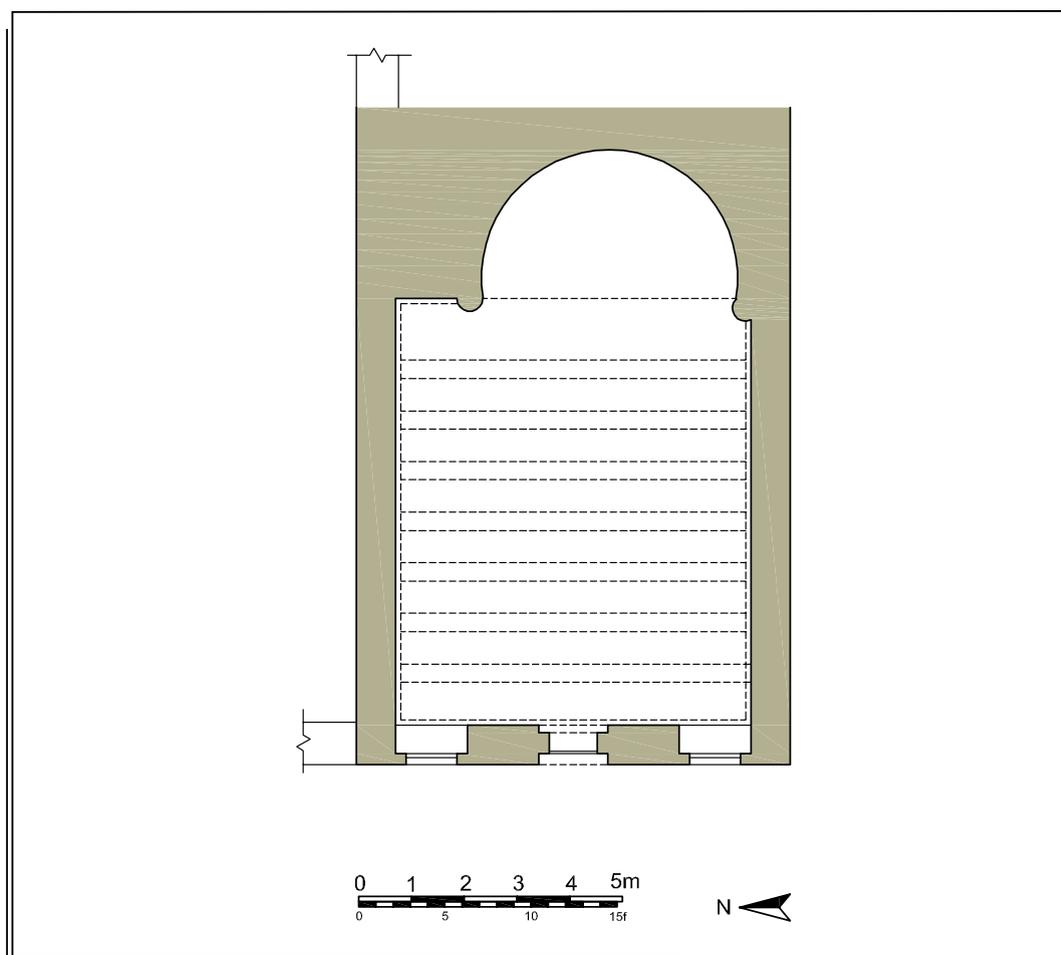
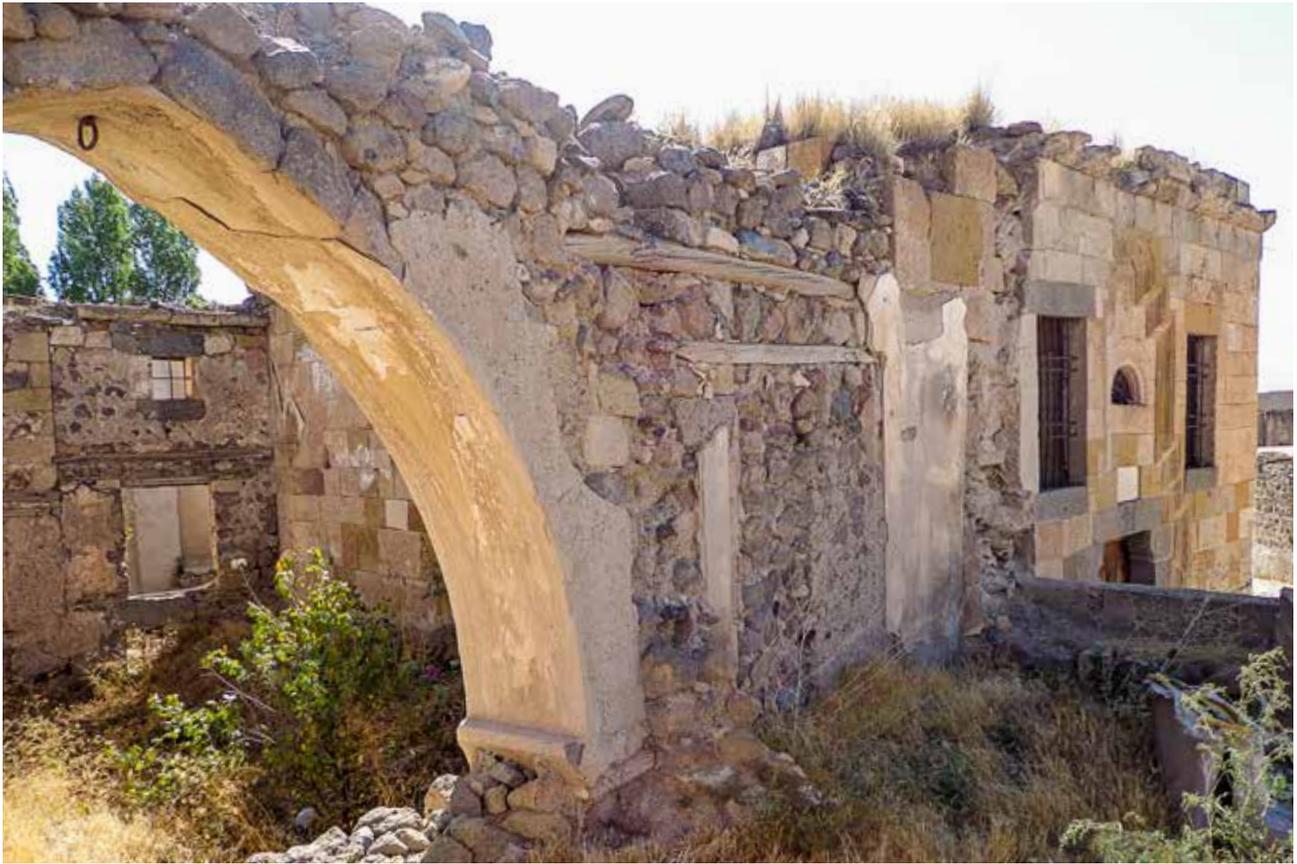
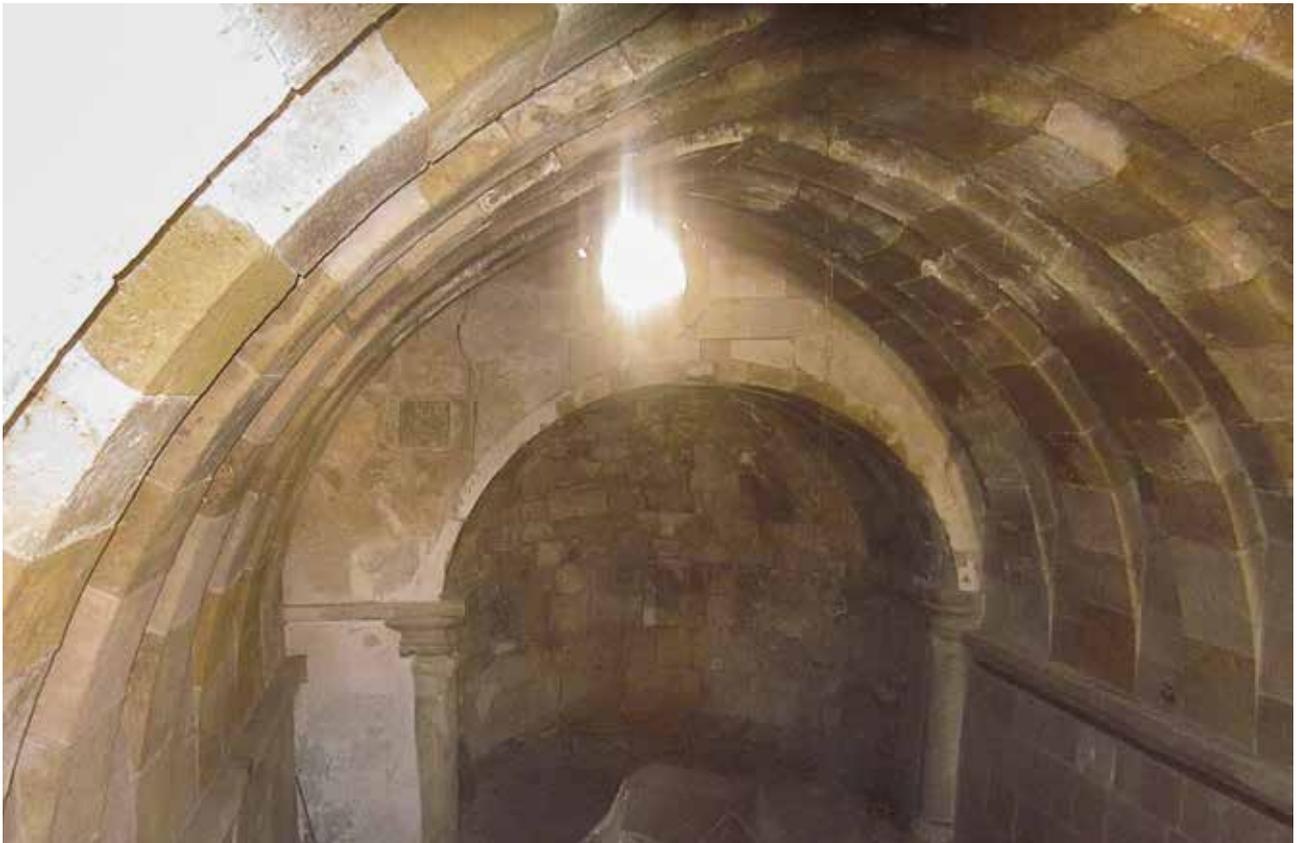
*The Chapel
Nigde Central county, Ferteek neighborhood*

The door to the structure, which is right on a road in the village, is locked; however, there is no glass in the windows and it is used as a neglected depot. There is no information plaque regarding the chapel. The architectural layout has been preserved, and it appears that in the interior wooden upholstery was later added to the point where the vault joins the western wall. The wall of the courtyard of the neighboring structure leans onto the southwest corner of the chapel. In the northwest corner, there is a courtyard wall of concrete block, extending westward. There are additional ruined structures adjacent to the northern façade.

A substantial portion of the stone covering of the southern and eastern façades is missing (probably removed to be used in other structures), thus the shape of the eastern wall cannot be understood clearly. The missing stones have exposed the vulnerable inner filling of the wall to the weather conditions and this filling is being eroded over time. There are cracks and cavities in the walls. Vandalism is seen on the exterior, in the form of incisions on the walls.

Having the external stones removed from the southern and eastern façades has caused the inner wall filling to be exposed to weather conditions and this fill is being eroded over time. The chapel is susceptible to earthquakes and the cracks in the wall will grow as long as it remains neglected. The roof cover has been nearly completely lost and the plants as well as water leakage from what is remaining of the roof is also damaging the building. Using appropriate materials, the external facing of the building must be completed, cracks must be repaired and the building generally reinforced and preserved. Glass must be installed in the windows to prevent rain from entering.

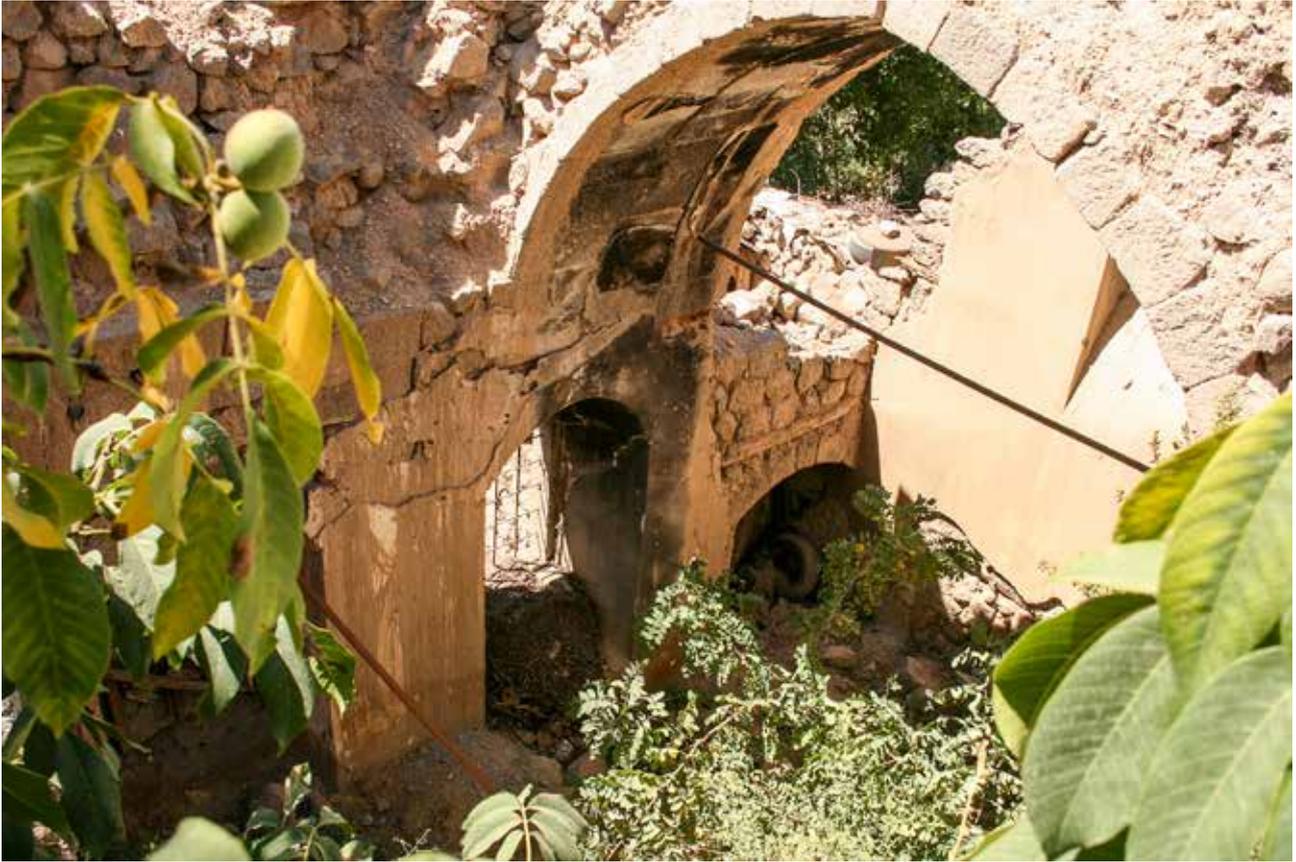
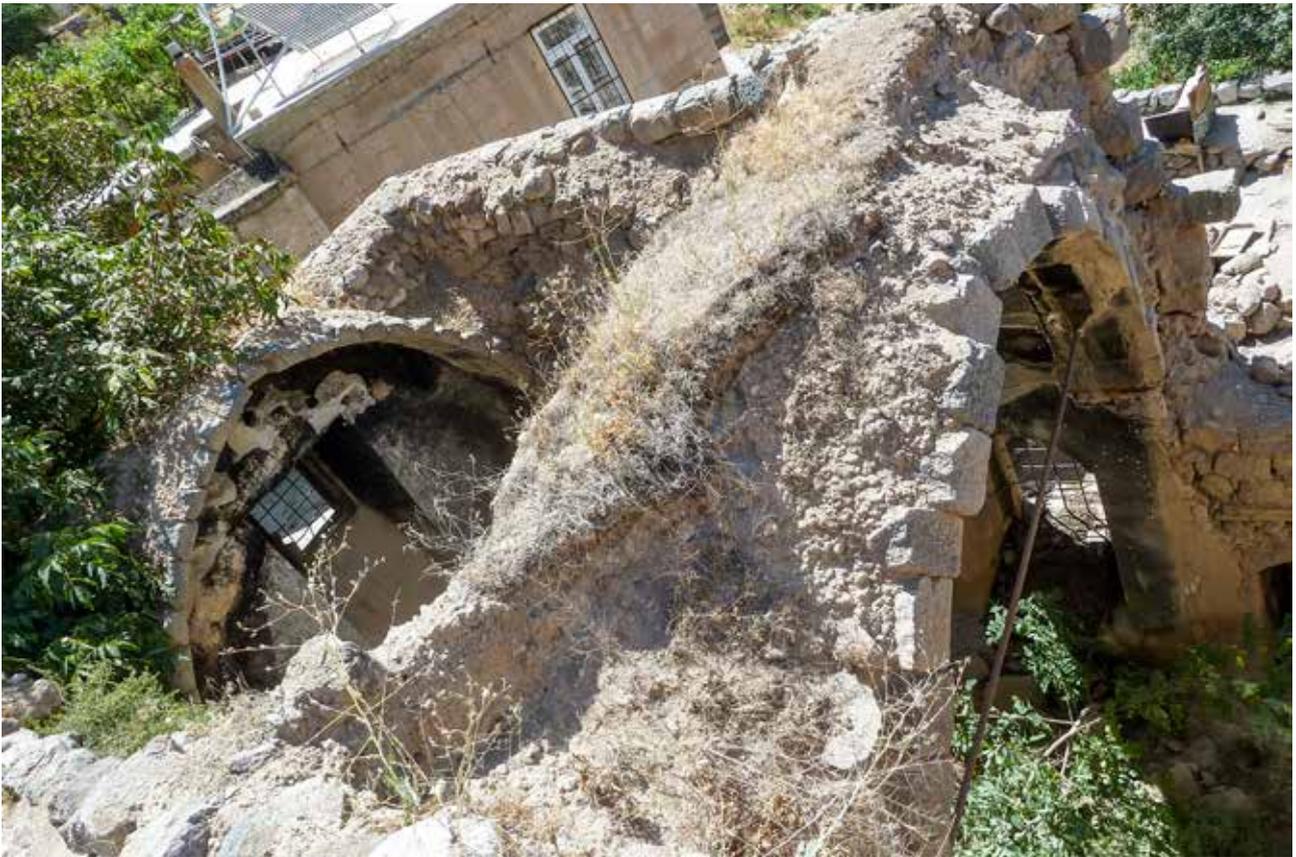
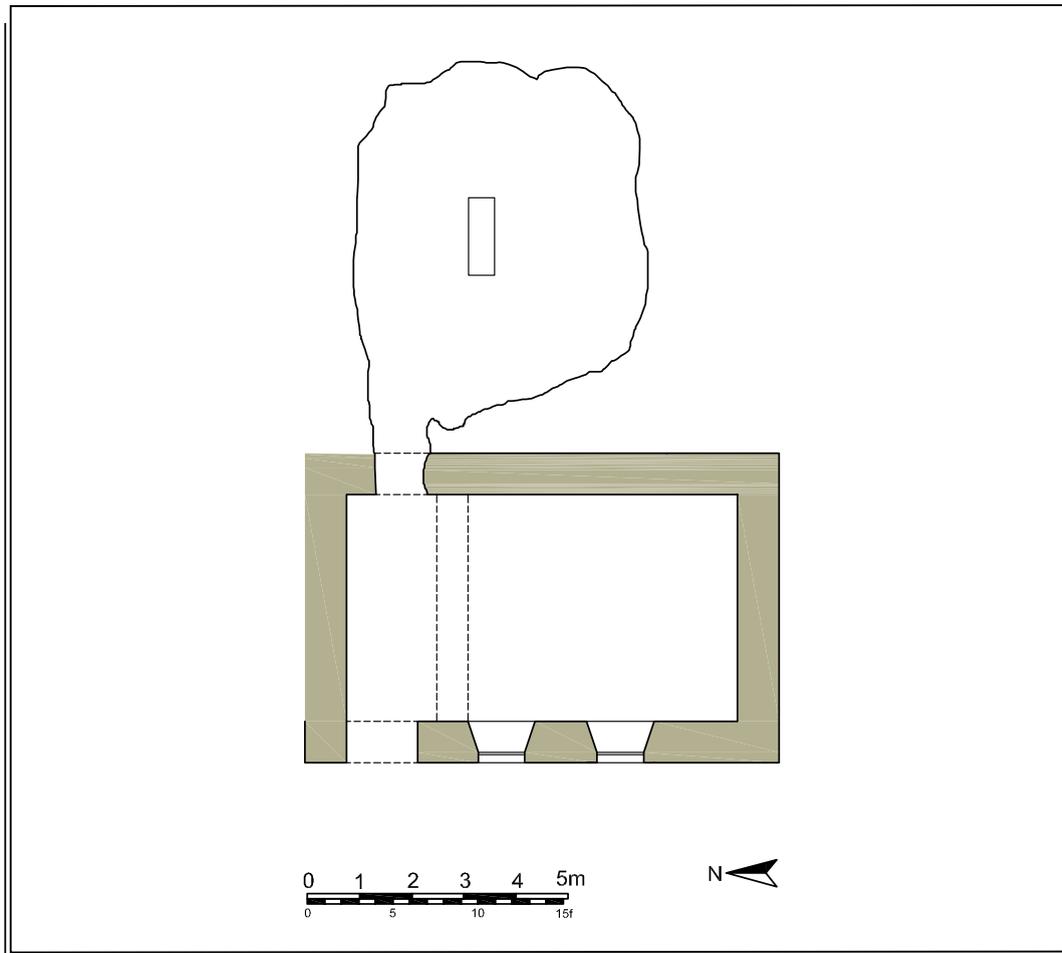
Though the structure is ruined, its plan is still readable. The structure is dilapidated and the majority of its materials have collapsed into the interior space. Soil and plants growing over these have completely filled the space, elevating the original floor level. The eastern wall of the structure is covered with soot. There are trees and weeds inside the structure. Apart from the openings mentioned above, further architectural details cannot be discerned or have been destroyed.

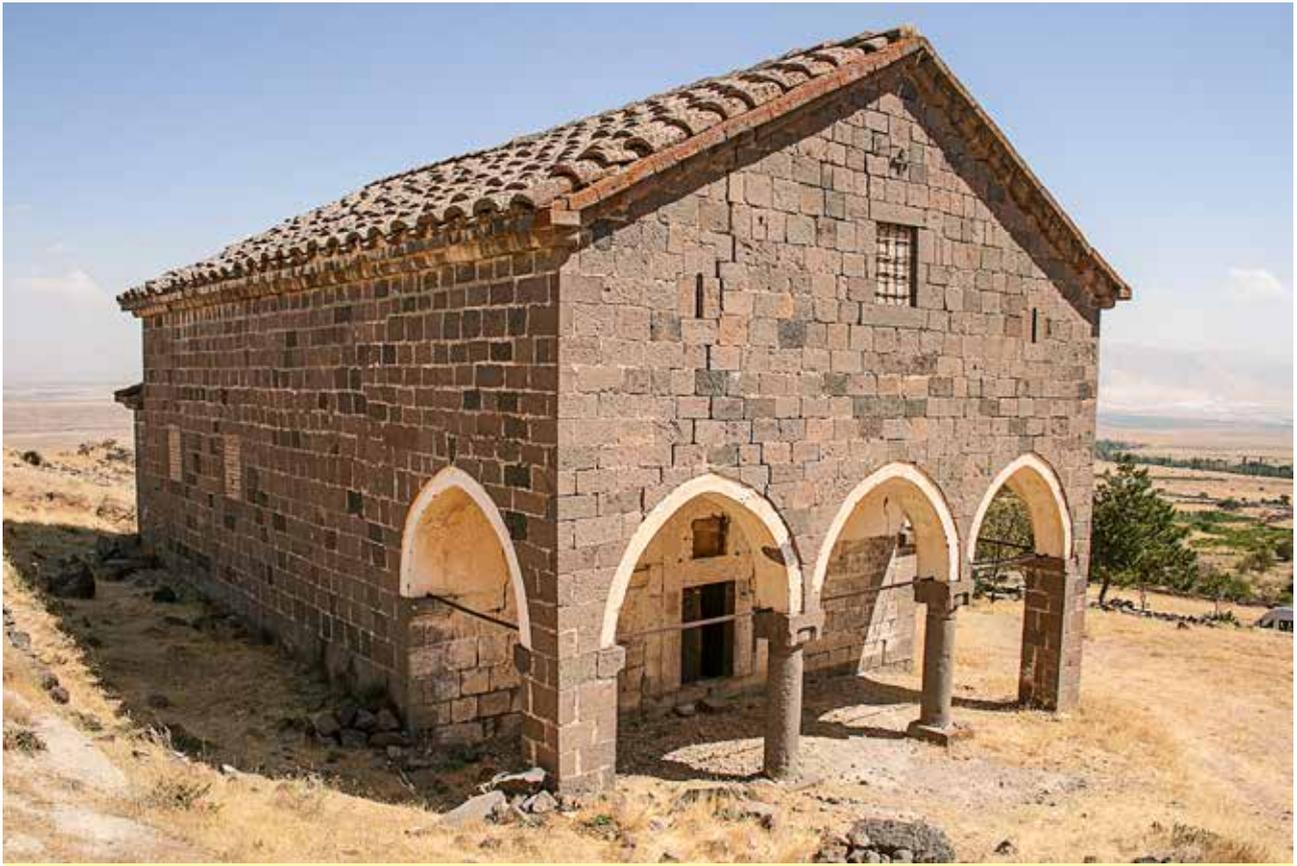
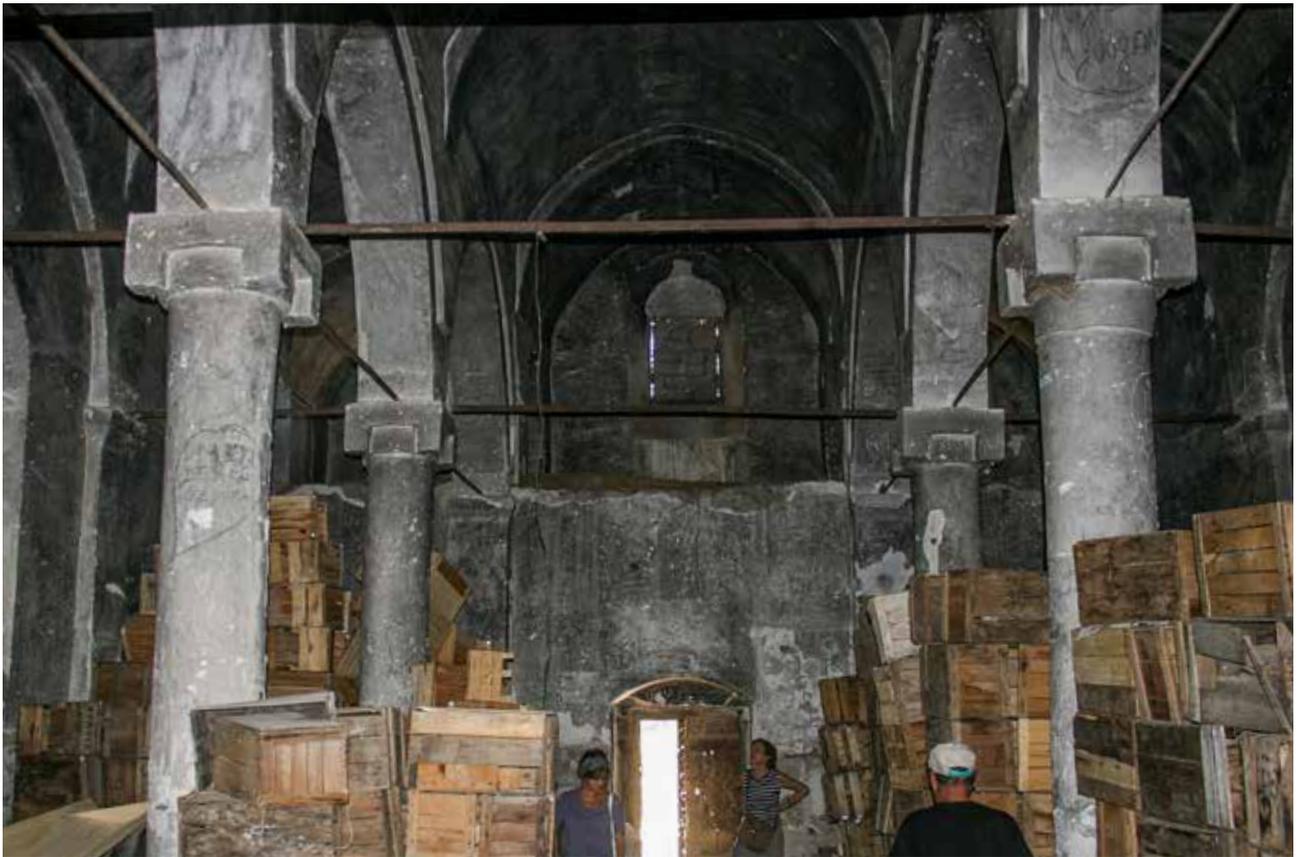
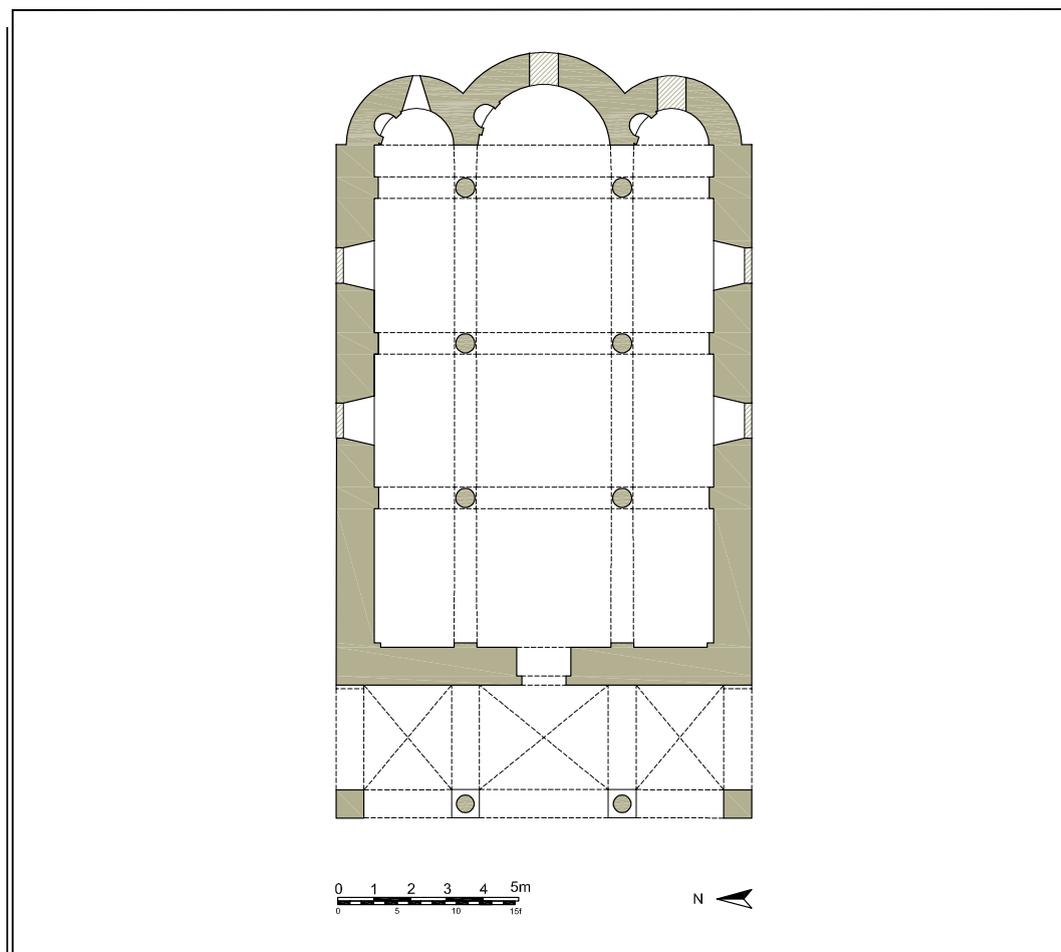
The structure is currently used as a depot and being full of crates obstructs an understanding of the space. All the openings of the structure have been filled in with concrete blocks and thus the interior is dark. The church has an unlocked, unoriginal door. The stairs to the gallery have collapsed and a majority of the original flooring stones have been removed. The southern side of the apse has been excavated by treasure hunters. There are graffiti marks on the walls. The bell tower is partly demolished.

The church has serious structural problems, which can also be observed on the façades. The eastern wall of the naos has deep cracks in it. The mortar in the external wall of the apse has been repointed with incompatible material and bad workmanship. The northern and western façades have cracks running from the eaves all the way down to the ground.

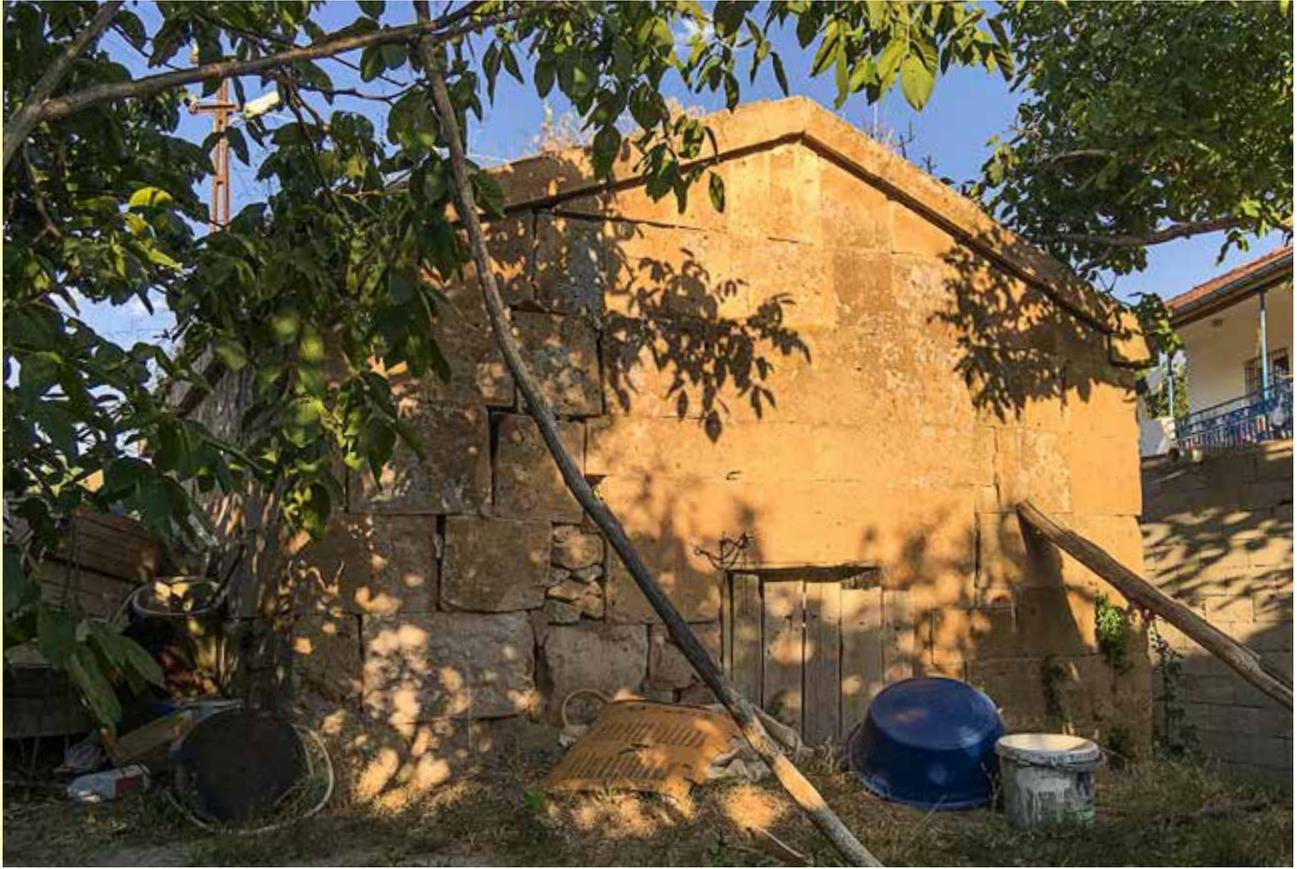
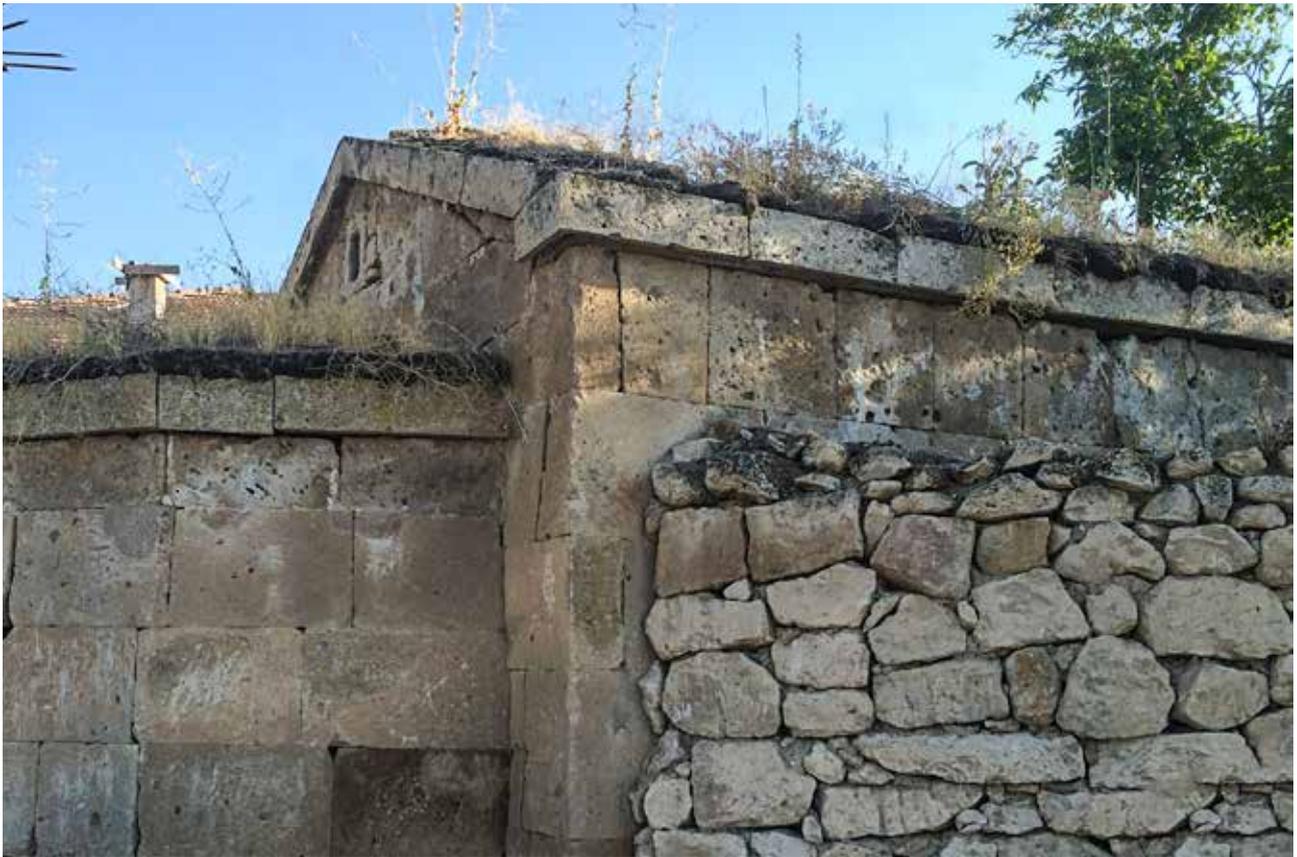
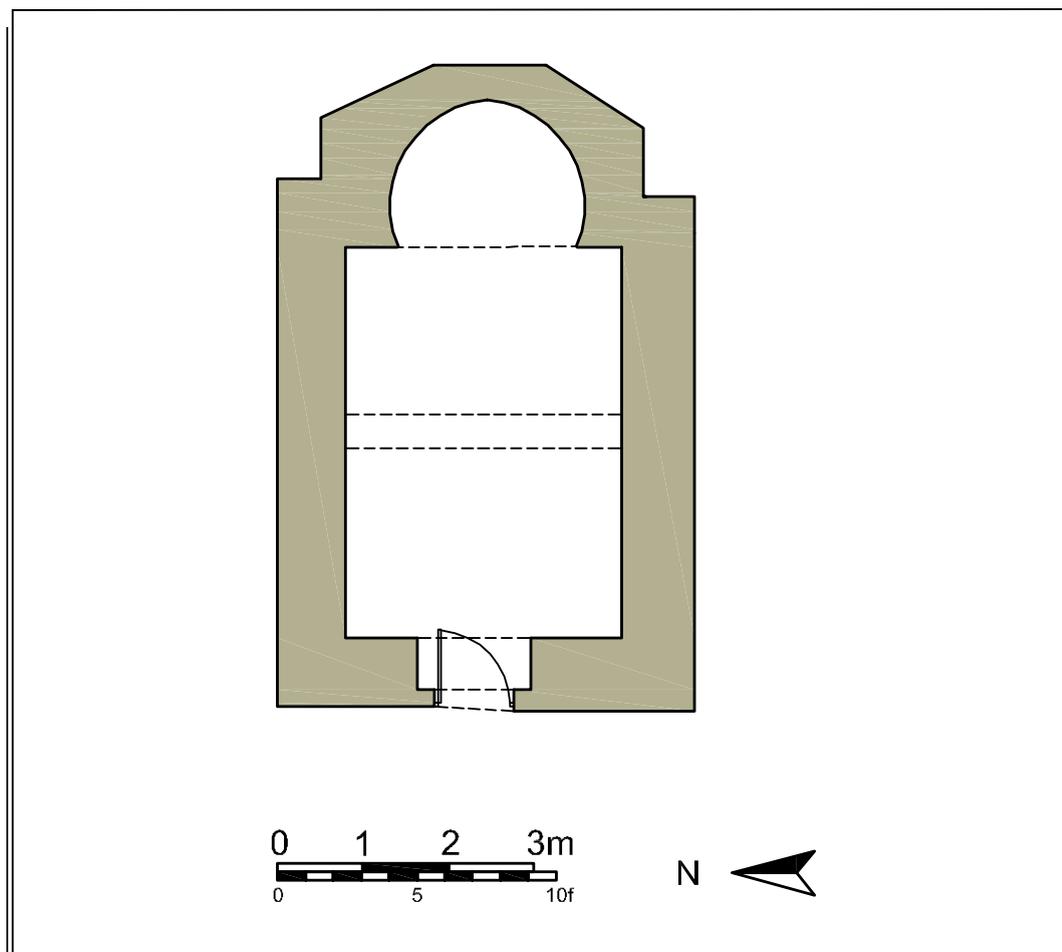
is an earthen floor. Inadequate interventions in terms of support and filling have been made recently in attempting to reinforce the structure (e.g., fractures have been filled in with rubble). Holes have been opened (probably by treasure hunters) in the interior and exterior facing of the church in hopes of reaching within the walls. Due to the erosion and rotting of the stones,

the surfaces have degraded with hairline and structural fractures visible in the walls. Nearly all the stone in the interior has been exposed to dampness, with chemical degradation present (efflorescence, mold). Again due to this reason, the majority of the plaster has fallen off with the very few remaining frescos in poor condition. Additionally, plaster in the interior has been

Plants have begun to grow at the junction points of stones in the main walls. However, the real danger to the main walls is the existence of structural fractures up to 5 cm wide. The apse wall has begun to separate as a whole from the other walls. The western wall has already separated and is leaning out at a dangerous angle with wide structural fractures.

There are plants growing on the roof, with the roots of these plants penetrating the stones and causing fractures.

The chapel is susceptible to earthquakes, with the broad structural fractures in the western wall reducing the structural integrity to dangerous levels. These fractures should be repaired at once and the structural integrity of the structure consolidated. The roof should be repaired as appropriate to the original technique, and appropriate windows and door fittings put in place.

After the cleaning, as well as reinforcement and preservation studies of the structure are complete, landscaping and division studies should be carried out. This structure is too valuable for use as a depot and this use causes harm to the building. The chapel may be used for cultural purposes. For better access to the structure, road signs and an information panel including the history of the church, a drawing of the remains and a probable plan, along with a history of Uluğağ and a map of historical structures in the area should be installed.

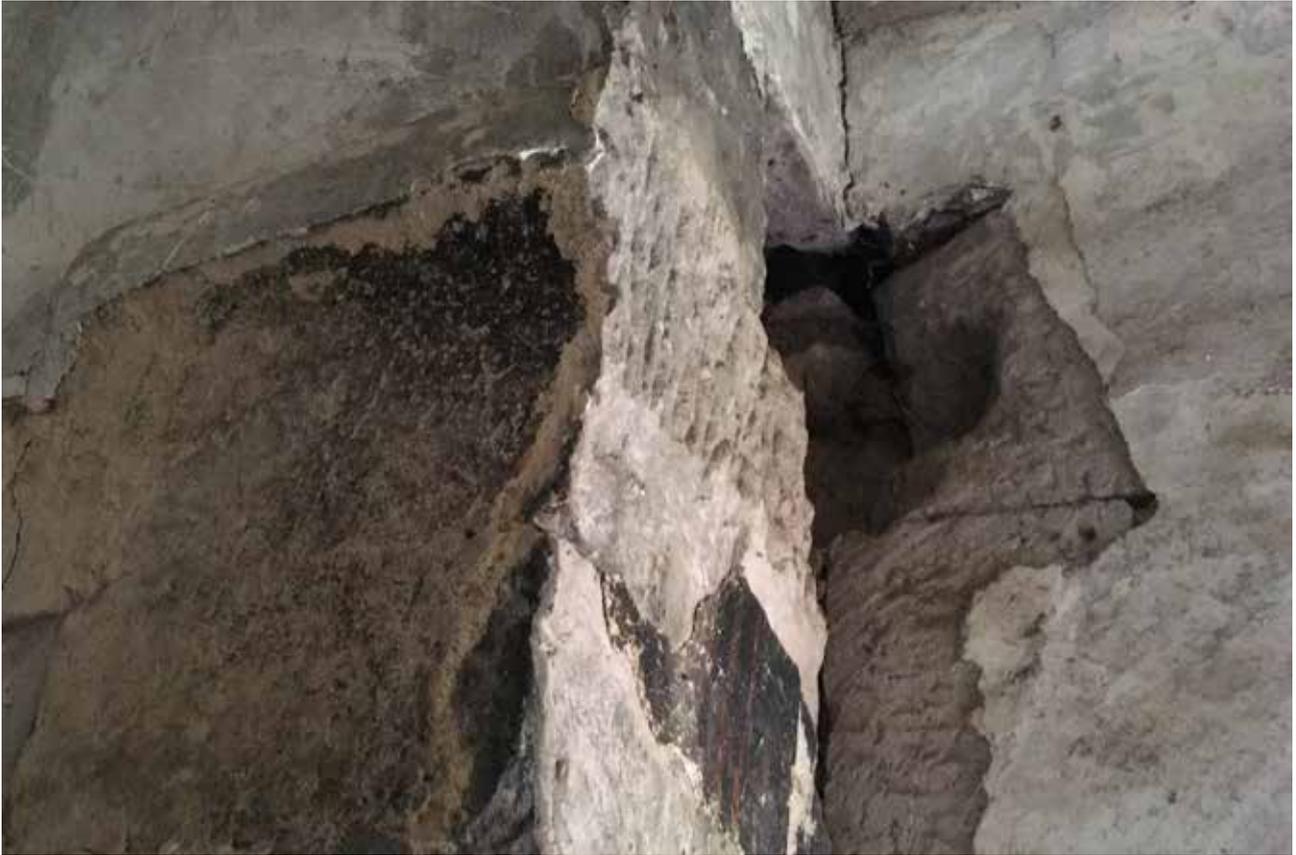
incised and vandalized. Recently the interior was painted white; however, due both to dampness and the use of paint unsuitable to the original plaster or stone it has begun to flake.

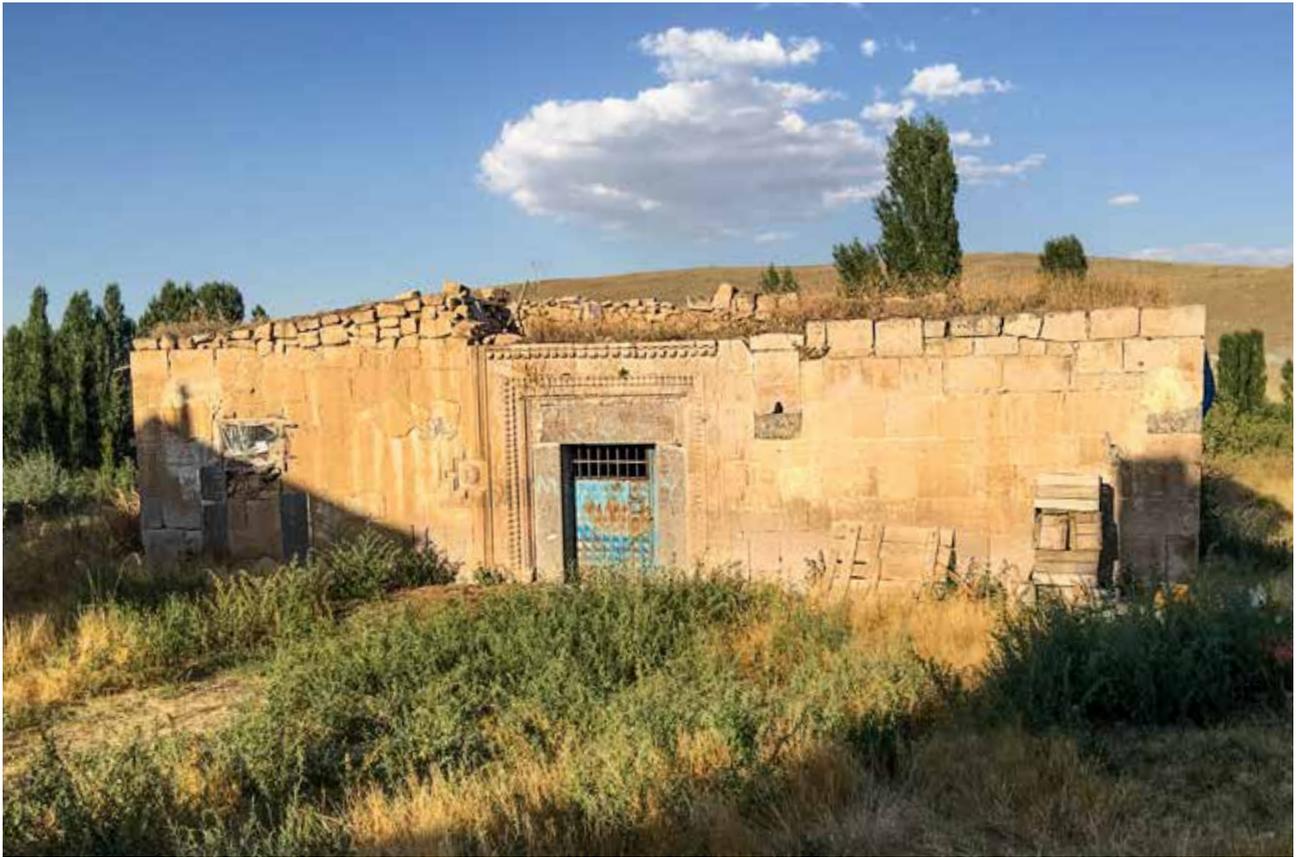
*Church of Archangelos Michael
Niğde Central county, Uluğağaç village, Köyönü locale*

Currently only the ground floor (about 3 m above ground) remains of the 12 m-long western wall of the church. A later hole was opened in the northern side of the wall, to create a window for the residential structure. The original door is not present, and has been replaced with a metal door of poor quality.

Due to erosion and the rotting of stones, the surfaces have lost material with both hairline and structural fractures observed. There are plants growing especially along the top of the remaining wall, with the roots of these plants penetrating the stone and causing fractures and parts to fall off. The remaining wall has been vandalized with paint. As it was not possible to enter the structure, no investigation of the western face of the wall was conducted. There is no information panel on it whatsoever.

Noted for the stonework around its entrance door, there is insufficient information for the reconstruction of this structure, so undertaking its restoration is a matter to be discussed. However, if archeological excavations are completed in the area, it is possible for the plan to be discerned. These foundations and the remaining western wall should be reinforced and protected.
