Niğde

NIĞDE SITE ASSESSMENT VISIT

Dates: August 23-28, 2016

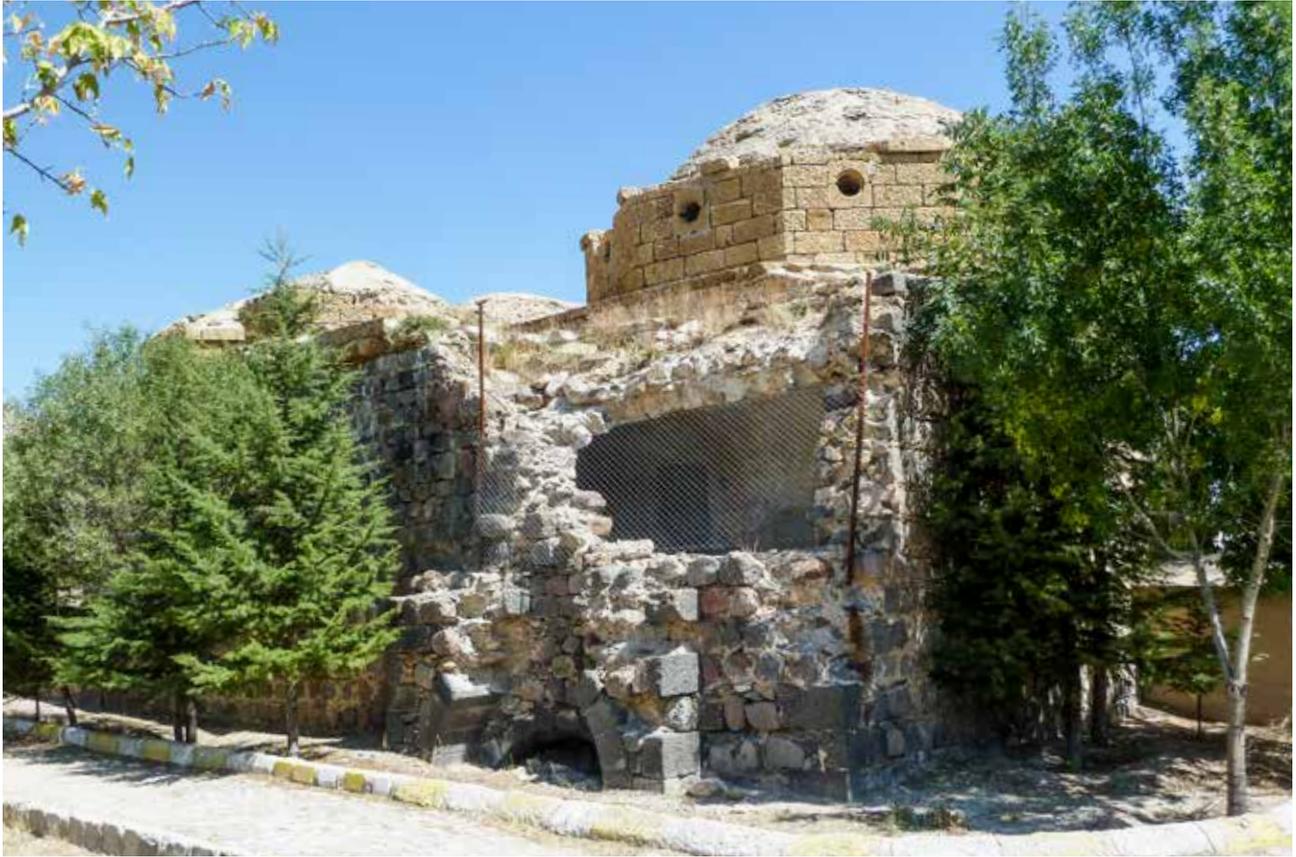
The cold section and furnace of the hamam have been demolished. The door between the original cold and warm sections is used as the entrance door to the structure today. A wall was built towards the northern façade as a buttress after the cold section was demolished, probably to ensure the integrity of the structure. Though the cold sections and furnace are completely destroyed, the plan of these areas can be read from the remains of the foundations of the walls. Rainwater enters the structure through the skylights and this has caused the plaster to peel as well as damage in the domes. There is severe damage in the water distribution and heating system, water channels and floor. The clay pipes within the walls have been removed and stacked in the hot section. The southwest corner and roof of the water depot have partially collapsed.

The structure is on a road between Kumluca and Hamamlı neighborhoods and there is neither an information panel nor visitors to the site. As the entrance door is locked, it is possible to say that certain precautions have been taken against vandalism; however, use of the building as a depot has caused serious damage.

Excavations must be completed in the area in order to understand the layout of the structure. The hearth in the furnace and the remains of the foundations in the cold section must be unearthed. A restoration plan for the structure must be prepared and the destroyed parts of the cold section must be repaired according to this plan. The structure may either be restored as a hamam or be given a new function that serves the public without contradicting its original fabric.

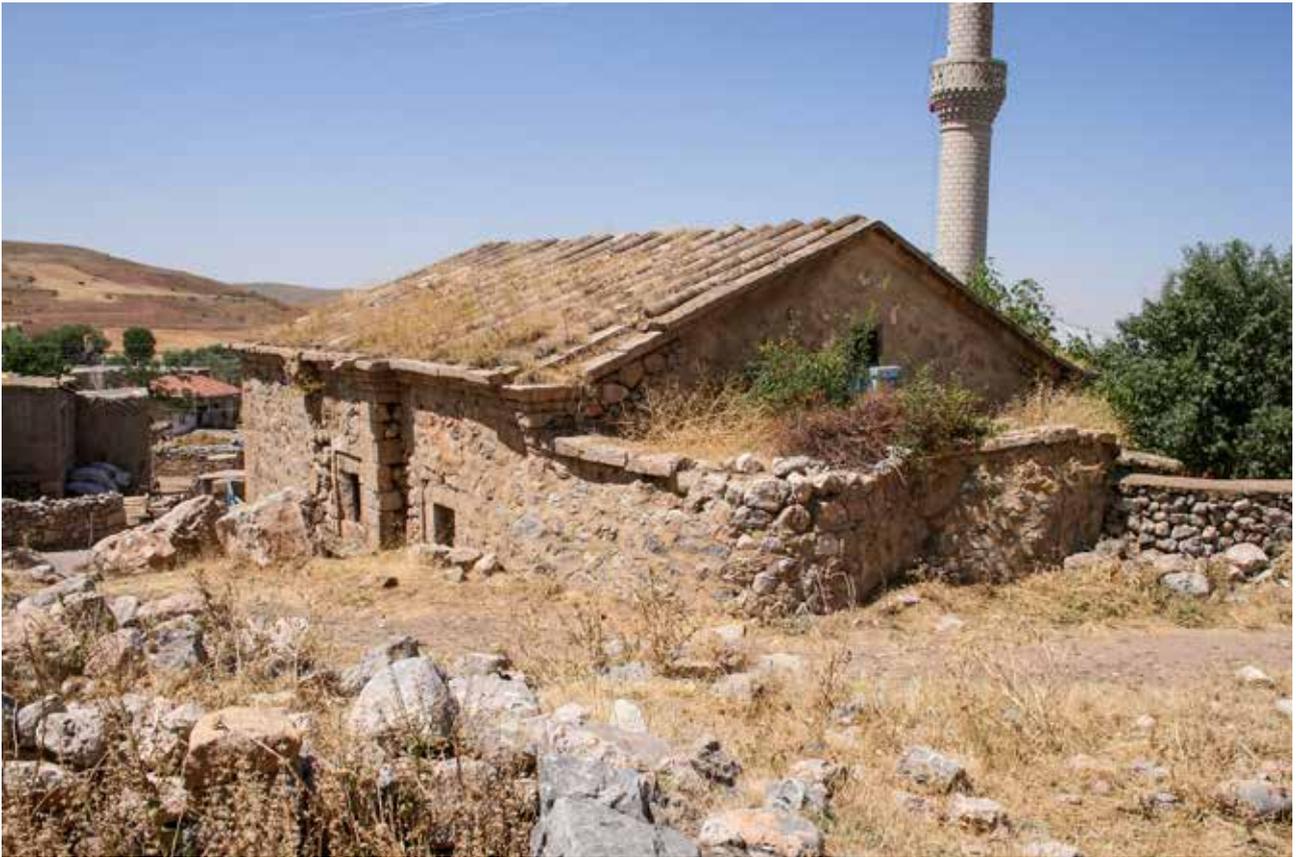
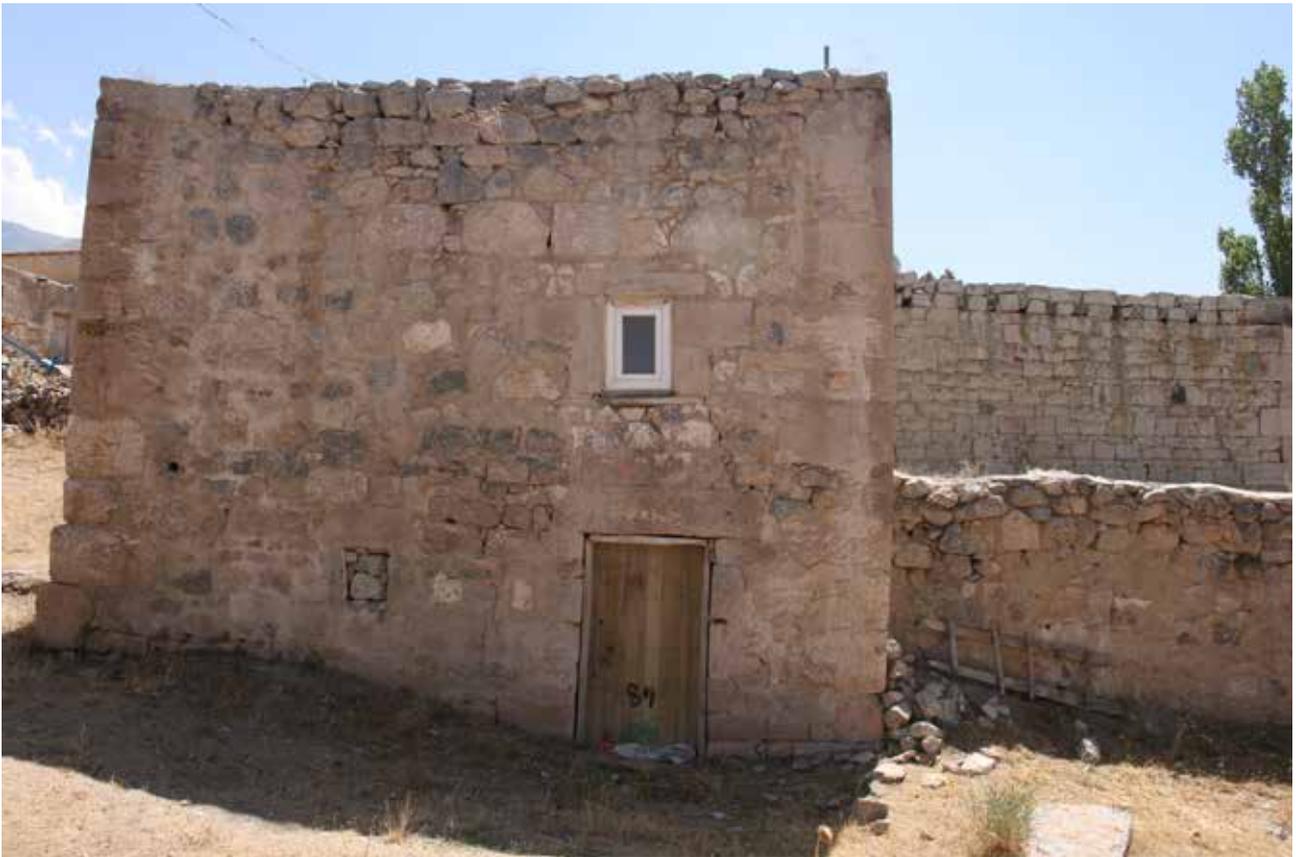
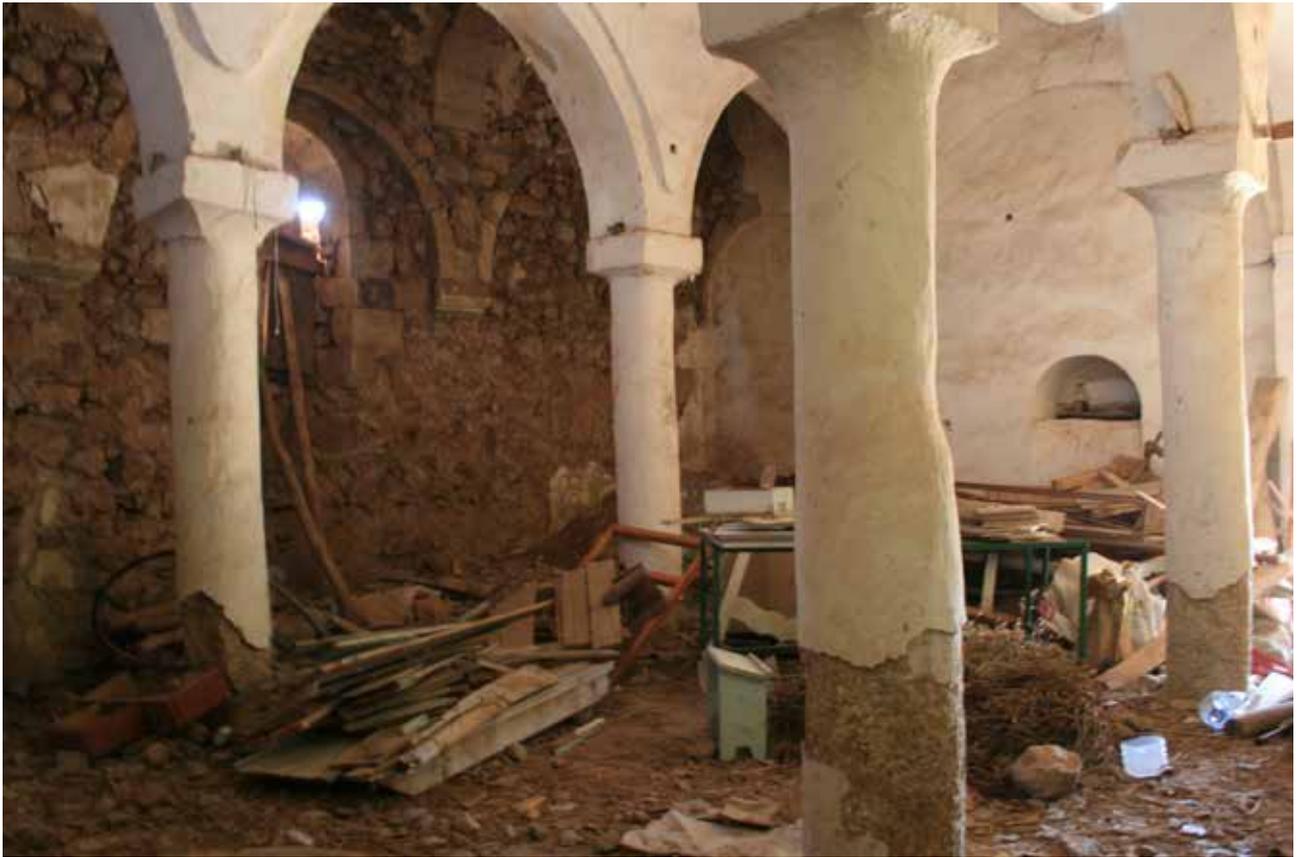
The original door opening on the central axis of the church has been bricked over. As this entrance has been closed, currently access is through a door later opened in the wall of the northern nave on its western façade. The lime plaster on the interior walls has peeled, most prominently on the southern wall. There are damp marks on the interior plaster. These damp marks point to the high probability of the roof

leaking; this is also supported by the fact that the current roof is covered with plant growth. The whole of the western façade and part of the northern façade has been covered with cement. Some cement pointing has also been applied to the rubble stones. Some of this pointing has degraded and cracks are visible in the walls. The cross-sections of the columns of the structure are irregular and their wooden tie rods are missing. The external façade has been ruined, and is covered with plants. The roof eaves of the apses have been destroyed.

The use of the structure as a depot and the lack of maintenance have put it at risk. It is necessary to solve the problems related to damp and humidity. The columns require urgent structural intervention. Access into this structure, which is not yet even listed as a historic building, must be

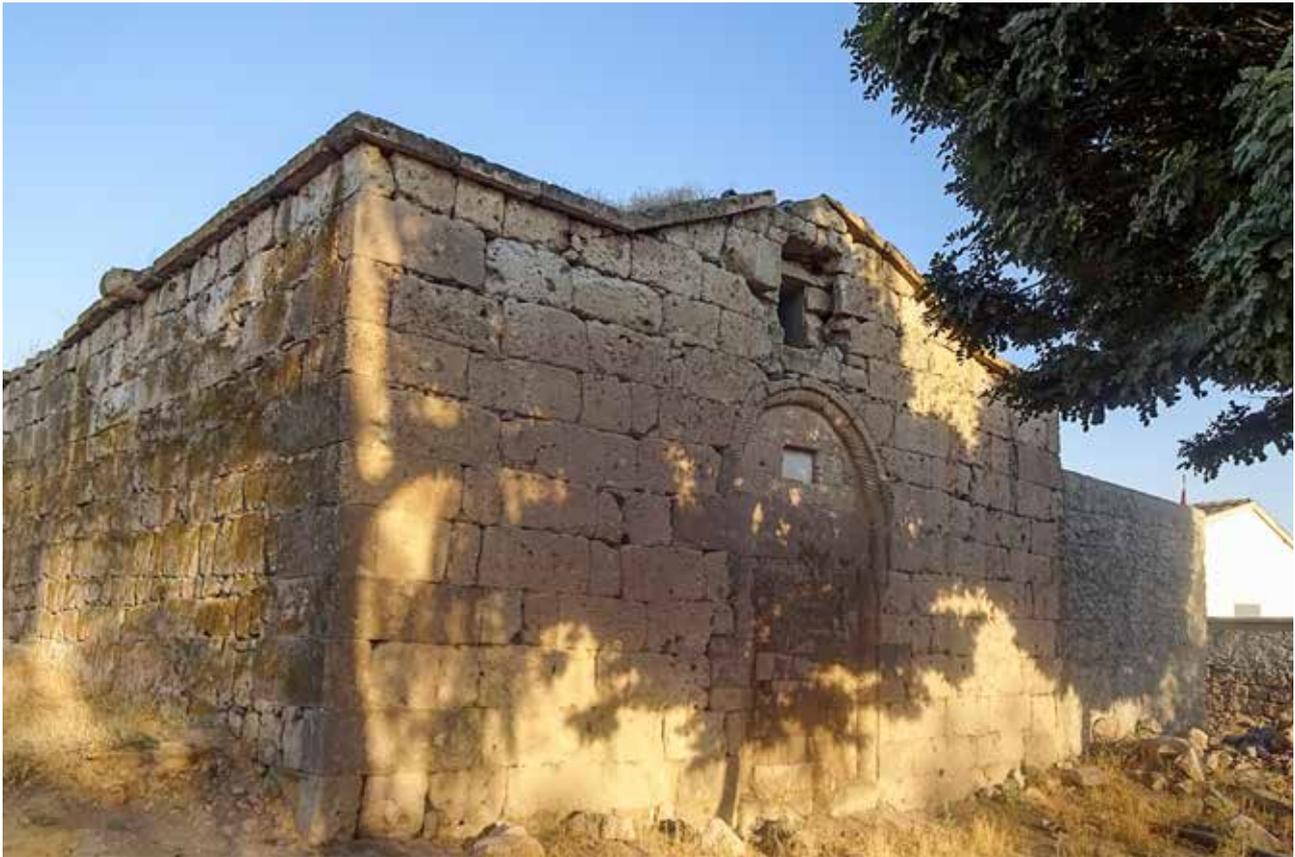
Though the apse and gallery section of the chapel have collapsed, the plan and spatial characteristics may still be perceived. After collapse of the apse, the semi-circular opening east of the naos appears to have been closed off with rubble stone. At the peak point of this rubble stone wall, a small opening was left to allow light inside. As the main entrance door to the chapel has been closed off with cut stone, currently access is through a door later opened in the eastern façade.

Built adjacent to the southern wall of the chapel is a later structure used as a classroom for the primary school in the village (Pekak, 1999, 32). For this reason, the southern window in the structure has been closed off. The eave moldings and waterspouts on this façade have been destroyed. Additionally, the stone of the interior southern wall and its molding have been damaged in order to carve out a mihrab.

The traces of dampness visible on the ribbed vault ceiling indicate that water is leaking into the structure. In addition to dampness, increasing humidity within the structure has caused the plaster to flake off. There are signs that fires have been lit within the chapel and vandalism is seen on the plaster.

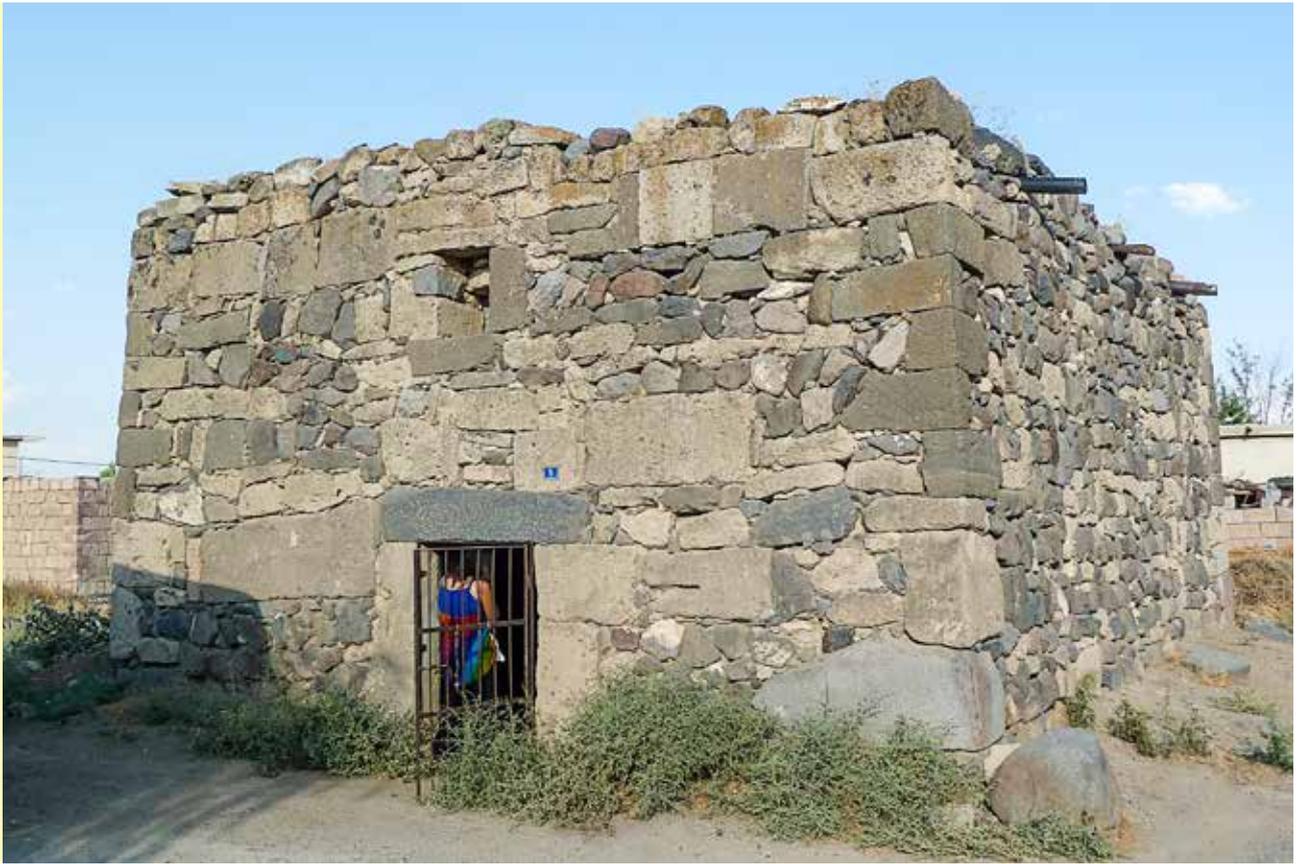
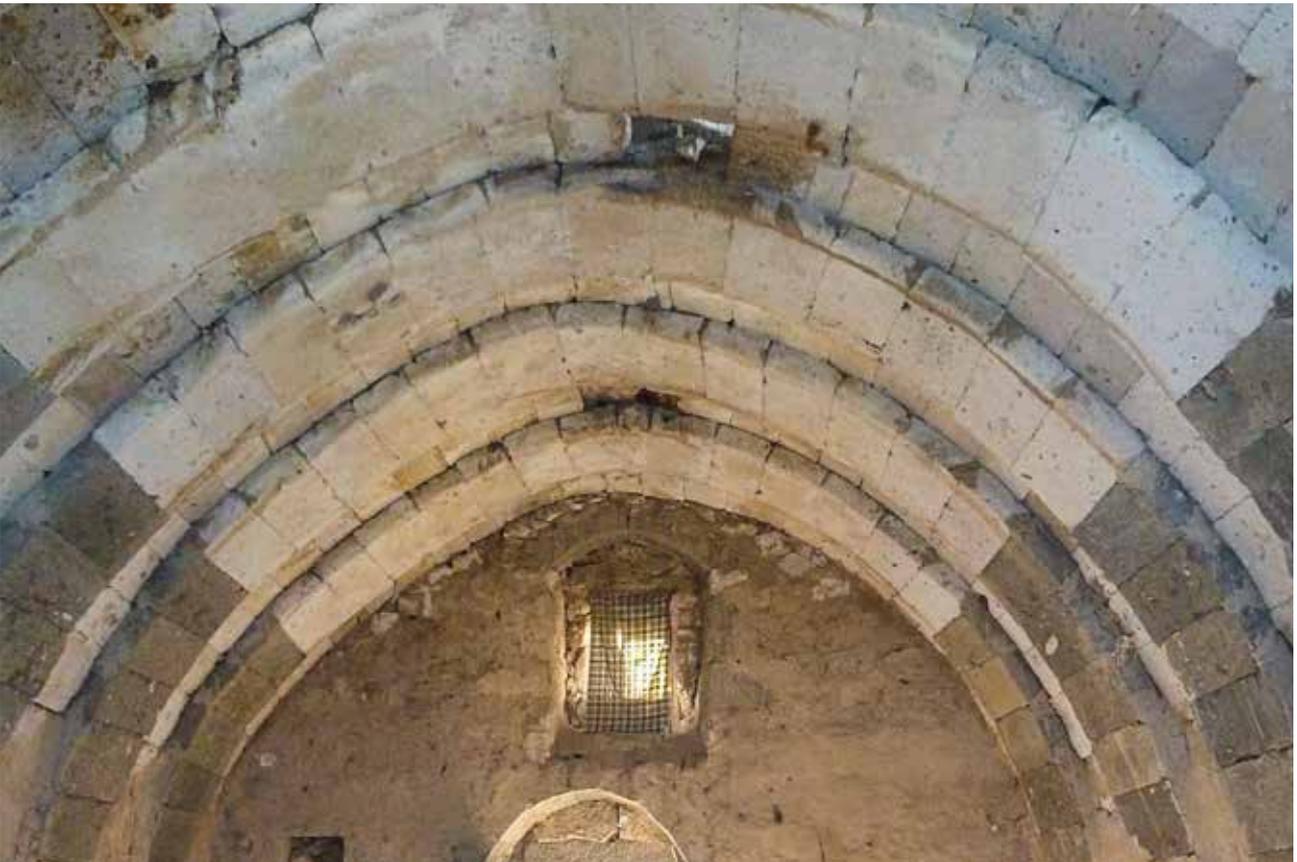
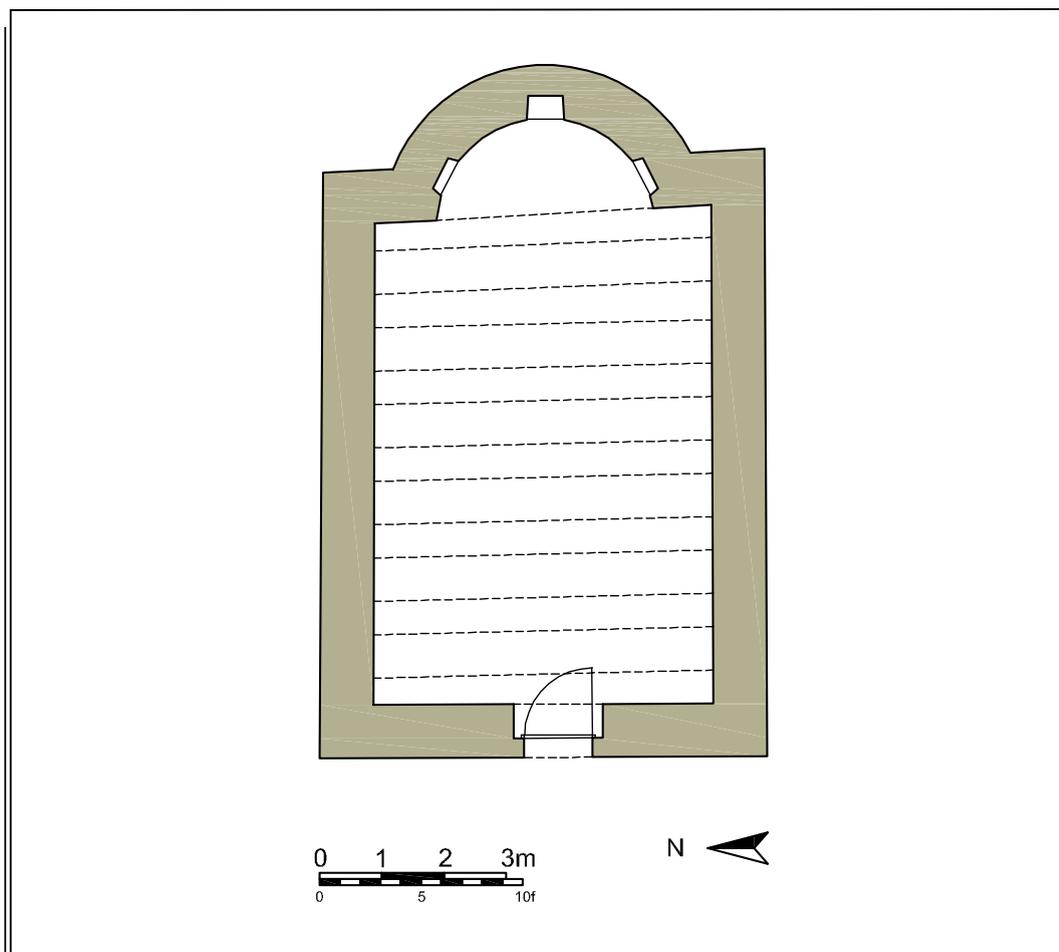
The chapel is moderately preserved at present, in a relatively good state and used as a depot by a private owner. The intense plant growth on the roof of the structure is a problem. Though no research has been conducted on the chapel, based on what is visible, it is possible to determine its spatial characteristics and floor covering. Disruption of the ground has led to an increase in the soil level, though only slightly visible from the outside. The vault surface has

small openings possibly made later to allow light into the interior. Another structure has been constructed at a later date adjoining the façade of the apse of this internally-plastered chapel. Due to its use as a depot, its identity as a place of worship has been lost, with a range of disruption to the interior due to these changes and lack of maintenance. The small niche in the semi-dome of the apse has been closed. The current door is clearly not the original entrance door.
