Bursa

BURSA SITE ASSESSMENT VISIT

Dates: September 28 - October 2, 2016

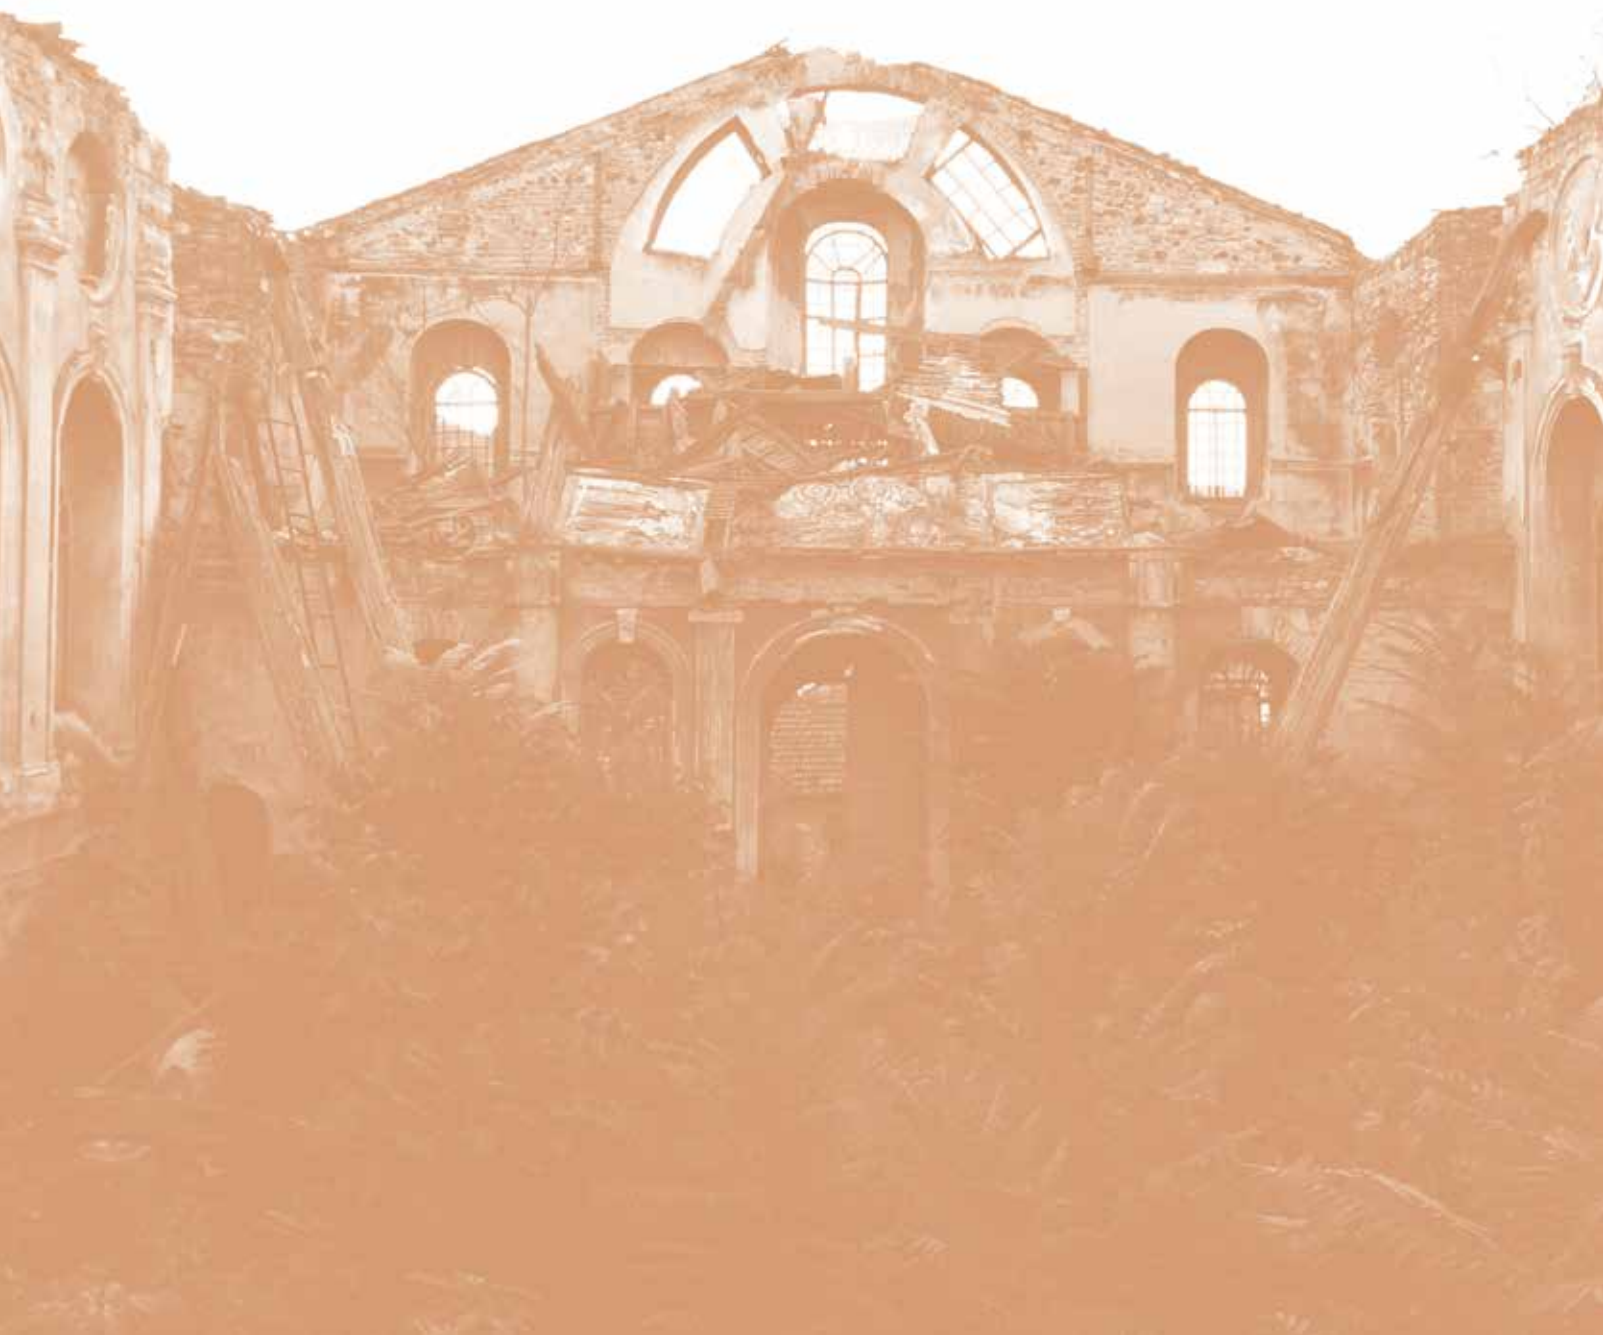
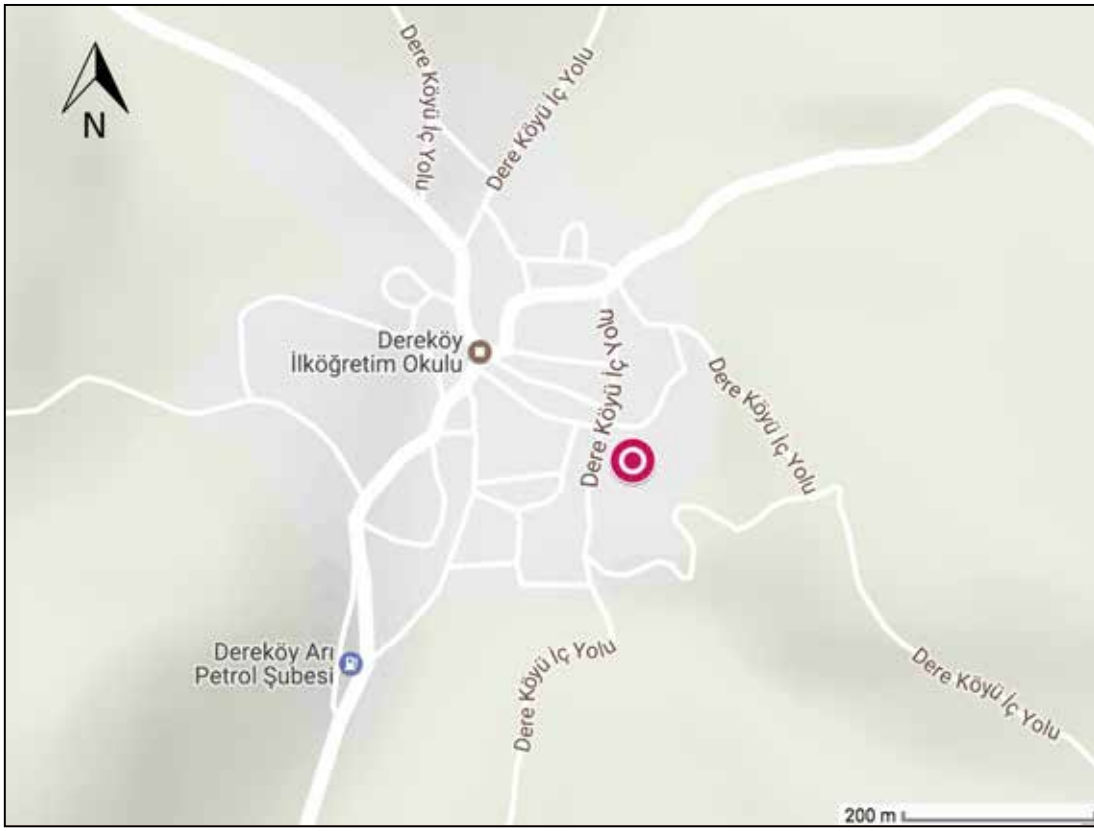
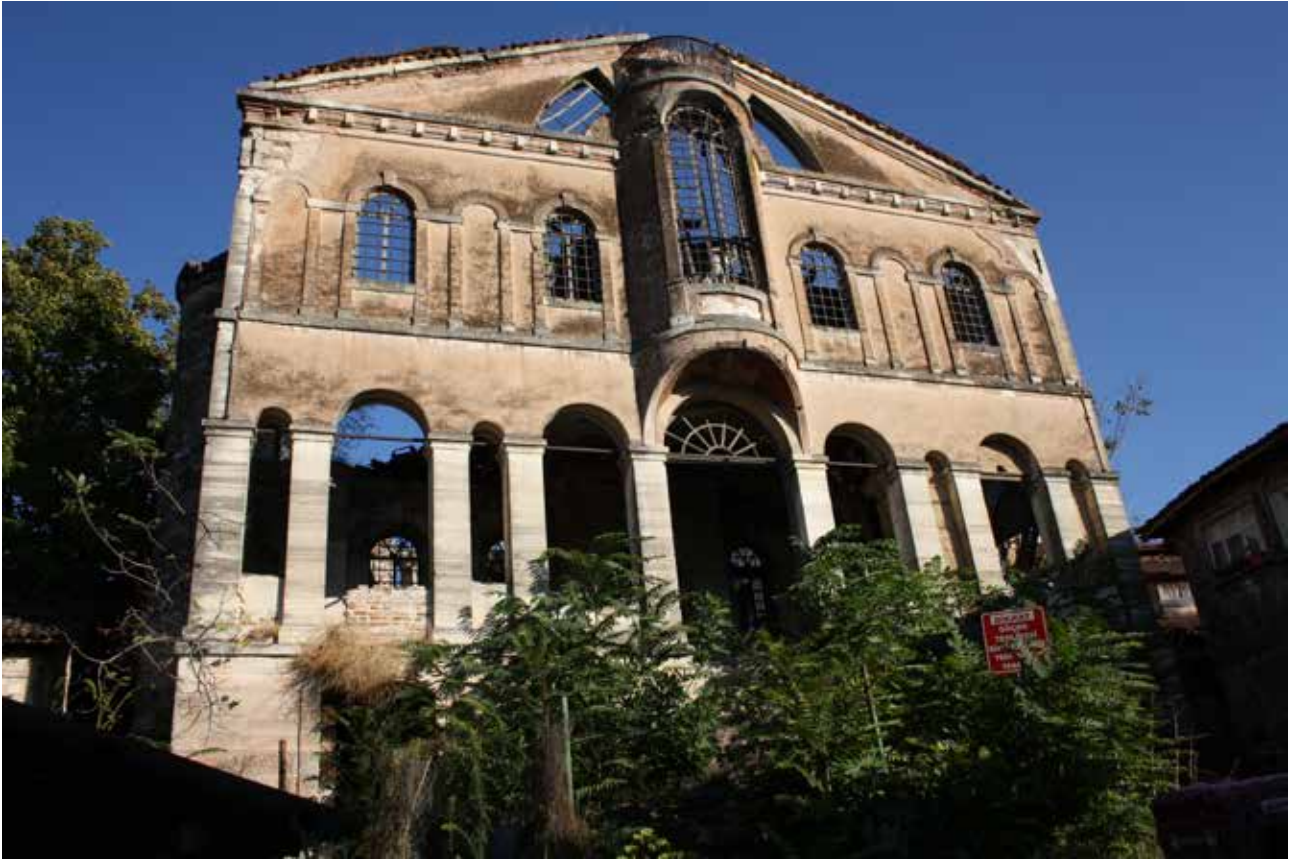
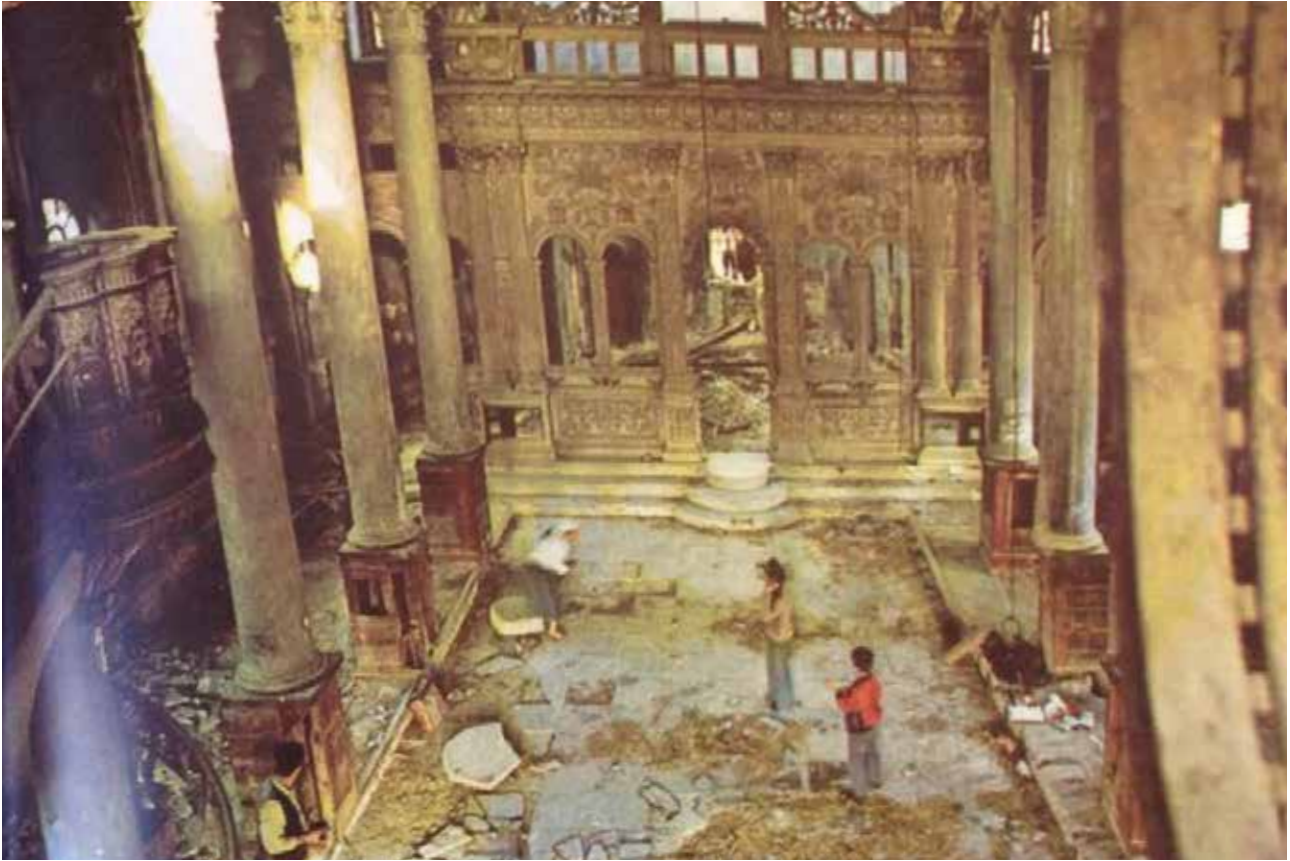
CHURCH OF SAINT PARASKEVI | AGIA PARASKEVI

The plaster from the ceiling of the narthex has fallen off, rendering the laths visible. The steps within the stair towers have collapsed. The eastern wall/railings of the gallery floor are also destroyed. Currently only a very small amount of some parts of the iconostasis remains. According to what the mukhtar (village headman) said in 1986, tourists dismantled and took it away and the remainder was destroyed. Photographs taken in 1986 show that the liturgical elements and fabric of the church was in much better condition then, than it currently is (Otügen et al., 1986, 472, 708-710). There is no lock on the door, there is graffiti both painted and incised on the façades.

This rapidly-deteriorating structure requires immediate protection. As the roof has collapsed, the internal walls are open to the forces of nature and are being damaged. Plaster and stucco details are flaking and falling off, the frescos are fading and main walls are weakening. The wooden liturgical elements on the naos floor are open to the effects of all kinds of weather conditions and human depredation, and are rapidly deteriorating.

A restoration project should be prepared, the additional structure leaning against the southern apsidiole should be removed, and environmental work and landscaping carried out. While awaiting restoration, the church should have a temporary protective roof put in place, and uncontrolled entry through its doorways and windows must be prevented. Its history should be researched in detail and an information panel and directional signs placed in the near surroundings. It is recommended that the structure be given a cultural function open to the public.

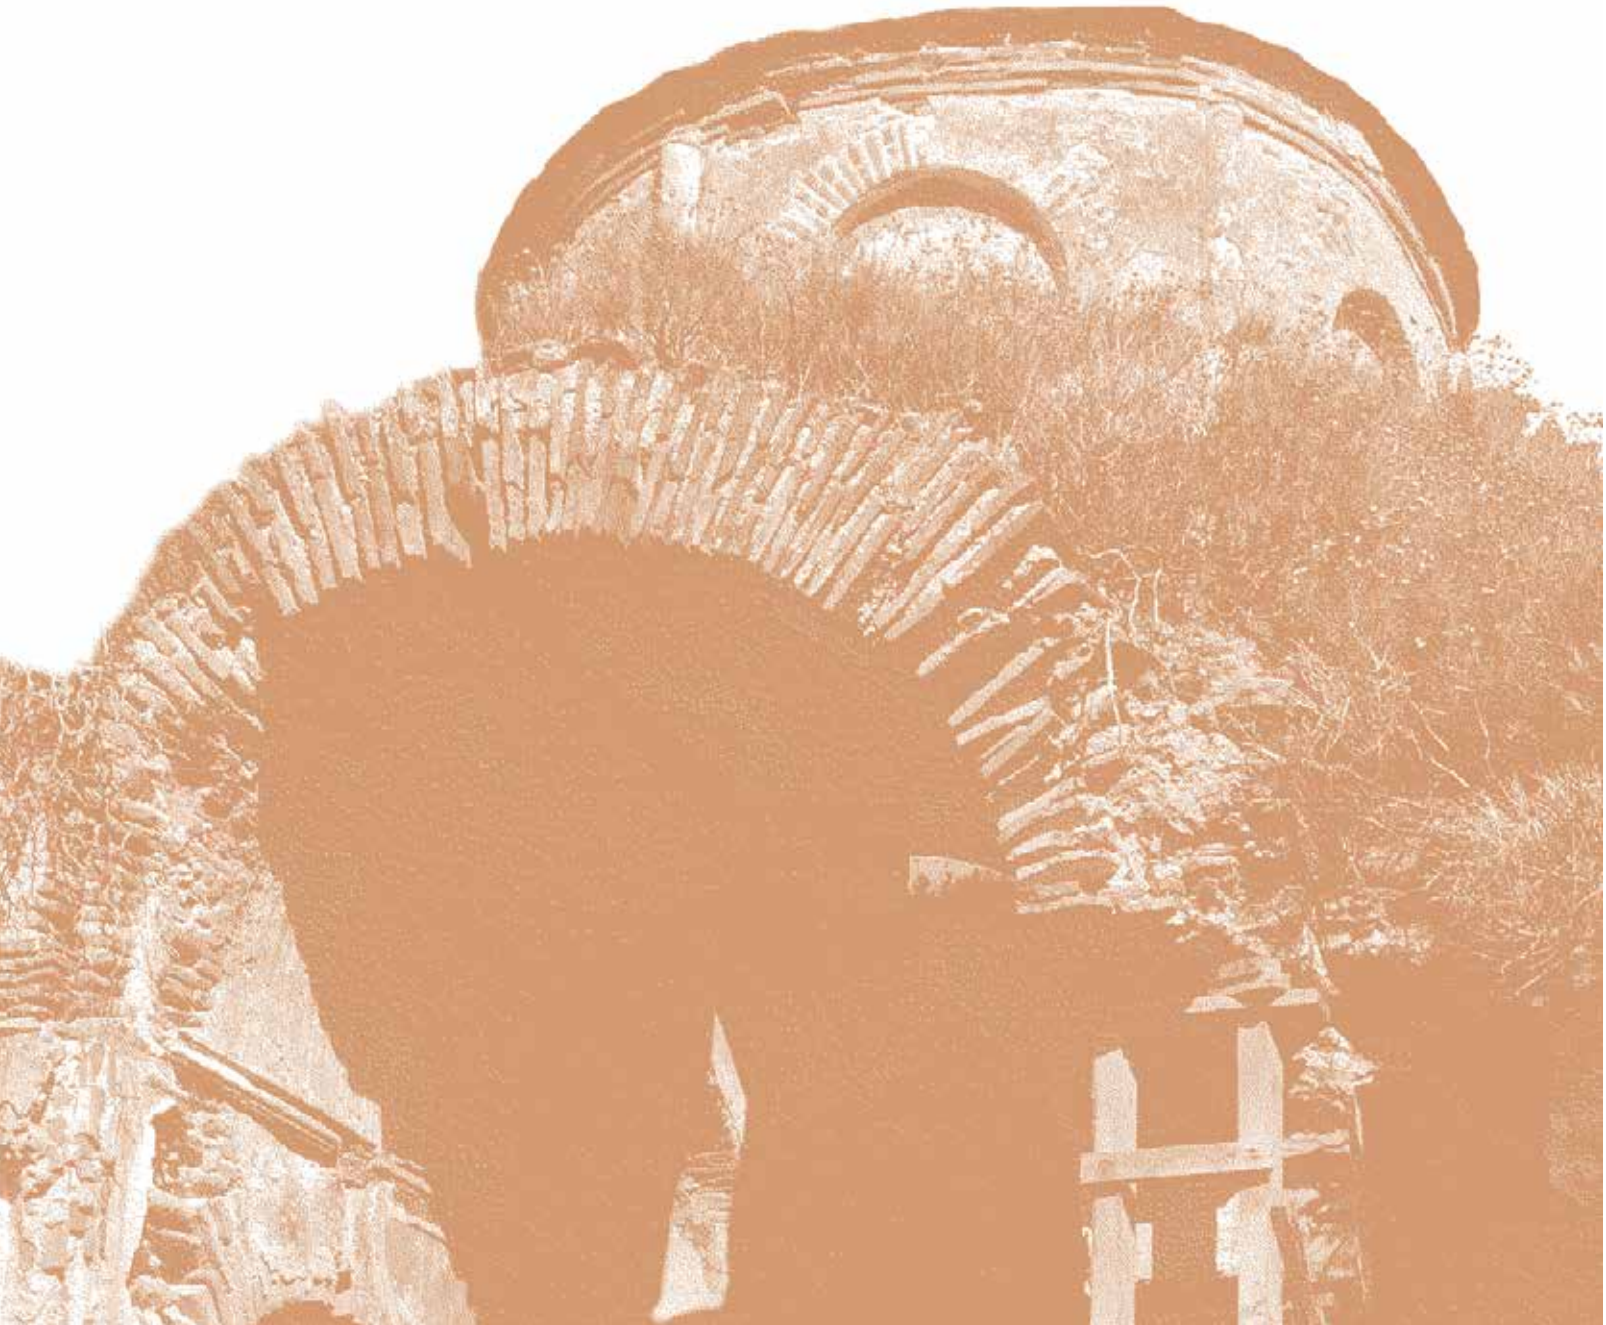
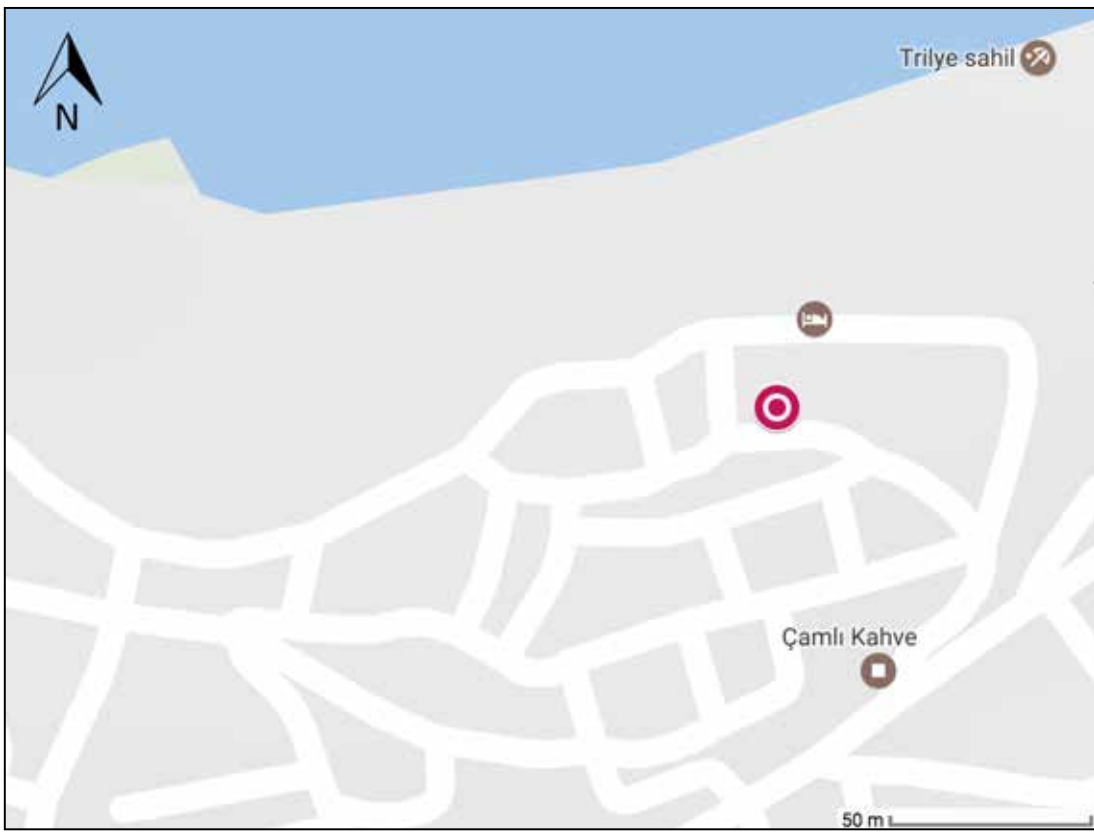
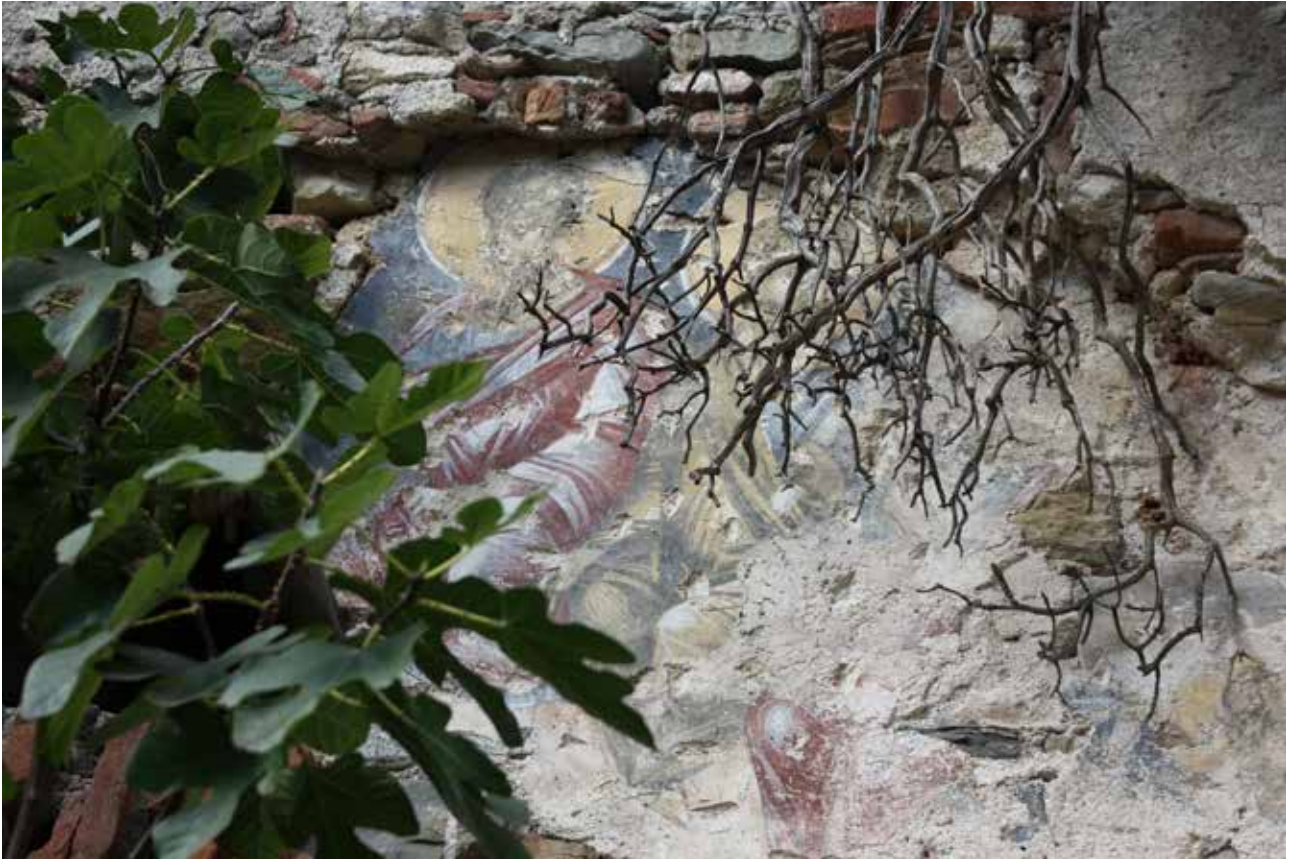
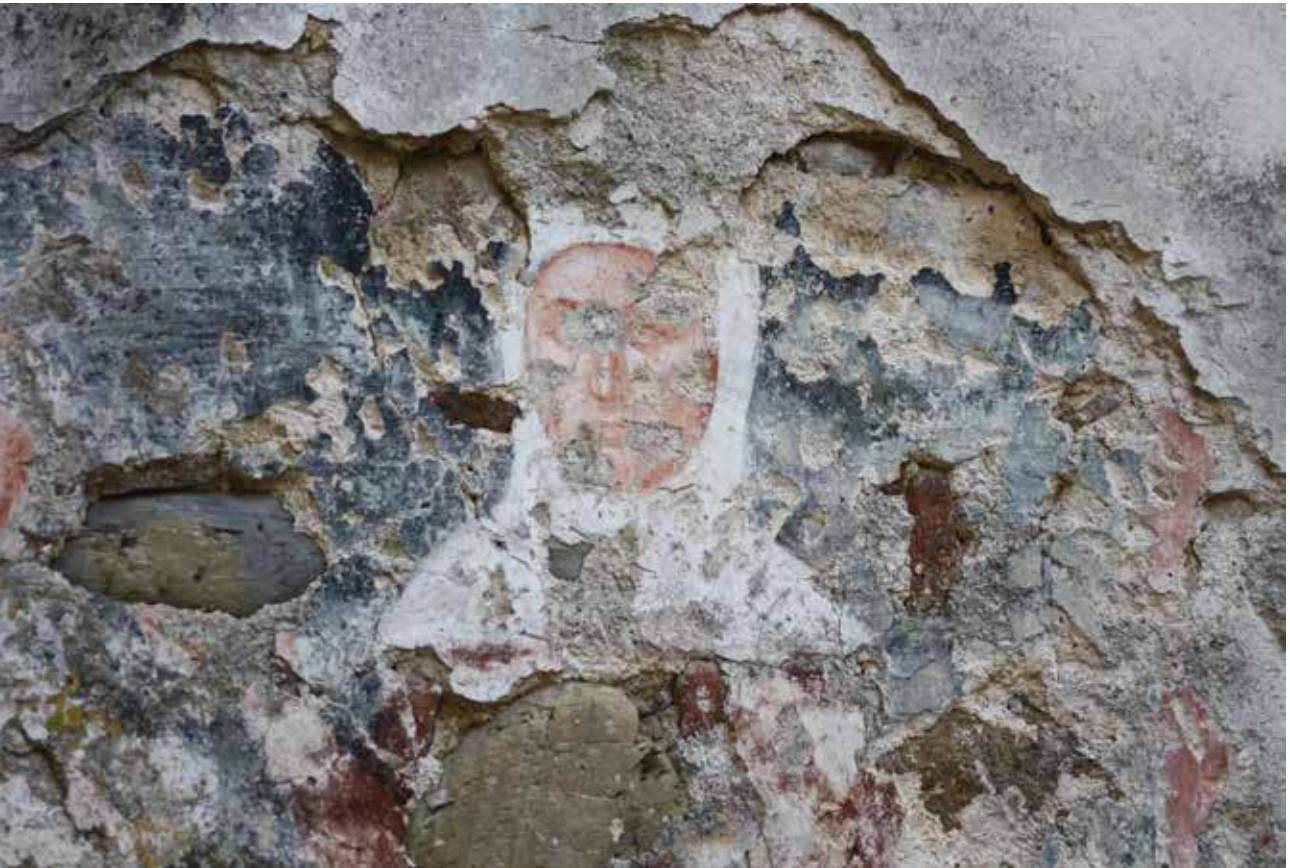
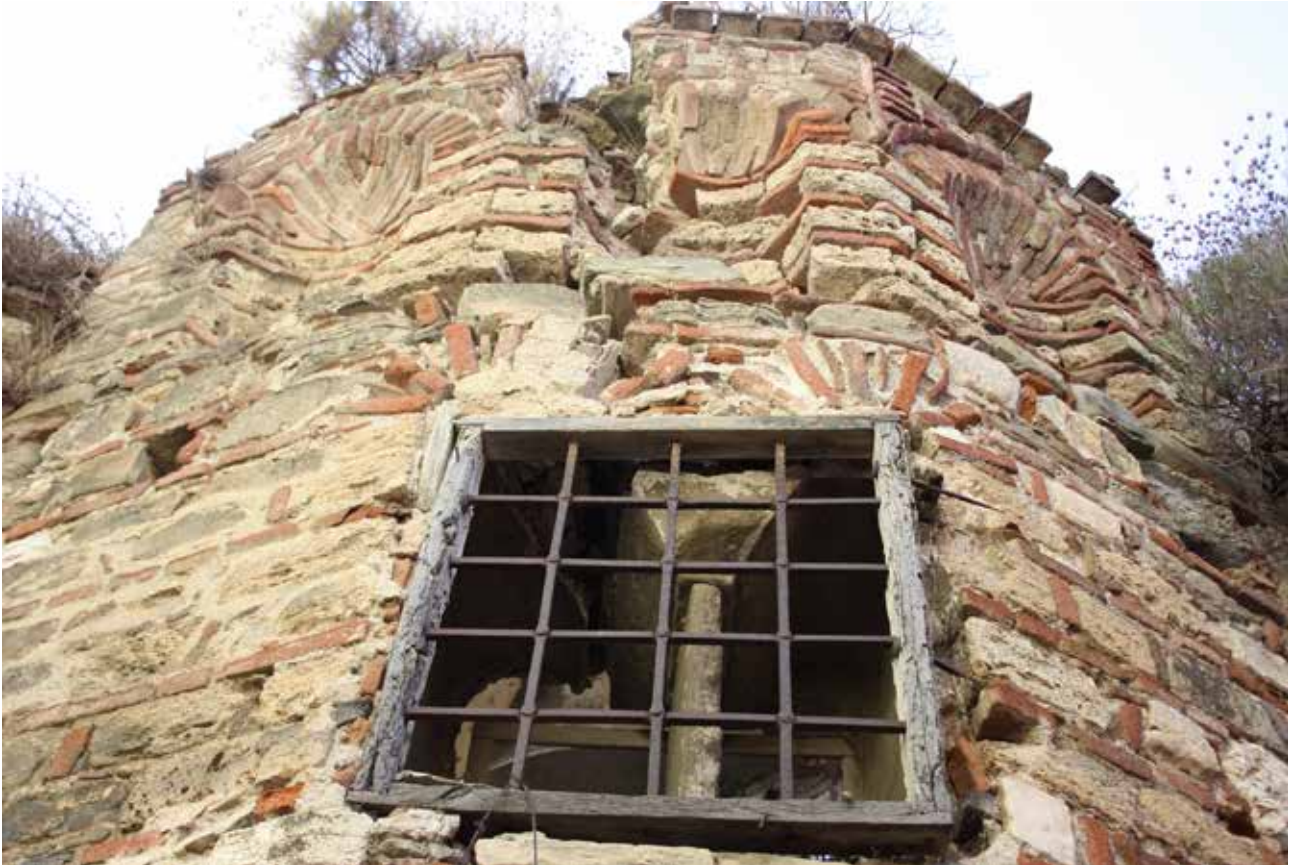
*Church of Panagia Pantovasilissa
Mudanya county, Tirilye town*

On the exterior, the separation of a large part of the main apse wall in the eastern façade of the building is news of severe damage that may be caused in the future by earthquakes to come. The arch rising towards the south from the pier in the western wall of the southern façade has collapsed. Internally, the roof of the narthex has collapsed, as a result of which the wall paintings are exposed to weather conditions. All main walls and the roof contain visible fractures, due to which even heavy rain may cause significant damage. The plant cover on the roof is weakening the structure. The wooden scaffolding put in place of a collapsed column in the southwest of the naos does not provide sufficient support. The structural stability of the structure is in danger and emergency precautions must be taken.

The structure is relatively protected from vandalism. To this end, the contributions of the local administration in Mudanya and Tirilye as well as the people of the area are significant. However, especially the interior of the structure has been neglected. A very detailed doctoral thesis was completed on this building in the recent past, and based on this partial restoration may be carried out. A church on the main road in Tirilye has also been recently restored by the municipality and transformed into a cultural center, while another church serving as the Fatih Mosque has been restored.

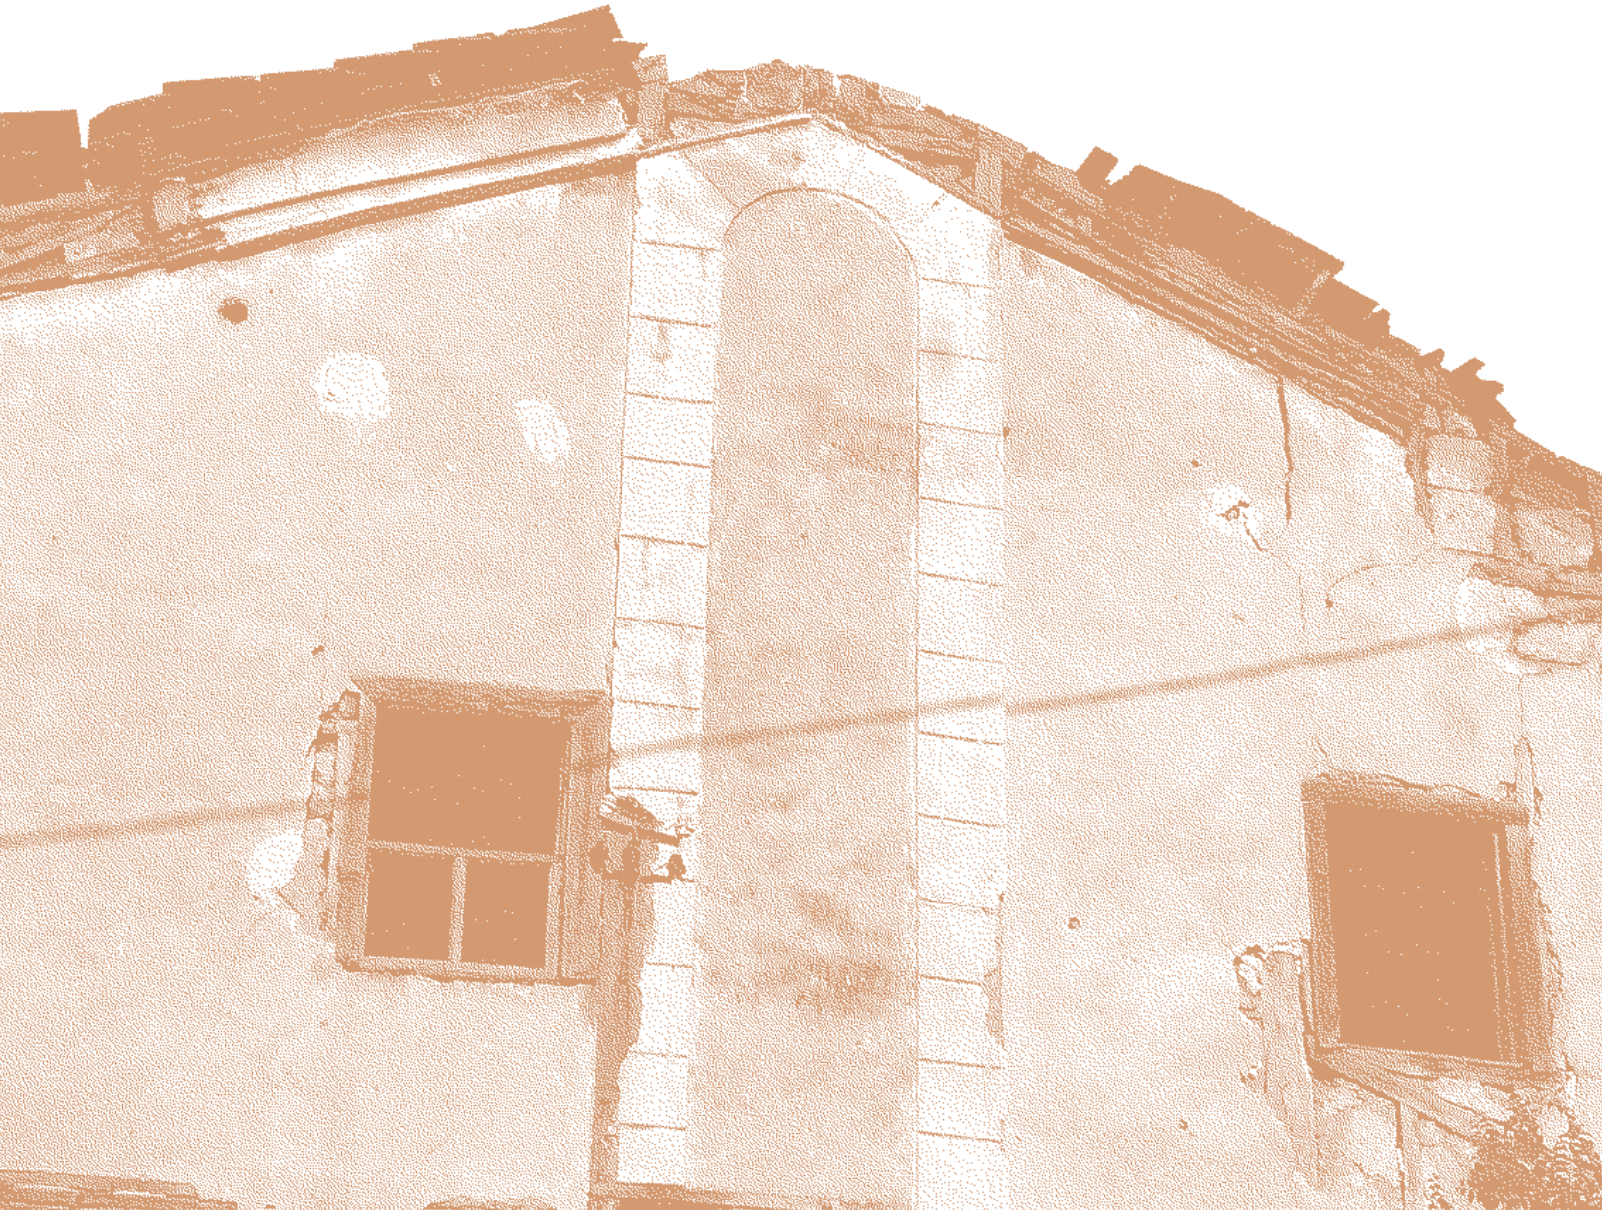
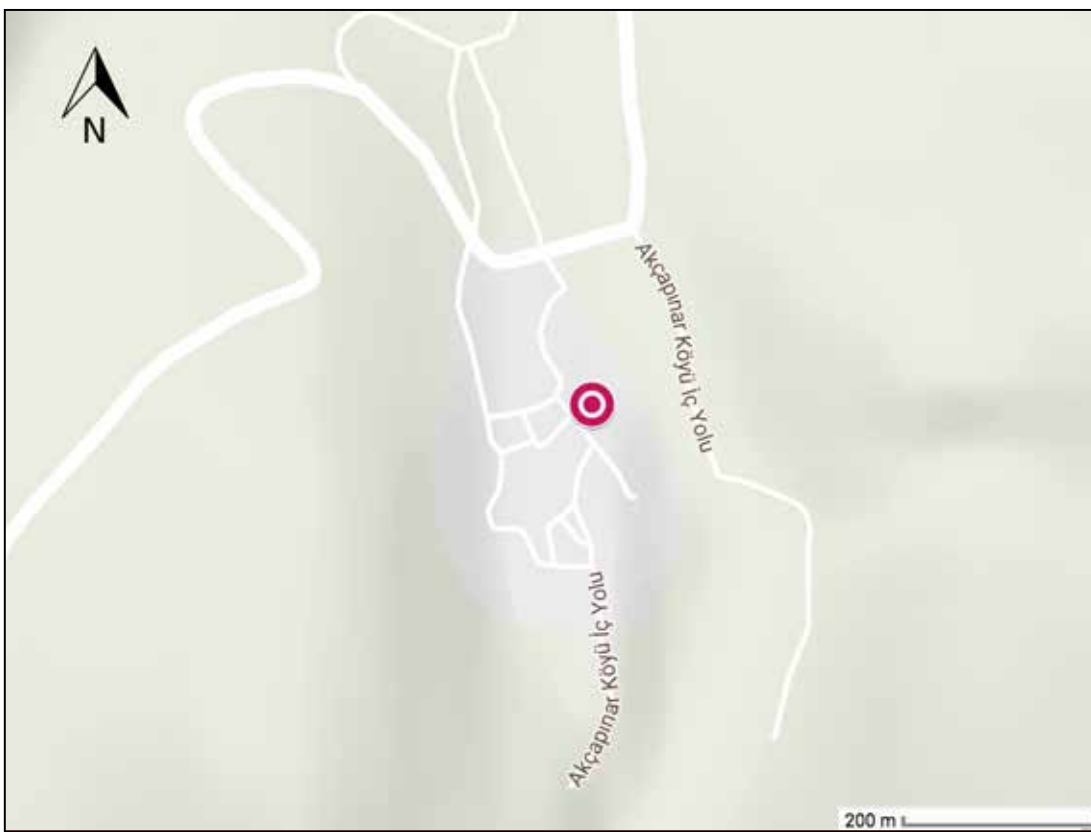
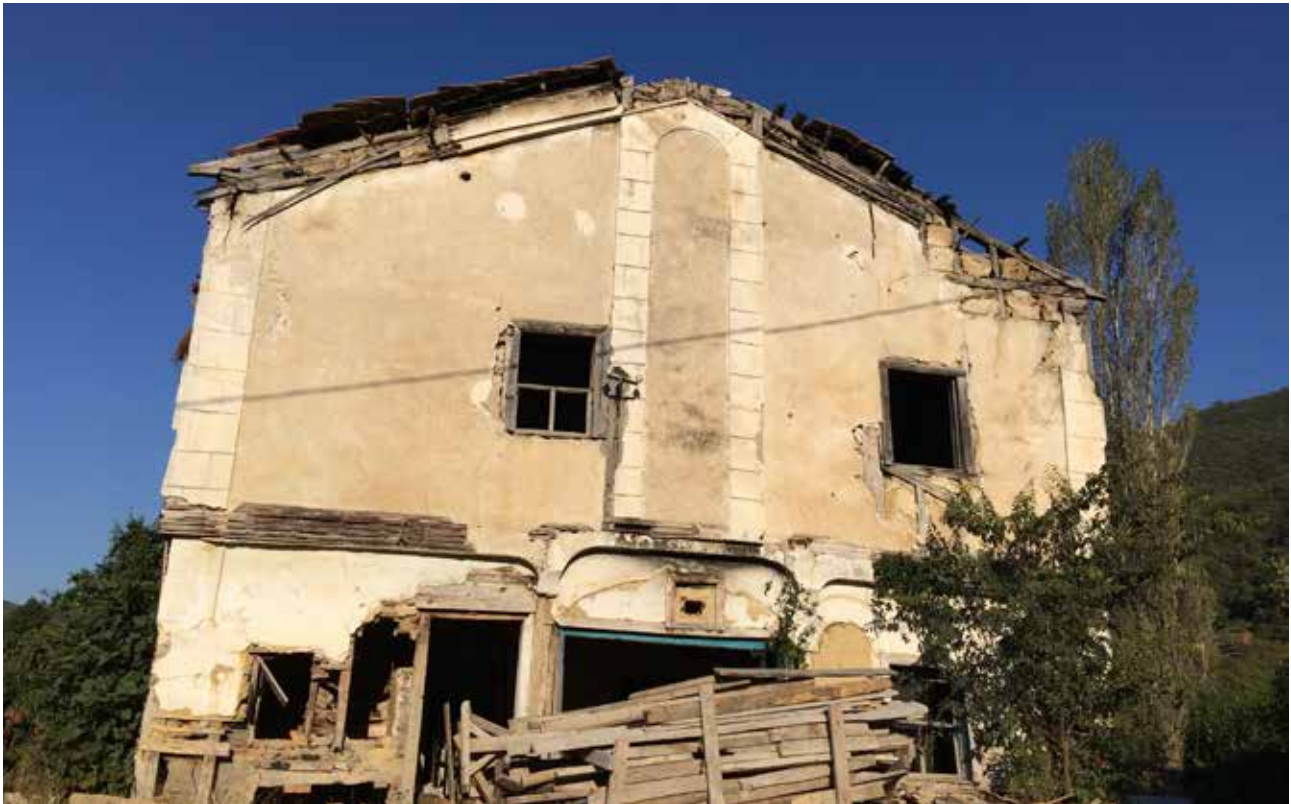
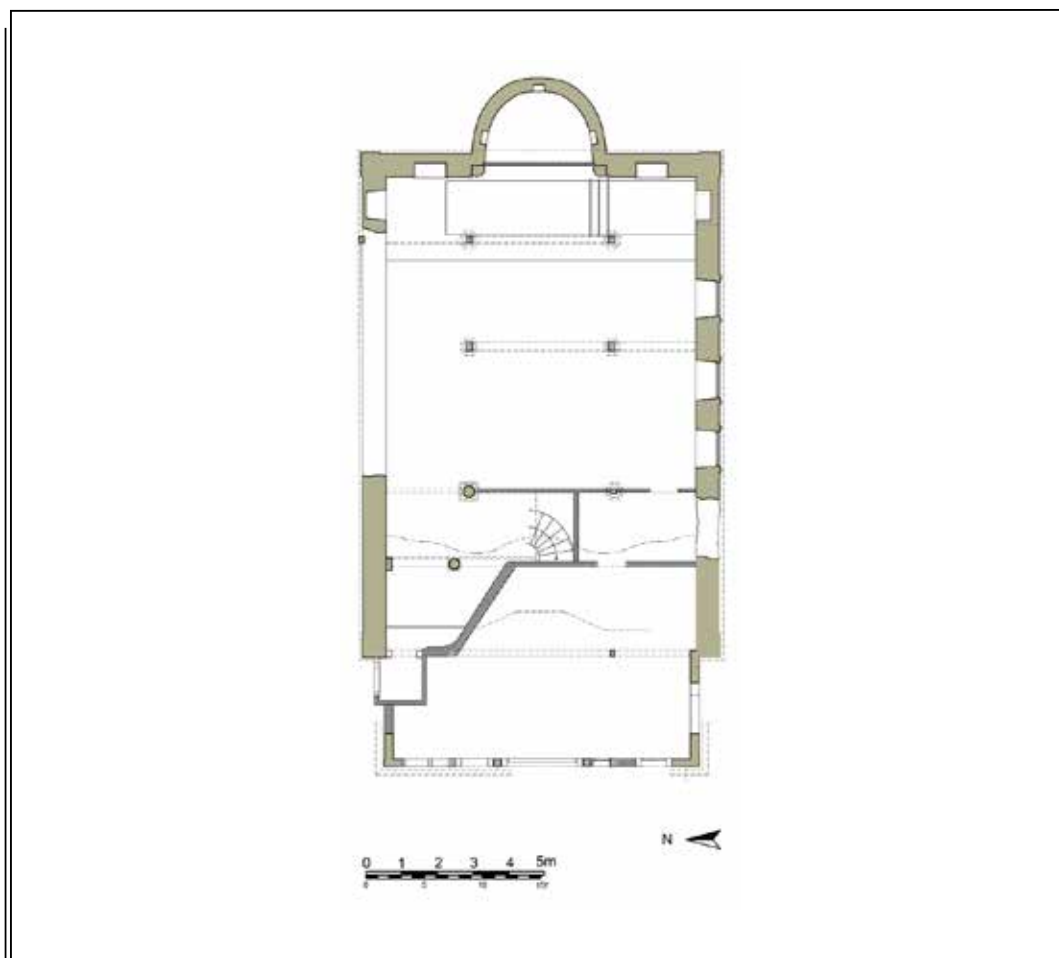
The roof of the structure is partially destroyed or damaged. This situation has left the structure defenseless against the effects of nature and has increased its rate of destruction. Currently a large section of the southern wall has collapsed, and because it is also missing its roof this destruction will continue. Cracks observed around what may be the doorway in the northern wall may cause parts of the wall on the upper level to collapse. On the eastern wall of the sub-foundation level of the apse, there are holes which may lead to the collapse of larger parts in the future. The roof of the apse is largely destroyed resulting in increasing damage to the dome.

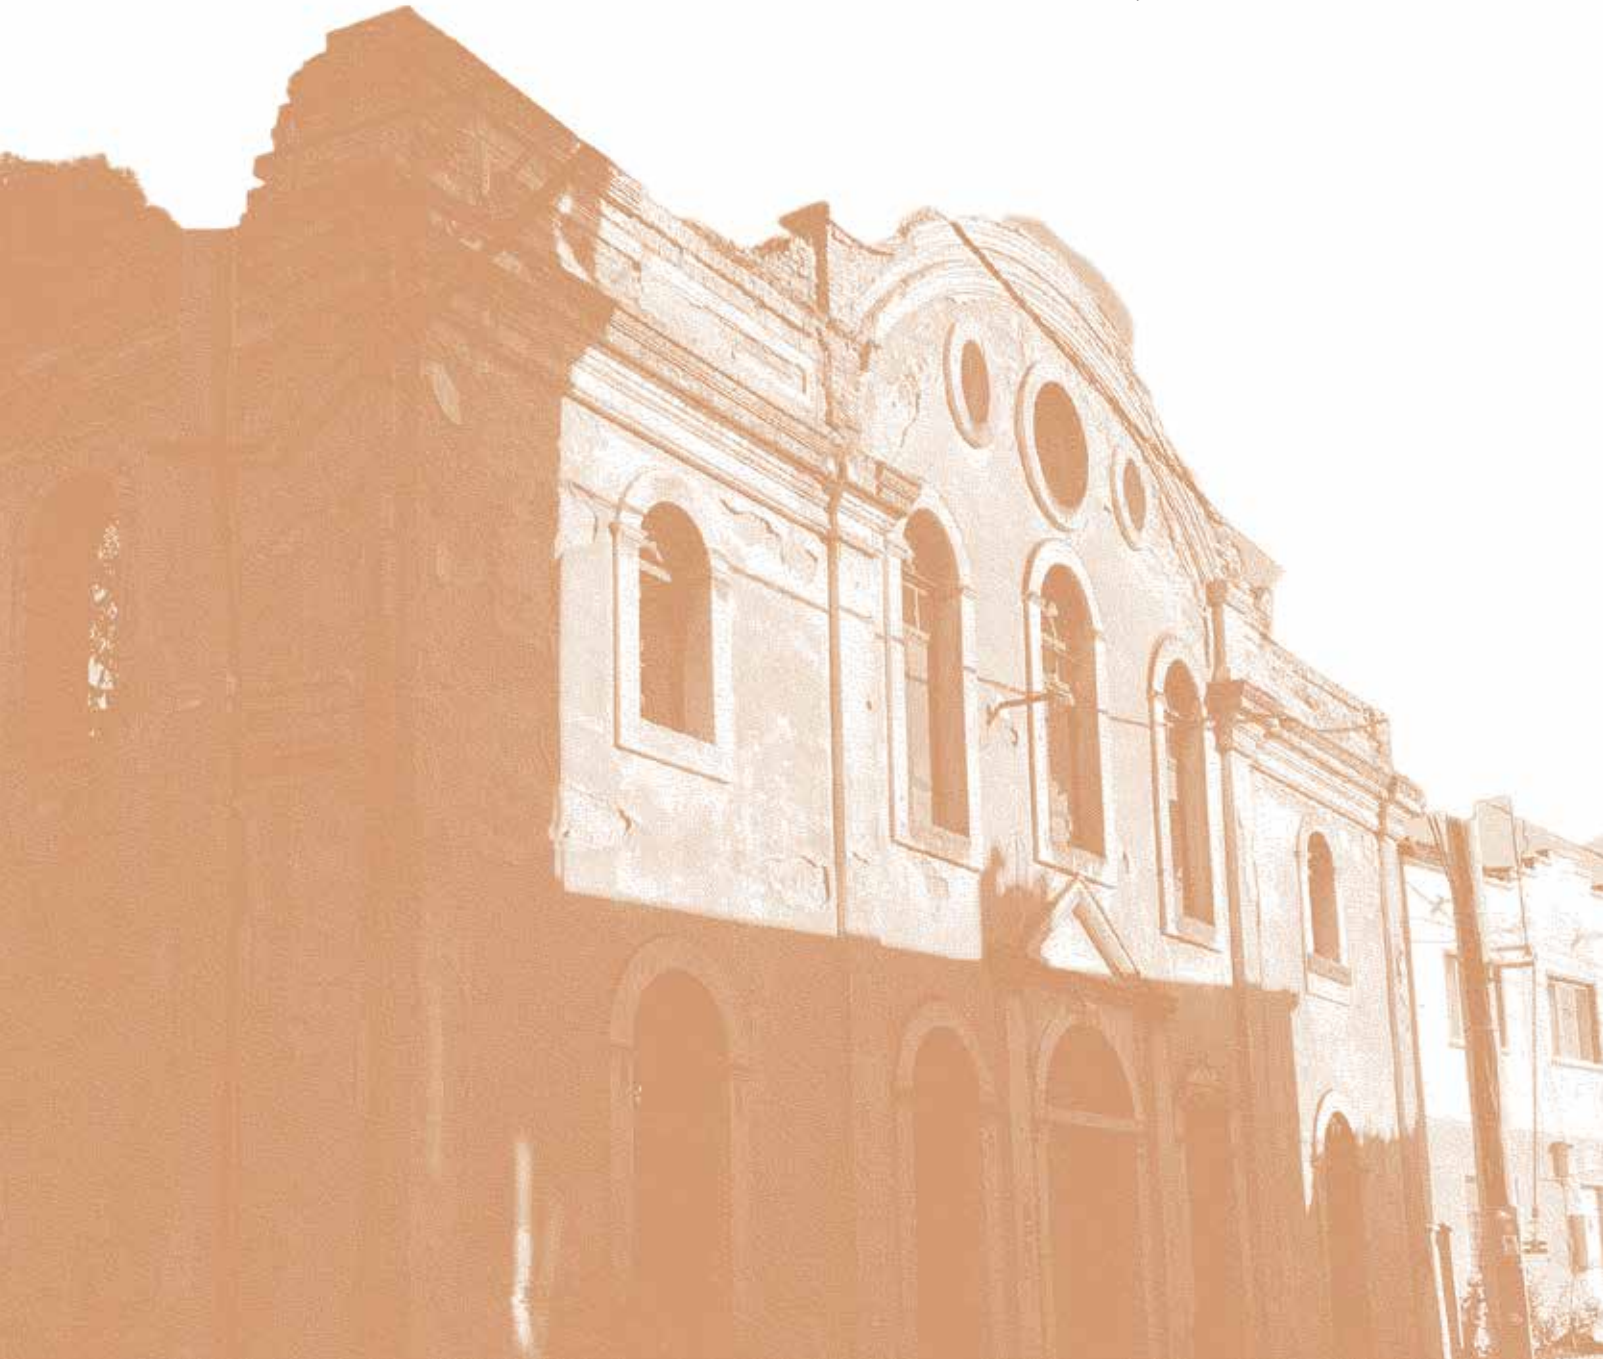
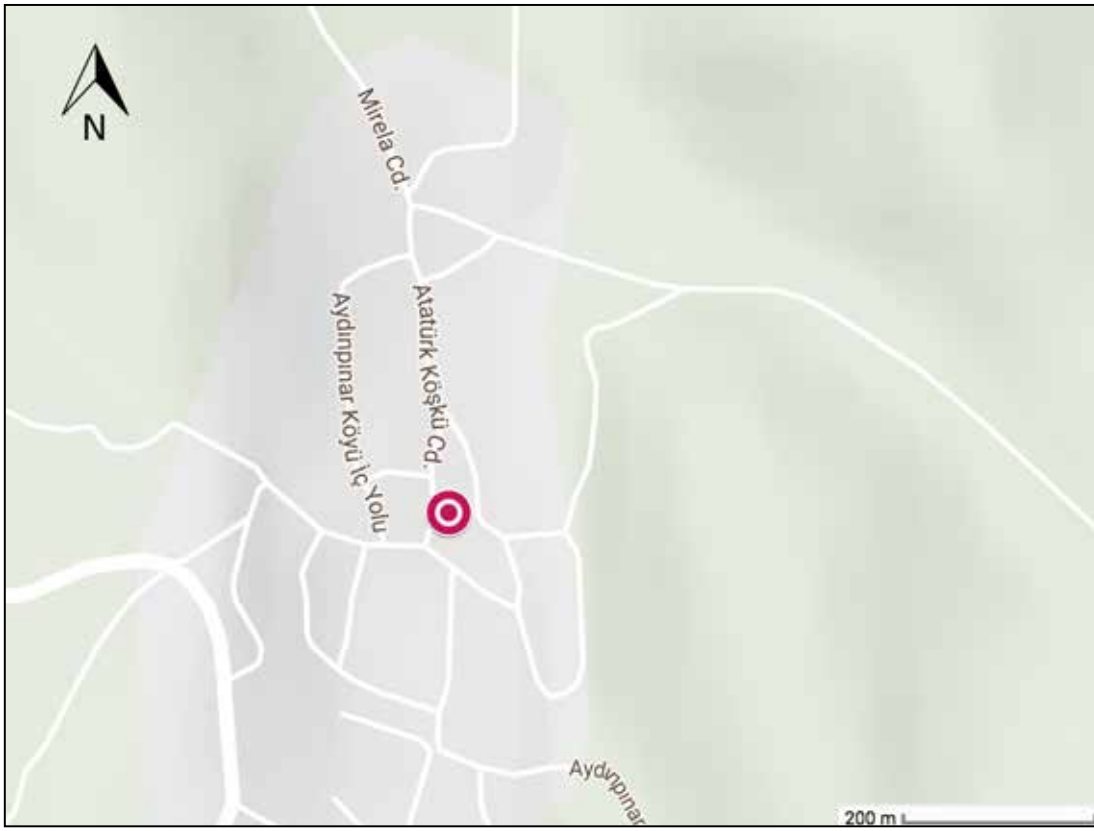
The church is currently in ruins. Not having been used for a long period, the structure has been left defenseless against the forces of nature due to lack of maintenance. The structure, which has suffered severe damage, has had additions including a minbar and walls in the narthex. Traces of its use as a mosque are discernible (calligraphy in the apse, etc), yet there is no trace of the bell tower of the church. As there is no barrier preventing entry, many valuable parts of the structure have been stolen (its ambon, etc.). The upper section of the narthex has not survived and the interior is filled with broken and collapsed remains as well as rubble. As the roof of the naos is completely lost, the remains of roof and ceiling are found within the structure, covered by plants and trees.

The plaster on nearly all of the façades has been lost, with the walls unprotected against all types of environmental factors. Plaster and surface loss is observed in the upper levels due to being exposed to open air. A large portion of the southern façade is current lacking any plaster. Plaster has flaked off the parapet walls and especially in the northern corner, leading to deterioration in the bricks in the parapet. The decorative plates on the parapet have been partly destroyed. There is fragmentation and loss in the capstone molding. Plaster, mortar and parts of the surface have disintegrated at the parapet and eave level of the eastern façade. The brick-cover of the apse has survived, in spite of dense plant cover.

The wooden window fittings on the upper level on the northern and southern walls have nearly been completely destroyed. Those that have survived on the western façade are stained due to dampness and rotting. Non-original wooden frames were installed in the openings of the central nave on the gallery level. The iron bars in the windows are corroding.

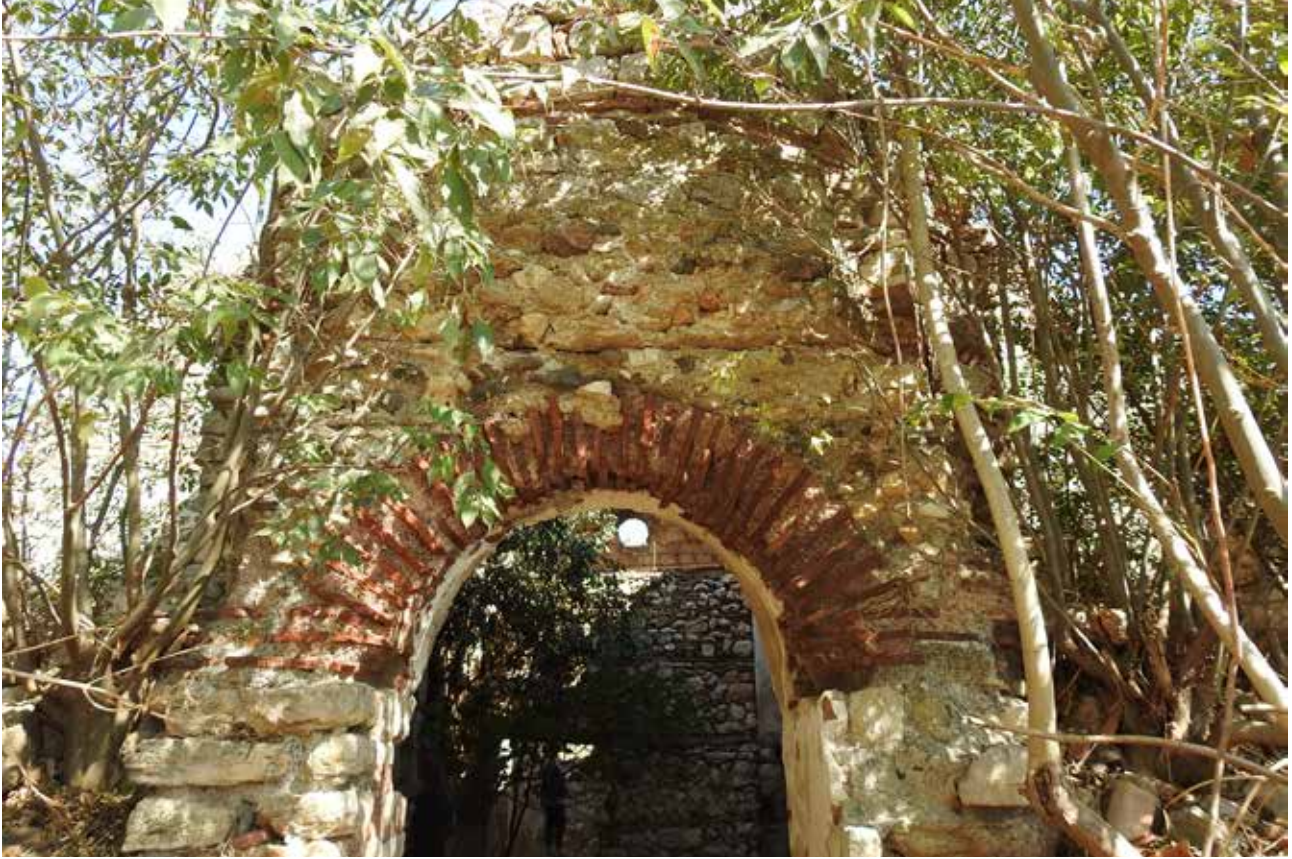
found. In the 20th century an additional floor with wooden support was added within the northern arm of the cross. The floor is covered with rubble, soil and collapsed material. The roofs of the corner rooms and narthex and a large portion of the walls have collapsed. The dome has collapsed; however, the semi-domes above the apses are still standing.

There are pits dug by treasure hunters in the floor. A large portion of the mortar has fallen off the walls, and has caused structural weakening. The layout is mostly discernible, but accessing certain areas is impossible due to destruction and plants growing in the interior. After the structure is excavated as necessary, the characteristics of the interior will be revealed more clearly. Its location on a privately-owned island makes access very difficult.
