Bursa

BURSA SITE ASSESSMENT VISIT

Dates: September 28 - October 2, 2016

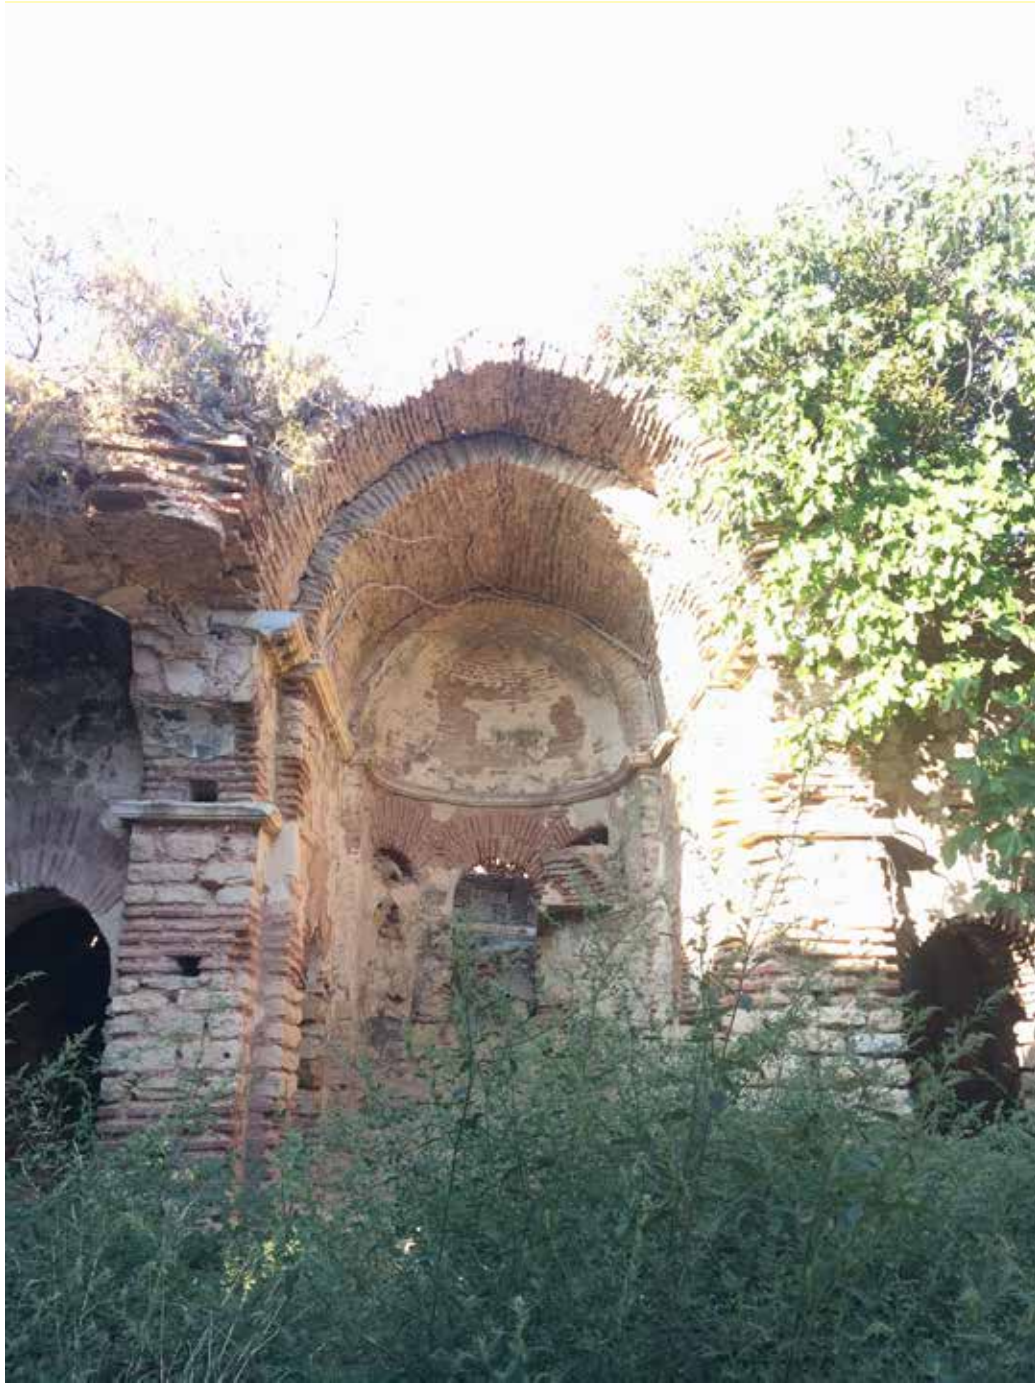
*Monastery of Saint Ioannes Theologos Pelekittis
Mudanya county, Tirilye town, Deniz çiftliği locale*

cross-in-square plan that is still discernible. There are only traces of a narthex on the western outer wall and the room accessed through the northern wall is no longer present. The roof of the church is gone, and the interior is filled with soil. A fig tree is growing in the northern wall causing damage. Apart from the central window in the apse, all the windows have been bricked up. Some of the wooden beams in the walls are rotting and decaying. The brick arch of the window above the door in the western wall is broken. Some of the interior moldings in the east have broken and fallen off.

There is abrasion of stone and brick material, and the mortar has lost its binding ability. The mortar is completely missing from the upper levels of the walls. Due to natural forces and illegal excavations, the architectural characteristics of the structure are being rapidly destroyed.

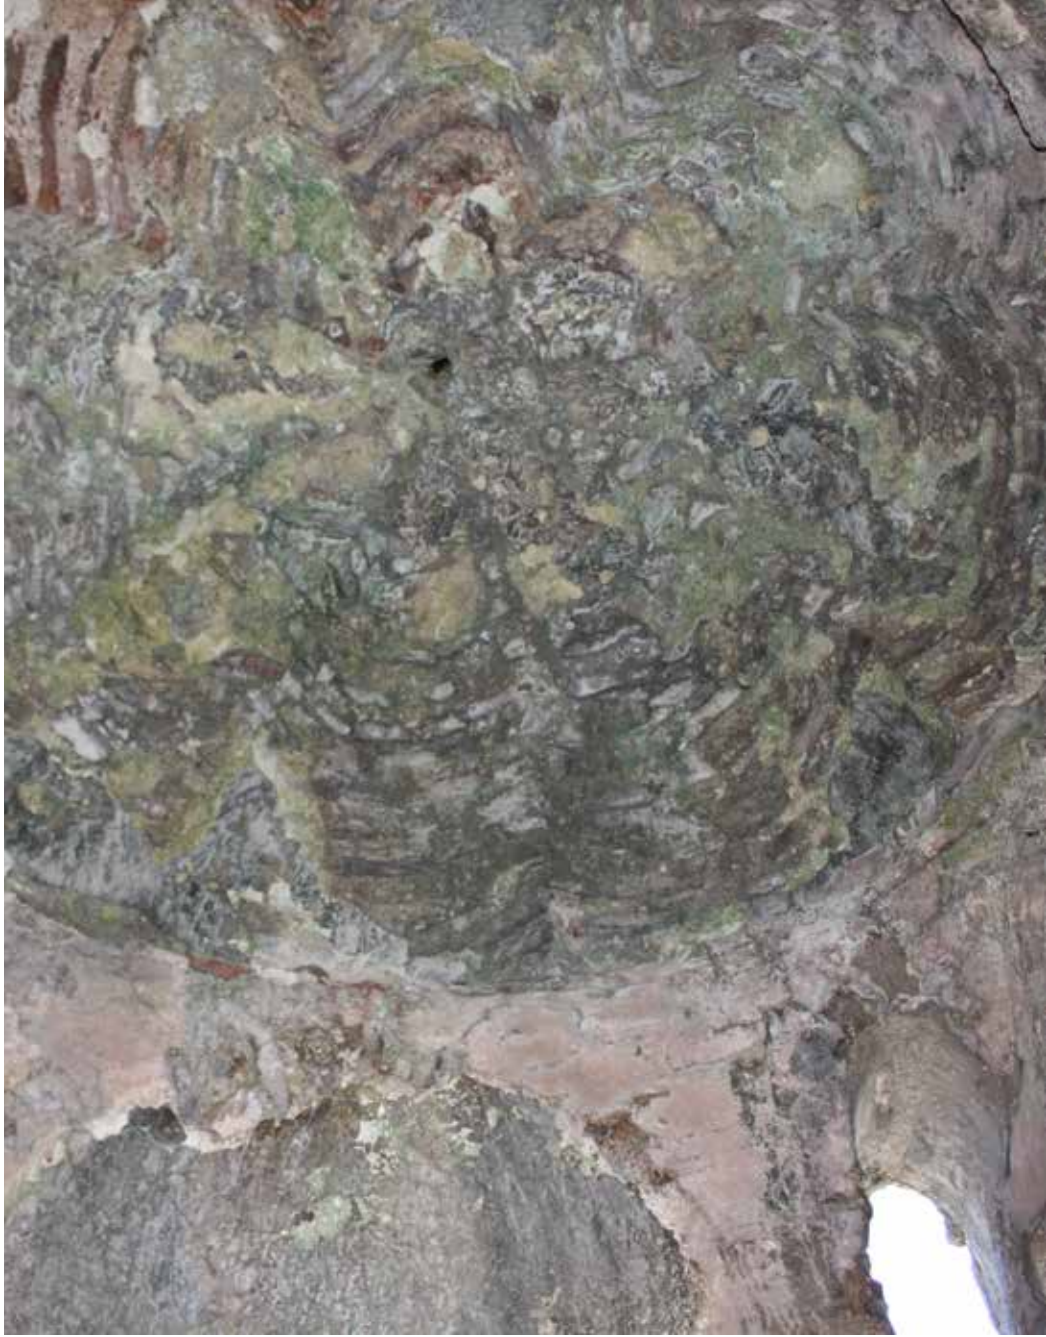
*Church of Saint Averkios
Gemlik county, Kurşunlu neighborhood, Çatal locale*

The church and structures belonging to the monastery are bounded by the Gemlik-Mudanya road to the south, by the Marmara Sea to the north, by residential structures and gardens to the west and by a lot containing a variety of inappropriate structures to the east. Currently not in use, the structure and remains of the monastery complex are surrounded by a fence. It is known that the whole structure was covered in frescos in 1956 (Mango, 1968, 172); however, currently very little of this is left. Many of the remains documented by Mango's photographs in 1968 no longer exist. An examination in 2010 revealed that the roof of the narthex was about to collapse. In 2015 the Ministry of Culture completed partial repairs to the structure, with excavations in areas belonging to the monastery; however the original brick material from the collapsed section of narthex has been taken away from the site. The dome of the building has not survived, with part of the vault covering the narthex also destroyed. There is surface and material loss in many parts of the structure. The fill between the rubble stone used later on to close off the window openings has deteriorated in various places. There is dense plant cover on the vaults, pendentives and wall surfaces.

Restoration work carried out in 2015 included completing the reinforcement of ruined sections in the structure. However, no precautions were taken to prevent the collapse of the dome of the apse, which has no load-bearing system remaining and only insufficient pillars placed for support. There are also no precautions taken regarding insulation or water drainage in the structure, considering the central dome and roof covering are lost. The vaults, domes, wall sections, and interior of the structure are open to all types of precipitation and damage. If precautionary measures are not taken soon, factors such as the separation of certain parts, the loss of material, etc. along with the extensive plant cover will cause severe damage in a short time period. Additionally, the remains revealed by excavation efforts must be protected from rain, and water drainage must be ensured. The

structural remains and ground pits are open and unprotected. As a result, it is necessary to immediately build a temporary cover for the remains of the monastery to be protected from rain. After a comprehensive restitution and restoration project to prevent future damage the lost parts of the structure may be rebuilt and the building used as a museum. The inappropriately-used eastern lot should be expropriated for public use, and may be made part of the museum. The Monastery of Saint Averkios and catholicon, which is an important assemblage of Byzantine structures, must be opened to visitors in order to contribute to the promotion of the region as well as Turkey, allowing this cultural heritage to be passed on to future generations.

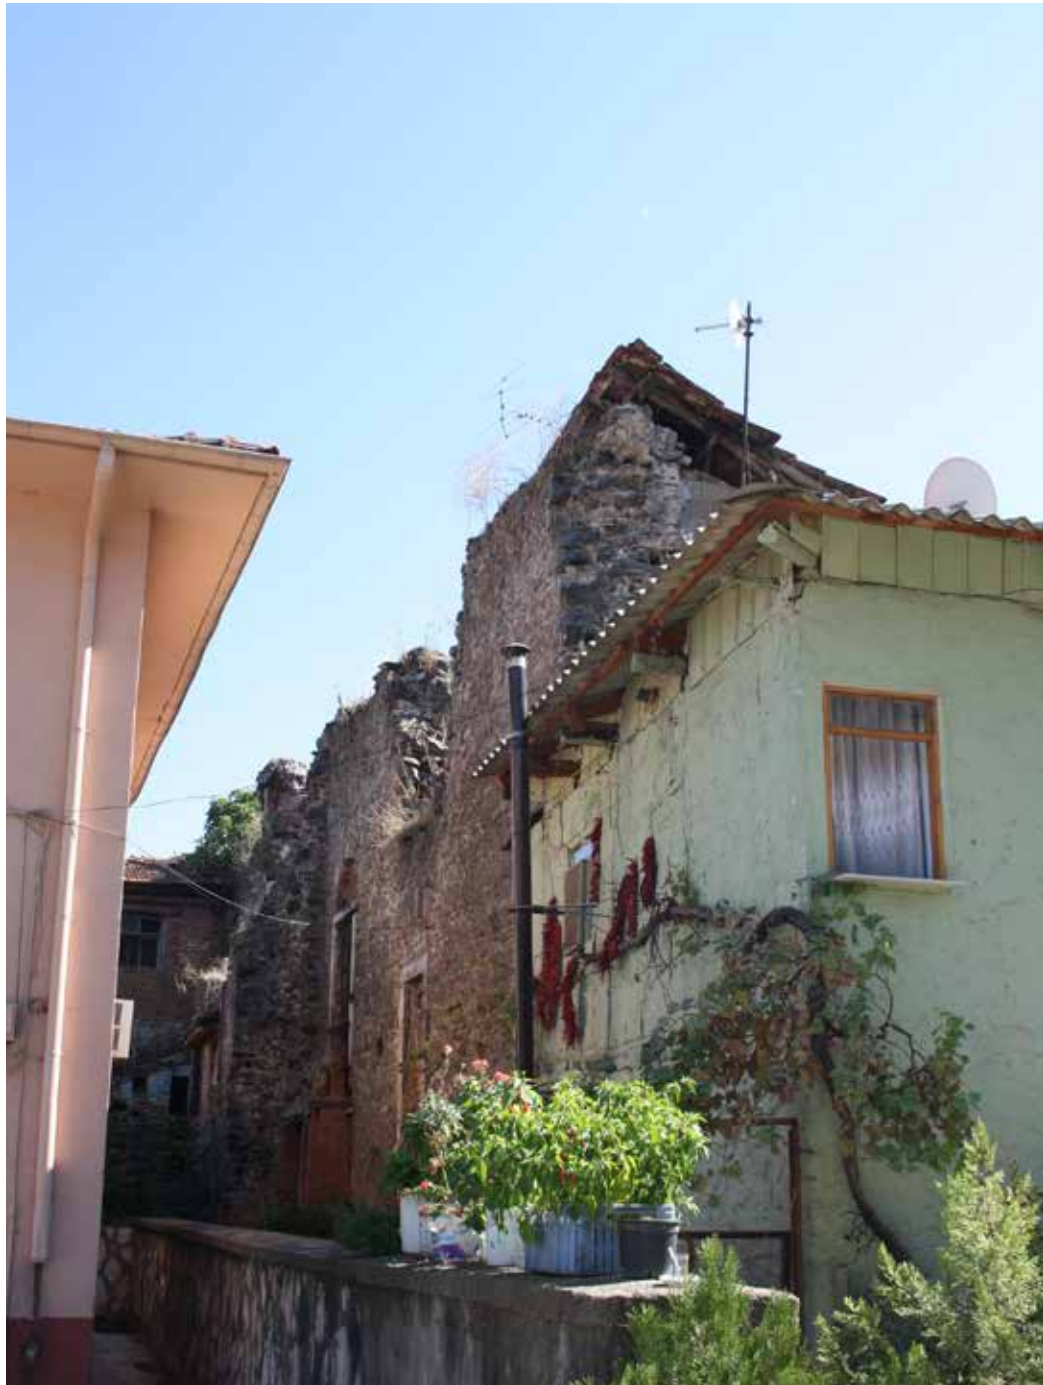
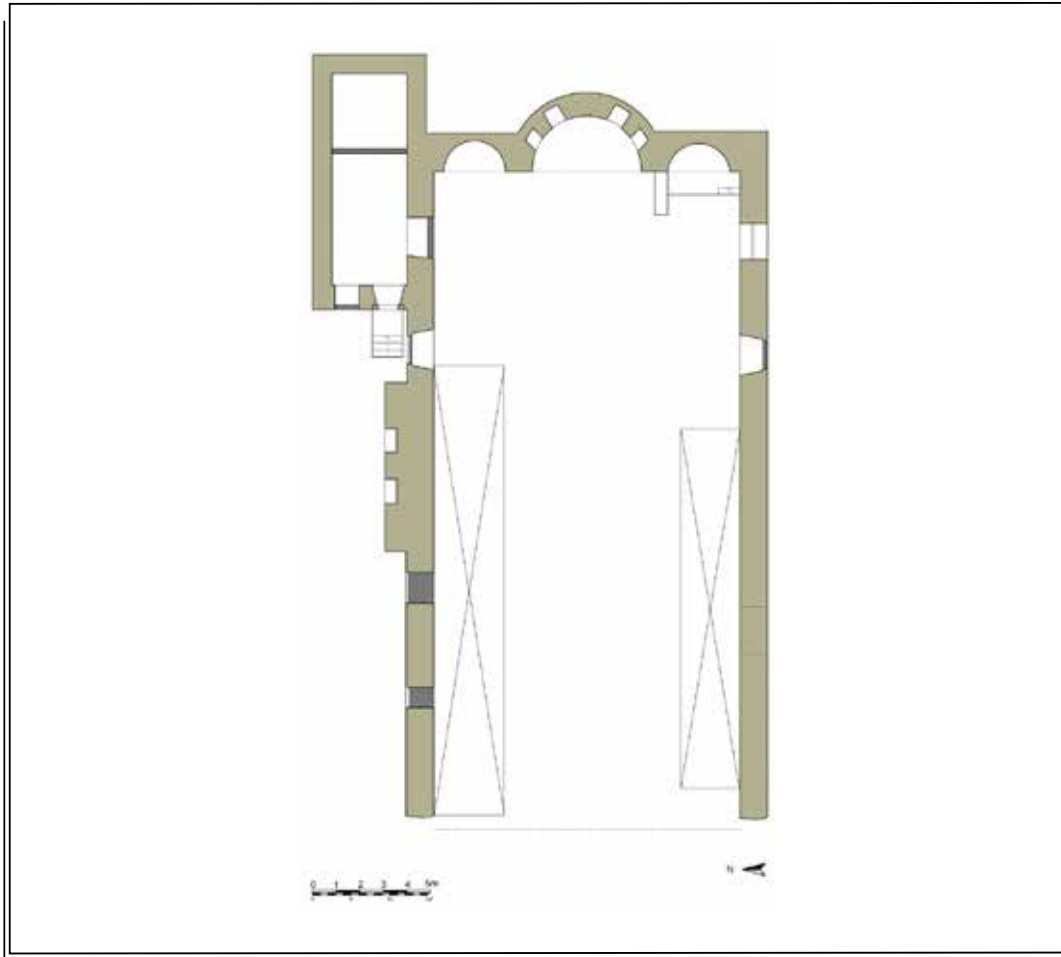
The plan is discernible and the spatial characteristics distinguishable. Apart from the eastern wall, the door and window openings and iron grills in the windows, the original characteristics have been destroyed. The western wall is completely gone. The arched window in the northern wall has been partially bricked up, and two windows with projecting stone jambs closed off and broken. The southern wall cannot

be accessed at present due to other constructions. The door allowing access to the main church from the southern wall of the chapel is closed off. There is plant cover on the remaining walls. The mortar has disintegrated and efflorescence is observed on the wall surfaces. The structure is in bad condition with later annexes and collapsed sections.

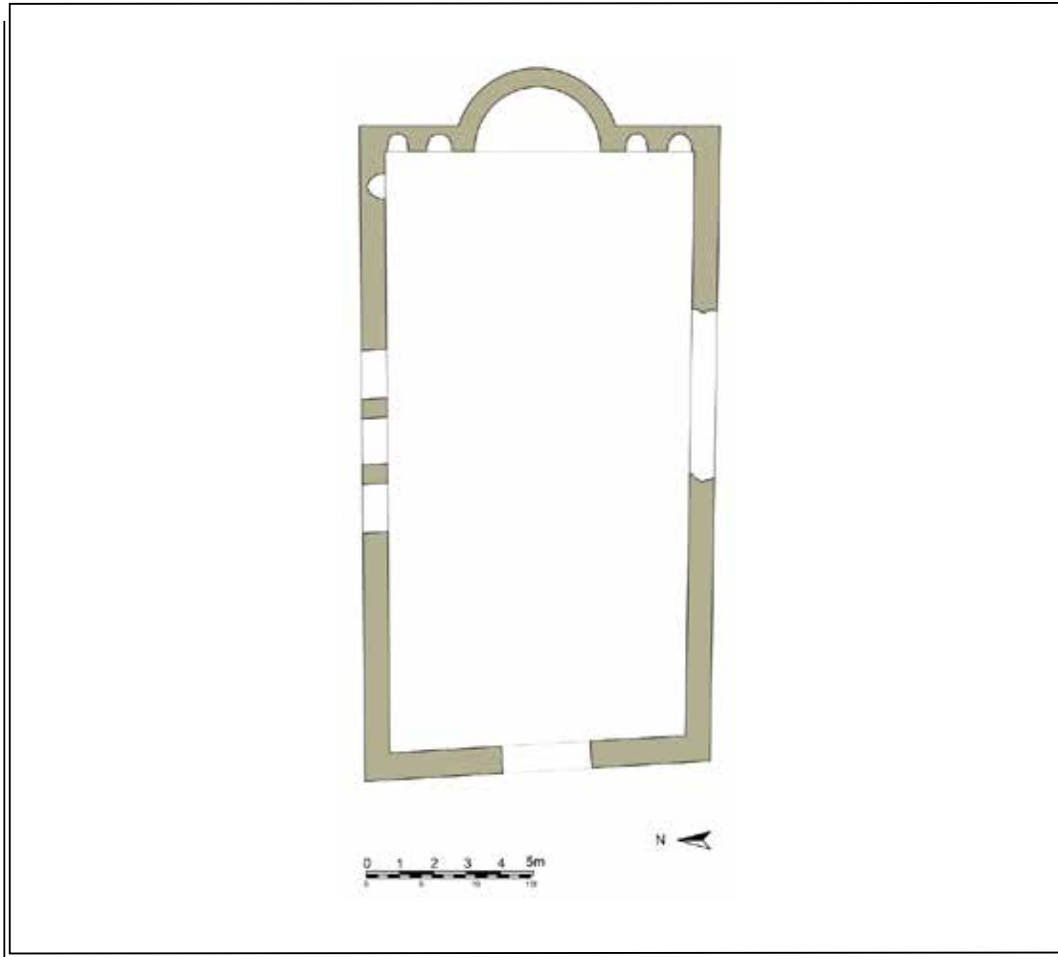
Currently as the structure is ruined and collapsed, the spatial characteristics of the interior are not discernible. The remains of the wall that are present allow for an estimation of the plan. The roof of the structure, which was probably wooden, is completely lost. As a result of this, the floor of the church is filled with soil, and weeds, shrubs and trees are growing within the building. Thus the composition of the façades and the height of the structure are unknown. Only the brick semi-dome above the apse is still standing.

The external walls of the church (especially the northeastern and northwestern façades) have large-scale material loss. Different column pieces are scattered around the ground. The ground also

contains pits dug by treasure hunters. The large scale of the destruction that has taken place in the structure and the lack of any inscription make it difficult to determine the age of the building. It is completely open to human and natural depredation, and its structural integrity is in danger.

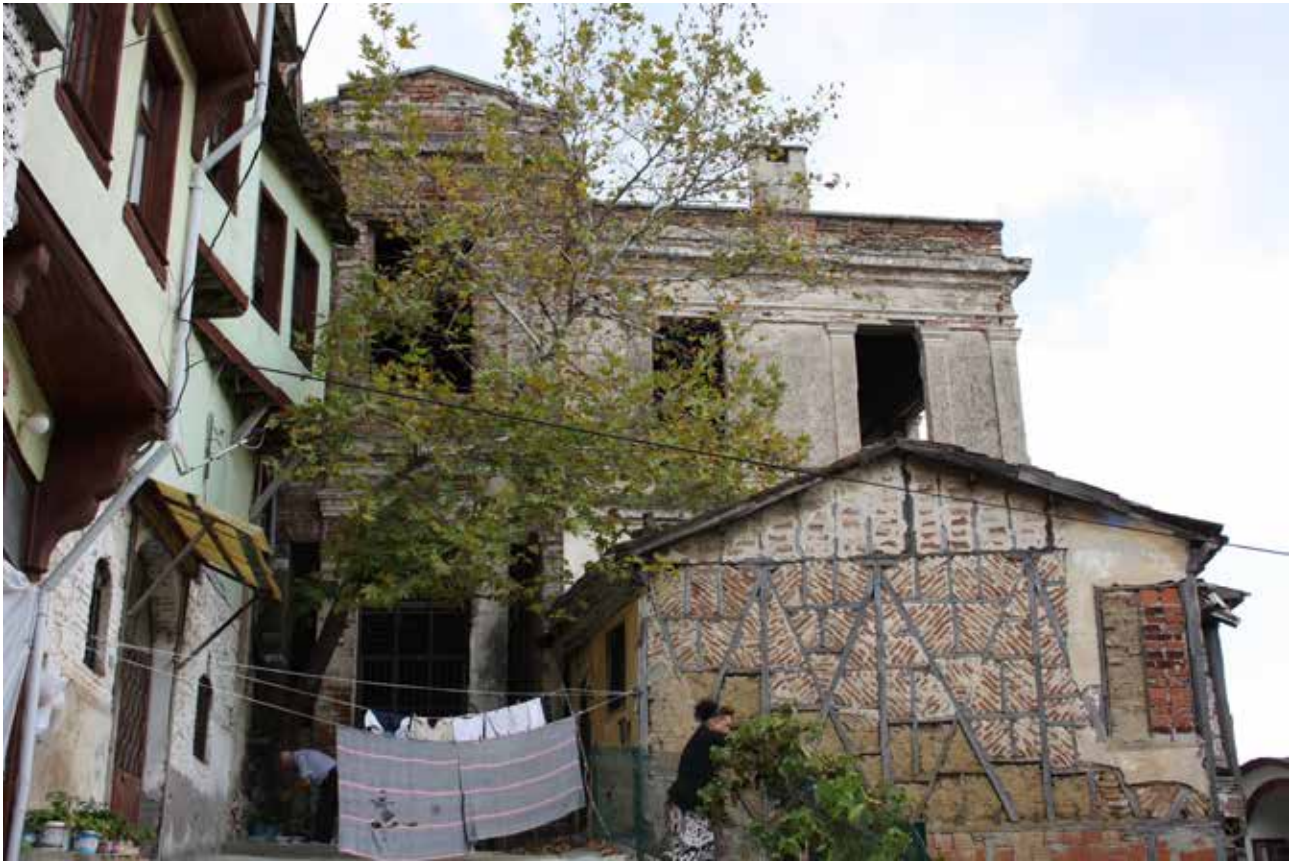
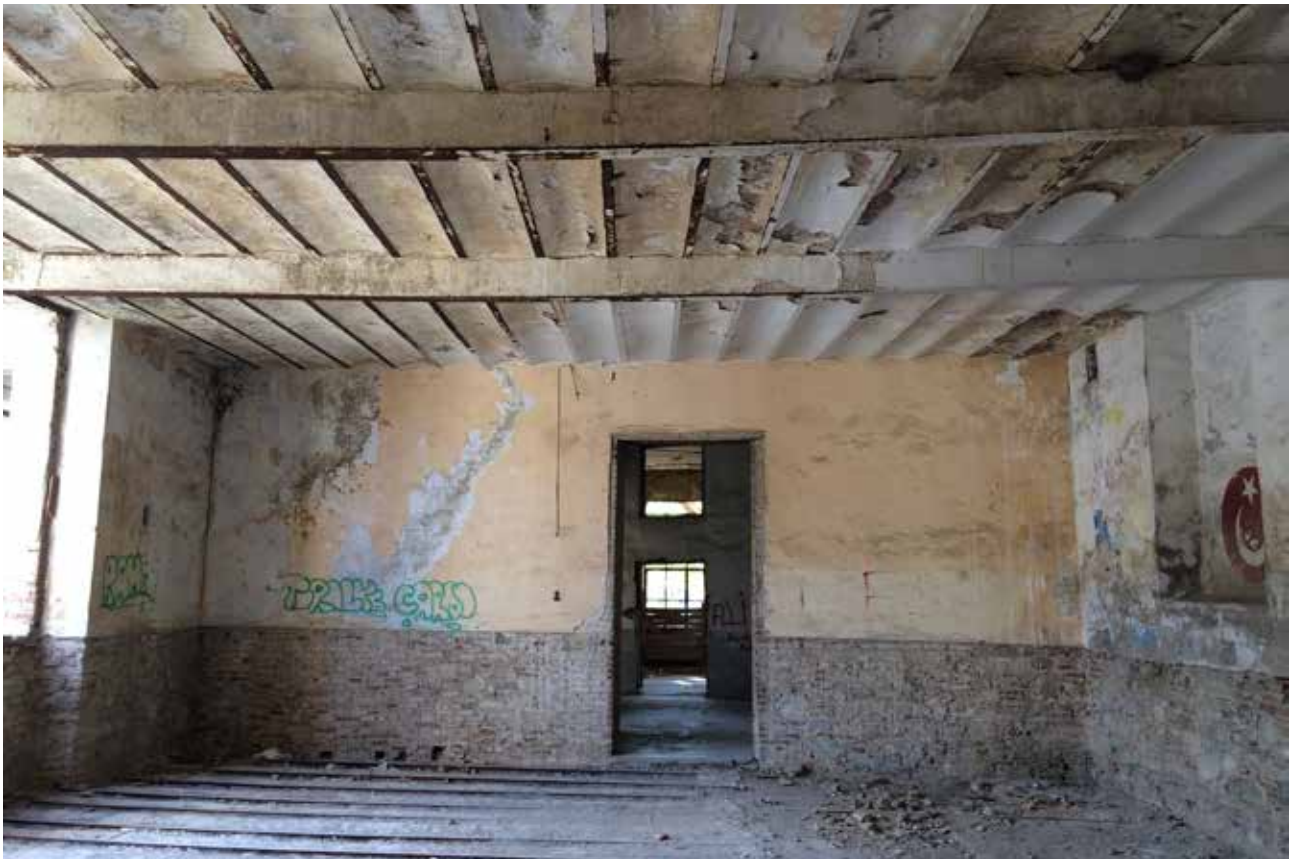
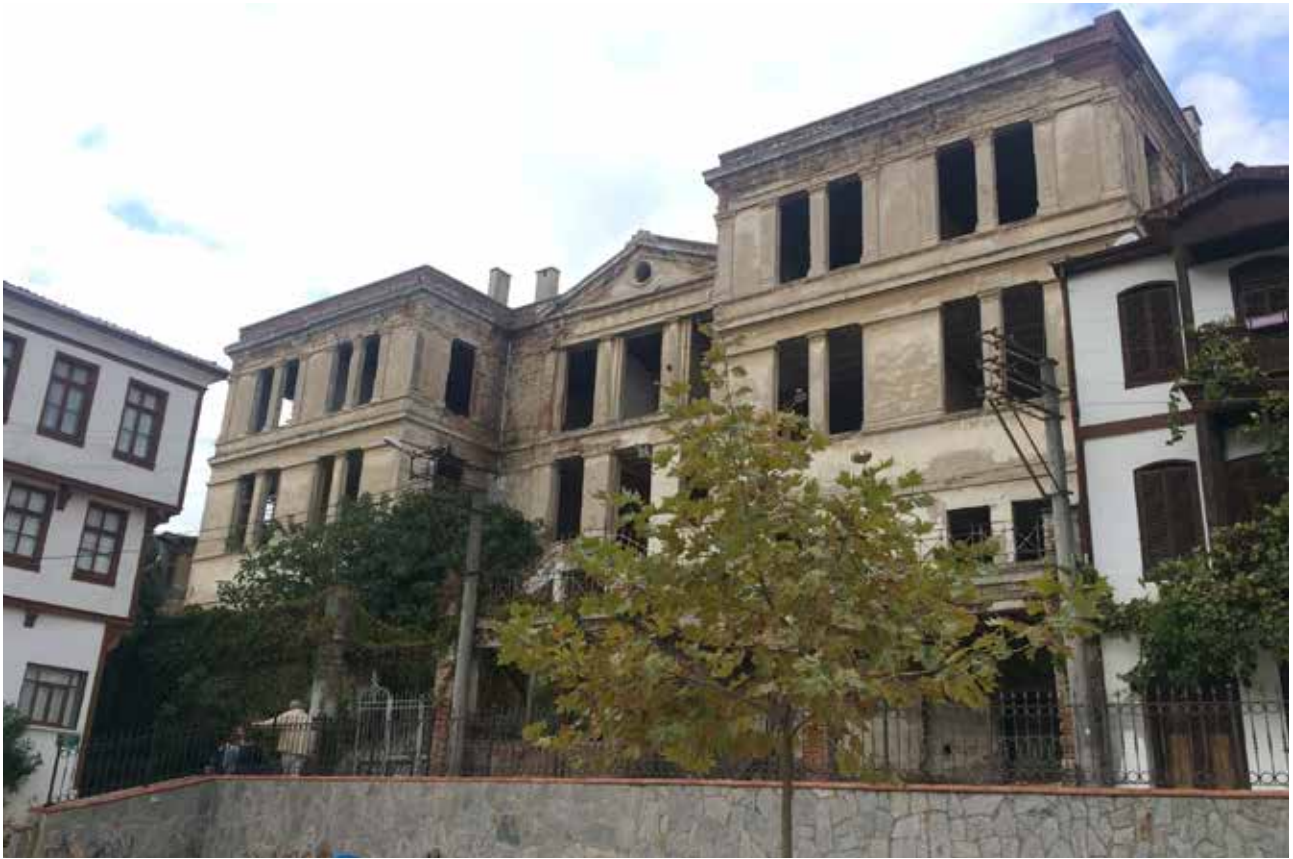
The later additional sections installed into the school, as well as the repairs are of poor quality. Due to structural problems in 1988, it was declared to be dangerous for use and was abandoned and survived to the present with only its roof being repaired in 2001. Despite this repair, the roof still leaks and the wooden supports have weakened. As a result of lack of care, vandalism and natural conditions, disintegration and ruin of the architectural fabric continues. There is a brief information panel outside the school close to the main road.

The load-bearing iron profiles in the brick vaults are corroded and there are separations in the walls of the structure revealing its danger in terms of structural integrity. The wooden stairs allowing access to upper floors have partly collapsed, with the remaining sections too damaged to be used. There is imminent danger of collapse in all floors. A photograph taken in January 1992 shows that some of the glass in the windows in the front façade remained and that the majority of window

Nearly all the plaster of the external façades has fallen off, with the mortar loosening. Close to the roof and at points where the roots of plants have attacked the structure, there are cracks and separations in the walls. Water entering the building for varied reasons has disrupted the physical and chemical structure of the walls and efflorescence is present due to dampness. As the northern façade leans against the hill, there is mold and efflorescence due to dampness coming from the ground in this direction. The fractures observed in the internal facades indicate that the load-bearing system of the structure is sinking into the earth. The majority of plaster from between the iron profiles in the brick vaults has fallen off, with bricks also missing in places. The interior has been painted with spray paint, and wooden elements have been lost due to vandalism.

and damaging the architectural texture must be removed as well. All non-original additions (including the concrete building adjacent to the northwest of the school) and repairs must be removed. Entry to the structure should be controlled and the door and window openings closed. Afterwards, general reinforcement and repair, especially of the load-bearing system, must be completed and the roof must be repaired once again. The restoration project must be implemented under expert supervision.

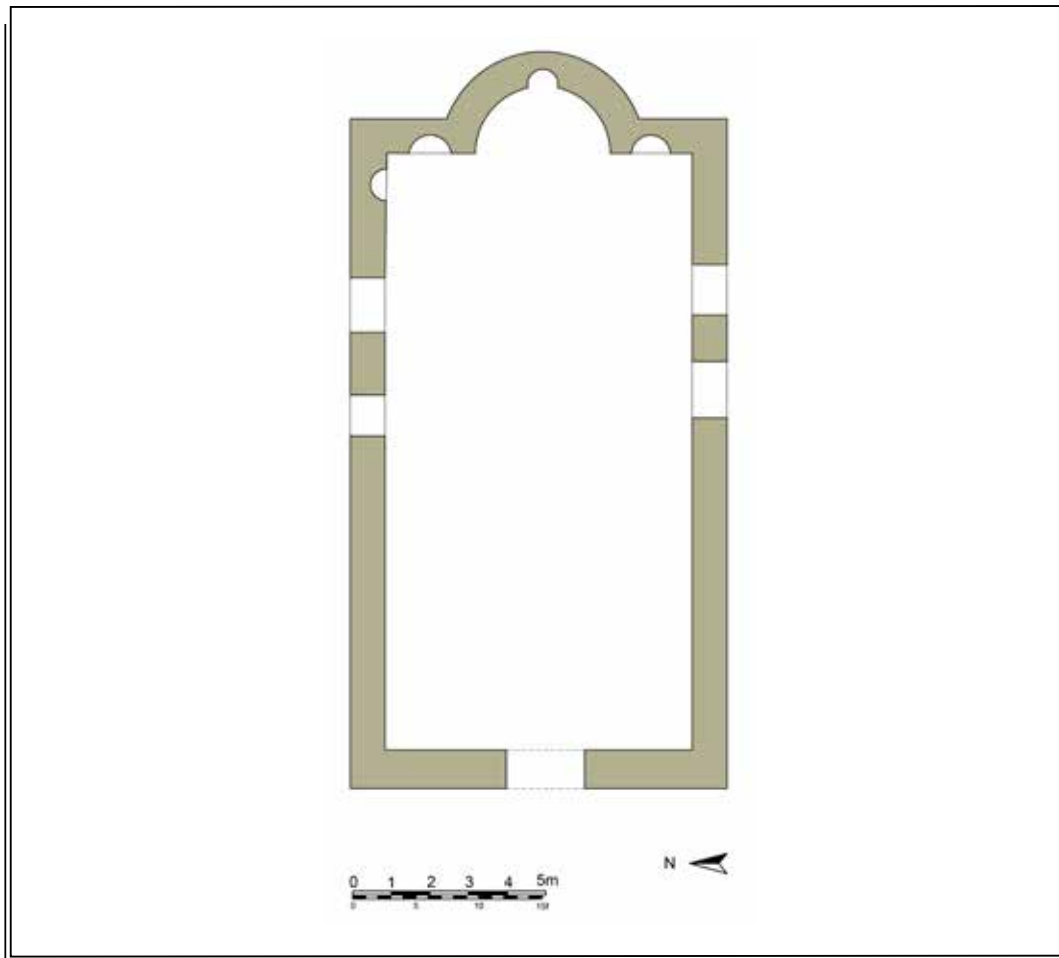
On the north, east and southern sides, the church extends into a school garden, which is surrounded by a retaining wall of 1.50 m. It is said that the garden was once a cemetery. The structure is ruined, unmaintained, completely overgrown with plants and open to vandalism.

The brick semi-dome above the apse in the east has mostly collapsed. As the roof has not survived, the walls have also begun to collapse. The mortar is mainly lost. In addition to dense plant cover within and around the building, it has been used as a rubbish dump by villagers and is a danger to public health.

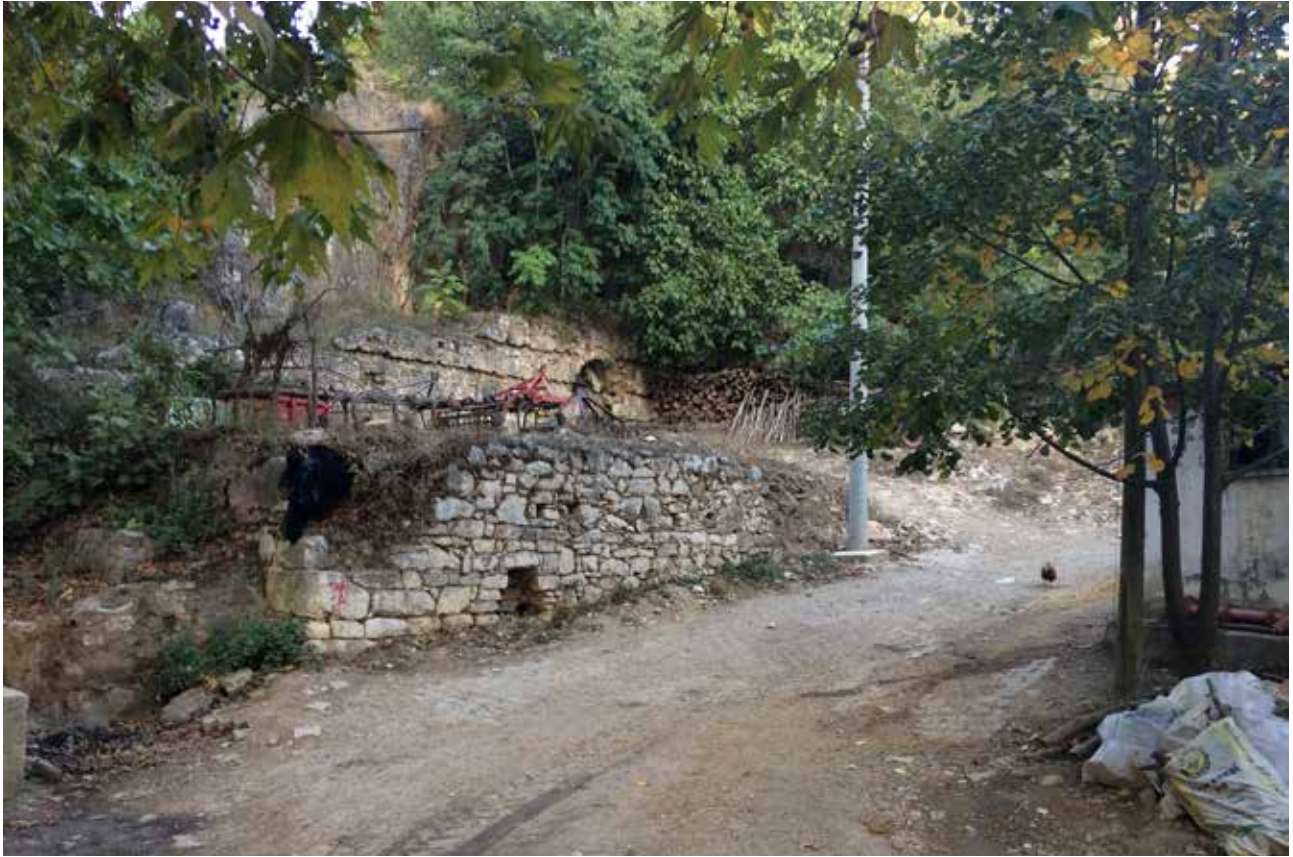
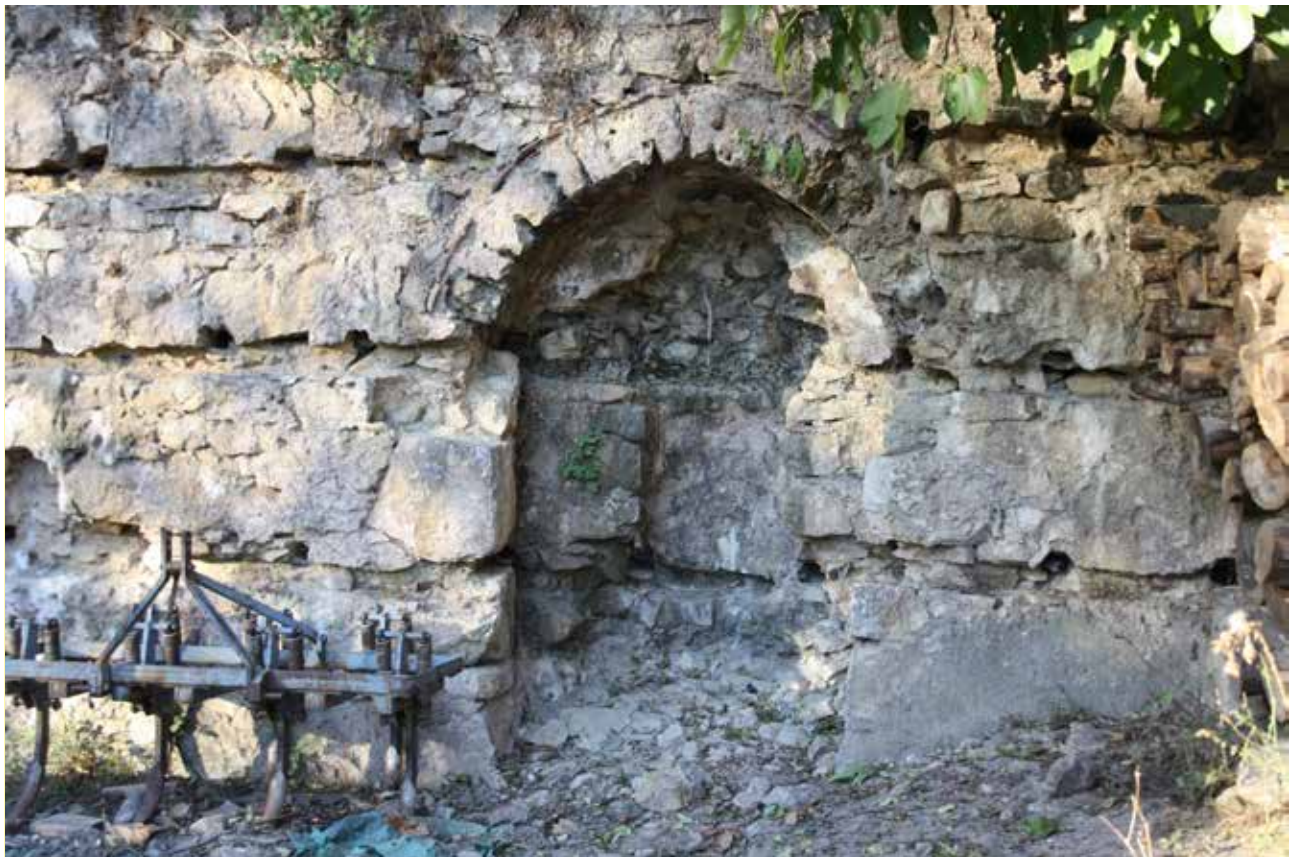
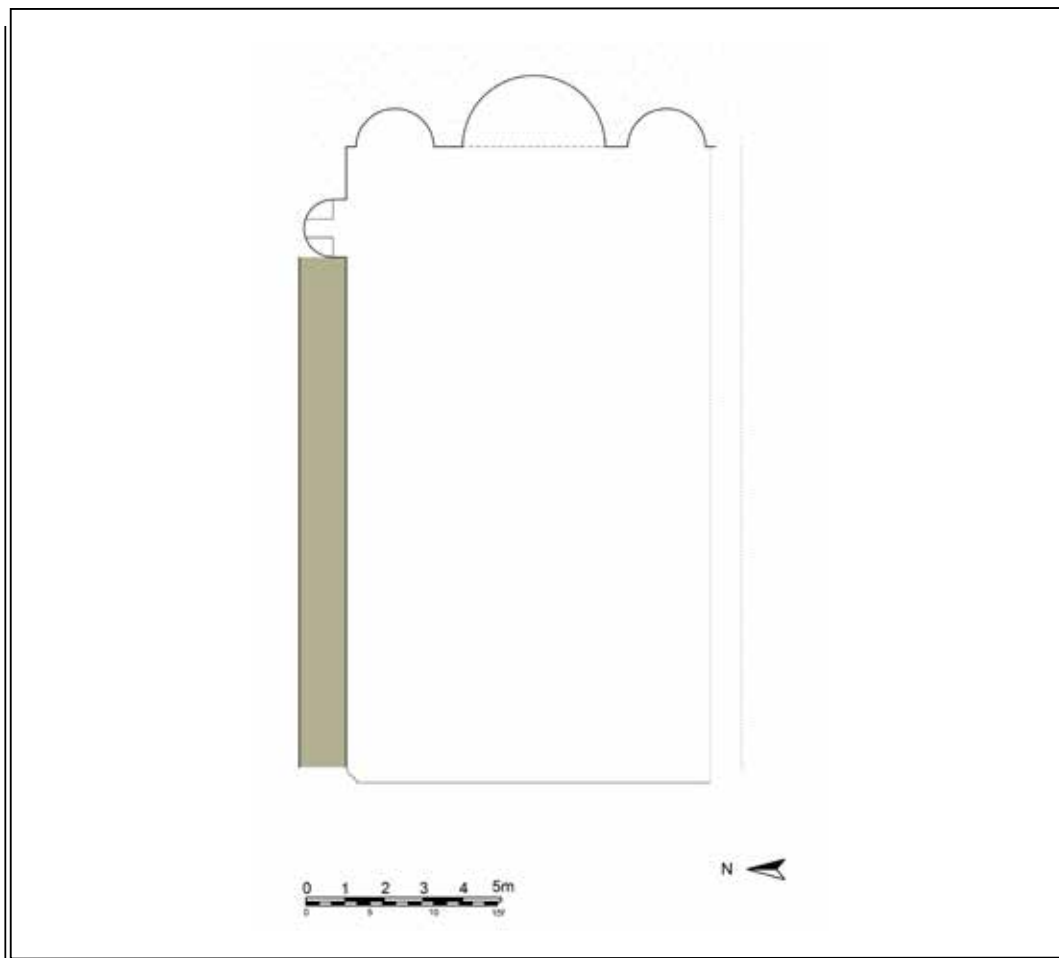
Many remaining houses built by the Armenian community are still in use in Şahinyurdu today, with the public bath in the square empty and neglected. On a village road within walking distance of the square, the Church of Saint James of Nisibis is in ruins and unrecognizable. There is a large plane tree with a flowing spring under it beside the church. The very few remains of the church provide information about its layout and location, but its spatial characteristics cannot be read. Apart from the eastern and northern walls, no architectural elements have survived. The horizontal wooden beam holes between the stone rows in the northern retaining wall are empty and the interior of the niche broken.

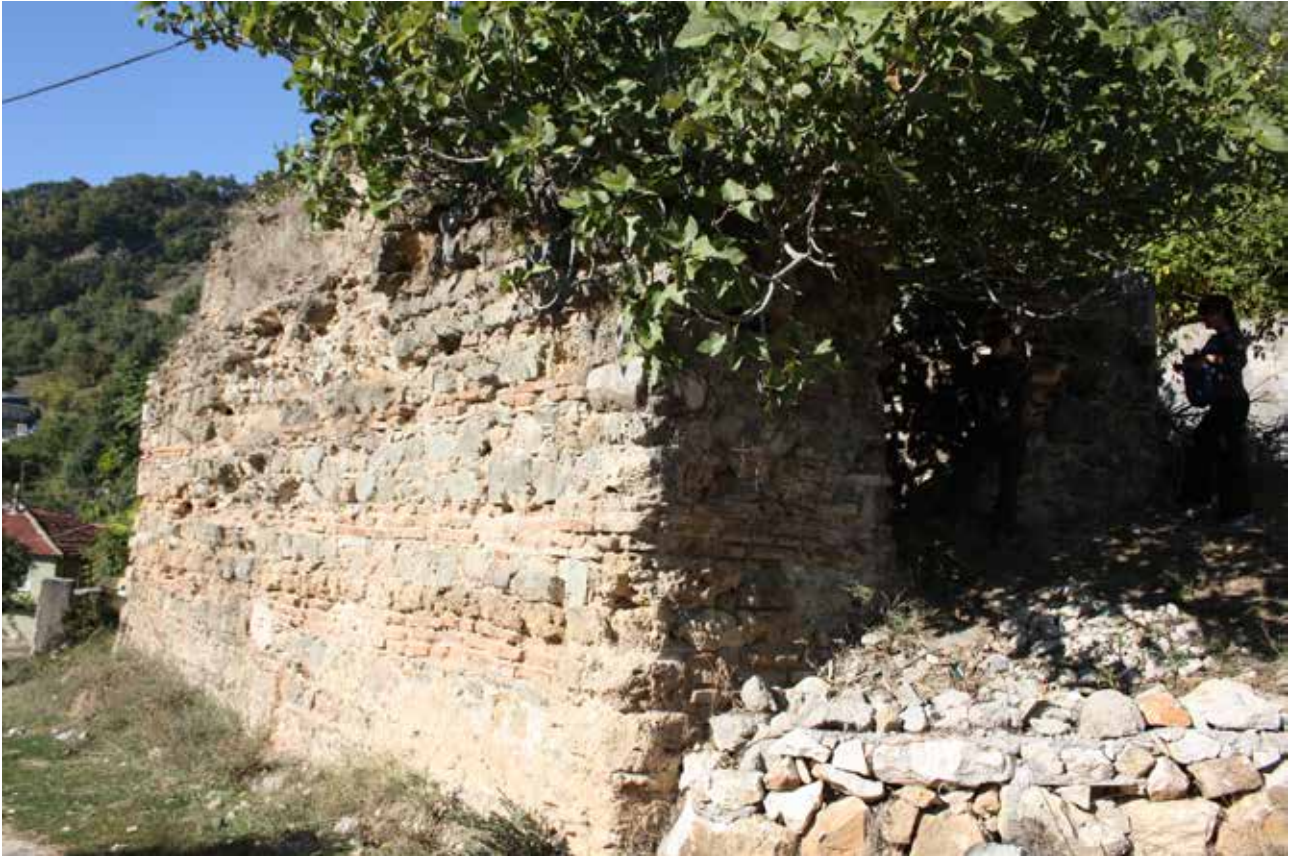
level as that of the arch of the central opening. The hot section also has an arched opening that connects to a rectangular section possibly used as a water depot. The crack in the southeastern façade of the water depot is thought to be due to damage over time.

Currently the layout is discernible; however, there is substantial destruction in the building. The whole roof of the water depot and part of the external wall has collapsed. The centers of the domes forming the roofs of the warm and hot sections have collapsed and, as a result, the structure is exposed to external weather conditions. Trees are growing in the floor of the warm section. Additionally there are pits dug

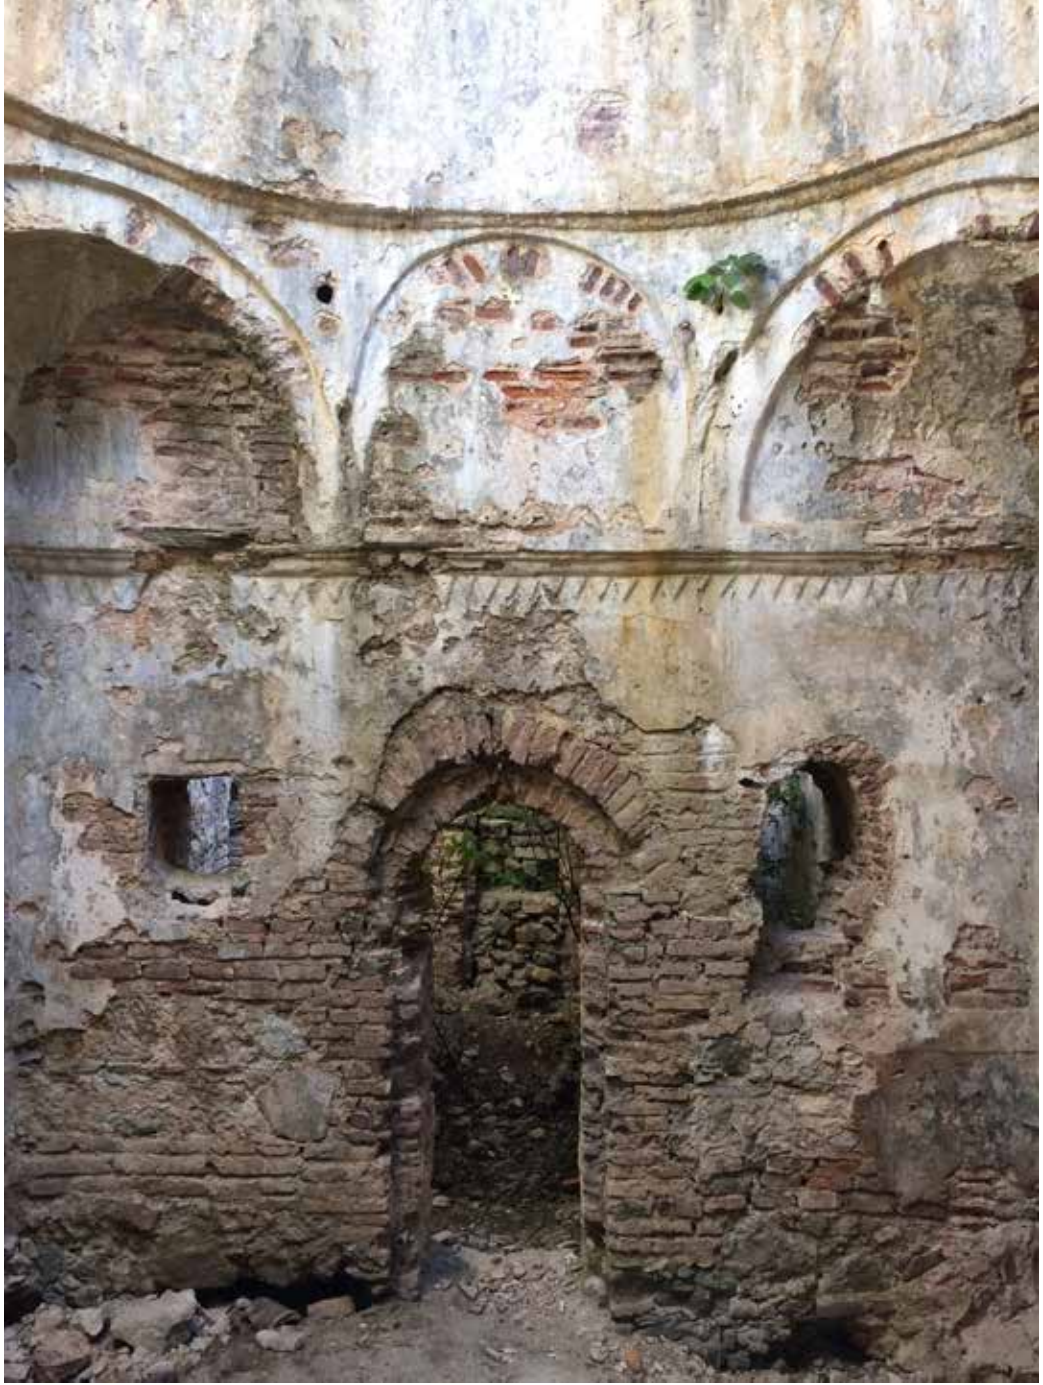
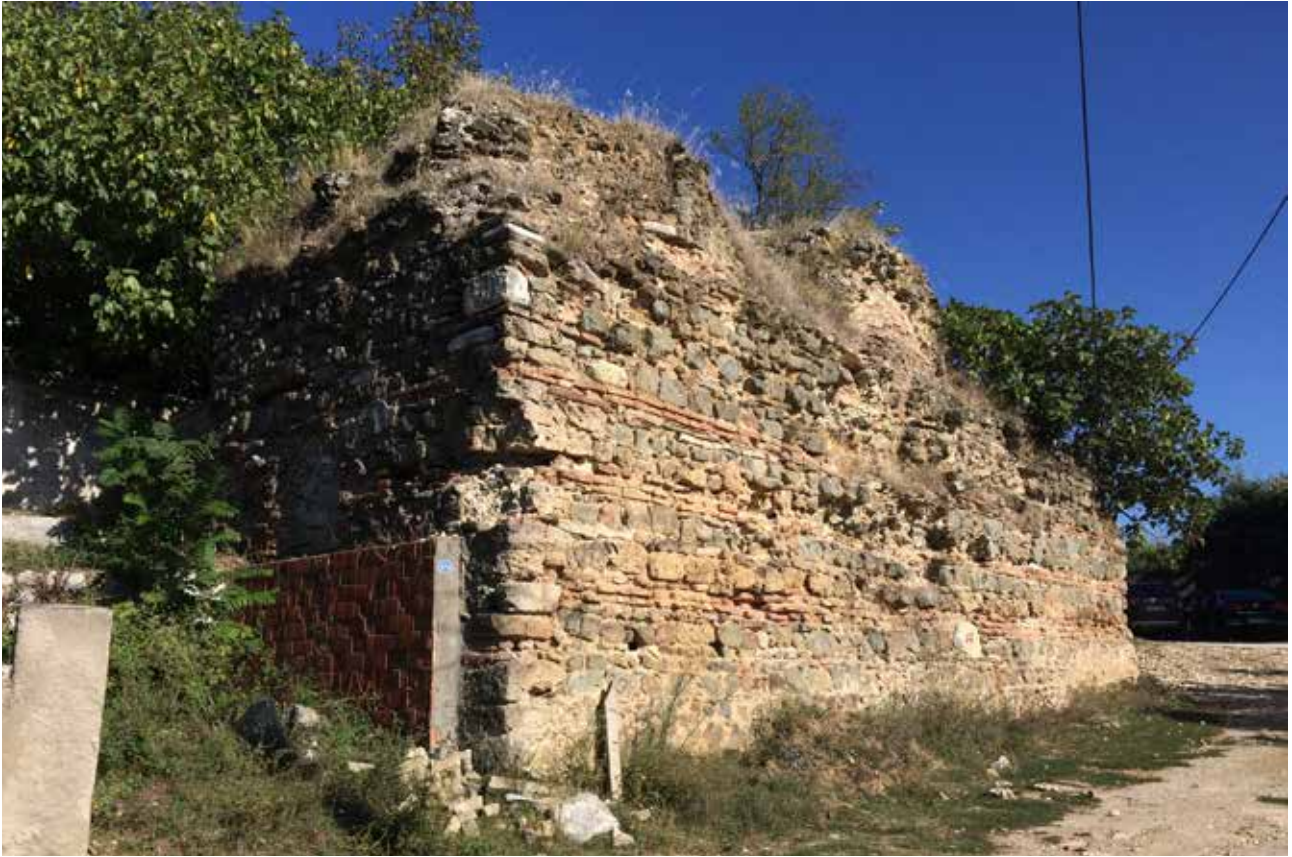
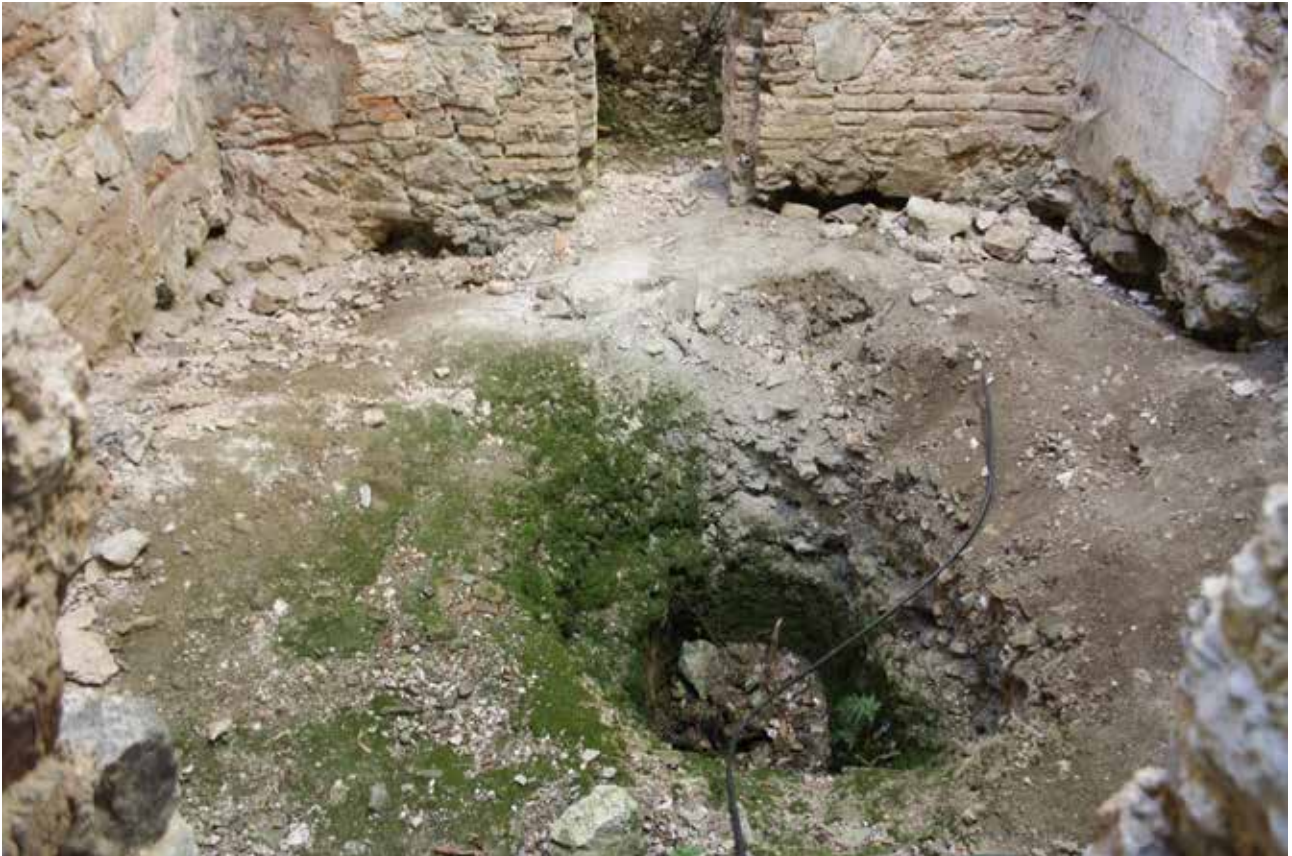
*The Public Bath
Orhangazi county, Ortaköy village, Kerpiçlik locale*

by treasure hunters in the floors and walls of all the rooms. The floor of the interior has sunk due to collapse and damage caused by treasure hunters. The plaster on the internal walls and domes has mostly fallen off.

Nearly the whole northeastern façade of the structure is covered with soil. The residents of the neighboring lot have closed off the opening on the northwestern façade and built a wall adjacent to the structure on the land boundary. In this way access through the original entrance on the northwestern façade is prevented. The internal space and roof of the structure have trees and weeds growing on them.

Currently in ruins, the structure is abandoned. There is no door at present, with increasing destruction due to cracks in the southeastern façade and collapse of the roof leaving the structure open to the forces of nature and human destruction. The internal space has damp marks, as well as biological and physical damage. Plaster has fallen off, with further

material loss in various places. The structure is close to a main road and access is easy. There are no information or directional signs relating to the structure. The building is significant, being the only Armenian structure in the village, and its location it provides a significant opportunity for enjoying the view.

and clearing out the soil cover currently burying the northeastern façade, will render all of the façades visible. Additionally, the structure must be preserved and an information panel put in place. In this manner, a restoration project must be developed considering the building along with its surroundings to give it a new function.

The greatest current danger is that the structure is open to natural and human destruction. Structurally in good condition, it is neglected and abandoned. Cleaning the close surroundings, removing later additions (the filling on the floor/the wall on the external façade), eliminating the plant cover on the structure
