Bursa

BURSA SITE ASSESSMENT VISIT

Dates: September 28 - October 2, 2016

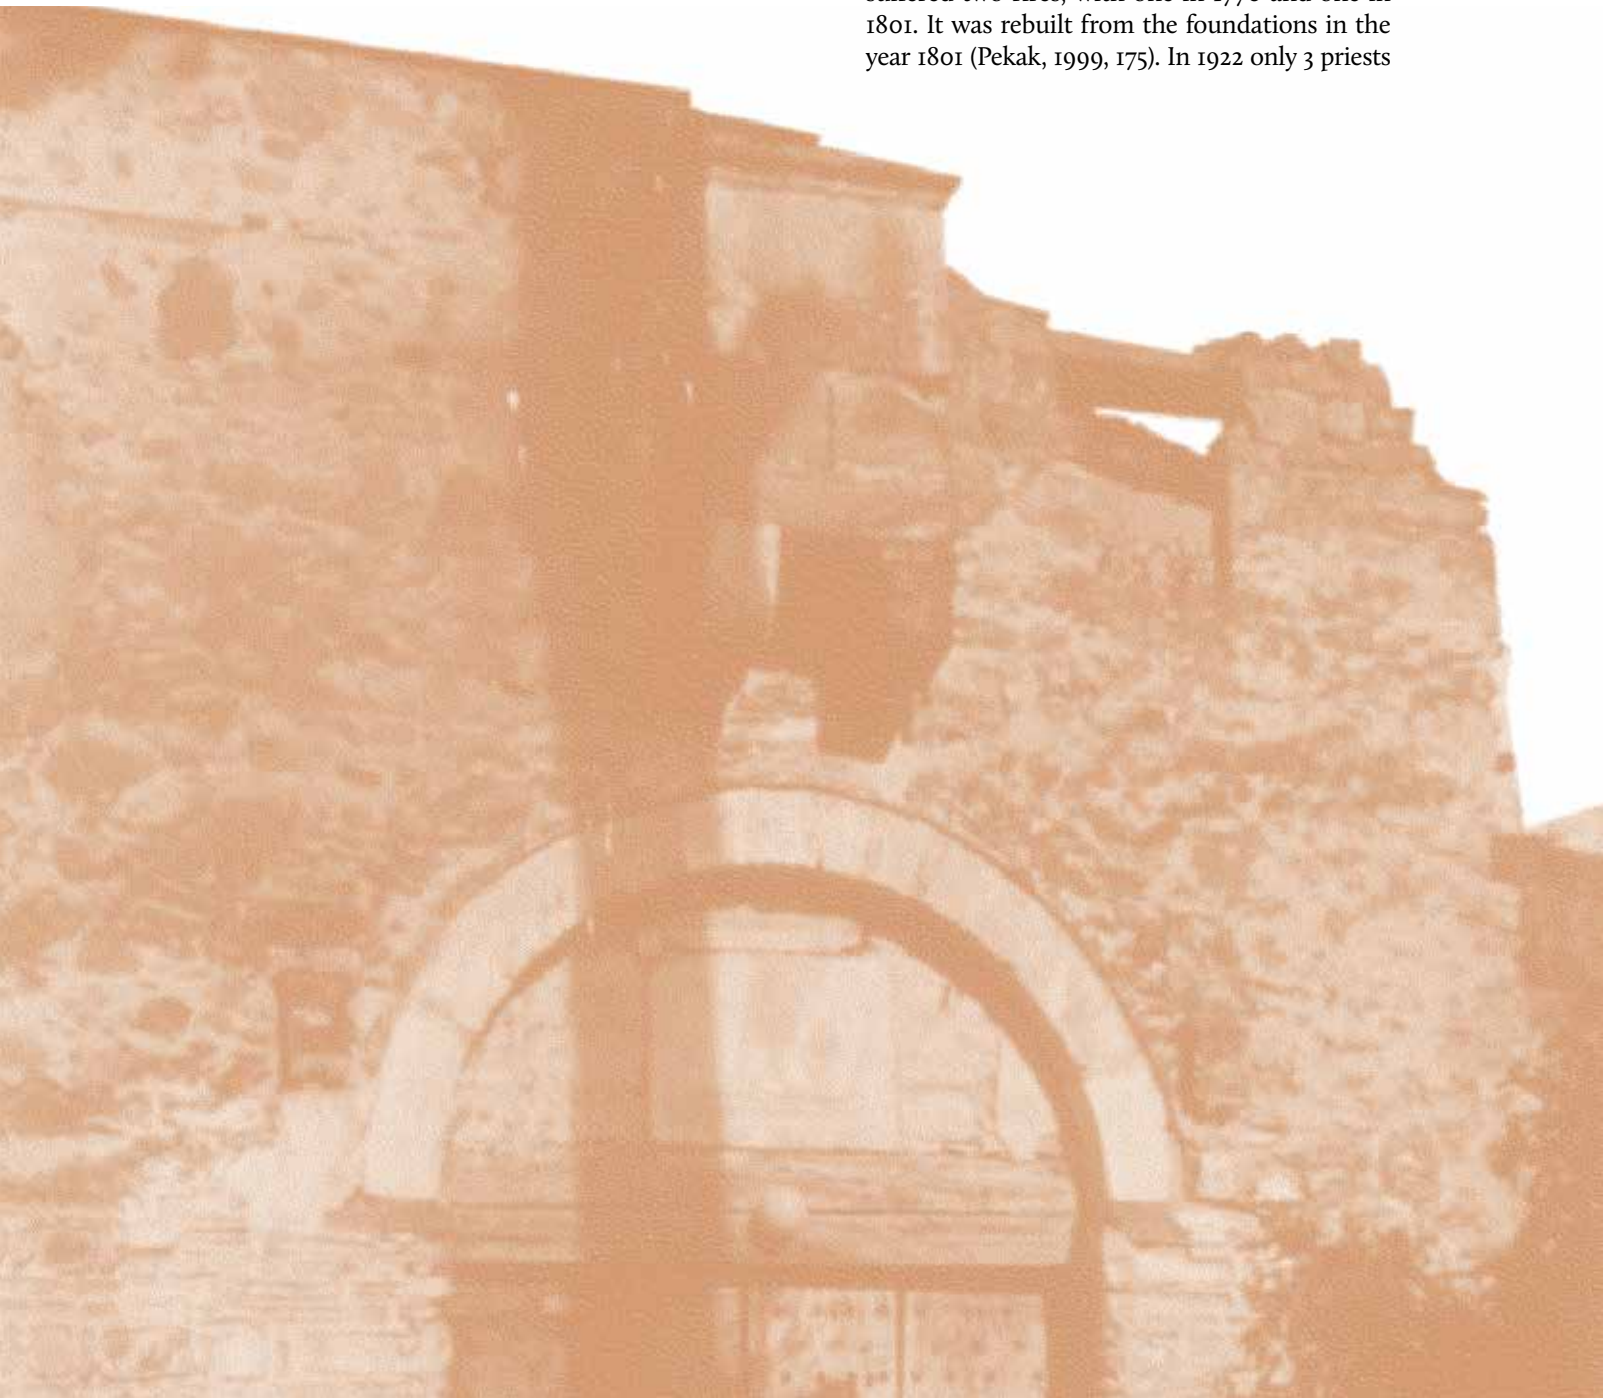
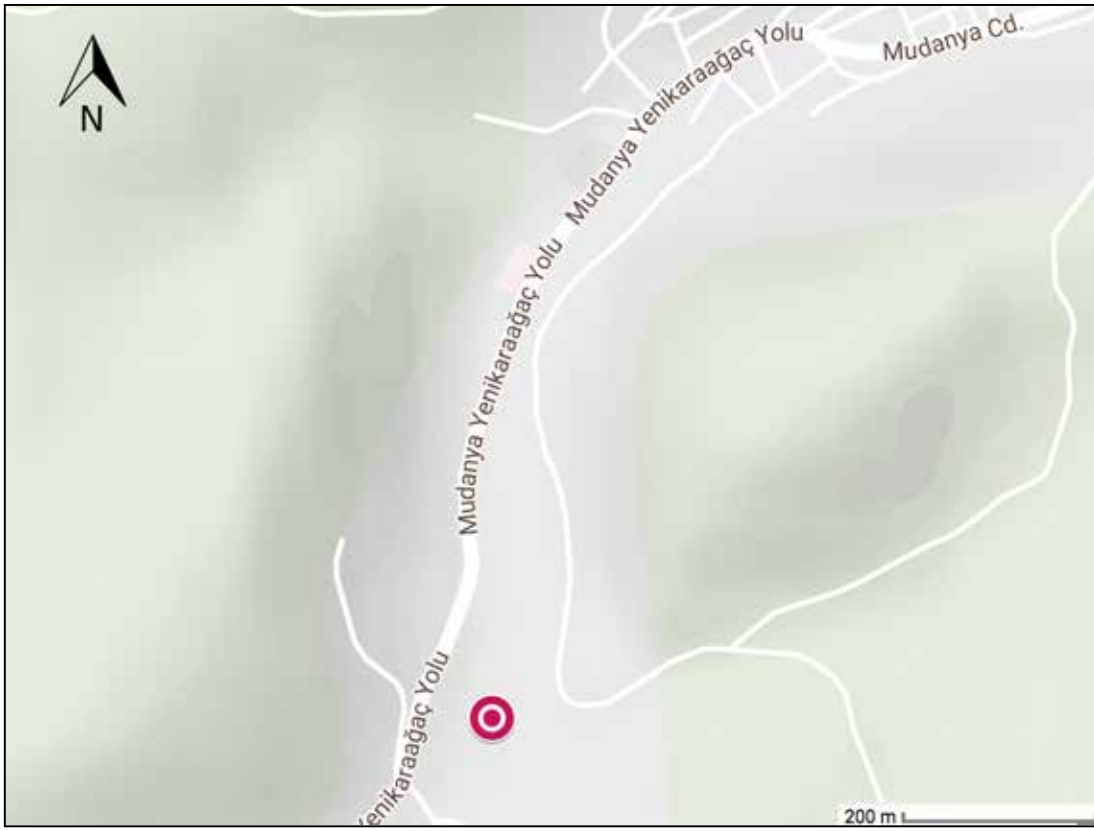
*Medikion Monastery
Mudanya county, Tirilye town*

The monastery itself has not survived to the present; instead the “Aşlar Farm” has been built in its place. Currently, only the wall on both sides of the wooden double door entrance in the west and two inscriptions from the pediment above the door’s arch remains. Photographs taken in 1973 show that the walls and door were not painted. Currently the wall is painted yellow while the door is green. Ivy is growing on the wall. The paint is flaking off, as it is not compatible with the original wall texture.

The wall has no capstone, so rainwater enters it causing damage. At the same time, there are pieces of historical columns lying in the farm garden. On one wall within the farm there is a Turkish-English information panel prepared by the municipality containing many spelling mistakes and missing information.

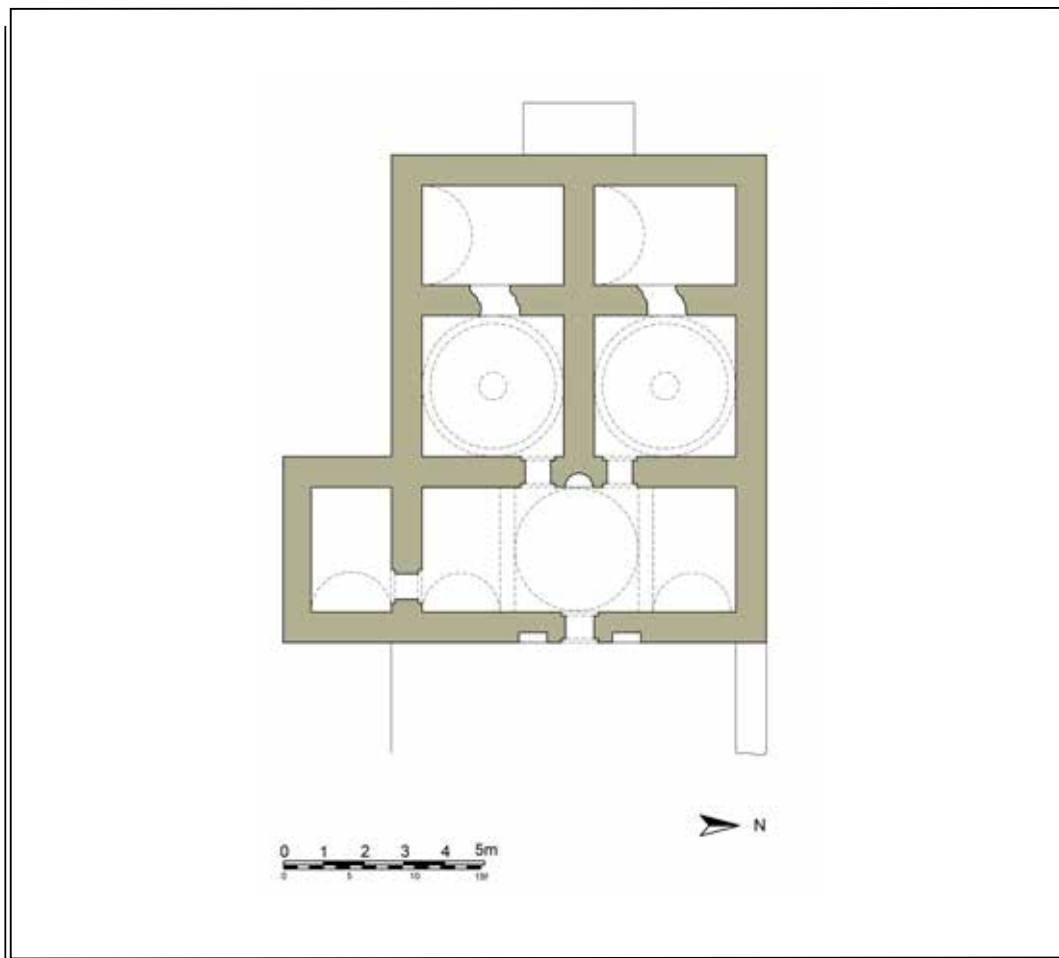
*The Public Bath
Gemlik county, Şahinyurdu village*

Currently, a large portion of the northern façade is buried under soil due to a rise in the road level. The remaining section east of the structure is filled with soil and the floor of the structure is not visible. The structure is in a seriously ruined and neglected state. There is no trace of the changing room and warm sections apart from their foundation walls. The area where these sections were probably located is buried under

soil. The roof of the hot section and secluded cells has partly collapsed. As a result, it is open to destruction by the forces of nature. There is severe disintegration and material loss in the walls and floor due to human depredation. Because of such vandalism, the clay pipes within the walls and the fittings originally underground are open and visible. There is material loss due to vandalism in the walls and floor of the water depot and furnace sections. The annex structure made of concrete blocks situated in the neighboring lot, adjoining onto the eastern façade of the hamam prevents the whole of the façade from being observed. The entire structure is unprotected, increasing the damage suffered due to animal and human activity.

The greatest danger at present is that the structure is completely vulnerable to human and natural depredation. If the surroundings of the building are excavated, traces of the sections predicted to be part of the original plan may be revealed. The structure is significant because it represents a unique example of a certain layout. It must be cleaned, preserved and an information panel put in place. Apart from the hamam, the village contains the remains of an Armenian church. Thus all measures taken must be considered as a whole. After restoration, the hamam could be repurposed and opened to the use of the village population or preserved as it is for tourism.

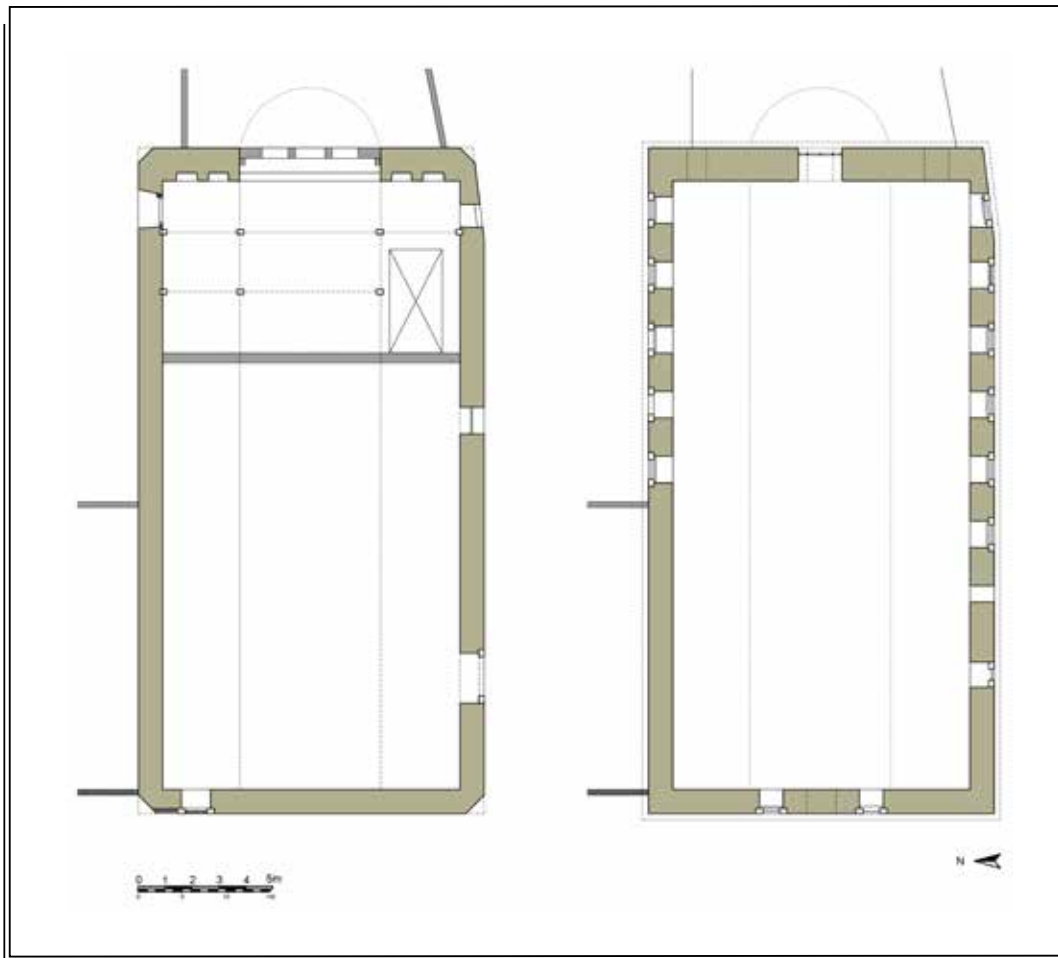
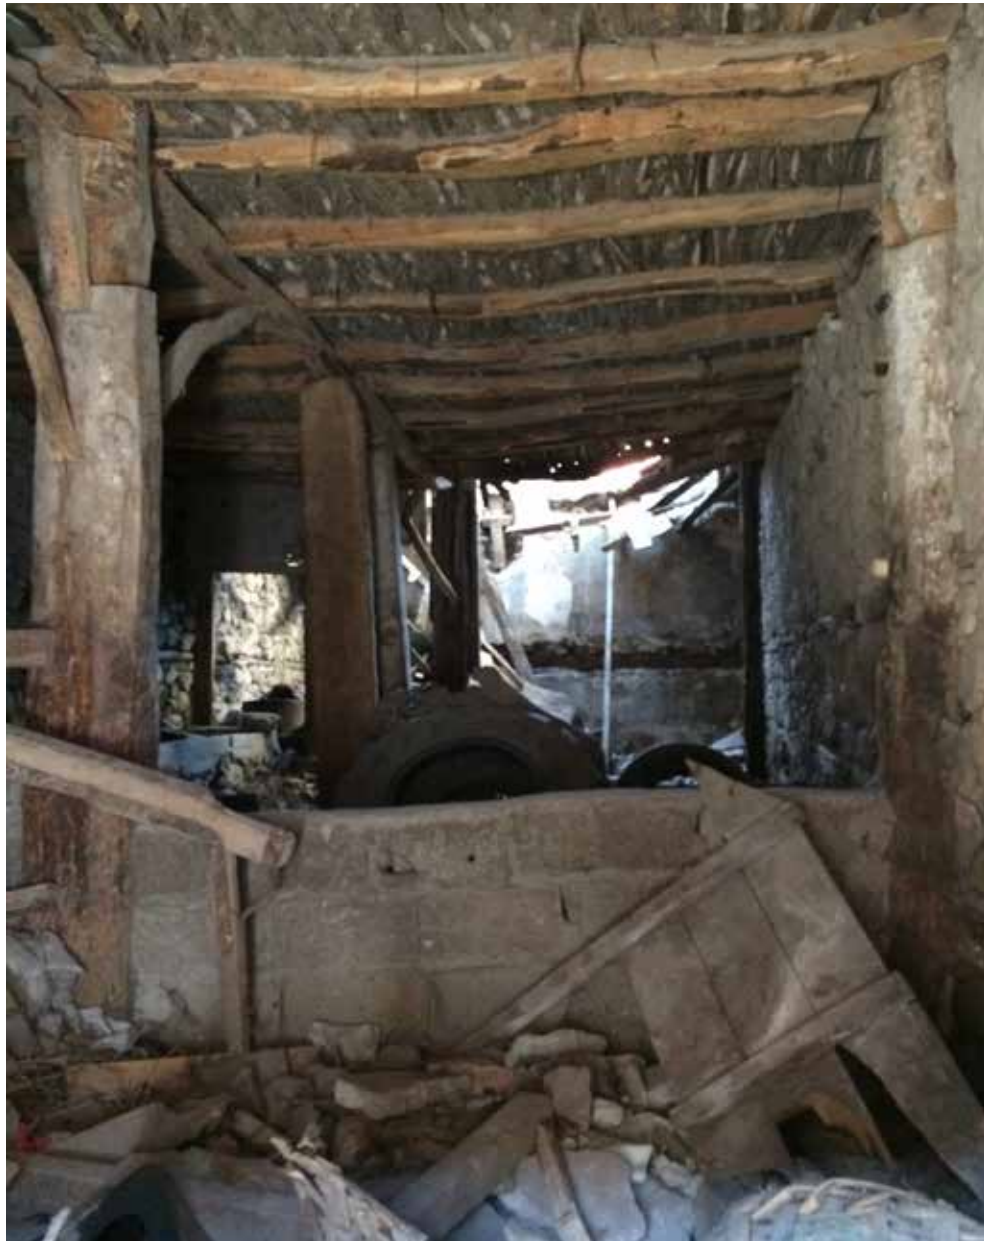
*Church of Taxiarchis
Gemlik county, Kurşunlu village*

currently abandoned. The wood is rotten in this part and there is moss growth due to water and dampness as well as other damage since it has partly lost its roof and the remaining roof construction has collapsed inward.

The roof is partly lost, leaving the building open to all types of damage. The structural precautions taken for the later openings in the main walls are insufficient, and there is damage in these parts. Due to structural weakness, these openings must be temporarily suspended and the necessary measures taken. Due to the inconsistent use of a large portion of the structure and its having been neglected, the building is not maintained. The structure must be bought from owner, who is not fulfilling his responsibilities towards this historic building, and expropriated for public use. After expropriation, temporary precautions must be taken for the roof, while documentation studies are completed and the structure repaired.
