Kayseri
Adana
Izmir
Elazığ
Niğde
Bursa

Assessment Report of Architectural Cultural Heritage

April 2018

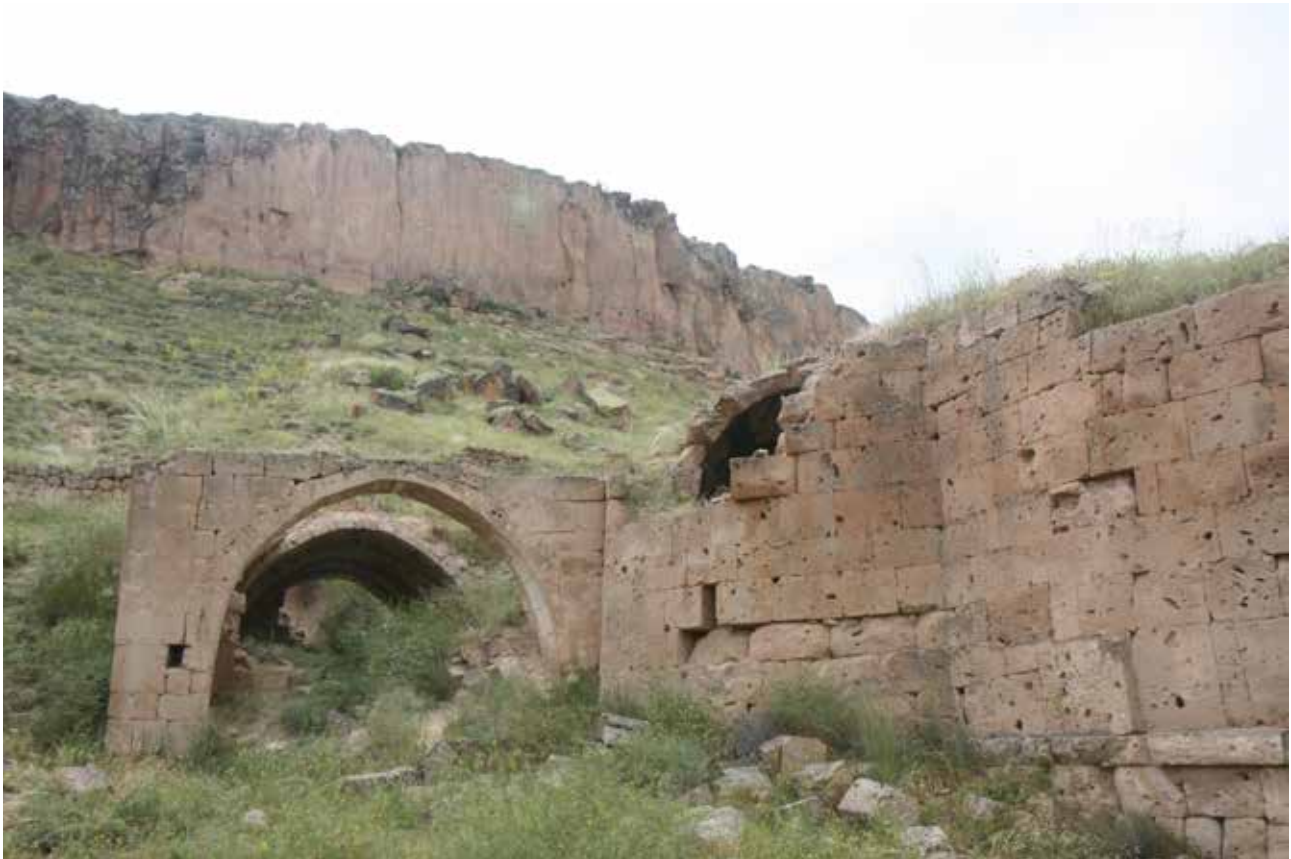
The major problems in the main body of the church are the fact that the dome, part of the apse of the southern wing, and a part of the western exterior walls are missing. These damages have resulted in the accumulation of debris and backfilling in the interior, which has, in turn, concealed the original floor. Furthermore, the support of the structure has been disrupted to such an extent that parts of the building are in danger of imminent collapse. This unfortunate condition is further aggravated by the humidity

caused by rain and snow and the vegetation that has developed in the interior. Building materials have also suffered from significant damage; some stones have disintegrated and others are covered with moss.

The roofing is completely destroyed and the surface is covered with vegetation. The vestibule is also damaged at various points of the masonry. Its walls have been weakened after the collapse of some of its parts, and it is covered with vegetation.

The protection, preservation, and restoration of the building are prerequisites for any future use of the space. Some parts of the structural system may easily be restored. The reconstruction of the missing dome, however, presents serious difficulties due to the lack of information and evidence on its original form. Still, it may be possible to replace the original dome with a light steel construction with stained glass, which would offer shelter and protection for the interior of the building and the painted decorations, while allowing for appropriate ventilation.

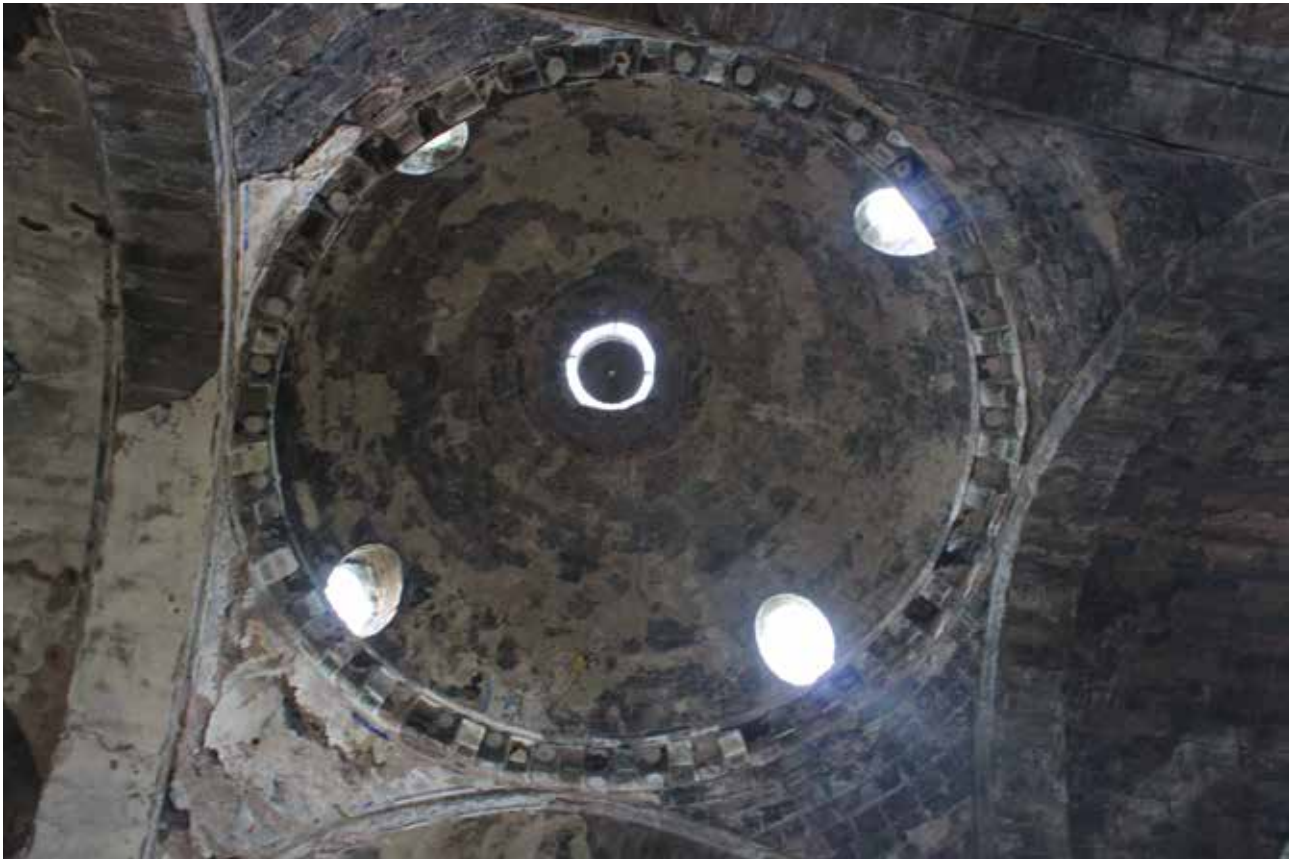
The most serious problems of the nave are located in its western part, which is connected with the gynaecoonitis. The stairs that lead to the upper floor have been almost completely destroyed while the decorative balconies have been drawn into the same fate by the collapse of the gynaecoonitis. The church floor has also suffered significant damage. Its marble tiles have been removed or destroyed during the illegal excavations. At the same time, its structural elements show significant damage due to high humidity and, more importantly, the humidity that descends from the ceiling. As a result, only

few of the plastered or painted surfaces have survived. Even the metal spreaders that remain in situ have been gravely affected by rust.

The roof has also suffered significantly: Its slate tiles have been damaged or removed, and vegetation has covered most of its surface. Similar signs of damage are evident on some of the masonry of the exterior wall, where small trees have grown within the structure.

The protection, preservation, and restoration of the building constitute major prerequisites for any future usage of the space. The arrangement of the façades and the plan according to a grid would allow an accurate reconstruction of the missing sections, making use of the original building materials that are scattered in the courtyard. Furthermore, old photographs may be of use in reconstructing elements that are now lost, such as the window glasses, the doors, and decorative elements of the interior.

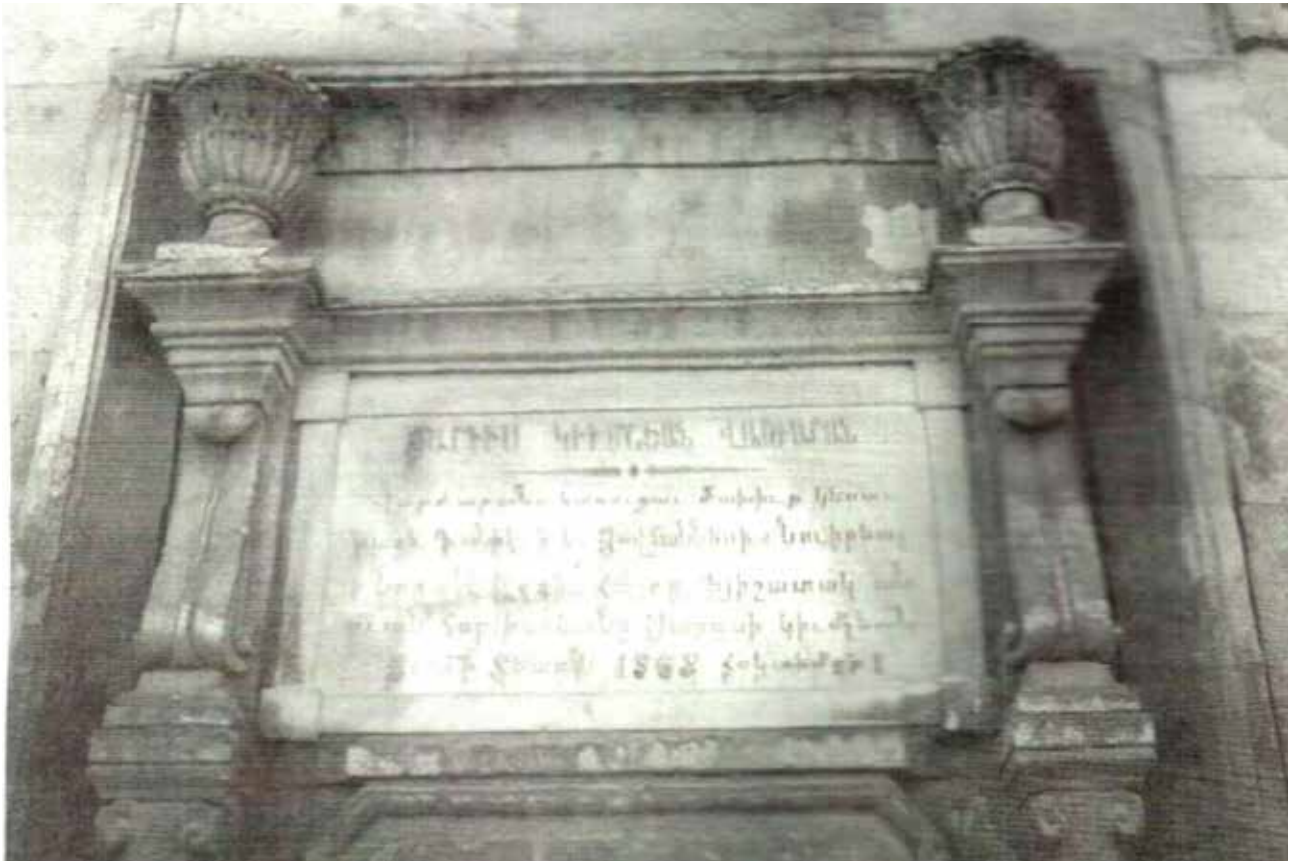
*The inscription of Sarkis Gümüşyan School
(Uğurluyan, 2014, 78)*

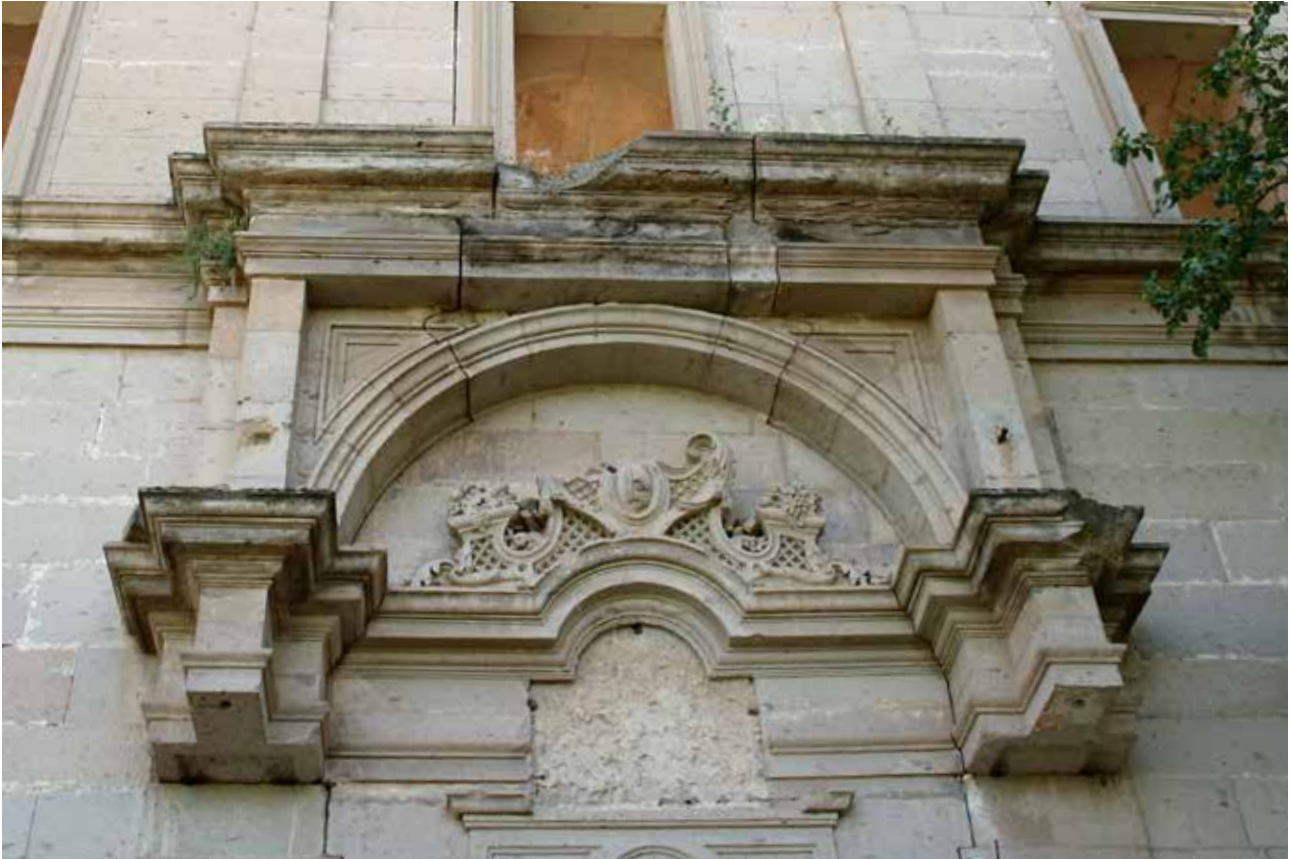
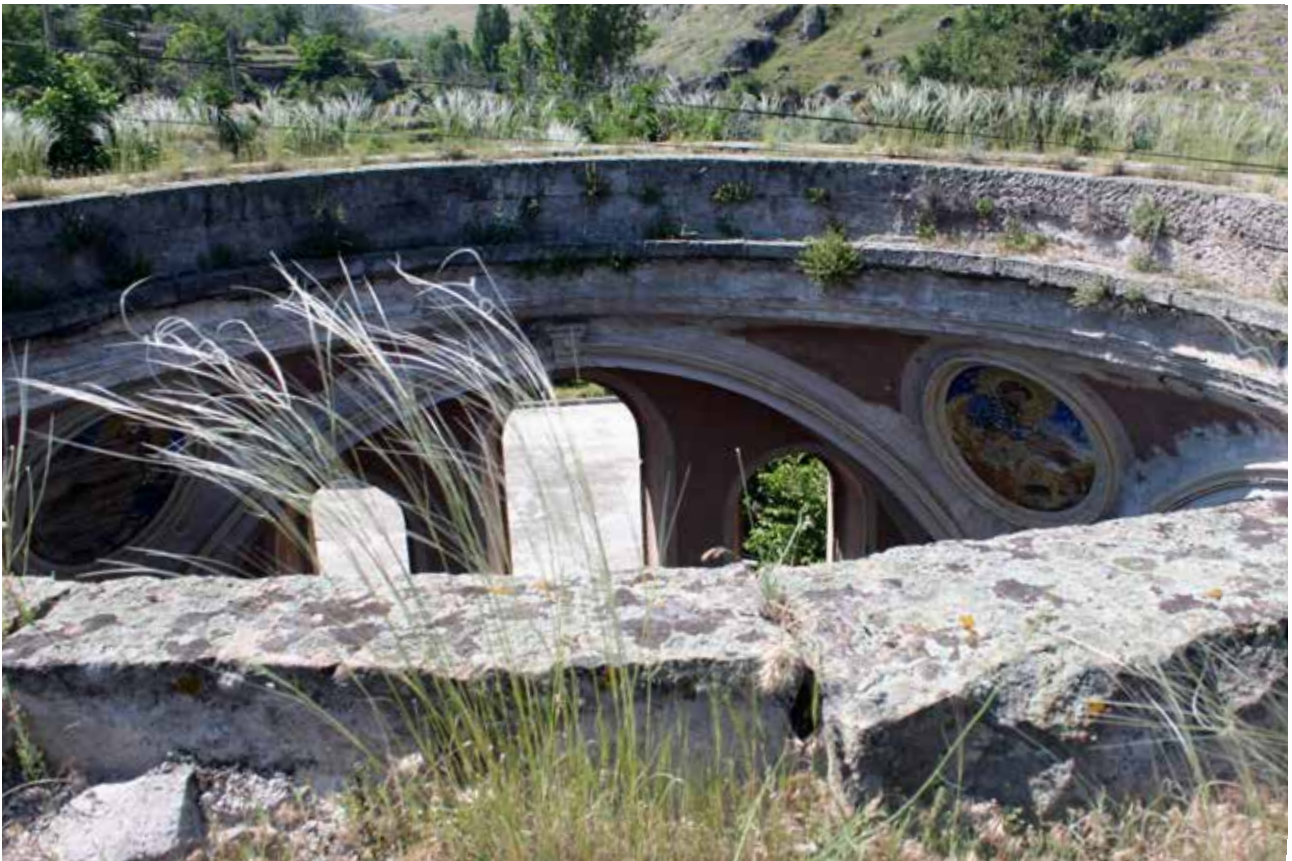
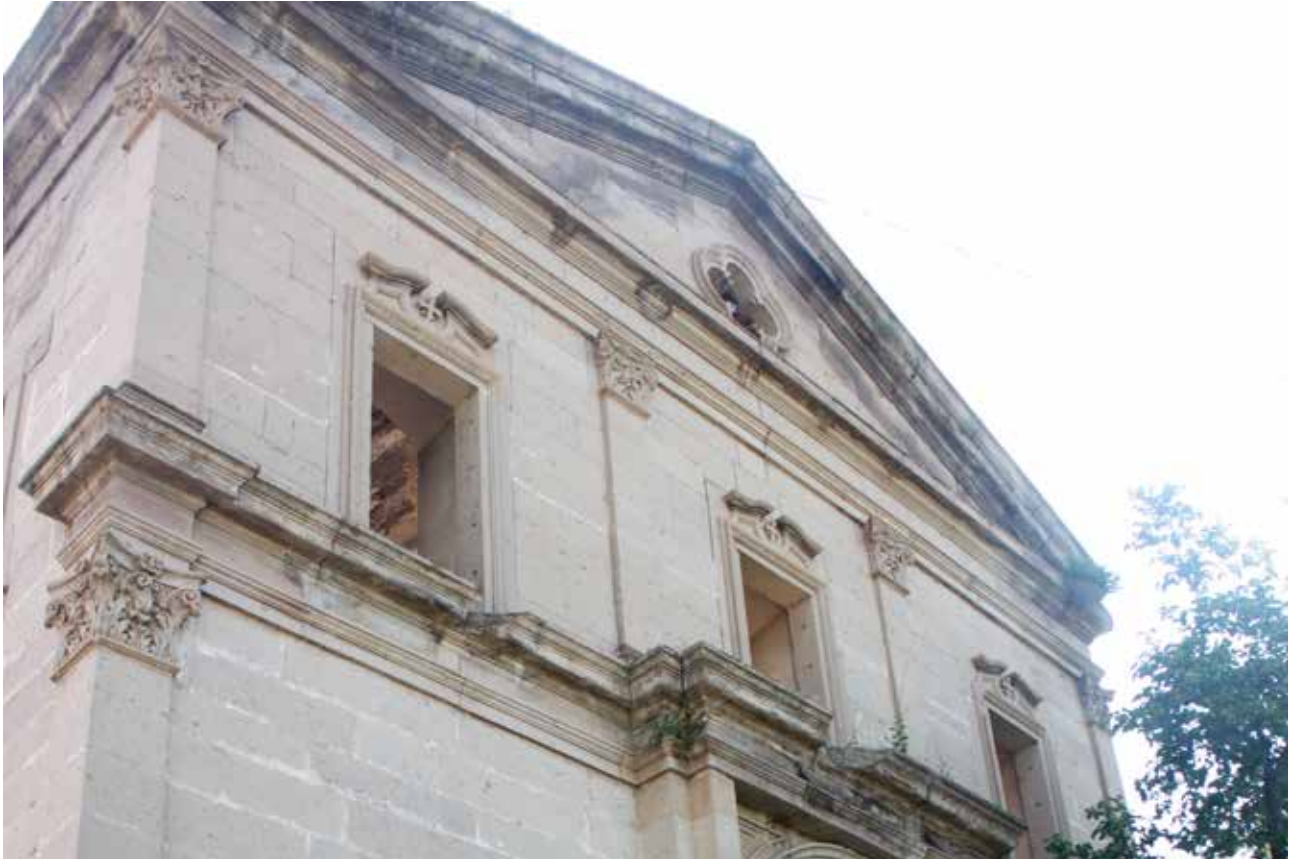
When it was used as a dwelling, several additions and alterations were made on the building, which are especially visible in the narthex. A wall is erected between the naos and the narthex, covered by wooden beamed slabs. All windows and doors inside the church are filled. Further alterations include the closing off of a window on the northern wall of the naos and its modification into a lavatory. The windows

and doorway on the west are made smaller, and a new window is built above the new door to let light in to the corridor. The remaining traces indicate further alterations. The galleries and the bell tower are destroyed. Armenians who returned to the village in 1919 reported that the dome and the altar were no longer there (Güngör Açıköz, 2007, 65).

The interior and exterior parts of the sanctuary have been severely damaged by the activities of treasure hunters. Furthermore, the collapse of the dome left the building exposed to external damage. Both weather conditions and vandalism have resulted in erosion and damage in the ornamental details, cornices, portraits on the pendentives, external façades, moldings, and surfaces. There is vegetation on the roof triggered by the fractures on the cladding. The fractures on the lower parts of the sets of three windows on the northern and southern façades and the pediment on the western façade with its fractures extending towards the gallery stand out as serious structural damages.

Immediate measures are necessary as the church is already structurally damaged and exposed to weather conditions due to its demolished dome. All additions to the structure must be cleared out. The church, whose artistic value can compete with the Armenian churches in Istanbul, must undergo restoration in accordance with the original design of the building. The permission for organizing rituals on the name day of Saint Stephan, to whom this church was dedicated, is another objective to be taken into consideration in attempts to provide the church with a current cultural function.

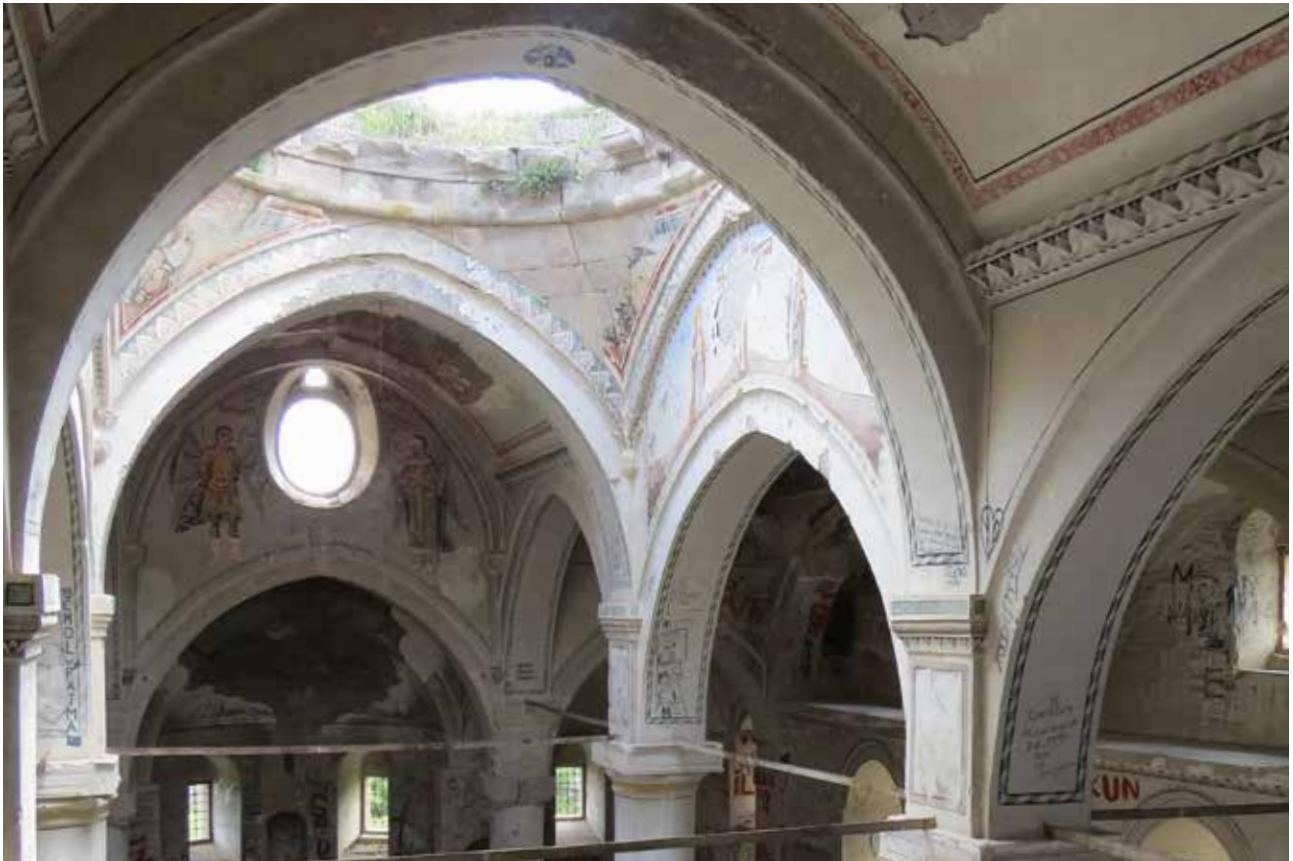
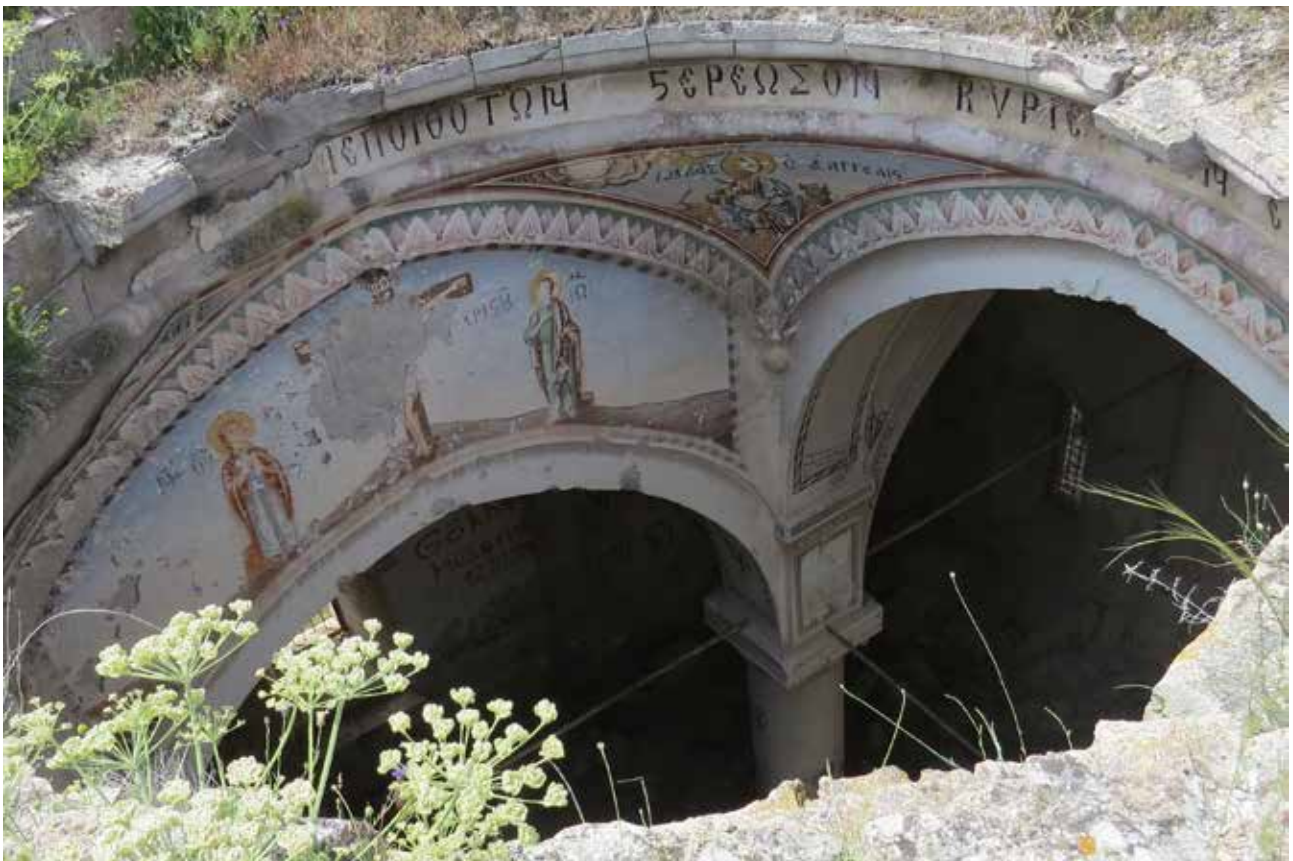
Wall-painted ornaments on the wall are damaged by vandalism and weather conditions, with some of them covered in white paint. Excavations of treasure hunters have almost completely destroyed the floor on the apse,

The church is exposed to adverse conditions of weather because of both the absence of dome windows and human neglect. The eaves of the east side have collapsed, which exposed the area to water and caused efflorescence. Roofing is partly damaged with vegetation growth, causing structural dangers and distortions on the underlying vaults and the semi-dome of the apse. Upper walls have started to split a part.

Mortar loss is found on all joints exposed to water. Vandalism and humidity have led to peeling of plaster across the structure on walls and vaults. Some of the iron features of windows and all the wood features are completely disassembled. Soot stains inside the church and damages to inscription and material on the exterior walls are indicators of vandalism.

The structure needs urgent protection against human damage with a restoration project to be supervised and implemented by experts. The structure and the surrounding area can be rearranged with landscape design and a museum-church function, with emphasis laid on its significance in culture tourism.

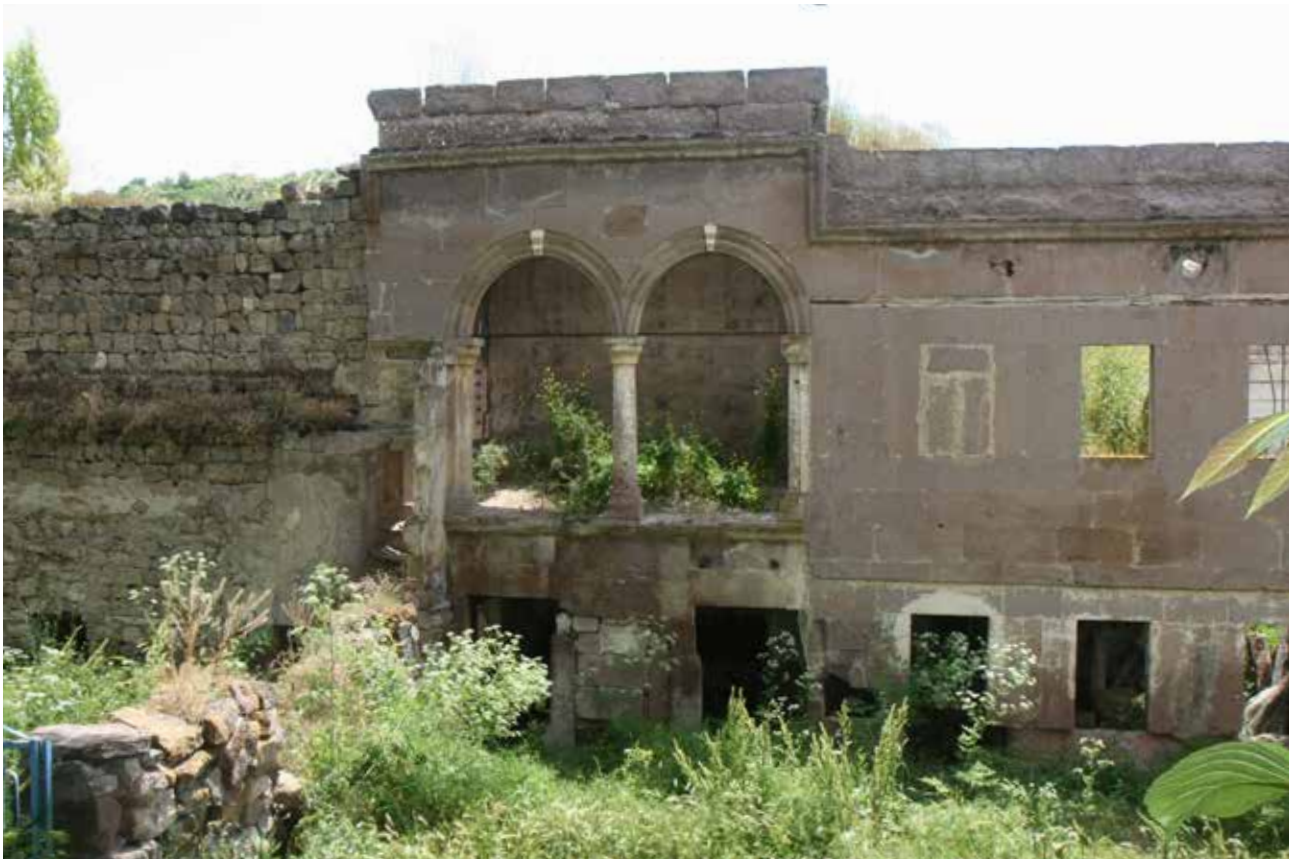
The most critical problems faced by the building arise from the collapse of the roof and the floors. Its structural system has been largely disrupted; it has obvious static issues that are further aggravated by the wearing out of its materials. Its masonry walls are no longer laterally held together by a roof and floors, and because of their thinness they have suffered cracks and tilting. The wooden lintels and beams in between the stones have suffered greatly, and the metal spreaders have accumulated rust. Damage and distortion due to human factors and the swift changes in humidity along with the vegetation that has taken over several parts of the building are also evident on the ashlar masonry, which constitutes the main building material of the school.

As a result, unless immediate action is taken against natural risk factors and human activities, there will soon be further damages that may lead to the complete destruction of the building. For its protection from weather conditions, it is necessary to construct a temporary roof, while protecting the building from seismic activity calls for temporary counter supports before a full restoration of the building is undertaken.

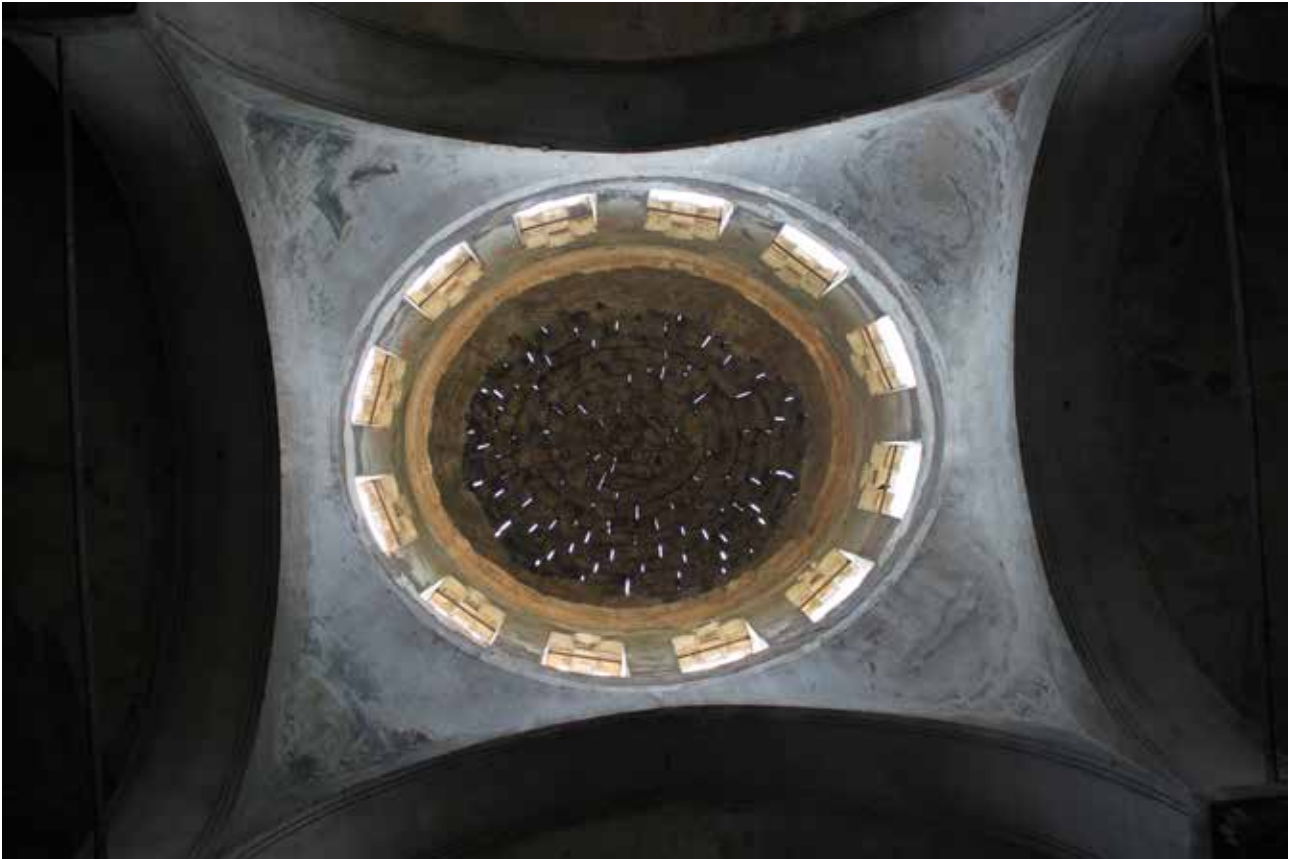
*Church of Virgin Mary
Melikgazi county, Germir neighborhood*

No traces of earlier structures or later interventions have been discovered, while evidence suggests that the noticeable covering of the frescos was undertaken by the inhabitants themselves, shortly before their departure from the village during the 1923 population exchange. Although the structure presents no distortions or alterations of the original plan, its current condition is not particularly good, since part of the gynaecoonitis has collapsed and the structural elements and materials of the nave have suffered extensive damage. The ground floor of the narthex is in a somewhat better condition but also presents significant damages, such as tilting of load bearing elements, cracks, dislodgement of the vaults from the ceiling, and removal of all its spreaders.

In the area of the nave, a large number of windows have been filled with rubble and the marble floor-tiles have been removed, while the few surviving metal spreaders have suffered from oxidation. All structural elements have received significant damage from high humidity, which has damaged the plaster and the wall paintings. Stone roof tiles have been damaged or removed and vegetation growth is apparent on the surface. The dome is still standing (a rare instance among the churches in the area) but has suffered heavy damages: the binding mortar has eroded which pits the dome under the risk of imminent collapse.

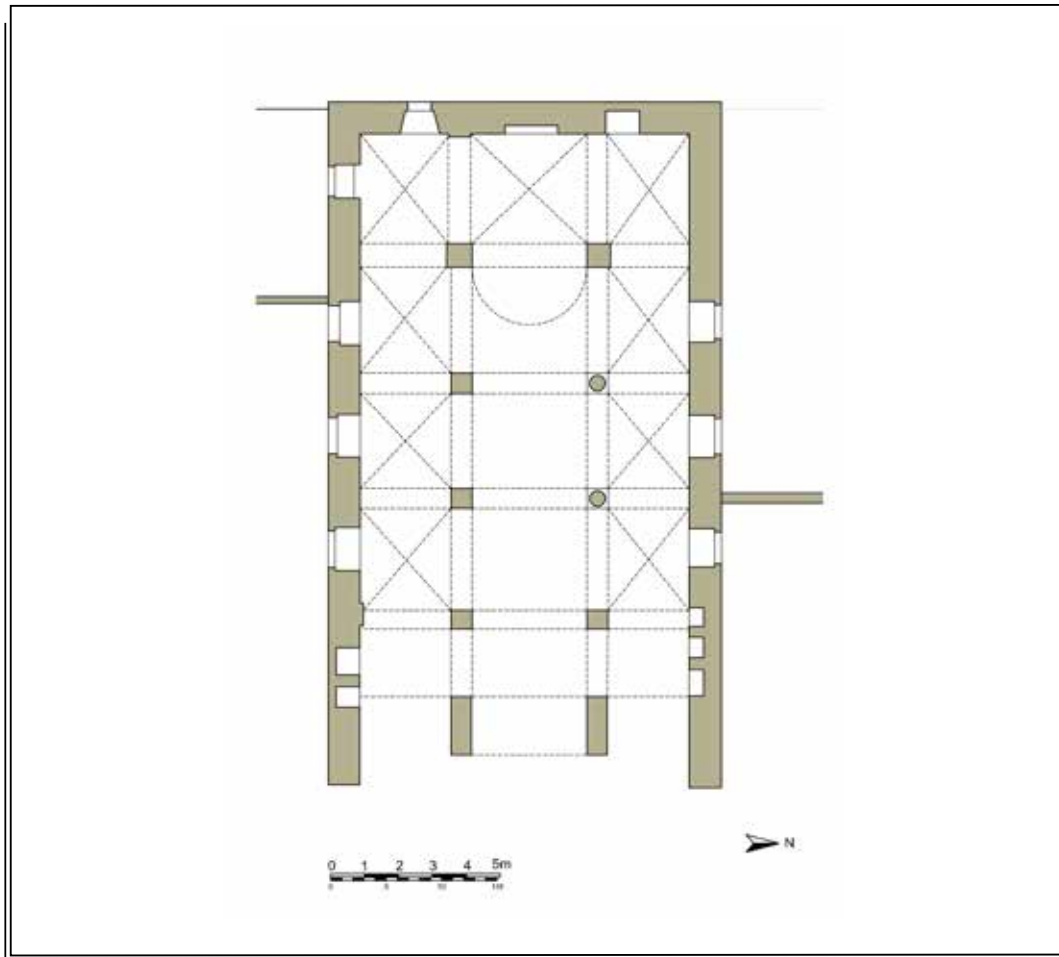
it was used as a factory, which also changed the structure's relationship with its environment. Today, there are additional spaces on the south end of the structure. The entrance is through the courtyard built with the additional walls. The east wall of the building is destroyed to open a new entrance. The original entrance to the structure (through the west wall) is closed, with the apse (on the east wall) destroyed to make way for the new entrance. The gallery story is removed. Stone blocks are later additions supporting the columns and a concrete area into the interior. It is possible that these additions accommodated a crane and a horizontal transportation system for the factory. The floor is covered with cement. A reinforced-concrete water tank was placed on the roof during this period. Vaults and arches are whitewashed. Religious frescoes appear on the vaults, but only few of them have survived as the plaster has fallen off.

Additional structures, new walls, and added masses have brought along structural issues as well. Drainage problems in the roof lead the plaster to fall off, and thus has damaged the frescoes. Joints and the roof have vegetation growth. Iron spreaders are rusting while the concrete mass on the roof weighs down on the structure.

Given its structural conditions and exposure to human and natural damage, the structure is currently under risk. Urgent intervention is required especially to prevent the collapse of the apse and the vaults. As the structure is inside

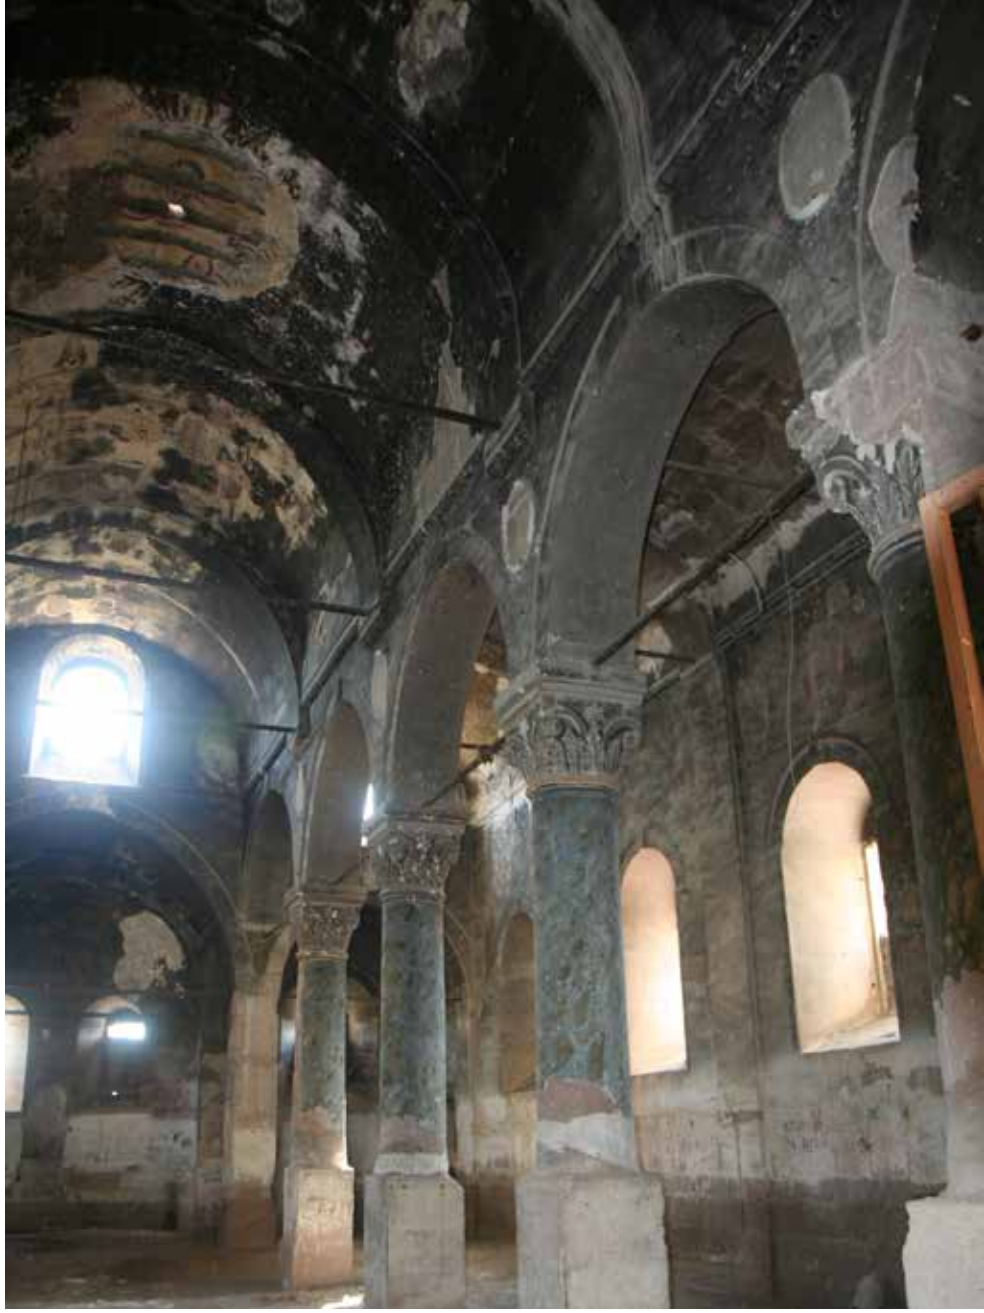
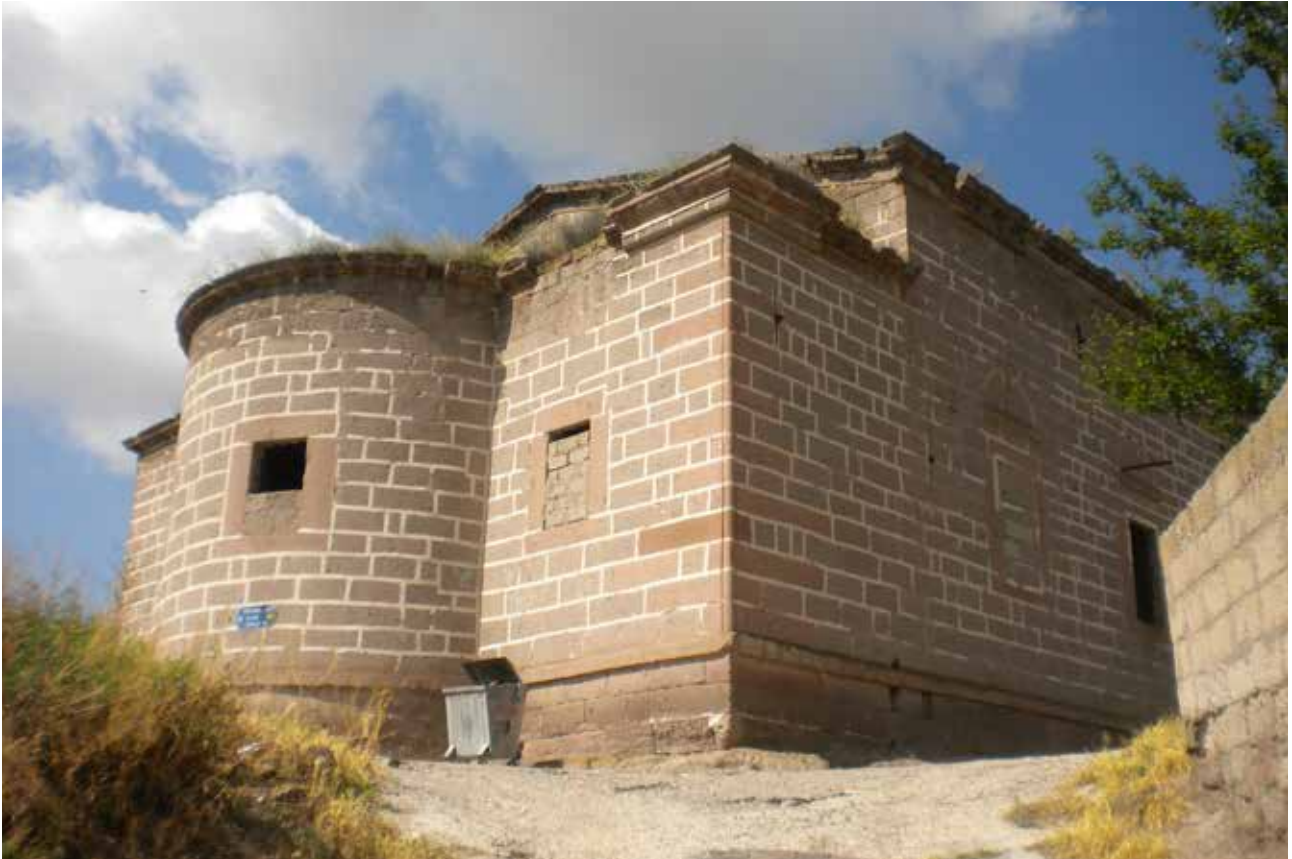
*Church of Saint Demetrios
Incesu county, Yeni Cami neighborhood*

The destroyed and exposed arches of the narthex and the gallery are walled with rubble and uneven stones and the resulting spaces are provided with new entrances. Some windows are also filled in. Most of the stone cladding of the roof has fallen off, with the molding broken in some places. The roofing is covered with vegetation. The floor of the interior is unrecognizable due to treasure hunters' excavations. Window grills are dismantled. There are visible cracks on the

apse and the columns. The frescoes and the floor are damaged. No trace of the bell tower survives.

The plan and the spatial features of the building are entirely recognizable. Research has been conducted, but no excavation or a far-reaching iconographic study has been done so far. The biggest threat to the structure today is its exposure to human damage. Deteriorated, neglected, and vulnerable to earthquake, it requires immediate structural intervention. Excavations in the vicinity could provide the

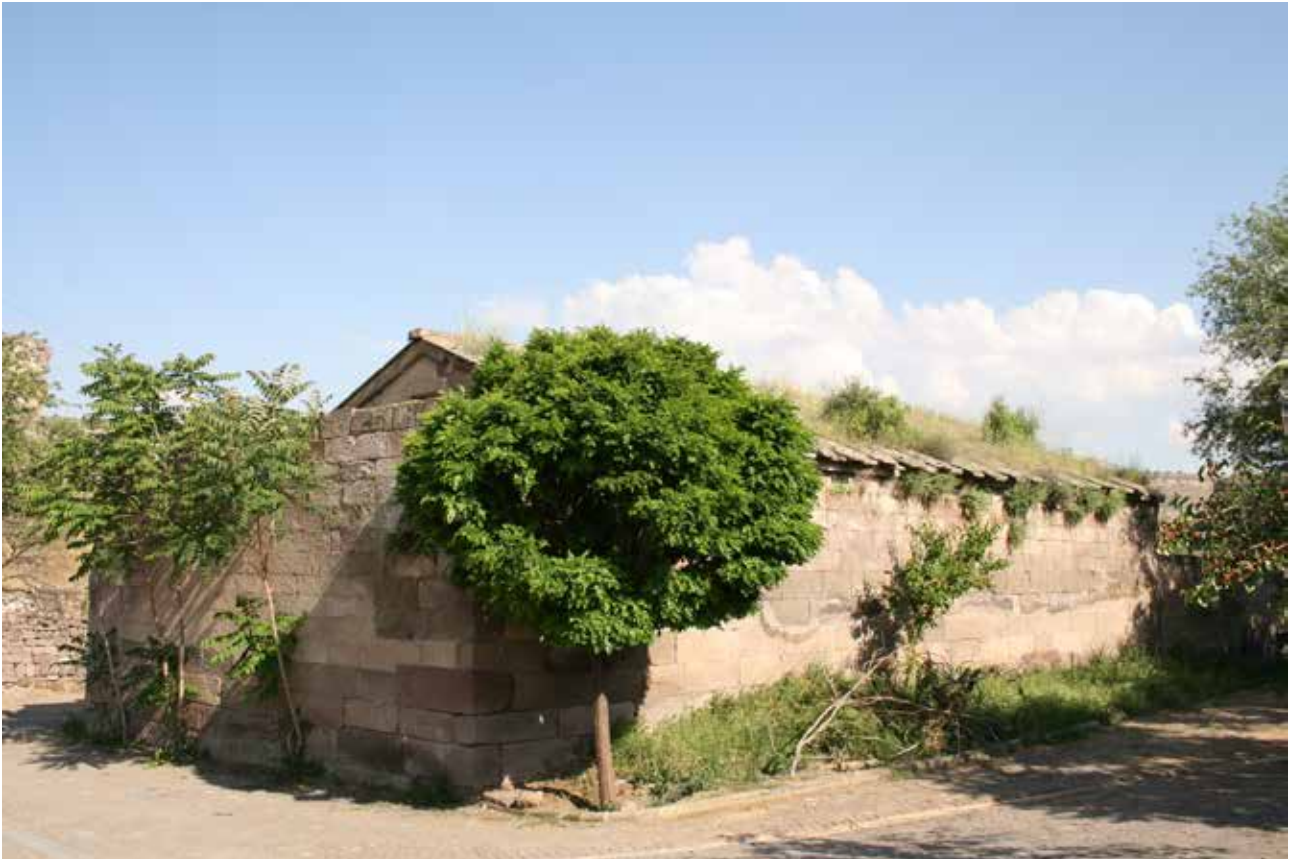
The façades and stones on upper and lower parts of the wall have corrosion on their surface and are broken off in various places. It is possible that the entry to the courtyard from the east wall, accessible with a staircase which is destroyed now, as well as the doors and windows on the courtyard wall were closed when the structure lost its function as a church. The door to the courtyard from what is assumed to be a chapel on the south of diaconicon is filled in. The gallery is completely gone. Only few traces remain of the bell tower rising from the hip roof in the axis of the main entrance. The decorated stones on both sides of the entrance are removed, and the inscription is scraped off. The iron elements of the apse window are broken and taken away, interior decorations and murals are damaged. Apparently the entire floor of the naos is dismantled and stolen by

The church is mostly damaged due to neglect. The plaster on the walls below the molding has in large part fallen off. The upper parts of the vaults are damaged by plaster flaking off and efflorescence, suggesting a leakage from the roofing. Humidity caused by the climate and the water leaking from the roof and the vault destroys the exterior walls. The molding running the main walls on the interior is broken in places. There is vegetation in some places below the cornices of the east and west walls while upper level stones have fallen off from the courtyard walls. The iron spreaders of the windows are rusting. The courtyard wall which is thought to

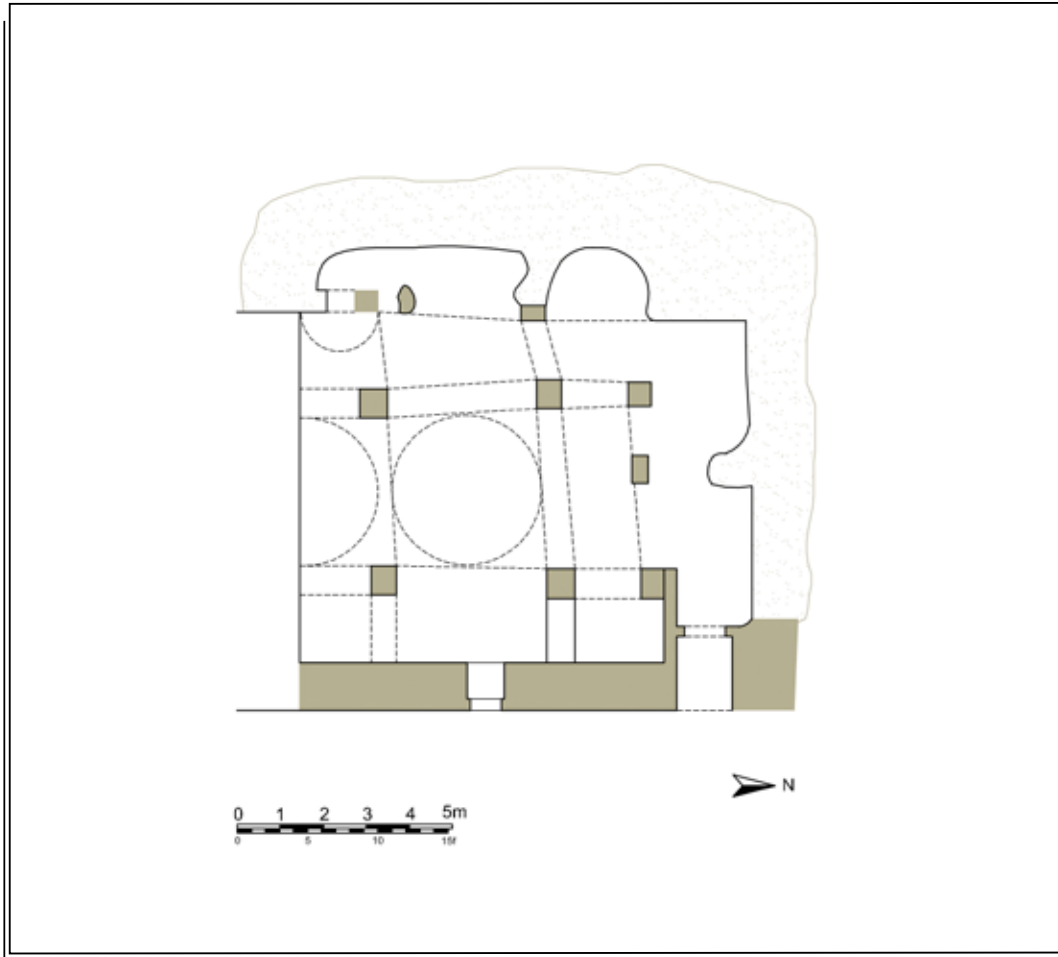
The structure is currently in ruins, and its original entrance, which is closed, lies underneath the road level. Ashlar facing on the exterior of the north and east parts of the drum has fallen off, and the rubble infill has scattered around. The structure is used as a stable and warehouse, and the unlocked door add to the threat, to which the structure is exposed due to this recent use.

The plan of the structure is largely in place, but has suffered from anthropogenic damage. Although the spatial layout and volumetric connections are not clearly recognizable, the plan is clear.

The structure has also suffered from humidity in the interior, efflorescence, stratification, and biological damage. The plaster has fallen off. Only a very small number of colors and patterns of the remaining frescoes are discernible. The roof has moss growth. Stones have fallen off from the drum.

The biggest current threat to the structure is exposure to human damage. Neglected and vulnerable to earthquake, it requires immediate structural intervention. More information needs to be acquired on the original ground levels by way of excavations in its vicinity. The structure also needs cleaning, preservation, and a sign.

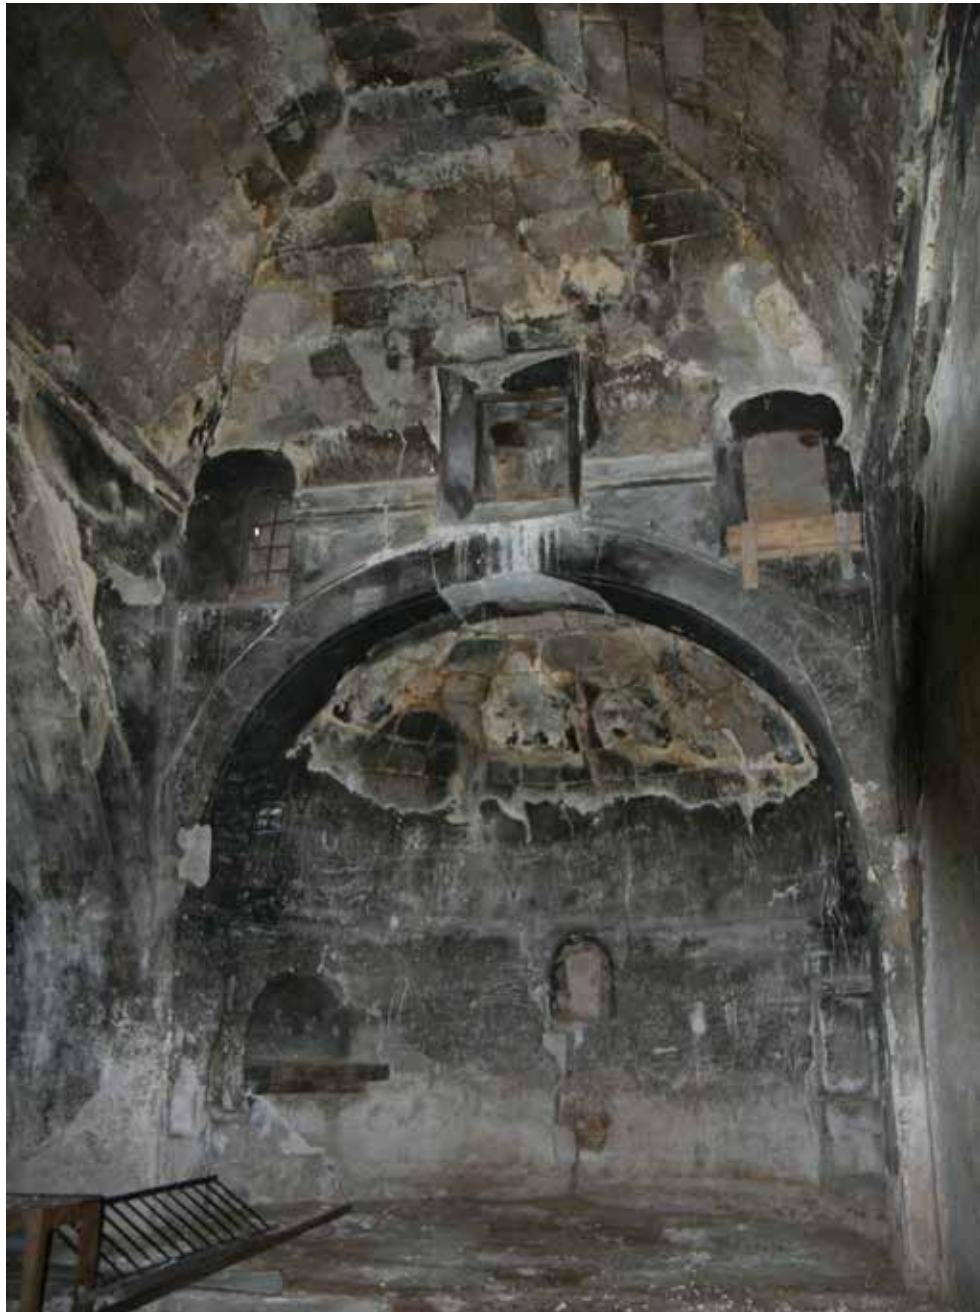
*Church of Saint George
Melikgazi county, Gesi Kayabağ neighborhood*

The original form of the structure is severely damaged. The only surviving traces are from the walls and the joints of the gallery. There is a wall in the arch span separating the side and middle naves to the south of the naos, with the side nave serving as a separate room. Ekin reports that the wall was built in 1940s to host weddings (Ekin, 2005, 90). The windows on the east and south sides of the church are filled in. A reinforced concrete flower pot is found on the outer side of the south wall.

Dense vegetation growth weakens the roofing, with humidity damaging the vaults. Upper side of the walls also have efflorescence. Plasters flake off the walls and vaults, which are further damaged with soot due to fires lit inside. Some parts of the beveled cornice are broken while ashlar on the exteriors are missing in some places.

The main damage to the structure are the cracks presumed to have emerged during the earthquake in 1835, which completely destroyed some of the churches in the region. These cracks are further deepened with ground subsidence resulting from the sloping site on which the church is built. There are severe cracks on west and east sides, below and above the north wall, and the northwest and southeast corners of the middle nave vault. There are traces of efforts to fill in some of the cracks with concrete.

Although the main walls and roofing of the structure survive, the deep cracks on the walls and the roofing have extended over time. The cracks and missing stones of the structure call for an urgent consolidation. This small, typical village church with a clear plan and predictable spatial characteristics will be further damaged if left to neglect. There is no sign. The gate, which protects the interior against vandalism, is kept locked, but this measure is not enough.
