Kayseri
Adana
Izmir
Elazığ
Niğde
Bursa

Assessment Report of Architectural Cultural Heritage

April 2018

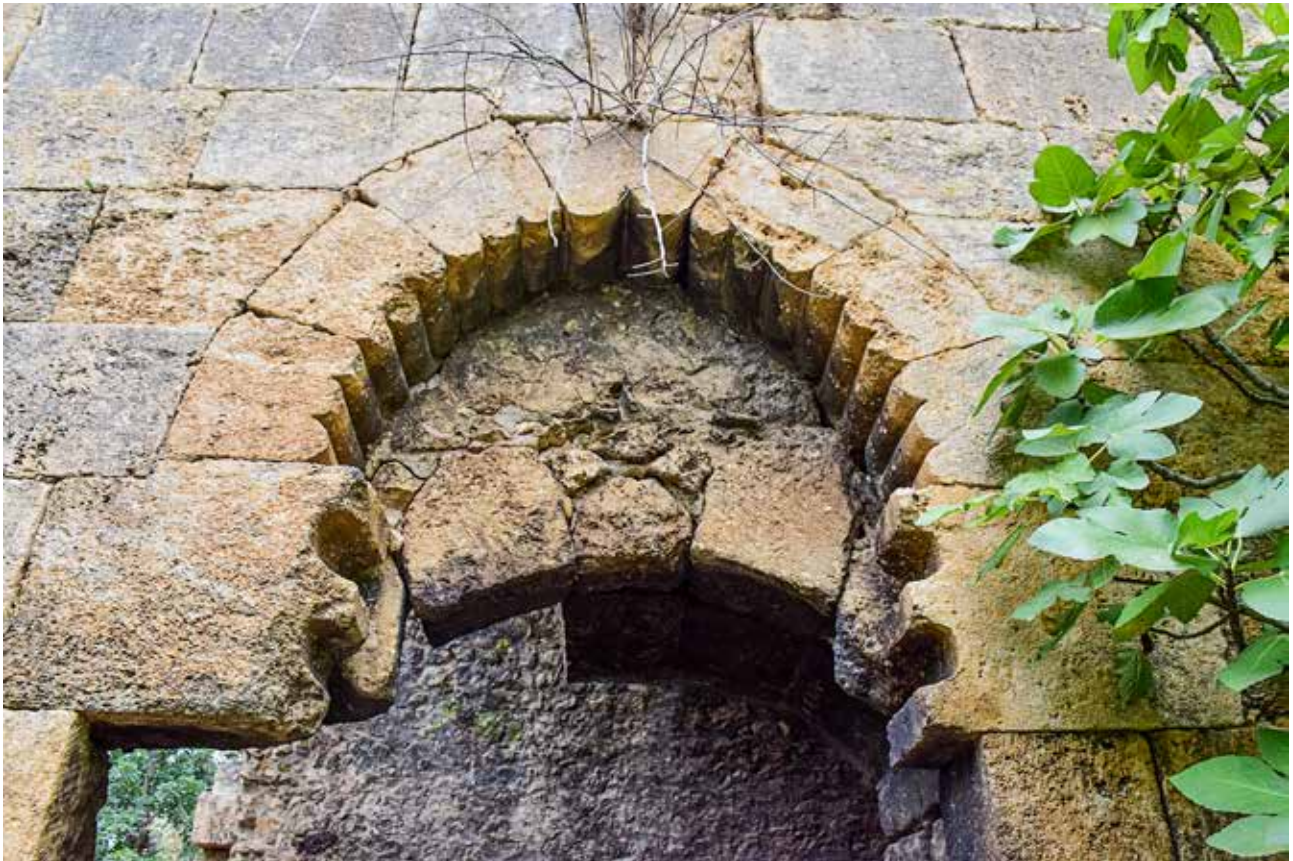
zigzag profile on the side where both the arch and the door jamb face the door opening; this is the most decorative portion of the church that remains. Edwards (1983, 141) proposed that there was a lintel between the doorjambes in the original. There may have been a woven section with traces remaining today behind this lintel (tympantum); however, the surface is damaged. The traces of stone around both doors indicate they surrounded a double wooden door. Traces of plaster and paint are encountered on the interior walls and vaults of the church.

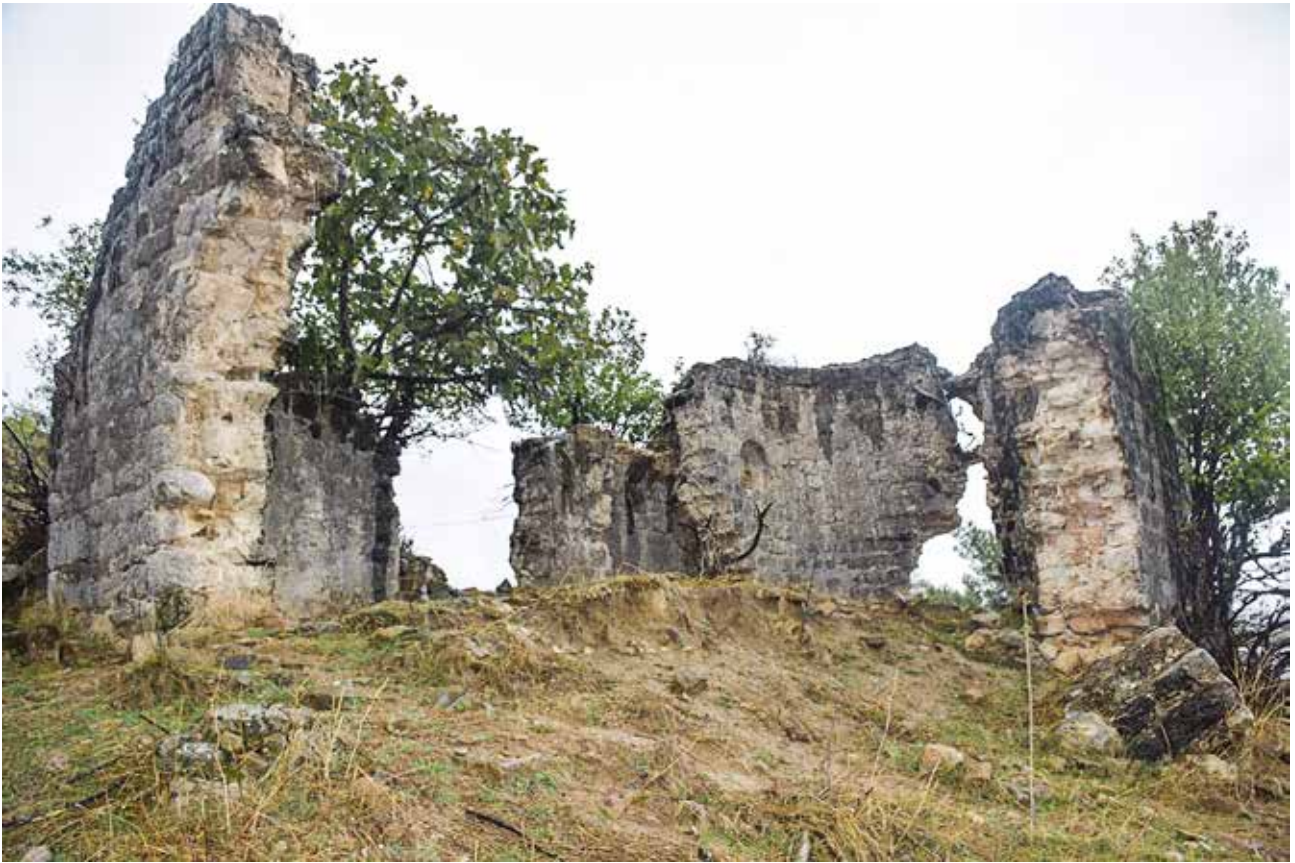
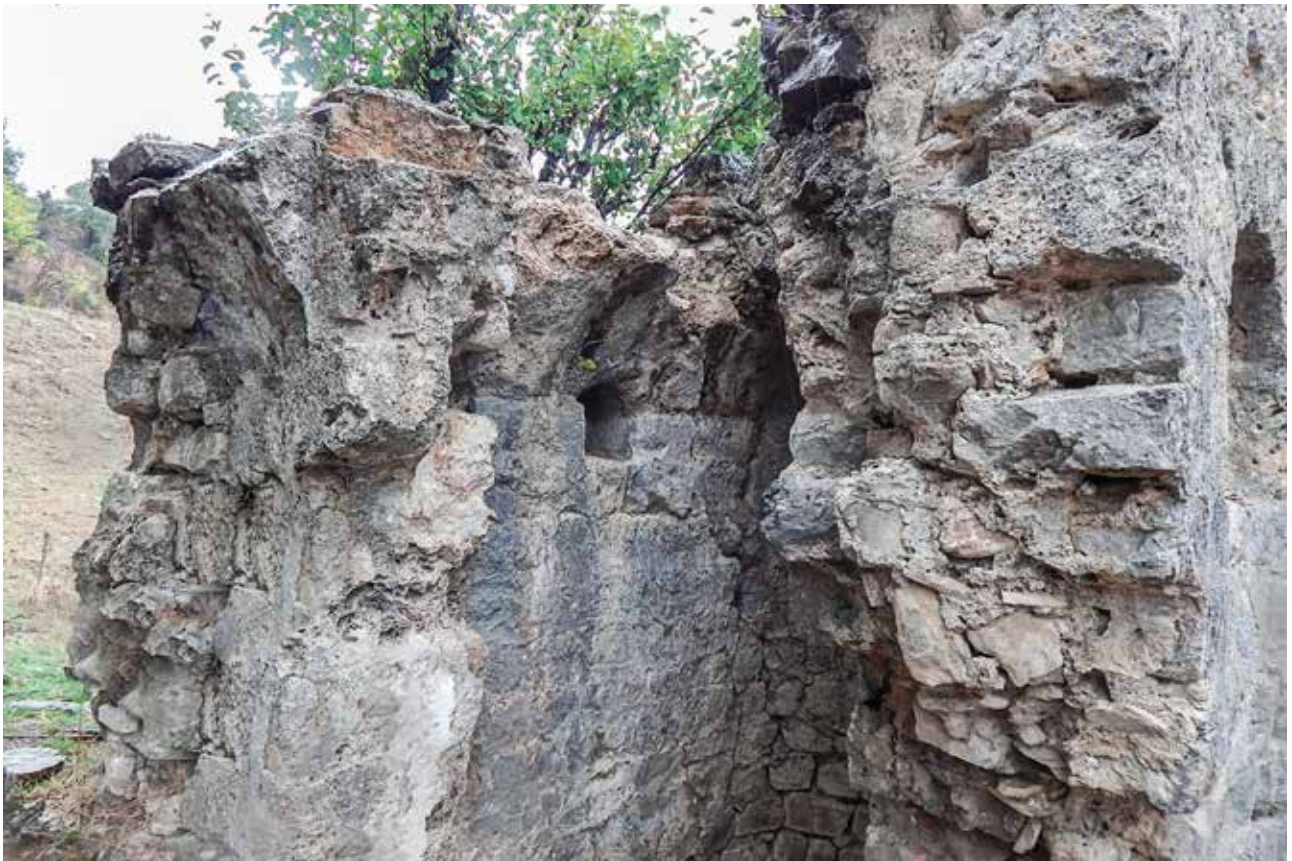
The structure is in ruins, probably the thin loamy soil in the foundations, plant cover, earthquakes and human intervention have caused the structure to be demolished. A large portion of the chapel walls are destroyed, with the eastern section, apse, sacristy, north and northwest walls partially preserved. Only foundations are preserved in some sections of the east and northwest walls and in the south. The stones in the lower rows of the apse dome are preserved, with the upper cover of the structure completely demolished.

The dense plant cover on the walls has opened many cracks; there are vertical and diagonal cracks in the extant walls. The west wall with the main entrance to the church is mainly demolished, with landslides and road construction completely destroying the south wall. Stones from the missing sections are not observed in the area; probably villagers have taken them away for use in other structures.

The church requires emergency reinforcement as it is in ruins. Research is needed to determine the original layout of the church. Further, to obtain information about the whole church, internal and external excavations should be completed. The plant cover surrounding the structure should be cleared, reinforcement projects should be prepared and work related to preservation and landscaping is recommended. If no precautions are taken, the remaining walls will not stand for long.

It may be necessary to reinforce with steel construction to counteract the effect of earthquakes. It is necessary to clear the plants covering the walls, fill cracks, restore mortar in the walls and protect from rain and snow damage.

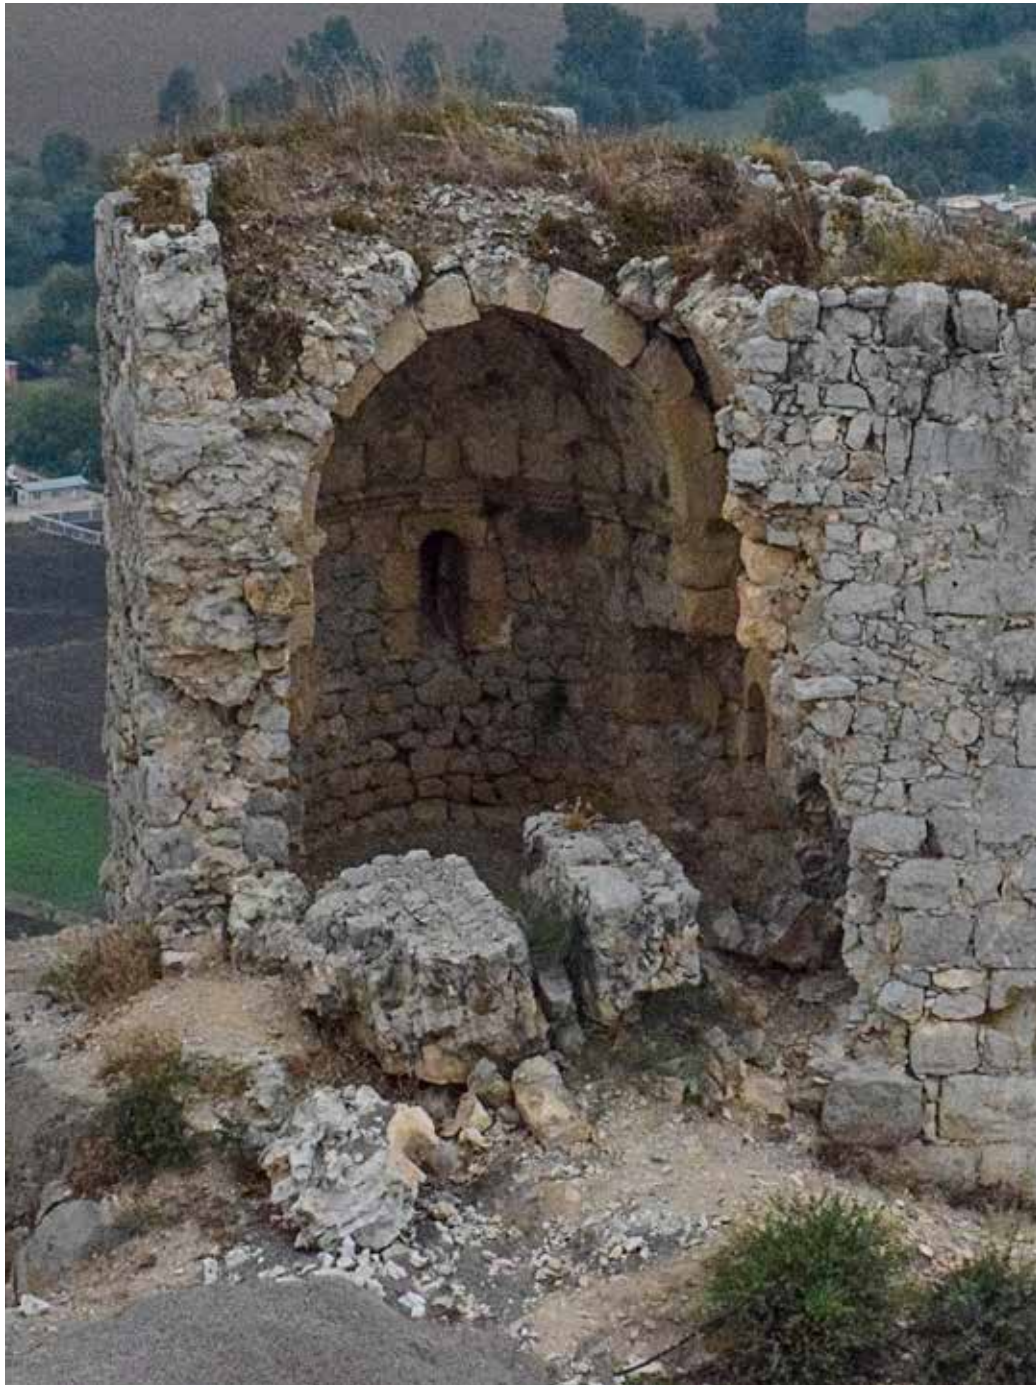
*Yılan Fortress
Ceyhan county, Yılankale village*

of the adjoining structures damaged. There is no plaster on the outer walls. Generally the mortar of the main walls has lost its properties due to being open to the effects of water. There is vertical separation observed in some walls.

demolished. The walls in the remaining sections contain vertical and diagonal cracks. The pieces of the demolished building are found near the chapel. The cause of the destruction is probably earthquakes or explosions.

The writings and inscriptions are destroyed. The lion figure in the coat of arms of the Armenian Kingdom of Cilicia above the arch of the entrance gate has been damaged with the cross motif above the lintel scratched.

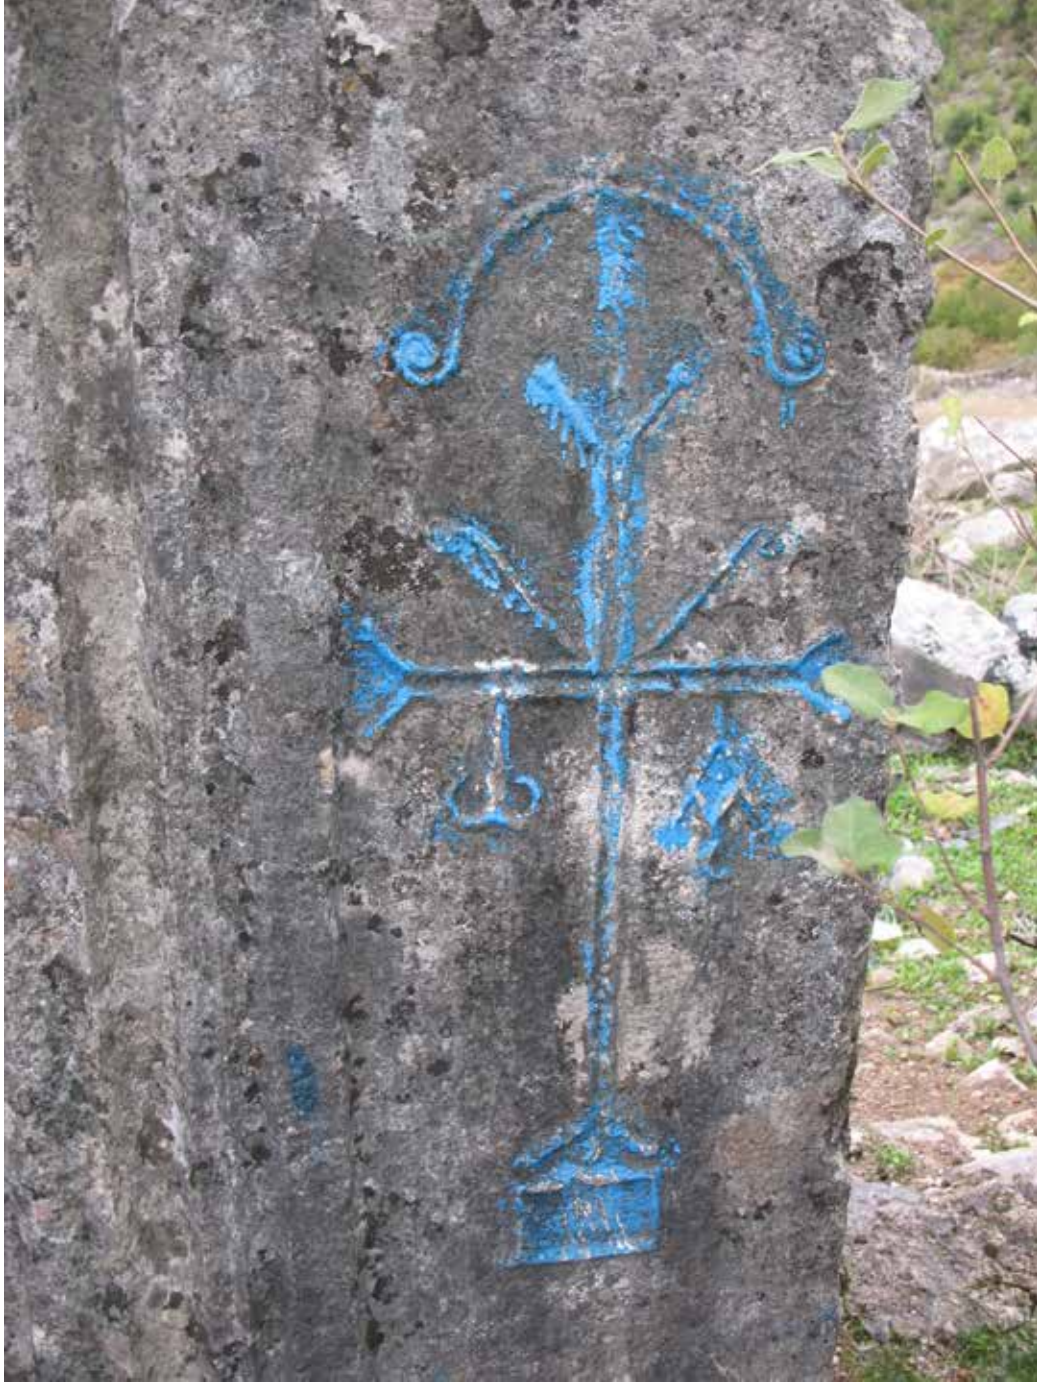
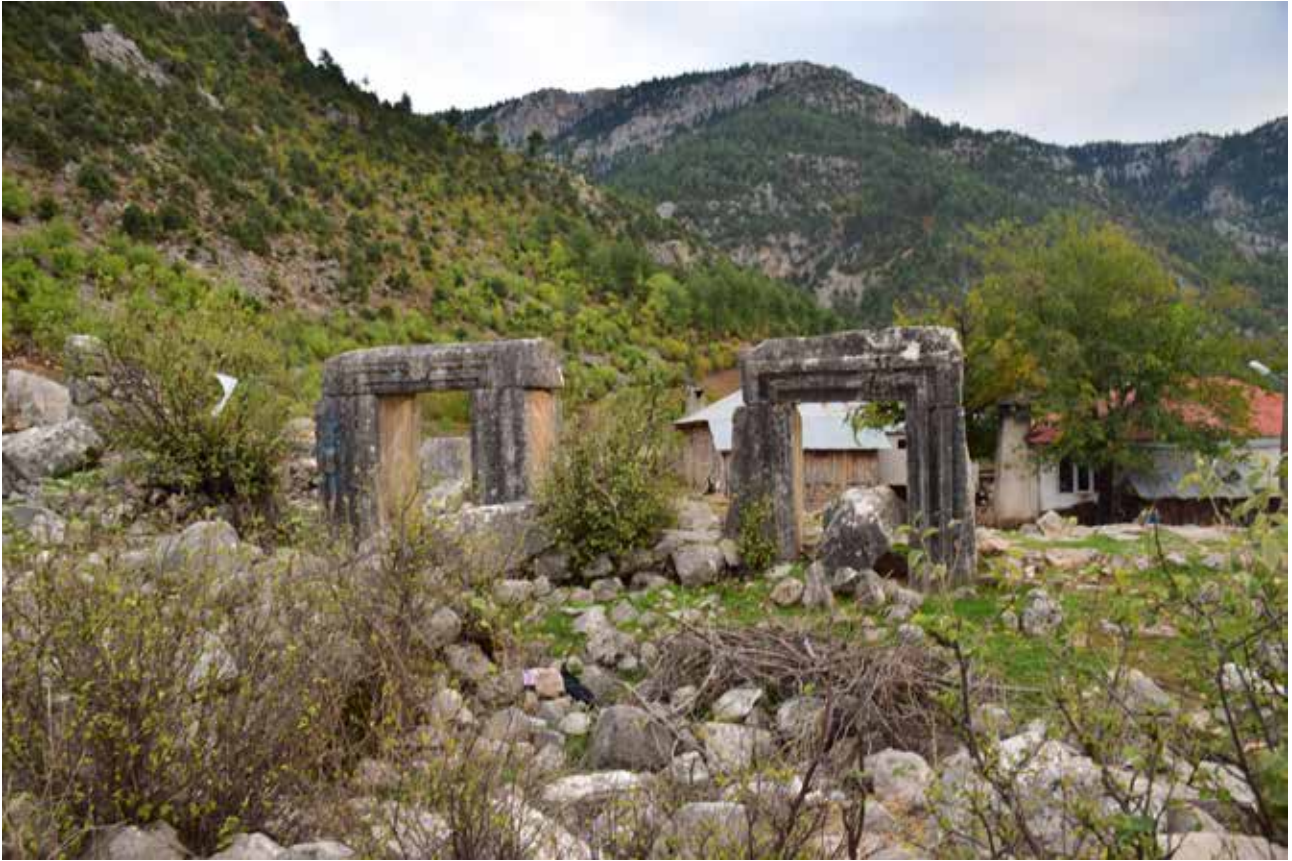
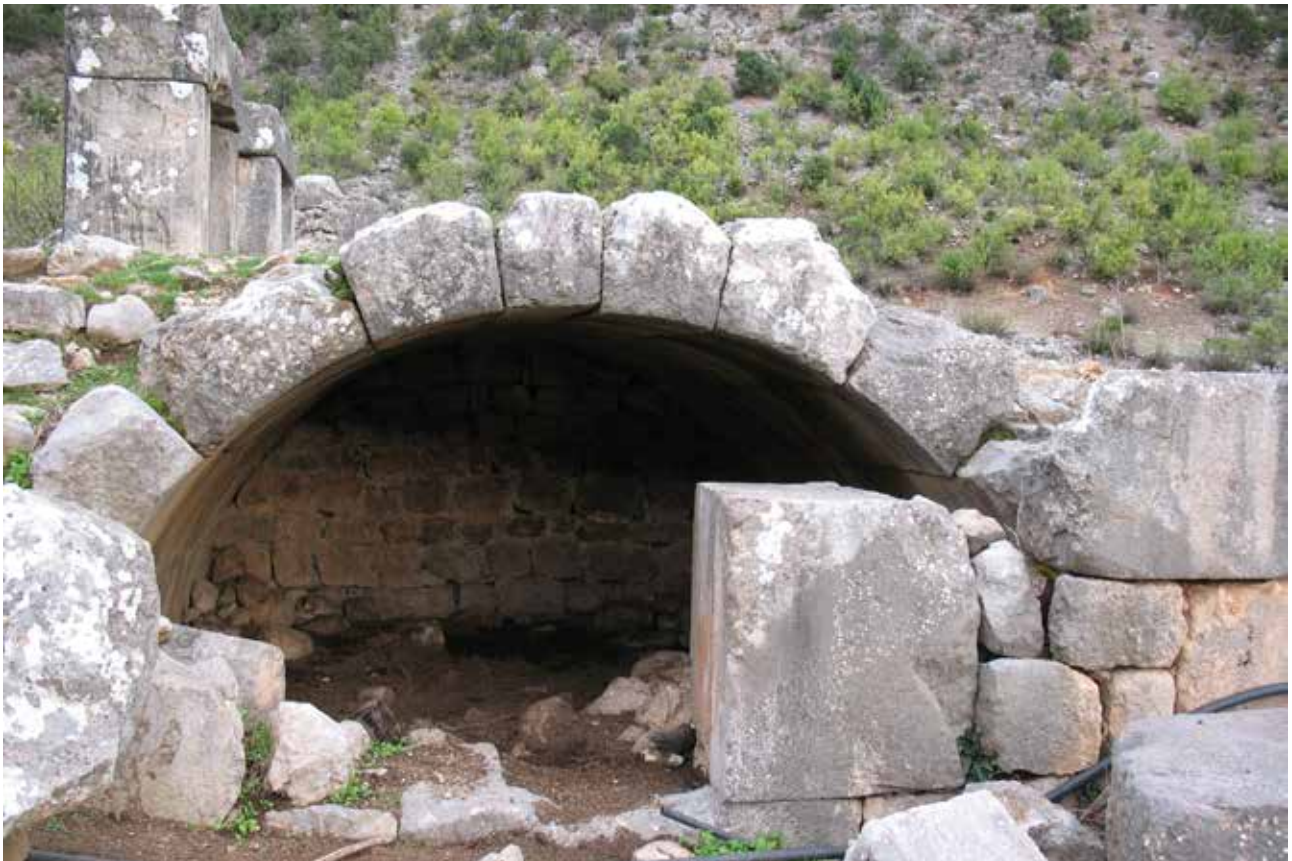
*Kara Church
Saimbeyli county, Cumhuriyet neighborhood, Çınarlı locale*

The advanced degree of vegetation growth, earthquake danger and human intervention may cause the church to be demolished. It is recommended that vegetation growth near the walls of the structure be cleared, and archaeological excavation of the site, architectural and archaeological documentation of the structure and fragments, engineering and material research, historic and archival research should be conducted along with reinforcement of the structure and the preparation of preservation and landscaping projects.

To preserve what survives, firstly general clearing of the site should be completed, stones fallen from walls and arches should be replaced, mortar repointed, walls cleared of plants and missing walls and arches and cavities in the floor be filled with original material.

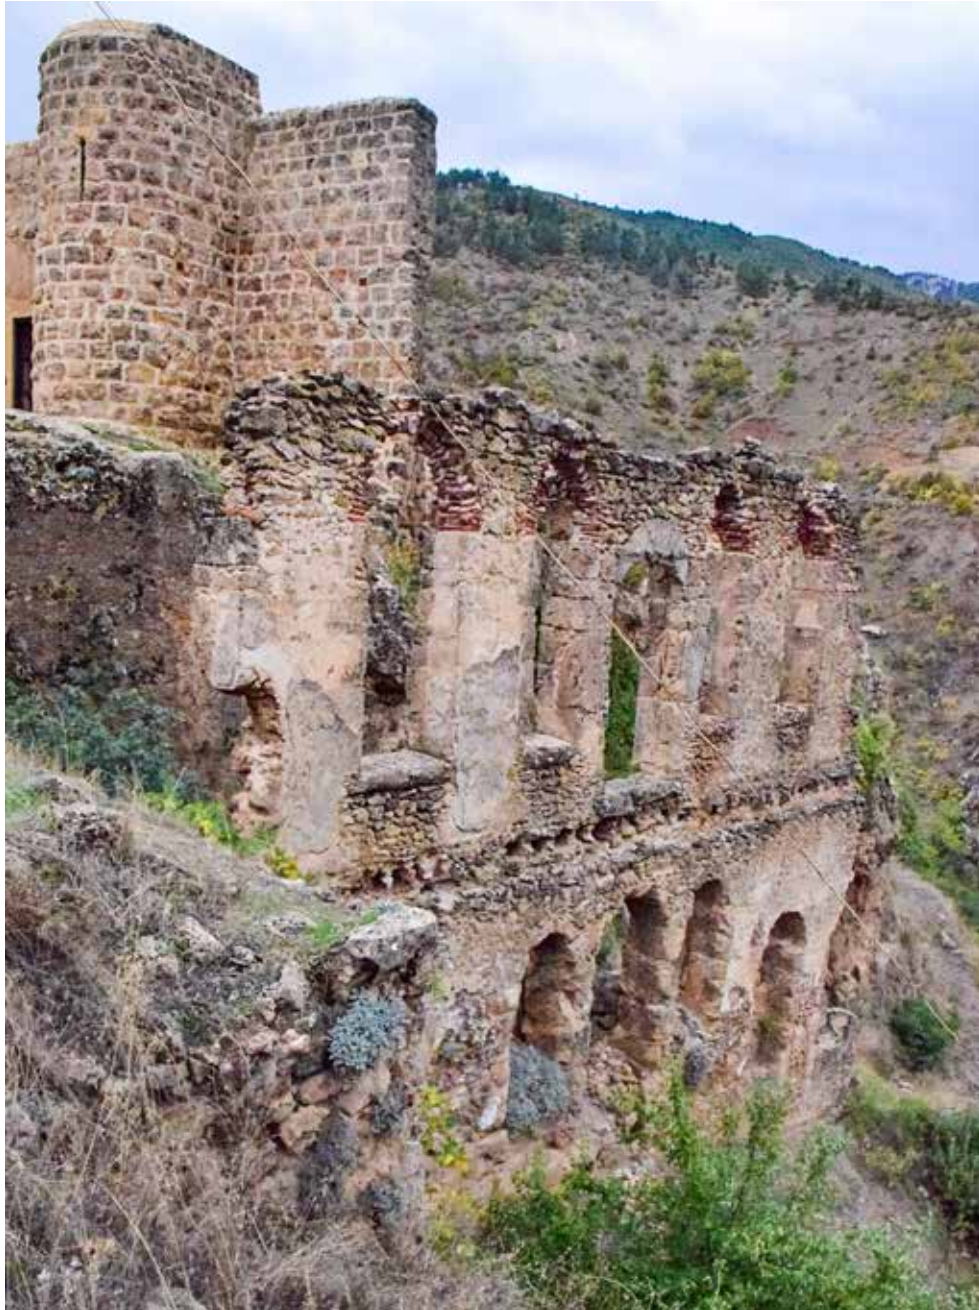
Only one heavily ruined wall of the building stands today at the western slope of the citadel. The plan of the building cannot be read at its current state. It is abandoned and unprotected. There is no signpost from the village road or information panel on the site. It attracts few

The ceilings, vaults and three walls have collapsed, leaving the existing architectural fabric open to all kinds of damage from the rain, wind and frost. Traces of moldings and lintels

The remaining wall has structural problems including being unsupported from both sides, having cracks, loss of mortar joints, surface deterioration in the stones as well as vegetation growth. The remaining plastering on the interior of the building are threatened with flaking off, due to direct contact with rain, wind and frost.

This building is an important example of multi-storey civic architectural heritage, and is the only remaining school building from the Armenian past of the village. However, the building fabric is in very poor condition, and needs immediate consolidation and stabilization in order to survive until any detailed conservation project is undertaken. The school is built on an extremely steep slope, which makes it susceptible to landslides and even collapse, considering the current unstable state of the remains.

An archaeological excavation of the monument and its surrounding will reveal more information and possibly the foundations of lost parts. This excavation must naturally be accompanied by a detailed architectural history study.

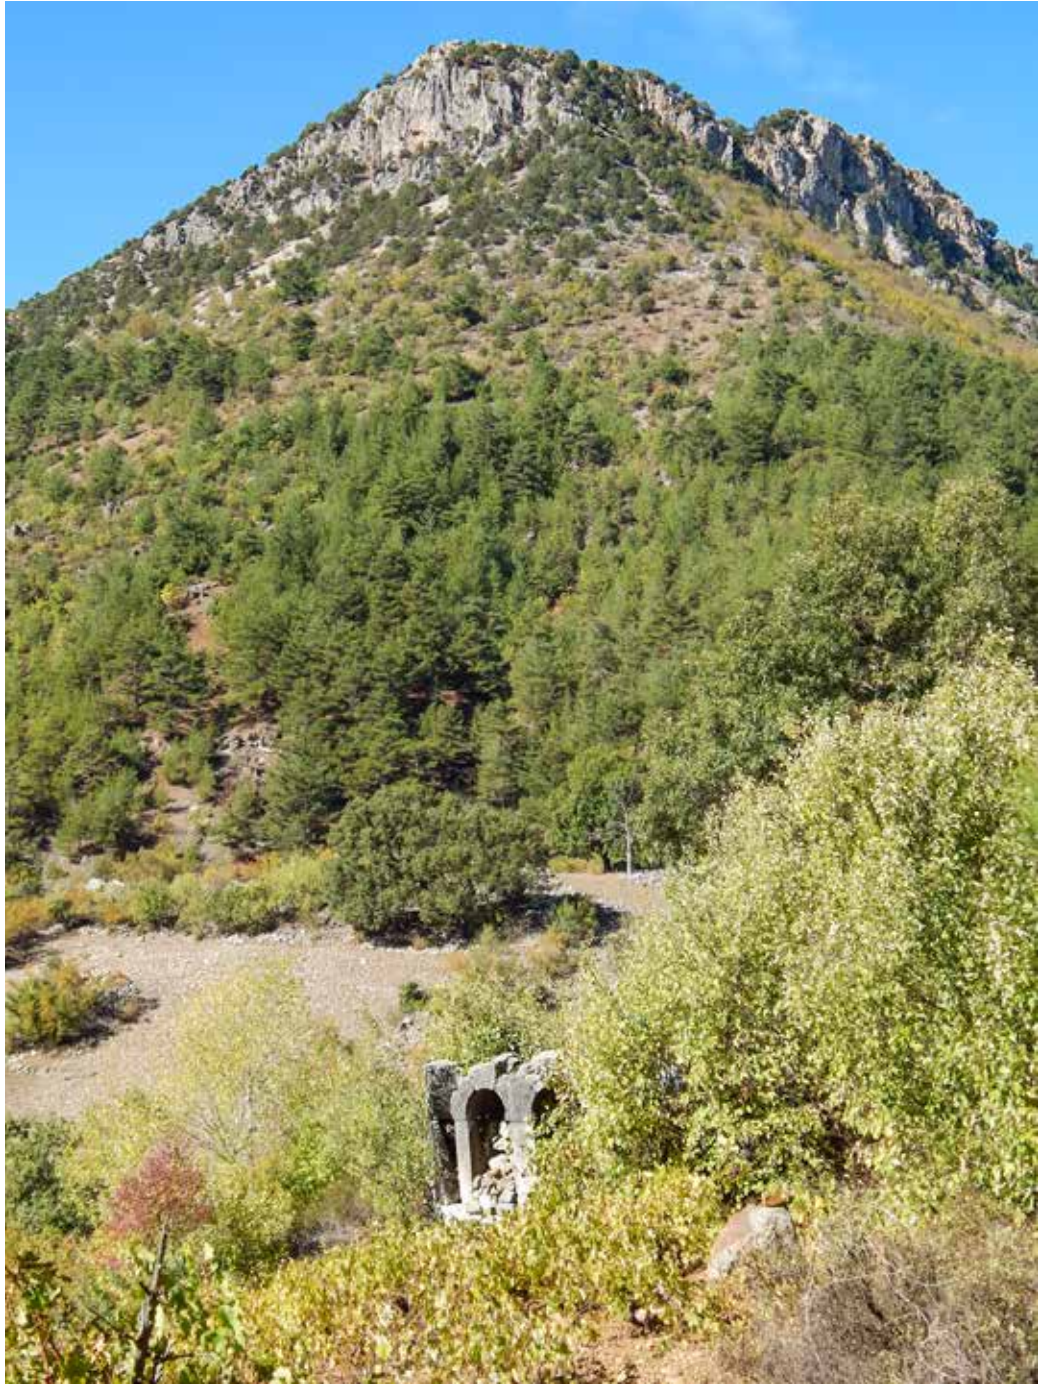
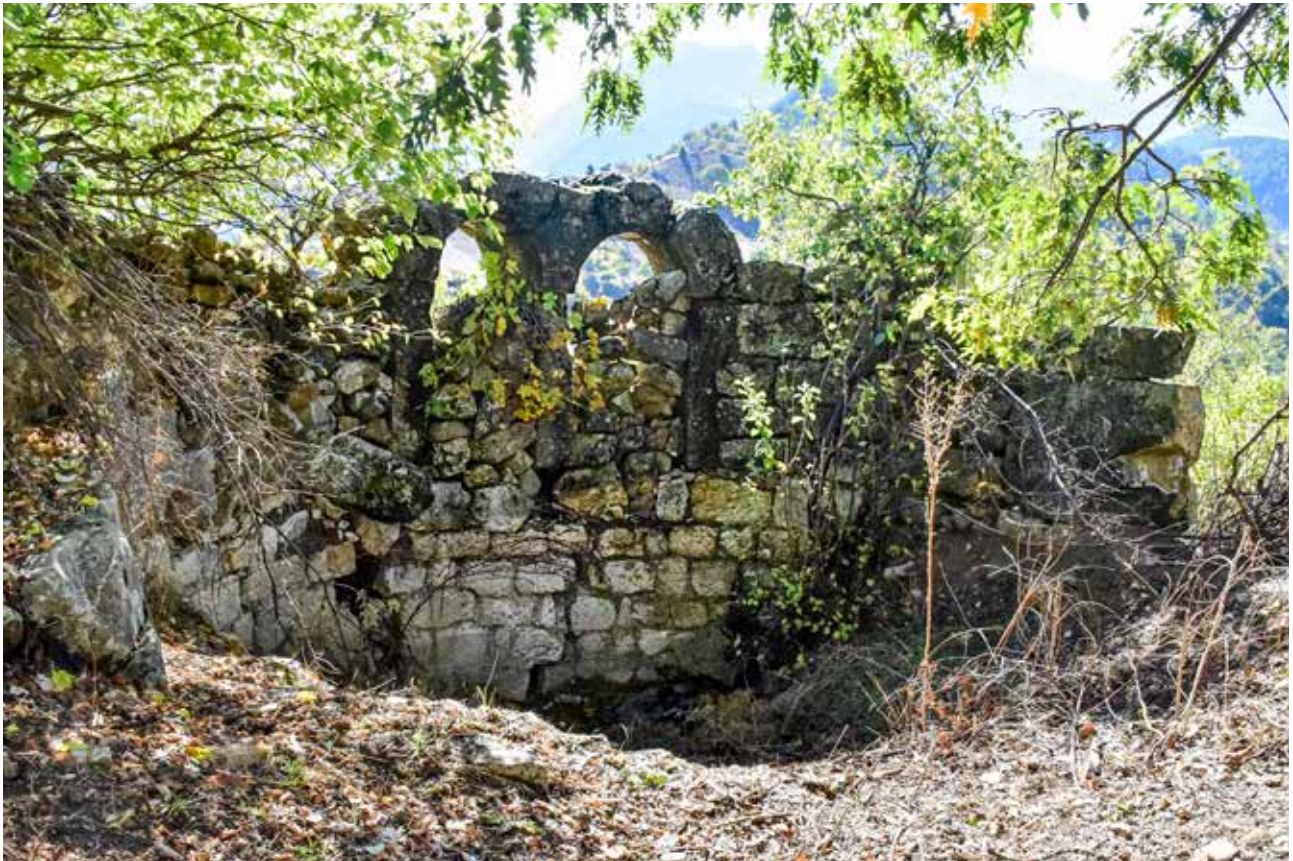
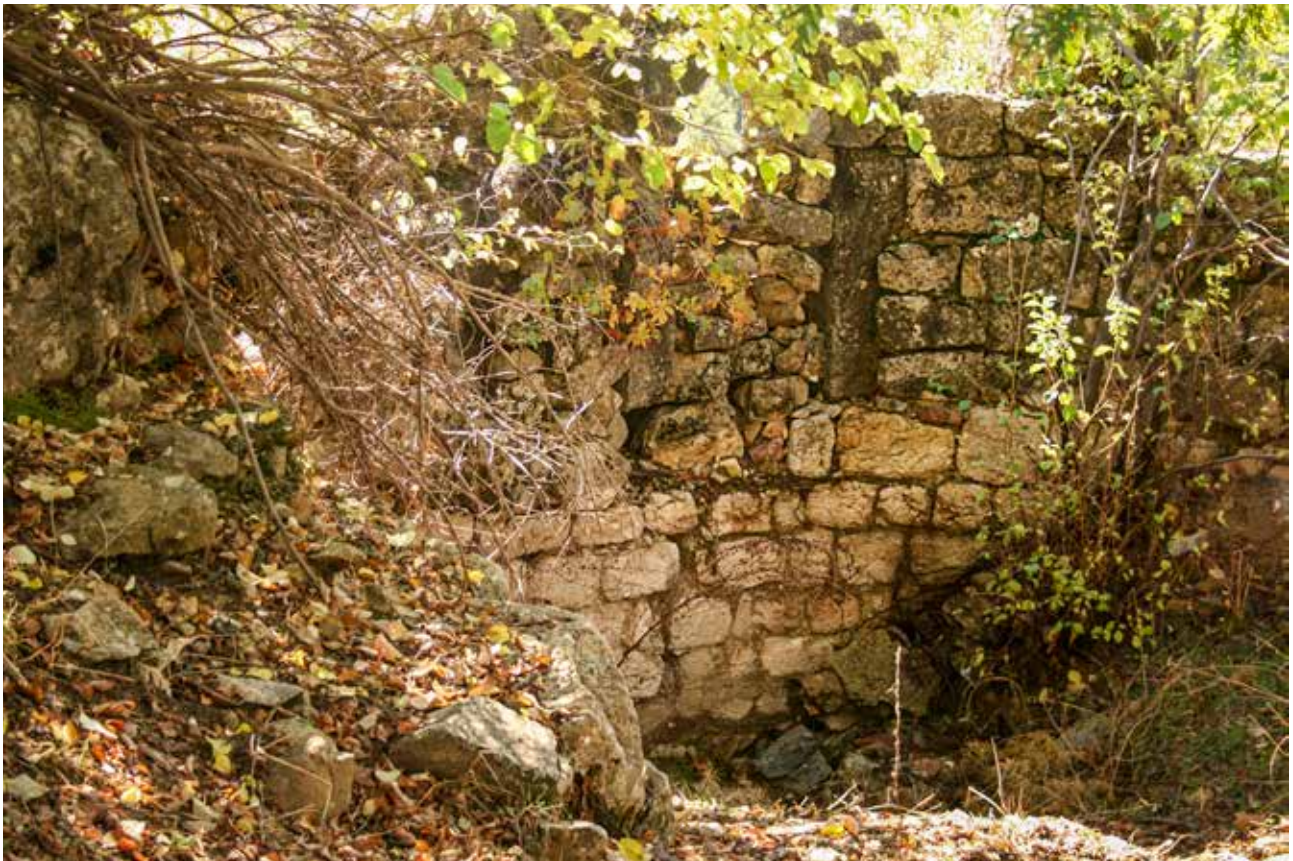
*The Church
Kozan county, Karacaşığı neighborhood*

Only a portion of the apse with two window openings remains. It is very neglected and ruined, with the remaining section in danger of complete destruction in an earthquake. There is deterioration of the stone surfaces. Under the two windows there is a broad crack in the wall. The majority of the remaining portion of the structure is buried in soil. There is high possibility that stones from the building have been used in the surrounding houses. Apart from those who know of it, there are no visitors and it is not protected. Access to the building is through village houses.

The structural state of the building is bad and susceptible to earthquake damage. It is open to the effects of wind and rain and has lost its structural integrity to support itself. It is unprotected and open to human destruction. There is advanced plant damage from large roots or branches in the remaining material of the structure.

Research must be completed to identify the structure of the church. Excavations should be conducted in the interior and around the church, though in some places the soil level has risen by 2-2.5 m. Clearing around the structure and separating it from the village is necessary. It should be reinforced in its current form. Road signs and information panels should be placed beside the building. Within the village, landscaping or pathways should be made to direct visitors to the church.

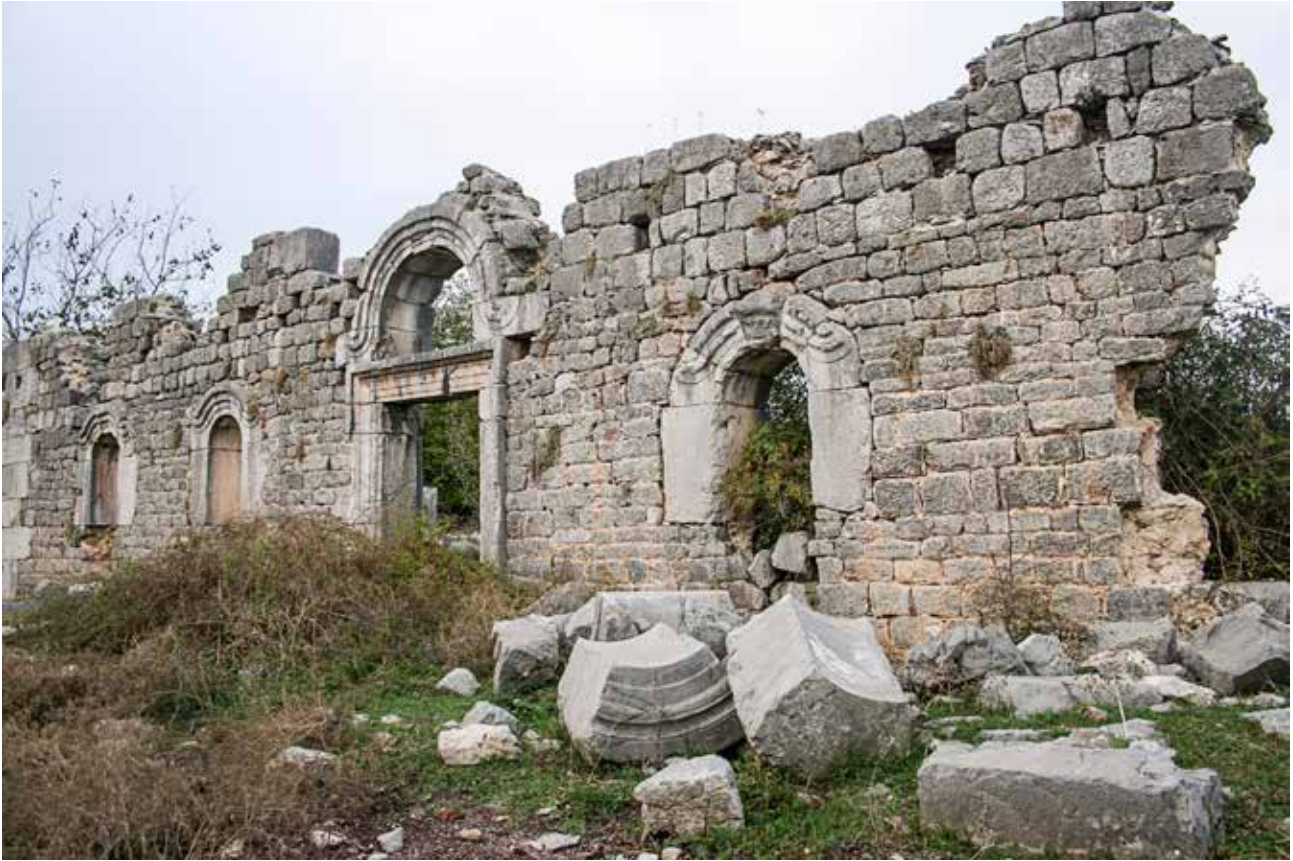
Only the south wall is partially standing in this semi-demolished and ruined church. Additionally, there is a fragment of wall in the central portion of the apse, reflecting the presence of an older apse and signs of a buried wall are observed. Though lintels and jambs are partly observed in the western façade with three entrances, the west, north and east façades are demolished with traces of the naves and upper gallery found in the interior. In this way, it is possible to predict that this structure had an upper gallery as mentioned above by Hellenkemper.

This church, with partial remains of the south and west façade, can be said to have an architectural value that requires anastylosis based on the visible and present architectural visual forms.

The results of archaeological excavations in Köreken Church itself and its surroundings will more clearly define the structural characteristics of the church in terms of the layout and dating and it will determine whether this is a single place of worship or part of a monastery complex. The local name of Kirkkapı (Forty Doors) may indicate the presence of a monastic settlement here.

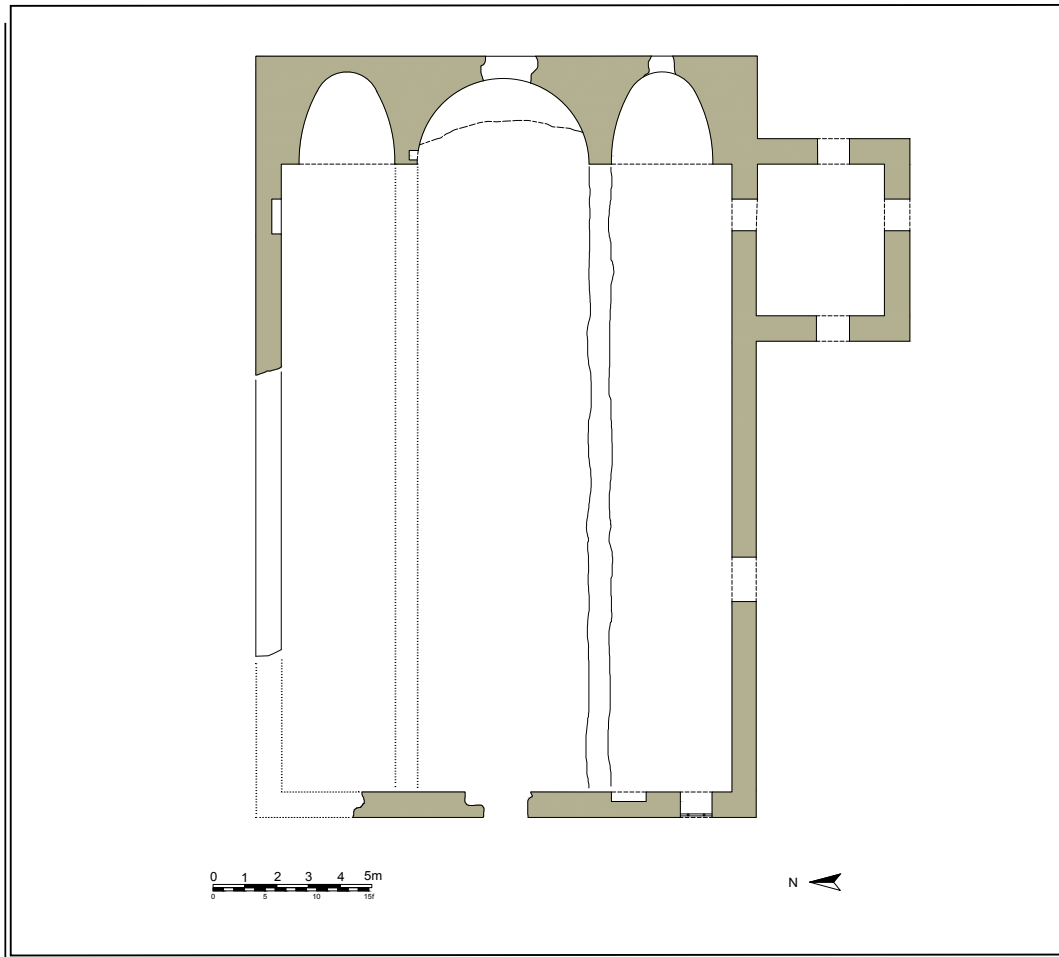
Today the monastery exists in ruinous condition; the main church and the fountain are visible. The east end walls are mostly intact; all other walls survive to a lower extent. The ceilings vaults and three walls have collapsed, leaving the existing architectural fabric open

to all kinds of damage from the rain and wind. The remaining wall has structural problems ranging from loss in mortar and chips, surface deterioration in the stones as well as vegetation growth. There is no visible plasterwork that has survived.

There are traces of an inner gallery in the south wall. There are some remains of window and door openings, moldings, lintels and timber sill plates both on the interior and exterior. The building at the side of the main structure has some of its timber roof still standing.

There are no doors in the doorways, and other entrances have been broken through the walls, leaving the building open to vandalism. There are indications of vandalism in the building, such as enlarged windows in the apses.

An archaeological excavation of the monument and its surroundings will reveal more information and possibly the foundations of lost parts. This excavation must naturally be accompanied by a detailed architectural history study.

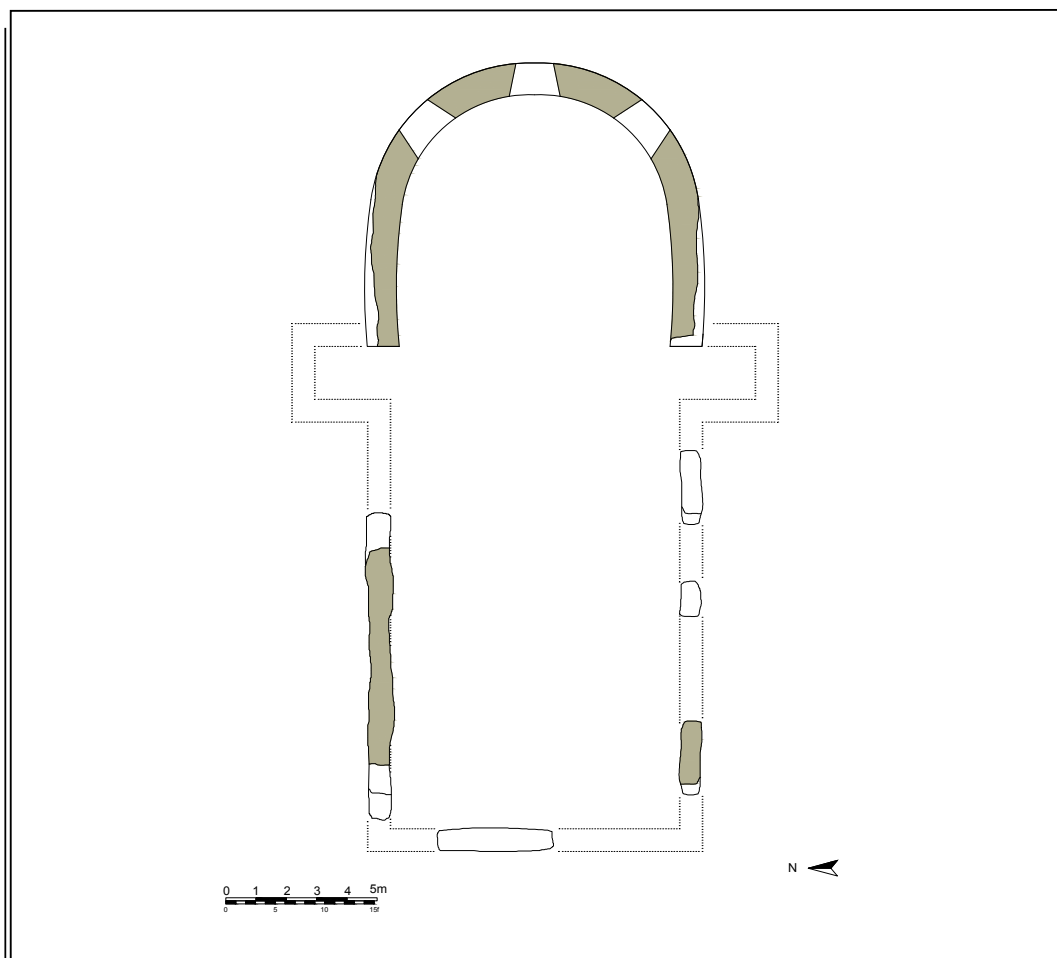
With only the apse section, and parts of the west, south and north walls remaining today, the church has experienced significant damage.

The western façade is completely demolished. The stone cladding of the western, northern and southern façade of the main walls of the structure has fallen off, and only a few remnants are visible.

he investigated in Flat Cilicia (Cilicia Pedias), Ferhatlı Church reflects the influence of northern Syria (Hellenkemper, 1994, 231-232). It is essential that necessary precautions be taken to prevent the demolition of the remaining wall sections and foundation traces of the church, which has almost lost its architectural features.

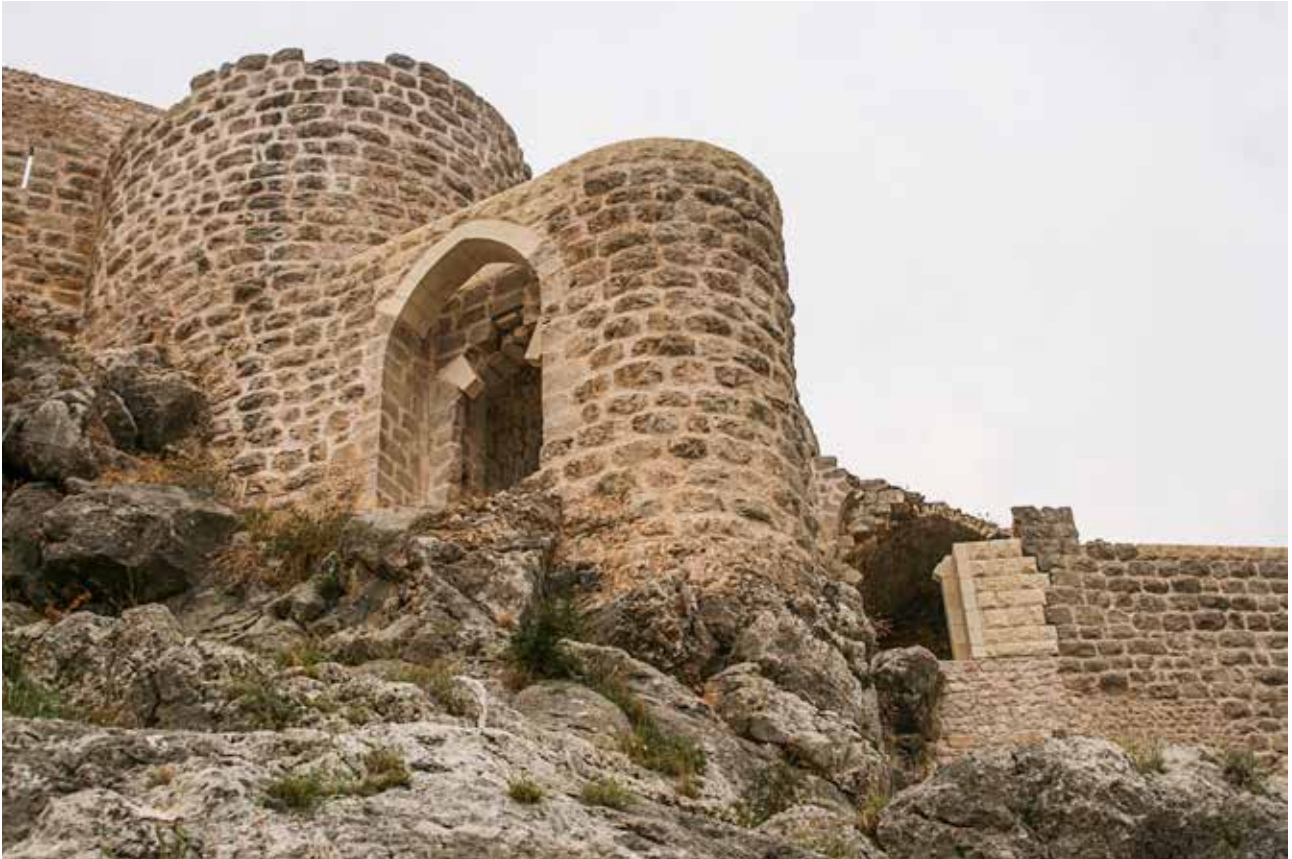
Currently, the upper roof of the sentry post is demolished. The completion of the demolished portions of the outer walls and their pointing works began and the partial changes in the plan due to demolishment of the rampart walls has been corrected. The replacement stones on the outer face of the walls can easily be differentiated from the original stones. As the interior of the fortress cannot be entered, it was not possible to assess the interventions conducted in the interior spaces.

The initiation of preservation and restoration works of the fortress is positive; however, their suspension is worrying. The implementation works should begin again as soon as possible. If new details are revealed during the project, it is important that experts should be consulted. Priority should be given to the reinforcement of walls that are damaged to a high extent and require emergency intervention. Additionally, in situations where there is insufficient information on the original form, reconstruction should not be attempted. The completion works implemented in certain sections of the corner towers end vertically in the center of the tower. If these towers are left in this state, visitors might consider these interventions as original and lead to misinterpretations. At the same time, all interventions should be conducted by stones compatible in quality and form with the original stones, lime-based mortar should be used and additions should be done in such a way that experts can differentiate them in future.

It was stated that stones threatening the integrity of the structure due to advanced deterioration were removed through disintegration techniques (Adana Tumlu Fortress Restoration Work, 2016). However, it is known within the current architectural preservation practice that some ways of this method damage the original architectural texture. This method should be applied without damaging the original texture, or an alternative method be implemented.
