Kayseri
Adana
Izmir
Elazığ
Niğde
Bursa

Assessment Report of Architectural Cultural Heritage

April 2018

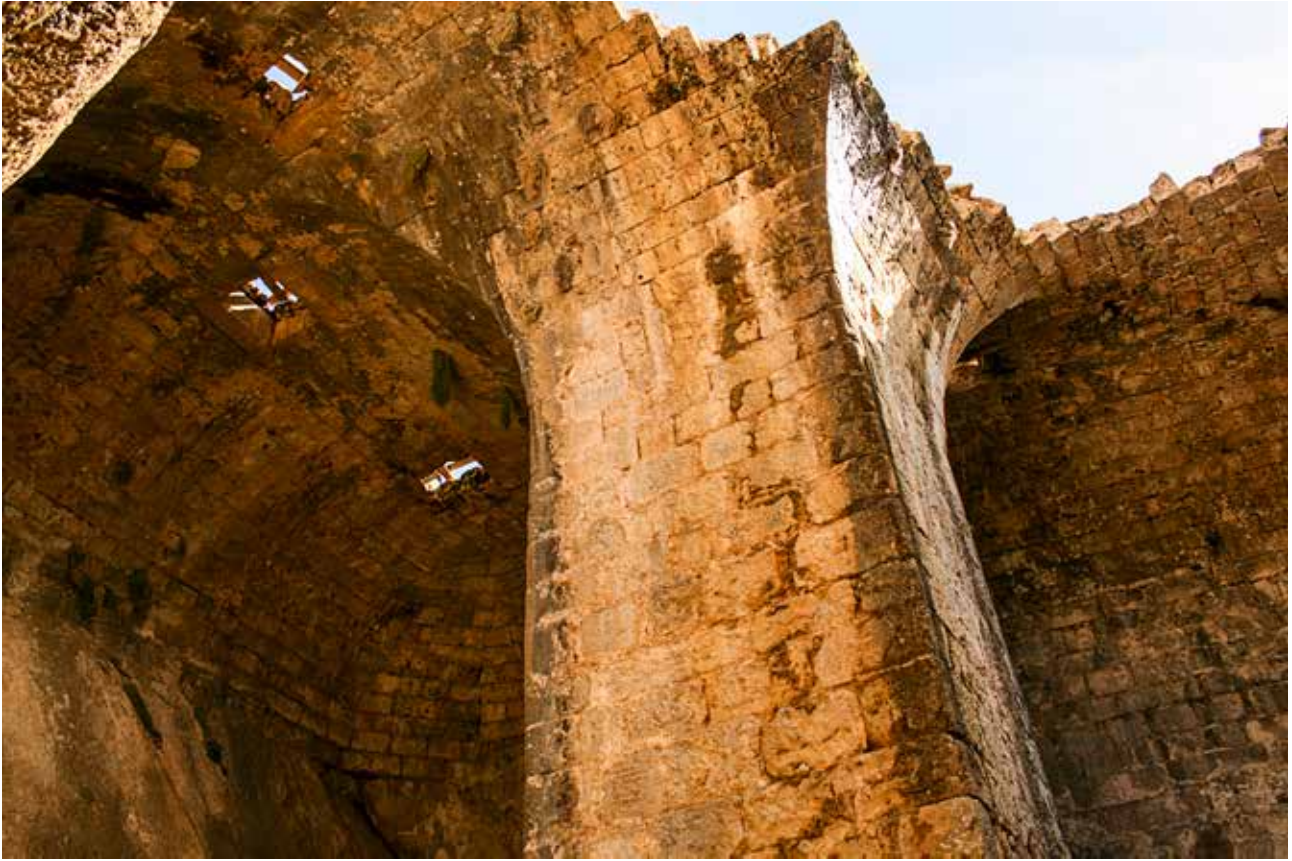
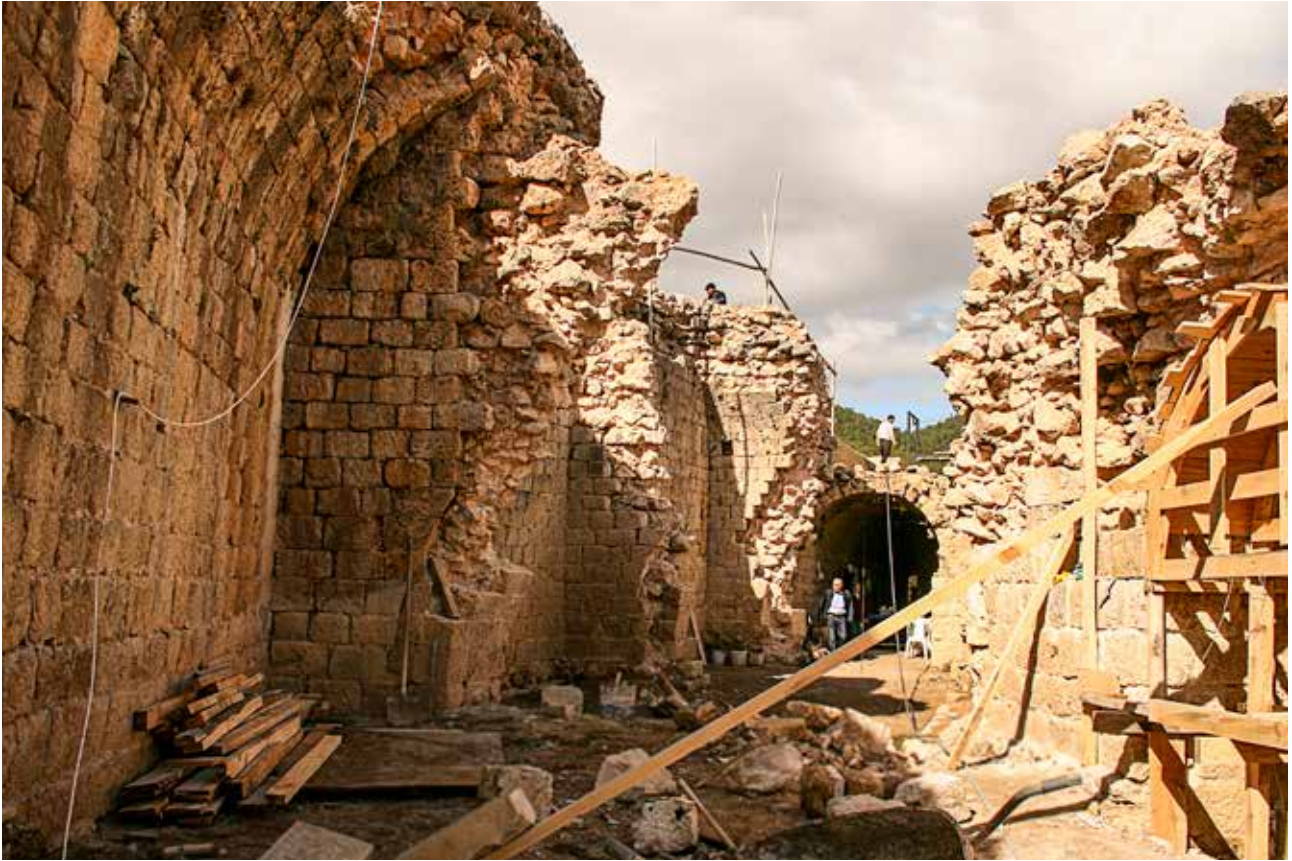
Feke Fortress was under restoration between November 2006 and July 2007, in accordance with a project by Bora Işık-Boaz Company. Bora Işık, the project coordinator, stated that the spaces at the upper level were easily perceivable; whereas significant information was found indicating that there were spaces in the lower level. Thus, a comprehensive excavation was recommended, which began in 2015 and unearthed certain spaces with the fortress area. Substantial interventions were avoided apart from parts with serious structural problems, whereas interventions were shaped by a preservation principle aiming to mainly consolidate the existing elements. Işık (2016) also stated that basic implementations were finished the same year, whereas the landscaping of the circulation route within the fortress might have remained.

The repair of this fortress with deep historical past will be an important step in terms of providing an example for the restoration of other fortresses. Converting this military architecture into a cultural function will make it possible for Feke Fortress to survive physically, and will form the basis for it to become a noteworthy destination, and contribute to the universal cultural heritage of the country. In brief, integrating fortresses into the everyday

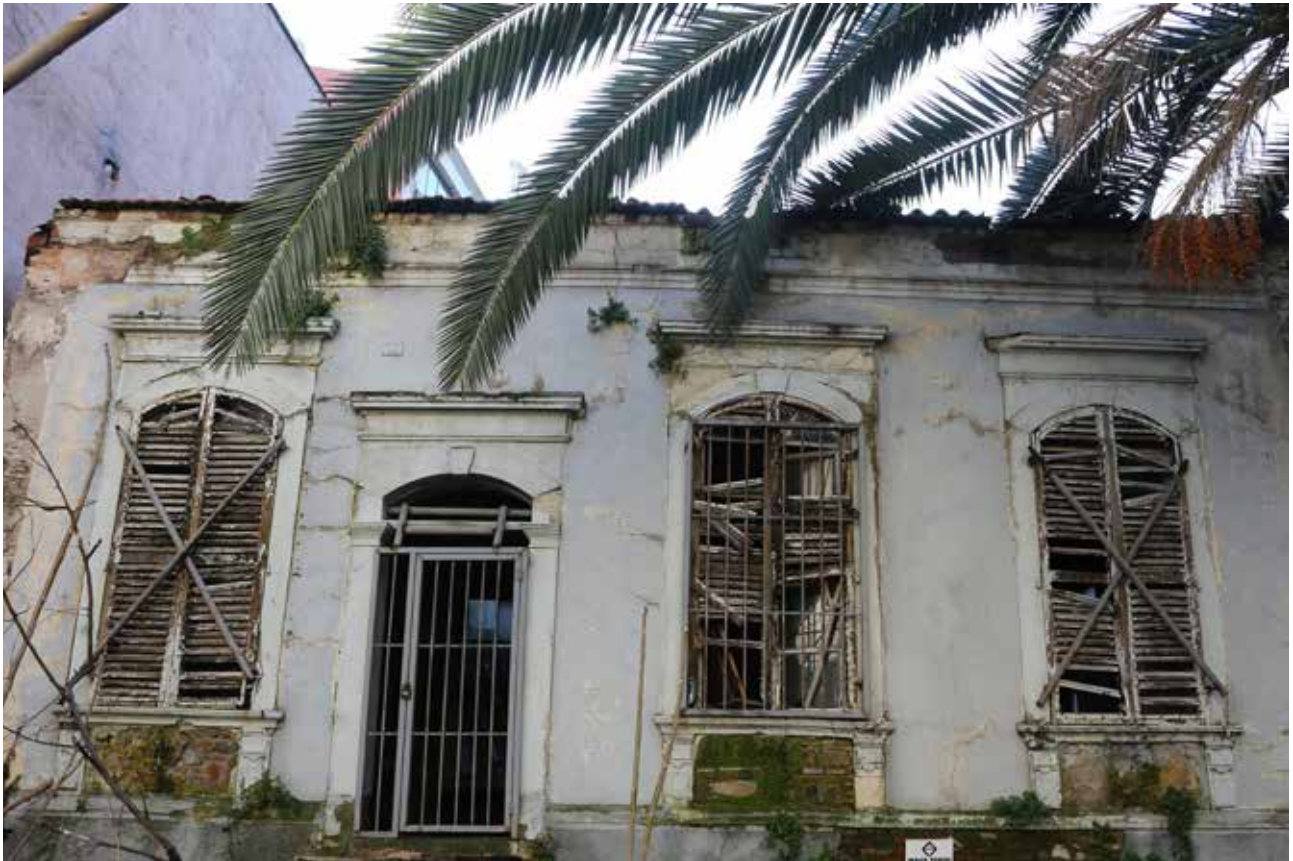
The yard is filled with wooden debris of the collapsed sections of the structure including the roof framing. The entire flooring connecting the main entrance to the areas behind has collapsed making it impossible to walk inside. The masonry parts of the external walls have collapsed in certain places and profiled roof moldings are partially preserved. The structure has preserved its original characteristics and is ready for surveying and recording studies.

The structure is under clear risk of being lost and of looting of available construction material due to both structural situation and being exposed to the elements. The lot on which the building stands is surrounded by encircling walls, but is easily accessed through a sheet metal door and walls contain holes at places. As the roof of the building has completely collapsed and nearly the whole internal space is open, it is exposed to wind and rain damage.

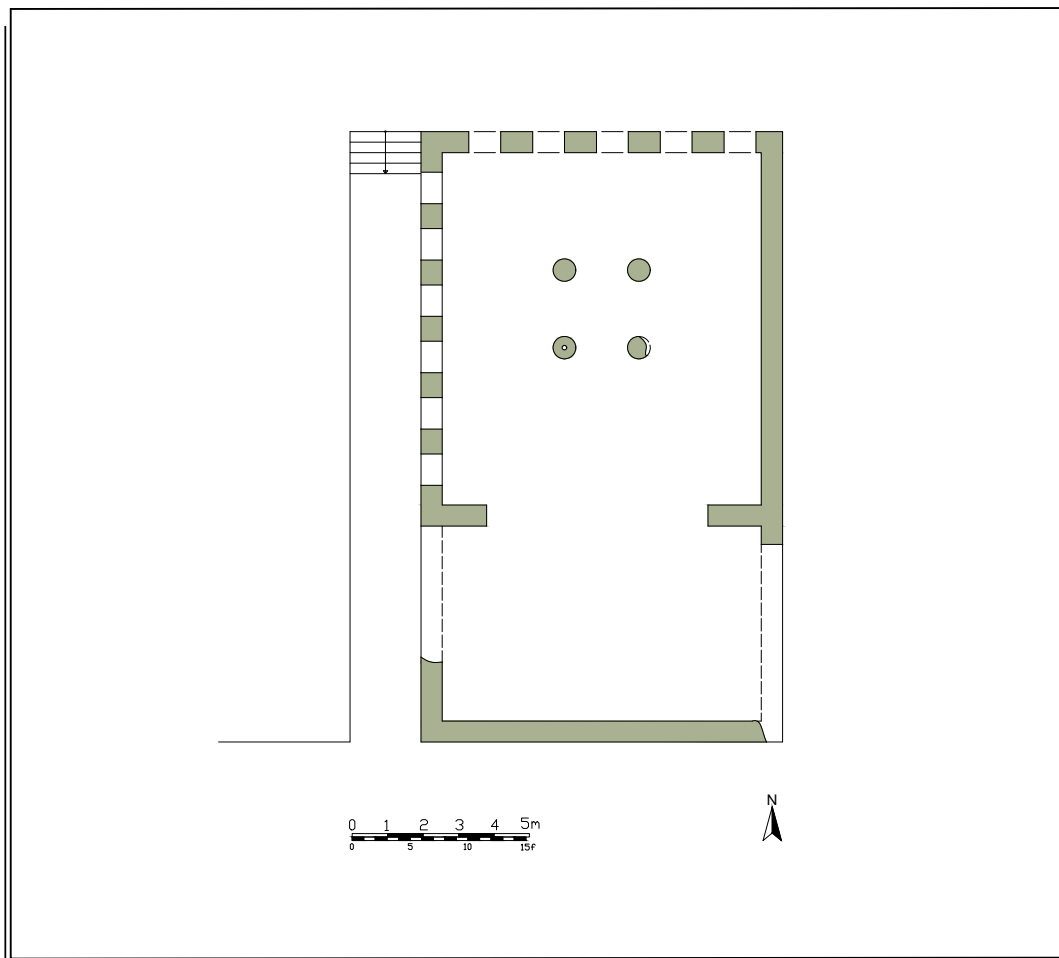
The exterior walls of the structure are partially standing, the roof is completely lost and the interior is filled with rubble and debris; the structure is in ruins. The four columns in the central area known to belong to the tevah are distinguishable among the rubble heaps and are the most substantial indicator of its architectural plan.

The walls along the slope on the south, north and west façades of the building are still standing with two vaulted cellar chambers at their lower levels. The cellar in the west has semi-circular brick arch, while the cellar in the east has a semi-circular arch of fine-cut stone. Though not accessible, the dimensions of the inner space of the cellars can be identified using

The site, has been within a residential area throughout history, is today like a slum area which has allowed for the rapid deterioration of the structure. The structure should be cleared of rubble and other debris, to reveal the level of synagogue's original floor. This debris has caused a large heap over years, severely damaging the building. It is appropriate to secure the site, clean the structure and place an information panel explaining the history and significance of the synagogue.

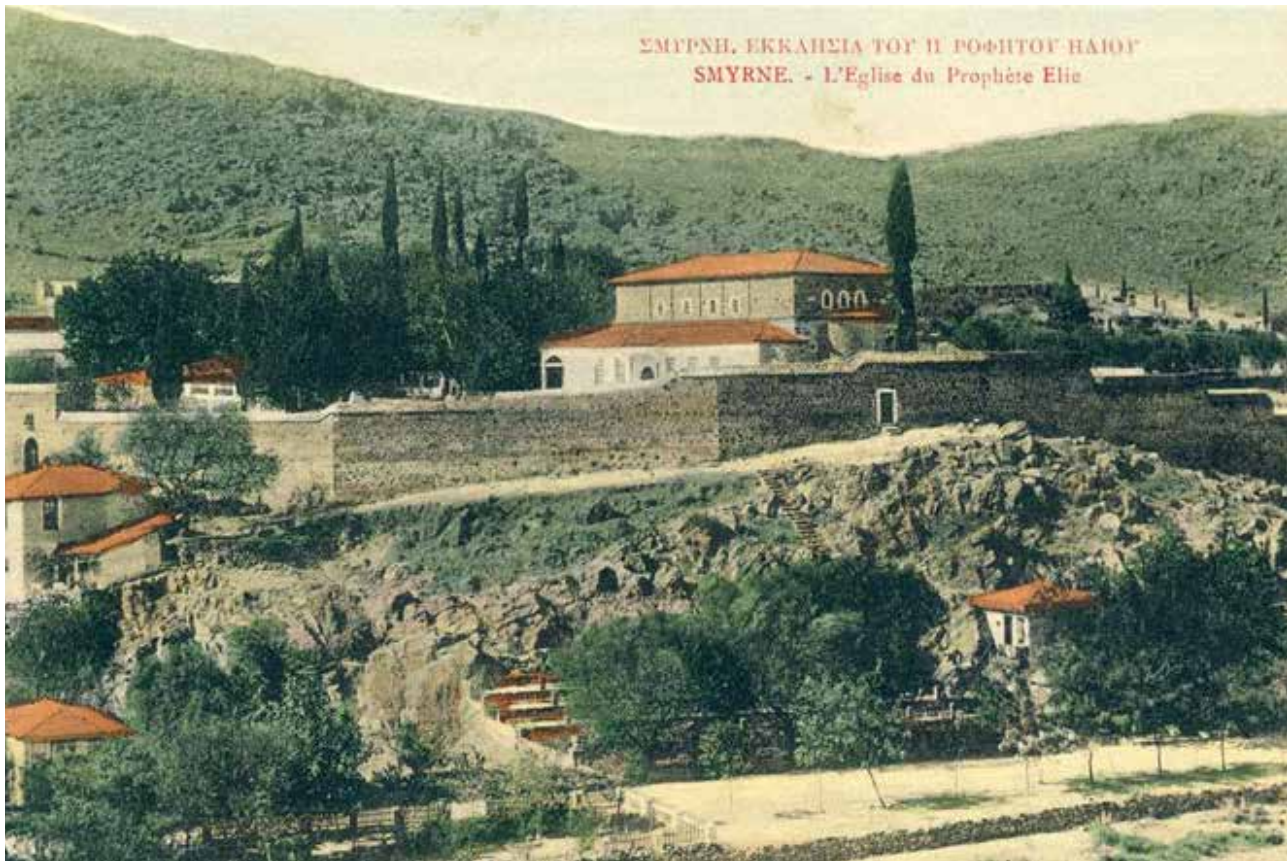
The structure is entirely abandoned today. The major alteration the church suffered is the complete disappearance of the narthex and parcellions, while the naos stands with its walls and the interior decoration in a comparatively good condition. The original flooring has disappeared and is presently covered with dirt, and the roofing is partly inlaid with earth and turf, as is the former conical roof of the apse. Many of the iron trusses spanning the supporting arches of the barrel vault are lost: five of them entirely missing in the lower row, and one in the upper row; the loss endangers the vault's

structural solidity. The western façade (the former narthex wall) is partly demolished due to the collapse of the entrance and the window opening to its left; only part of the rectangular molding survives. Doors and windows are wide open and original joinery has been destroyed. Material deterioration is more pronounced than the structural problems of the building.

Though listed in 2009 as a building requiring first degree conservation, no conservation action has been undertaken so far and the church is left to neglect, exposed to weather conditions and unprotected from vandalism.

Given the 2011 architectural restoration study, a detailed structural consolidation project should be carried out. Until a restoration project addressing both the architectural and structural problems of the building is put into effect, immediate rescue measures are necessary to protect the structure from further damage of its elements. Excavation works

should be conducted to survey and document the traces of the lost parts –the narthex and the parecclesions– and consolidation works necessary for their maintenance should be undertaken.

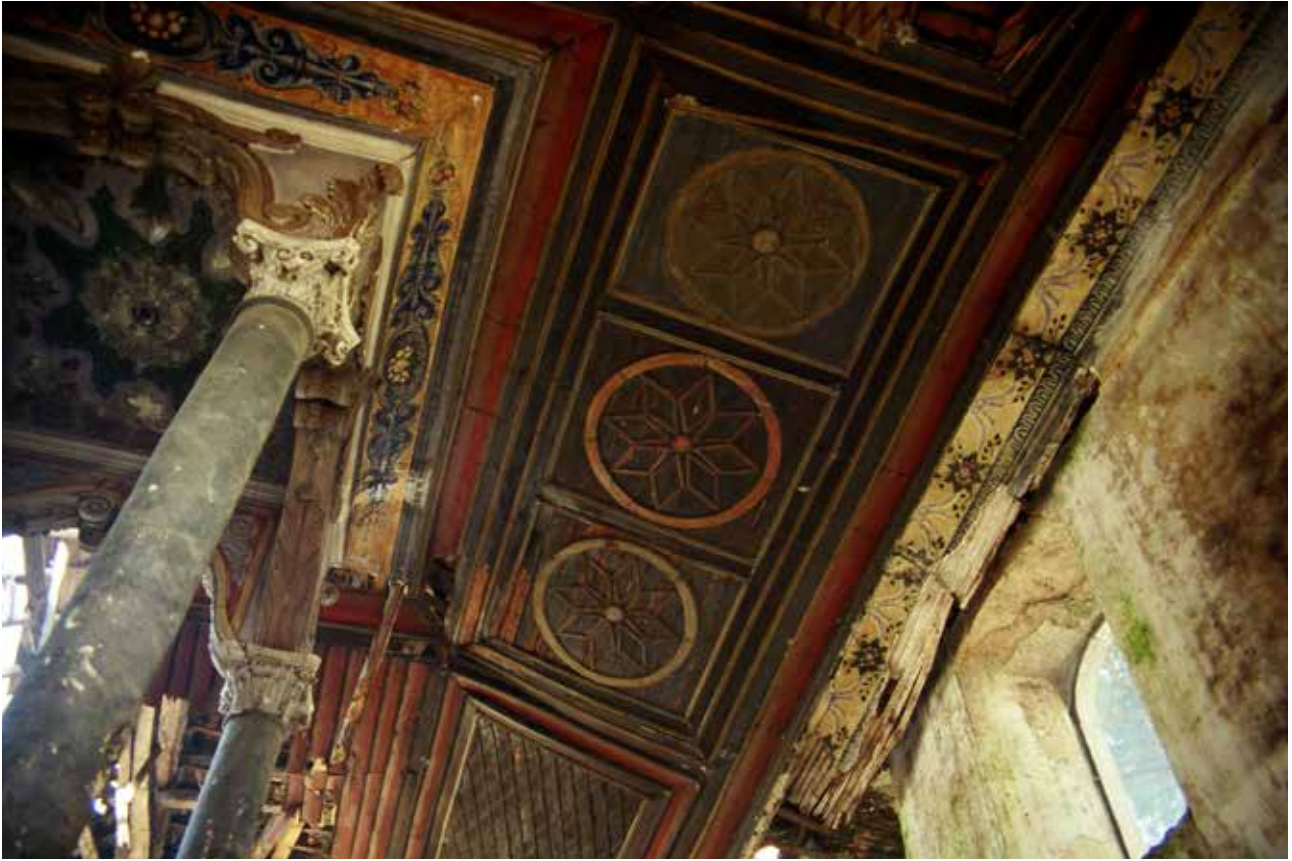
*Yabets Synagogue, before restoration
(Inci Türkoğlu Archive, 1999)*

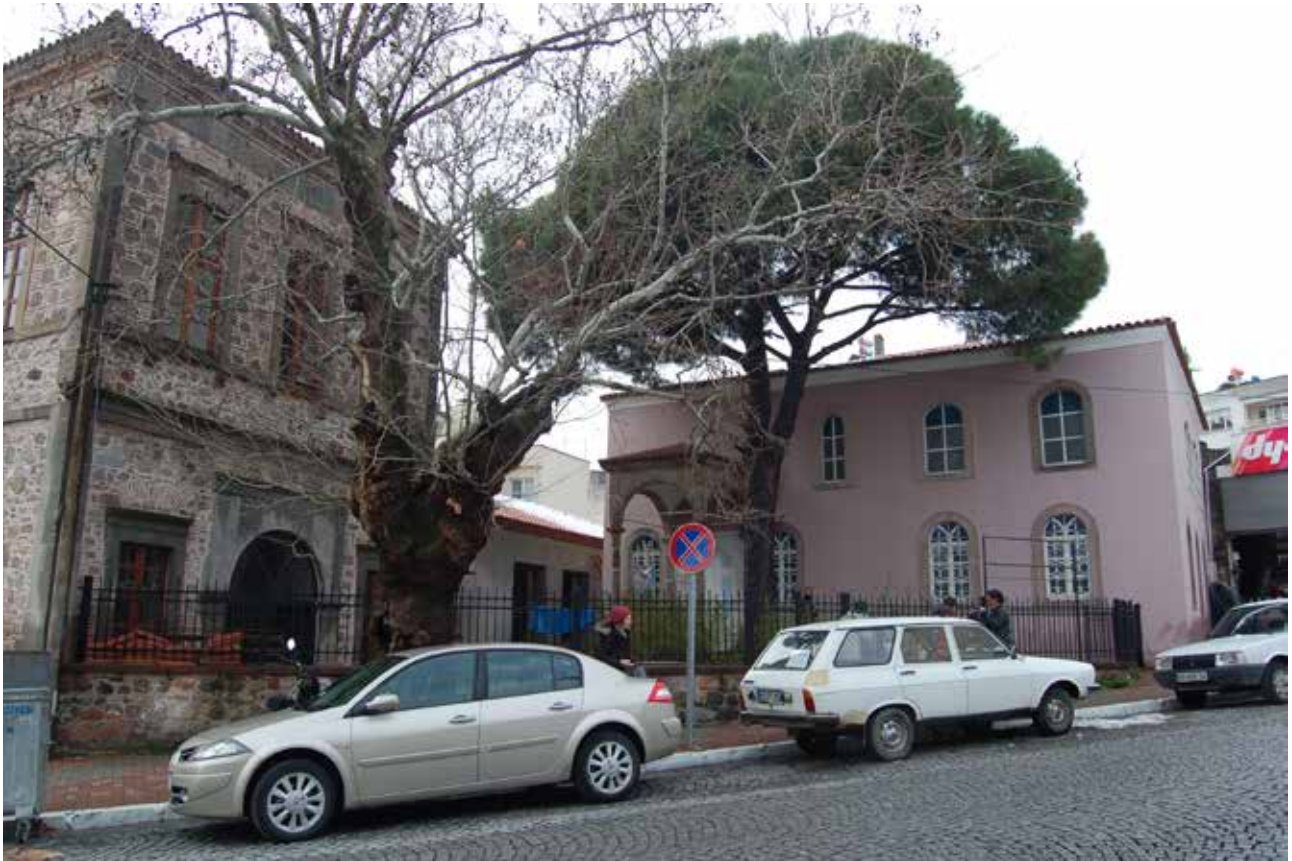
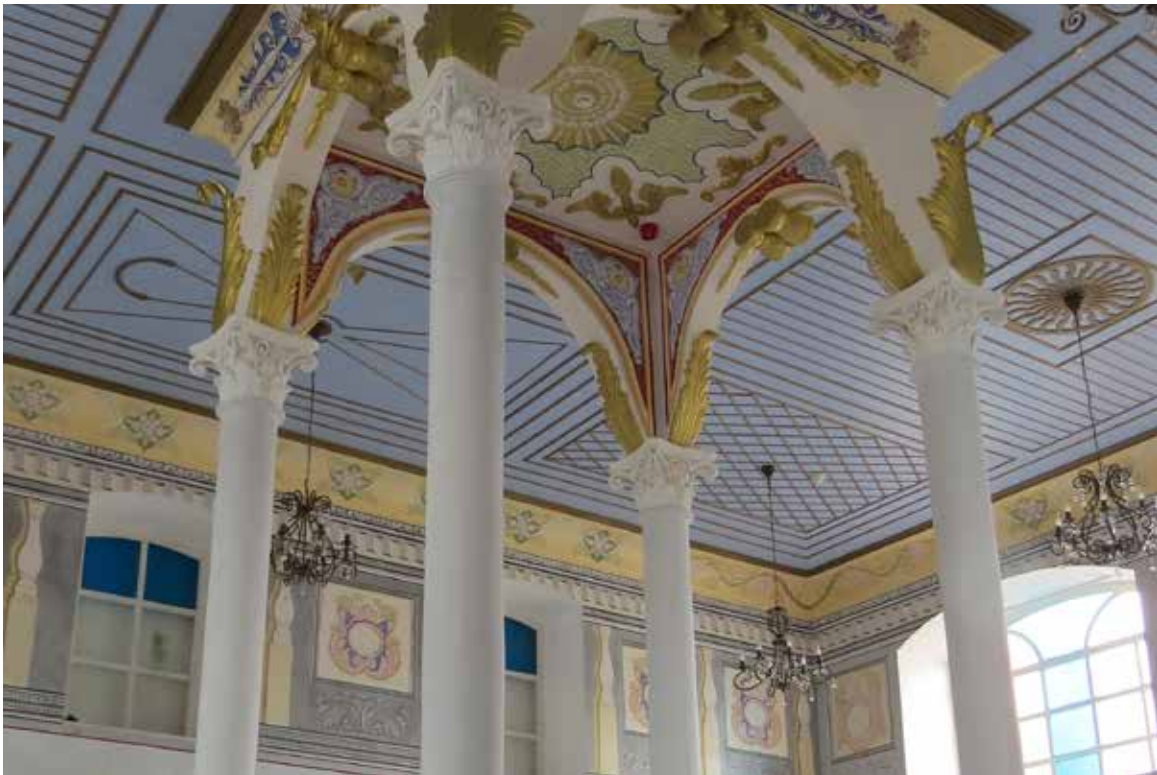
Yabets Synagogue, after restoration

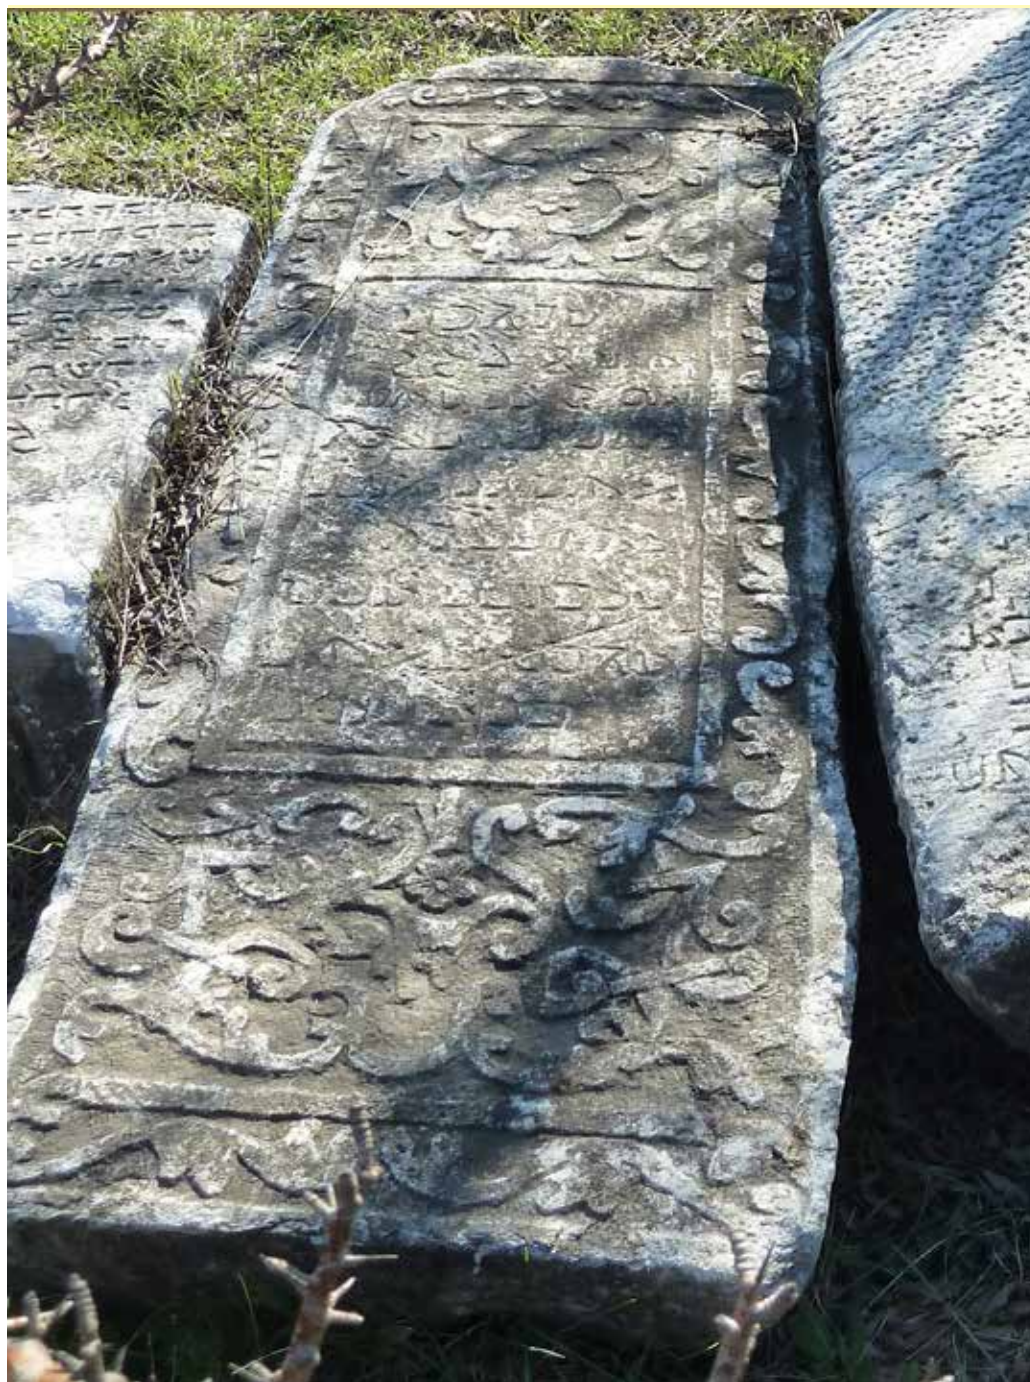
*The Jewish Cemetery
Tire county, Tire Organized Industrial Zone*

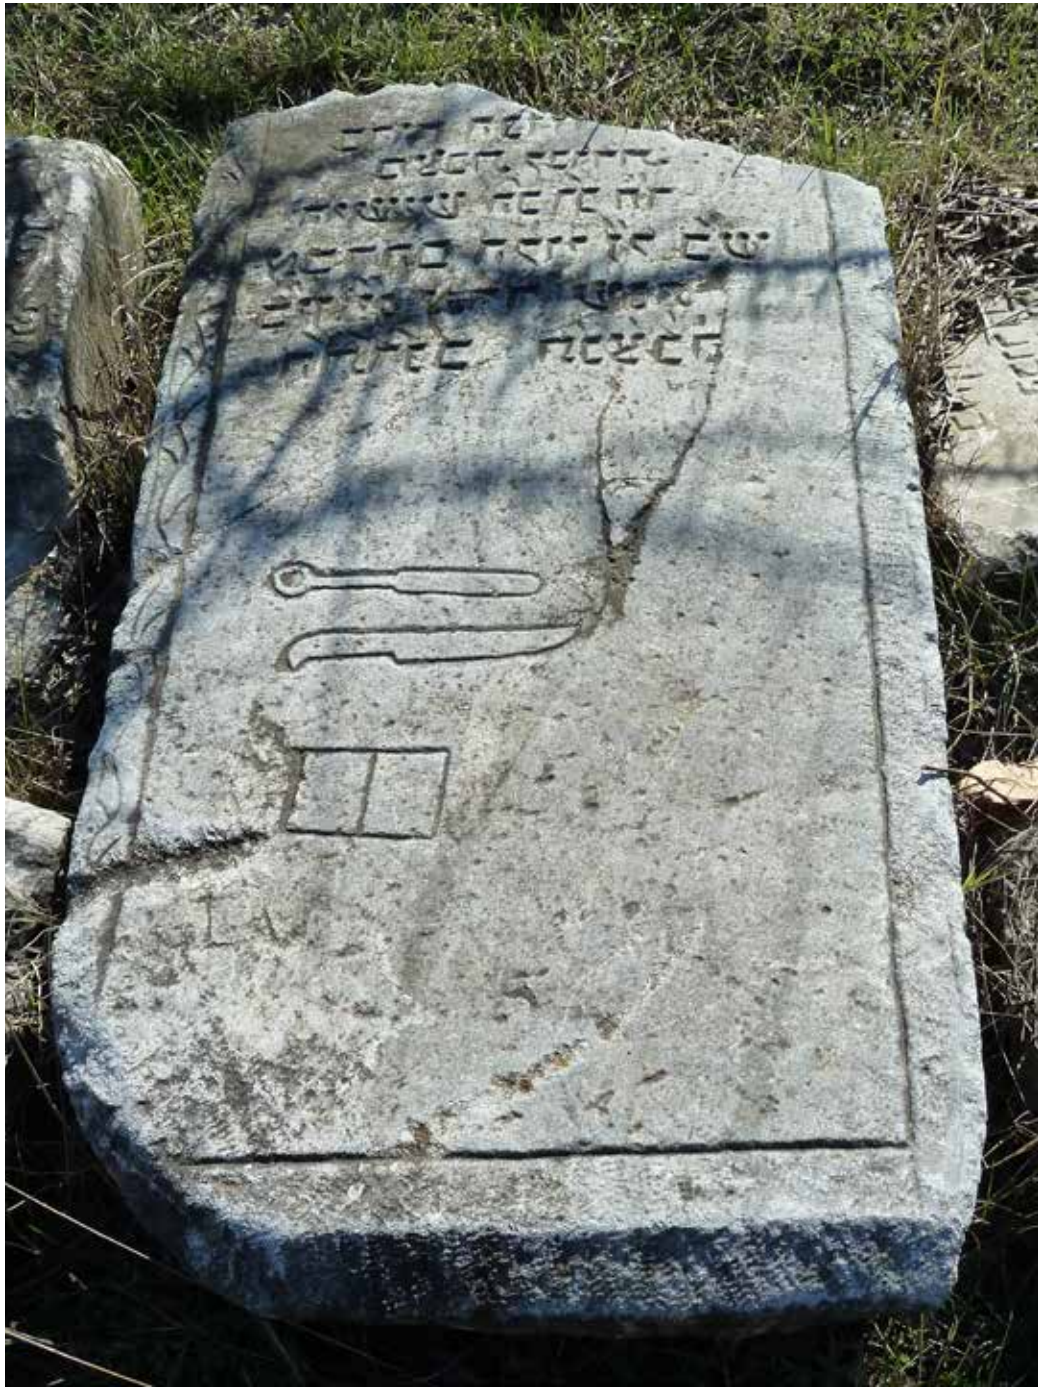
*The Jewish Cemetery
Tire county, Tire Organized Industrial Zone*

Today, the preserved gravestones are in the new cemetery site, which lies within the Tire Organized Industrial Zone, next to nearly 10 graves dating from after 1959. However, there is no available map of the cemetery indicating the limits of the present site delineated for the purpose. Neither is any sign or map indicating its location for the prospective visitor. The cemetery site has no gate/entrance neither an enclosing fence. It presents an image of neglect. The gravestones are laid down in long rows without any apparent order, whether by date of death, name, or any other. The existing foliage and vegetation is untended, and the unobstructed view of the close-by industrial plant clashes the visual isolation required for meditation and remembrance.

Immediate rescue actions are necessary: The overgrown vegetation should be removed, and the gravestones should be uncovered. The land terrace should be repaired where necessary, to prevent landslides and the drifting of gravestones. The precise borders of the site should be delimited by a fence and the main access to it should be clearly marked.

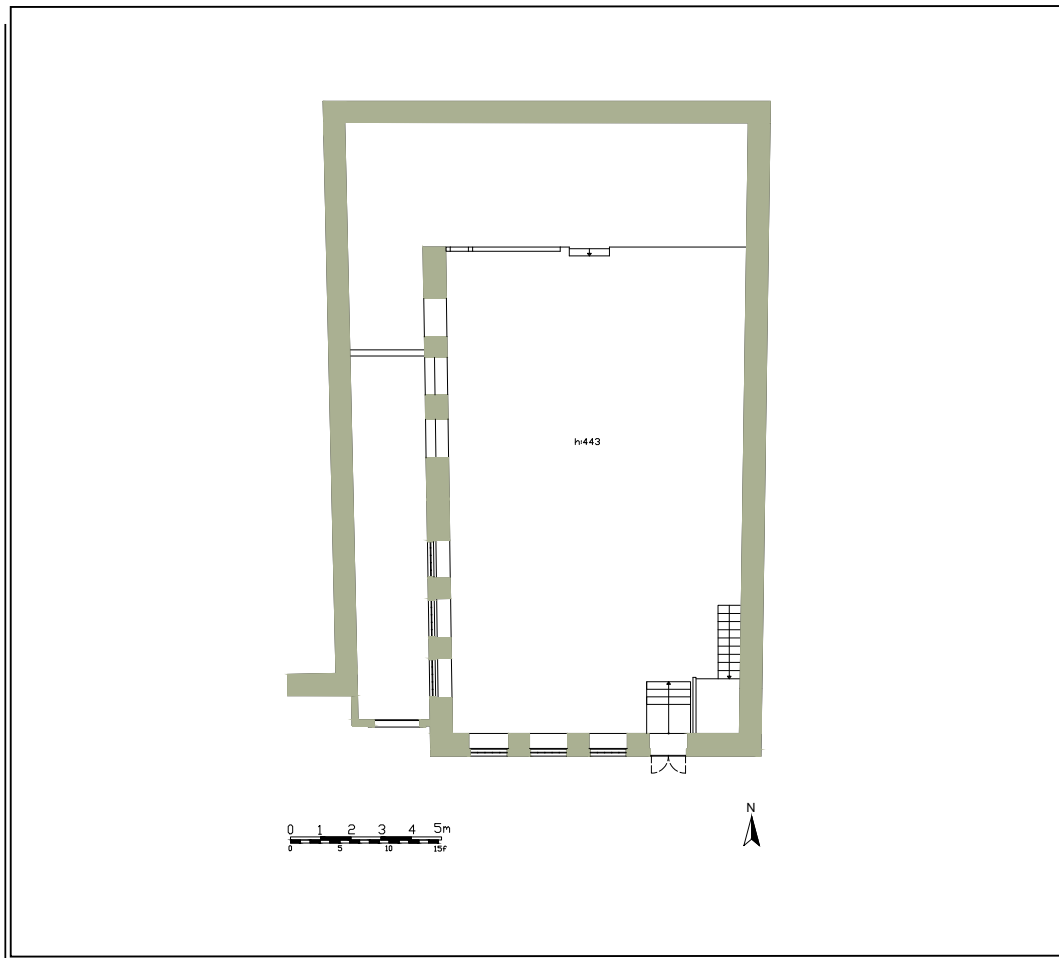
Today the plan layout of the synagogue has altered, and the building has lost its function and is used as a depot. The remaining original fabric are the façade walls overlooking the road and the walls around the courtyard. One of the windows on the south wall has been closed, and the building is accessed through a new door opening at a lower level, benefitting from the slope of the road. Due to various interventions, the other sections of the structure have lost their originality. The current roof and eaves are also not original.

There are no traces of the ehal (ark) or gallery floor. The floor is timber and there is a suspended ceiling. The arched windows in

the walls overlooking the road and courtyard are plastered. The bottom half of the windows overlooking the courtyard have been bricked up, and the courtyard door has a new shutter. Nearly the entire plaster on the exterior has been lost. Due to dampness and plant growth, efflorescence is observed on the stone and brick outer wall. Due to humidity on the east outer wall, mortar and stone surfaces are disintegrating. On the south wall of the structure, at the west side of the courtyard entrance there is a signboard with the name of the synagogue. The building is on a slight sloped narrow alley, close to the main road and surrounded by other historic buildings.

The structure has lost its authentic characteristics, with only the original façade overlooking the road and courtyard entrance being discernible. Vandalism to the interior is prevented since its door is locked. Due to the interventions made over time, the structural stability has weakened, making it susceptible to earthquakes, and rain and damp have deteriorated the walls. A restoration project should be prepared for the structure followed by the implementation of necessary restoration interventions. The structure should also be refunctioned.

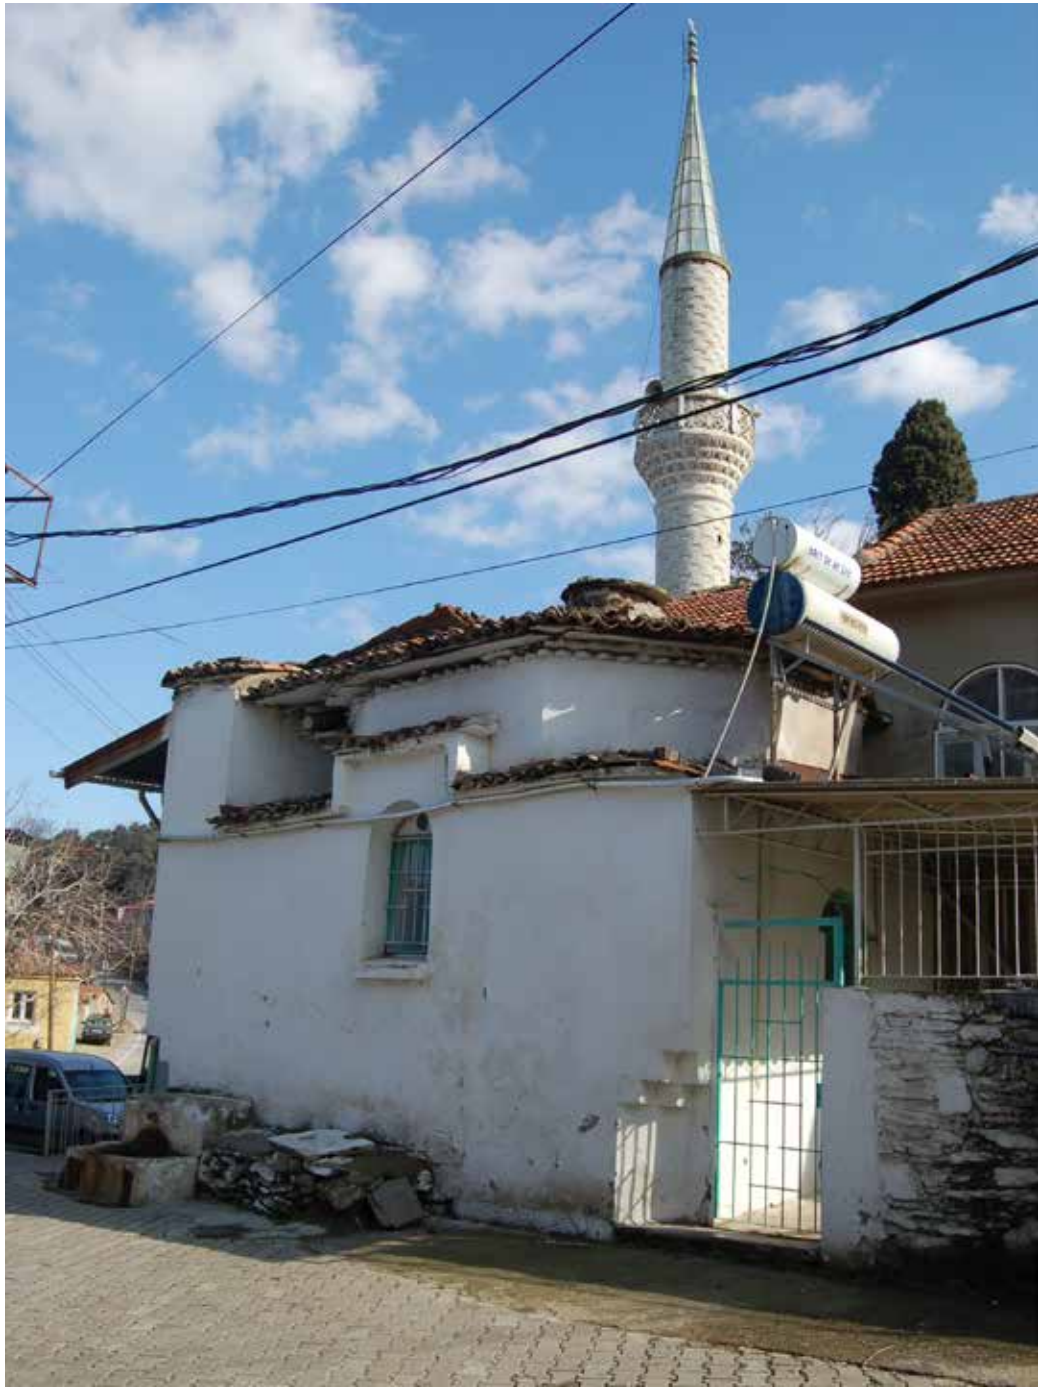
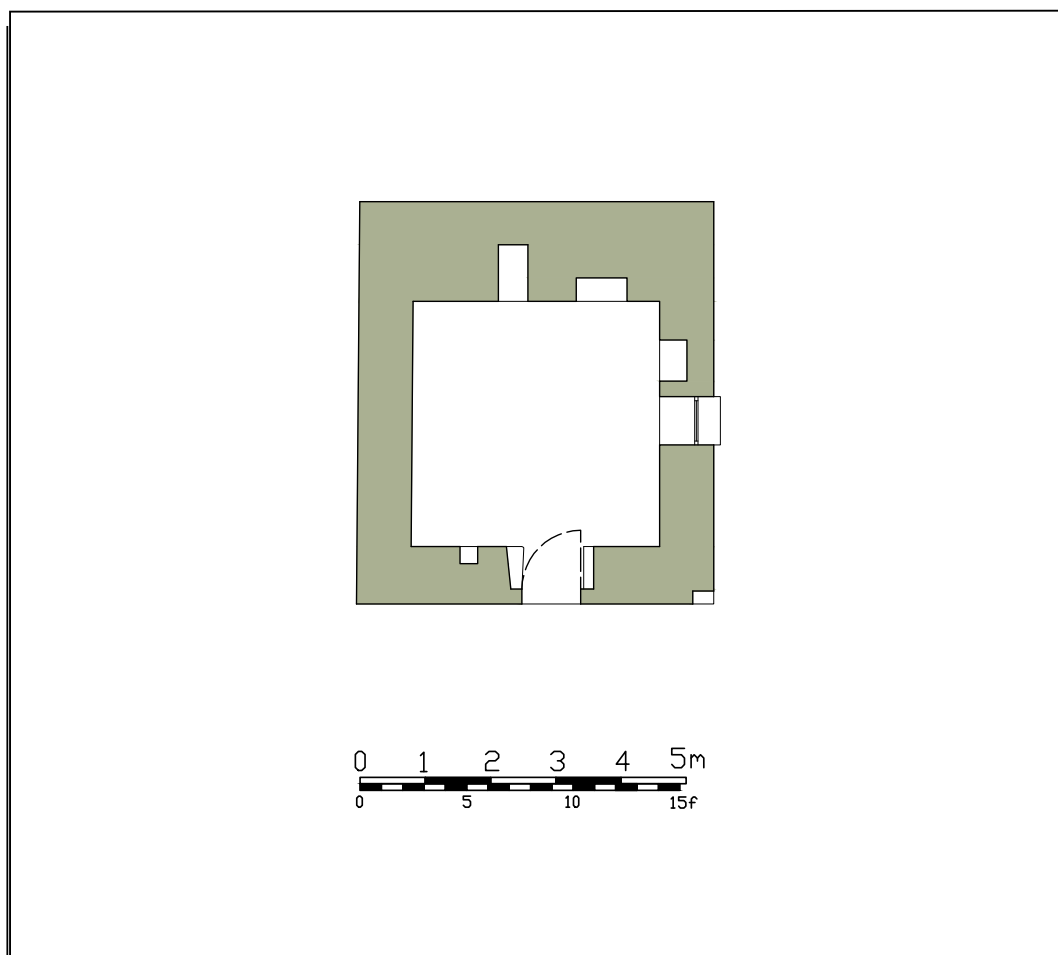
*Church of Saint Kyriaki
Tire county, Ekinhisar village*

It is impossible to ascertain the spatial characteristics of the church although its plan organization is legible. The structure has been partially researched and appears to be in good condition. As it is used by the muezzin of the adjoining mosque, it is being looked after. However, on the façades where the fountain is located, rising damp is visible both inside and outside

Simple repairs and stripping of the plaster layer are required to reveal the original architectural features of the church. Additionally, it is necessary to solve the dampness problem on the façades adjacent to the fountains.

It is recommended that the structure regains its original function and an information panel be put up to increase public awareness.

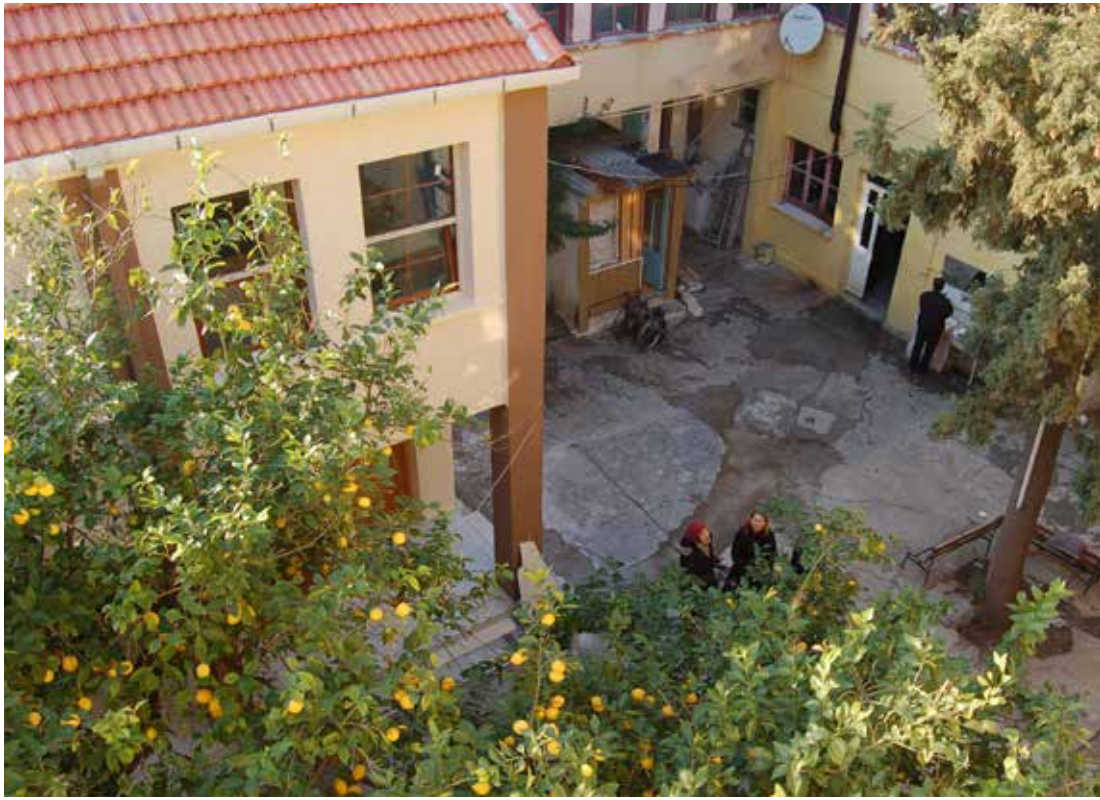
*Cortijo structure no.1
Blocks containing rooms around the courtyard*

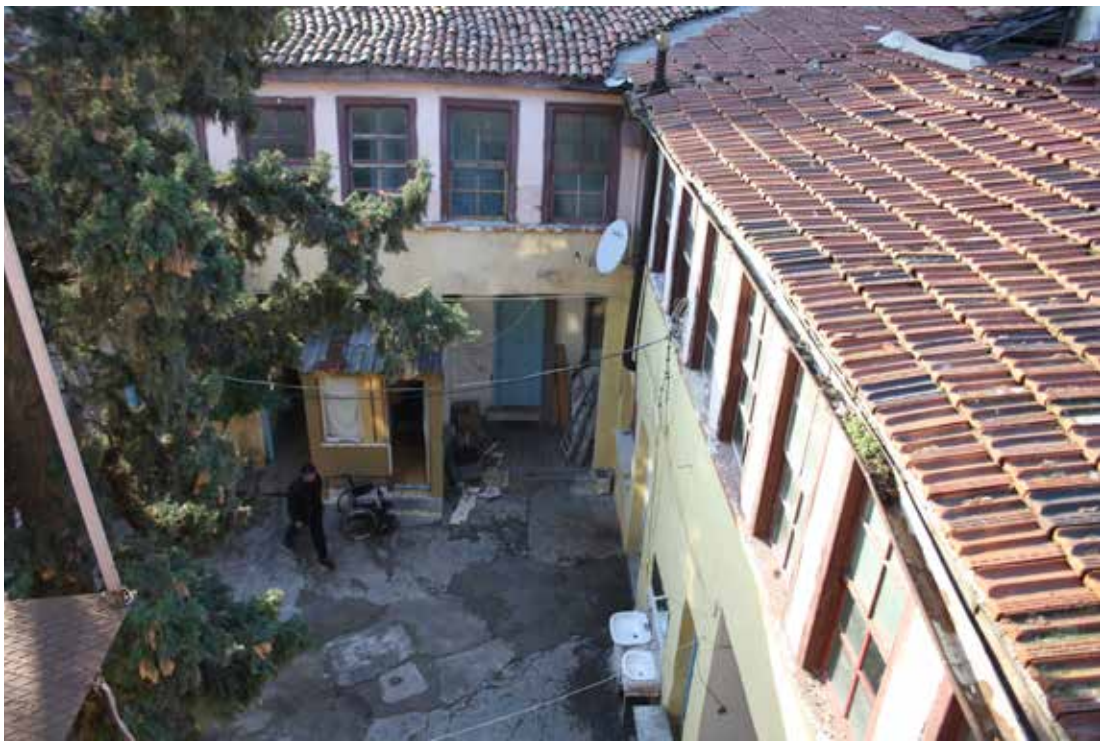
*Cortijo structure no.1
Courtyard and blocks opening to the courtyard*

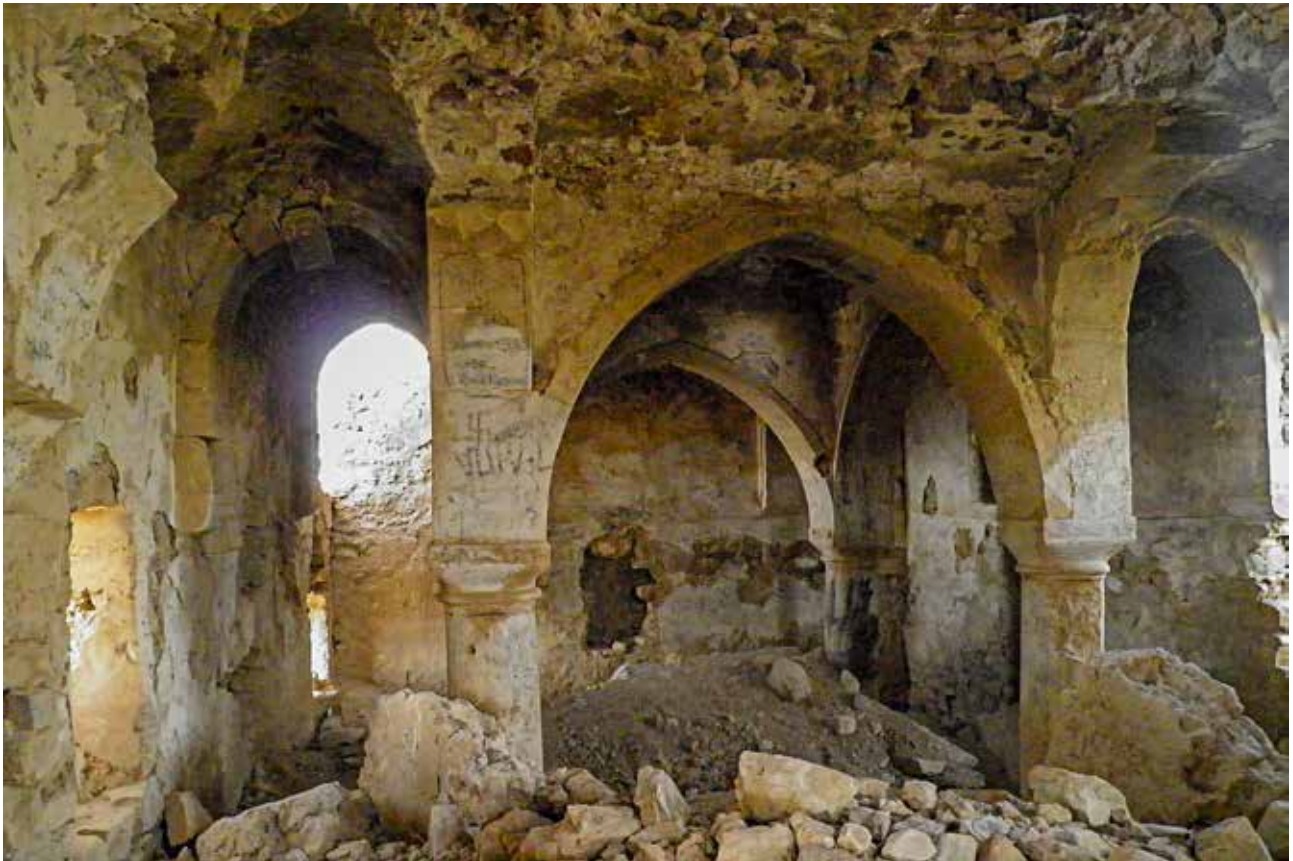
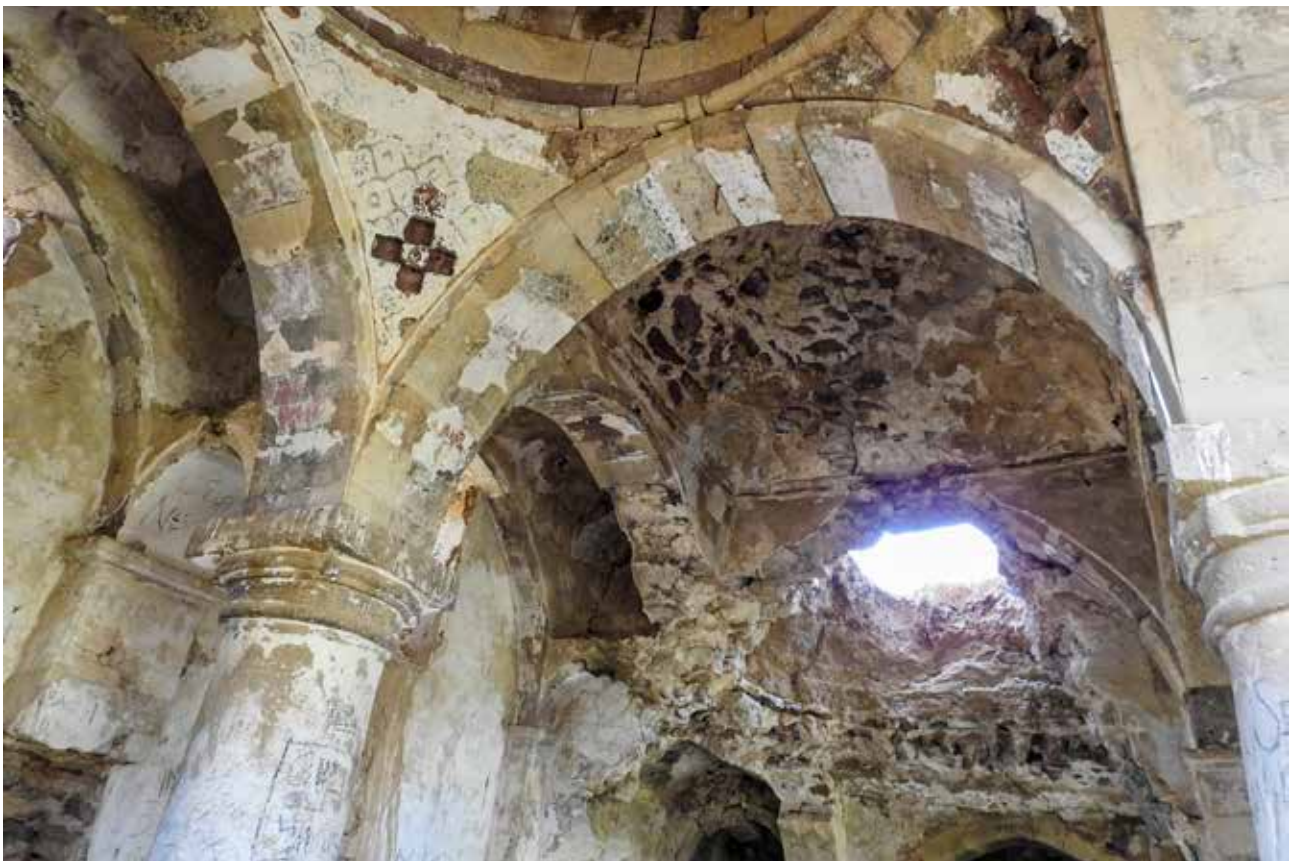
In the stone masonry walls, there are deformations because of natural deterioration and vandalism. One of the supporting columns is completely broken vertically, with the beam

and arch connection was left unsupported. This caused the building to move and resulted in severe fractures in the ceilings and vaults. Similarly, the south wall was detached vertically on two sides. In the interior the pits occasionally dug in the floor probably have led to weakening of the foundations of the structure.

The roof covering has been completely destroyed, filled with a thick layer of soil and occasional plants. The circular opening of the collapsed dome was covered with wooden logs probably during the last restoration (1890-1895). However, currently part of the dome has collapsed. Rain and snow enters the structure through the hole opened in the vault on the other side and the chimney opening in the jamatun. There is no rising damp observed in the structure.

By considering the importance of the structure in terms of societal and architectural history, it is necessary to begin emergency precaution works immediately. Taking account of the structural fragility of the structure, careful interventions should be made before more damage occurs.
