Kayseri
Adana
Izmir
Elazığ
Niğde
Bursa

Assessment Report of Architectural Cultural Heritage

April 2018

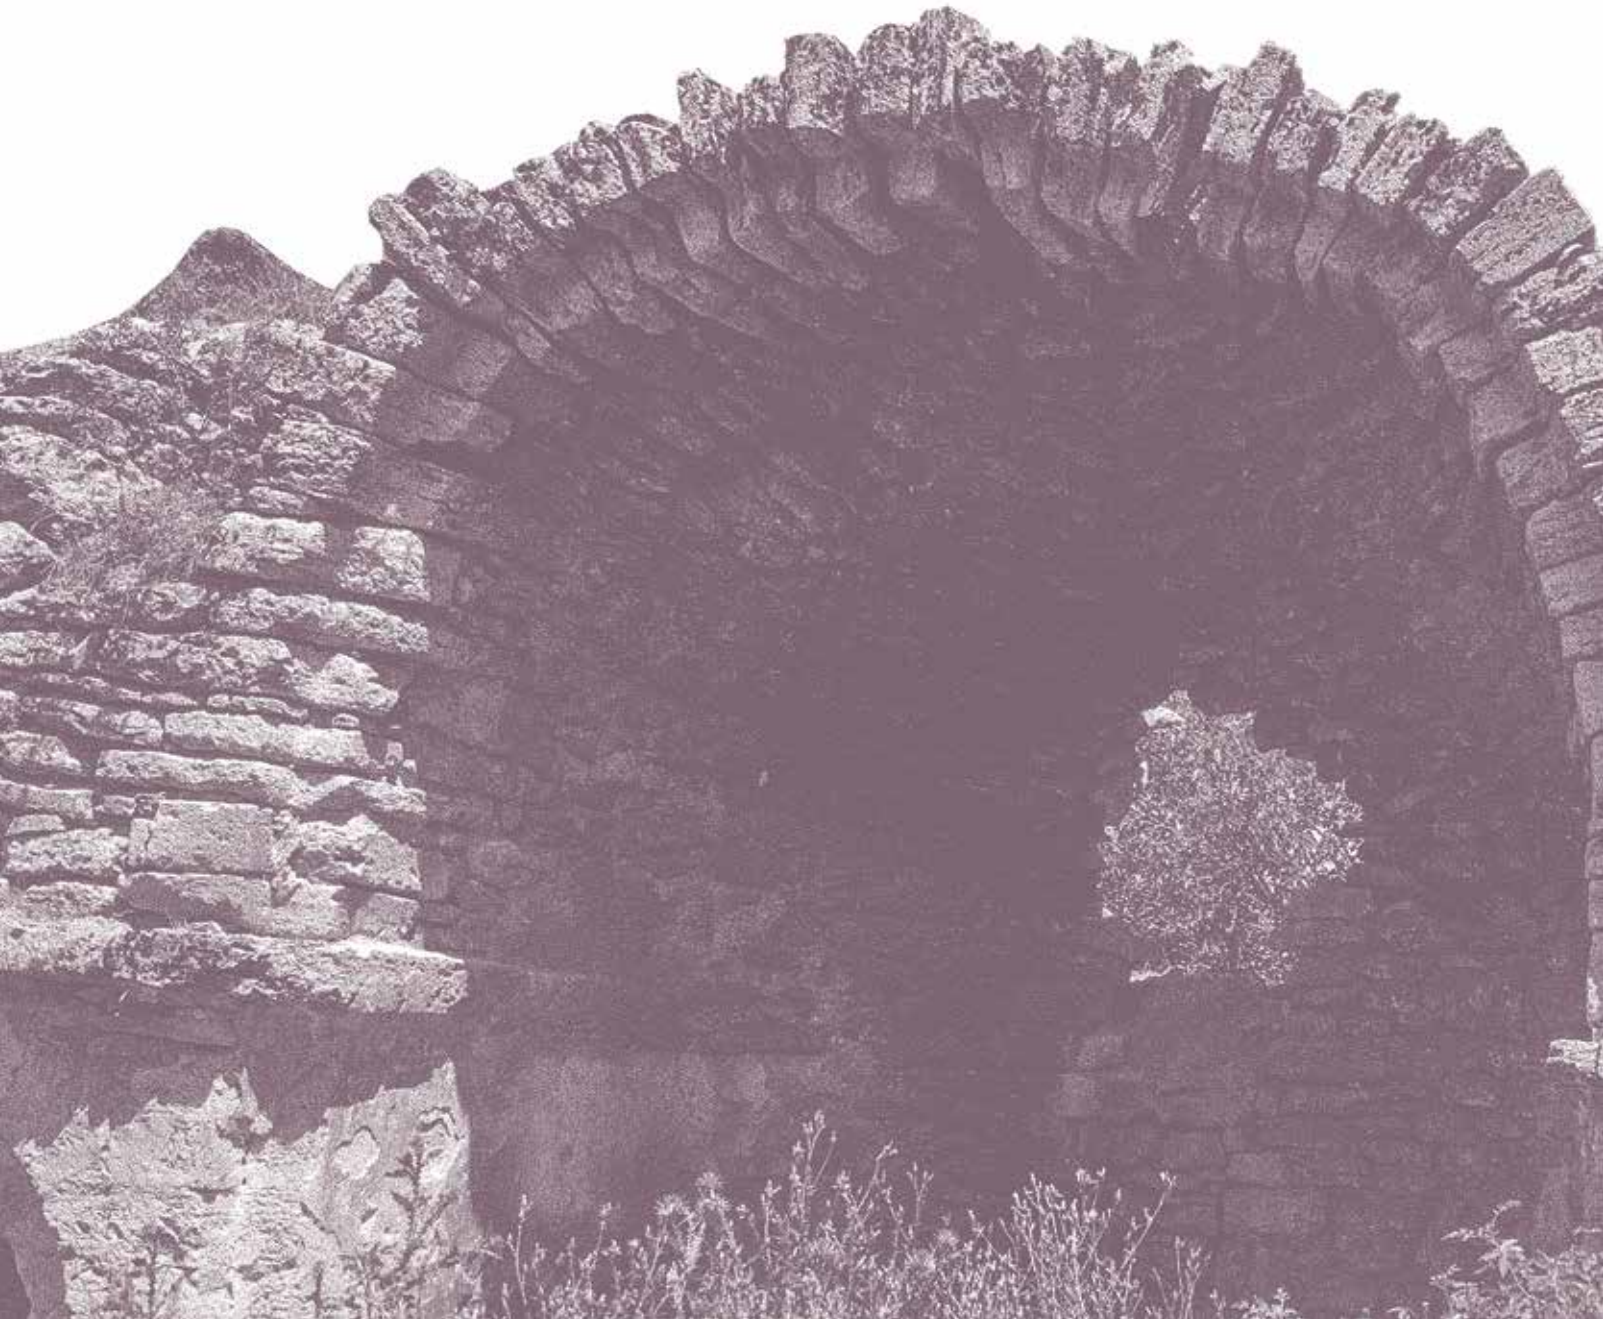
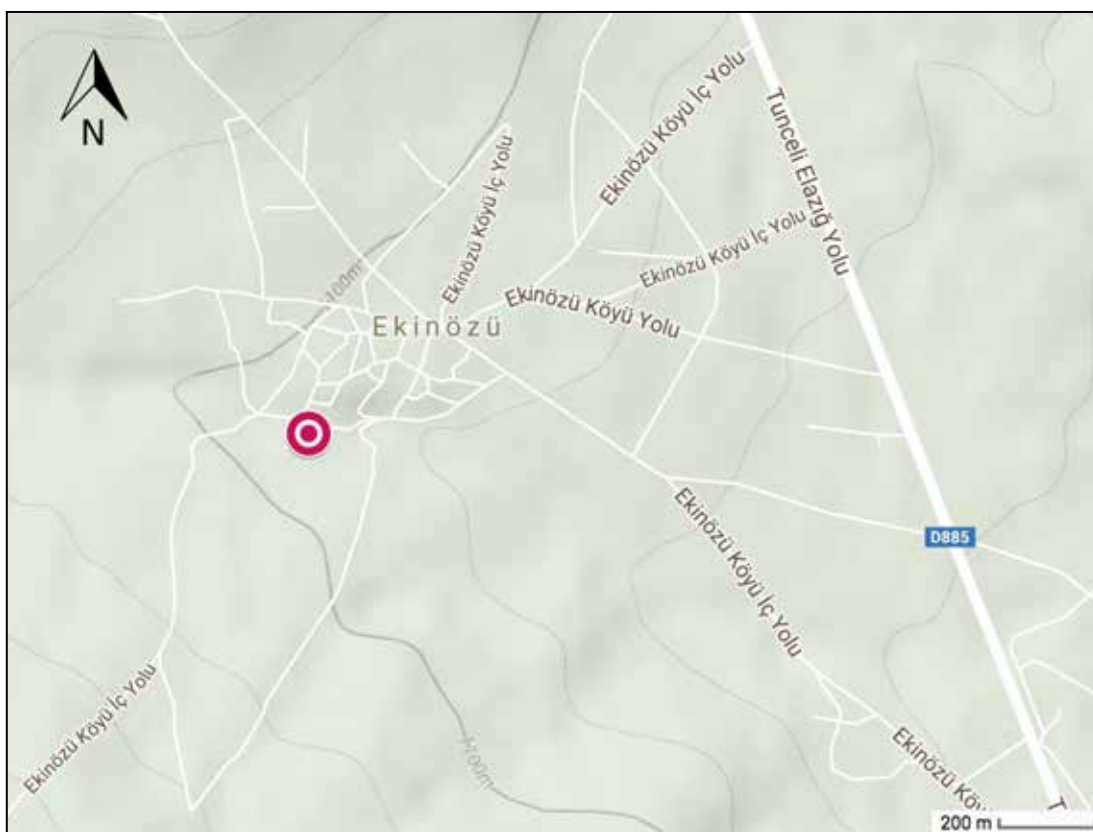
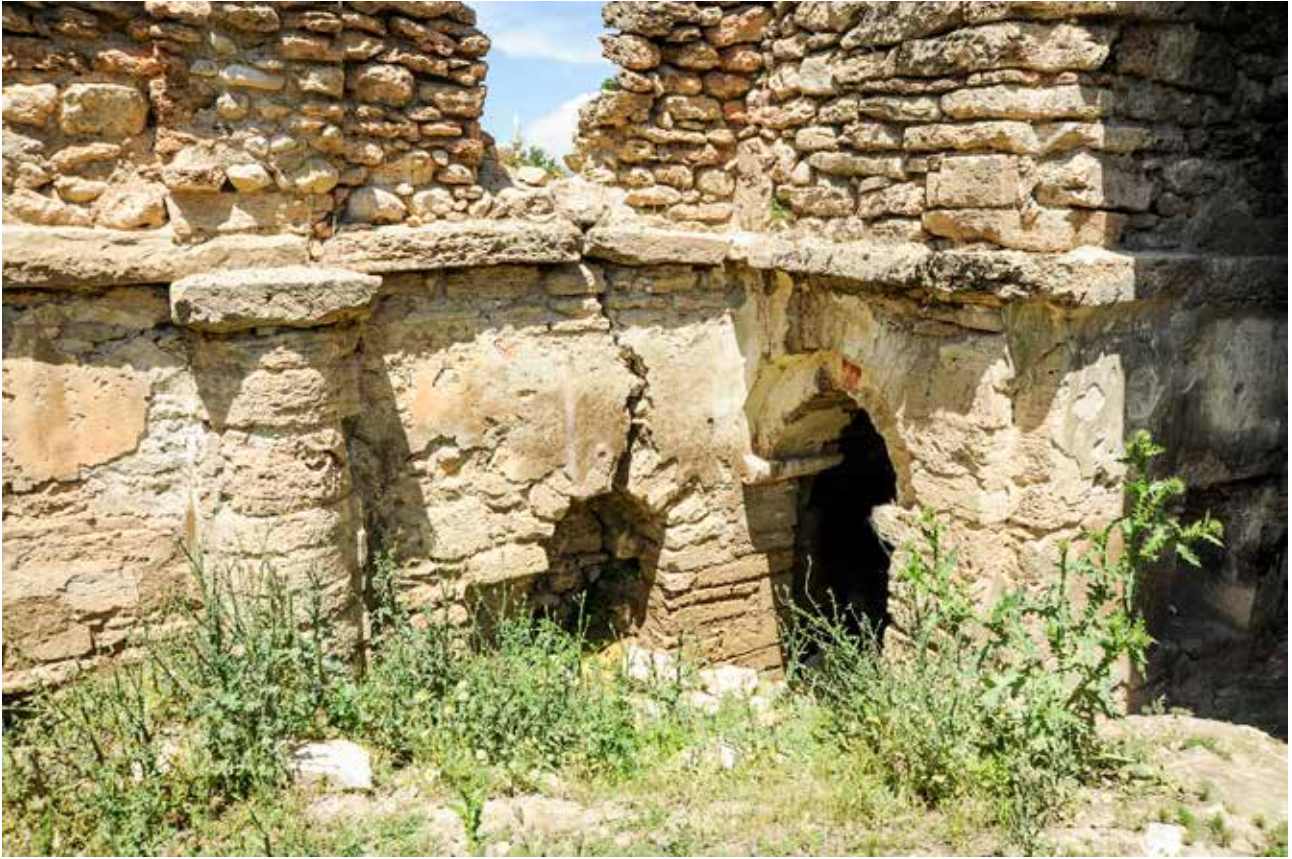
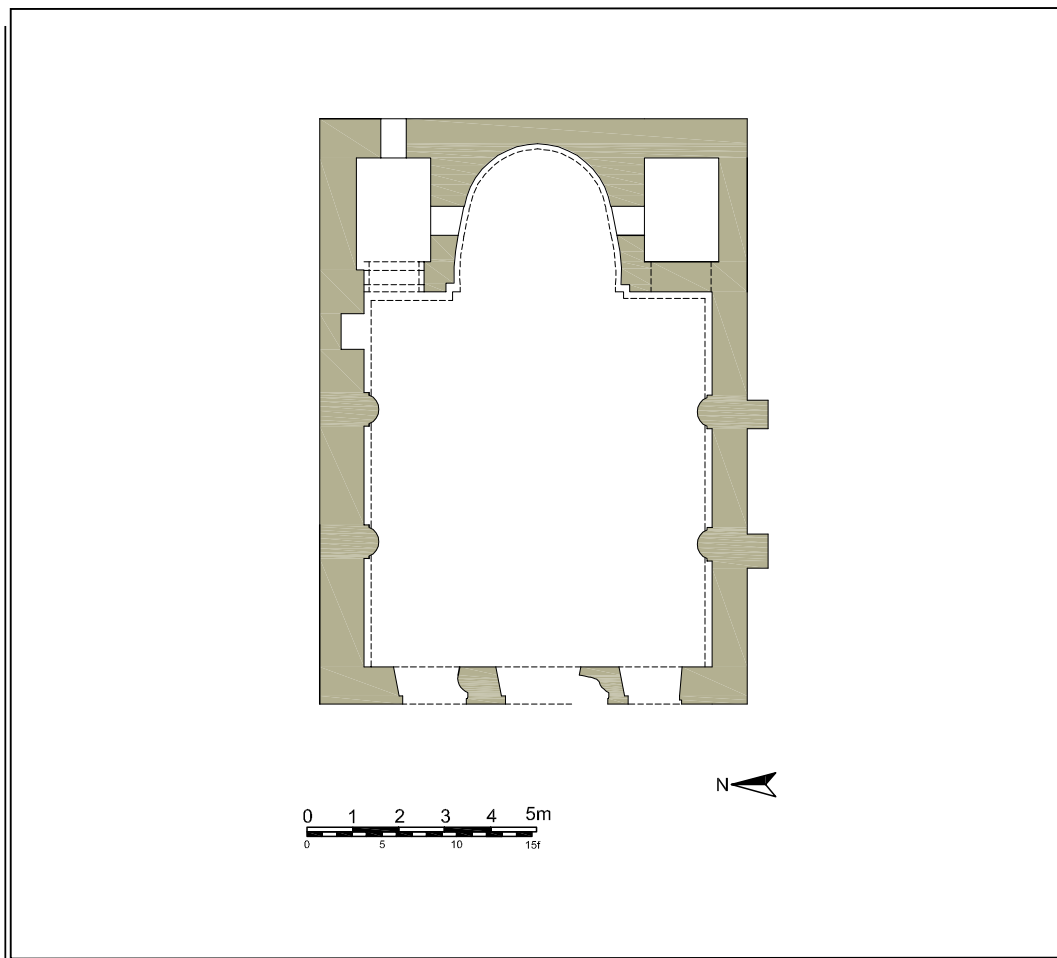
The plan is sufficiently recognizable despite its collapsed parts. The ground level could not be observed. There are no informative traces

observed about the upper structure, except the partial dome above the apse and arches. Nearly the whole structure has significant structural problems. All walls have significant loss of material, in addition to the problem of serious structural fractures beginning above the arches and continuing above the walls. Loss of material, fractures in the monolithic stone sections of the windows on the west wall, general material fatigue, mosses and microorganisms growing above the apse and stone material will lead to serious loss in the future.

Although the structure, with its decorations, visible plan and construction techniques are largely preserved; it has severe structural degradation. The structural fractures

observed largely in the walls may cause collapse of the building in the short term. Additionally, it is completely open to human and natural depredation. With high value due to its architectural characteristics and partial preservation, the structure immediately requires an emergency reinforcement project. Later, a detailed survey, restitution and restoration projects may be prepared and its documentation and repair should be ensured. After the restoration projects and appropriate repair of the structure, the surrounding should be cleaned, arranged and information panels located. A cultural awareness project should be developed to allow villagers to play a role and participate in preserving the structure (e.g. economic benefits for the village and income opportunities for the villagers by tourism should be emphasized) and long-term preservation of the structure should be ensured.

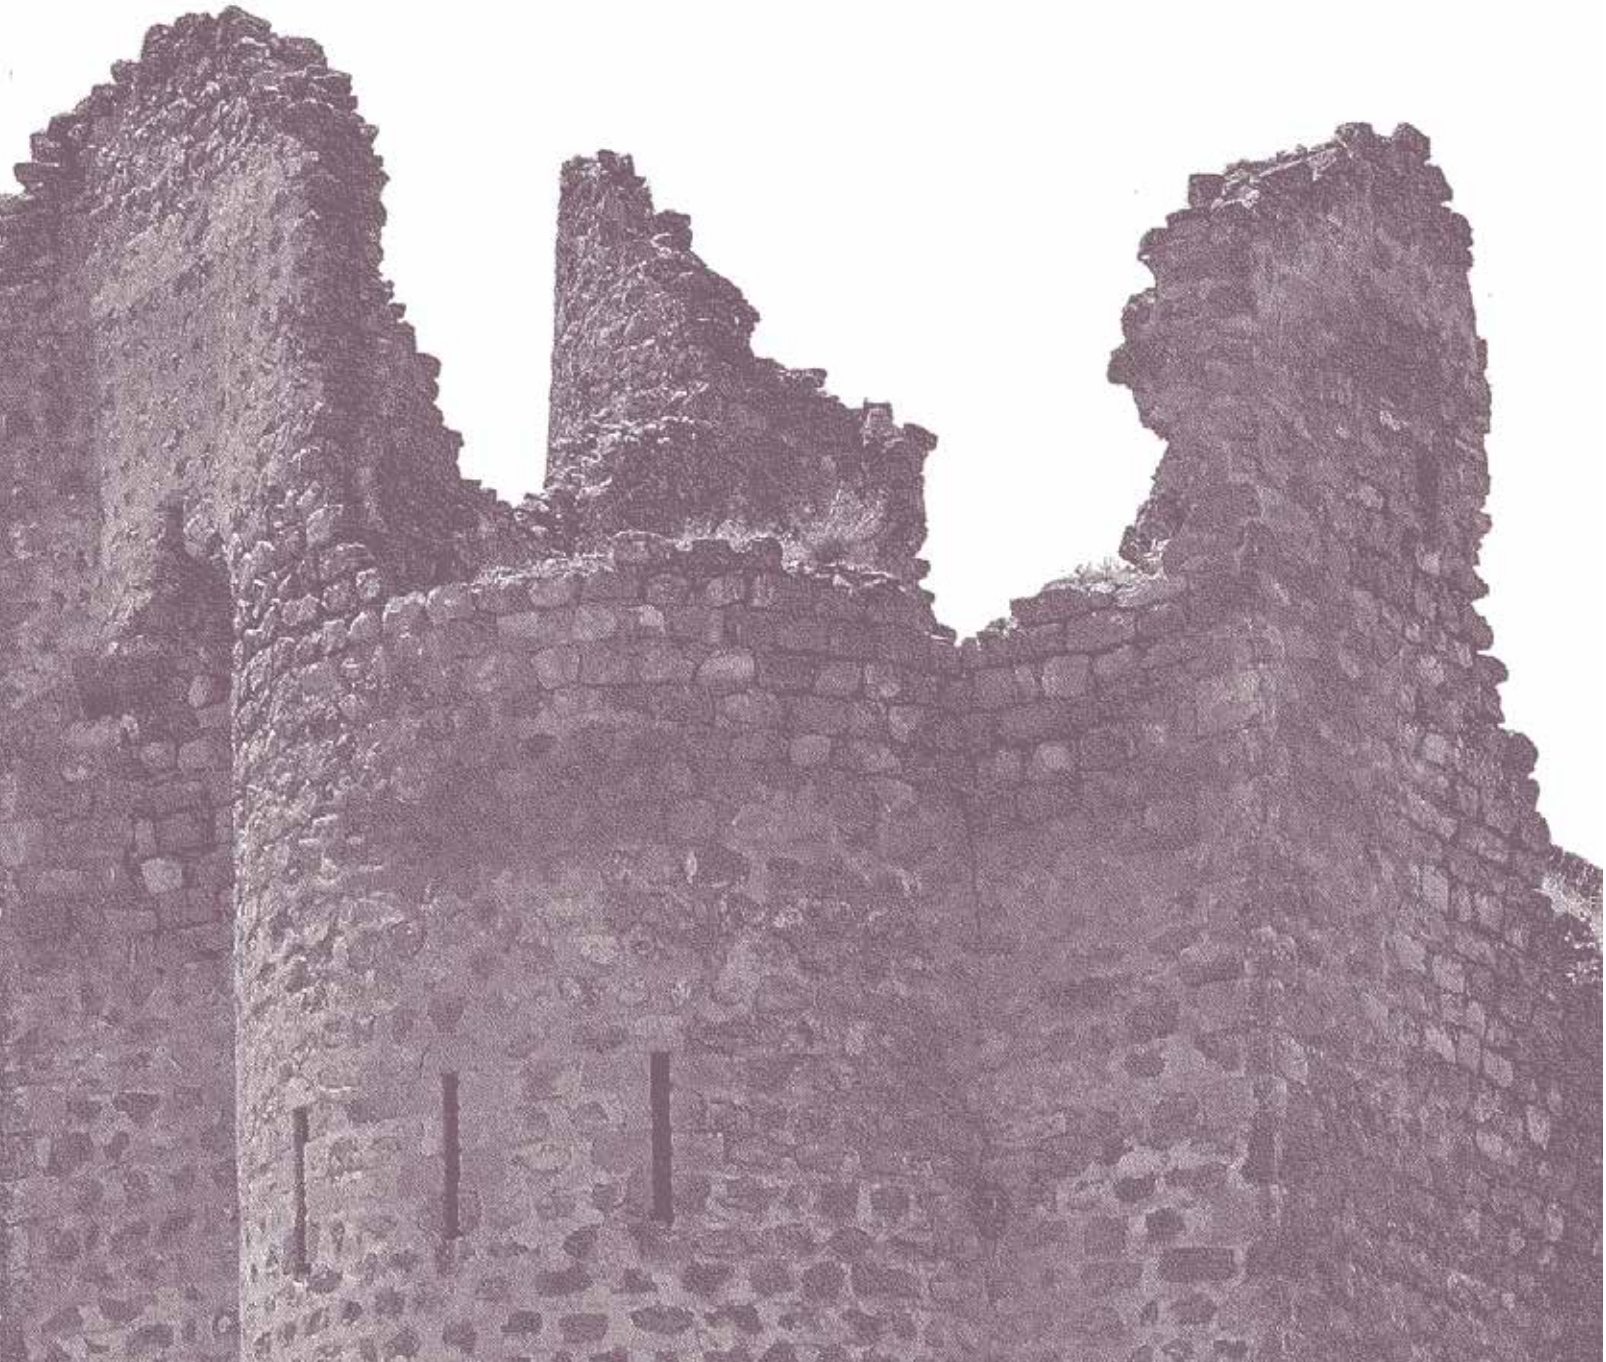
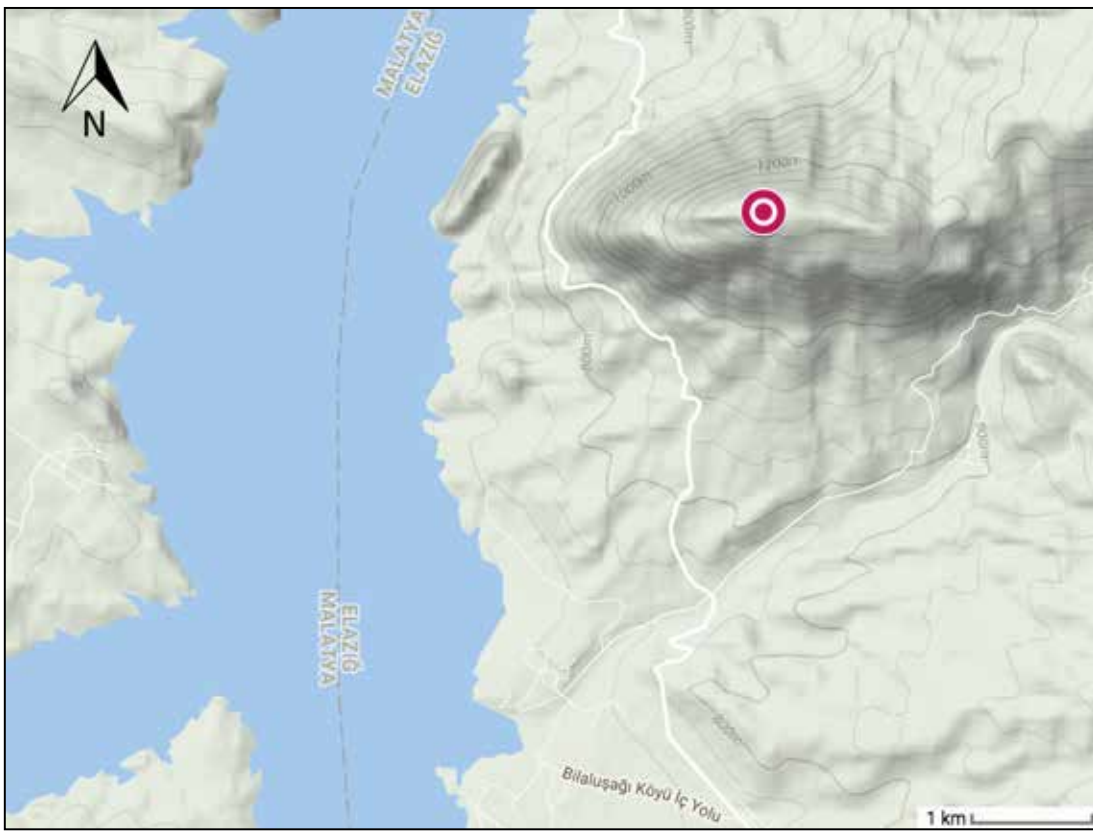
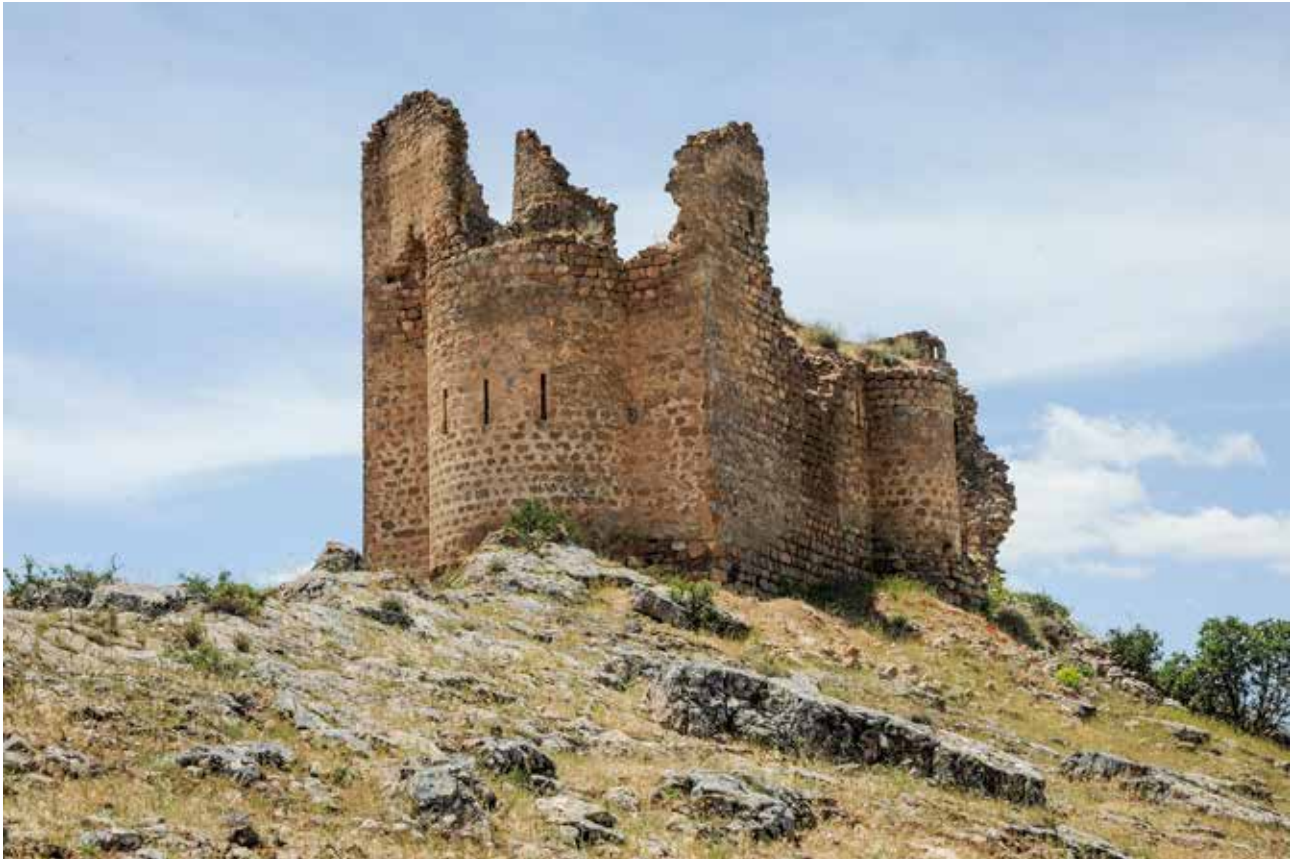
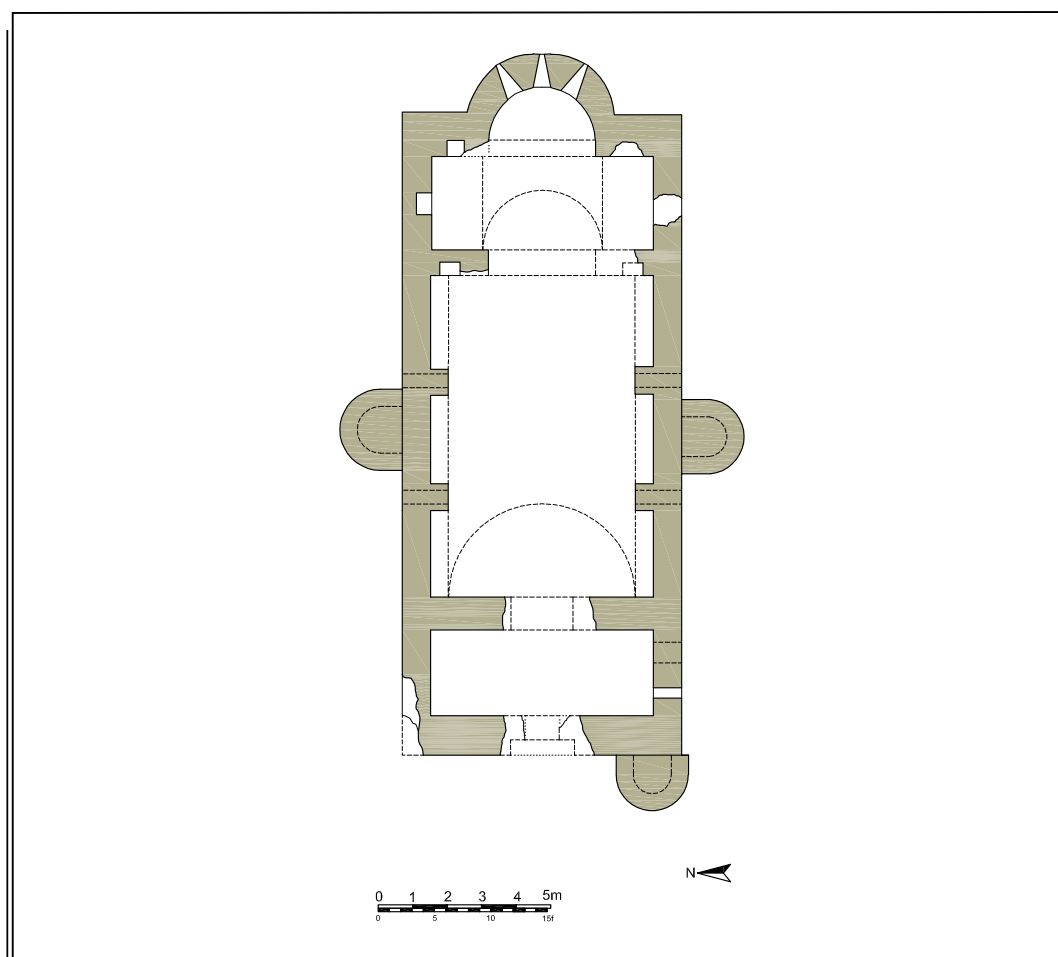
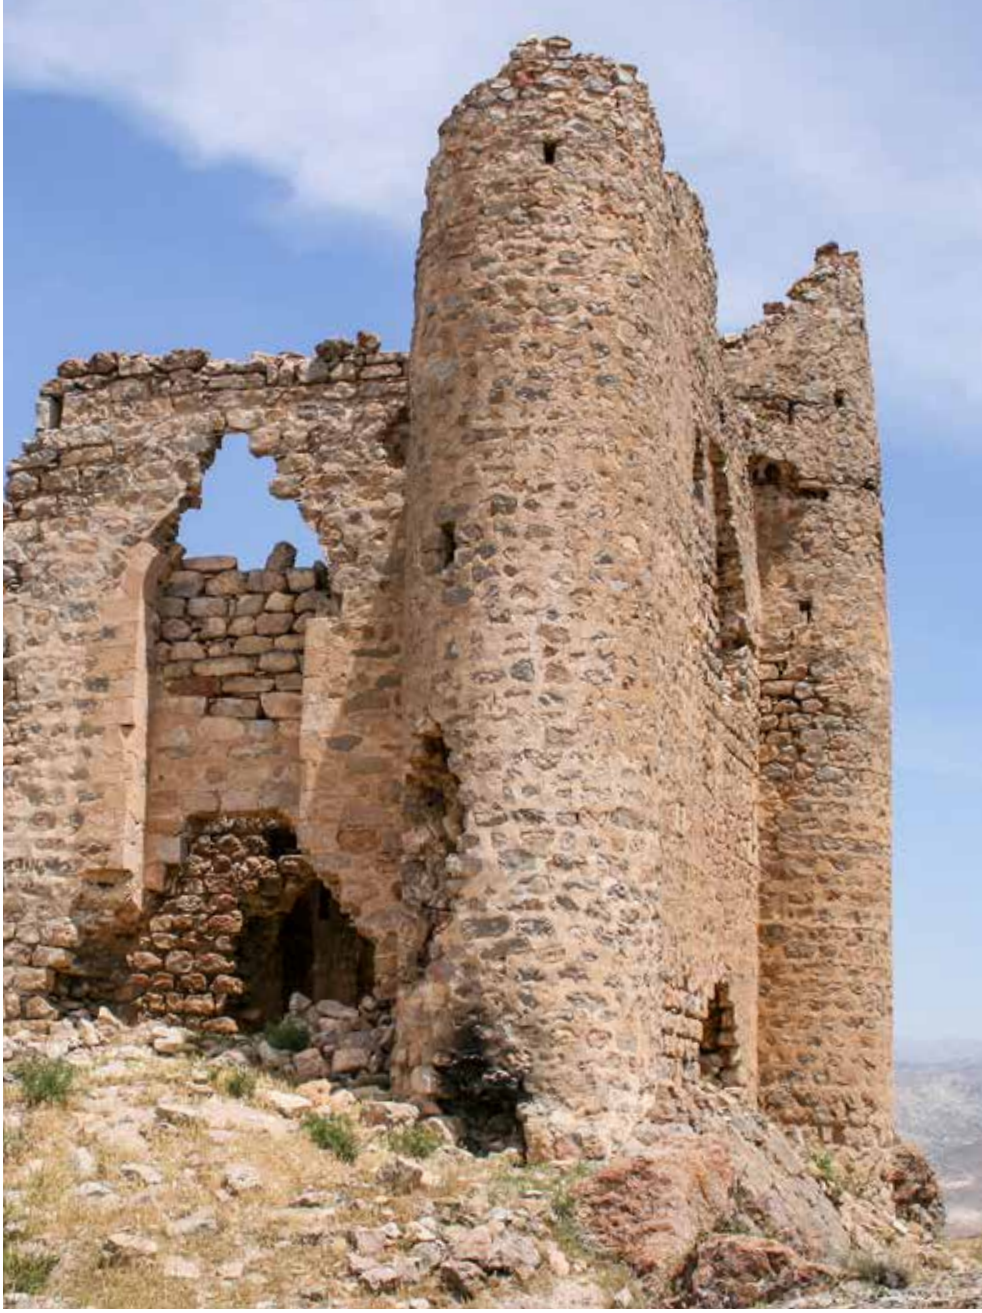
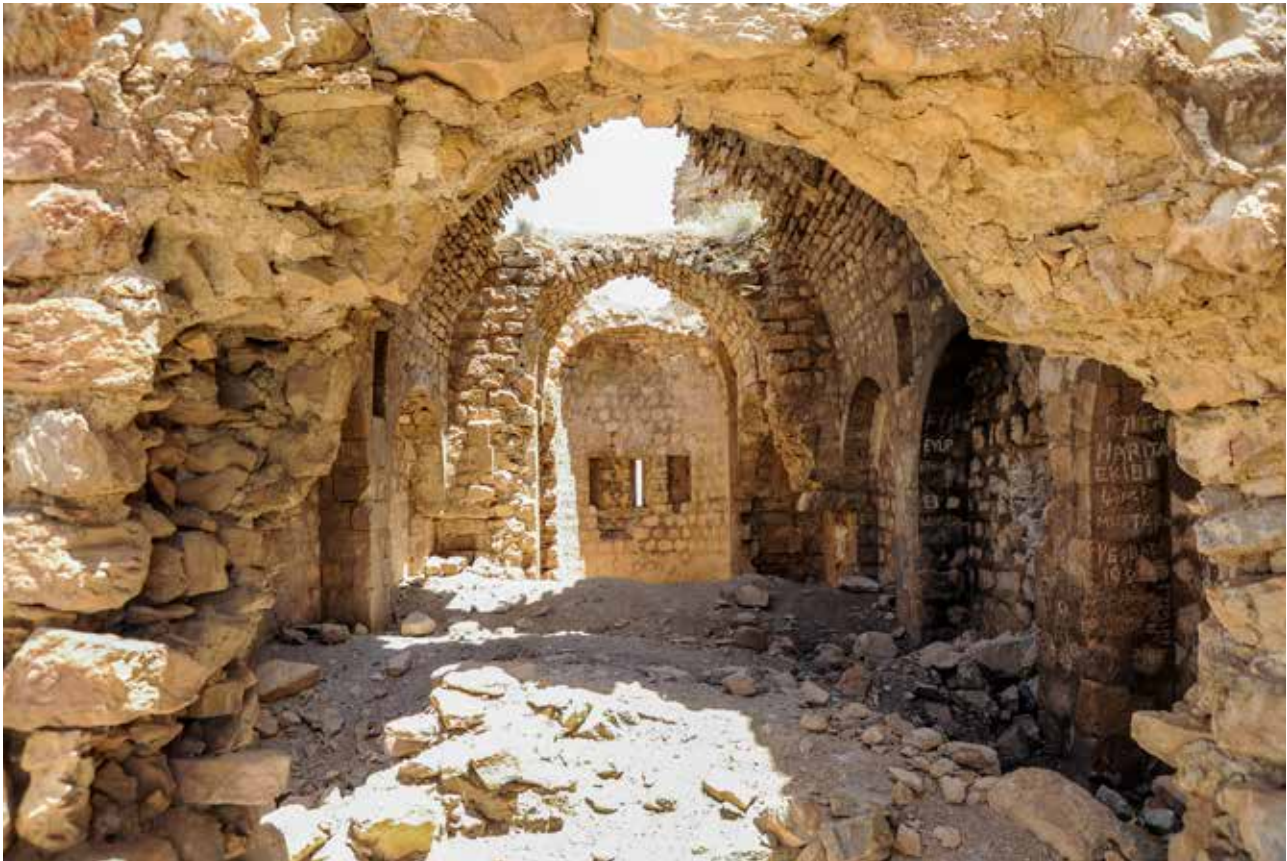
*Monastery of Saint Aaron
Baskil county, Işıklar village*

The monument is in half-ruined condition. The roof of the upper storey and the narthex has mostly collapsed. Portions of the vault as well as several sections of the northern and western walls and towers have holes in them and are ruined. There are large holes in the floor and the apse is in ruin with the altar's podium destroyed. Surrounding the monument, mainly in its western vicinity and the graves nearby,

The monument urgently needs to be secured for the stabilization of its walls and towers, and for repairing of the vault. The church and the rocky territory around it should be declared as an archaeological site, and controlled against treasure-hunters. Further archaeological surveys and excavations should be carried out for detailed investigations. Detailed architectural conservation works should be initiated. In the short term, a landscaping project with an information panel should be prepared.

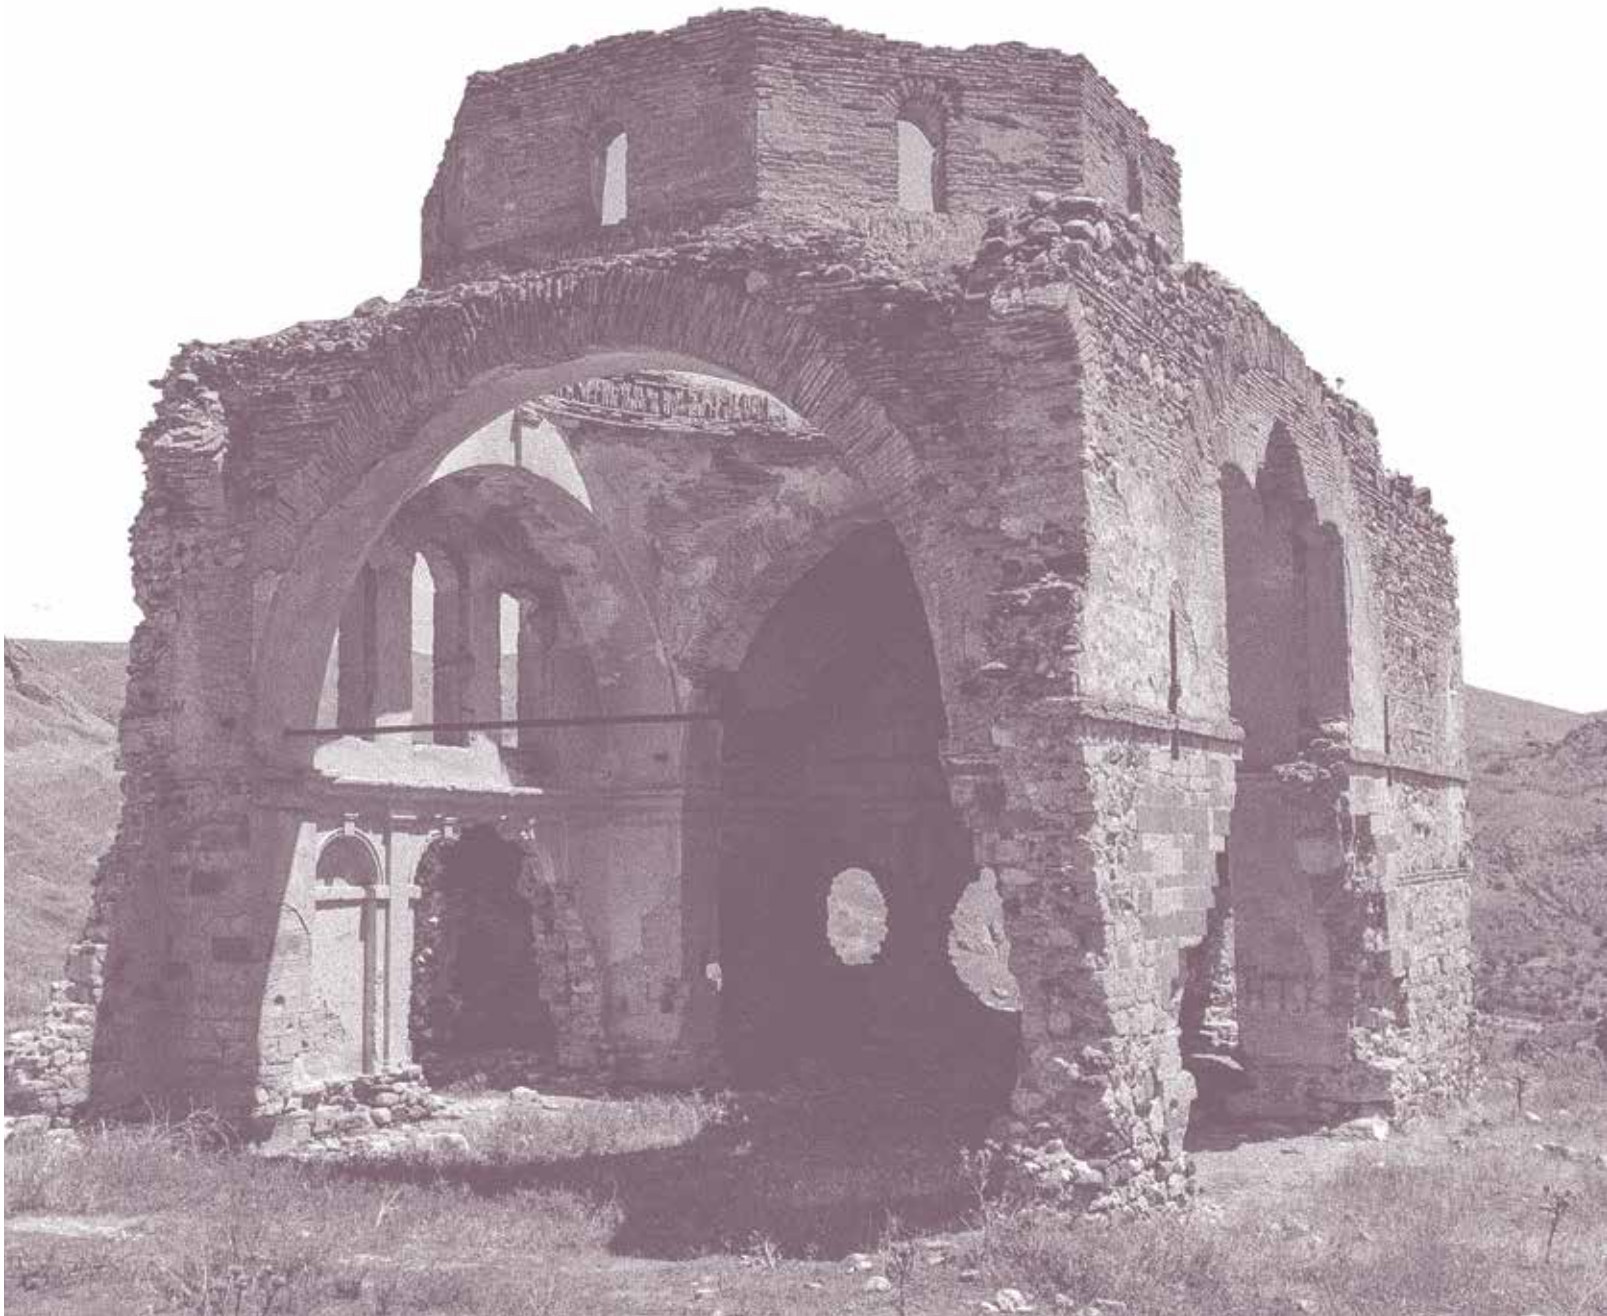
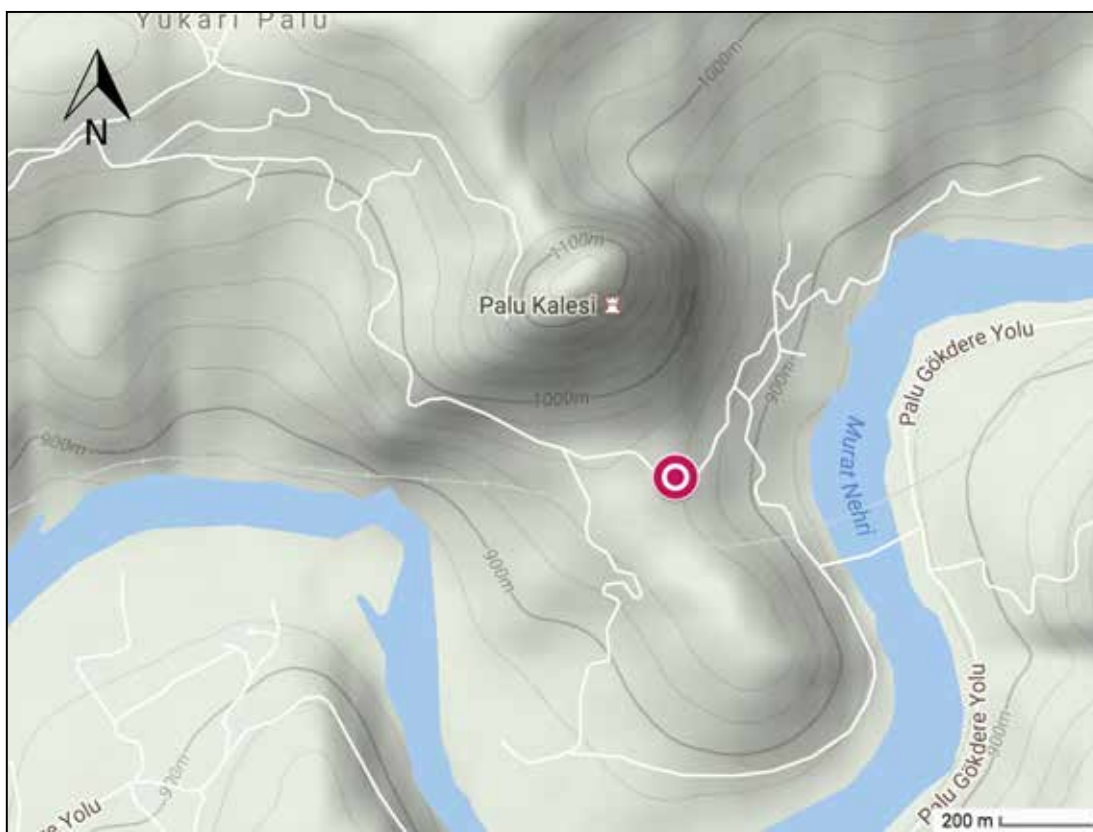
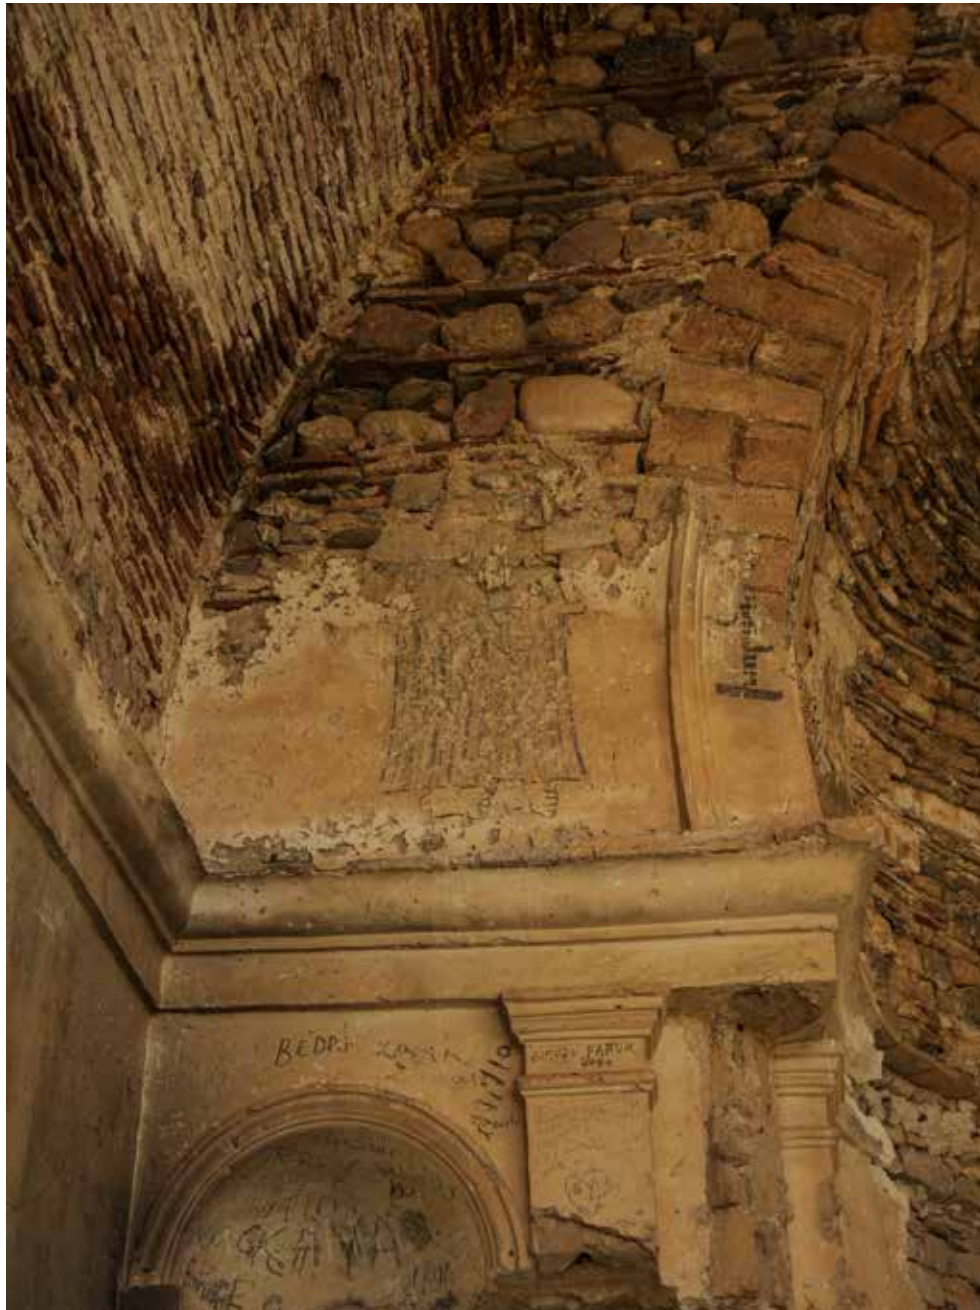
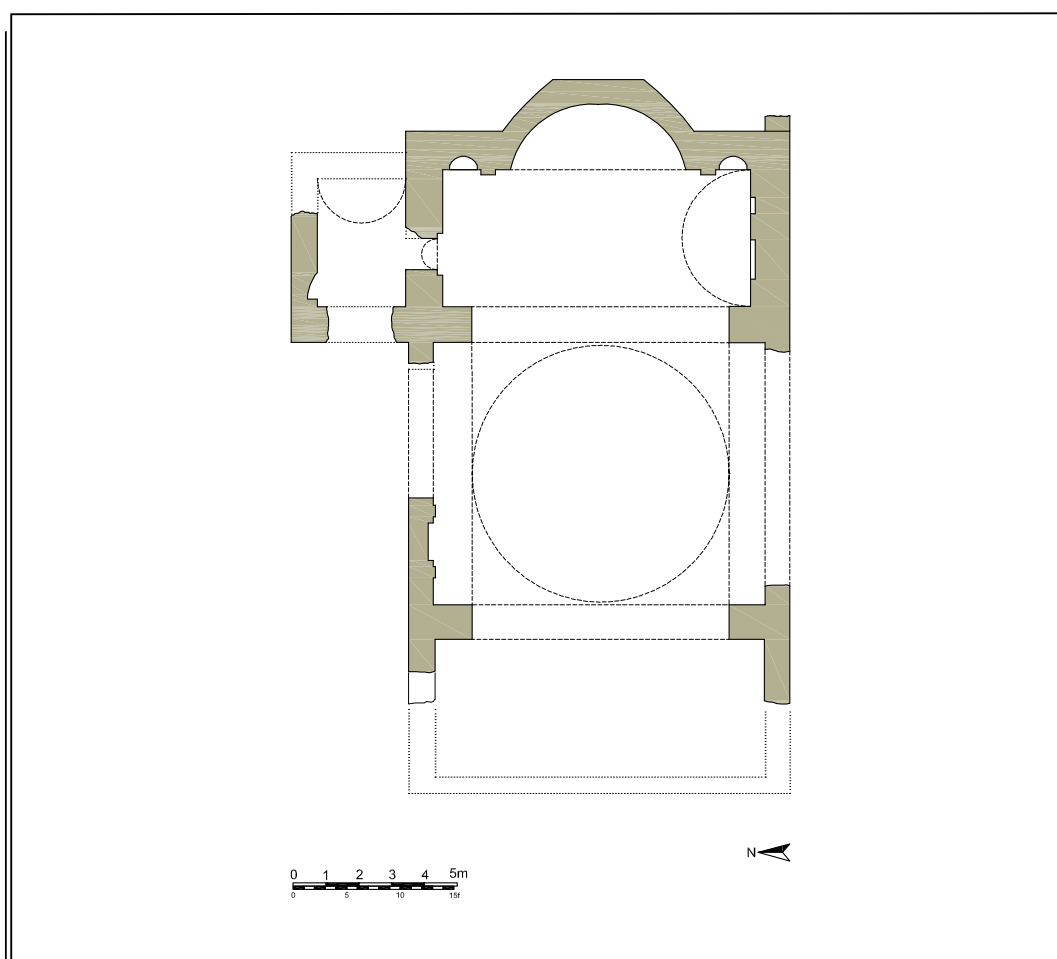
*Church of Saint Gregory the Illuminator
Palu county, Aşağı Palu neighborhood*

The upper and lower window openings in the south wall are partially demolished. The lower floor opening in the south wall is not visible while the upper floor windows are preserved. The west wall has been completely destroyed. There are wall pieces observed continuing toward the north and south walls. The projecting apse has been partially demolished. Though the apse wall is preserved, there are large cavities. Only the octagonal drum and the windows in the drum under the dome have been preserved with the dome itself demolished.

On the interior, the plaster, inscriptions and portraits have been largely destroyed. There are problems related to material loss, corrosion and damp. Additionally, the damage caused by treasure hunters to the structure is severe.

Severe degrees of structural deformation were observed. There were collapses of the outer walls, arches and supportive corner pillars and excavations under the foundations. Some main walls have been destroyed. It is open to human and natural depredation and structural disruption increasingly continues.
