Kayseri
Adana
Izmir
Elazığ
Niğde
Bursa

Assessment Report of Architectural Cultural Heritage

April 2018

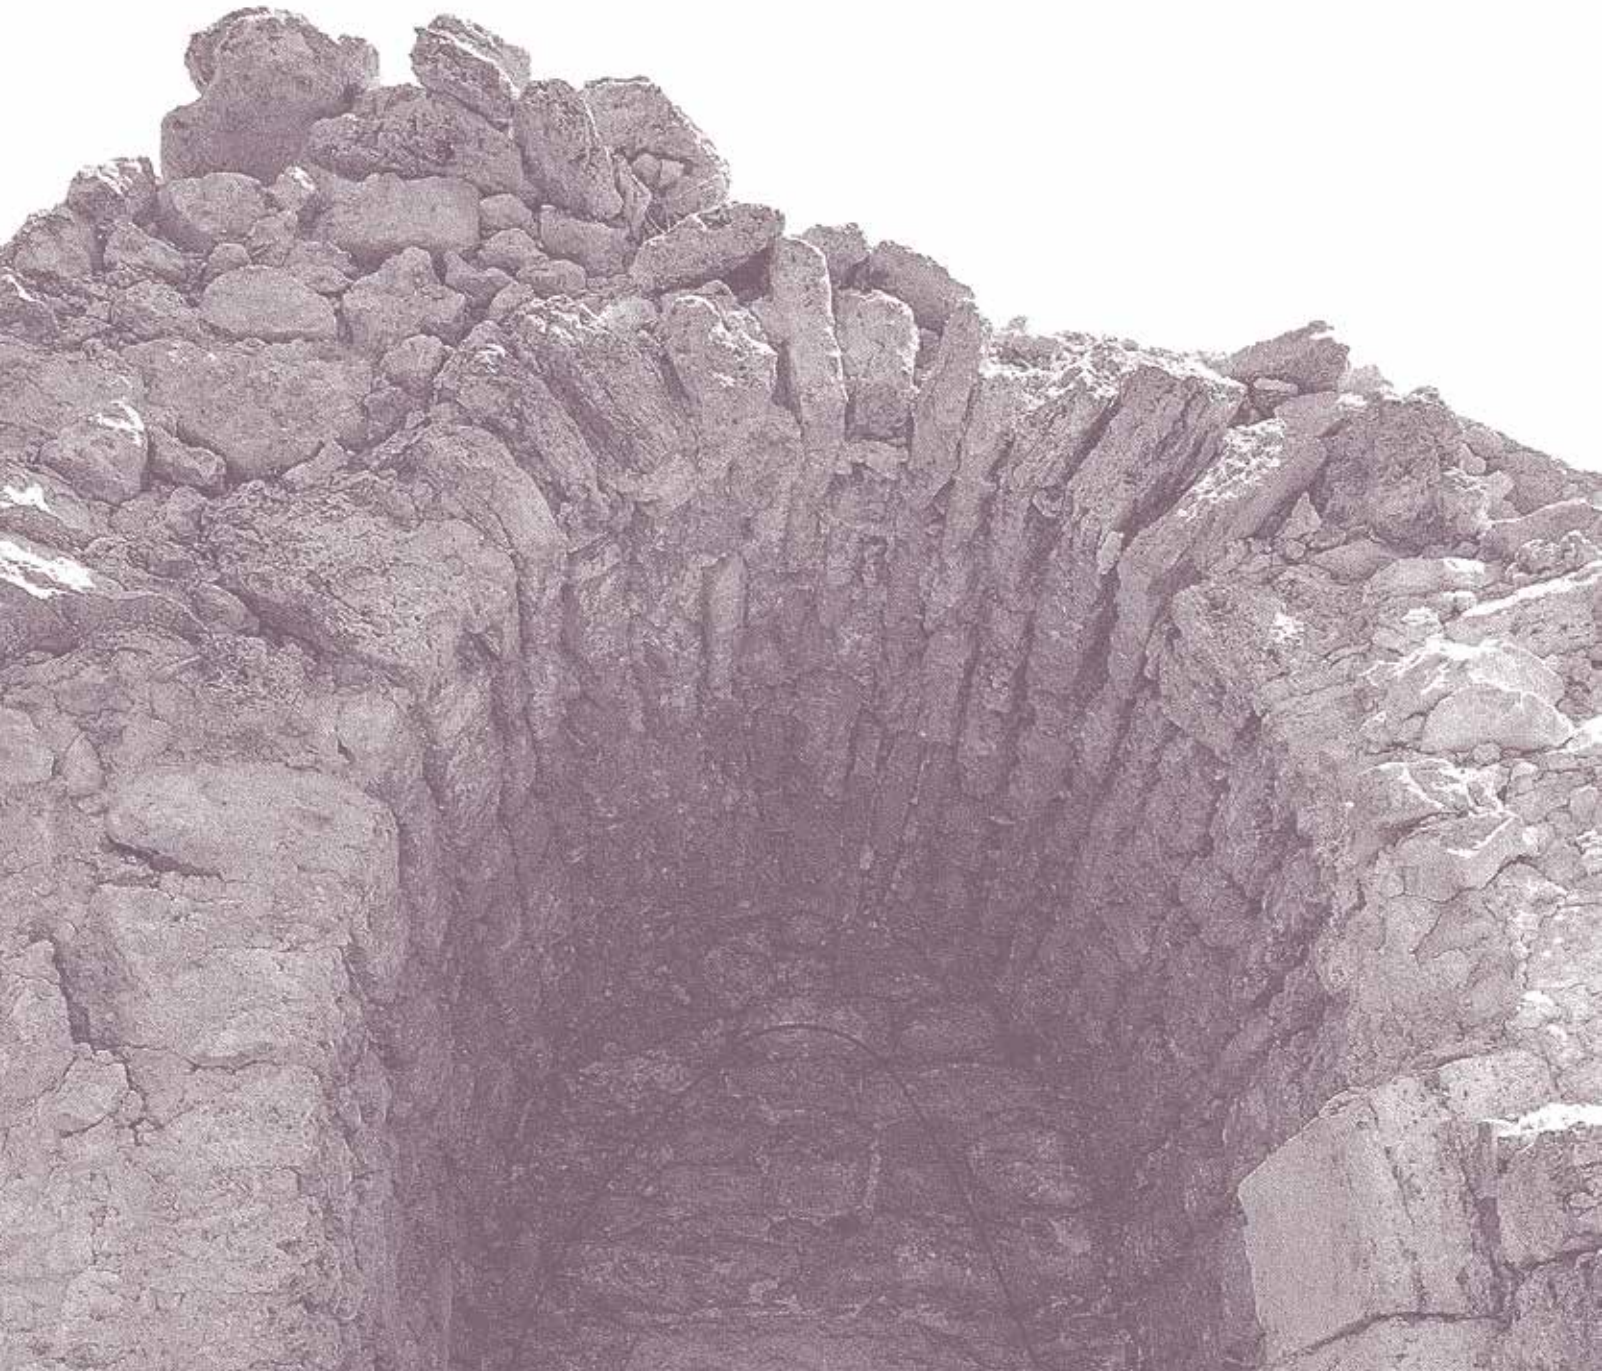
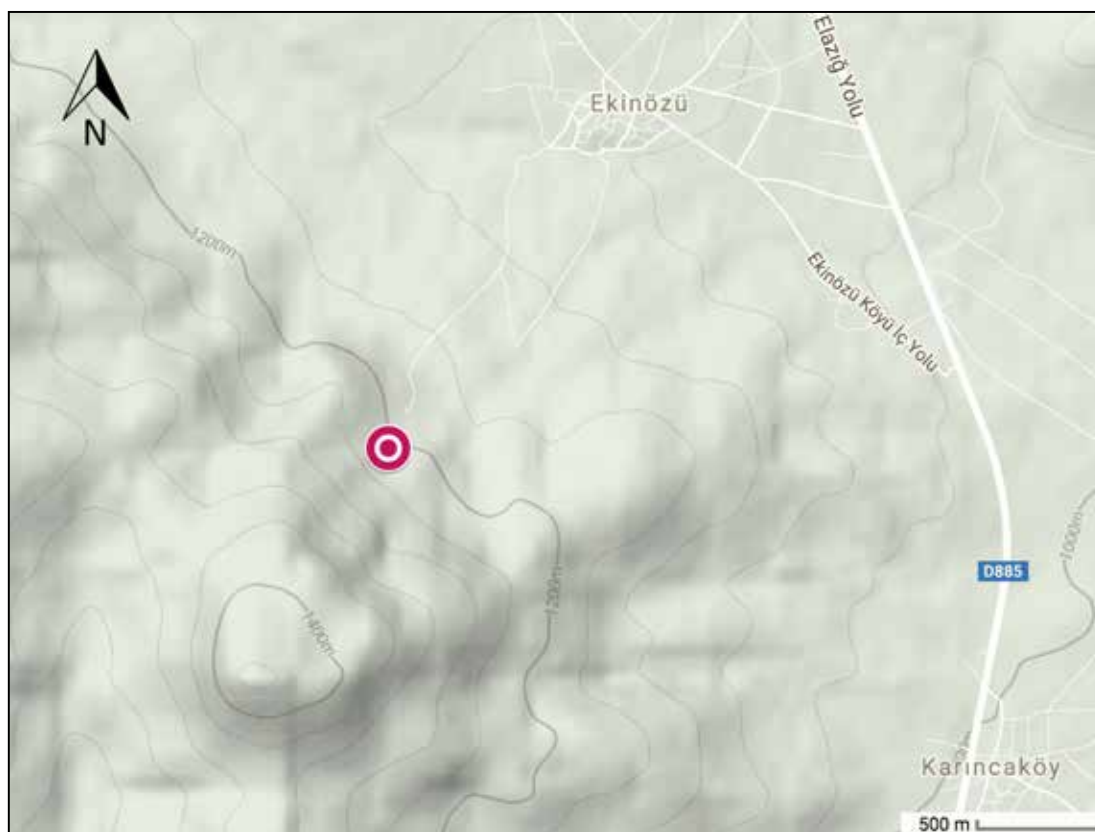
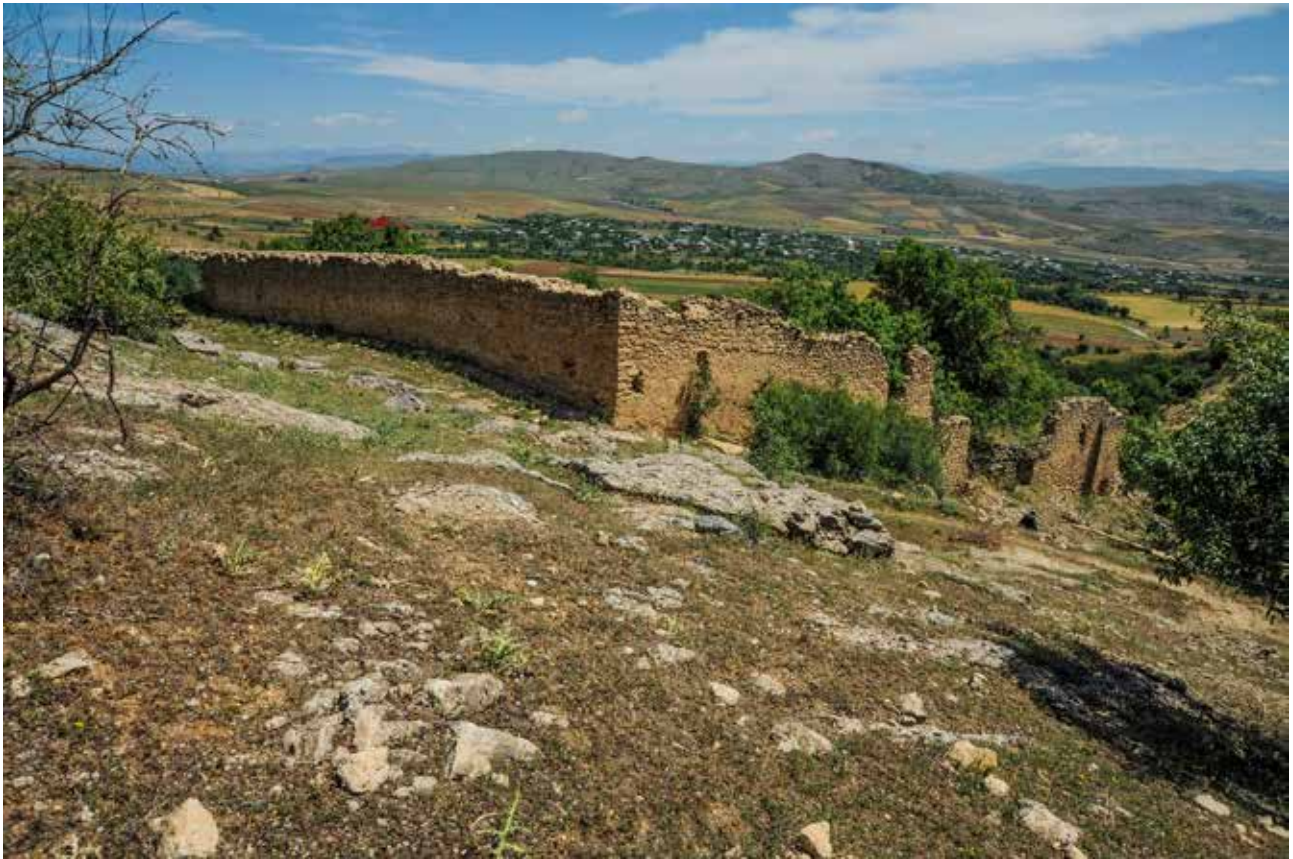
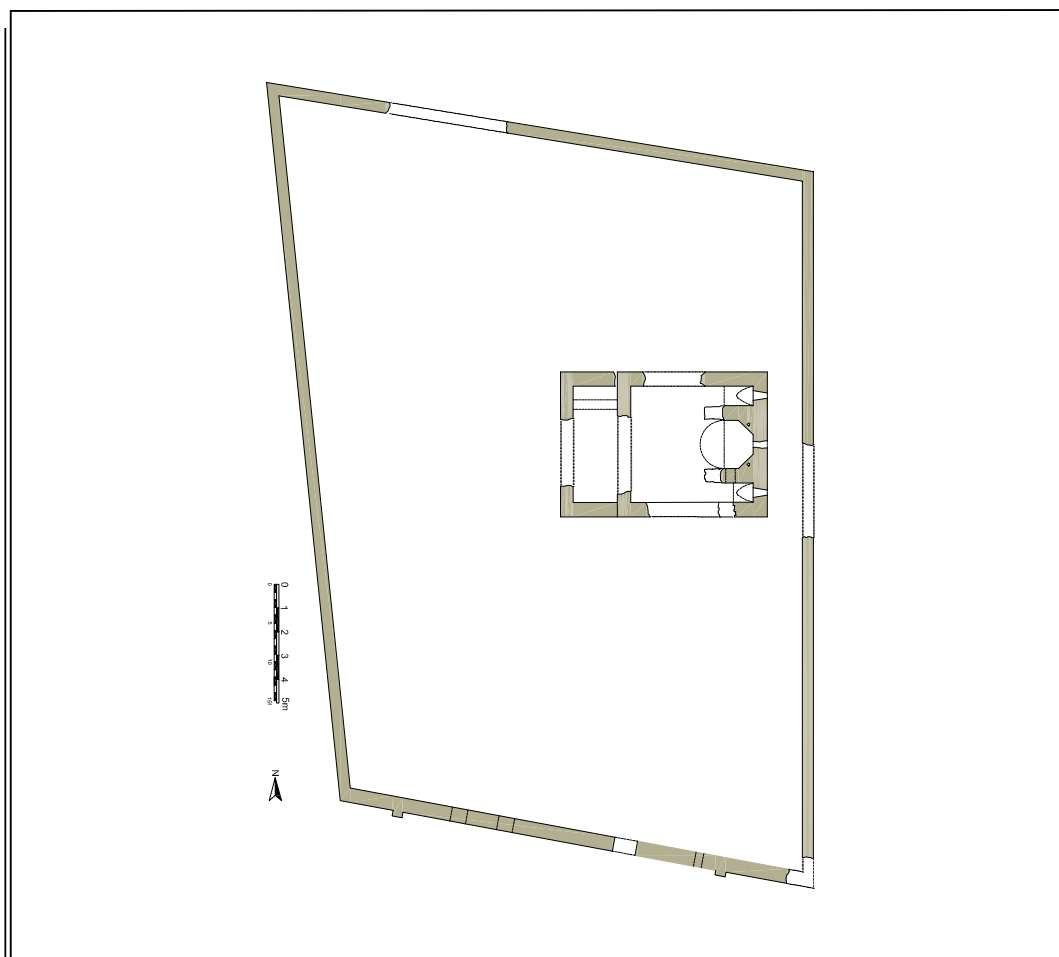
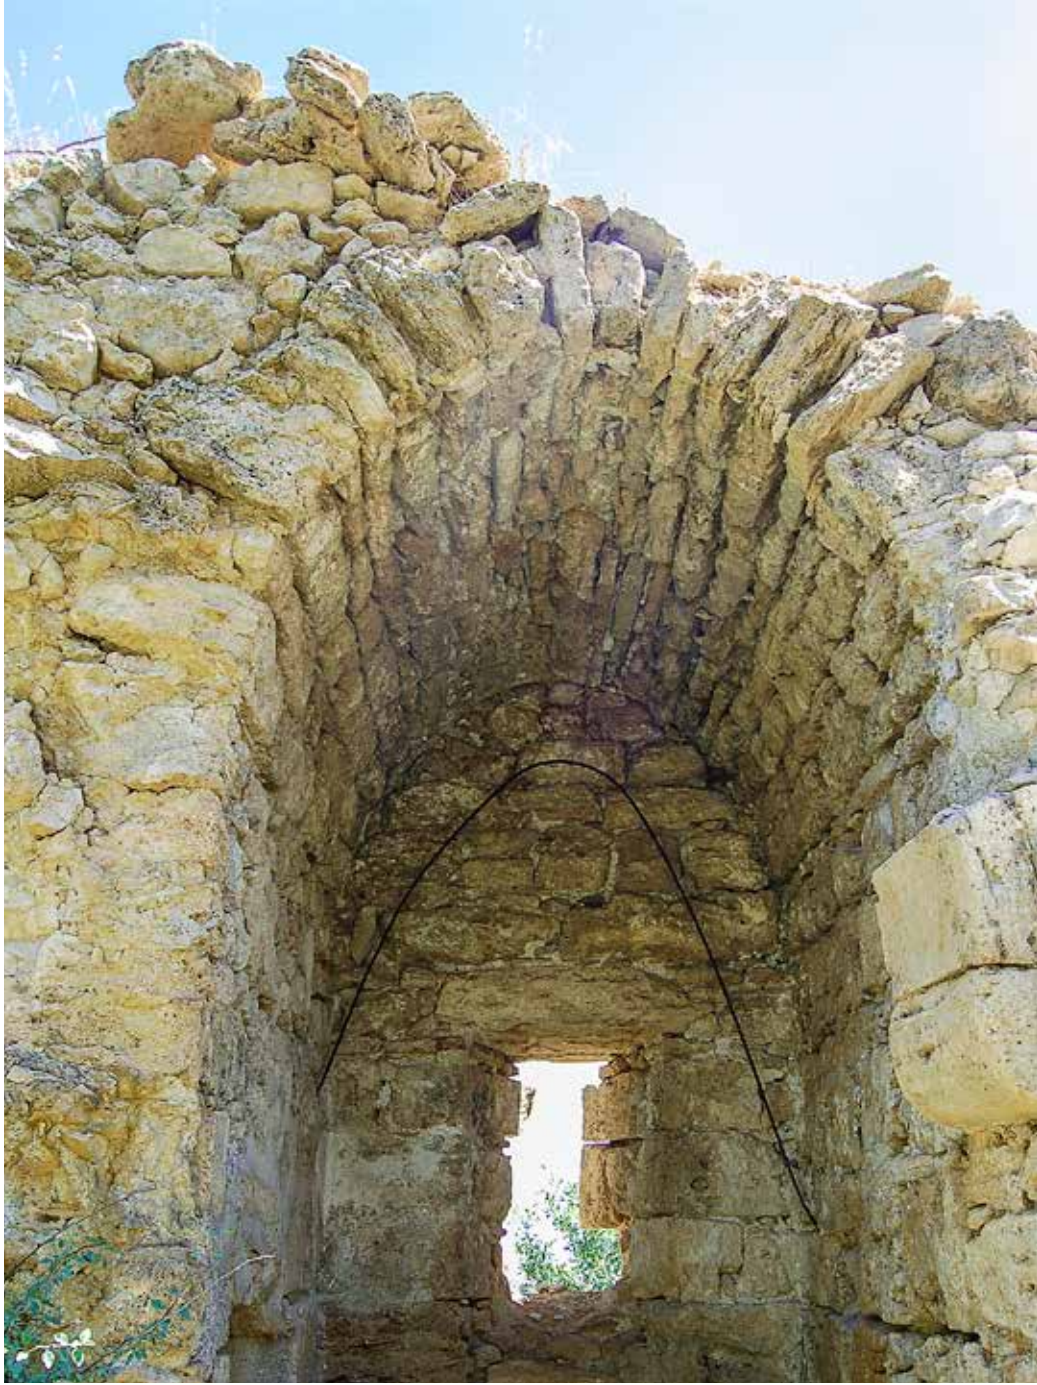
*Monastery of the Holy Mother of God
Kovanclar county, Ekinözü village*

The walls of the monastery are standing, but they don't give any information about the general structure. The plan of the church is partly observed.

The monastery walls and the church as a whole, have significant structural problems. The textures of all walls are affected by dampness in the sections near the ground level, while other sections have extensive material loss and degradation of stones due to weather exposure. The structure itself is at risk due to excessive collapse and demolished parts.

With consideration of the spring near the structure and the surroundings, a landscaping project should be developed and information panel should be placed near the structure.

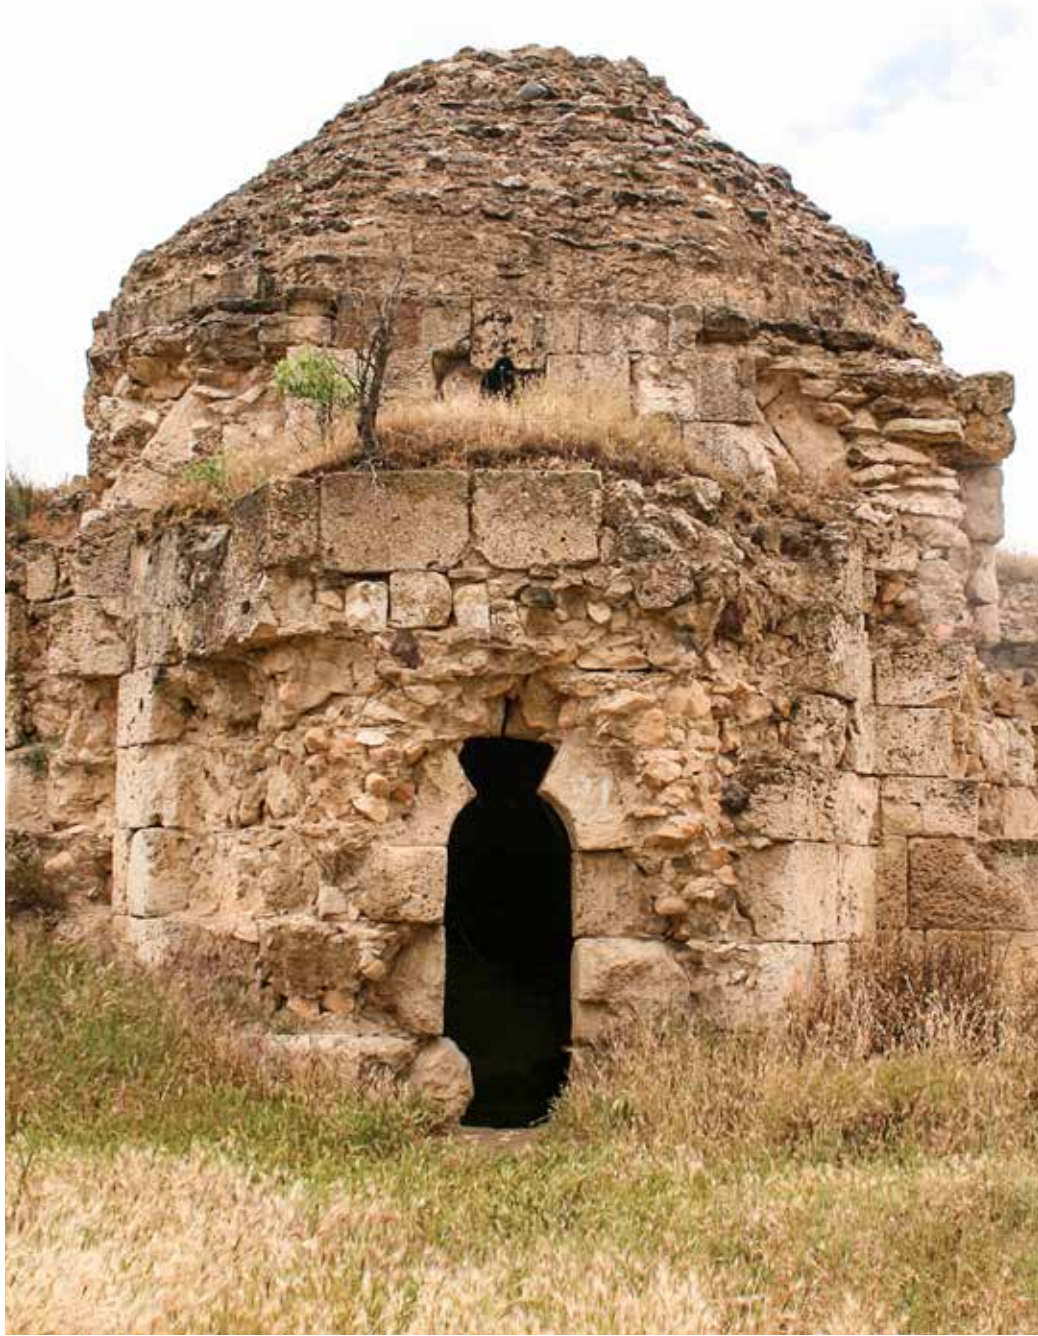
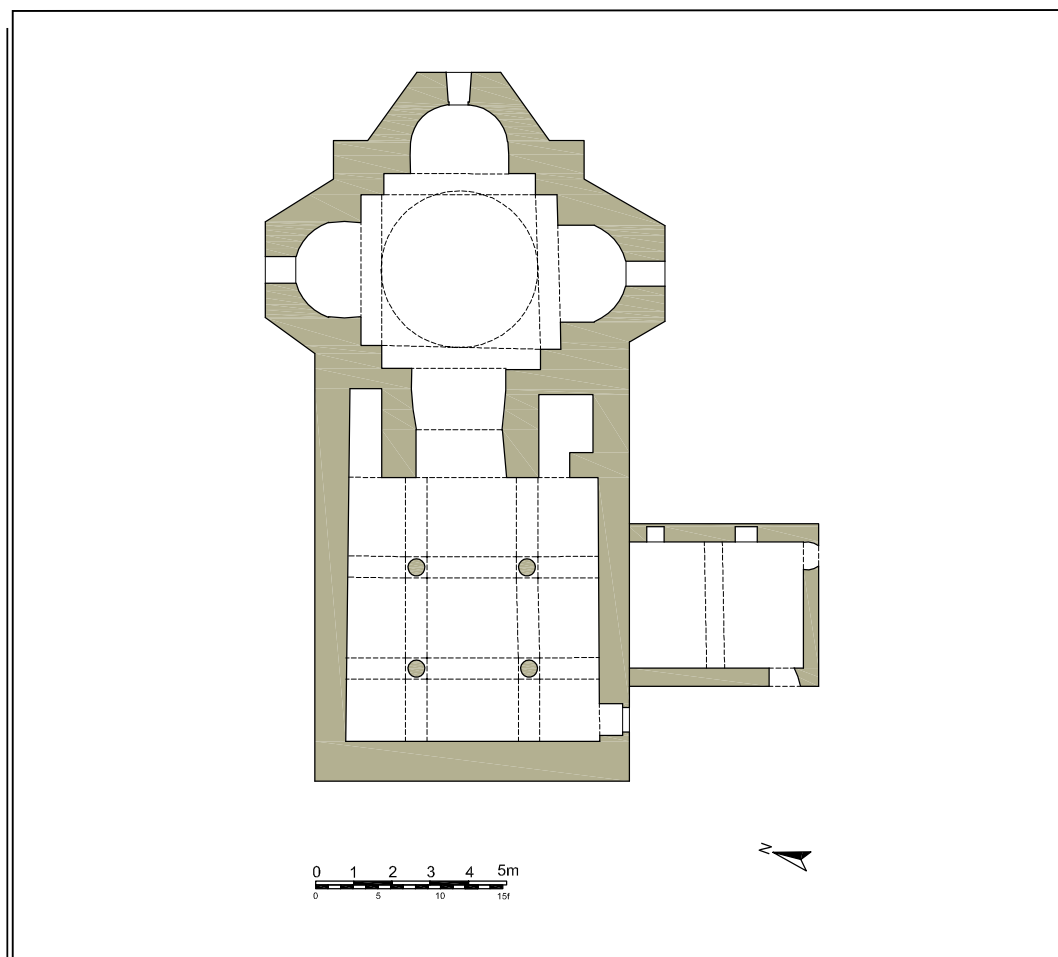
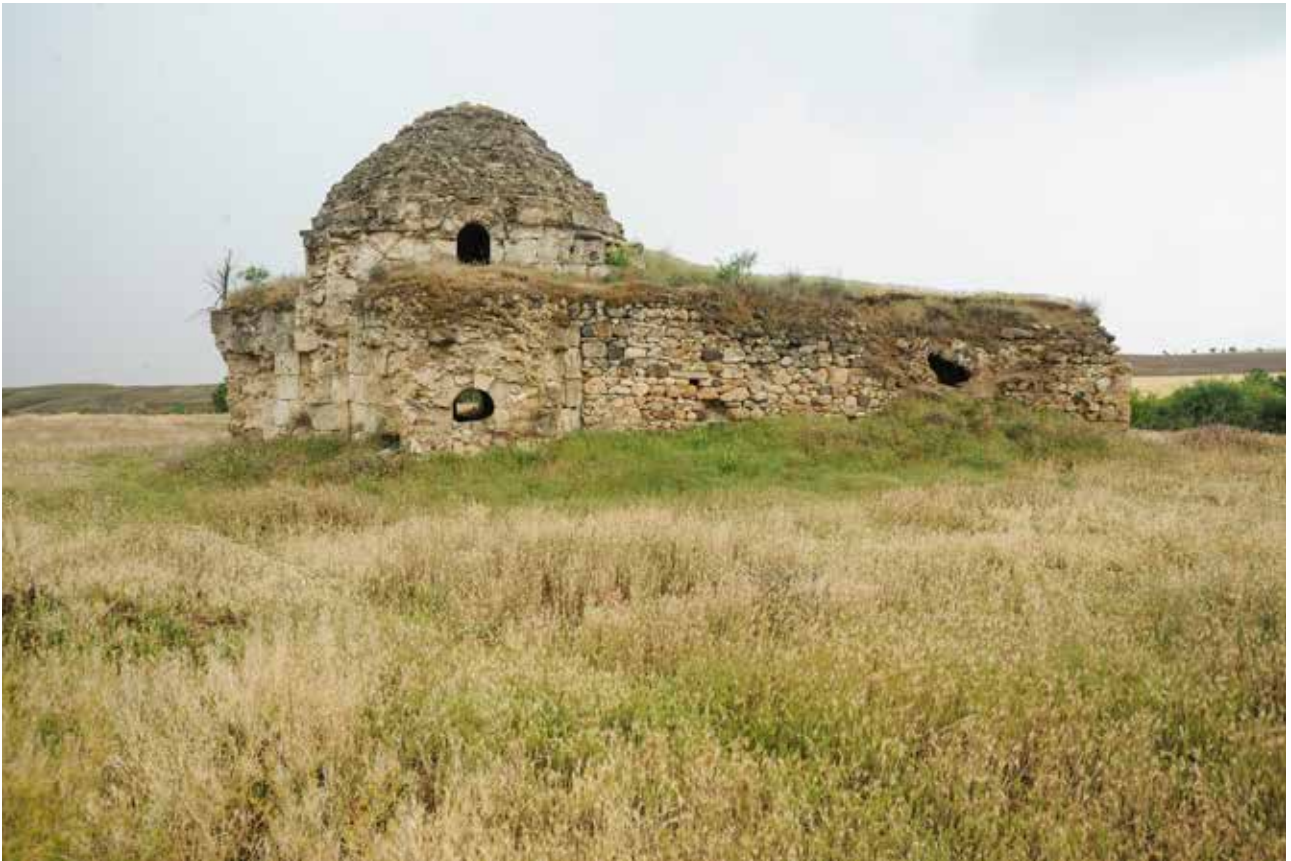
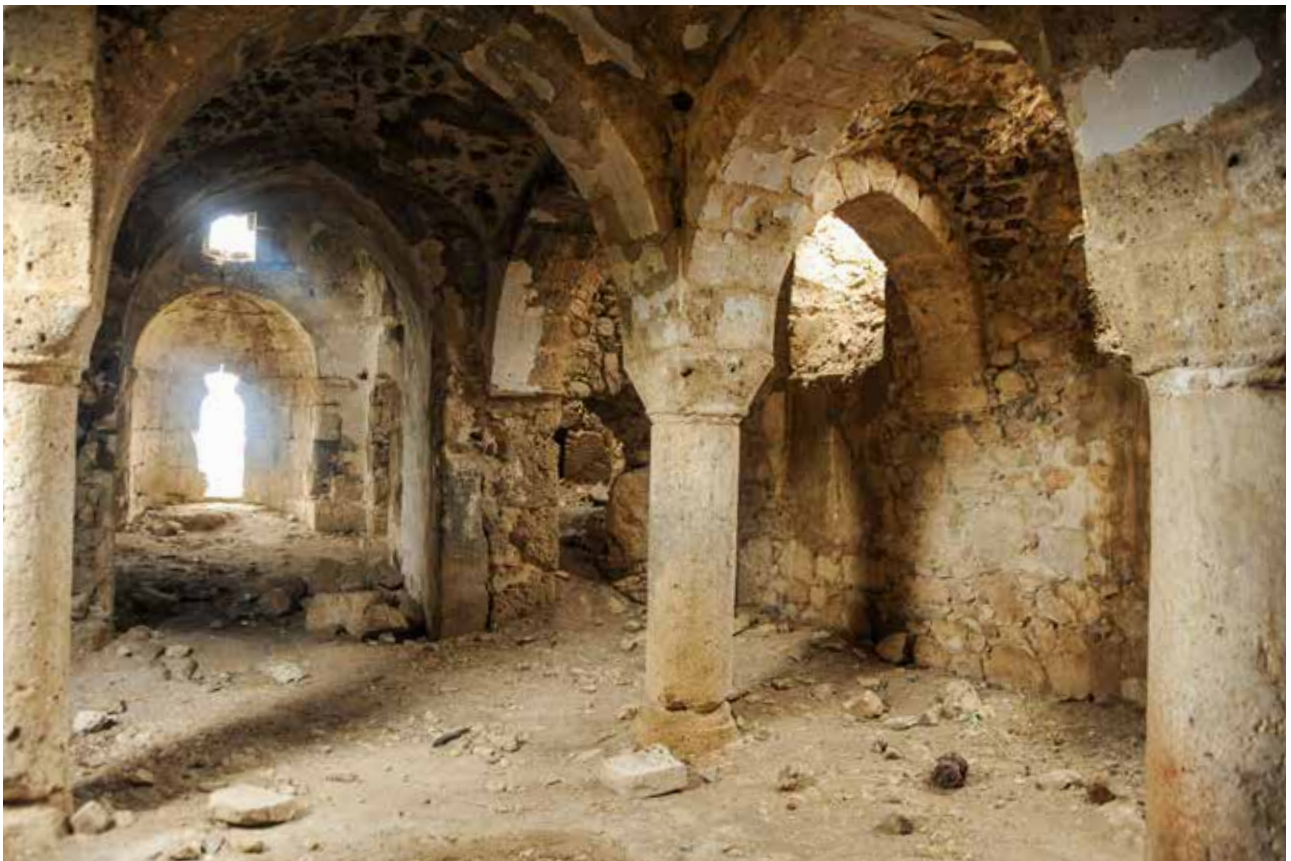
*Church of the Holy Mother of God
Elazığ Central county, Yalmız village, Venk neighborhood*

The structure is in very bad shape, though the layout is preserved. The earth fill around the structure has risen and the entrance doorway is at lower level. The load-bearing system of the masonry stone walls has severe damage due to natural causes and vandalism in many places. The high floor level in the apse section of the main church has been almost totally destroyed. The south wall of the adjacent room is extremely damaged, with high risk of collapse.

The exterior of the church once clad with cut stone, remains now only as rubble stone, and the extremely degraded mortar has lost its binding quality. There is nearly 80 cm of soil and debris above the roof material of the structure. This debris adds additional loads to the load-bearing system. Moreover, roots of plants growing in the soil in the debris have penetrated the load-bearing system and caused damage.

The interior walls of the abandoned structure have been damaged by vandalism, with columns in the jamatun section broken off from where they join the lower level and their load-bearing capacity weakened. There are occasional fractures in corner columns and walls.

The structure has not lost its original characteristics, and its monumental importance is still notable. Due to its poor structural condition, because of the destruction in its walls and roof, the church may easily be damaged by natural disasters like earthquakes and floods. It is open to human and natural depredation.

fragility of the building, careful interventions should be made to prevent further damage. The roof should be cleared, solutions should be used to kill the plants, and the entire roof be covered with a waterproof yet breathable material. In the jamatun, the weakened load-bearing columns should be supported with appropriate material to prevent collapse. It is necessary that the very weakened walls of the additional room adjacent to the south façade also be supported and protected.

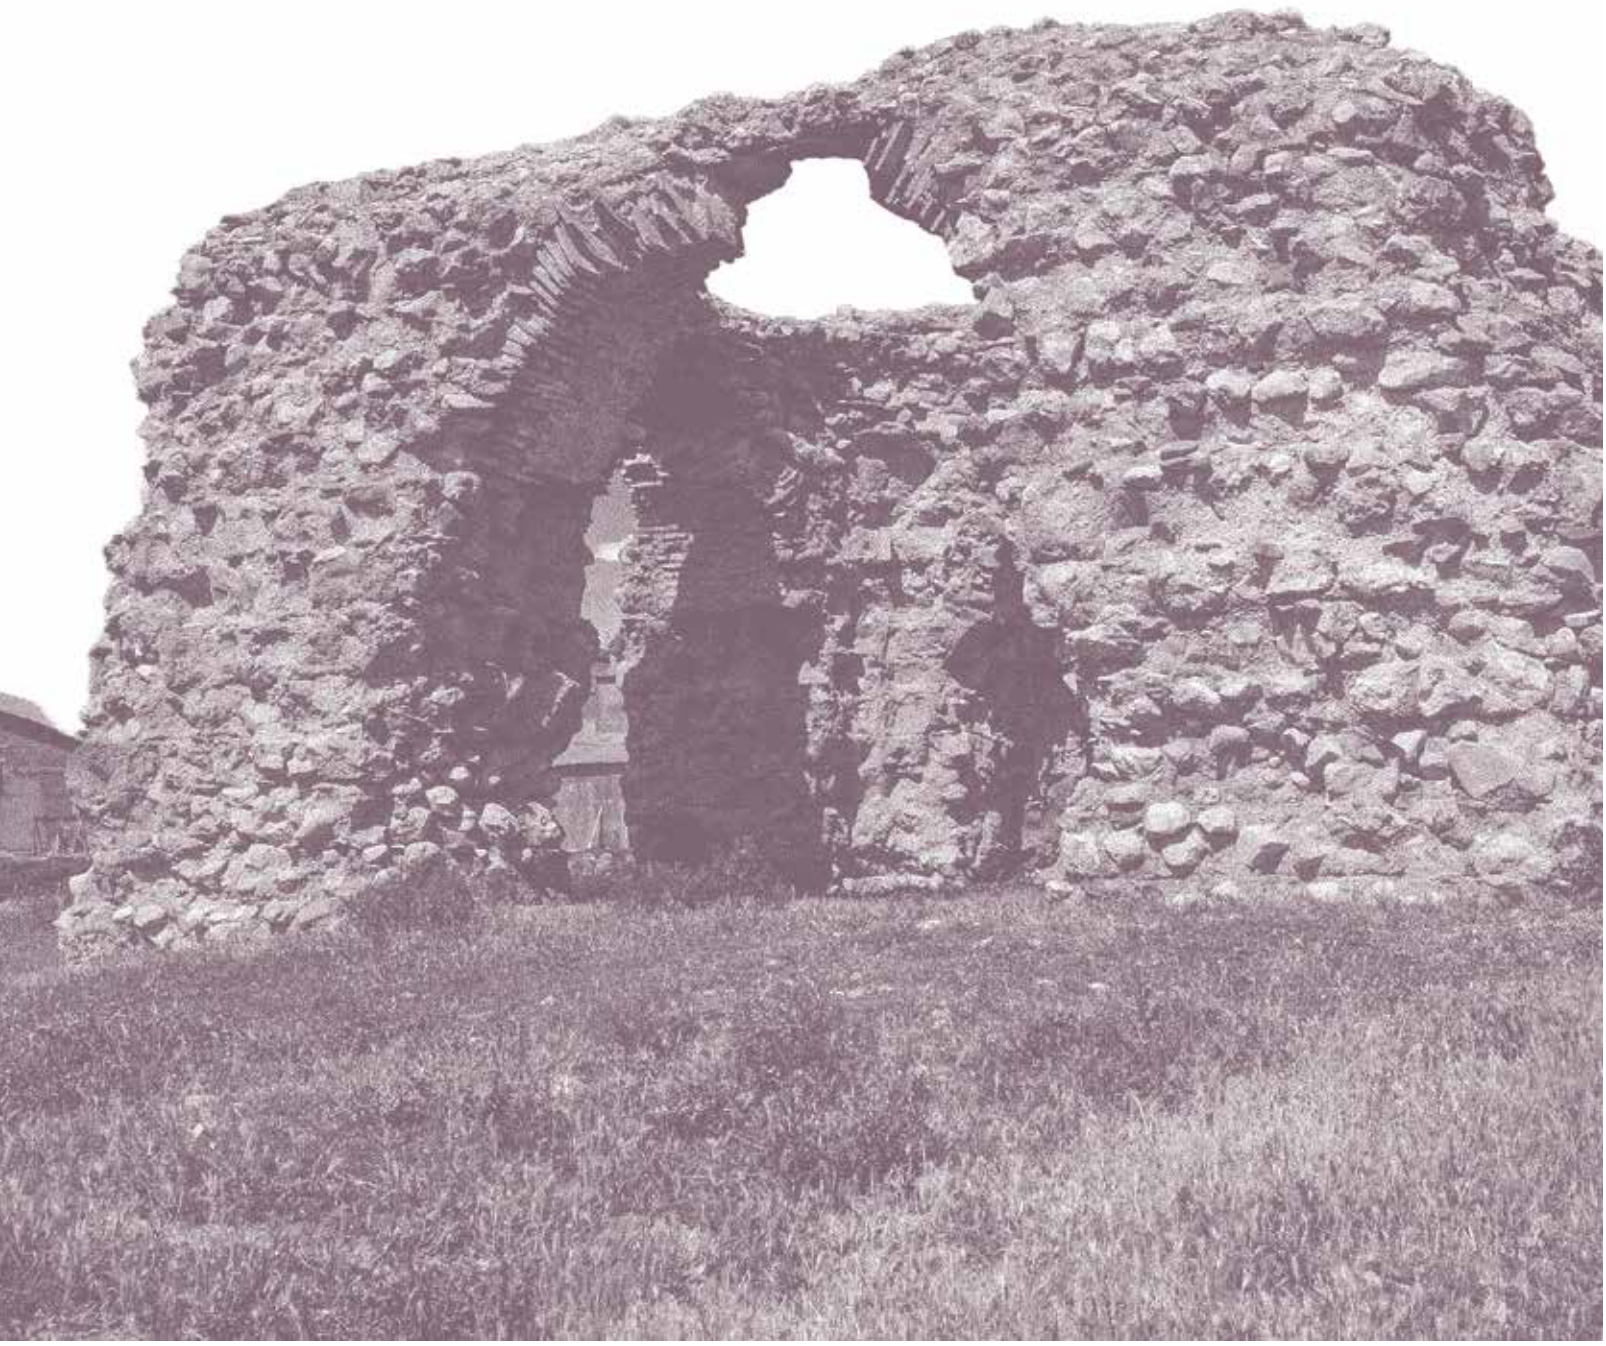
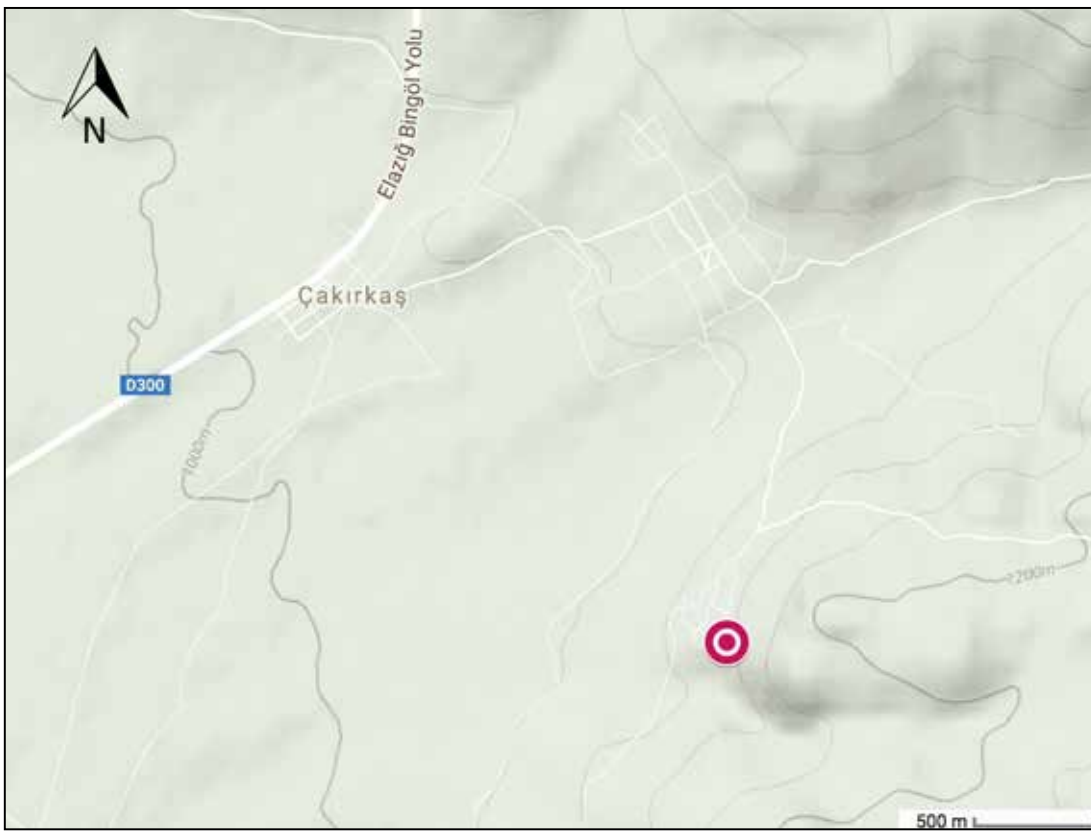
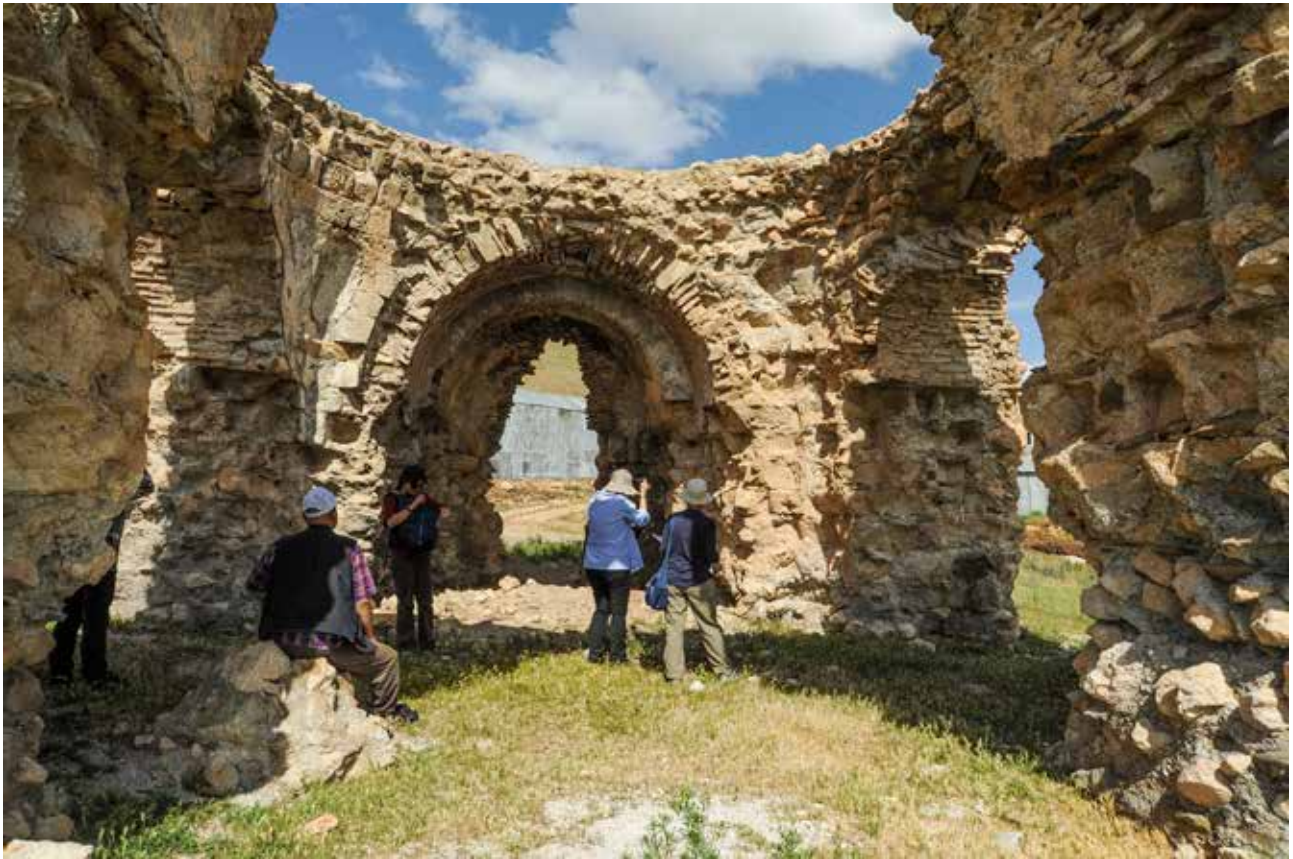
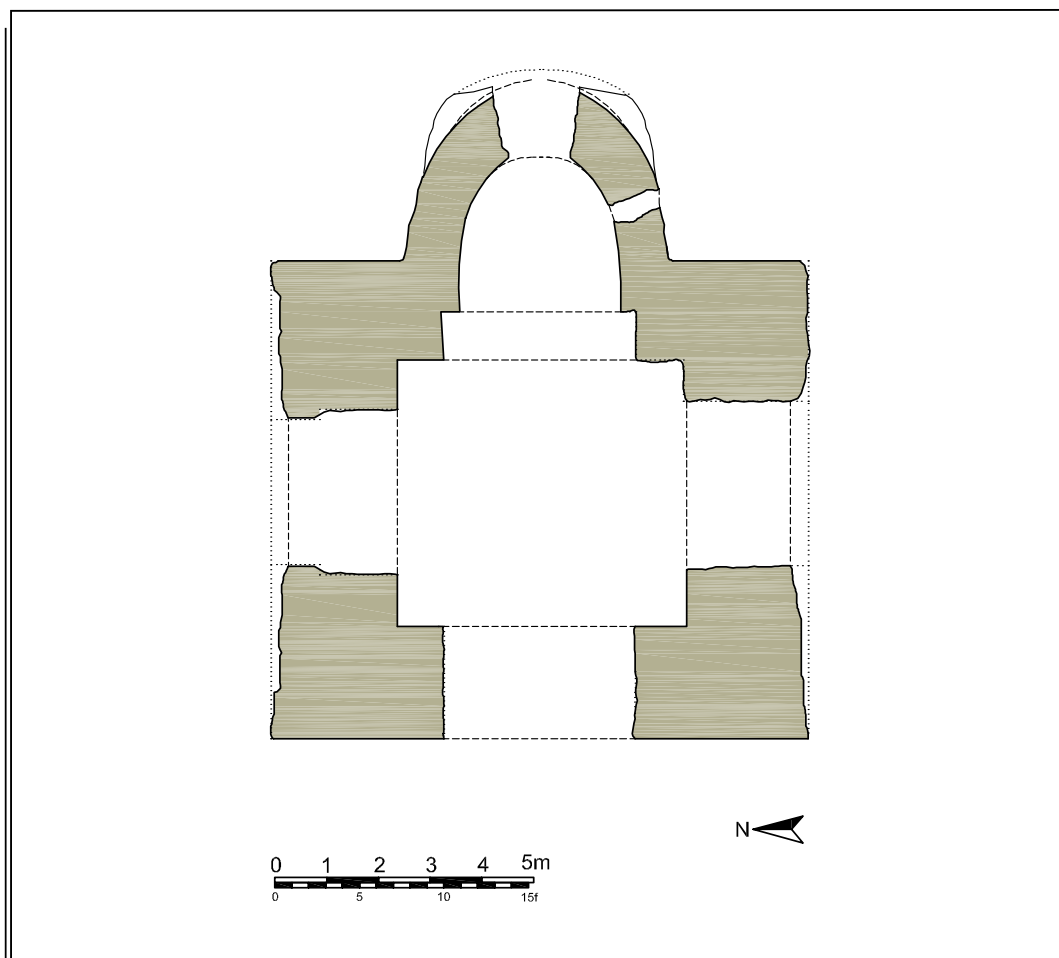
Unfortunately, the condition of the totally abandoned monument is very poor. Almost every stone block is damaged by vandalism, climate conditions and treasure hunters. Drawings and graffiti are seen all over the walls and stones. The rubble core of the main constructions is badly destroyed. Three of the main arches are barely preserved, only because of the mortar between their elements. Therefore, those arches are in the high risk of collapse. There are gravestones scattered around the area indicating that the place was used as a burial ground as well.

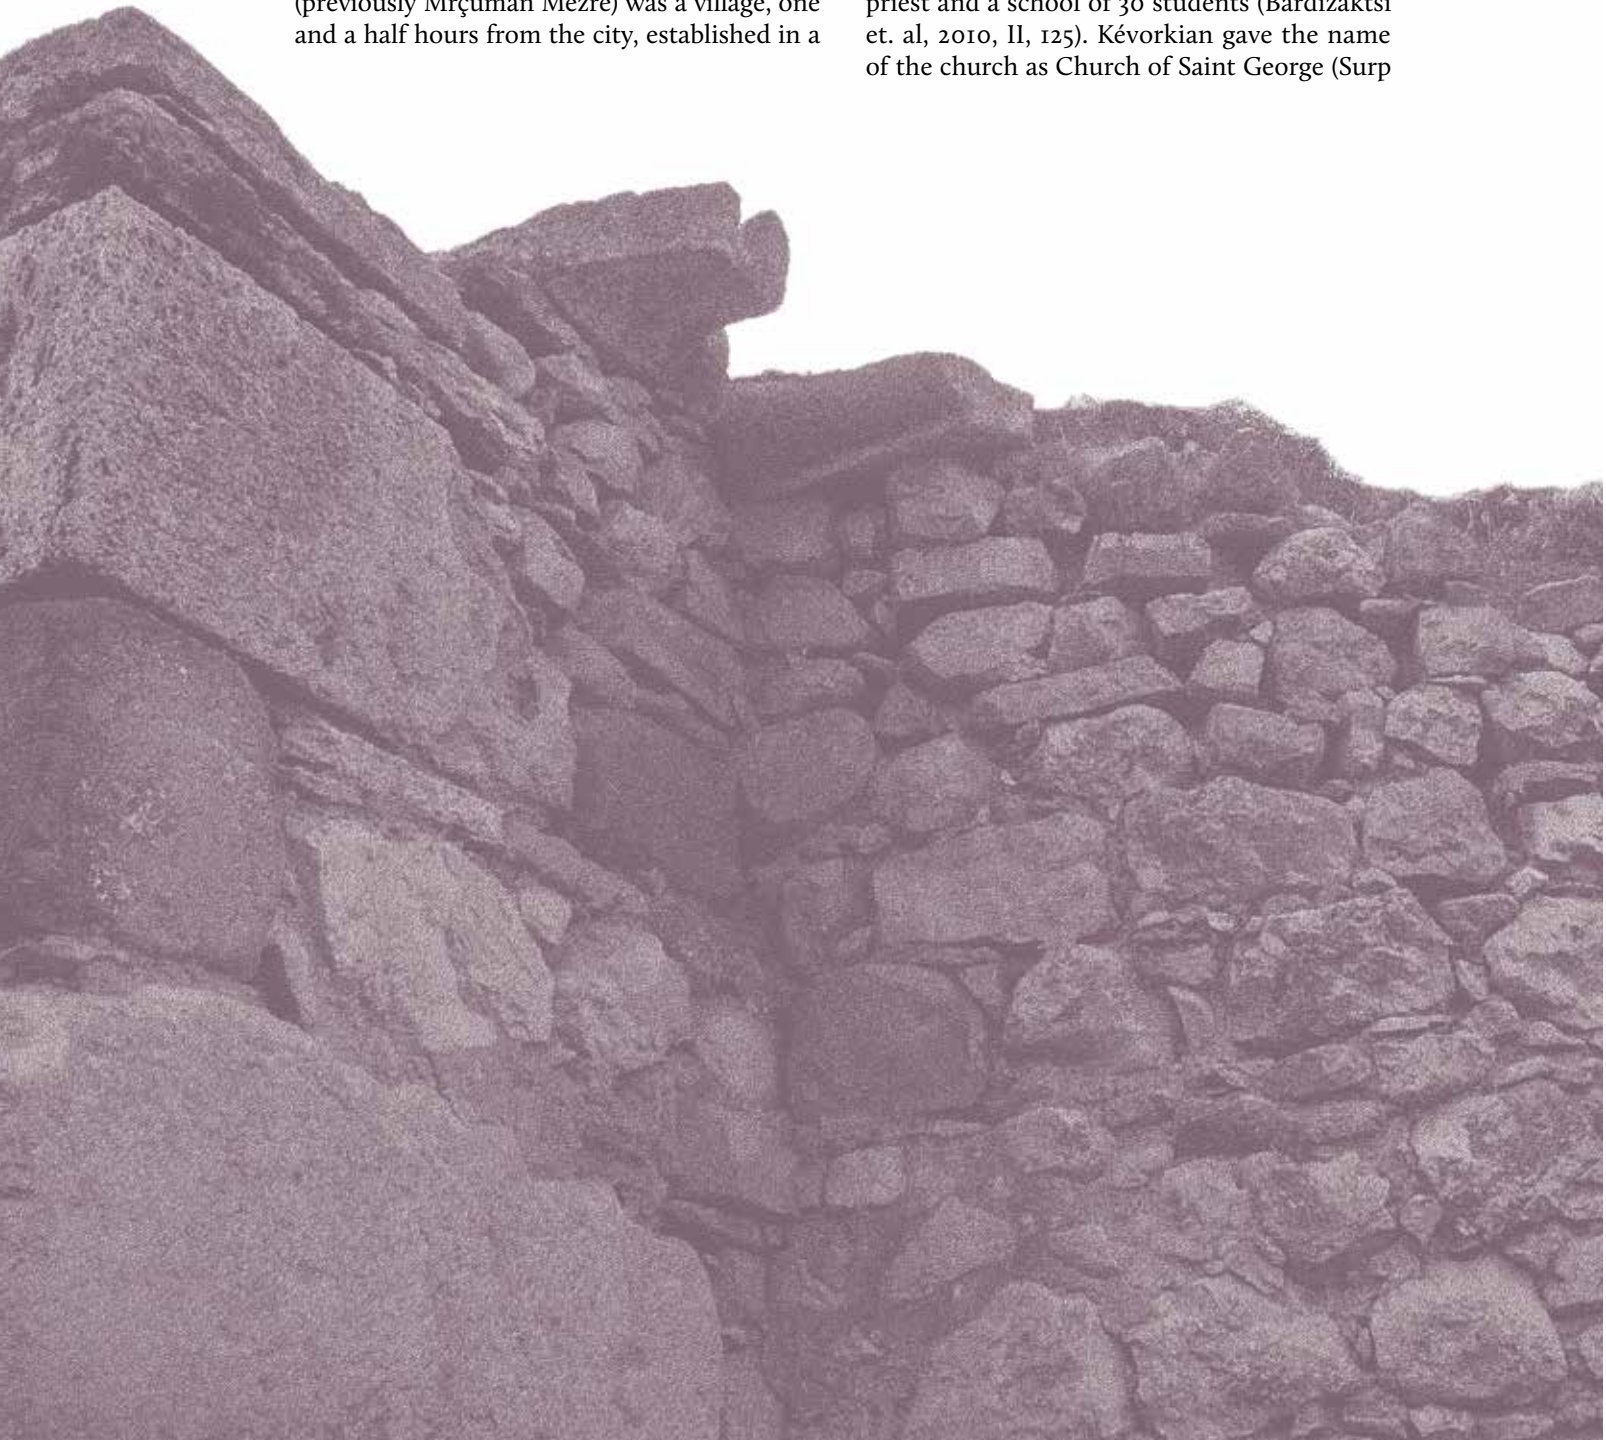
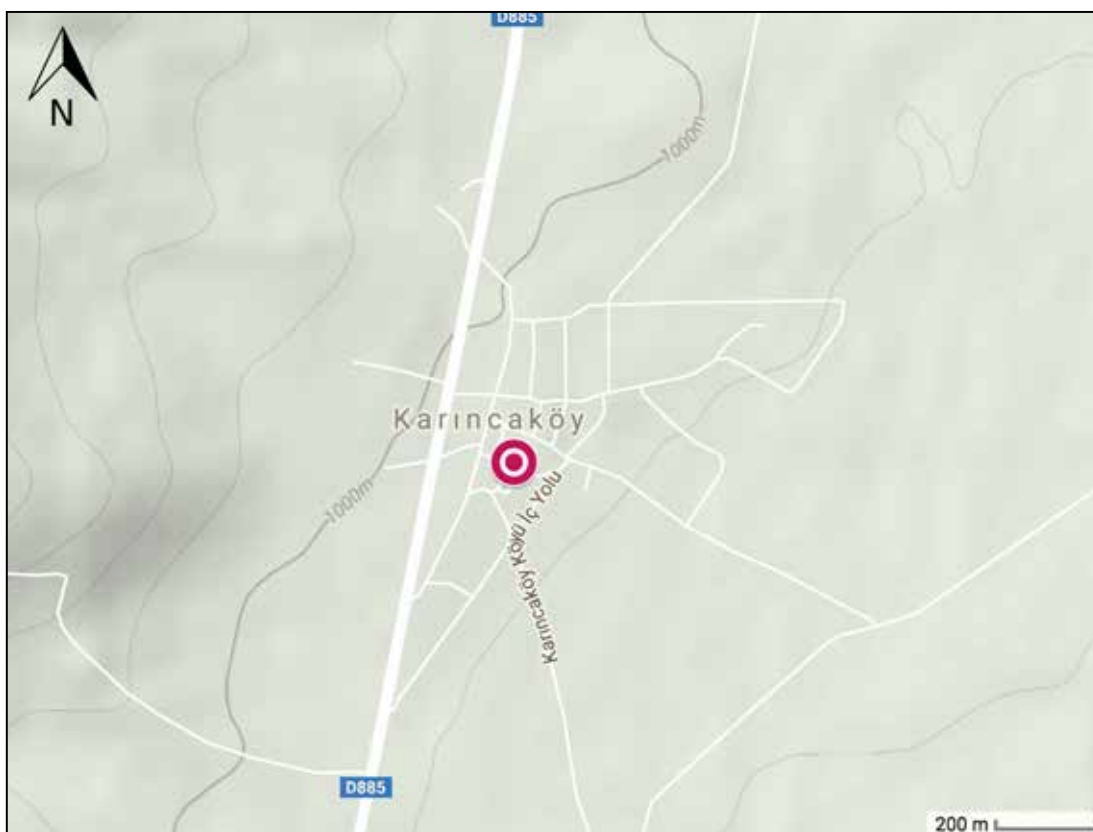
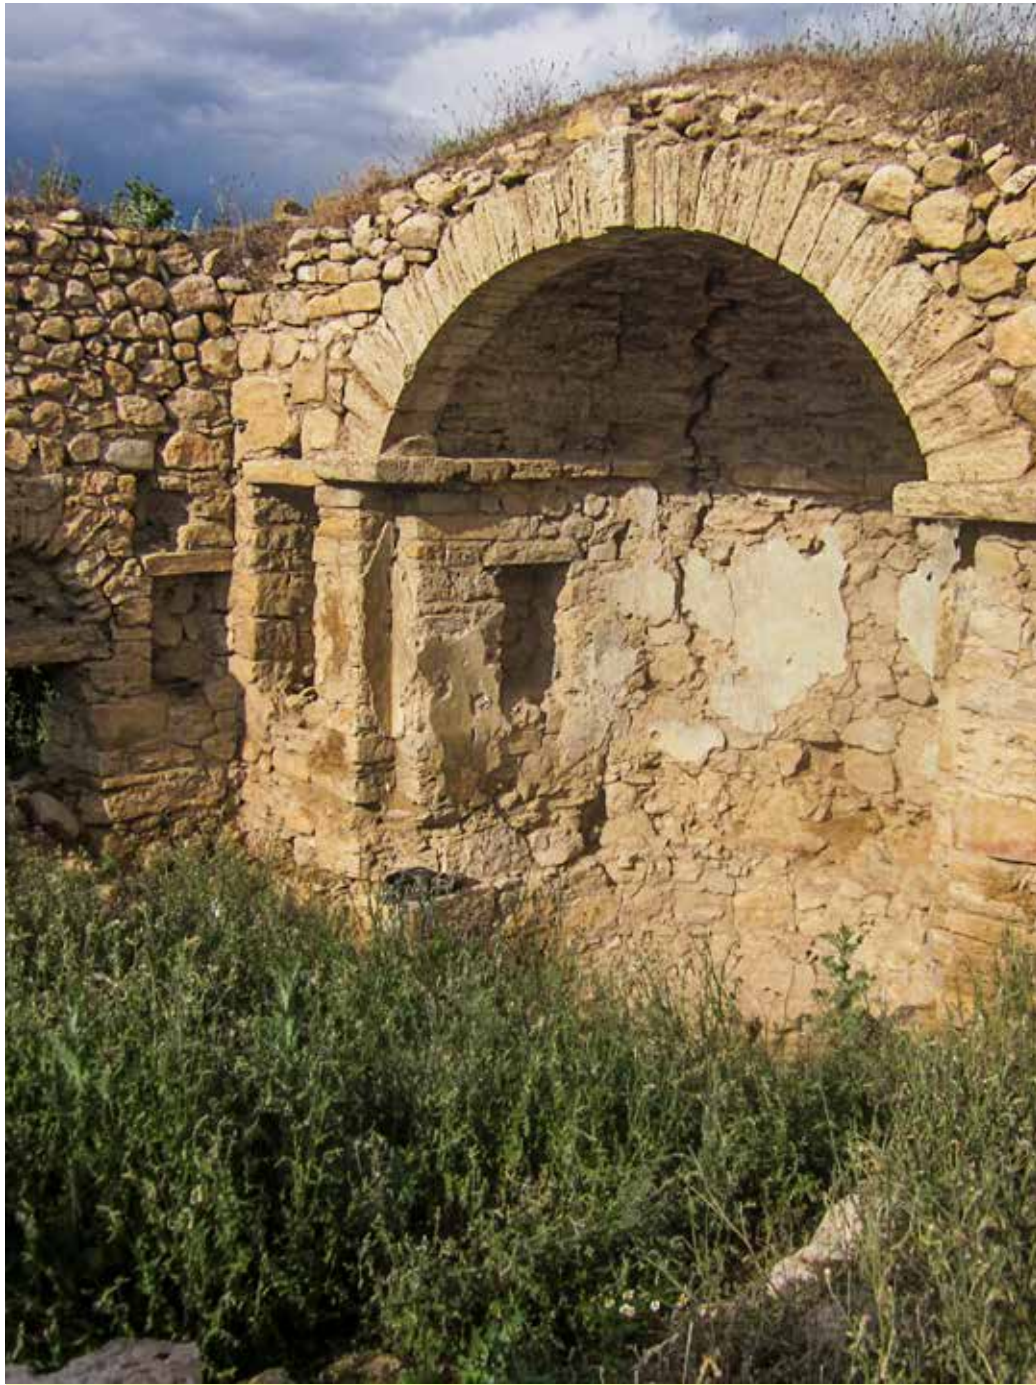
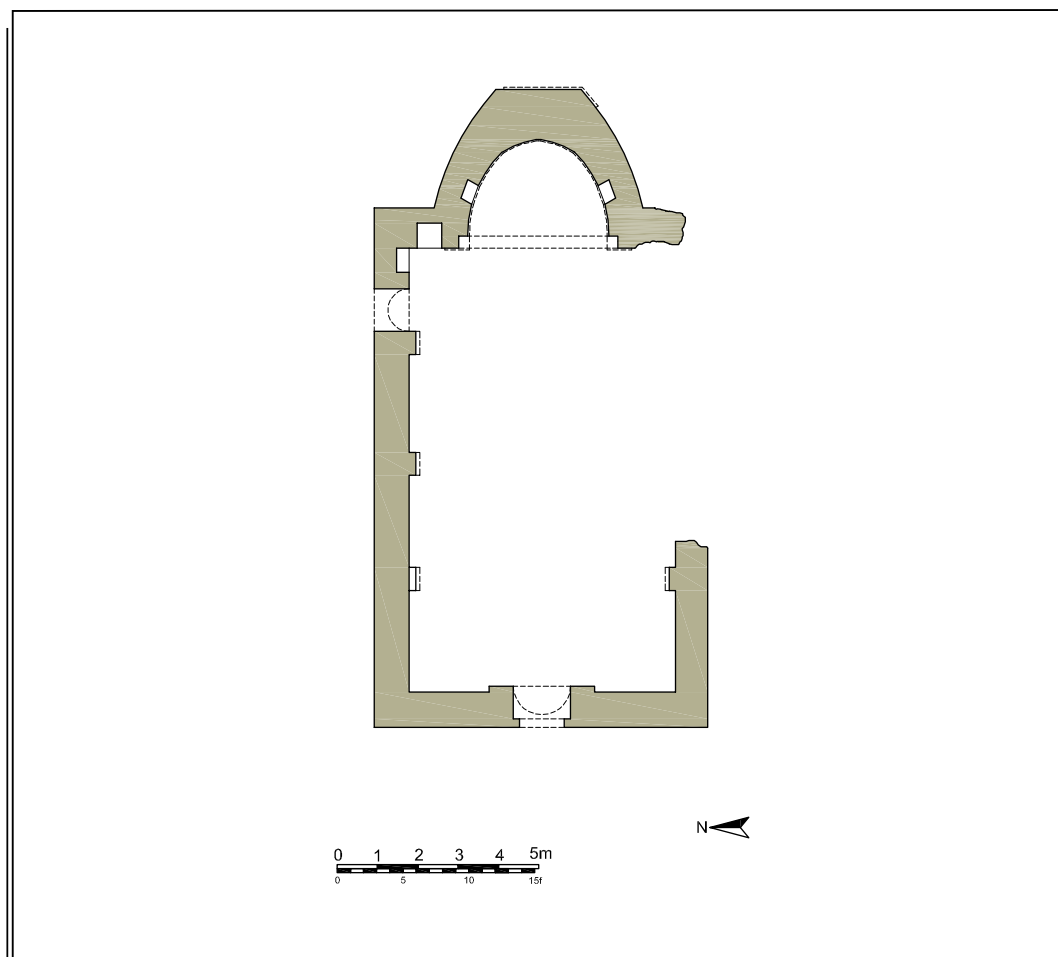
*Church of Saint George
Kovancilar county, Karinca village*

The monument is seriously ruined. The main hall's superstructure is completely destroyed. The southern wall is totally destroyed, while the others are partially destroyed. Beside its structurally unstable condition, the building is in a neglected state, and is covered with garbage. The floor is dug, and some huge holes are in the places of previously indicated graves. Around the building, its collapsed stones and other remains lie unpreserved. The western façade and the main entrance are currently part of a private garden.
