Kayseri
Adana
Izmir
Elazığ
Niğde
Bursa

Assessment Report of Architectural Cultural Heritage

April 2018

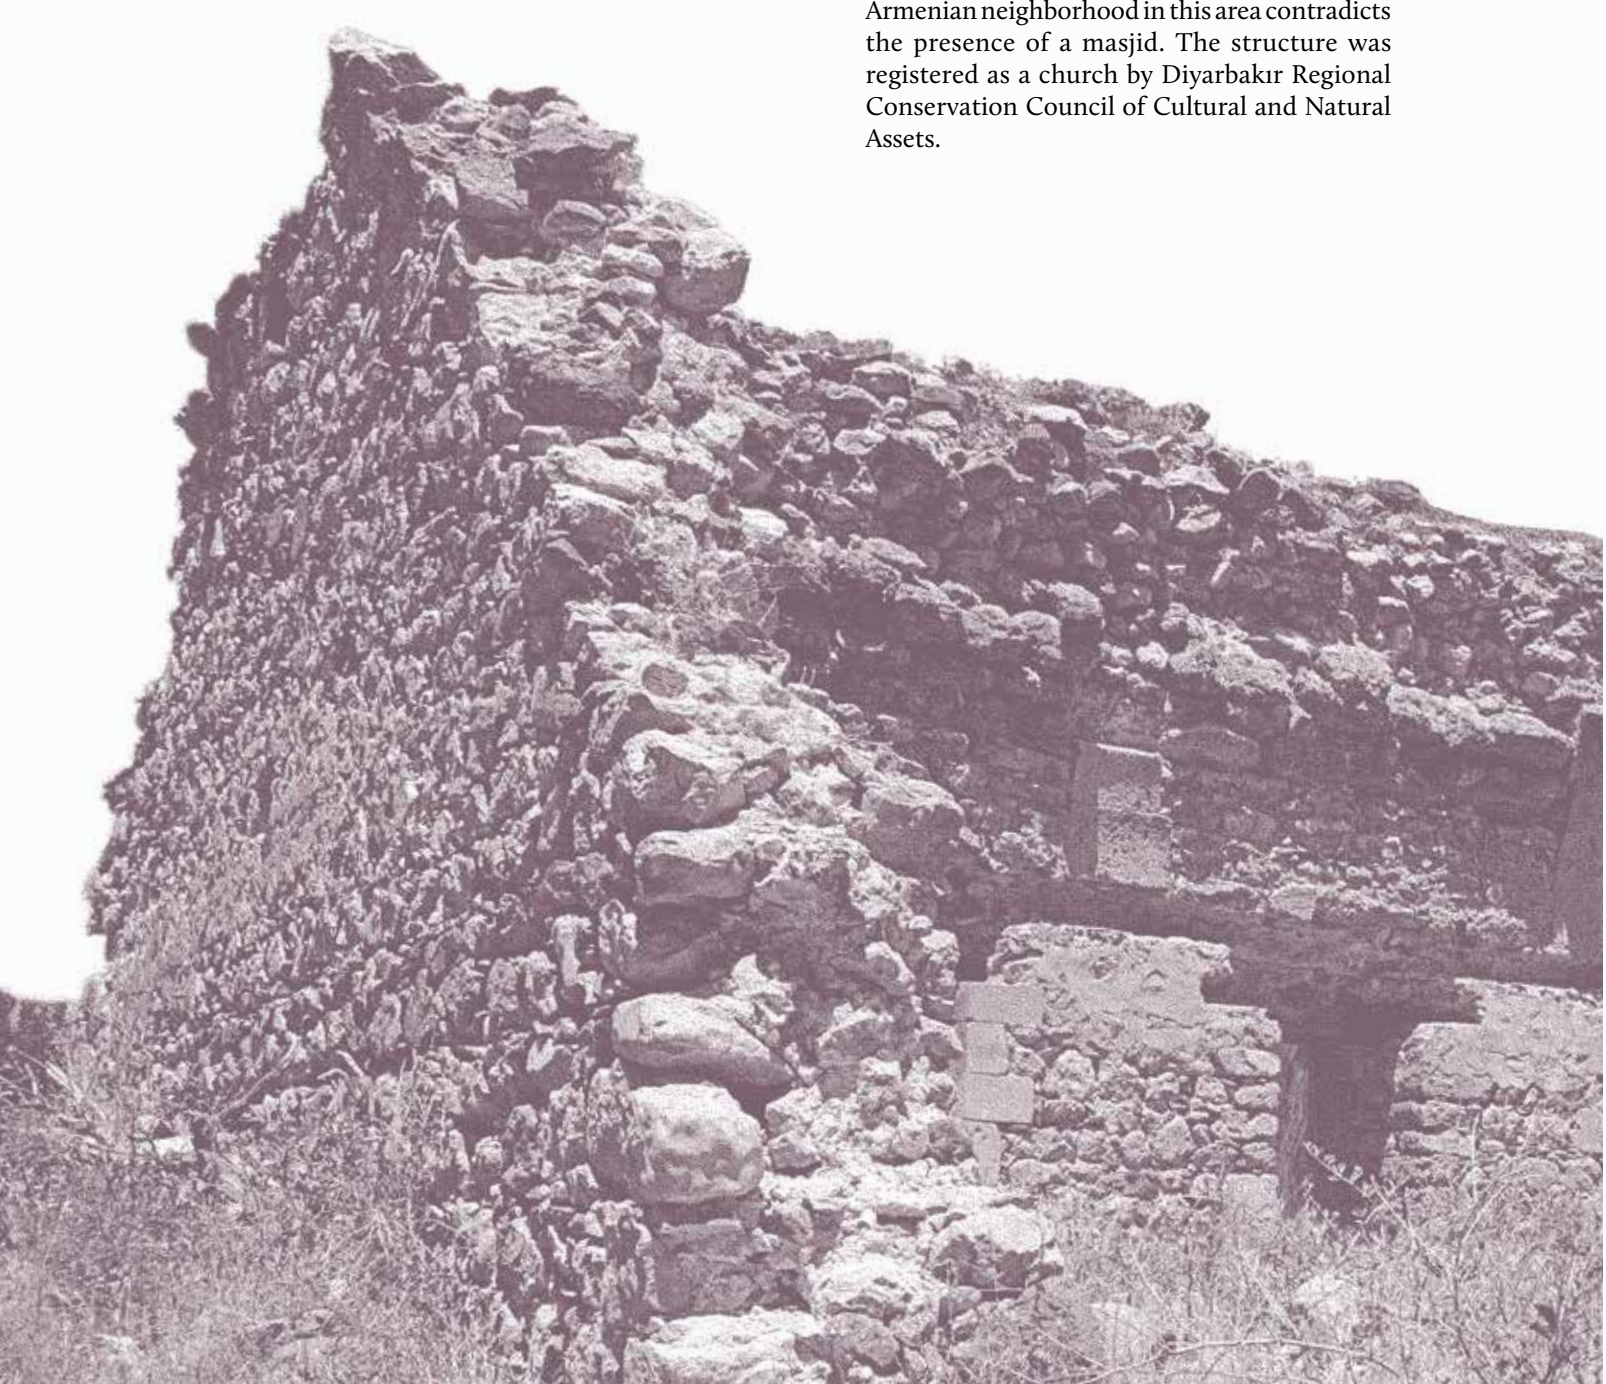
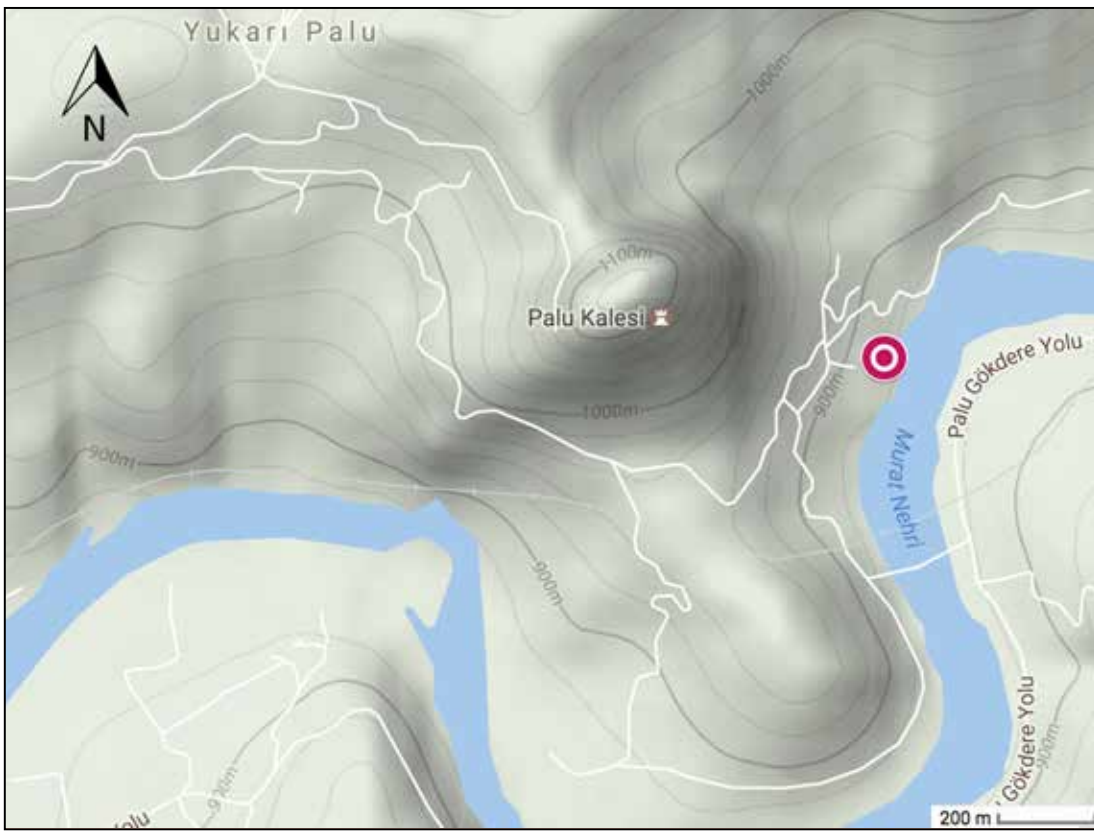
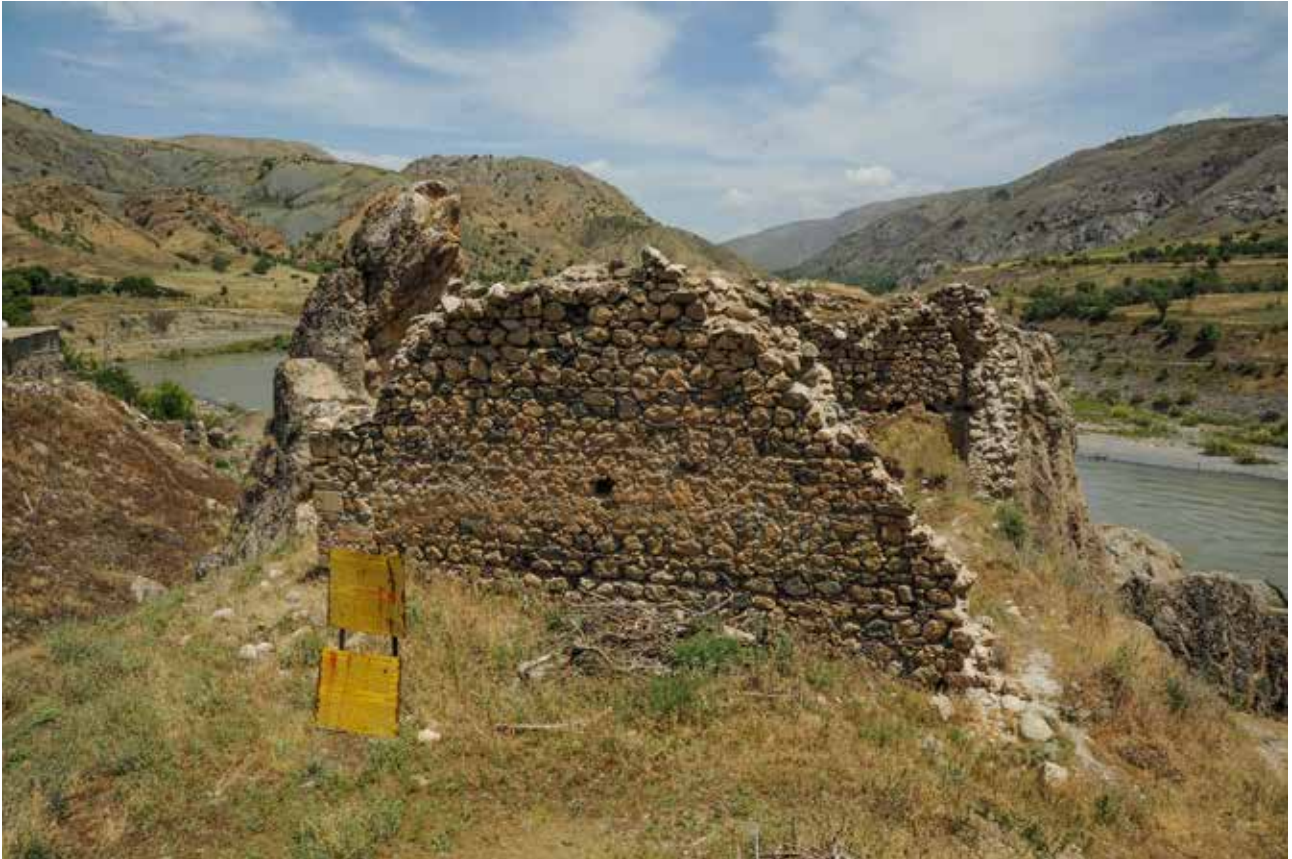
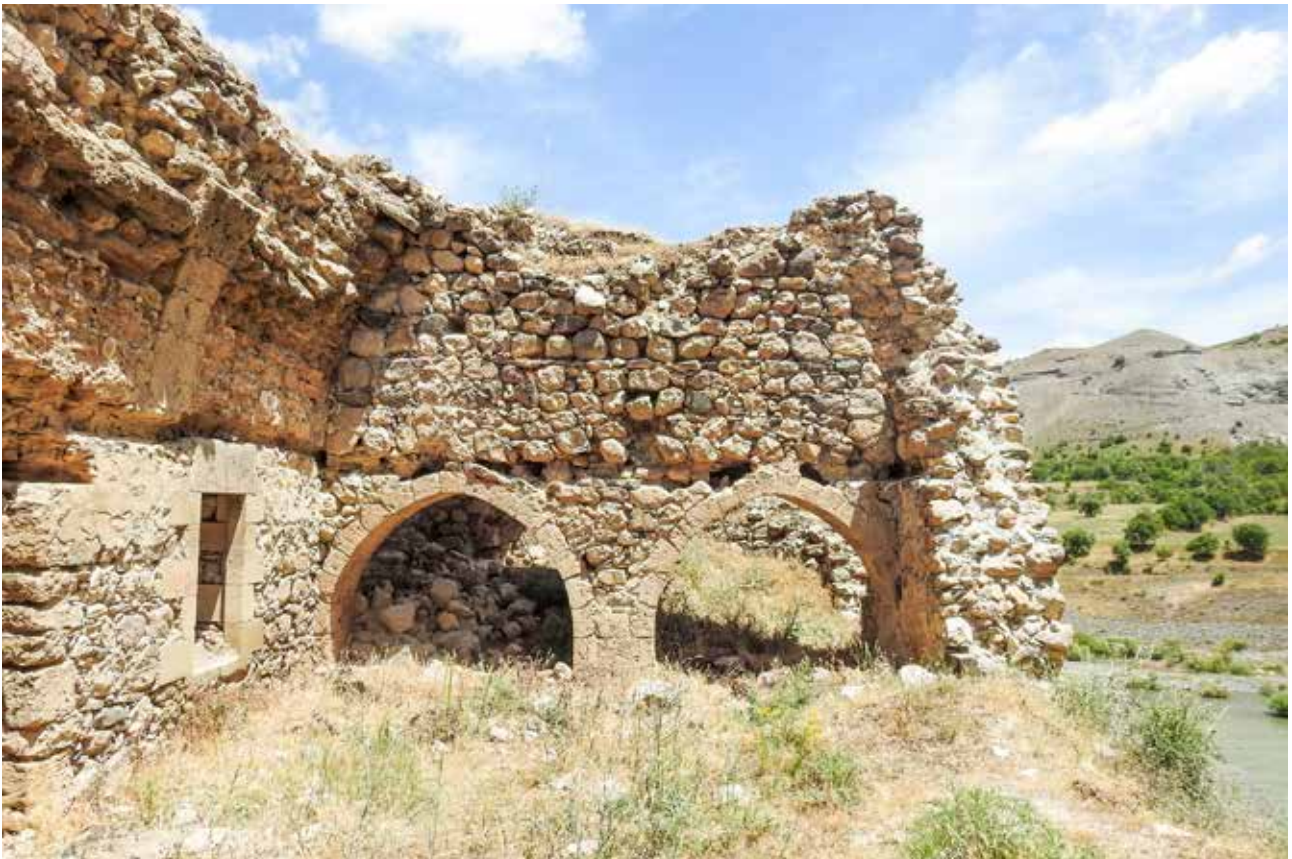
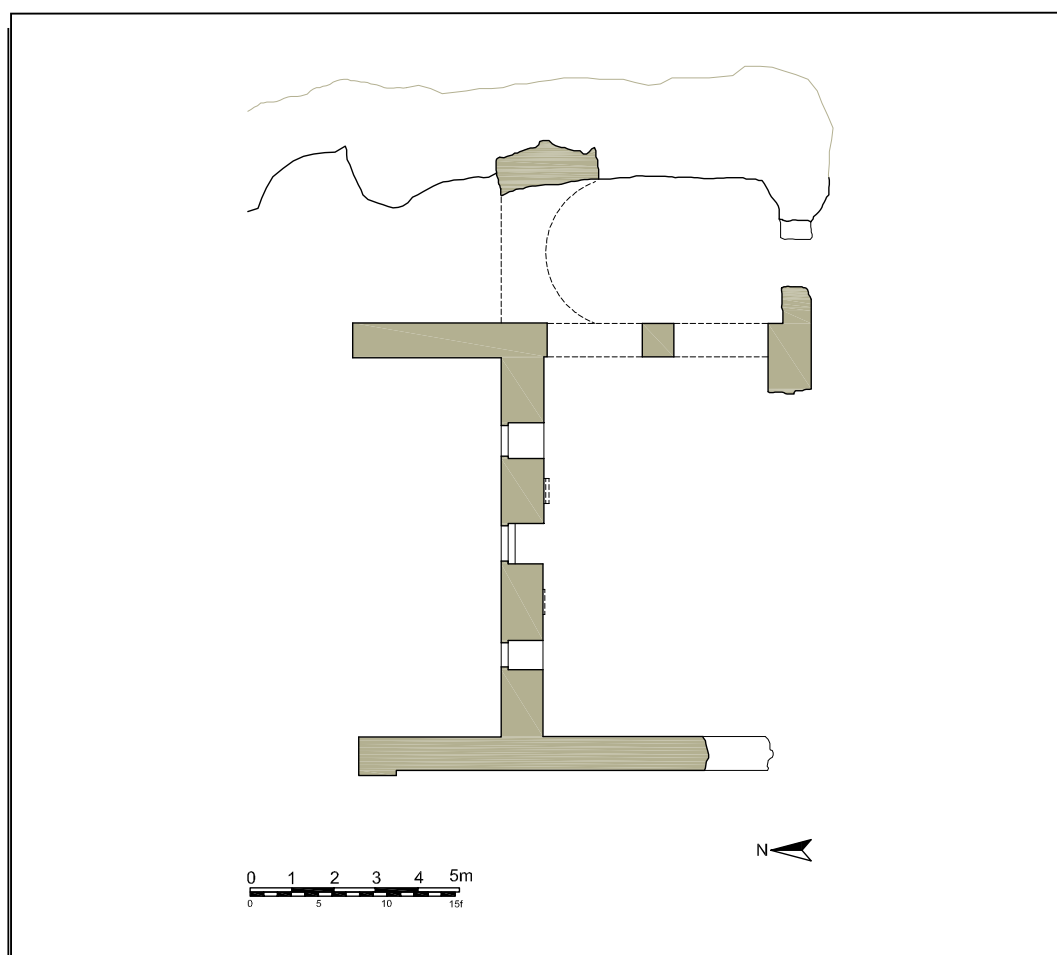
The east and west walls of the semi-open area in front of the structure are partially destroyed, and the vault totally collapsed. In the interior, the south wall and west wall are largely demolished. All walls have significant degrees of collapse and material loss, with cavities in stones and structural fractures in the walls. The entire floor is covered with rubble.

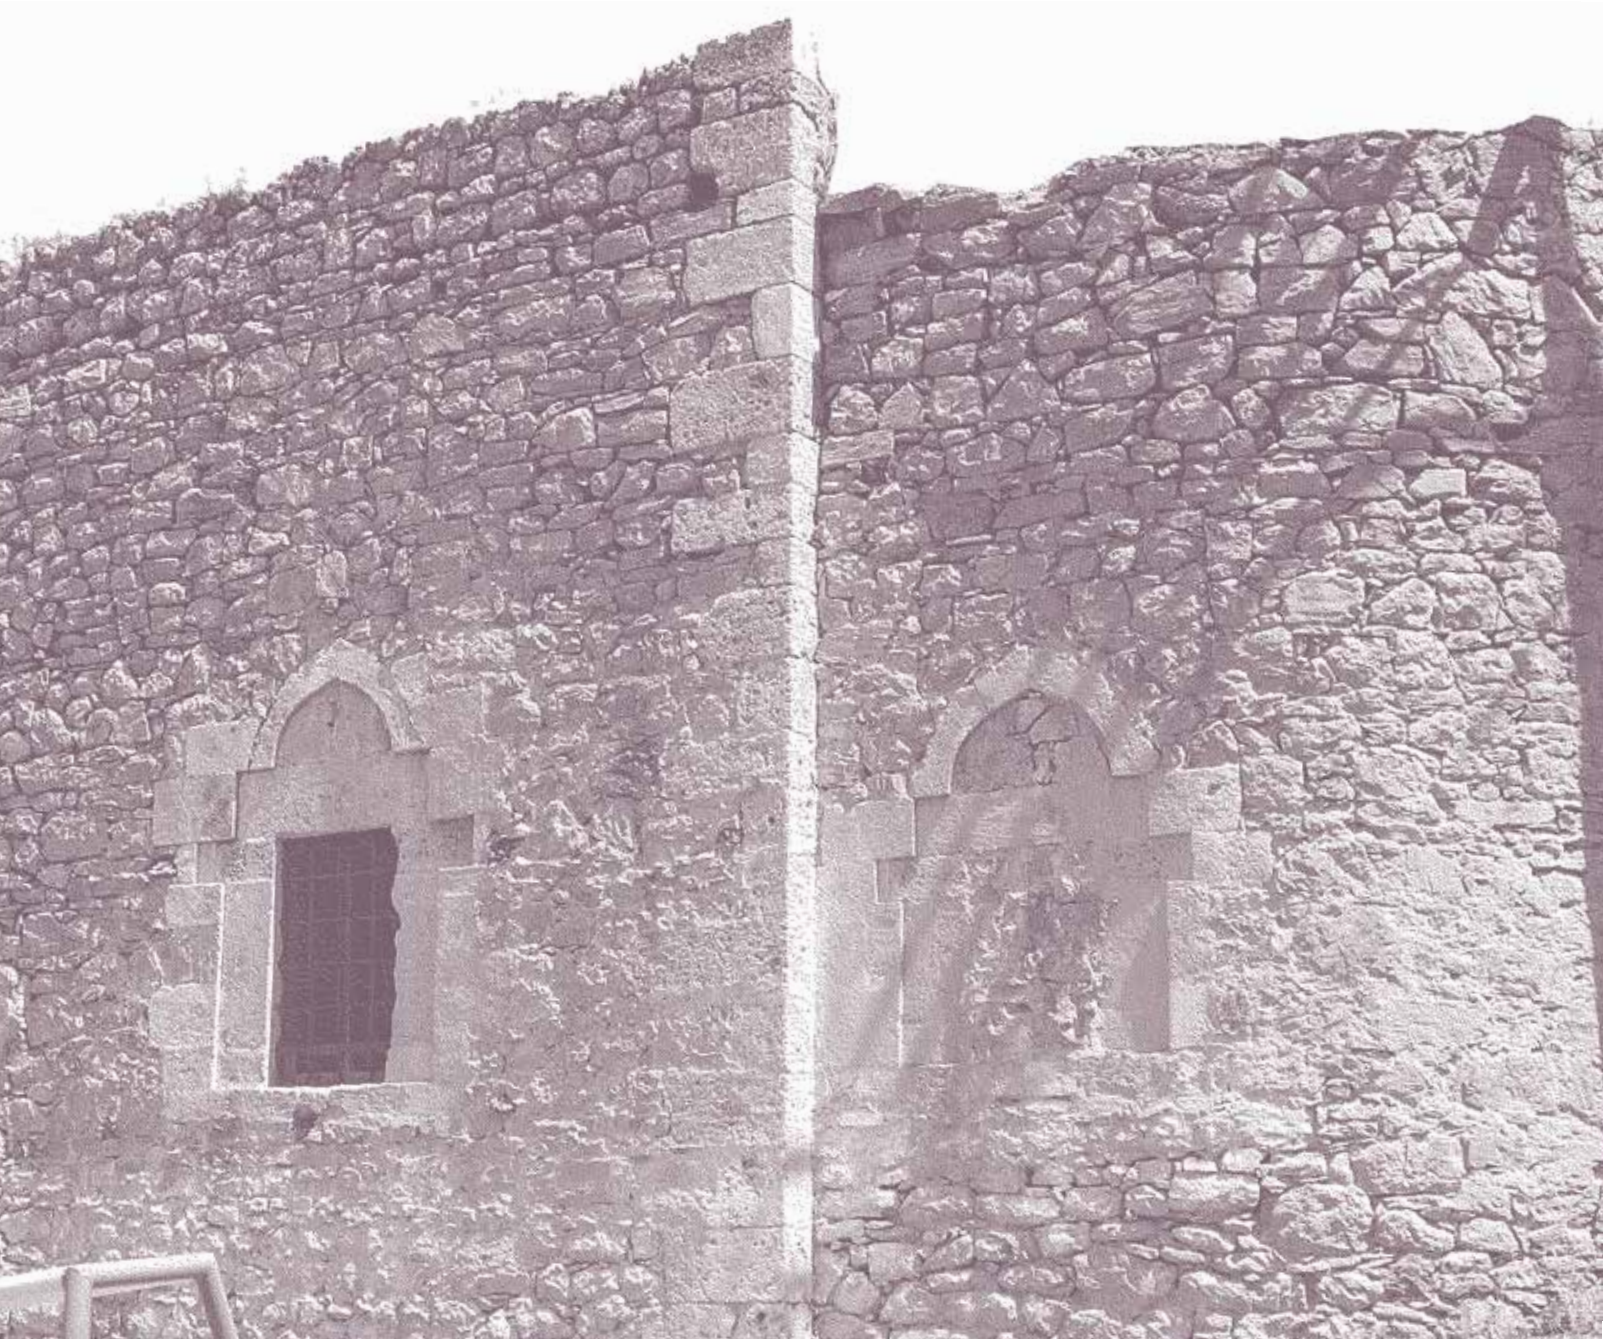
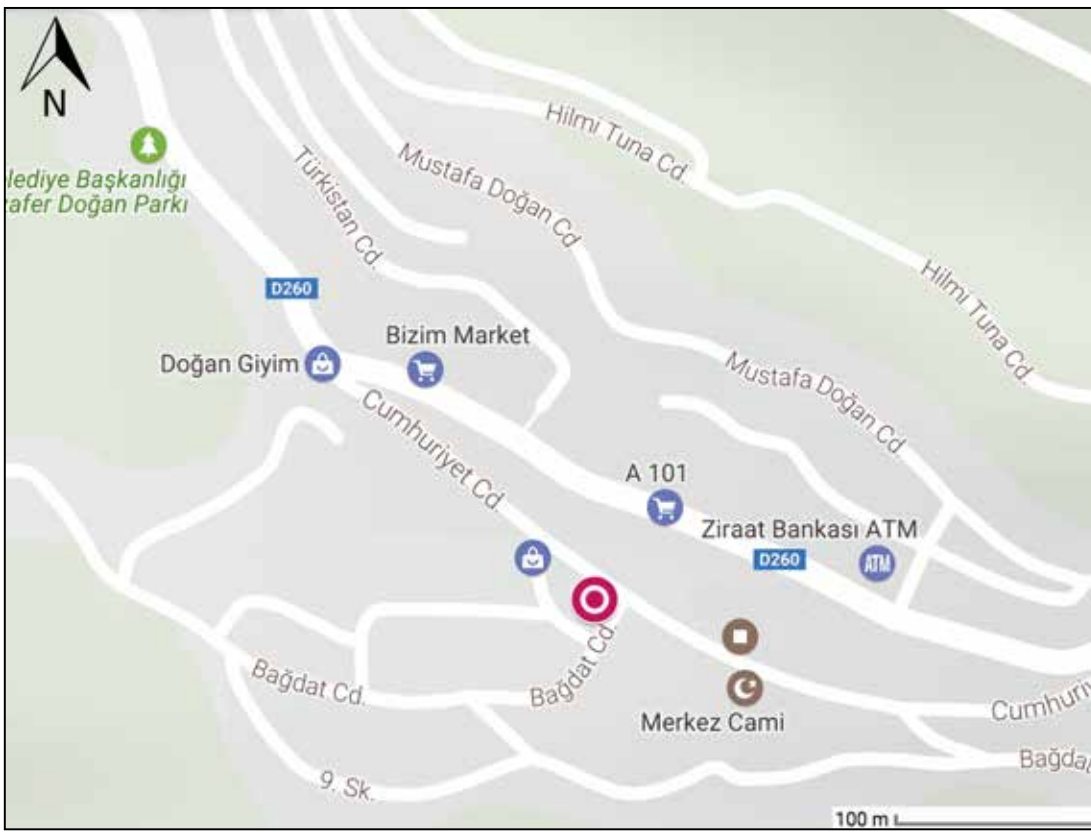
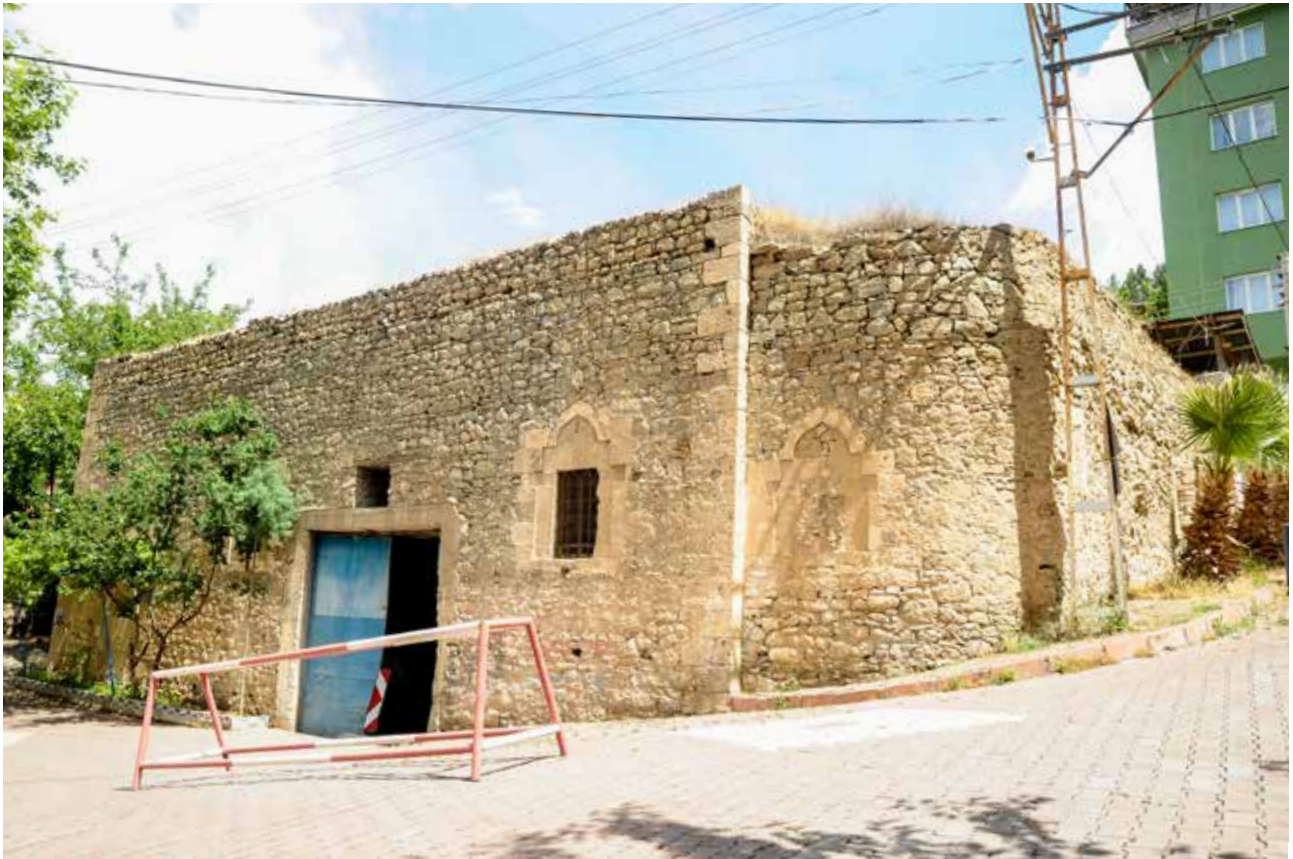
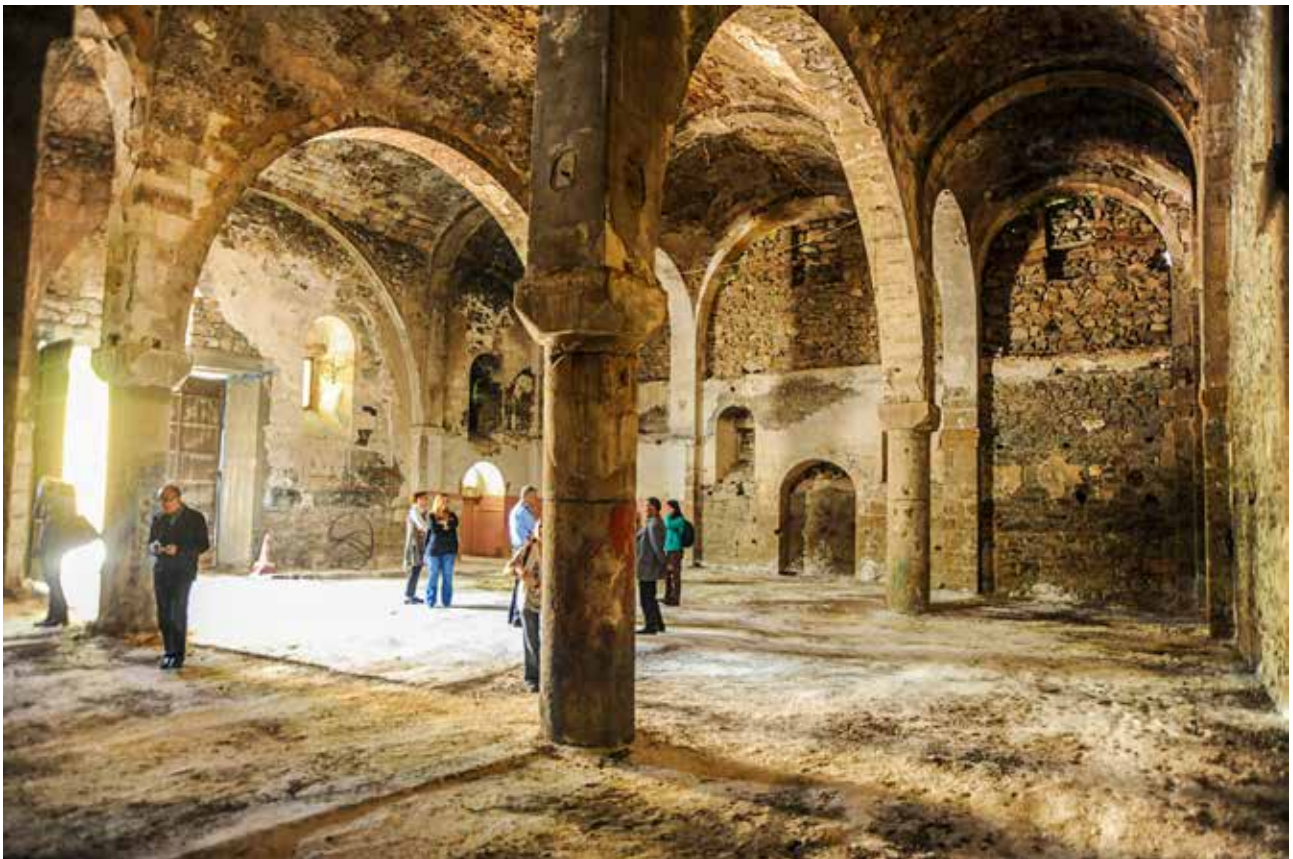
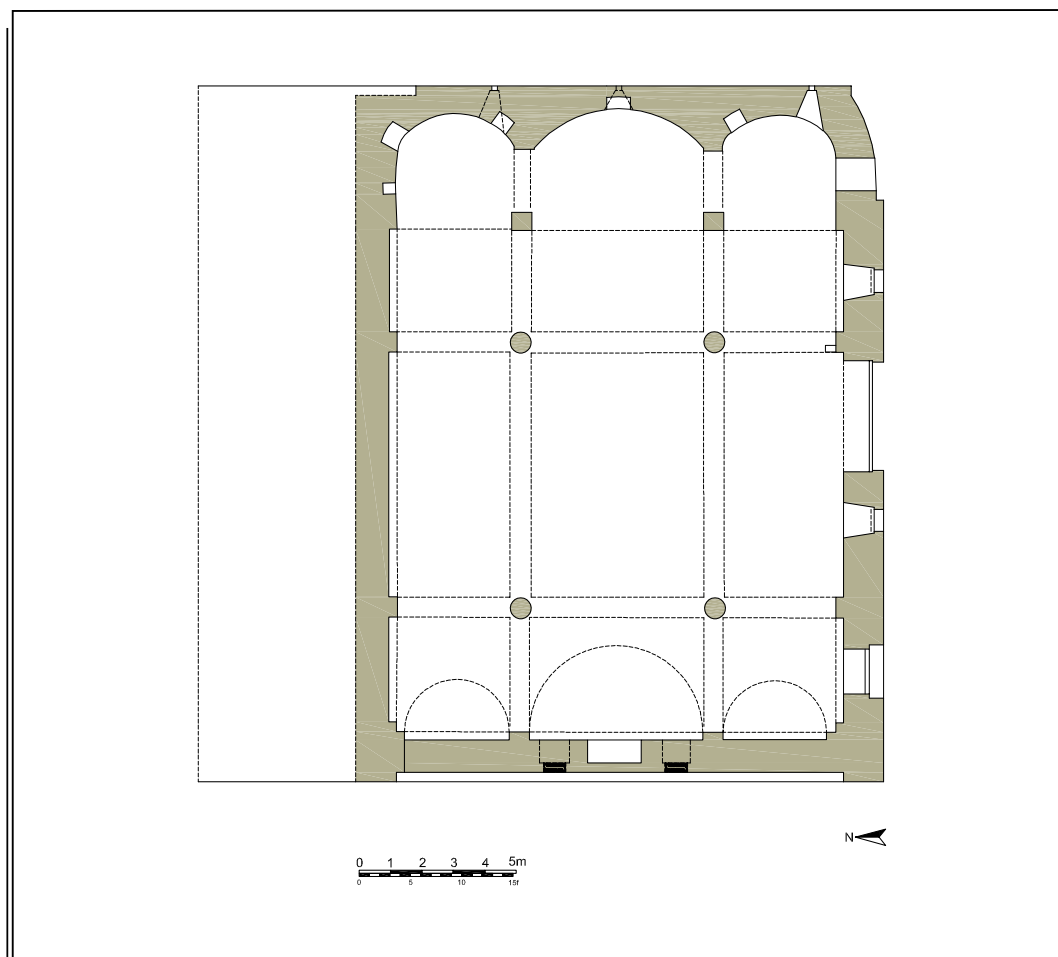
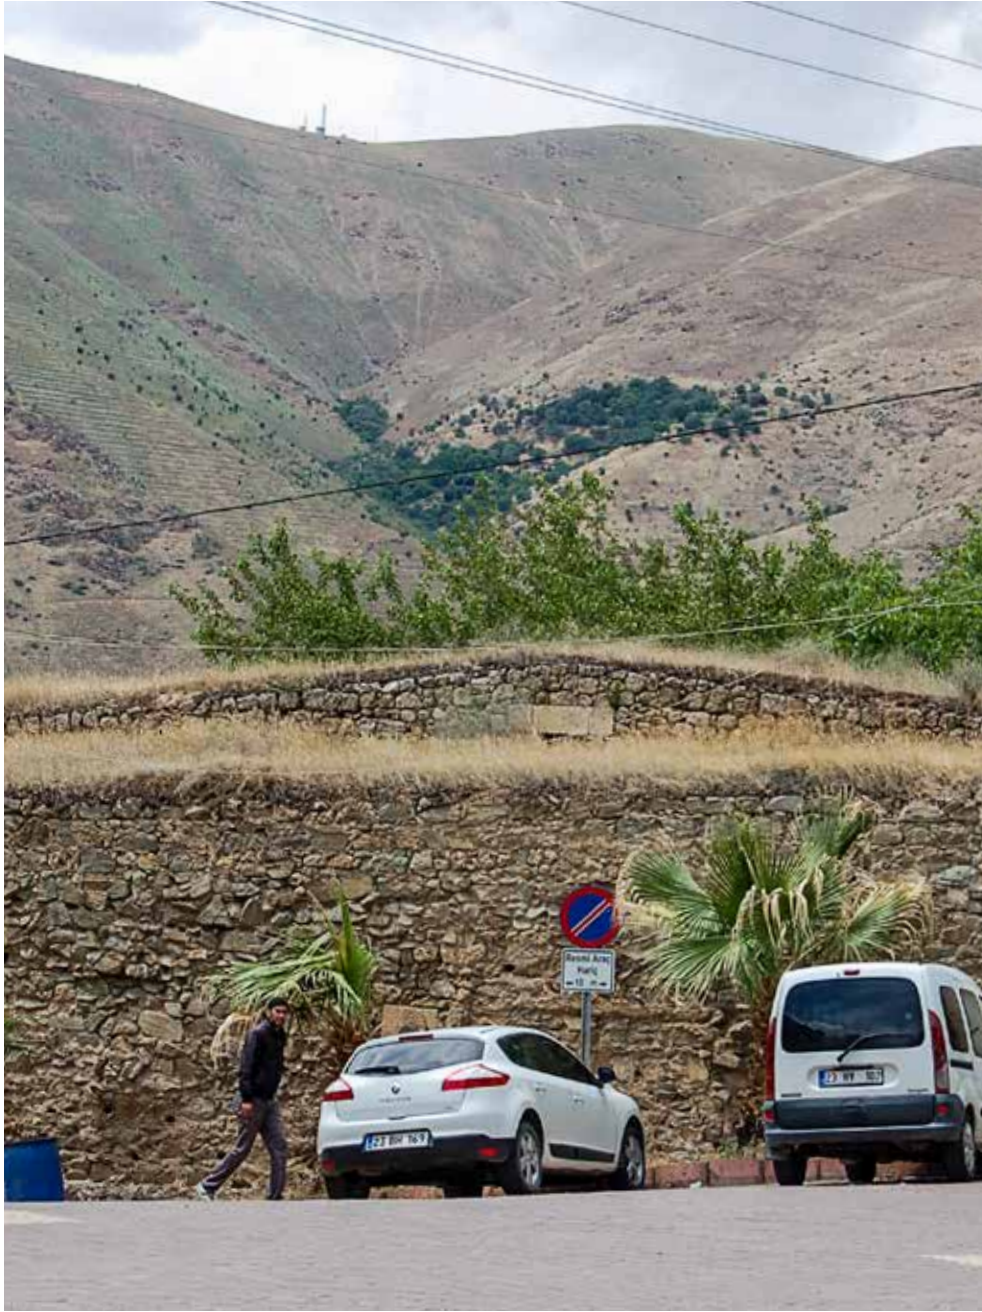
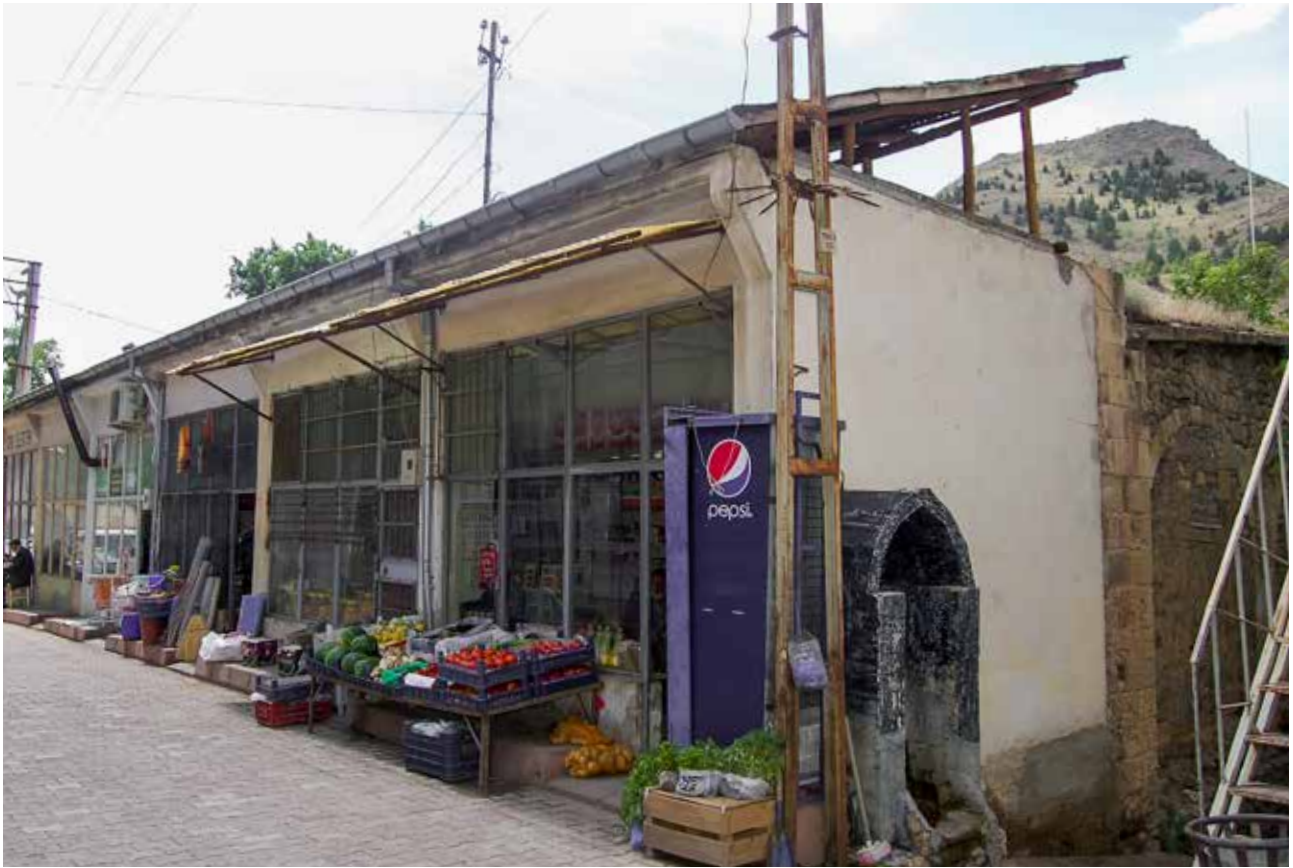
*The Church
Keban county, Kallar neighborhood*

The church is located in the center of Keban, within the market area near the municipality building. There is a row of shops adjoining its north wall. The main entrance door and west windows on the west façade are below the current road level and have been closed. A disproportionately large, 3,5 m wide door was opened in the south wall of the structure for access in later periods. The original ground level is not fully observed due to interventions to the floor level.

There is severe material degradation linked to damp in the whole structure. There is efflorescence, due the cement-based plaster used in repairs. The frescos have been destroyed, with very few remaining traces. The roof is covered with plants.

The layout, material and roof are largely preserved, with severe moisture problems in the structure. It is unavoidable that these problems will increase as long as the building remains abandoned and closed. As the tie rods linking the arches have been removed, the structure is weakened. Though the external walls have not undergone much change, the interior has been degraded due to inappropriate use and the changes within have damaged the architecture of the structure. Due to the legal difficulties in removing the shops along the north façade, this area may remain as it is at present, but it is necessary to excavate the buried west façade and open the original doorway, evaluate the current entrance façade and door according to survey/restoration projects, resolve the severe moisture problem in the interior and clean the roof cover.

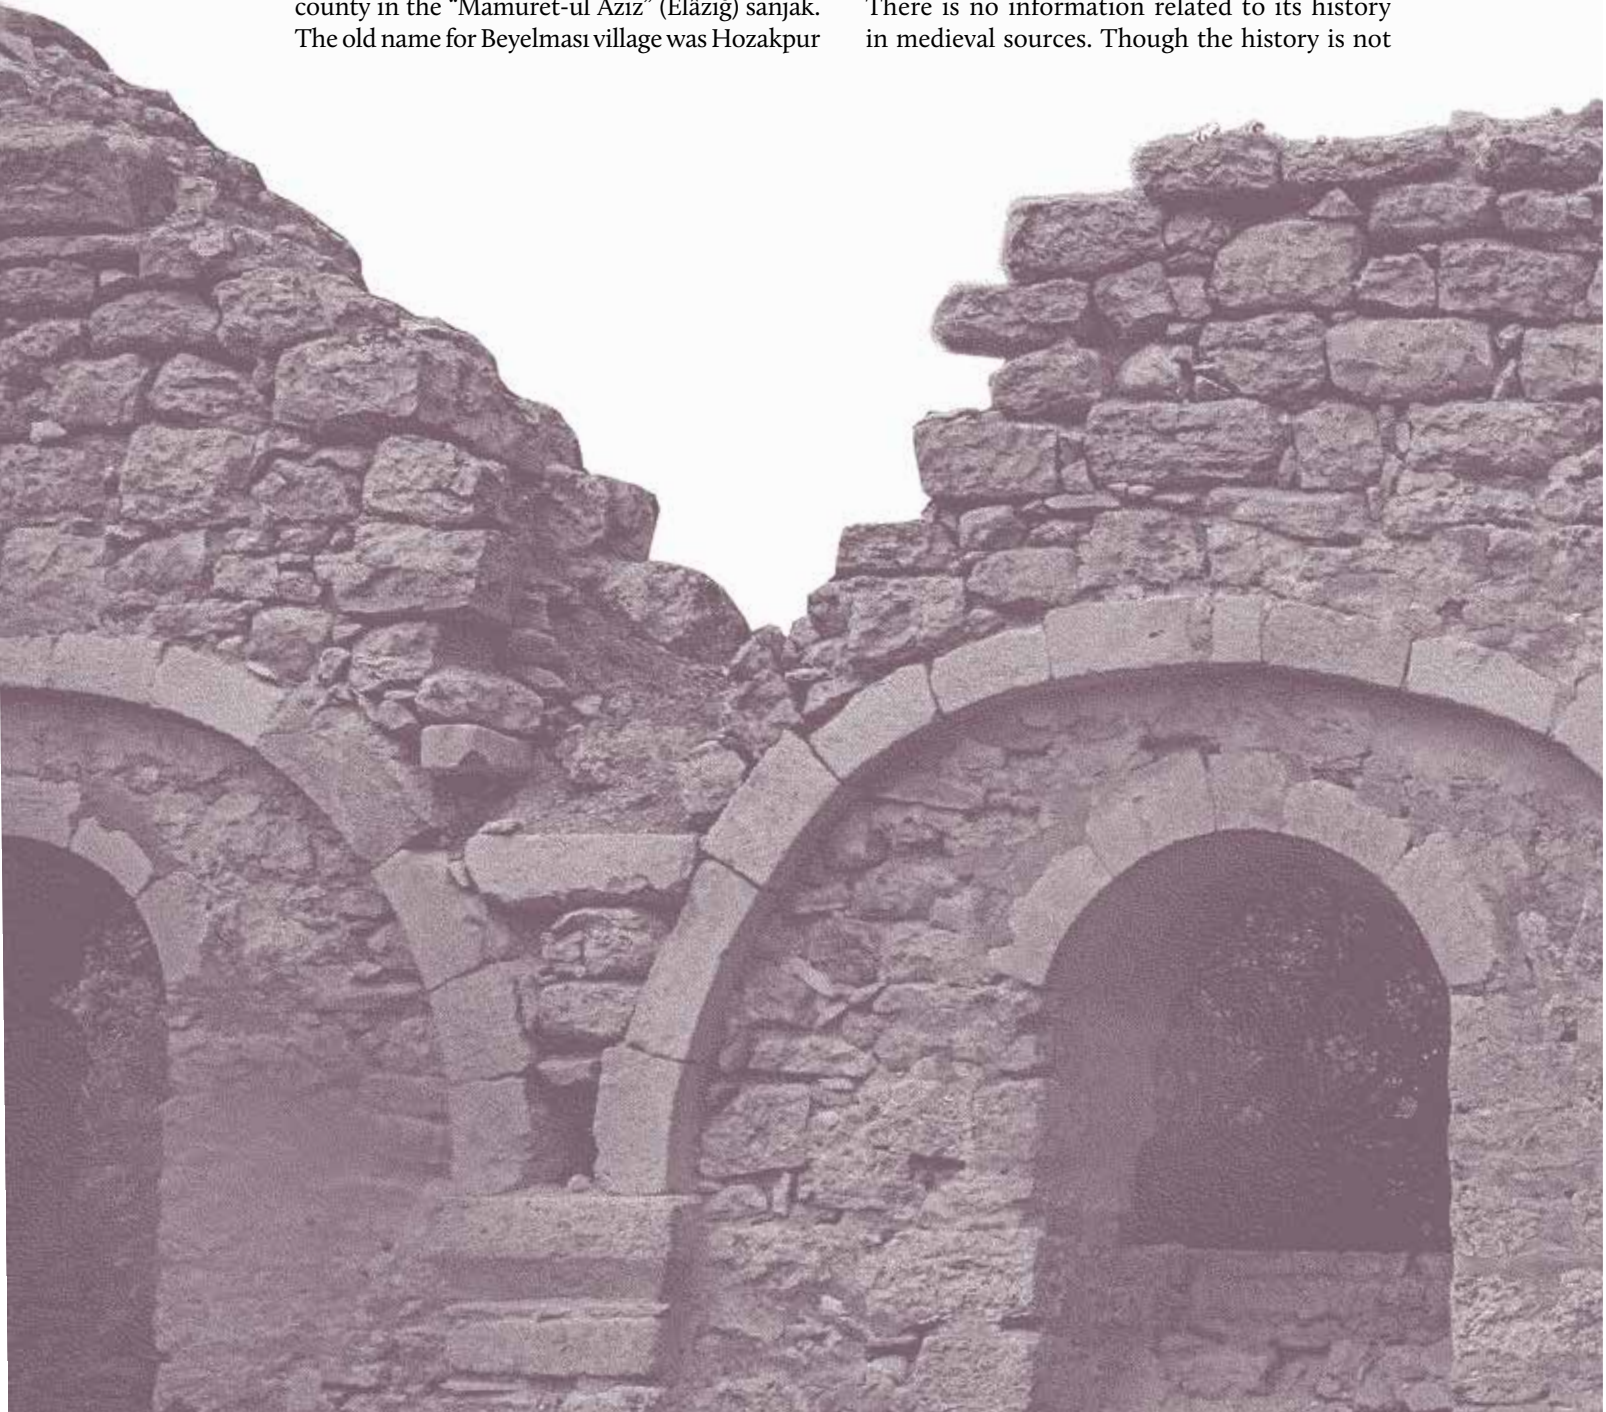
Only the northern wall is preserved up to the beginning of the vault. The western wall and the apses are partly preserved, and the trajectory of the southern wall could be traced underneath the ground. To the north of the monument, one can see graves that have been excavated by treasure hunters. The building is open to external factors of damage.

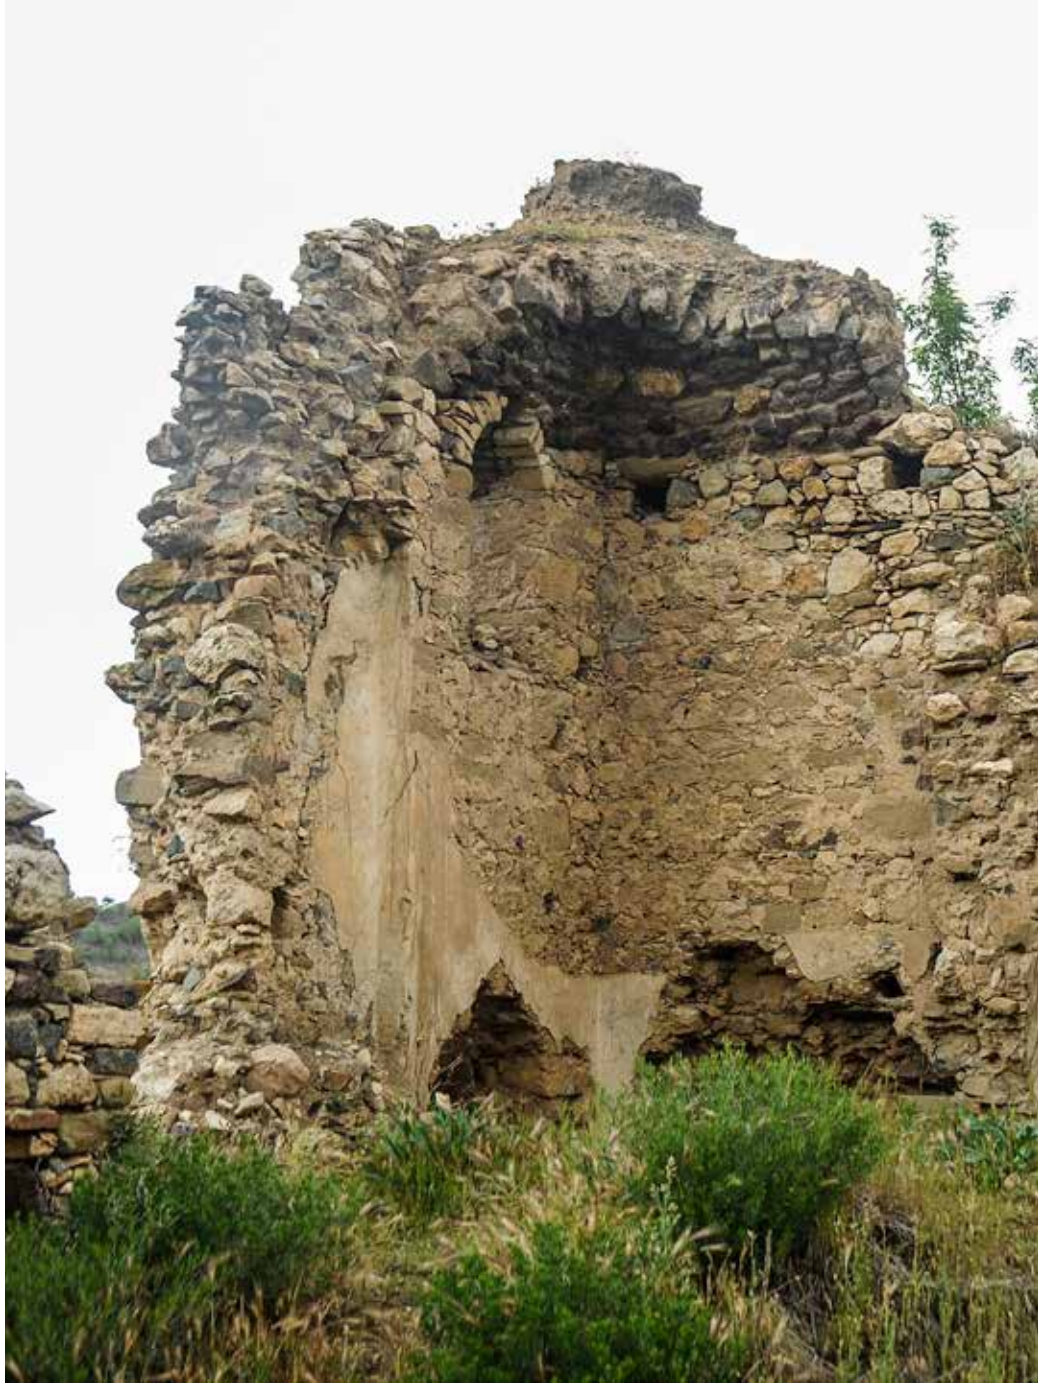
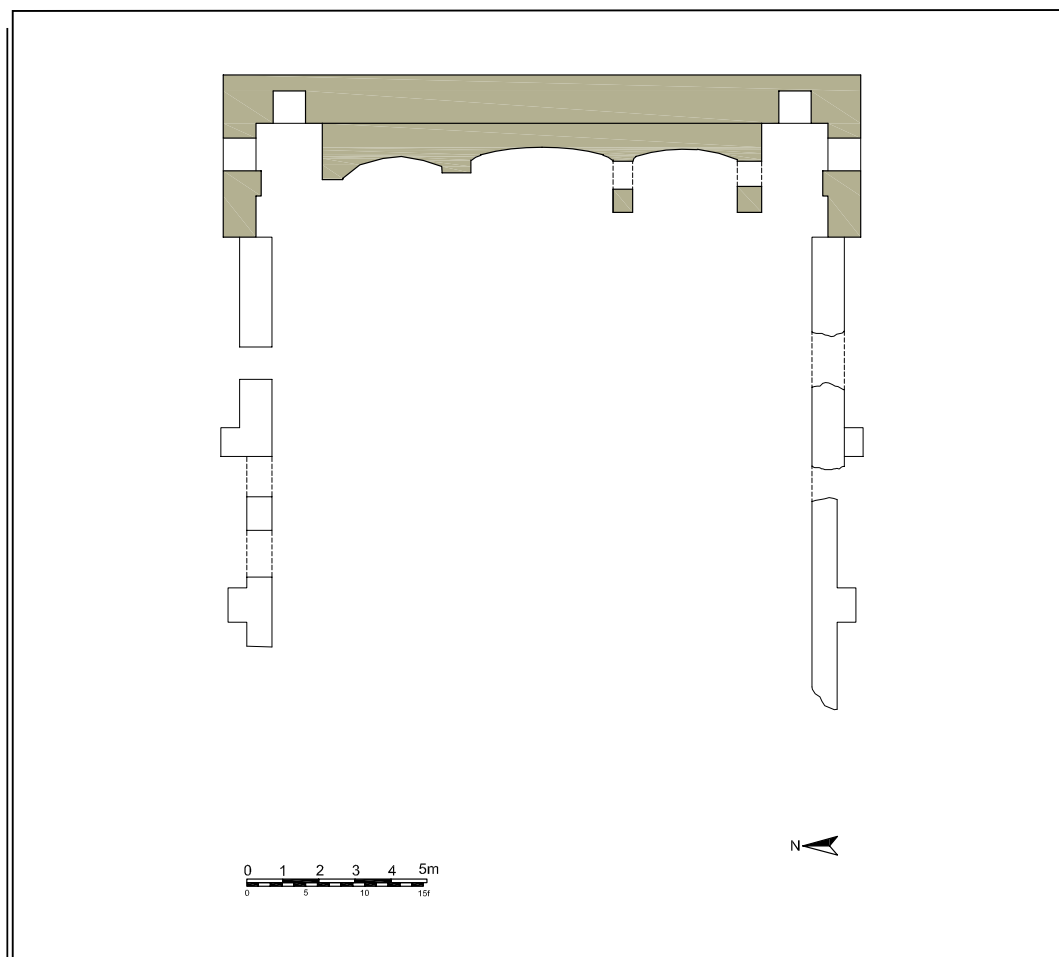
*Church of Saint John the Baptist
Elazığ Central county, Harput neighborhood*

The north and south walls are partially standing, while the east wall is completely preserved apart from its upper section. There is no visible information about the end of the north and south walls and their upper levels. The roof is completely demolished, apart from some stone rows indicating the beginning of a dome roof partially observed in the lateral cell walls and central apse. The architectural layout is not fully visible.

Nearly the whole of the structure has large amounts of material loss and degradation. Although the east wall and lateral cells are still intact, severe degradation is observed in their masonry walls. The material loss in the north and south walls is slightly more advanced compared to the east wall.

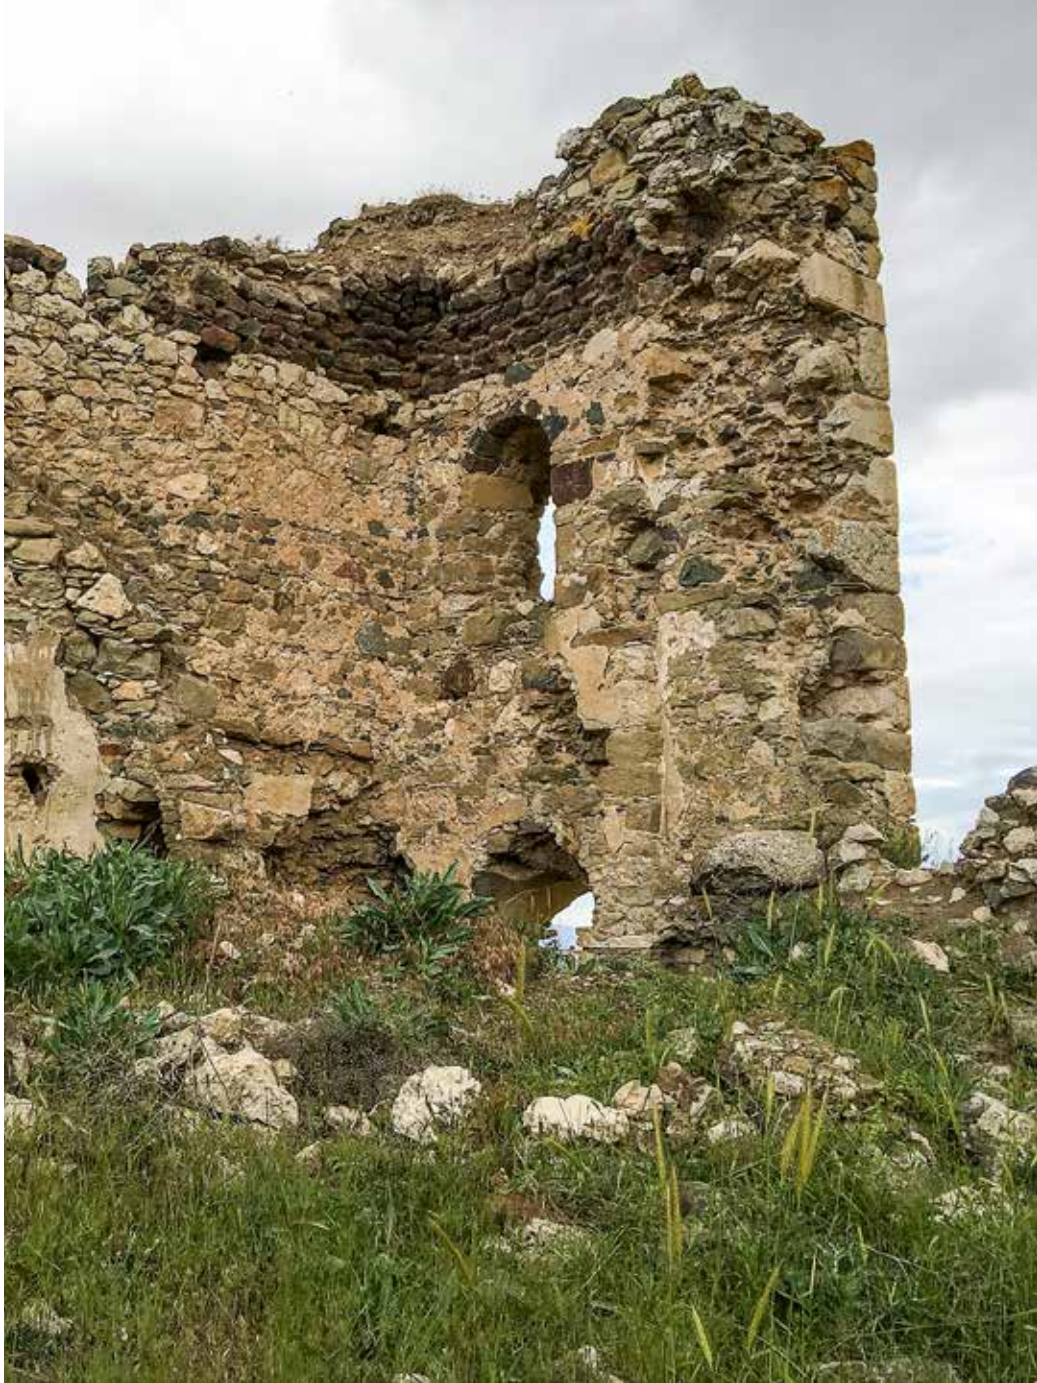
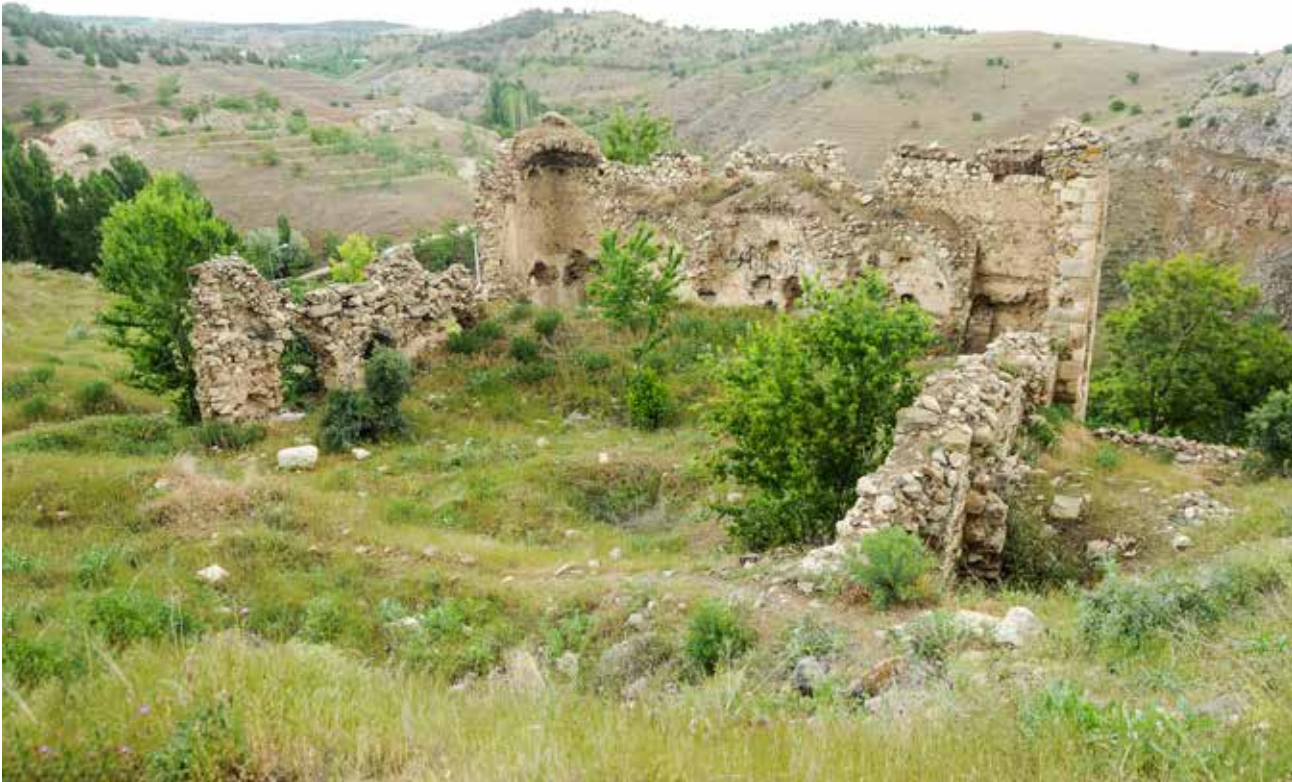
*Church of Saint John the Baptist
Elazığ Central county, Harput neighborhood*

The structure is largely demolished and as there is no precaution taken around it, it is open to human and natural depredation and at high risk. The walls have deteriorated due to material loss, and this is more of a problem than severe structural degradation. A large portion of the north and south walls and the whole of the west wall are demolished. The ground level is filled with soil and covered with plants and weeds.

Initially, emergency preservation precautions should be taken, and the remaining section should be preserved. A detailed preservation and repair plan should be prepared, research
