Kayseri
Adana
Izmir
Elazığ
Niğde
Bursa

Assessment Report of Architectural Cultural Heritage

April 2018

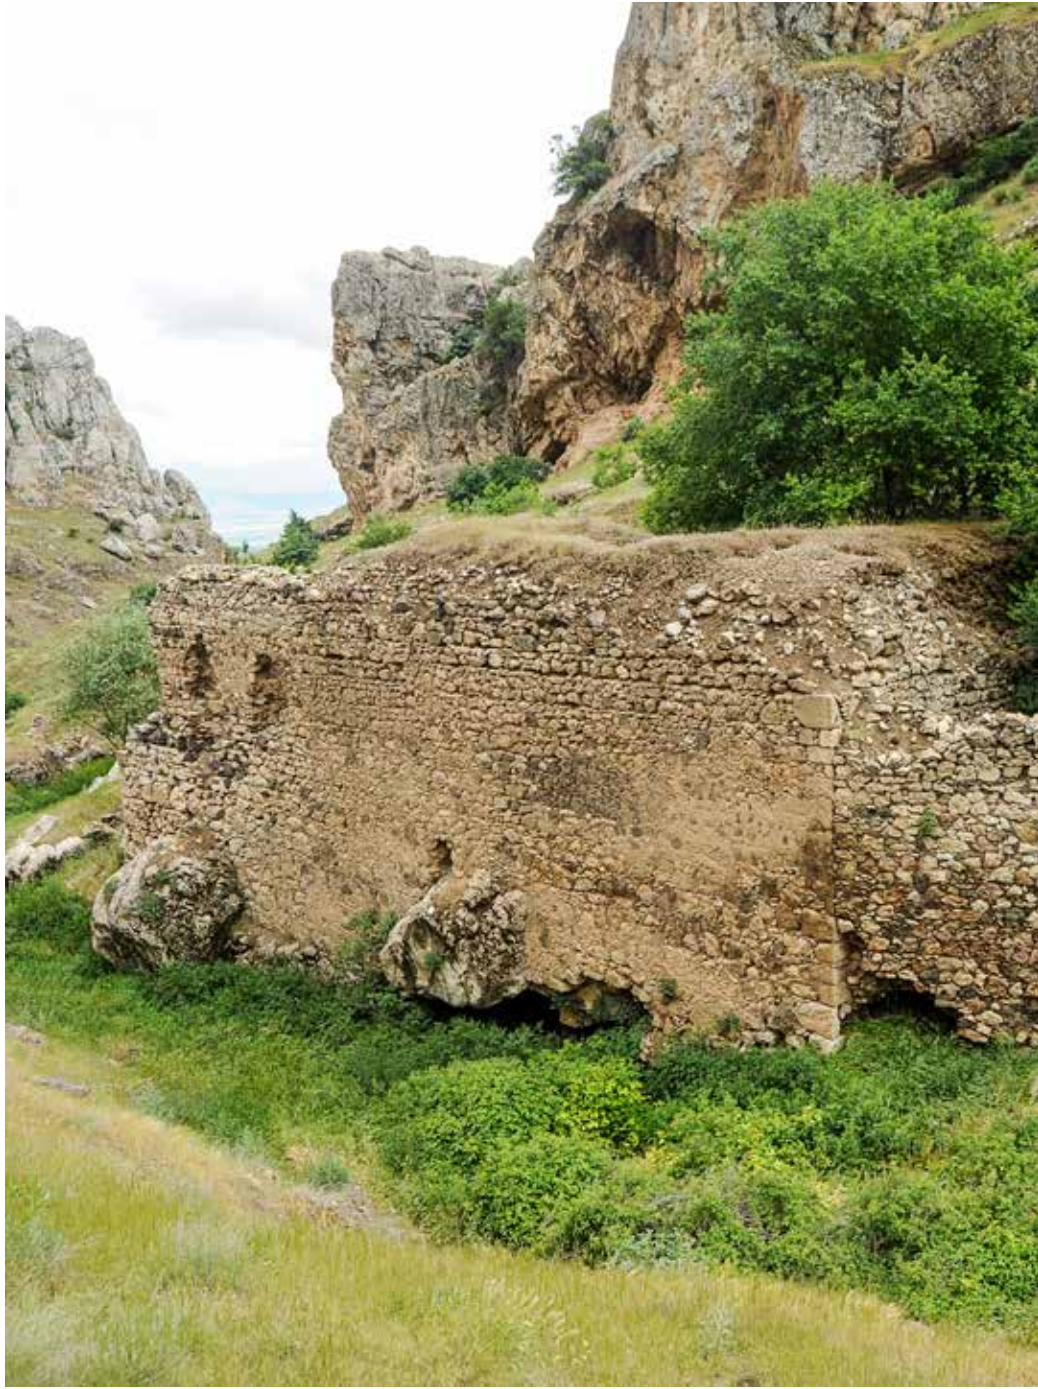
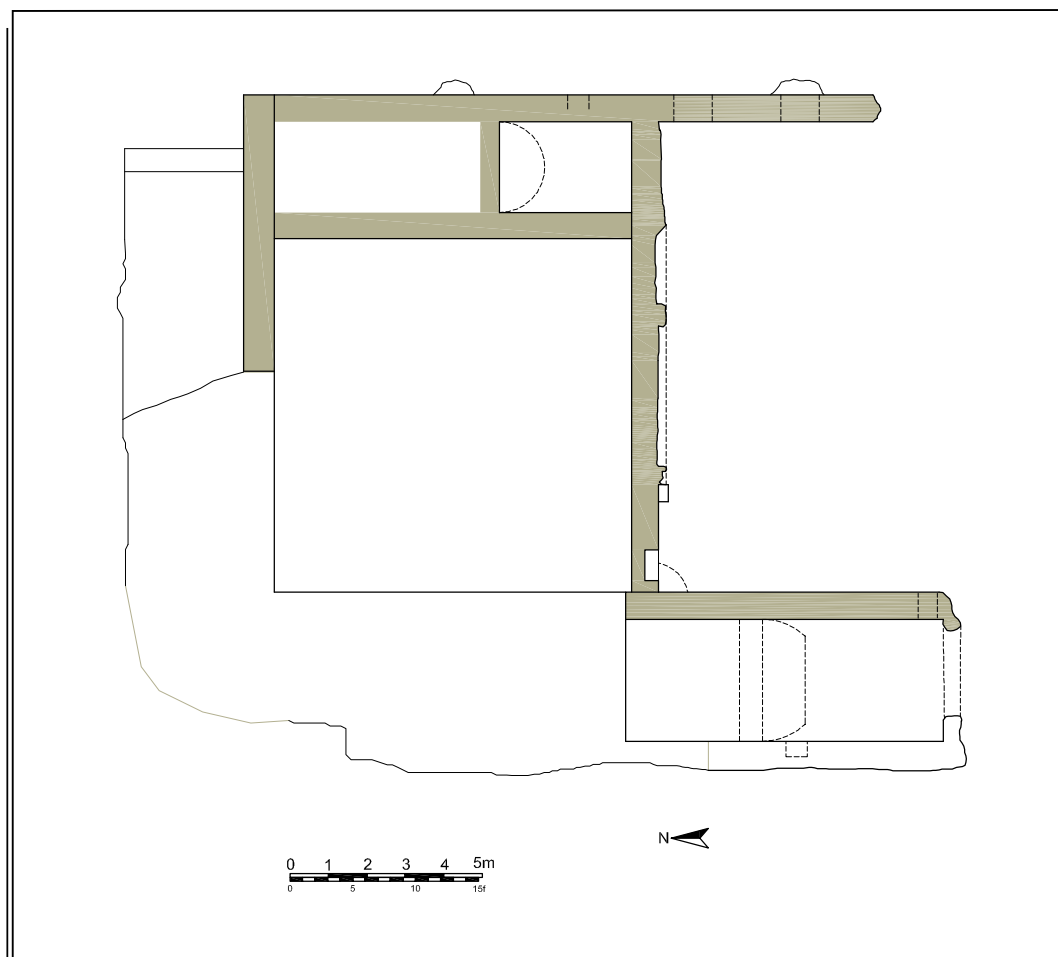
*The Public Bath
Elazığ Central county, Harput neighborhood*

The plan is degraded and undecipherable. The roof is completely collapsed. As the structure is partly underground, all spaces have not been identified. Nearly all of the structure has serious loss in its fabric. The northwest wall is relatively sturdy, yet its upper and front sections are completely demolished.

A large portion of the structure is demolished and as no precaution has been taken for its protection, it is completely open to human and natural depredation and at high risk. Initially, emergency preservation precautions should be taken to ensure the survival of the remaining section. Cleaning of its surroundings and research excavations should be planned. After correct information is obtained through excavations, a detailed preservation and repair project including survey, restitution and restoration projects prepared.

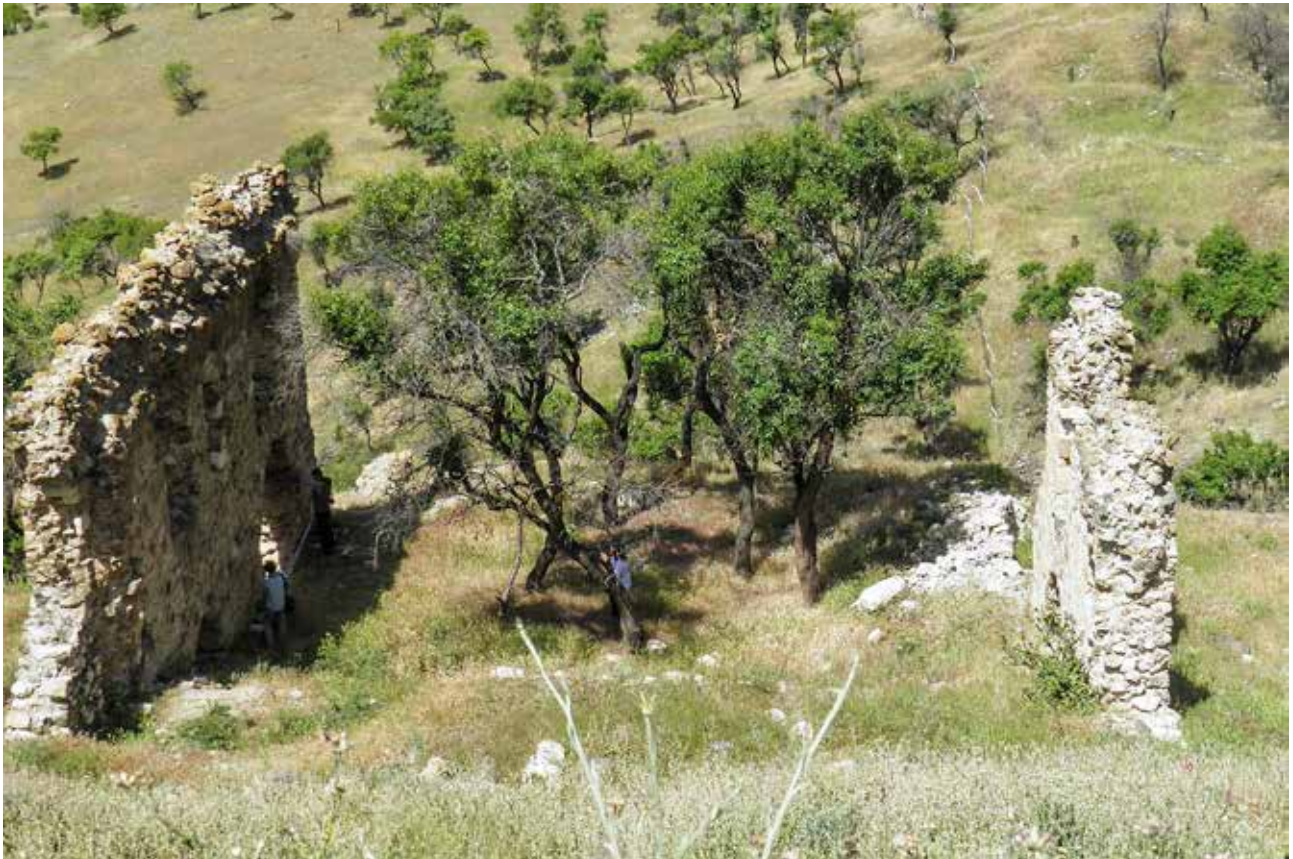
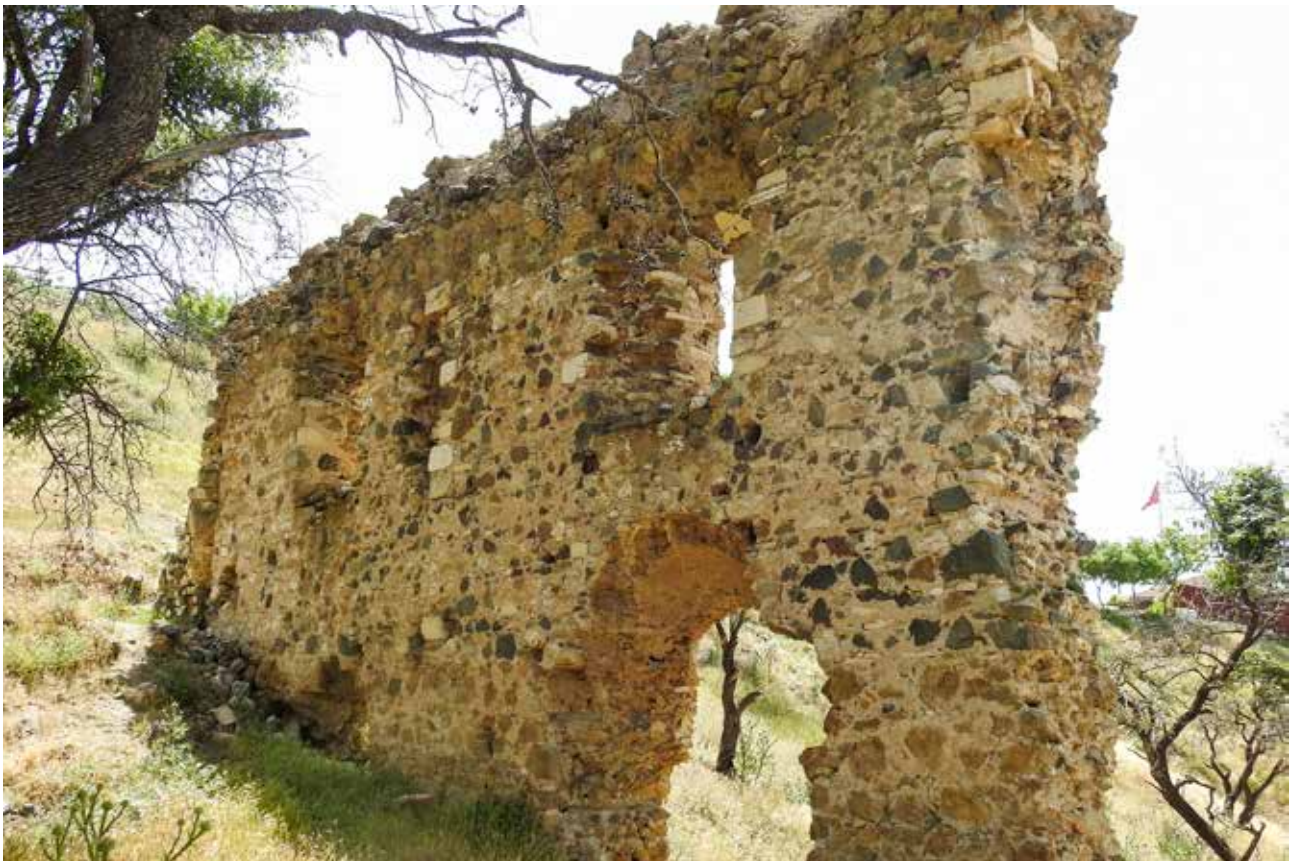
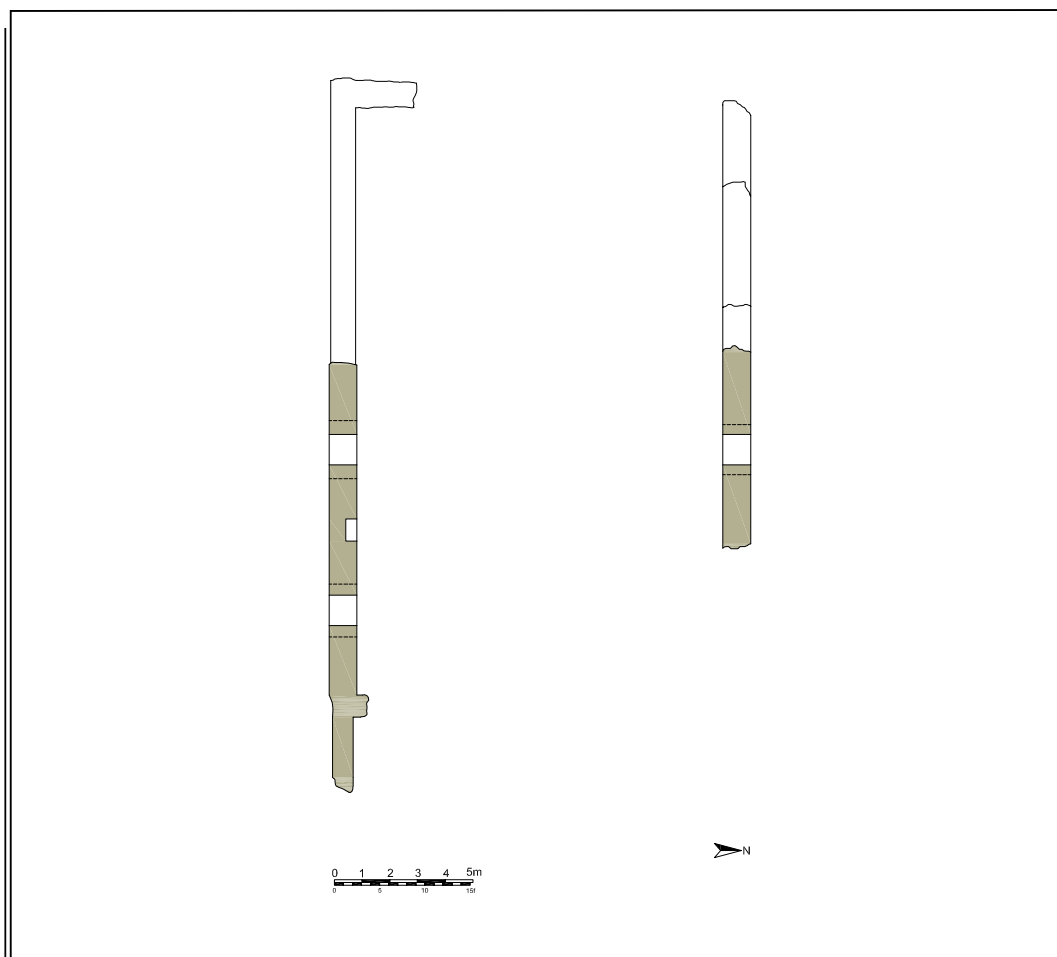
The church is currently close to a settlement area, west of the main road, on sloped ground at a level below the road. A very small portion of the walls remains standing and the north wall is proportionally more demolished than the south wall. There is material loss and severe corrosion in the walls.

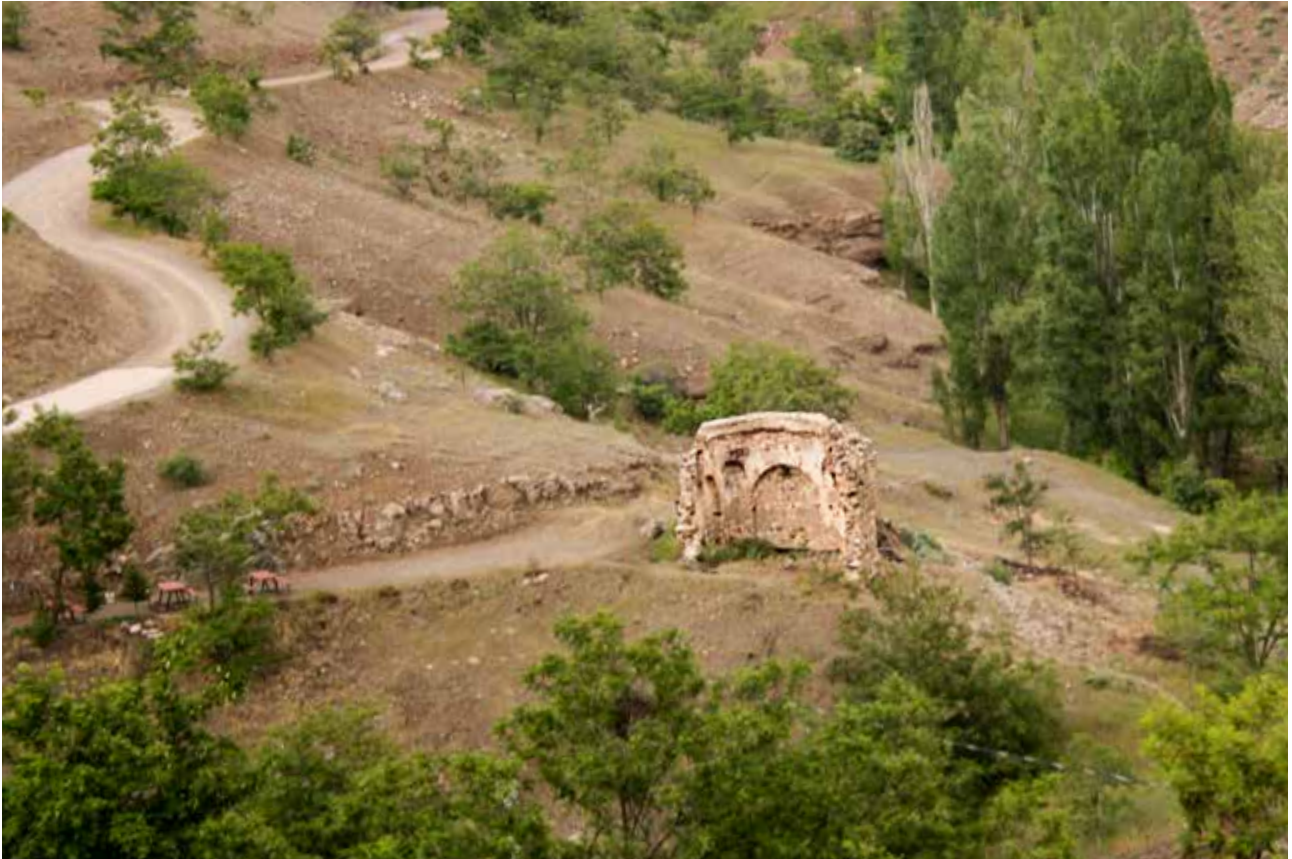
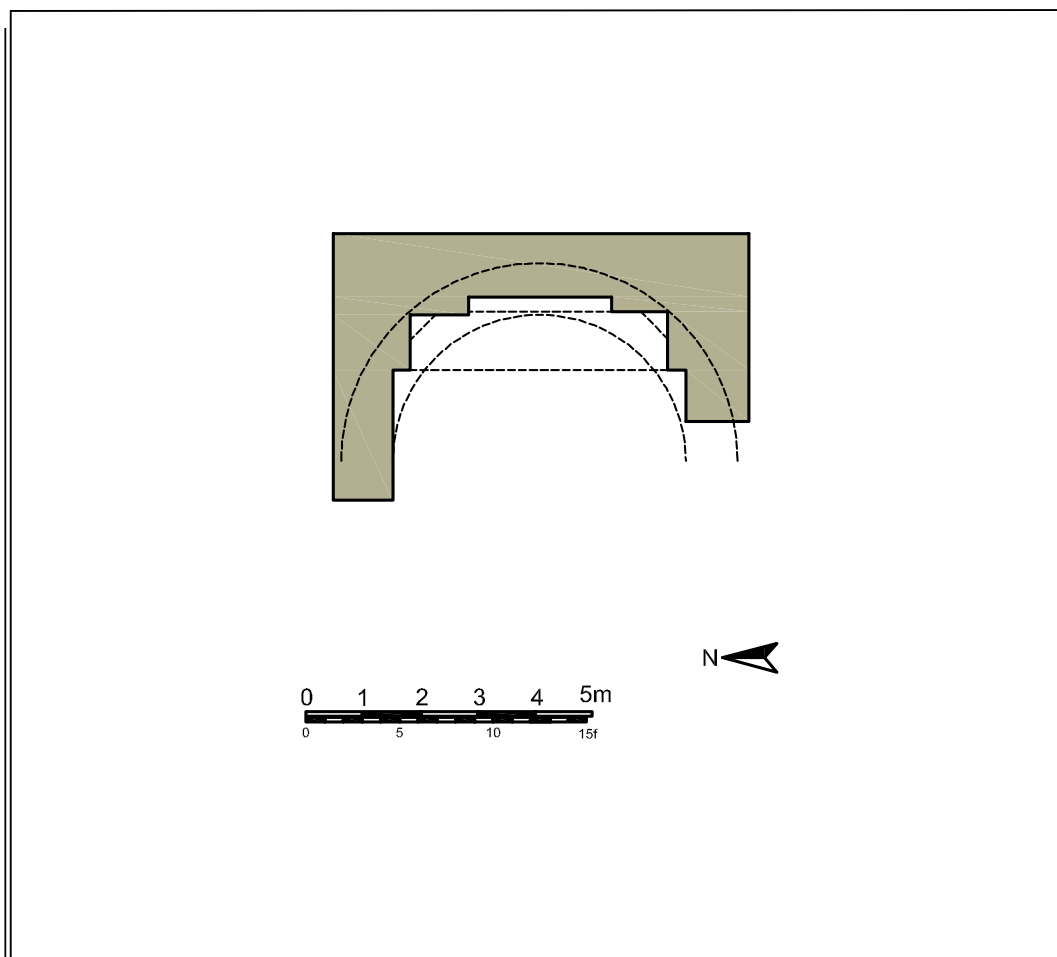
The north, east and south walls of the structure are partially standing; while the west wall is completely demolished. The upper section of the dome above the remaining walls is almost demolished, with only a few rows of brick remaining.

There is a large proportion of material loss in the entire structure especially at the base of the walls. Erosion, structural fractures in load-bearing elements, vertical structural fractures in the keystones of arches, window and corner buttresses are observed. Only three walls are partially standing and the roof is completely collapsed, leaving it open to more severe collapse. There is serious material loss linked to dampness in the lower 5-6 rows of stone masonry near the

ground. The six rows of stone in the center are preserved along with mortar. The upper 5-6 rows of stone have preserved their material integrity despite rain and weather conditions, but mortar is lost. There are vertical fractures in the keystone sections of the load-bearing arches and window arches. All walls contain structural fractures. On the three façades of the partially preserved interior walls, plaster is observed.

The structure is at high risk due to its structural state and vulnerability to both human and natural depredation. It is fully open to vandalism and external factors. With half of the structure collapsed, the structural state is bad. It requires emergency intervention for preservation and repair.

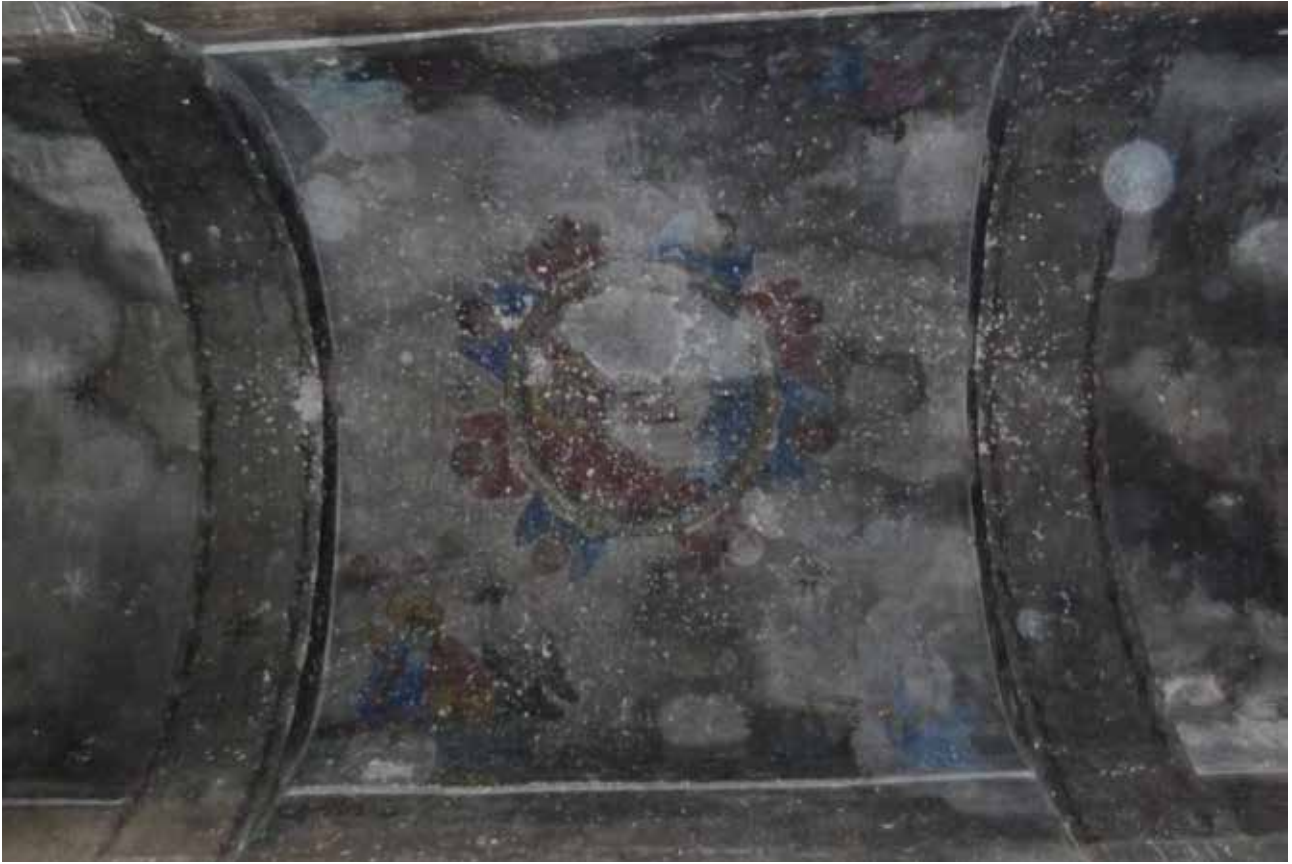
There is degradation of the stones on the external façade, occasional breakage of roof moldings and plant growth.

Due to the loss of parts of the roof, water has entered the structure and caused efflorescence in the vaults. Due to damp, all structural elements have been badly damaged; with plaster loss and disintegration of the frescos.

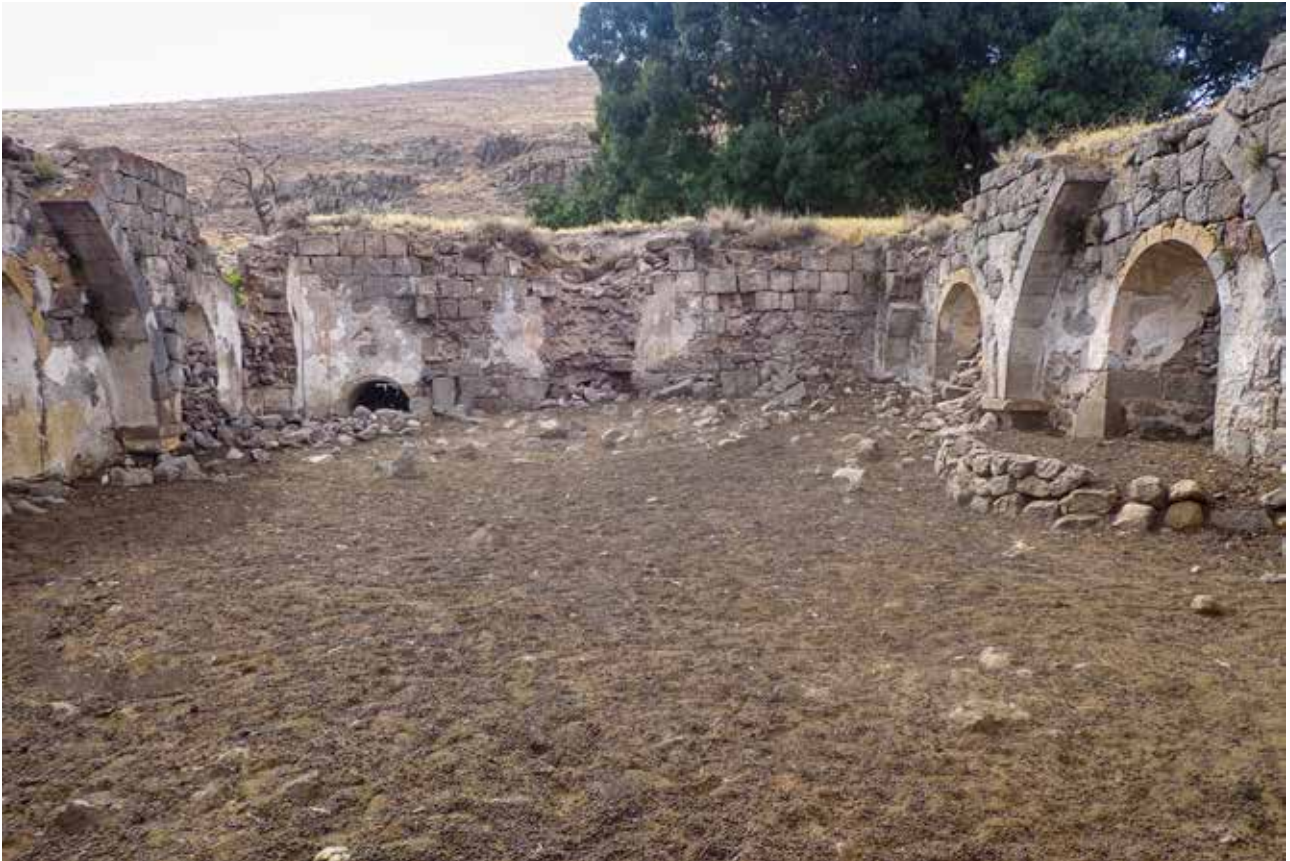
There are only remains of the outer walls of the structure and the original main entrance has collapsed. Some of the walls hint at the original plan of the church; its spatial characteristics are, however, unknown. Though the church has reached the present with its entrance portico and four outer walls, it is in a ruined state. The north and south corners of the external

narthex west of the church have been damaged. The three doors providing entrance into the church from this external narthex has been filled in and closed, and the floor has also filled up so that entry is through a window in the northeastern façade. The church is filled with at least two meters of soil and animal manure so that the floor covering and traces of columns separating the naves and carrying the ceiling

are not visible. There are very large structural problems as may be seen in the façades of the church. Intense destruction is observable in the main walls of the structure. The ceiling of the naos and the roof are completely lost and the upper portion of the main walls has collapsed. The plaster on the walls has fallen off, mortar has been lost and there is plant growth on the remaining architectural fabric.

The surviving structures, the existence of plentiful water sources, the fact that it is situated immediately in front of high rocks, with Hançerli village below and a broad panorama of the valley, indicate that the monastery was founded in very appropriate topography for its function. Currently only the ruined church remains standing, but in its original state it is clear that this was a monastery complex with a chapel, and probably additional areas like the priest's residence, a guest house, refectory, and fountain. It may be inferred that this was once been an important religious center, yet the clearest structure remaining of the monastery is currently the church. The interior must be cleaned up, an archeological study must be performed to identify the church, the buried sections of the structure and the remains of the aforementioned chapel, and survey studies must be prepared. As a later step, the conservation of the church and other structures to be unearthed must be carried out, with the necessary safety precautions taken so that this cultural heritage is revitalized in terms of contributing to the historical wealth of the region.

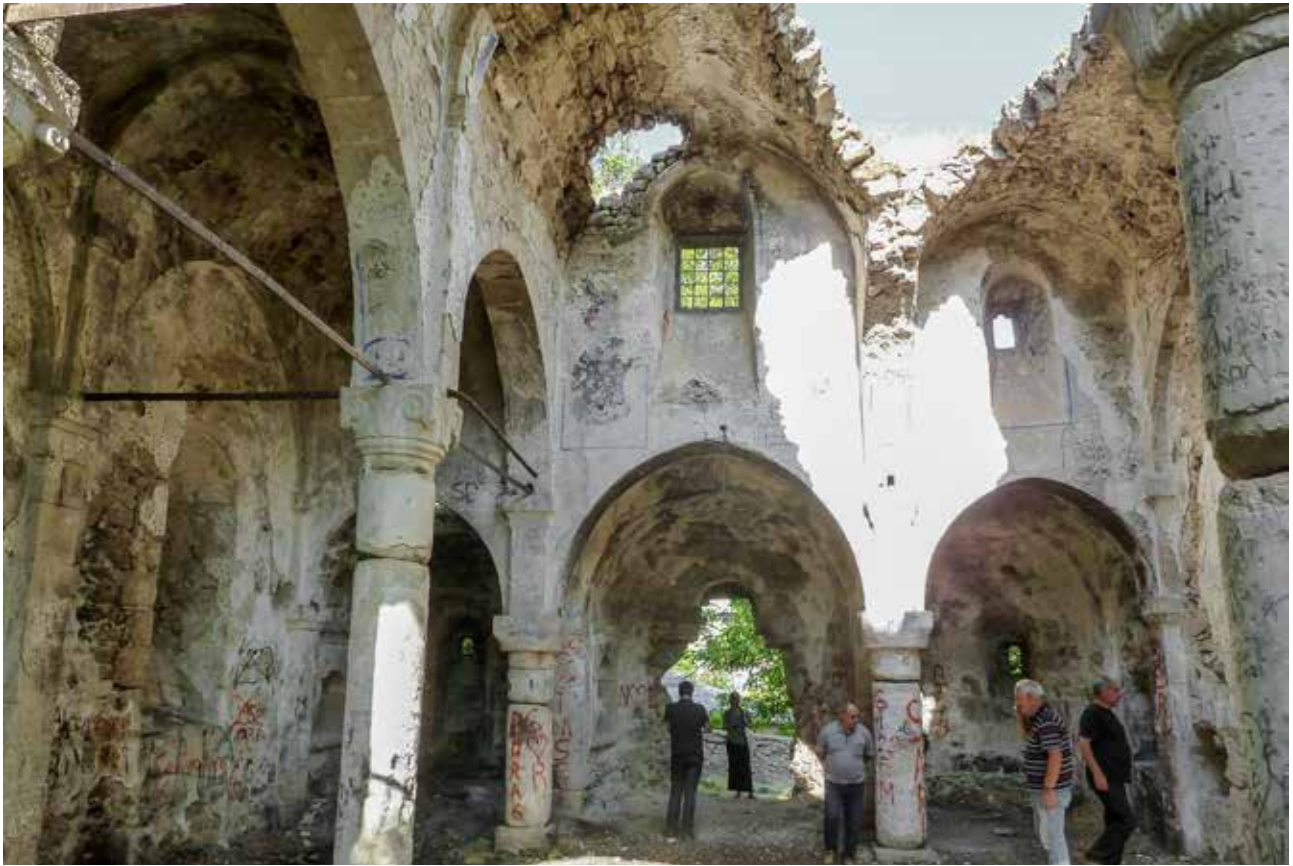
The linking rings and lead in the columns, which are connected by arches and standing on square pedestals, have been removed. As a result, the column and capital in the central axis of the nave on the southern side have fallen into the structure. The ceiling supported by the column that has collapsed has also fallen in. The ceiling is partially destroyed in the southern aisle and central nave, while the ceiling of the northern apse has been damaged. Only the eave moldings on the south and north have not been lost.

The roof of the structure has partly collapsed and as the gabled roof has been destroyed, the structure is open to the impact of wind and rain. The soil accumulation on the western and northern façades has caused even more dampness on the external walls and structural damage. The removal of metal accents on the pillars has negatively affected the structural integrity of the building. The current barrel vaults supported by the columns are in danger of collapsing at any moment. With no environmental protection, the structure is open to destruction through human intervention.

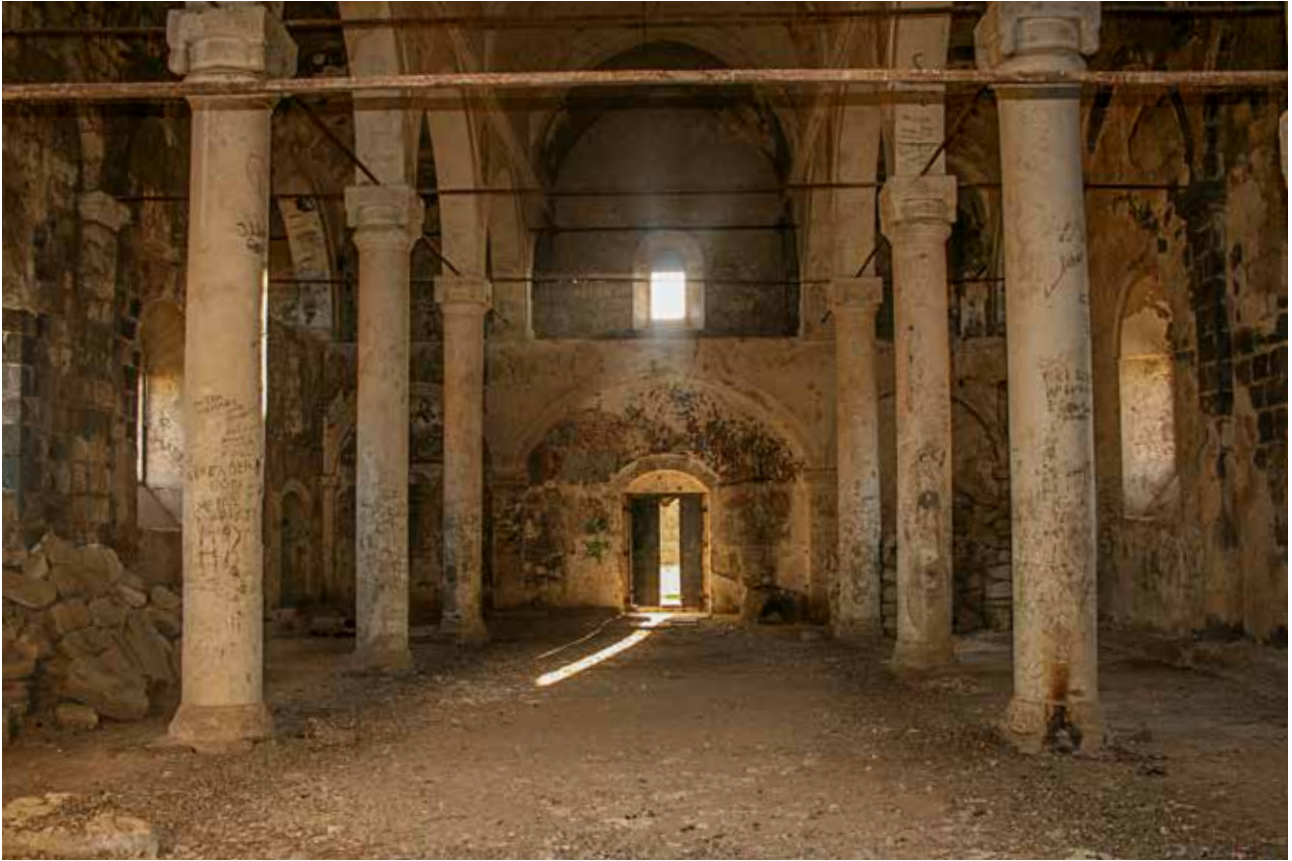
Currently, Church of Saint Macrina survives in a decrepit and neglected state. Due to the impact of the passage of time and of environmental as well as human factors, great destruction and degradation has occurred. All wooden window fittings within the structure have been carved out, and the stone flooring in the central nave and side aisles has been taken out and stacked inside. A niche for a mihrab has been created in the southern side of the nave wall, and some windows have been covered up with bricks. The main altar stone in the center of the bema has been knocked over. Apart from the northern aisle and narthex door, all original doors have been replaced with iron doors. The lower parapet stones and wooden parapets of the gallery floor and the stone and wooden stairs providing access to this floor have been removed. The iron bars in the windows, cramp irons and tie bars have been removed. The stone columns within the structure have been painted over. There is serious destruction in the sepulchre chapel as well.

Within the courtyard, the water wells have all been filled up and closed. Due to the soft soil upon which the structure is built, there are horizontal

and vertical structural cracks in the vaults and main walls. There is a general loss of materials in many places, abrasions, deformation, as well as corrosion and bending in the iron fittings. Within the interior, large sections of plaster have fallen off; plant growth is visible as well as efflorescence. There are problems related to dampness and the destruction of frescos has taken place due to these intense factors. However, it is still possible to discern the subject matter of compositions that have survived up to this day (Songur, 2016a, 43-45).

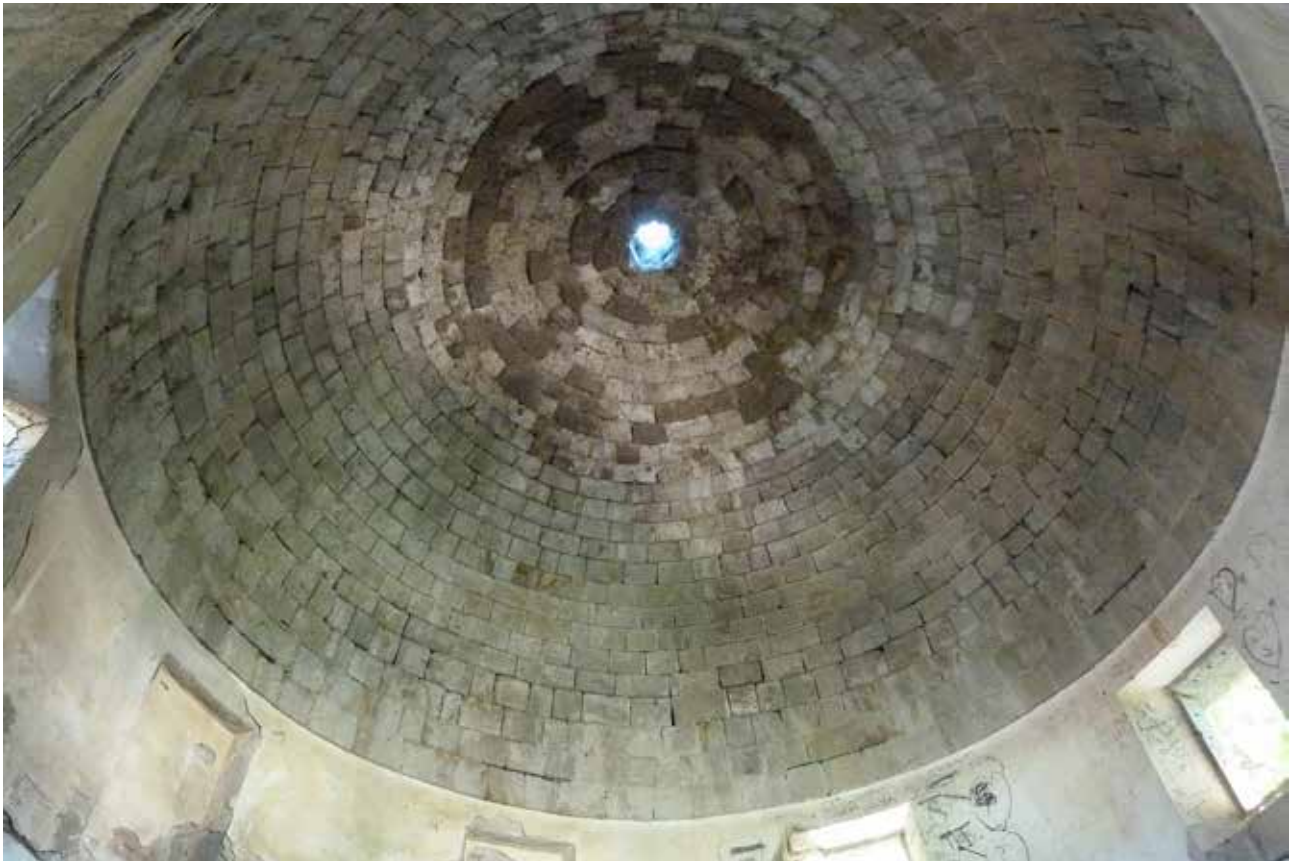
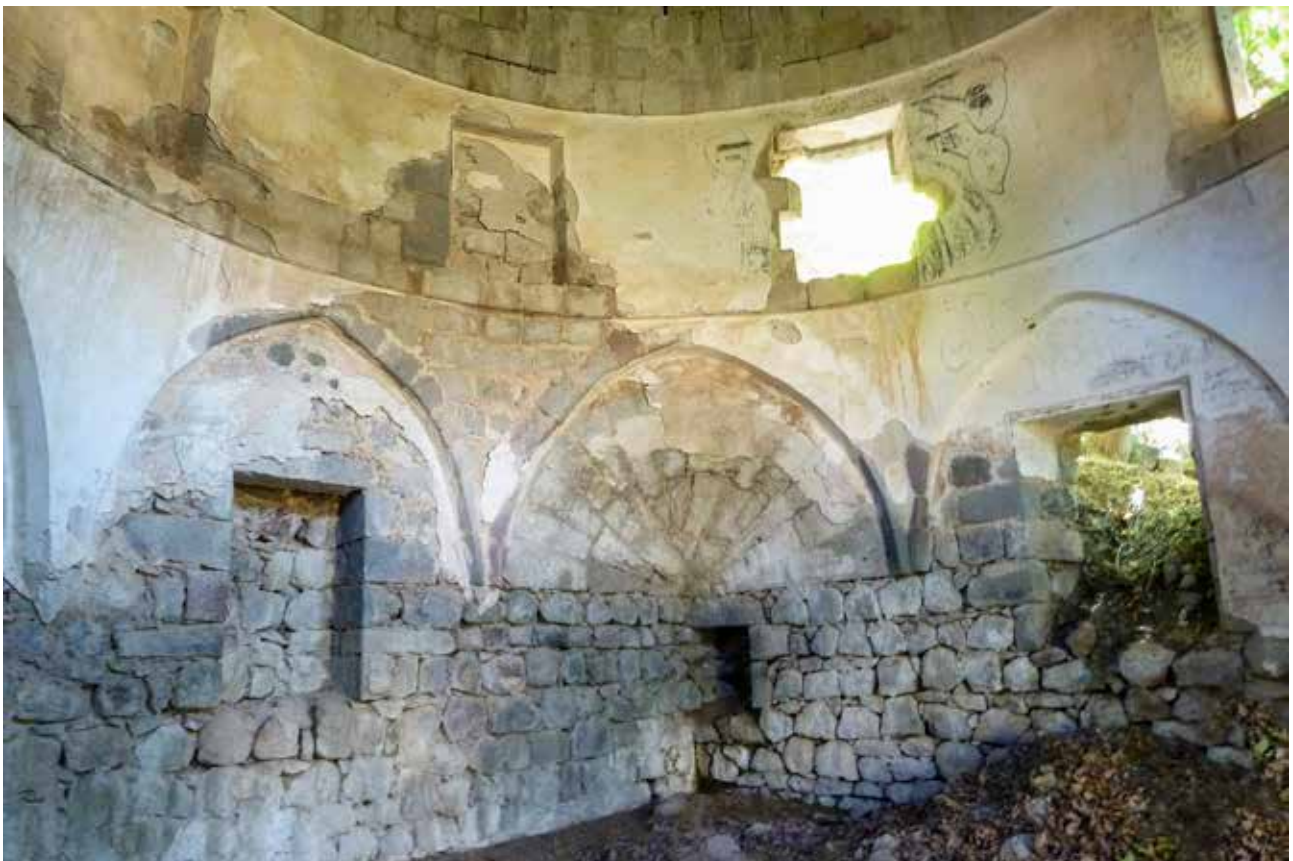
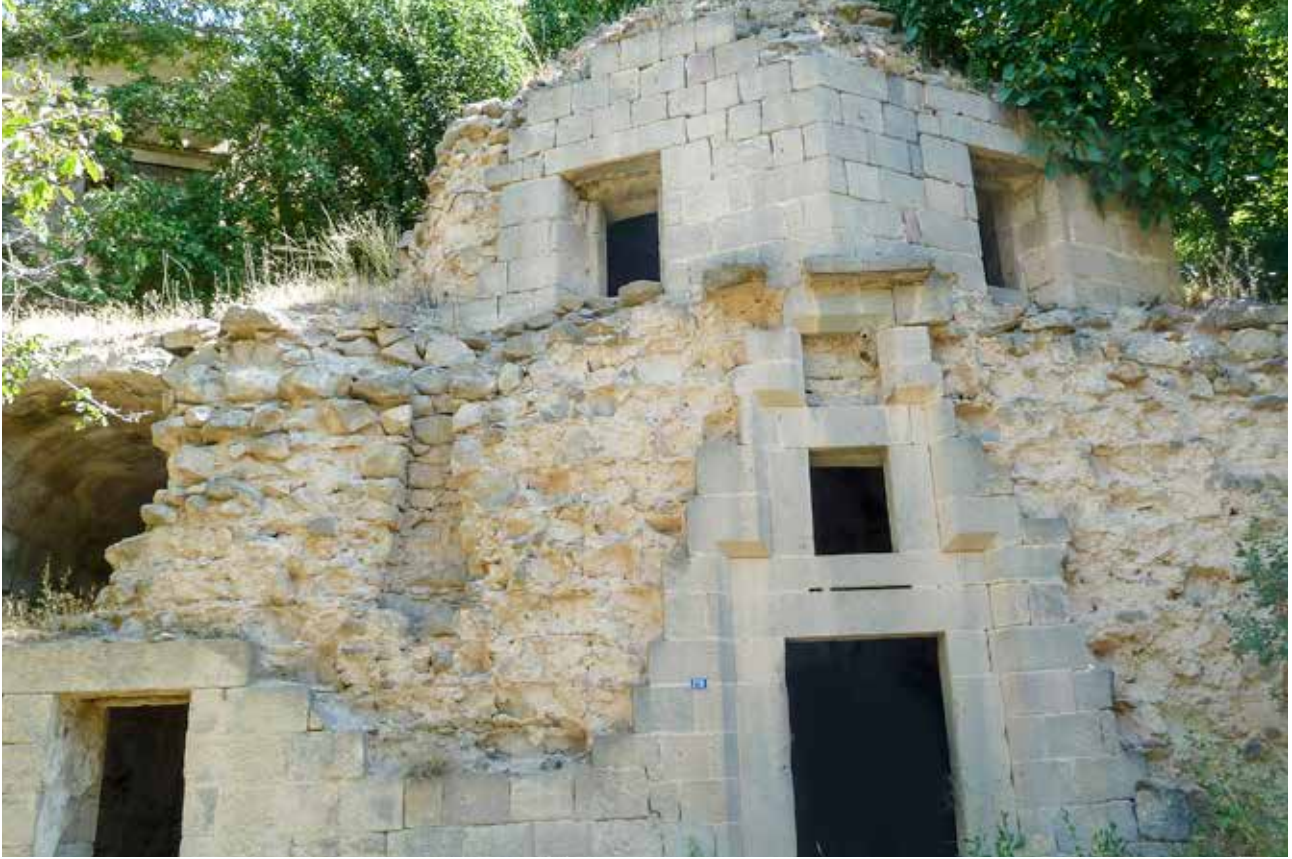
*The Public Bath
Niğde Central county, Yeşilburç village*

An example of 19th century Ottoman hamam architecture, Yeşilburç Hamam is currently not used and is in ruins. The facing and flooring stones of the structure have been removed and used in other constructions in the village, with the furnace, chimneys, and drains exposed as a result, and the hamam brought to its current ruined state (Ozkarıcı, 2013, 48).

There are severe fractures in the structure and plants have begun to grow on the roof. The dome stones have been removed or have collapsed so that the interior is filled with soil. Nearly all of the plaster has been removed. Almost none of the elements of the hamam, such as basins and massage stones remain.

The structure is in a poor and unmaintained state with almost no measures for its preservation. It is structurally in bad state, extremely open to human depredation and vandalism. It is also unprotected against the forces of nature.

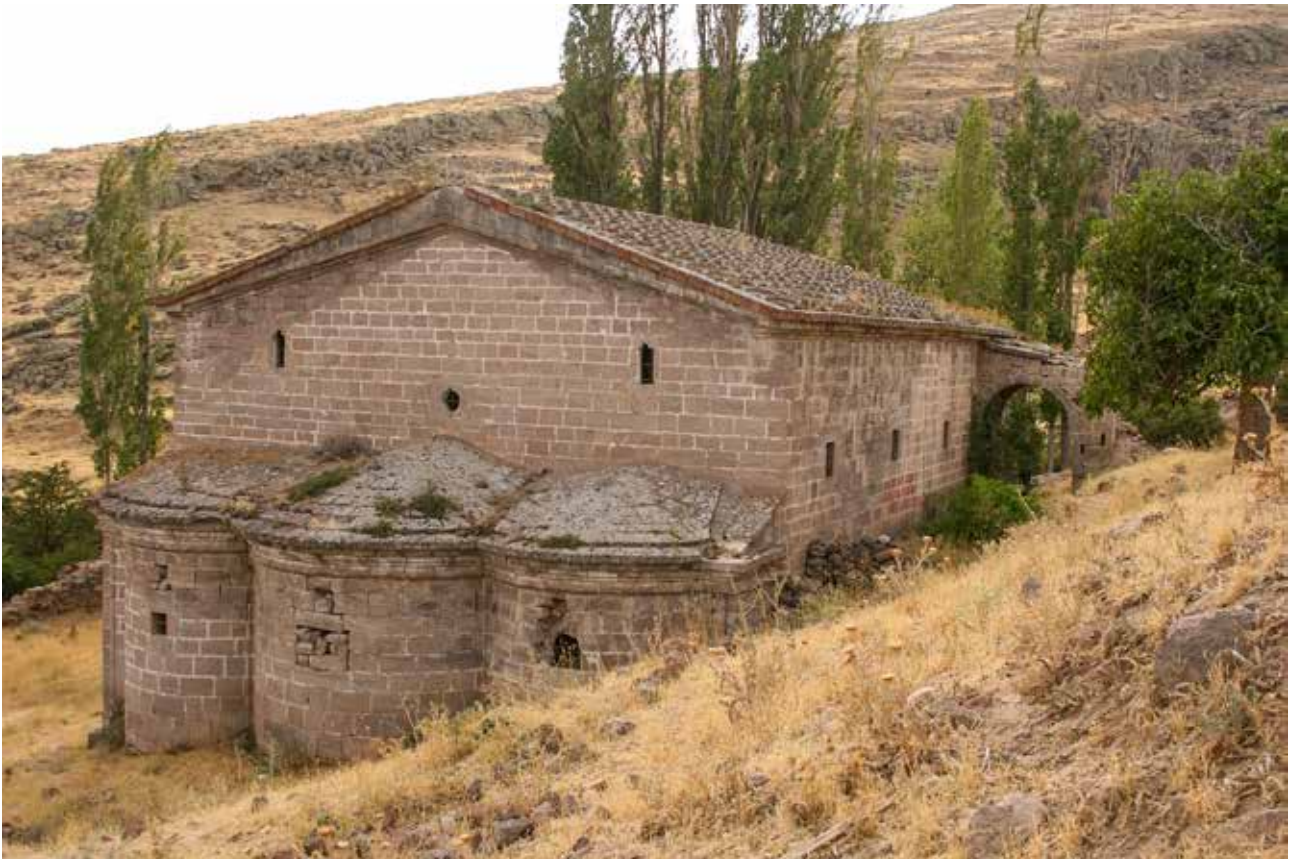
*Church of Saint Nicholas
Niğde Central county, Küçükköy village*

The northern and southern walls have lost parts of their mortar in the upper levels and this problem is even more pronounced on the southern façade. There are fractures in the gallery floor, and later interventions made with cement are observed. In addition to fractures in the plaster, there have also been interventions using cement to the parts where mortar has fallen off. Moreover, a unit south of the narthex has been closed off with concrete blocks and an additional room thus created later. A portion of the stone facing on the roof is missing and this has left the structure open to forces that degrade it.

The window opening in the apse has been closed with rubble stone, yet the window openings in

the diaconicon and prothesis remain (although the bars have been removed from the window in the diaconicon). The niches here have been destroyed. The plaster on the columns has peeled. The majority of frescos on the ceiling and walls remain; however, these frescos and decorations are at risk of being lost to vandalism. Of the saint figures on the arches in the central nave which were painted with blue paint, only

The simplest and most urgent precaution required for this structure in a poor and neglected state is to control entrance to the building. The structure has no door and people can easily enter and damage it, which will lead to this relatively preserved structure becoming a ruin in a very short time. In addition to this primary precaution, a comprehensive restoration project should be prepared and the problems mentioned above must be resolved.

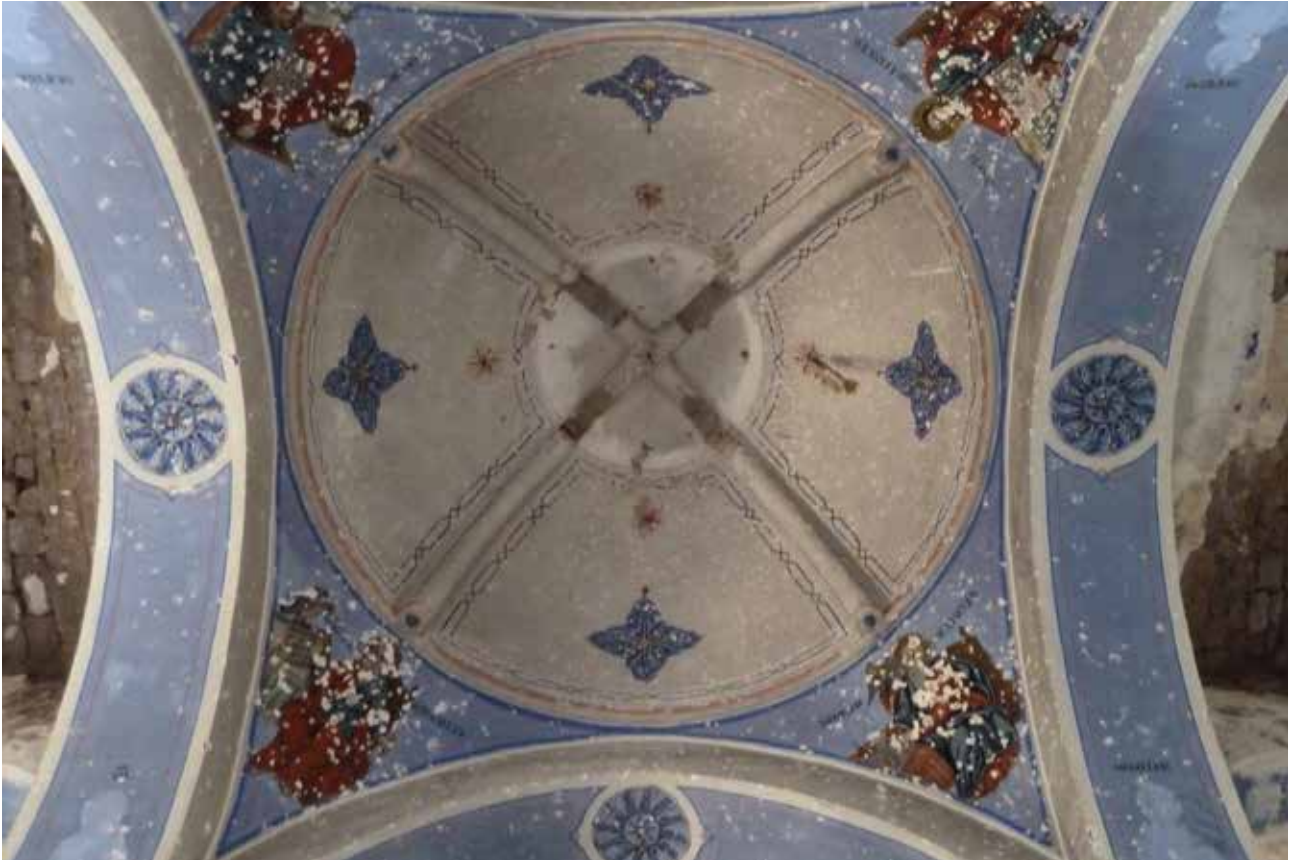
the silhouettes are now visible. Additionally, the tie bars in the between arches are largely present, though some have been removed. During field research, it was mentioned that locals used the structure as a mosque at one point; however, there are no traces of such use within the structure (there is no mihrab and the figures of the saints remain).
