Kayseri
Adana
Izmir
Elazığ
Niğde
Bursa

Assessment Report of Architectural Cultural Heritage

April 2018

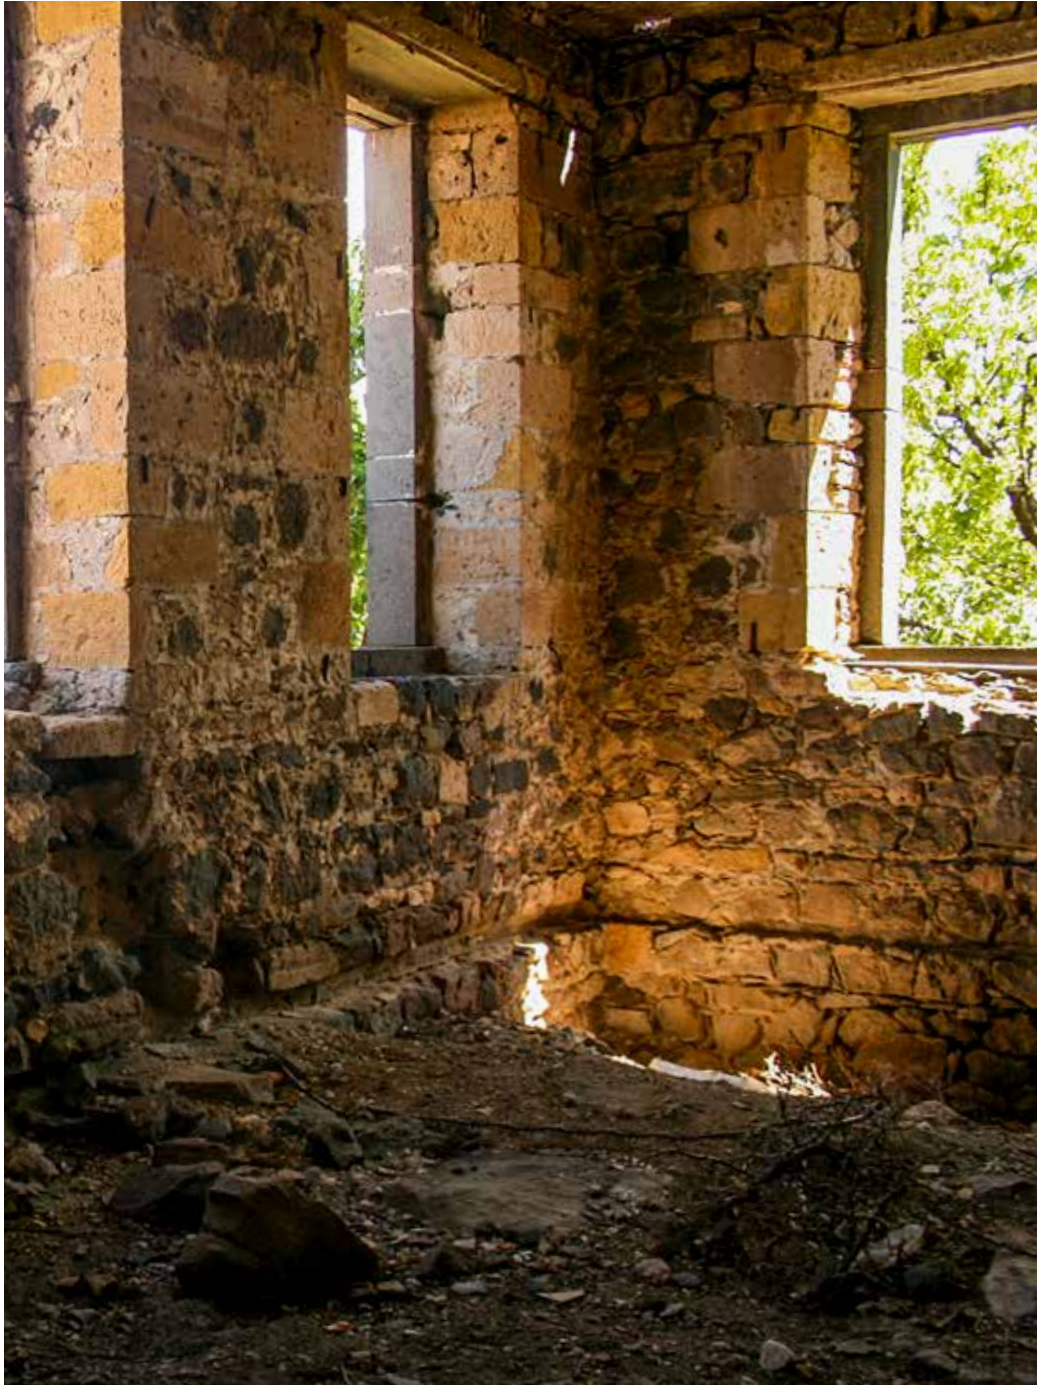
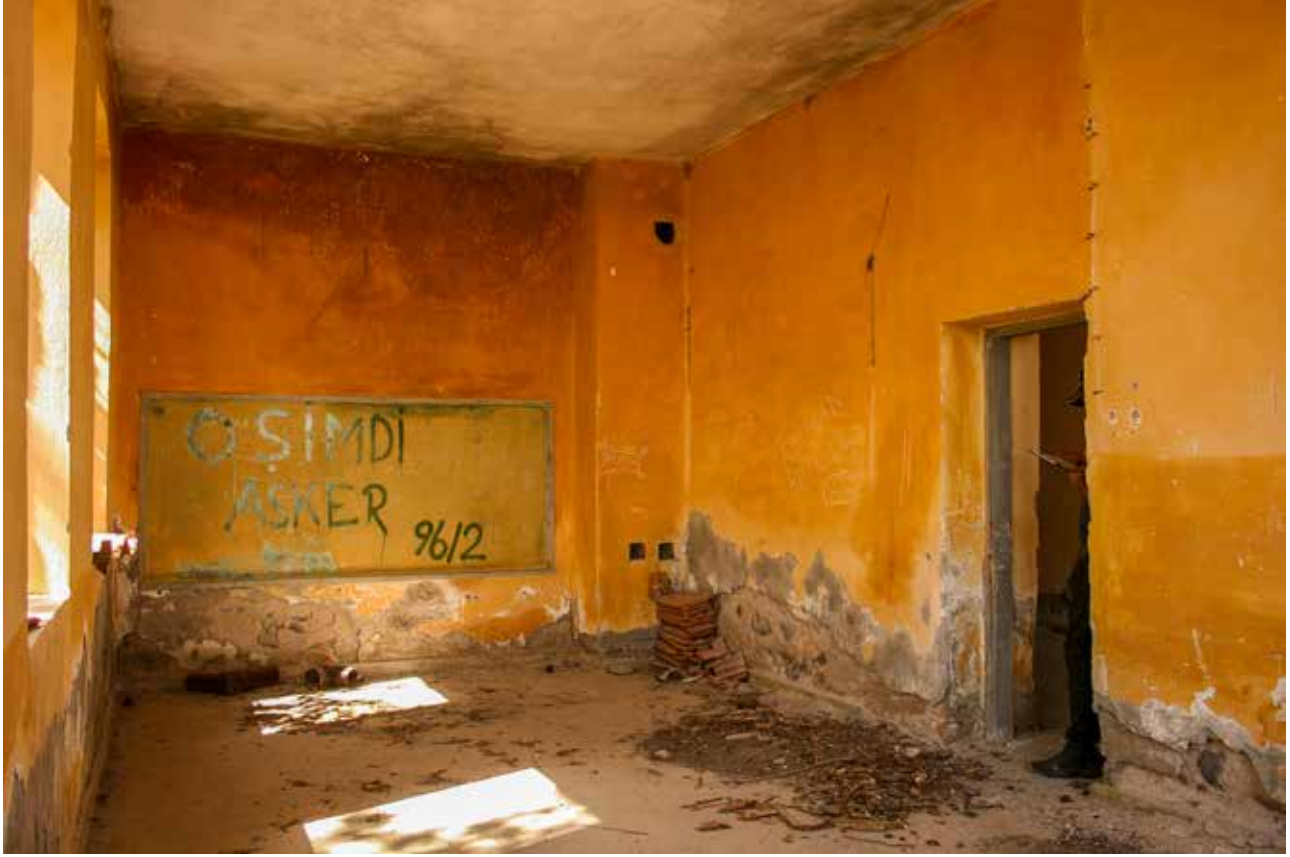
*The Greek School
Nigde Central county, Ballı village*

The roof of the building is in very poor condition and requires an emergency intervention. The lack of glass in the windows means that rainwater can easily enter the building. Some openings in the southern façade have been filled in with concrete blocks. The northern façade is packed with soil, and this load of soil poses structural risks to the building. The plaster has begun to peel. There is no flooring or wall plaster in the east wing.

The school and church should immediately be registered as historic buildings by Nevşehir Directorate of the Regional Board for Conservation of Cultural Assets. The structure should be assessed along with the church. As stated in analysis reports for other structures in Niğde, taking action with regards to this single structure will not be sufficient for the development of Ballı village; there is need for a regional strategy. The Ballı village school and church are valuable structures that can be used as an important parts of this strategy.

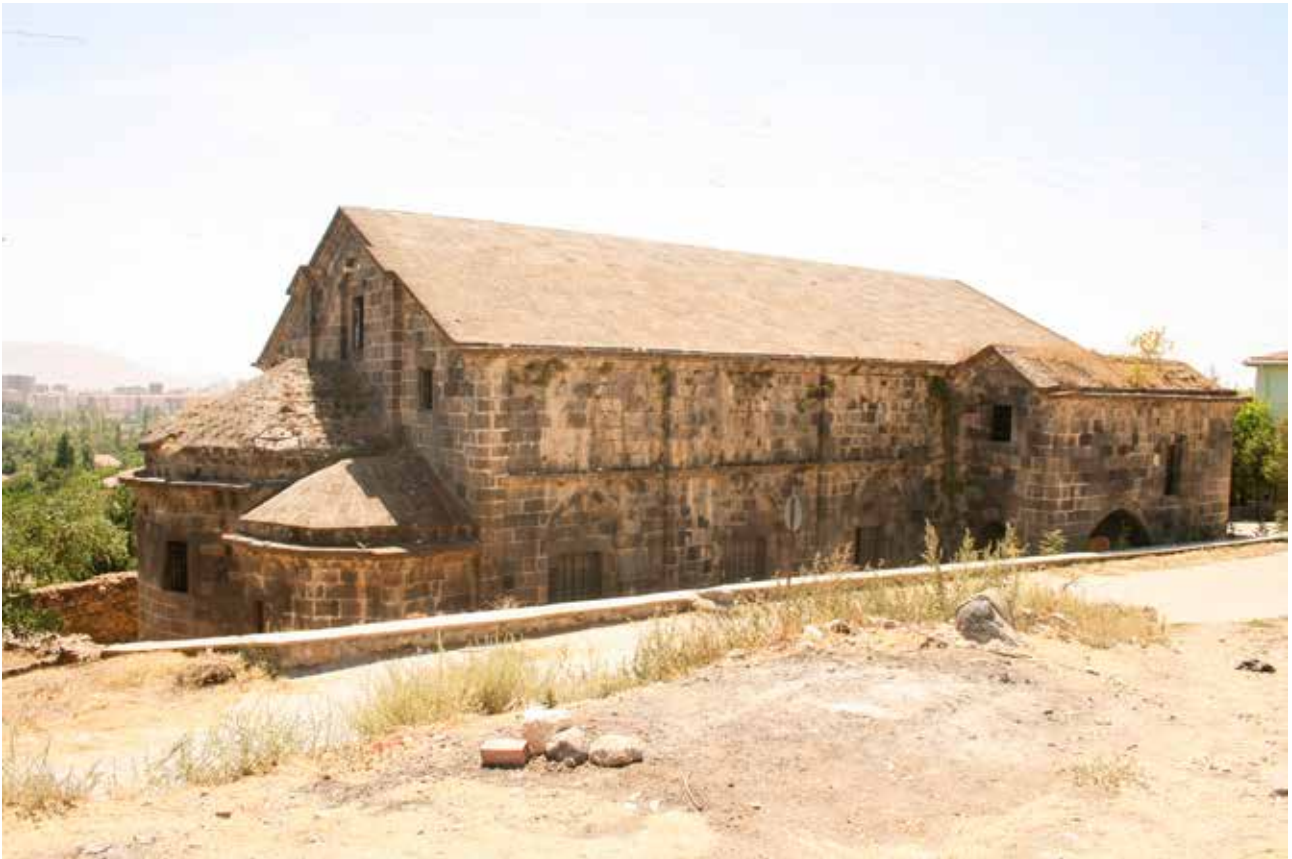
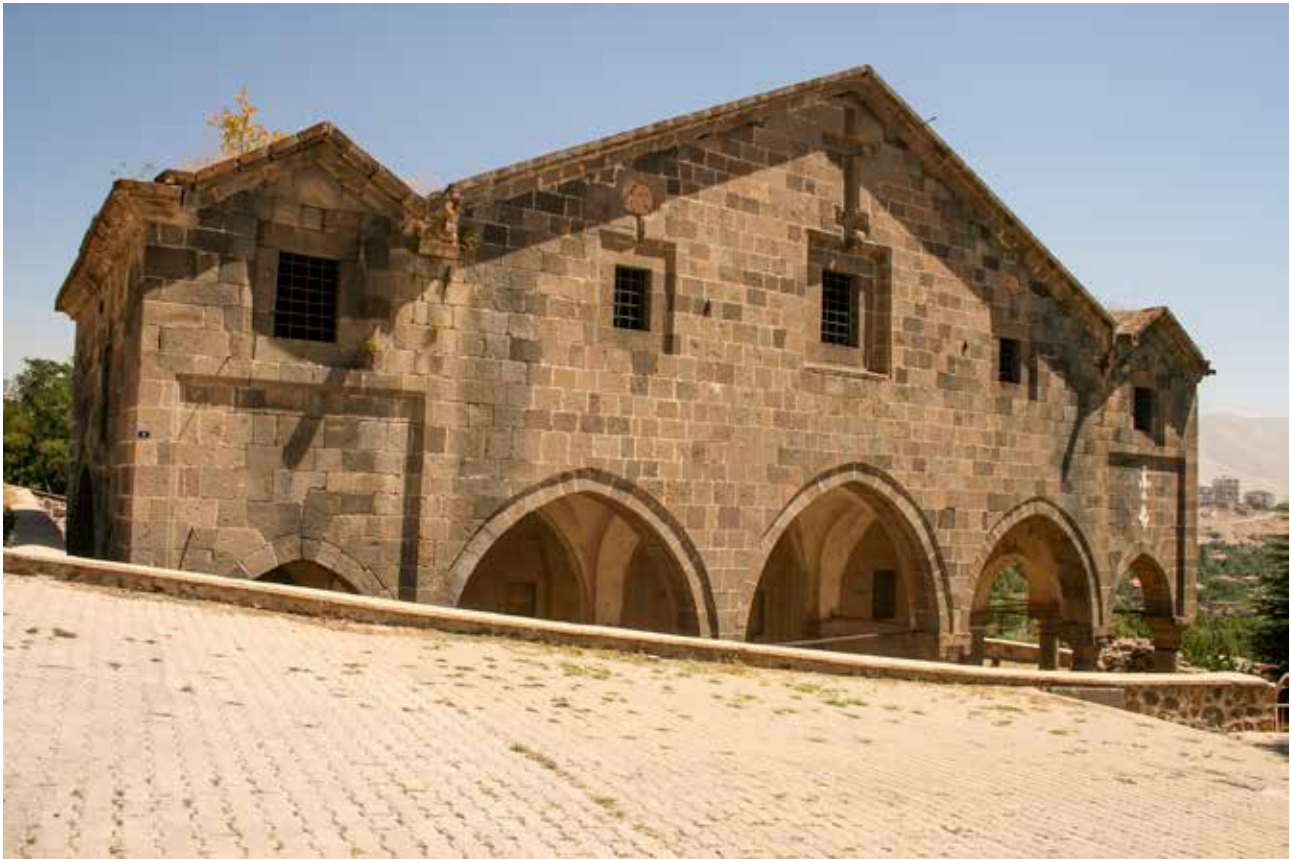
*Church of Metamorphotos
Niğde Central county, Hamamlı neighborhood*

Apart from the division in the originally undivided gallery floor and the closure of door openings on the southern façade, no changes are visible. The spatial characteristics are therefore fully discernible. The main walls, apses and narthex of the structure are in place. However, there is mortar loss in the vaults, and structural fractures in the roof of the narthex and gallery sections. Generally, due to fallen plaster, vandalism and dampness in the structure, the frescos have been severely damaged. The floor covering of the interior has reached the present day without destruction.

The interior of the church had been protected from human depredation due to its being locked at present. The fact that the structure is located in a settlement area and that the locals are aware of its existence have contributed to its preservation. The western and northern façades of the structure are below the road level, which obstructs its visibility so the landscape should be arranged accordingly. Preventive conservation work should begin, and it is recommended that the structure be given a cultural function open to the public that does not conflict with its original function.

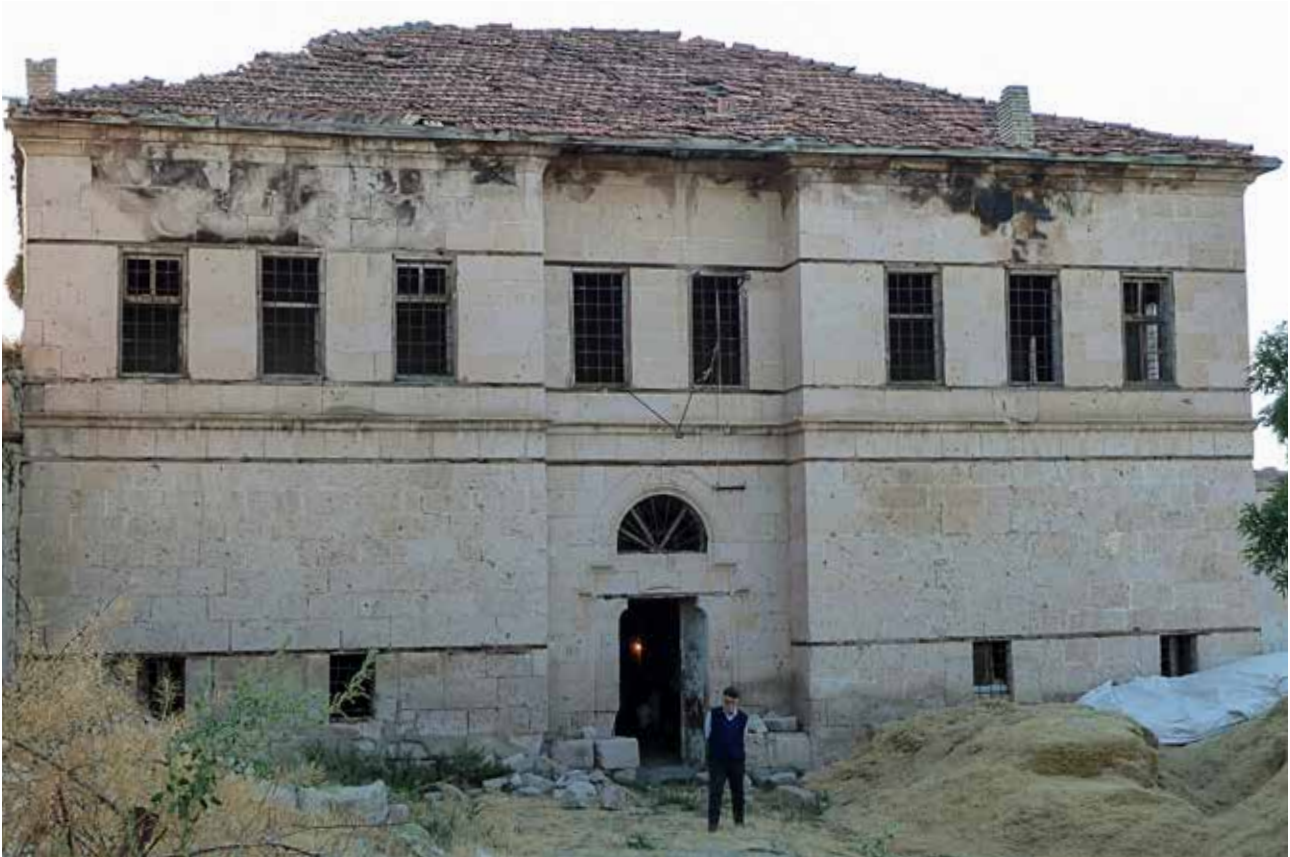
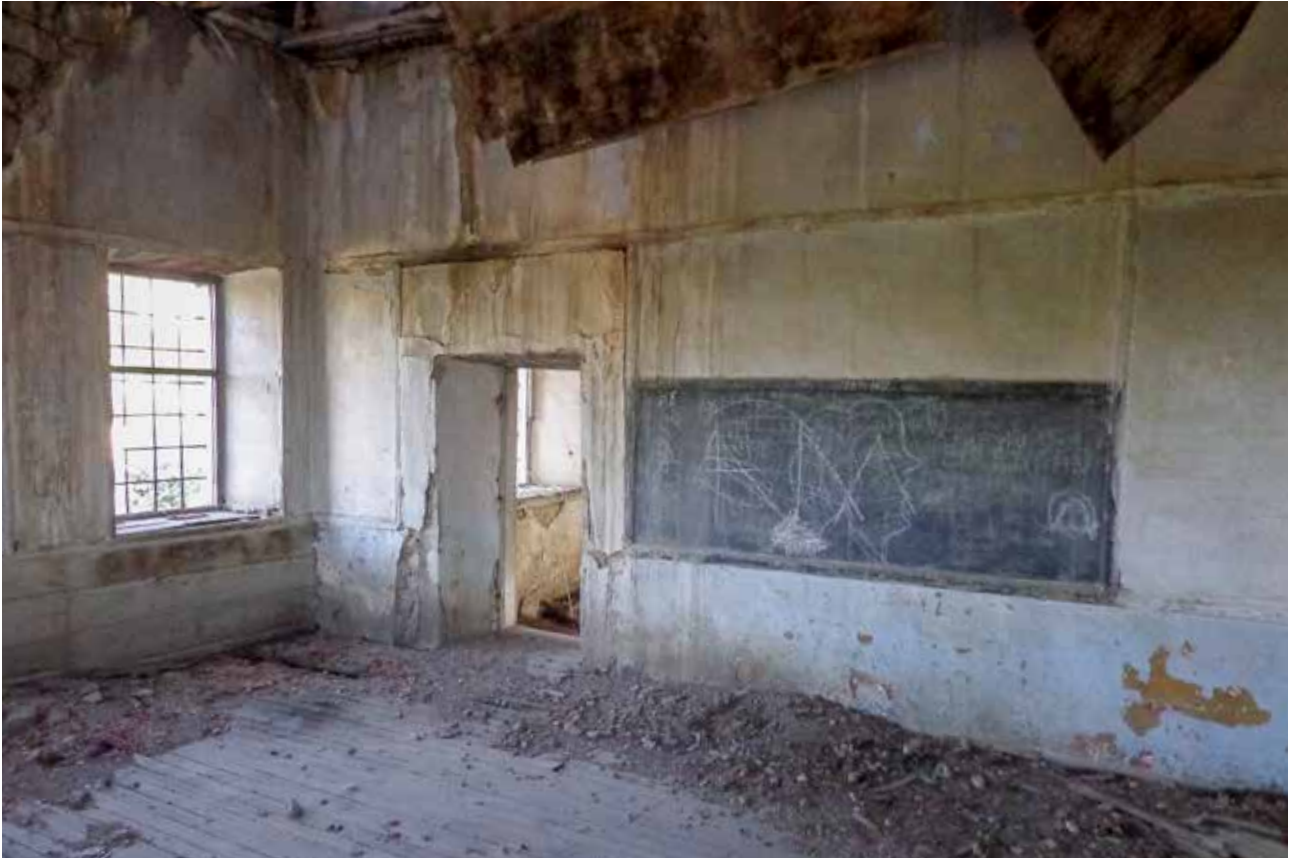
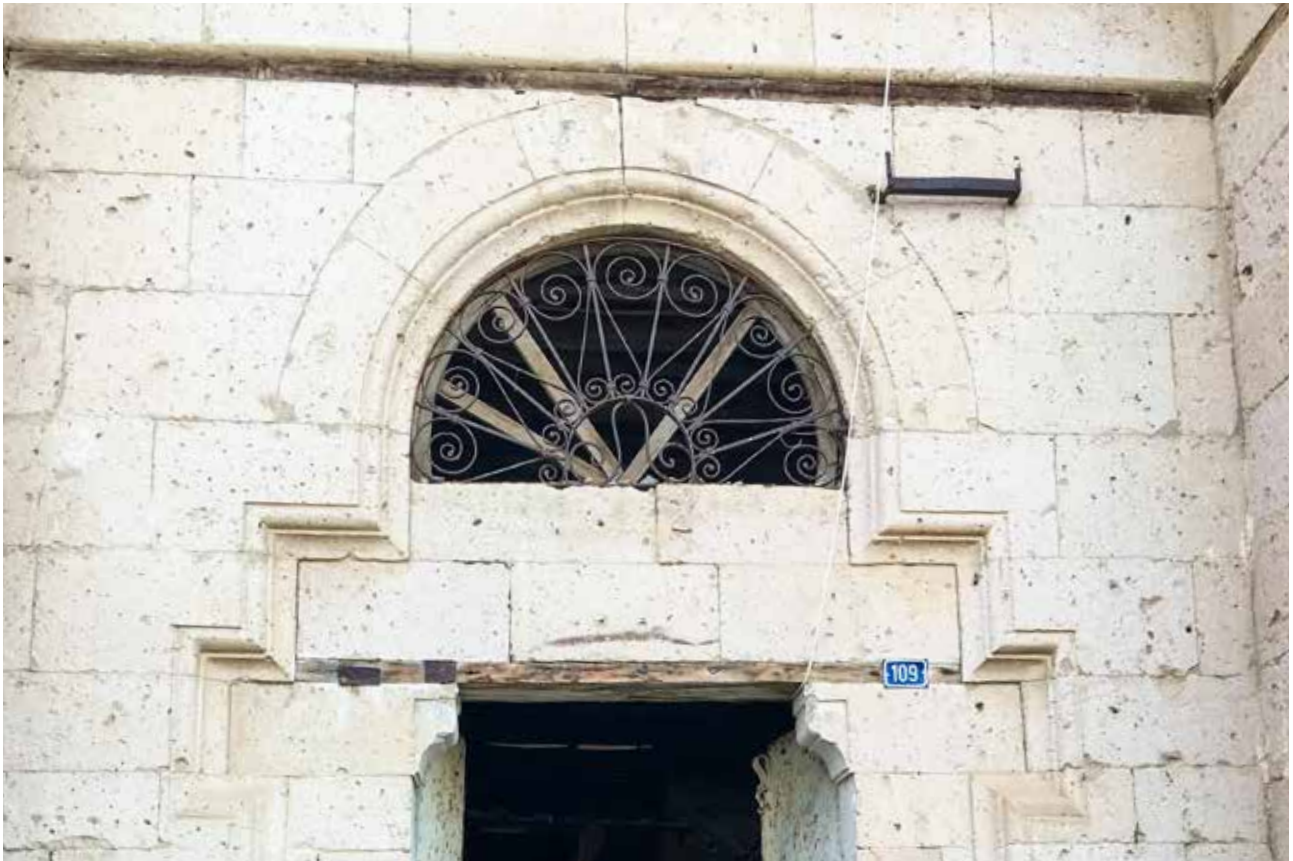
*The Greek School
Niğde Central county, Uluğaç village, Köyönü locale*

In the first floor hall, the flooring to the northeast has been partly destroyed. The original stone main wall between the two northern rooms on this floor has been removed and a wall has been built from concrete blocks. All the wooden flooring in the first floor rooms has been renewed, and the ceilings replaced using plywood. Some of the doors and shelves of some of the built-in closets are missing.

A large portion of the clay roof tiles of the structure have been destroyed and lost. As a result of this, the wooden eave plates, the wooden roof construction and first floor ceiling cover have suffered serious loss of material and rotting. The chimneys on the roof have partly collapsed or are sagging. Due to the general water problem in the roof and lack of glass in the windows, a large portion of the plastered surfaces within the structure are peeling and falling apart, with hairline fractures in the main walls.

The facing on the façades, especially the molding stones, have suffered deformation, efflorescence and erosion due to dampness. The stone shapes beside the main doorway are destroyed and deformed. The wooden beams in the façades are rotting and have started losing their integrity. There is corrosion, bending and deterioration in the window bars.

The wooden staircase used to access the upper level is rotting and losing its ability to carry weight. The railings on the upper floor gallery are no longer in place. All of the wooden doors and windows have lost parts of their material, are rotting and infested with termites. Fires lit inside and outside the structure have created soot and caused color changes on the stones.

As the beams for the annex were installed by the removal of part of the main wall, this has damaged the structural balance. Due to sinking and deviations in the structure, the vault surfaces and main walls contain structural and hairline fractures.

In addition to the effects of wind and rain, the walls are completely open to vandalism and contain hairline and structural fractures. Accessing the upper floor is risky, with danger of breakage or collapse in the wooden flooring. At the same time, the ongoing degradation of the wooden roof is a serious problem. The entrance should be locked immediately to prevent vandalism. Then the necessary efforts for preservation and repair must be carried out. When compared with other structures in the region (as the outer facing has not been destroyed), it will not be difficult to renovate this structure.

The landscaping of the building's garden should be completed, with the courtyard walls repaired and put back together. It is necessary to place road signs and an information panel about history of the school and Uluğağaç with maps of other historical structures in the area.

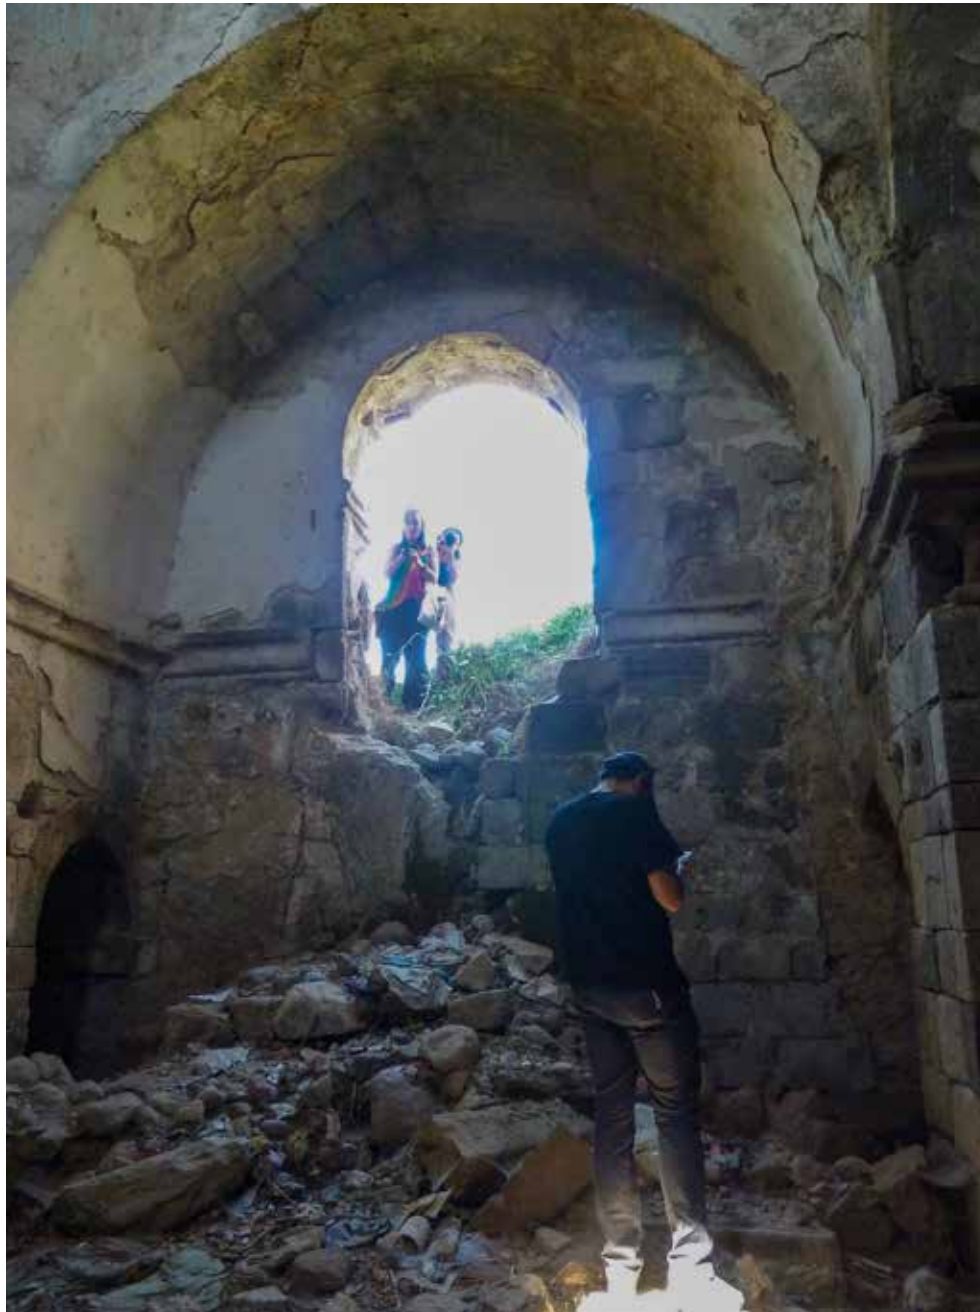
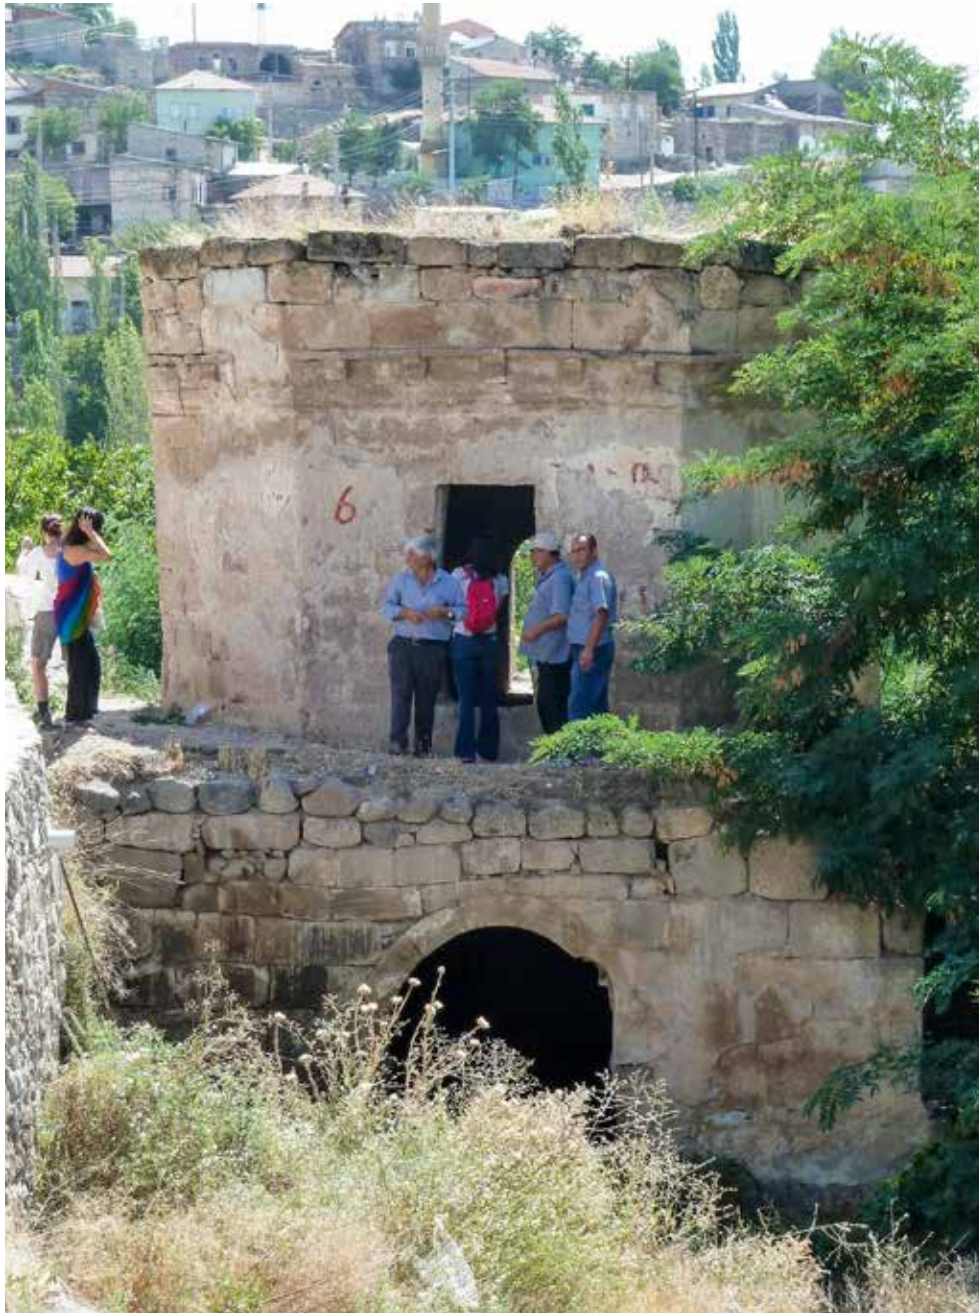
*Sivri Church
Altunhisar county, Yeşilyurt village*

The building is in relatively good state, with no major damage. The original entrance of the church on the southern wall is covered by the thick layer of dirt and rubble, filling the interior. For the same reason the original height of the church (today measuring 9.82 m) cannot be properly established. Sparse traces of the original frescos survive on the interior surfaces. Two of the three apse openings are closed off with rubble, and the damaged and enlarged windowsill on western wall is currently used as the entrance to the structure.

The use of the drum as a masjid in the 18th century has caused notable alterations to the original church, which are obvious in its present state: in the interior, a niche was created as a mihrab on the northern side of the dome, on top of which there is the sacred inscription "La ilahe illallah Muhammede Resulullah". The western window of the drum was enlarged as a door allowing access to the prayer space. On the exterior, the roofing of the church was flattened, and the upper stone courses in the apse and the drum were repaired with rubble. A Muslim tombstone was used as construction material in doing this. An inscription incised on the block outside the western window of the naos, "Hijra 1185" (corresponding to the year 1771) gives probable the date of these interventions (Pekak, 2008, 101).

Though registered as a historic building in 1999, no conservation action has been undertaken so far, and the church is left to abandon, exposed to weather conditions and unprotected from vandalism.

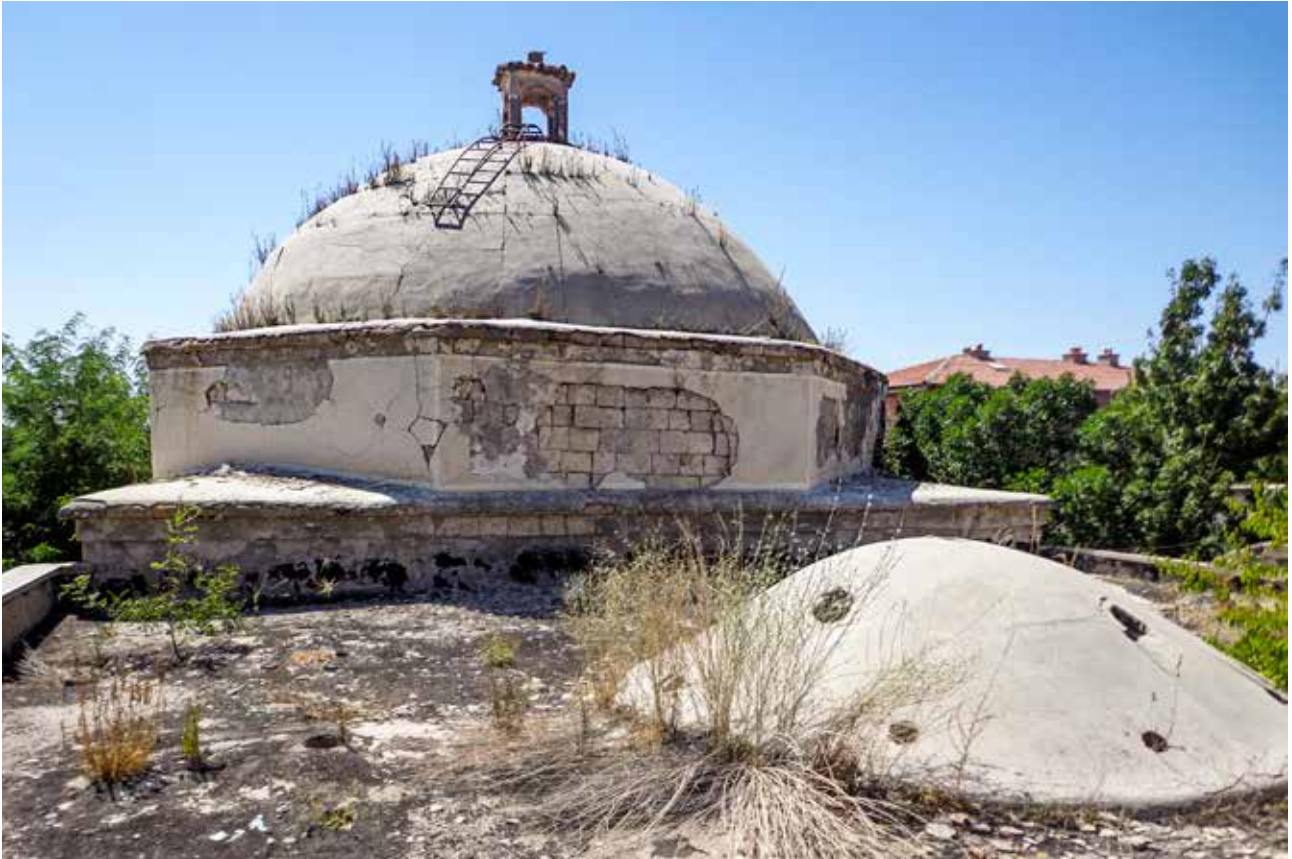
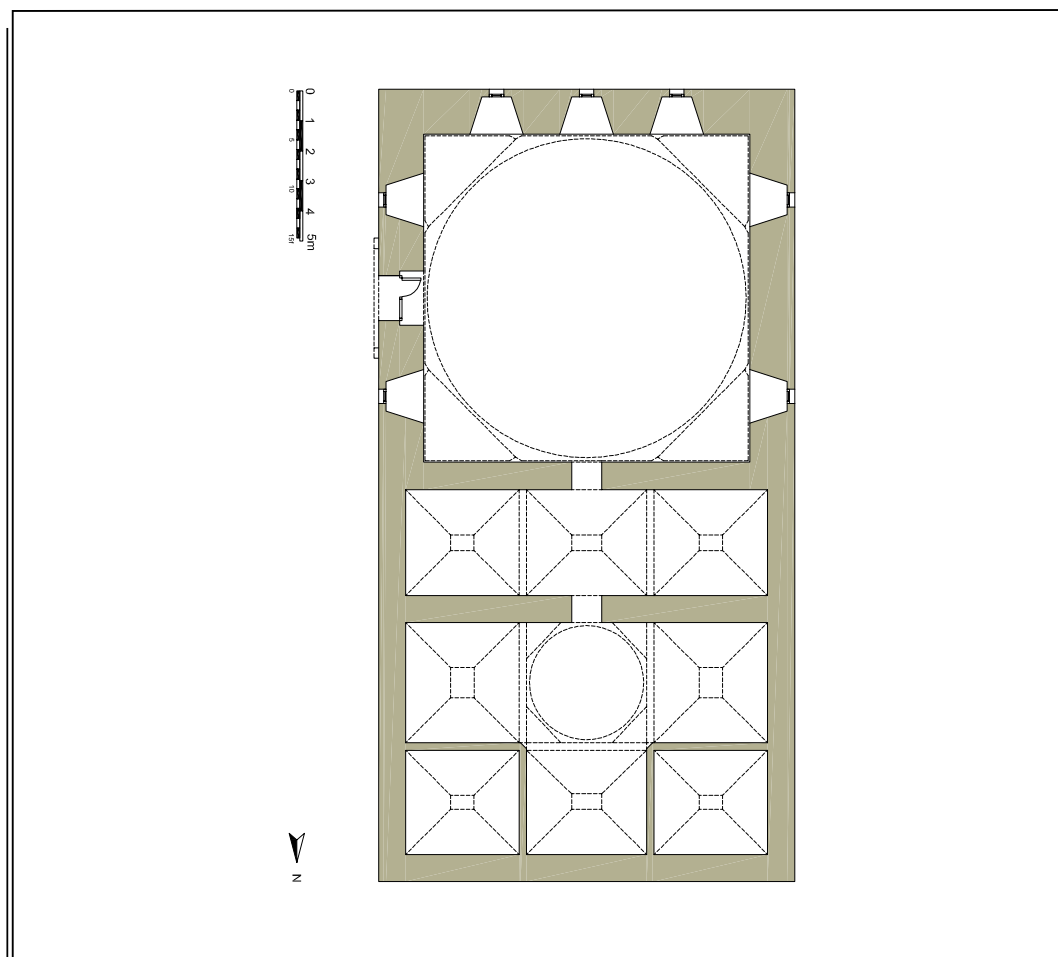
The hamam is currently moderately intact; however, since unsuitable additions and repairs were later made and it has been abandoned for nearly 15 years, structural degradation has taken place due to lack of protection and maintenance. At the same time, the interior houses the unused benches of the village and the hamam is partly used as a depot. As the door is not locked, entrance to the hamam is unchecked.

Because of the cement plaster, the main construction material, which is stone, cannot breathe. This has led to widespread efflorescence, moss growth, and falling plaster in the interior. Mortar has been lost in the dome and cracks may be observed. As the cement has

not quite adhered to the stone, plaster has fallen off the exterior (especially the roof) with plant growth beginning on the dome. Graffiti can be seen on the external façade. Additionally a large satellite dish has been added to the roof of the hamam recently, adding weight to the roof and disrupting the integrity of the original structure. As there has been no glass in the small skylights for a long time, rainwater entering the building has caused dampness related problems. During renovations that took place probably within the last 50 years, electrical lines, as well as heating systems and radiators, have been added upon the plaster on the walls.

All of the later reinforced concrete additions, the plaster, plumbing and the satellite dish must be removed. Reinforcement and protective actions should be undertaken. Visually, the interior must be furnished so as not to disrupt the original texture, and infrastructure must be installed in order to provide for the daily needs of the hamam. It is recommended the hamam be made functional again based on a management model including the locals living in the village. Having this chance of fulfilling its original function, an information plaque should also be added to Fertek Hamam explaining the history of the structure. It must be emphasized that it historically met one of the basic needs of the village, but at the same time is a common heritage with important social aspects.

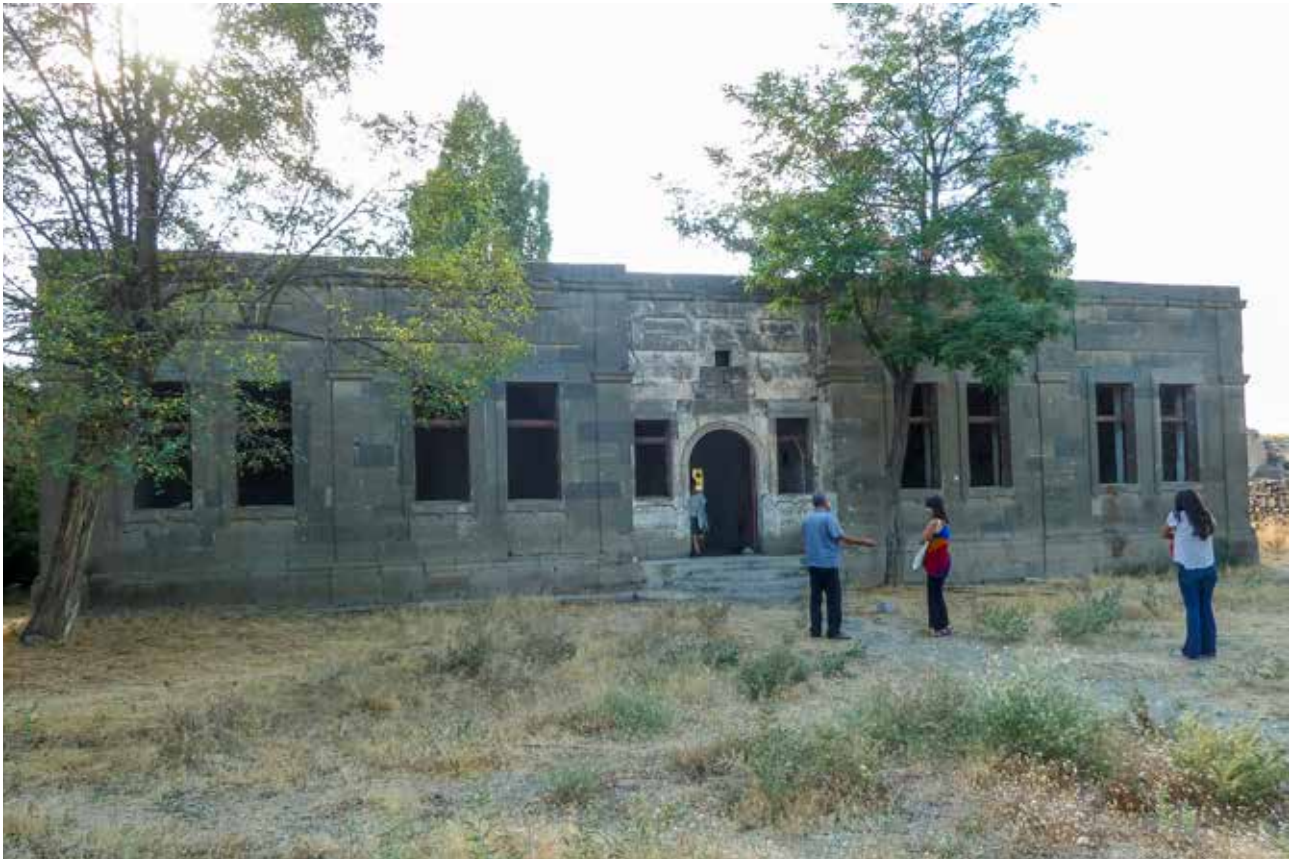
Abandoned since 1979, the Hasaköy Greek School has reached today in a seriously ruined state. Though the external façades do not look badly damaged, degradation and interventions are visible in the interior. Toilets were built at the end of the south arm of the cross-plan corridor, at this time the lower window in the southern façade was also closed off, the stairs to the roof were removed and a reinforced cement ceiling was built. An additional room was created by adding a wall, east of the western entrance to the corridors. The terrazzo covering on the stone classroom floors was laid down later on, and the stone walls were plastered and painted. The plaster on the walls of the interior later flaked off and the cut stone wall is partially visible. The entrance doors and wooden window frames were changed, and the wooden doors and window bars were removed. Currently only some of the wooden frames of the doors and windows remain. Three arms of the cross-shaped window over the western entrance were filled in and closed off. Cement in the stone steps leading to the entrance doors is clearly visible, and parts of the staircase in the west have been removed. A concrete fountain has been built in the courtyard towards the wall, and the western garden entrance has been removed. The roof which used to be soil consists of pebble stones today.

The use of wrong material and its faulty application on the roof have led to the seepage of water through the main walls. Due to this dampness, the mortar between the stones has cracked open, there is deterioration in the surfaces and deformation in the parapet, parts of the surfaces of the vaults in the interior have fallen off, cracked and separated, and yellowed. There is sagging in the chimneys of the roof. The material comprising the external facing and moldings is partly lost; deformation and dampness has led to mold and dirt on these surfaces. The remaining portions of the wooden elements have begun to rot, with corrosion and deformation in the iron bars and doors. Some of the cramp irons have been removed, with corrosion in the remaining iron sections.

To stop this degradation, outlined in detail in Songur's report (Songur, 2016, 47-48), the restoration project that has been prepared must be approved and immediately put in motion. This school, a witness to history and carrying architectural value, should be restored, and a multifunctional new and historical educational facility opened for the village. At the same time, this structure may become a regionally important cultural center, bringing about quite significant development locally. In addition to serving the village, this may be an important source of motivation for visits by the grandchildren of people who migrated to Greece and a source of tourism for Hasaköy, along with the rest of its cultural and architectural heritage.

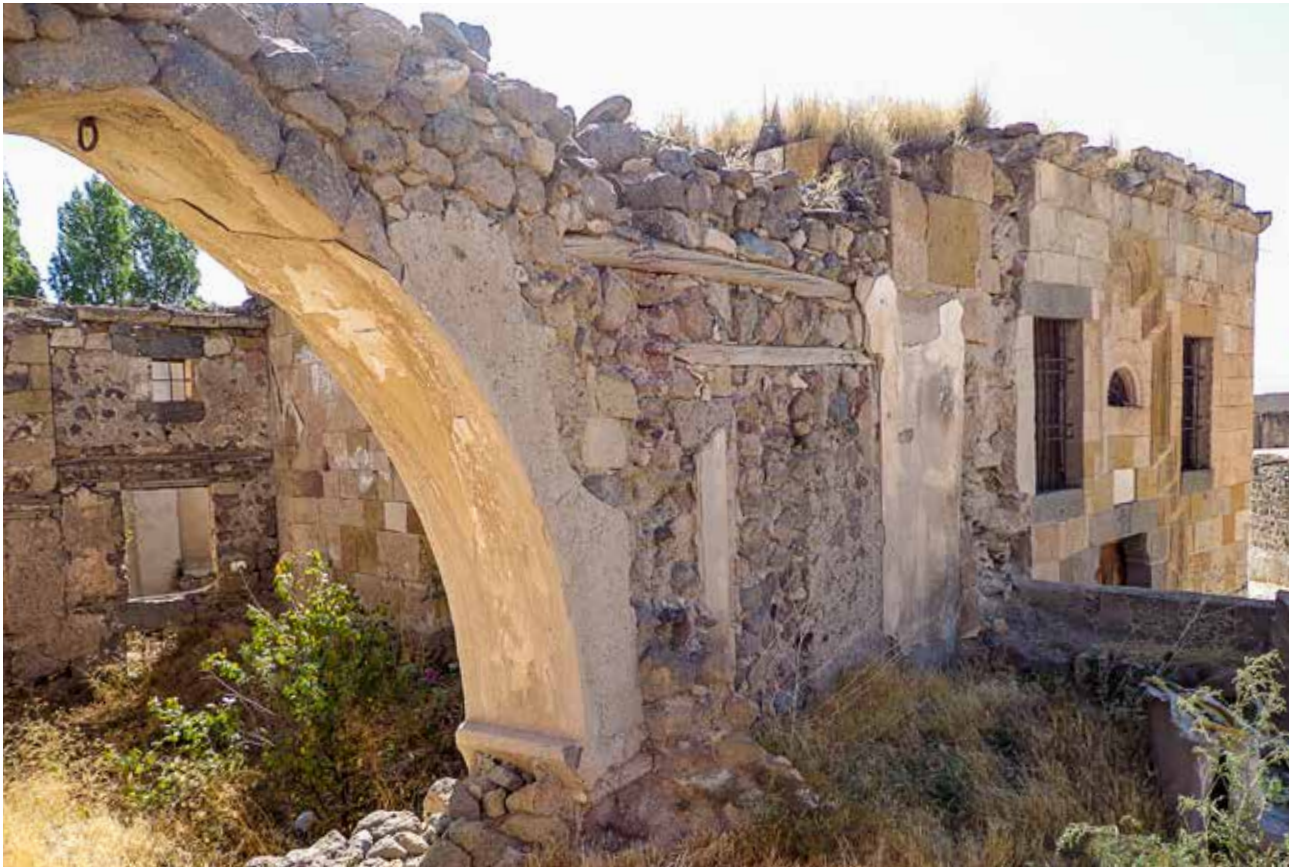
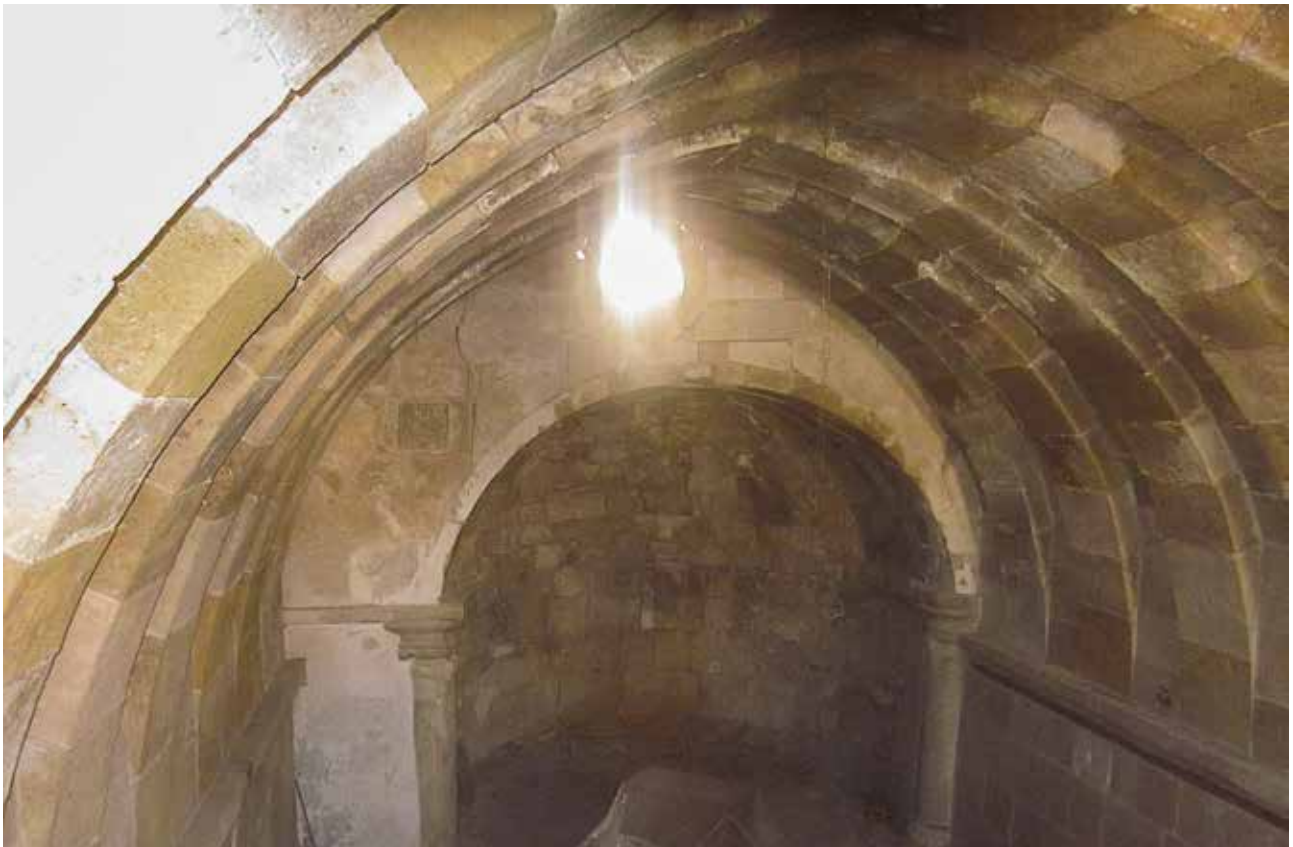
The door to the structure, which is right on a road in the village, is locked; however, there is no glass in the windows and it is used as a neglected depot. There is no information plaque regarding the chapel. The architectural layout has been preserved, and it appears that in the interior wooden upholstery was later added to the point where the vault joins the western wall. The wall of the courtyard of the neighboring structure leans onto the southwest corner of the chapel. In the northwest corner, there is a courtyard wall of concrete block, extending westward. There are additional ruined structures adjacent to the northern façade.

A substantial portion of the stone covering of the southern and eastern façades is missing (probably removed to be used in other structures), thus the shape of the eastern wall cannot be understood clearly. The missing stones have exposed the vulnerable inner filling of the wall to the weather conditions and this filling is being eroded over time. There are cracks and cavities in the walls. Vandalism is seen on the exterior, in the form of incisions on the walls.

Having the external stones removed from the southern and eastern façades has caused the inner wall filling to be exposed to weather conditions and this fill is being eroded over time. The chapel is susceptible to earthquakes and the cracks in the wall will grow as long as it remains neglected. The roof cover has been nearly completely lost and the plants as well as water leakage from what is remaining of the roof is also damaging the building. Using appropriate materials, the external facing of the building must be completed, cracks must be repaired and the building generally reinforced and preserved. Glass must be installed in the windows to prevent rain from entering.
