Kayseri
Adana
Izmir
Elazığ
Niğde
Bursa

Assessment Report of Architectural Cultural Heritage

April 2018

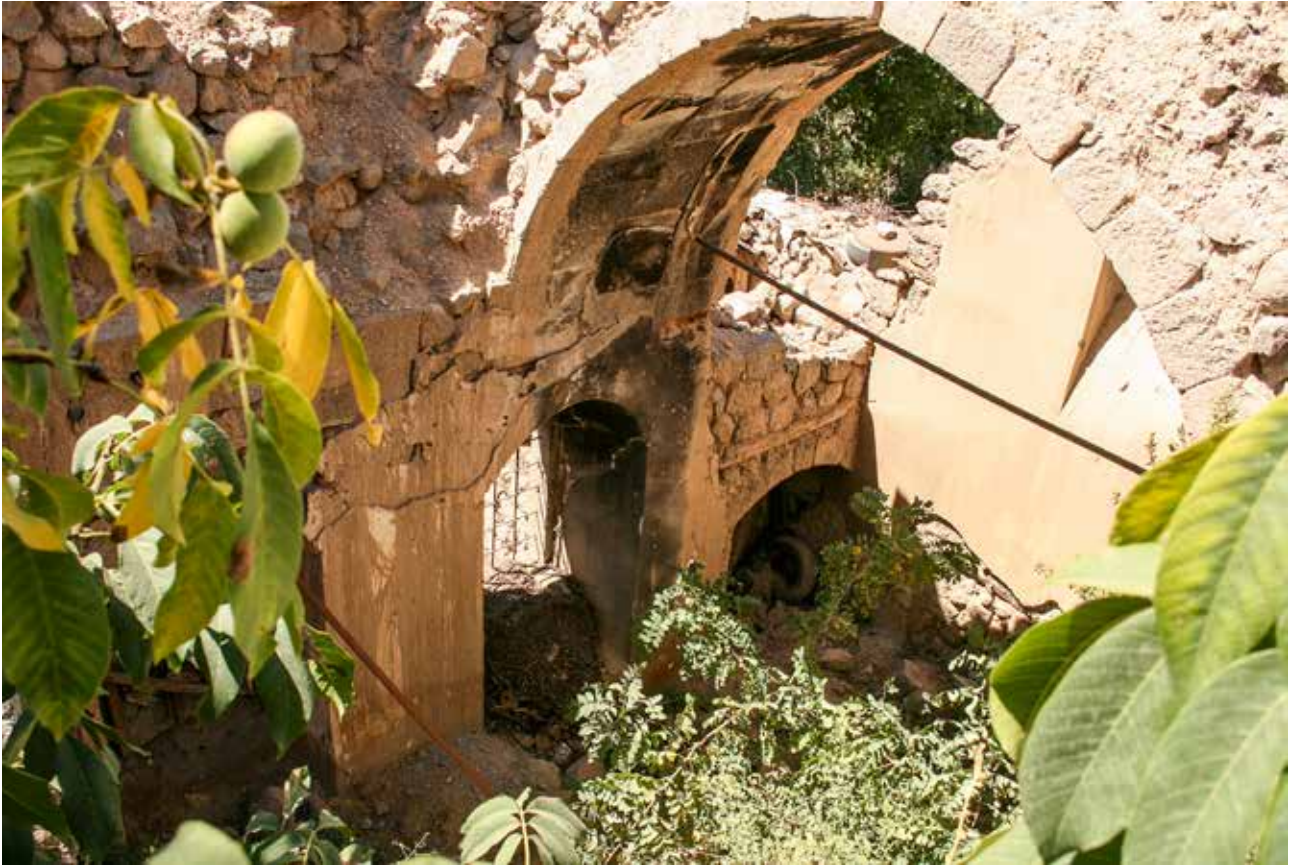
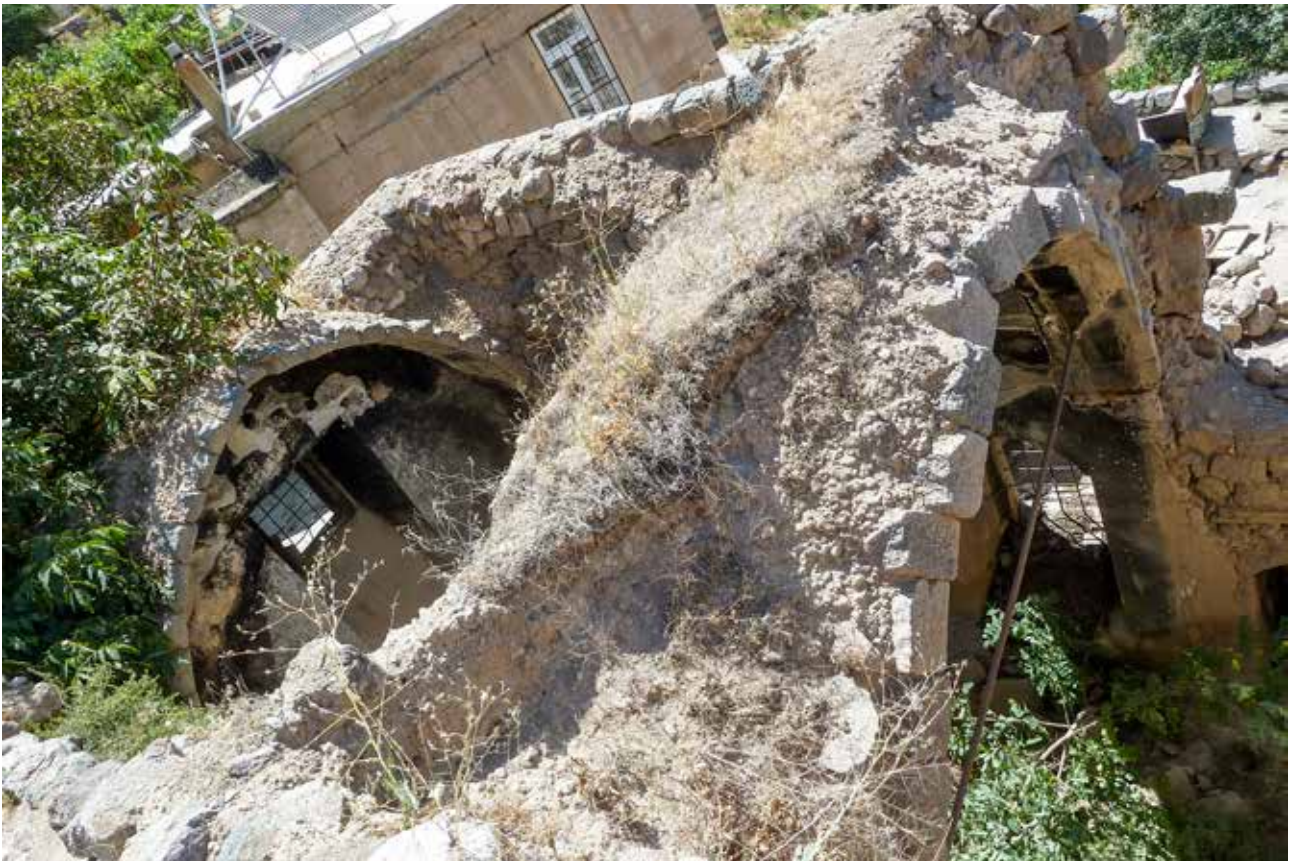
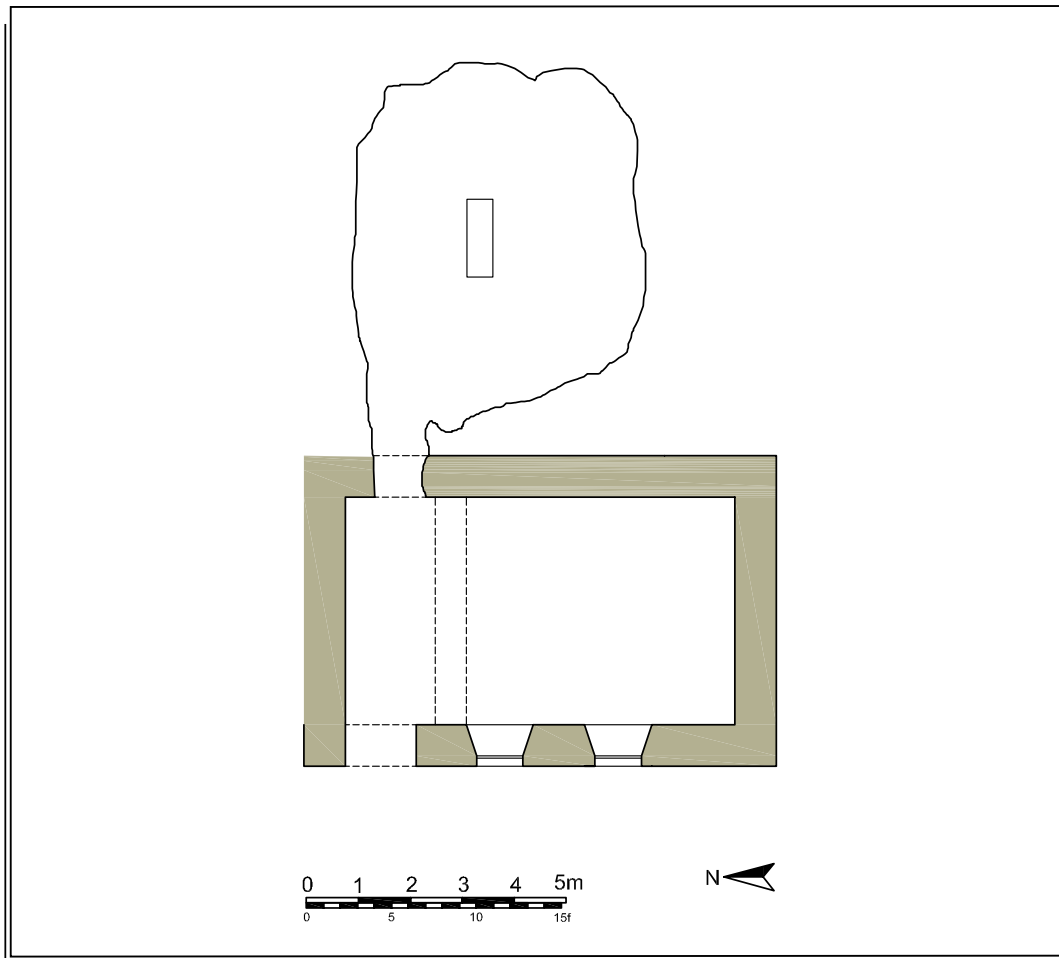
Though the structure is ruined, its plan is still readable. The structure is dilapidated and the majority of its materials have collapsed into the interior space. Soil and plants growing over these have completely filled the space, elevating the original floor level. The eastern wall of the structure is covered with soot. There are trees and weeds inside the structure. Apart from the openings mentioned above, further architectural details cannot be discerned or have been destroyed.

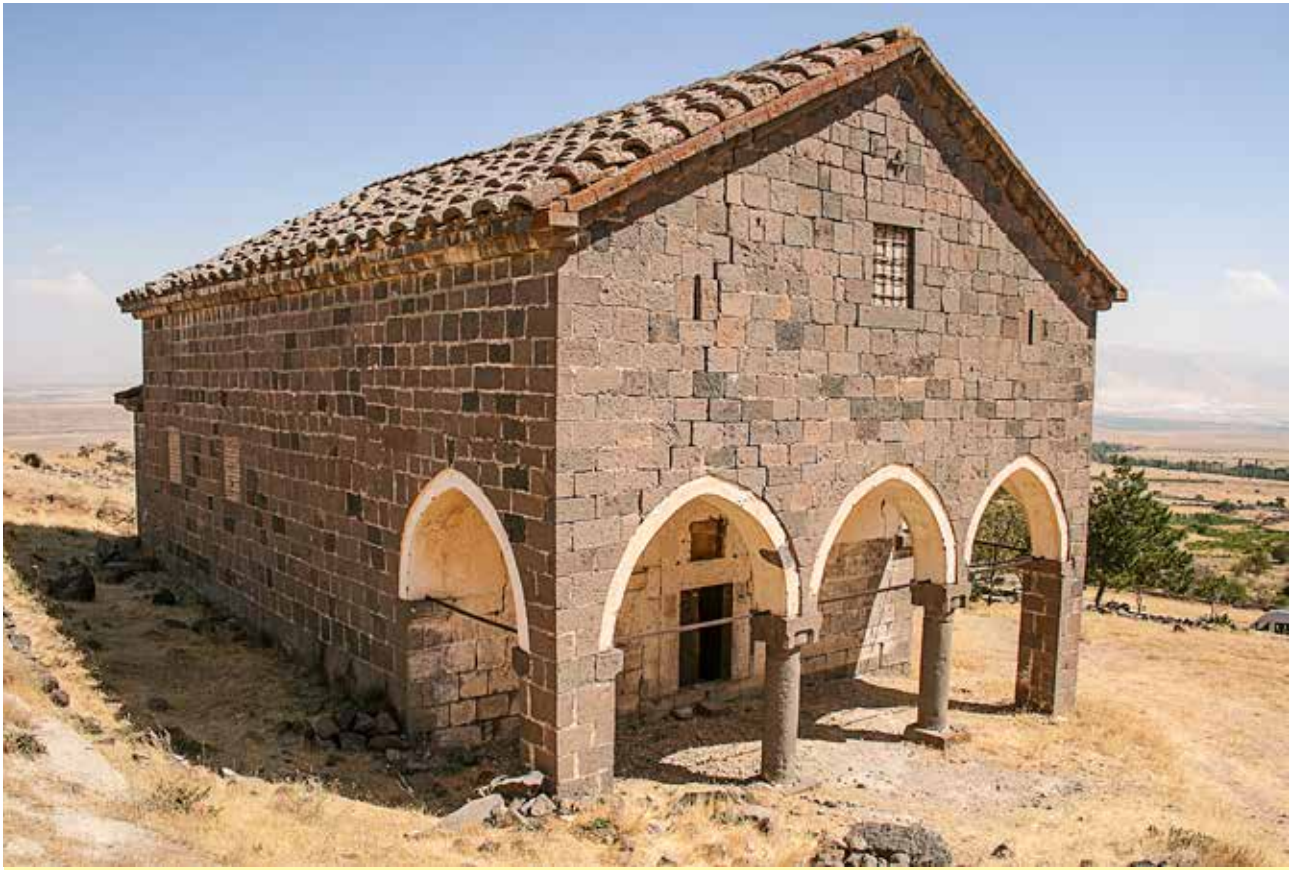
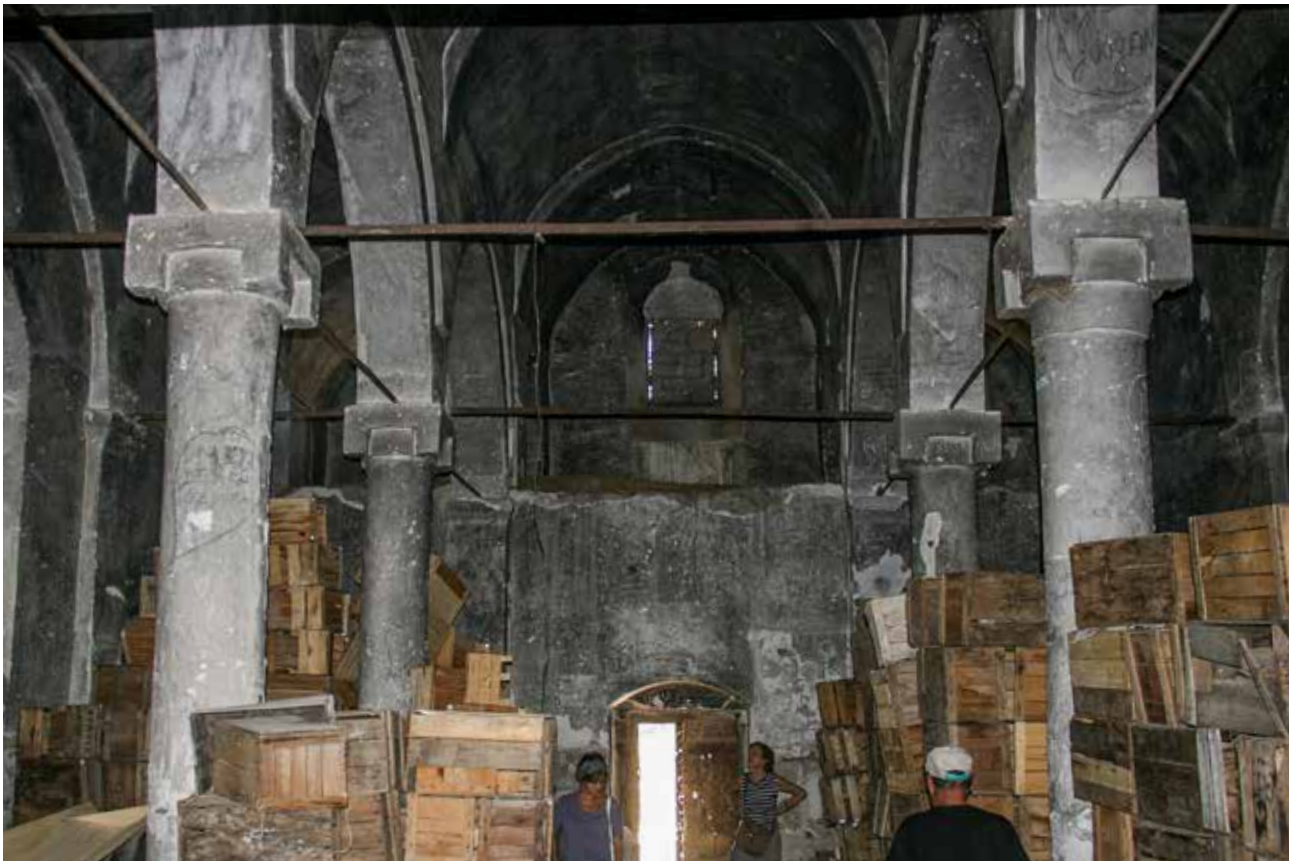
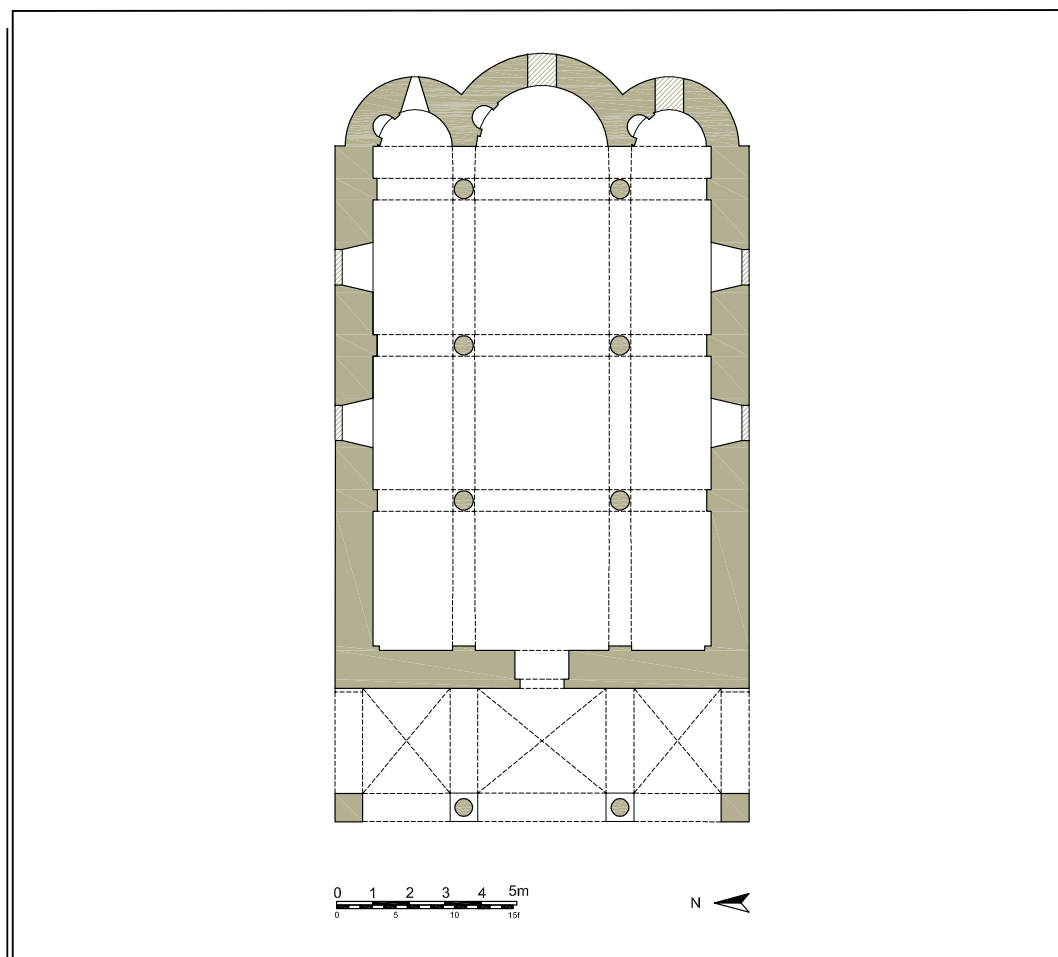
The structure is currently used as a depot and being full of crates obstructs an understanding of the space. All the openings of the structure have been filled in with concrete blocks and thus the interior is dark. The church has an unlocked, unoriginal door. The stairs to the gallery have collapsed and a majority of the original flooring stones have been removed. The southern side of the apse has been excavated by treasure hunters. There are graffiti marks on the walls. The bell tower is partly demolished.

The church has serious structural problems, which can also be observed on the façades. The eastern wall of the naos has deep cracks in it. The mortar in the external wall of the apse has been repointed with incompatible material and bad workmanship. The northern and western façades have cracks running from the eaves all the way down to the ground.

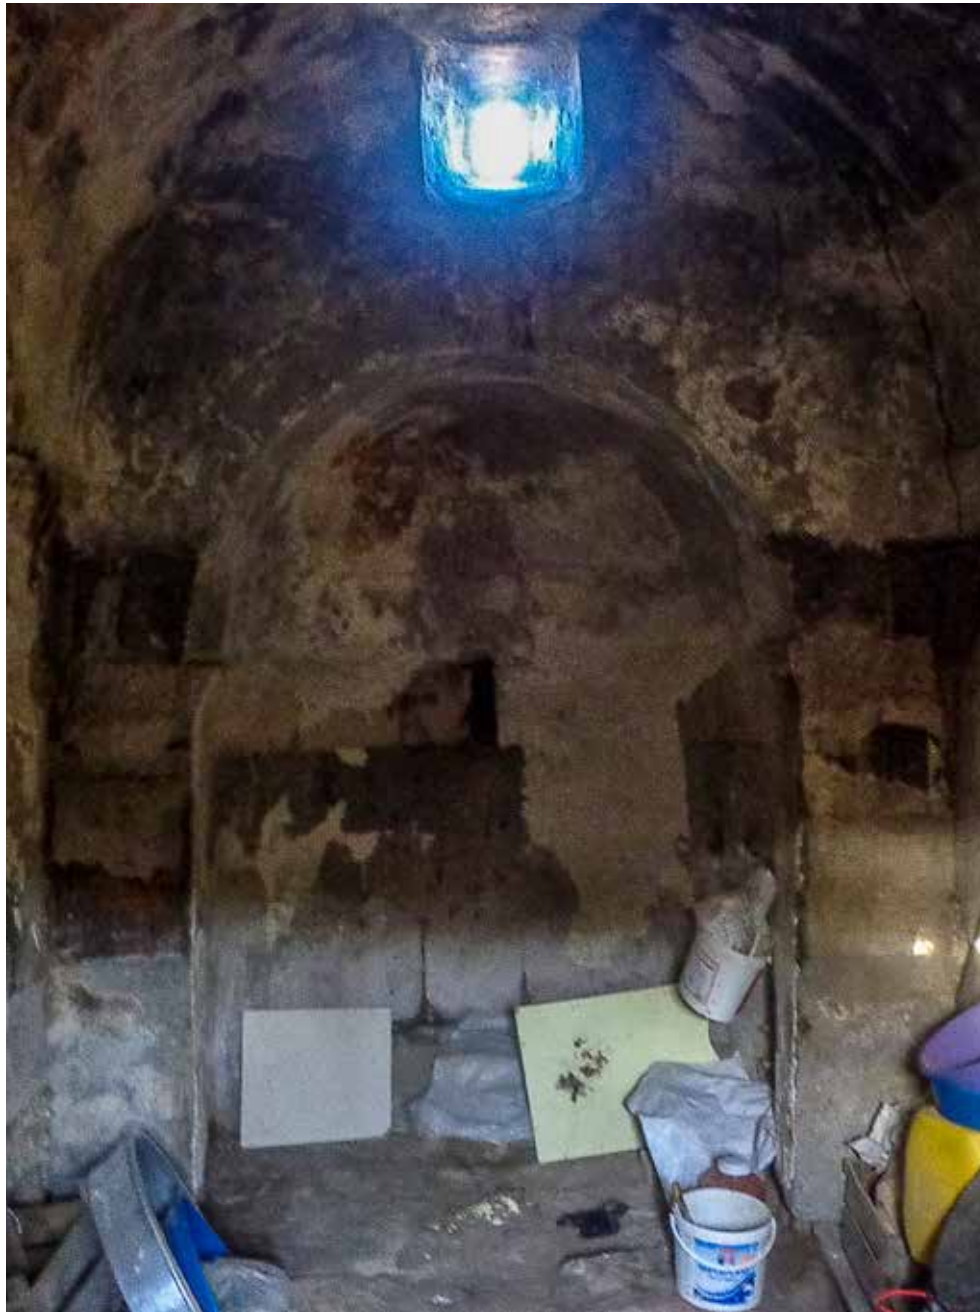
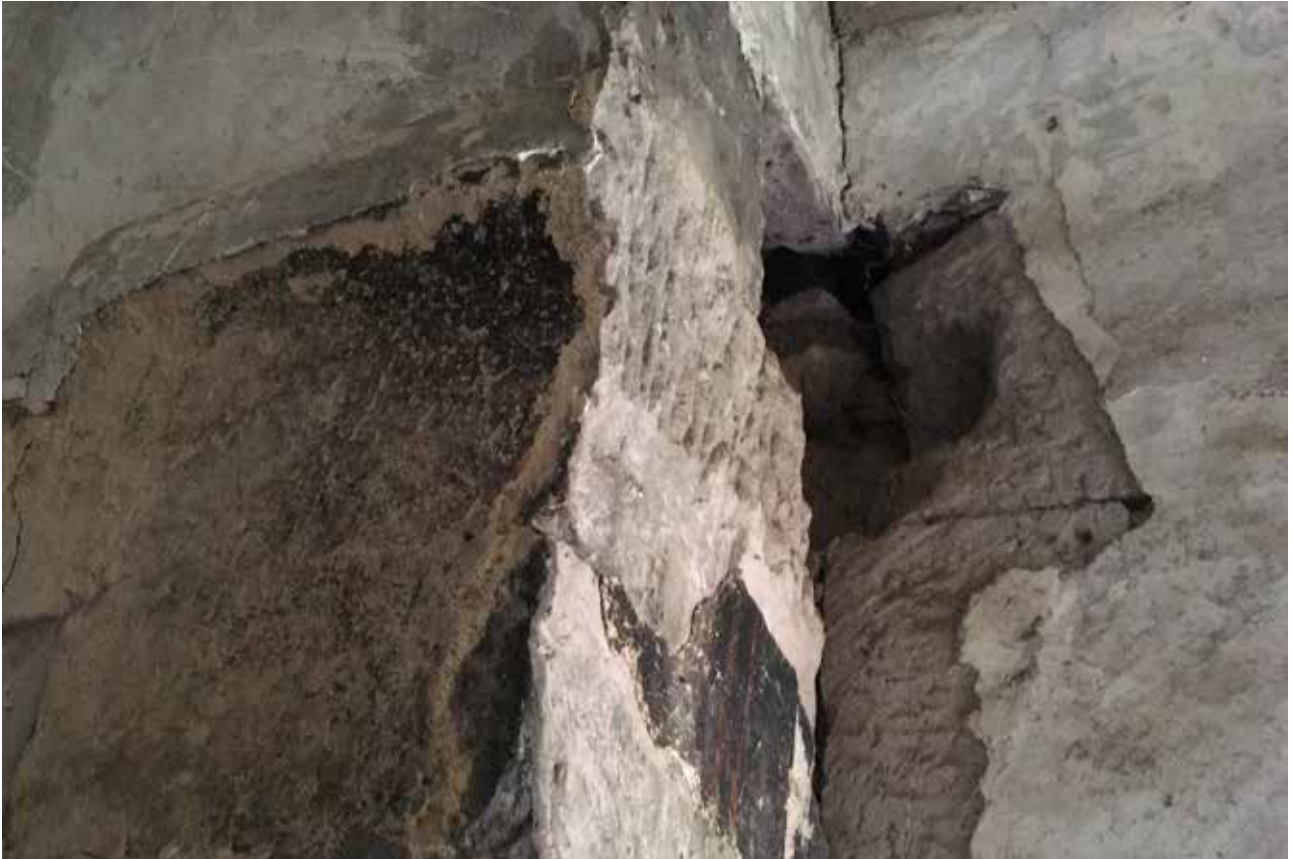
*The Chapel
Niğde Central county, Uluğağaç village, Köyiçi locale*

is an earthen floor. Inadequate interventions in terms of support and filling have been made recently in attempting to reinforce the structure (e.g., fractures have been filled in with rubble). Holes have been opened (probably by treasure hunters) in the interior and exterior facing of the church in hopes of reaching within the walls. Due to the erosion and rotting of the stones,

the surfaces have degraded with hairline and structural fractures visible in the walls. Nearly all the stone in the interior has been exposed to dampness, with chemical degradation present (efflorescence, mold). Again due to this reason, the majority of the plaster has fallen off with the very few remaining frescos in poor condition. Additionally, plaster in the interior has been

incised and vandalized. Recently the interior was painted white; however, due both to dampness and the use of paint unsuitable to the original plaster or stone it has begun to flake.

Plants have begun to grow at the junction points of stones in the main walls. However, the real danger to the main walls is the existence of structural fractures up to 5 cm wide. The apse wall has begun to separate as a whole from the other walls. The western wall has already separated and is leaning out at a dangerous angle with wide structural fractures.

There are plants growing on the roof, with the roots of these plants penetrating the stones and causing fractures.

The chapel is susceptible to earthquakes, with the broad structural fractures in the western wall reducing the structural integrity to dangerous levels. These fractures should be repaired at once and the structural integrity of the structure consolidated. The roof should be repaired as appropriate to the original technique, and appropriate windows and door fittings put in place.

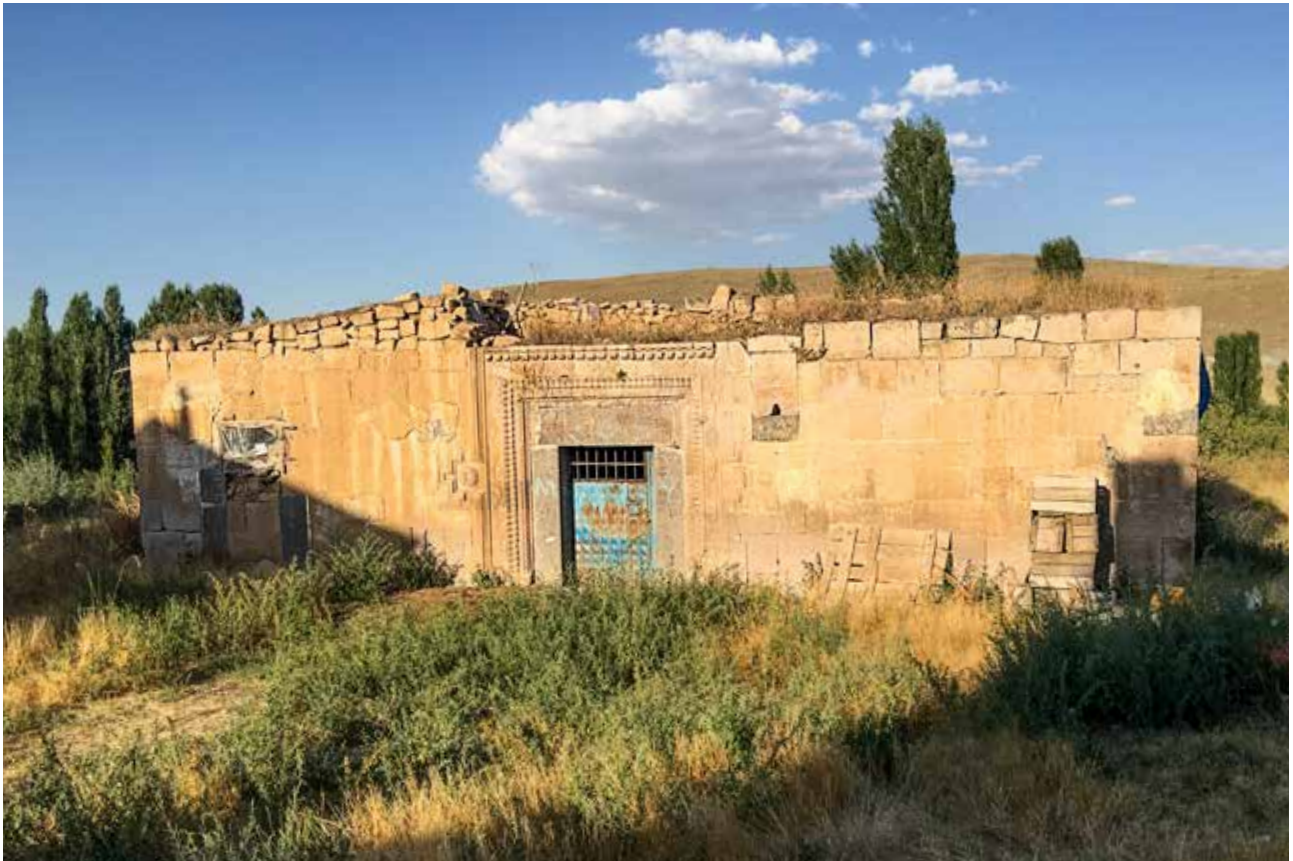
*Church of Archangelos Michael
Niğde Central county, Uluğağaç village, Köyönü locale*

Currently only the ground floor (about 3 m above ground) remains of the 12 m-long western wall of the church. A later hole was opened in the northern side of the wall, to create a window for the residential structure. The original door is not present, and has been replaced with a metal door of poor quality.

Due to erosion and the rotting of stones, the surfaces have lost material with both hairline and structural fractures observed. There are plants growing especially along the top of the remaining wall, with the roots of these plants penetrating the stone and causing fractures and parts to fall off. The remaining wall has been vandalized with paint. As it was not possible to enter the structure, no investigation of the western face of the wall was conducted. There is no information panel on it whatsoever.

Noted for the stonework around its entrance door, there is insufficient information for the reconstruction of this structure, so undertaking its restoration is a matter to be discussed. However, if archeological excavations are completed in the area, it is possible for the plan to be discerned. These foundations and the remaining western wall should be reinforced and protected.

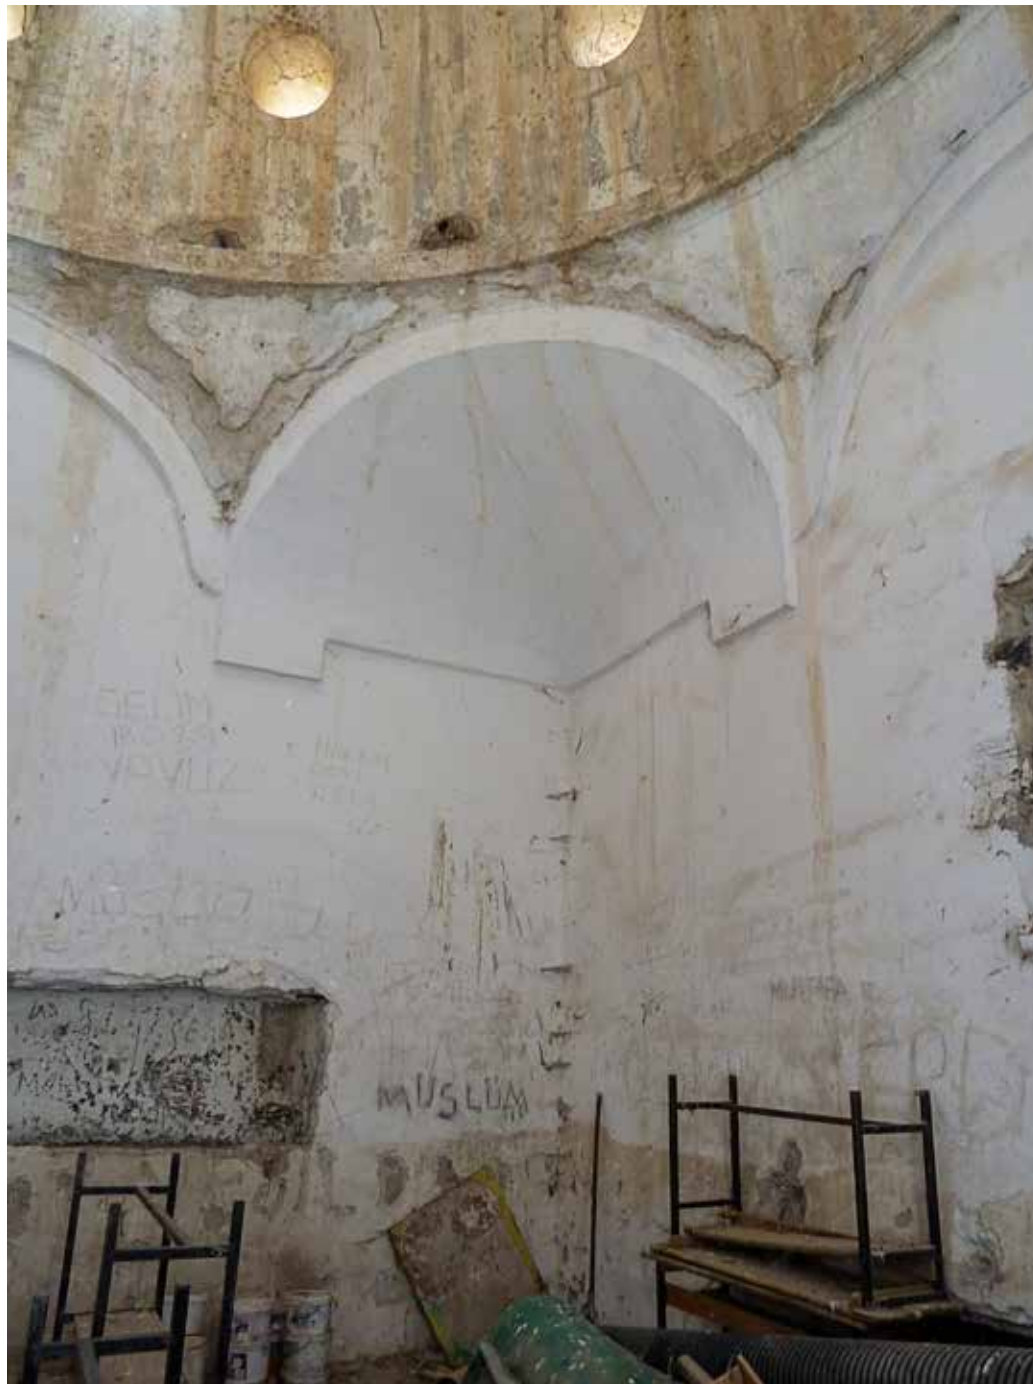
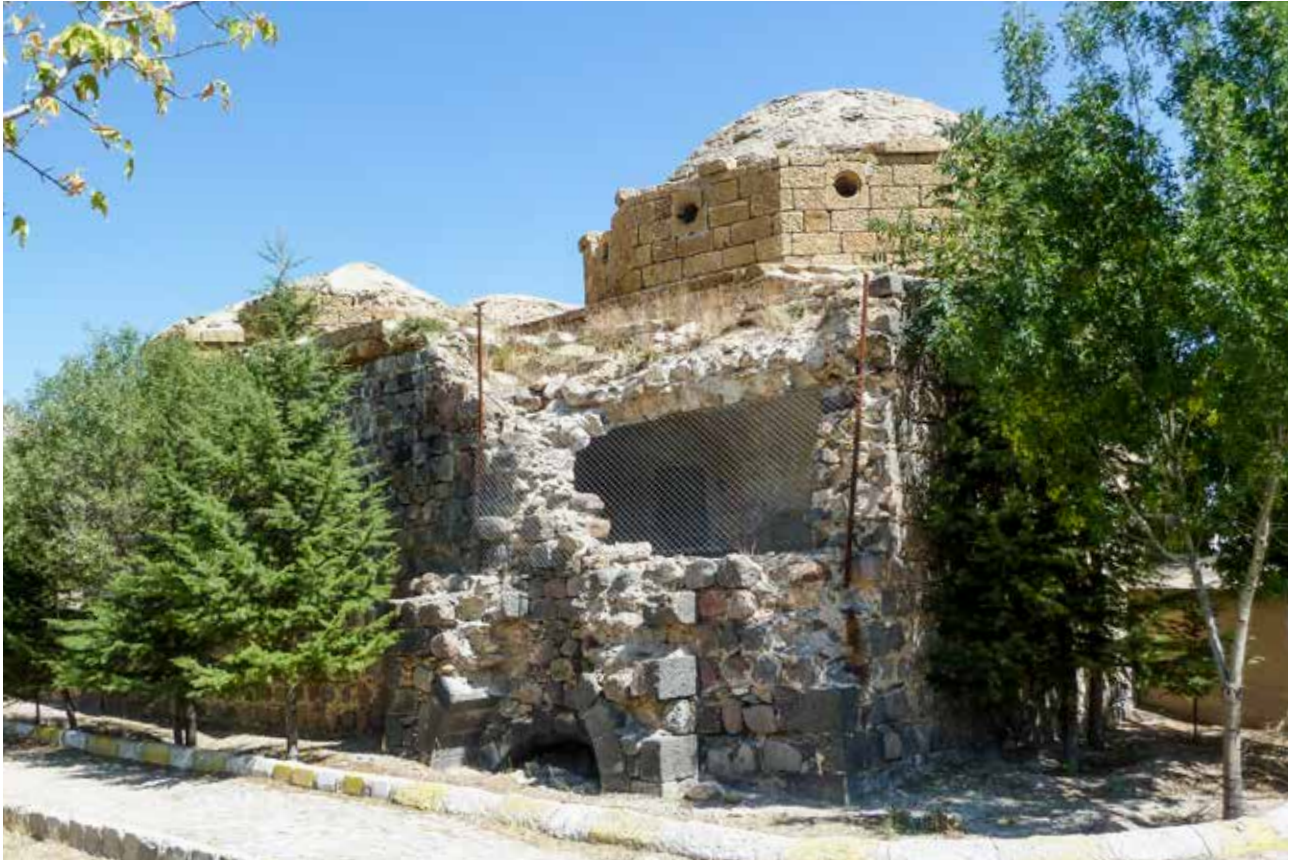
*The Public Bath
Niğde Central county, Hamamlı neighborhood*

The cold section and furnace of the hamam have been demolished. The door between the original cold and warm sections is used as the entrance door to the structure today. A wall was built towards the northern façade as a buttress after the cold section was demolished, probably to ensure the integrity of the structure. Though the cold sections and furnace are completely destroyed, the plan of these areas can be read from the remains of the foundations of the walls. Rainwater enters the structure through the skylights and this has caused the plaster to peel as well as damage in the domes. There is severe damage in the water distribution and heating system, water channels and floor. The clay pipes within the walls have been removed and stacked in the hot section. The southwest corner and roof of the water depot have partially collapsed.

The structure is on a road between Kumluca and Hamamlı neighborhoods and there is neither an information panel nor visitors to the site. As the entrance door is locked, it is possible to say that certain precautions have been taken against vandalism; however, use of the building as a depot has caused serious damage.

Excavations must be completed in the area in order to understand the layout of the structure. The hearth in the furnace and the remains of the foundations in the cold section must be unearthed. A restoration plan for the structure must be prepared and the destroyed parts of the cold section must be repaired according to this plan. The structure may either be restored as a hamam or be given a new function that serves the public without contradicting its original fabric.

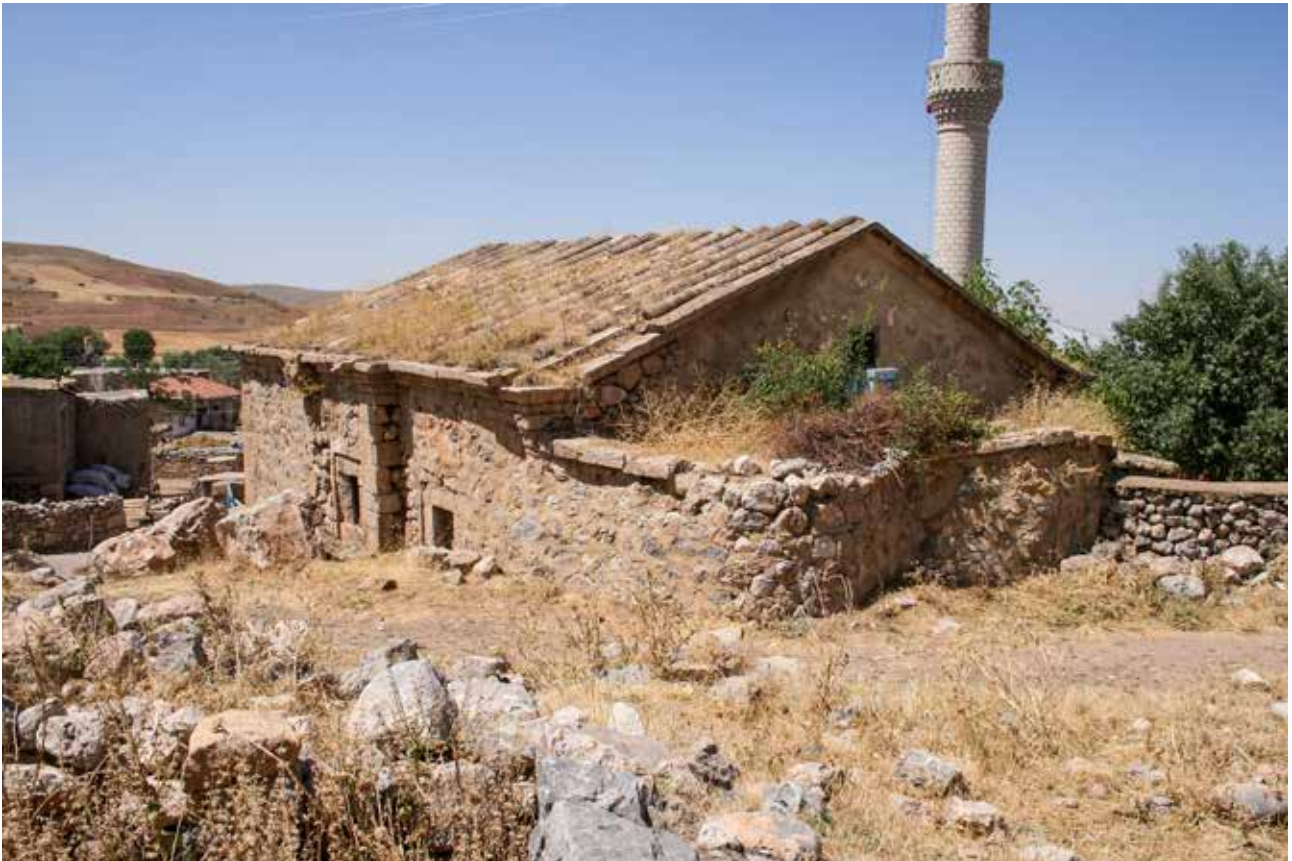
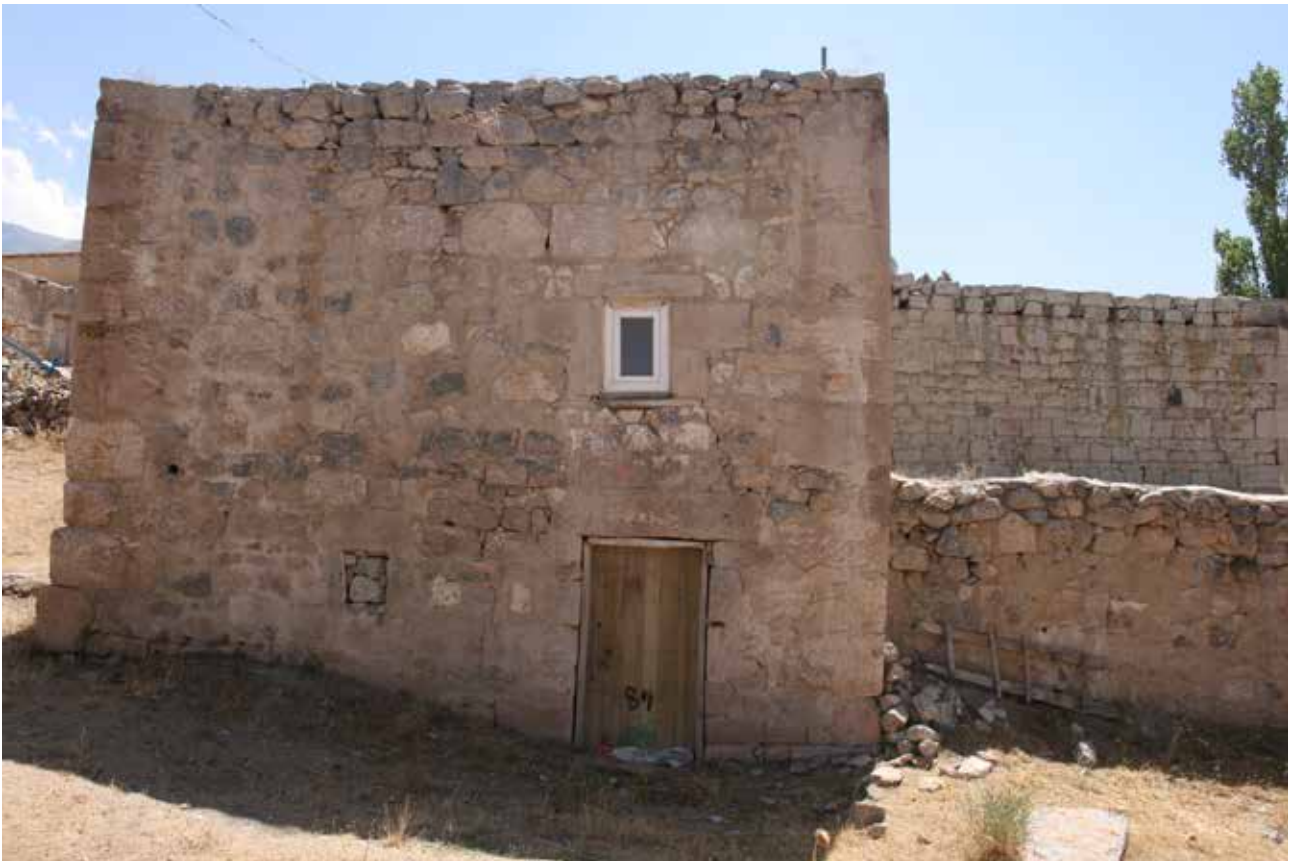
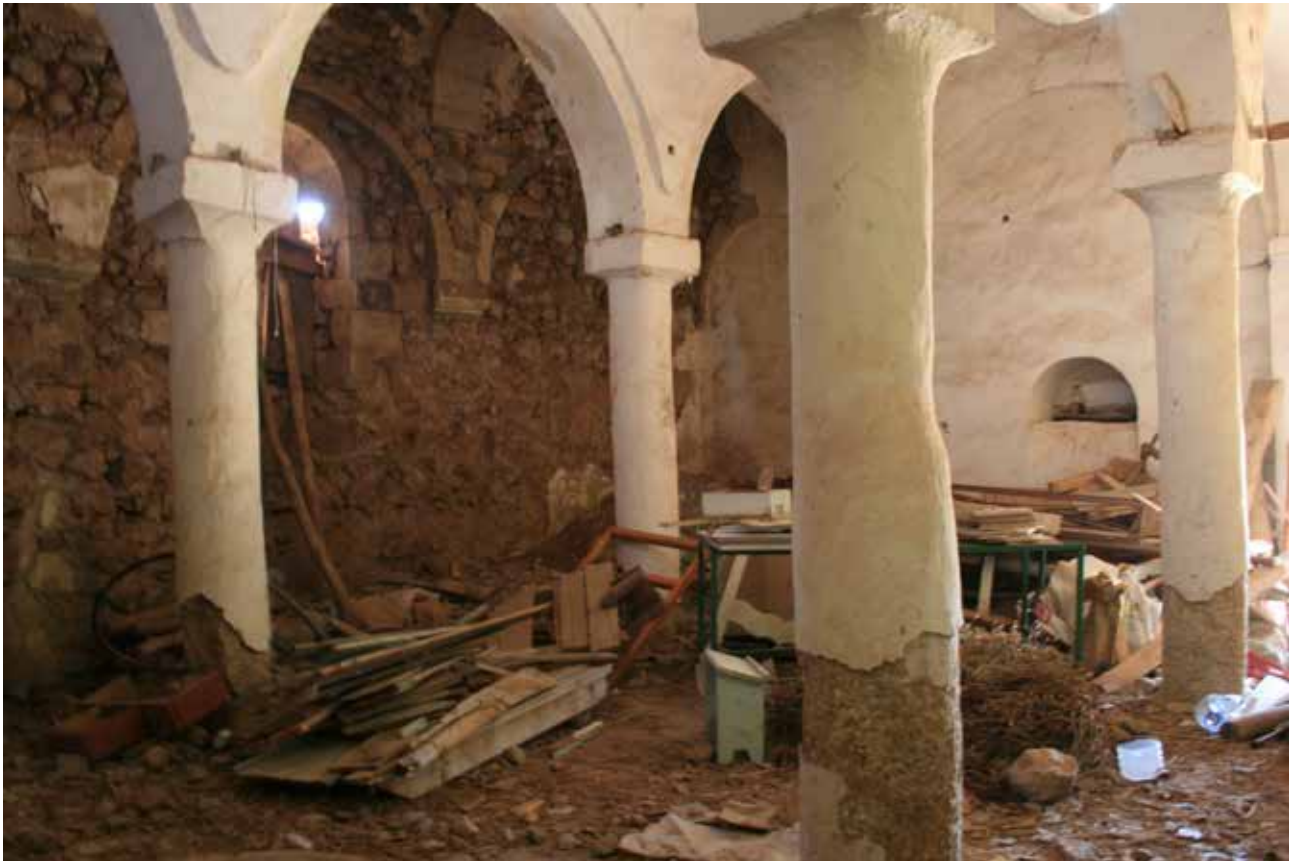
The original door opening on the central axis of the church has been bricked over. As this entrance has been closed, currently access is through a door later opened in the wall of the northern nave on its western façade. The lime plaster on the interior walls has peeled, most prominently on the southern wall. There are damp marks on the interior plaster. These damp marks point to the high probability of the roof

leaking; this is also supported by the fact that the current roof is covered with plant growth. The whole of the western façade and part of the northern façade has been covered with cement. Some cement pointing has also been applied to the rubble stones. Some of this pointing has degraded and cracks are visible in the walls. The cross-sections of the columns of the structure are irregular and their wooden tie rods are missing. The external façade has been ruined, and is covered with plants. The roof eaves of the apses have been destroyed.

The use of the structure as a depot and the lack of maintenance have put it at risk. It is necessary to solve the problems related to damp and humidity. The columns require urgent structural intervention. Access into this structure, which is not yet even listed as a historic building, must be

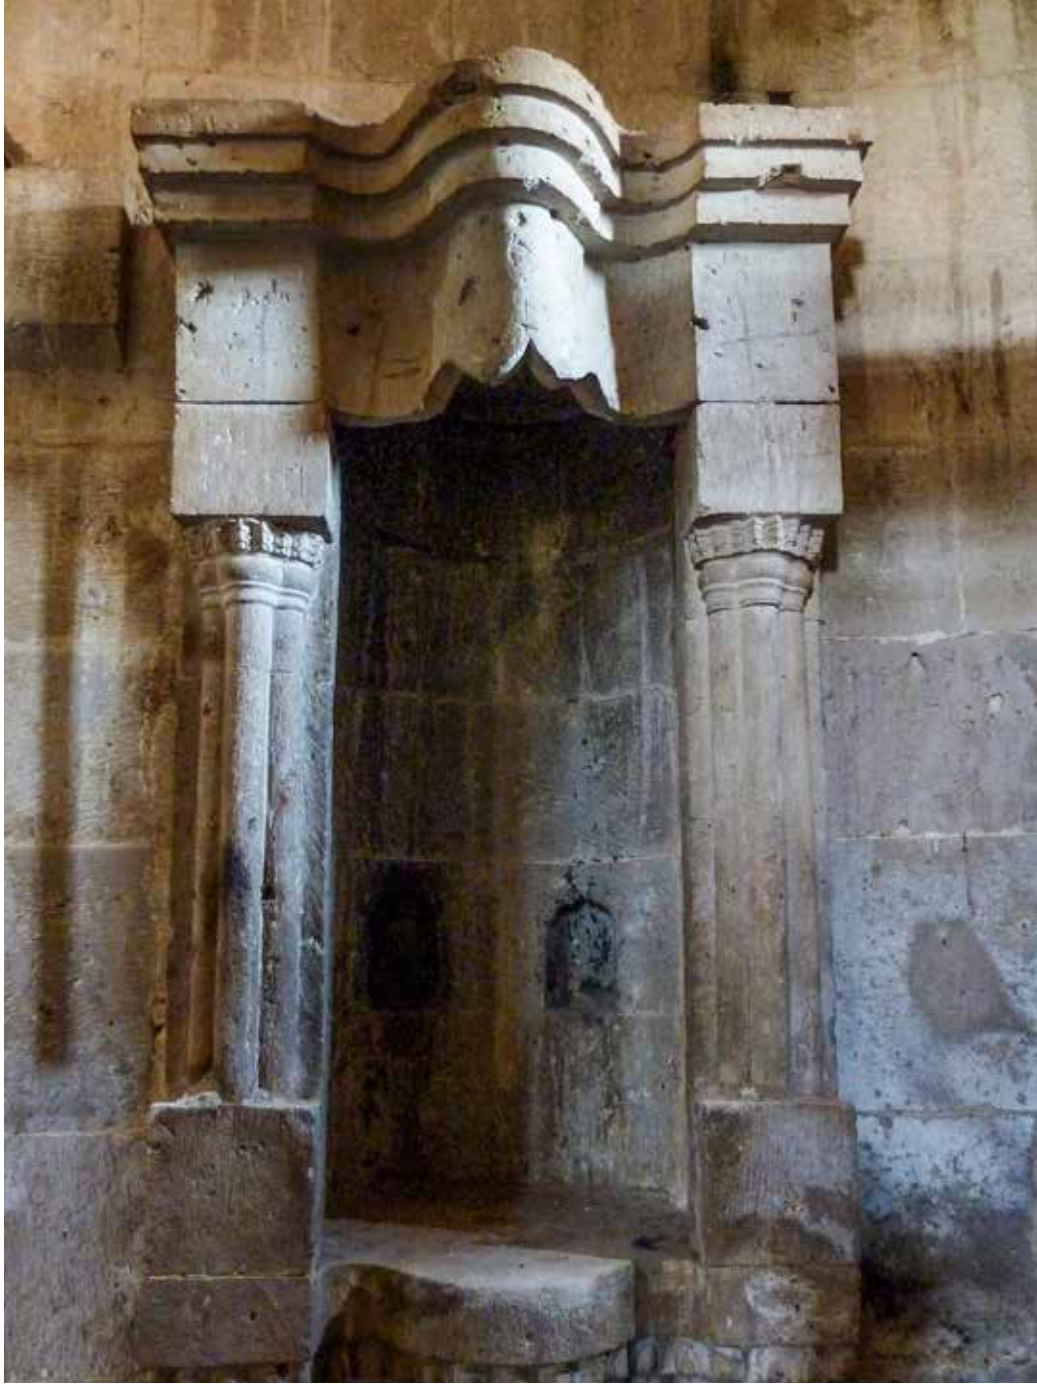
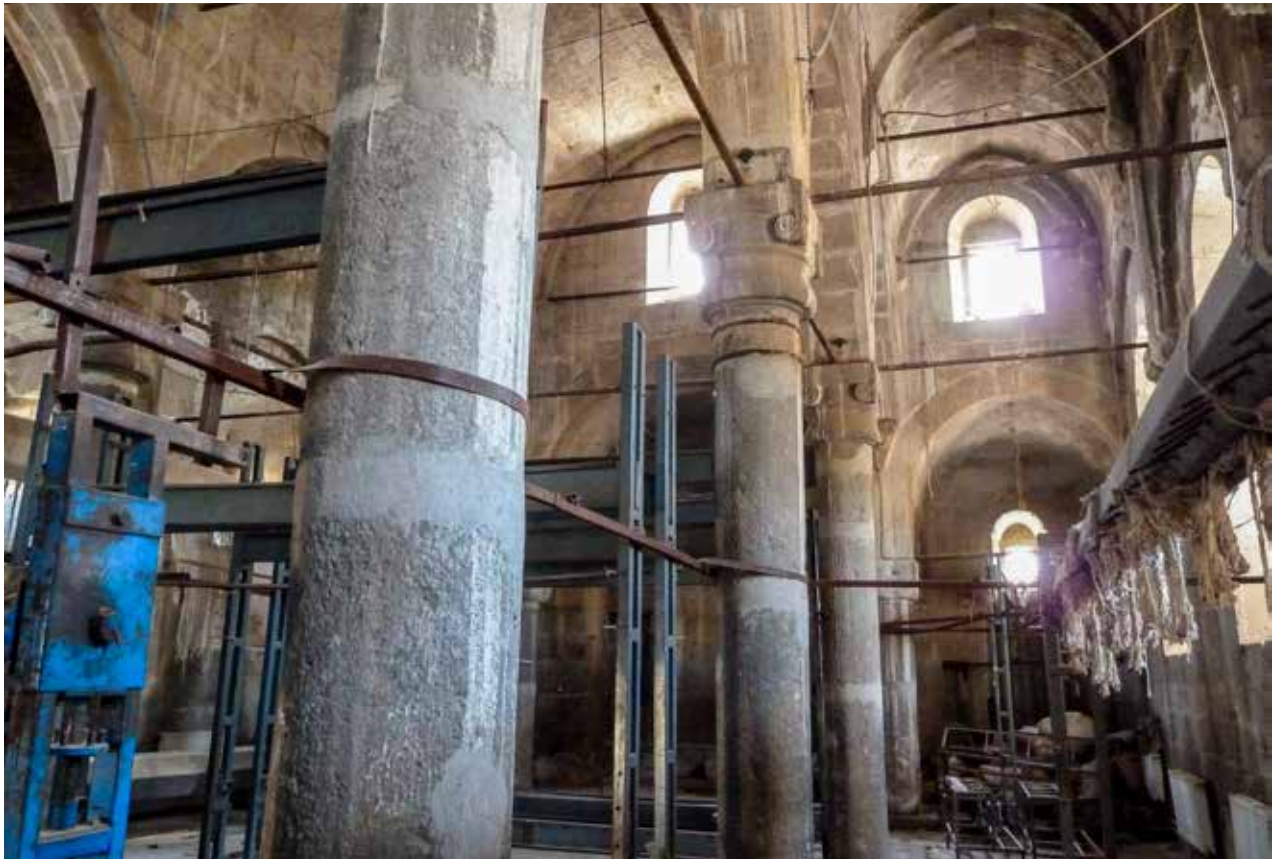
*Church of Saint George
Niğde Central county, Dikilitaş village*

The structure is preserved in its entirety in relatively good shape, but with no maintenance. Its repurposing as a carpet weaving workshop has prevented the usual vandalism encountered in abandoned churches; however, this use has also inflicted unacceptable interventions to the monument, such as the extended iron ties added in order to attach weaving machinery, the demolition of the interior gallery, damages to the original stone-cut decoration of the niches, the installation of incompatible heating equipment, and the existence of random piles of raw materials and manufacturing waste.
