Kayseri
Adana
Izmir
Elazığ
Niğde
Bursa

Assessment Report of Architectural Cultural Heritage

April 2018

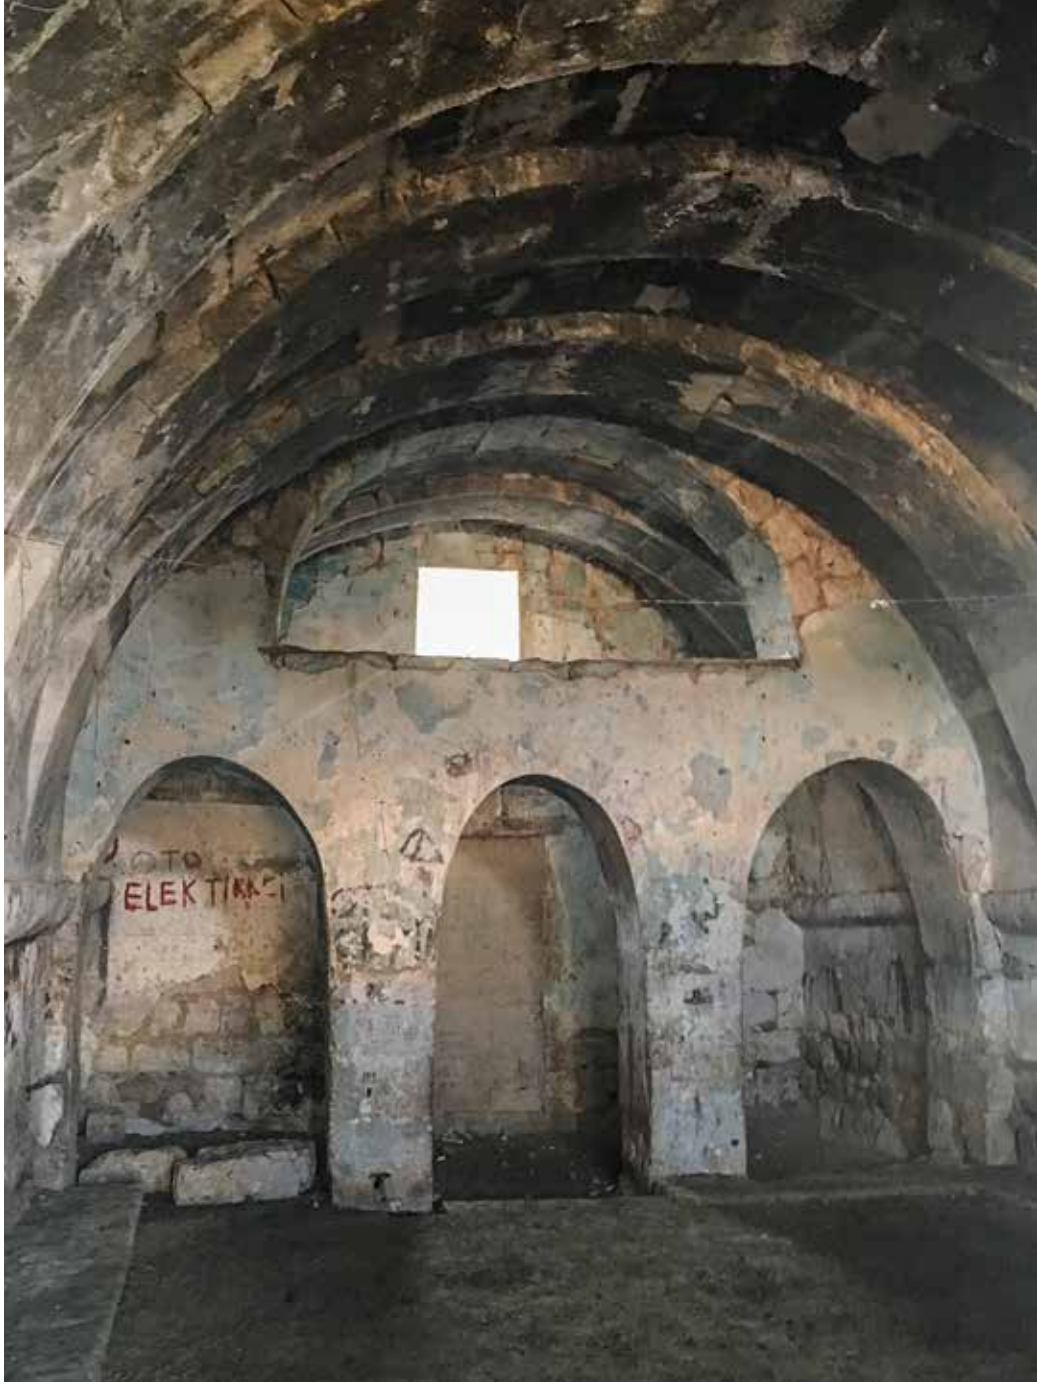
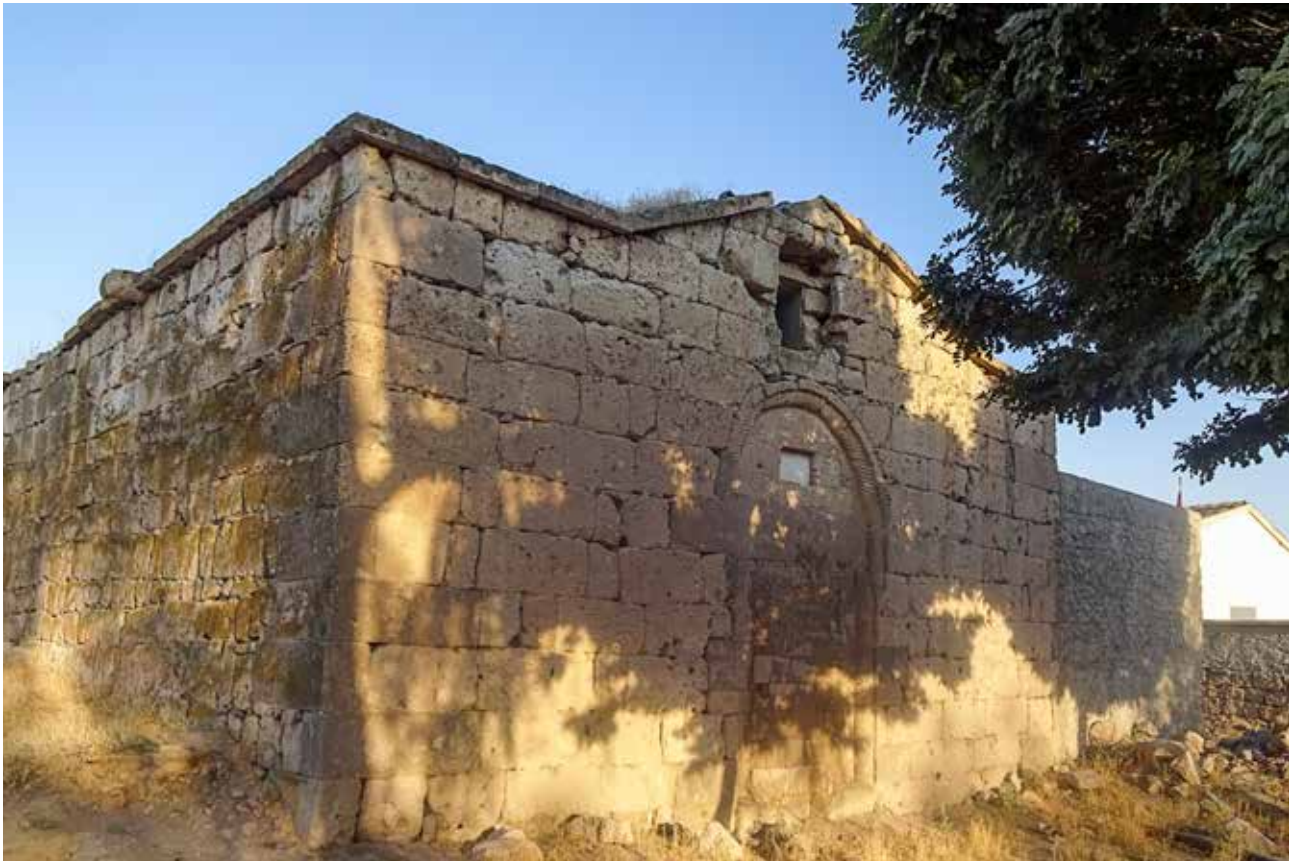
*Chapel of Saint Macrina
Niğde Central county, Tırhan village, Köyiçi locale*

Though the apse and gallery section of the chapel have collapsed, the plan and spatial characteristics may still be perceived. After collapse of the apse, the semi-circular opening east of the naos appears to have been closed off with rubble stone. At the peak point of this rubble stone wall, a small opening was left to allow light inside. As the main entrance door to the chapel has been closed off with cut stone, currently access is through a door later opened in the eastern façade.

Built adjacent to the southern wall of the chapel is a later structure used as a classroom for the primary school in the village (Pekak, 1999, 32). For this reason, the southern window in the structure has been closed off. The eave moldings and waterspouts on this façade have been destroyed. Additionally, the stone of the interior southern wall and its molding have been damaged in order to carve out a mihrab.

The traces of dampness visible on the ribbed vault ceiling indicate that water is leaking into the structure. In addition to dampness, increasing humidity within the structure has caused the plaster to flake off. There are signs that fires have been lit within the chapel and vandalism is seen on the plaster.

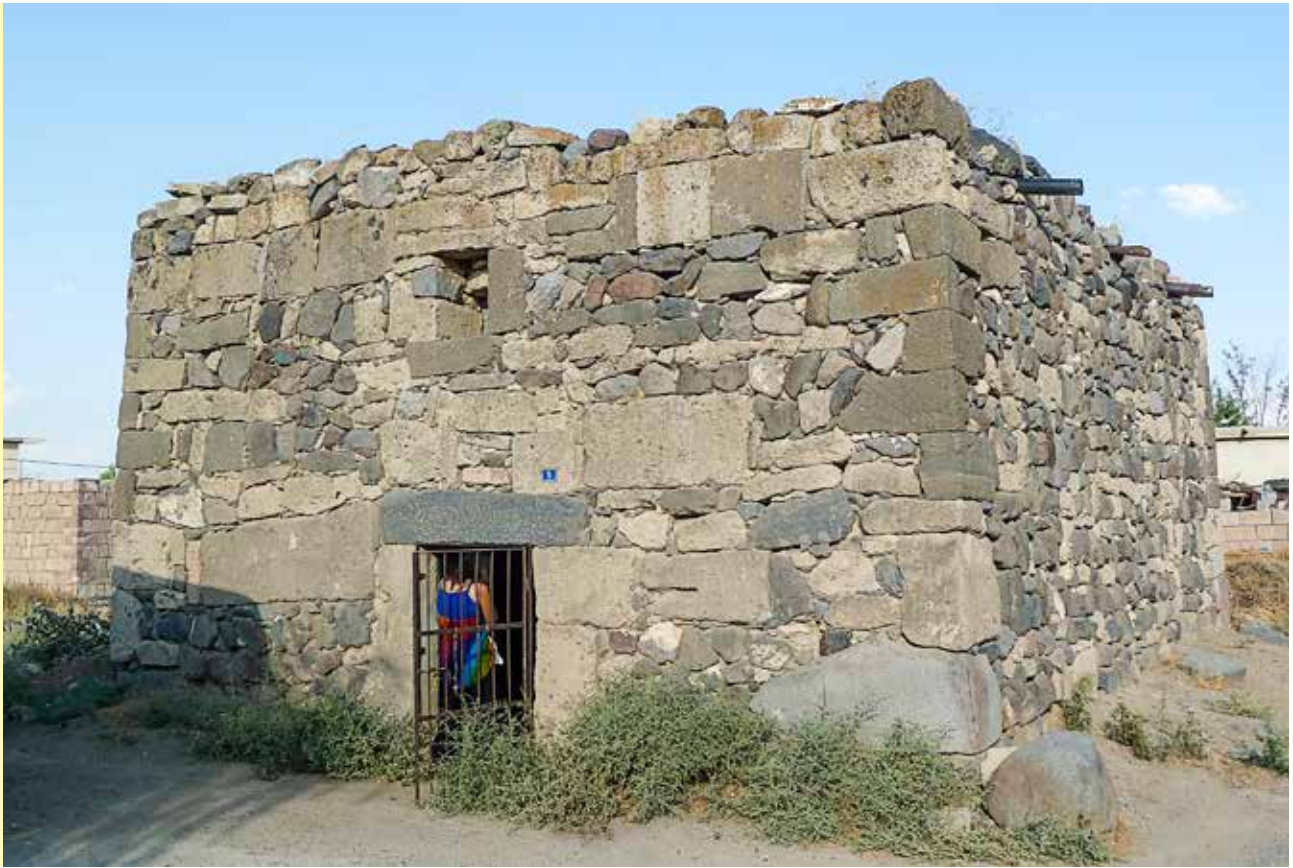
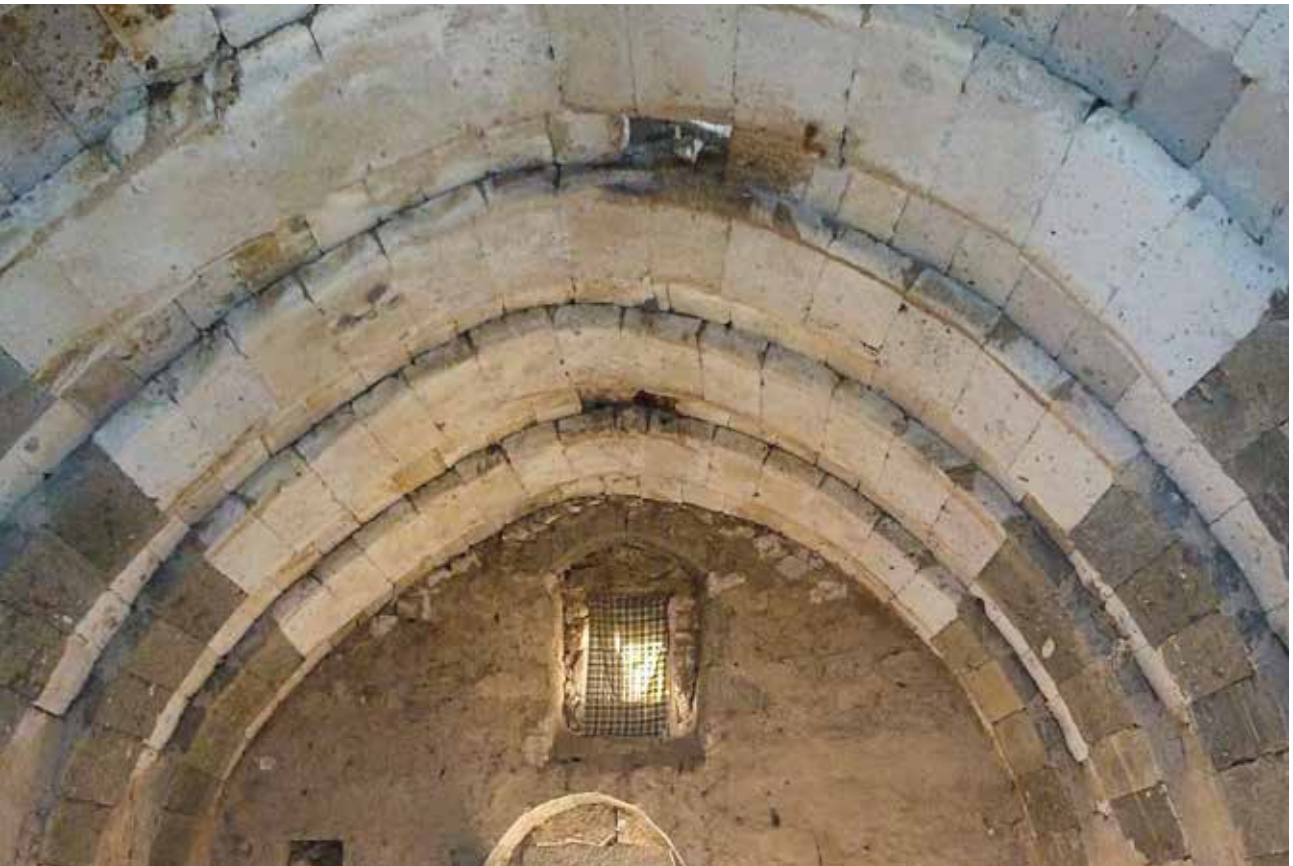
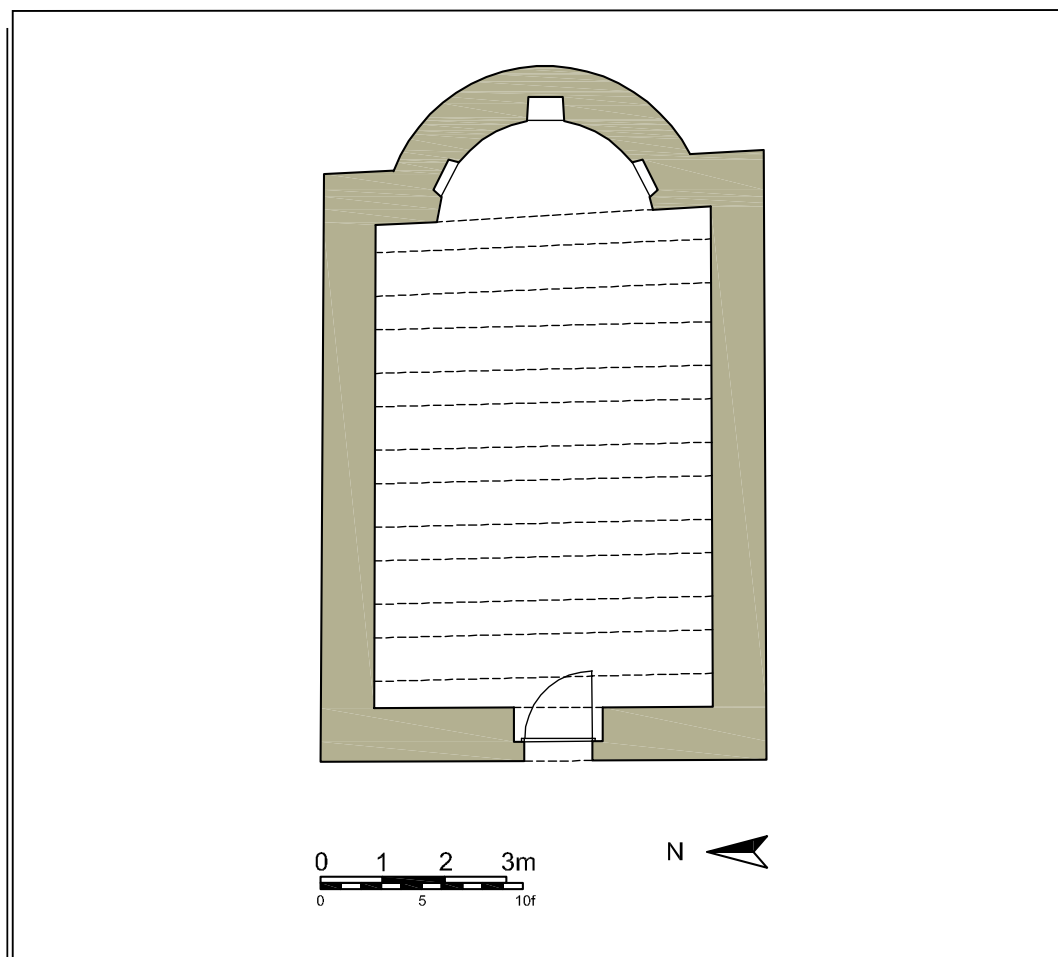
The chapel is moderately preserved at present, in a relatively good state and used as a depot by a private owner. The intense plant growth on the roof of the structure is a problem. Though no research has been conducted on the chapel, based on what is visible, it is possible to determine its spatial characteristics and floor covering. Disruption of the ground has led to an increase in the soil level, though only slightly visible from the outside. The vault surface has

small openings possibly made later to allow light into the interior. Another structure has been constructed at a later date adjoining the façade of the apse of this internally-plastered chapel. Due to its use as a depot, its identity as a place of worship has been lost, with a range of disruption to the interior due to these changes and lack of maintenance. The small niche in the semi-dome of the apse has been closed. The current door is clearly not the original entrance door.

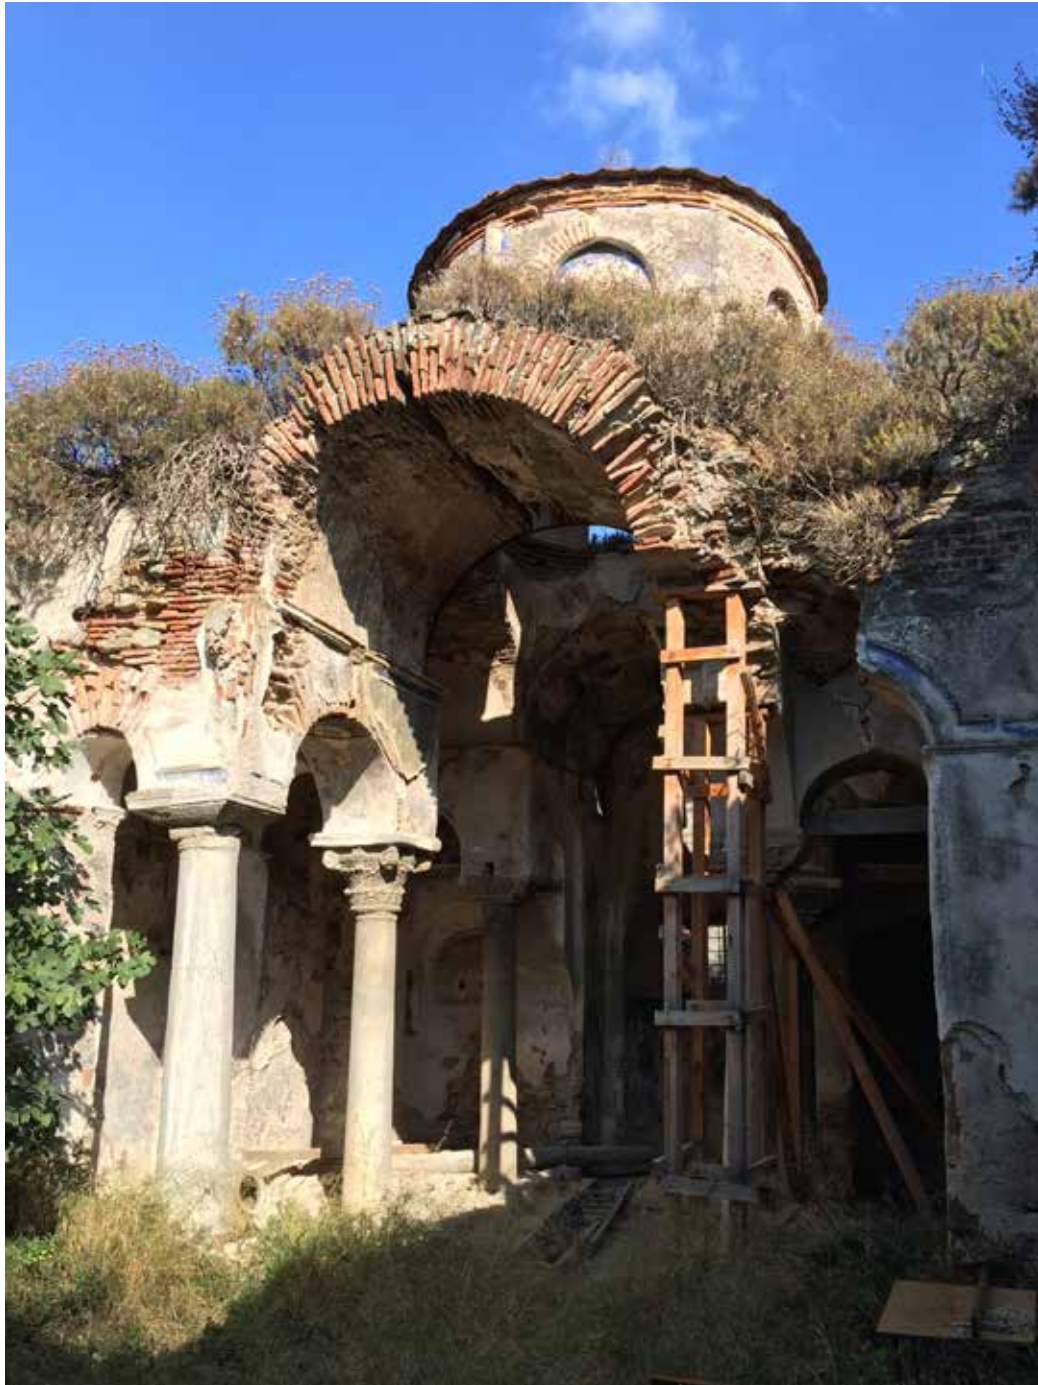
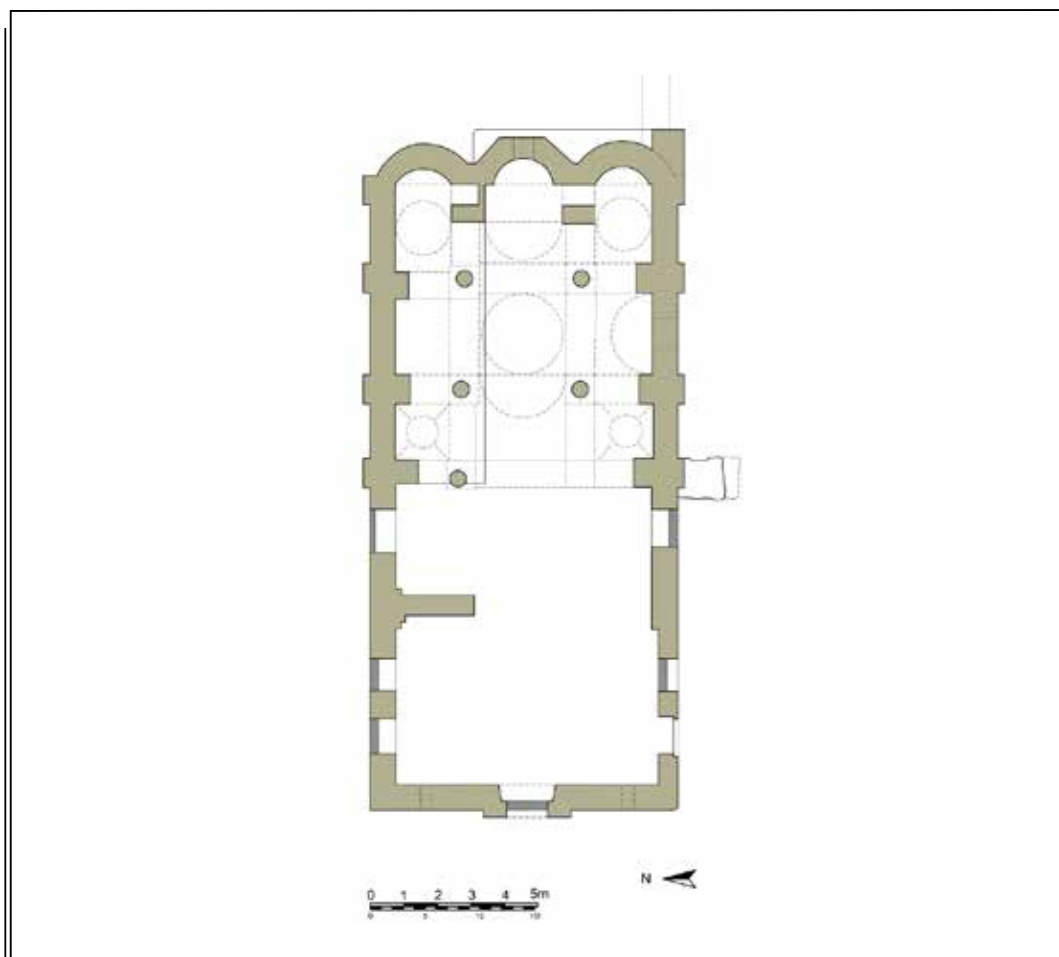
*Church of Panagia Pantovasilissa
Mudanya county, Tirilye town*

On the exterior, the separation of a large part of the main apse wall in the eastern façade of the building is news of severe damage that may be caused in the future by earthquakes to come. The arch rising towards the south from the pier in the western wall of the southern façade has collapsed. Internally, the roof of the narthex has collapsed, as a result of which the wall paintings are exposed to weather conditions. All main walls and the roof contain visible fractures, due to which even heavy rain may cause significant damage. The plant cover on the roof is weakening the structure. The wooden scaffolding put in place of a collapsed column in the southwest of the naos does not provide sufficient support. The structural stability of the structure is in danger and emergency precautions must be taken.

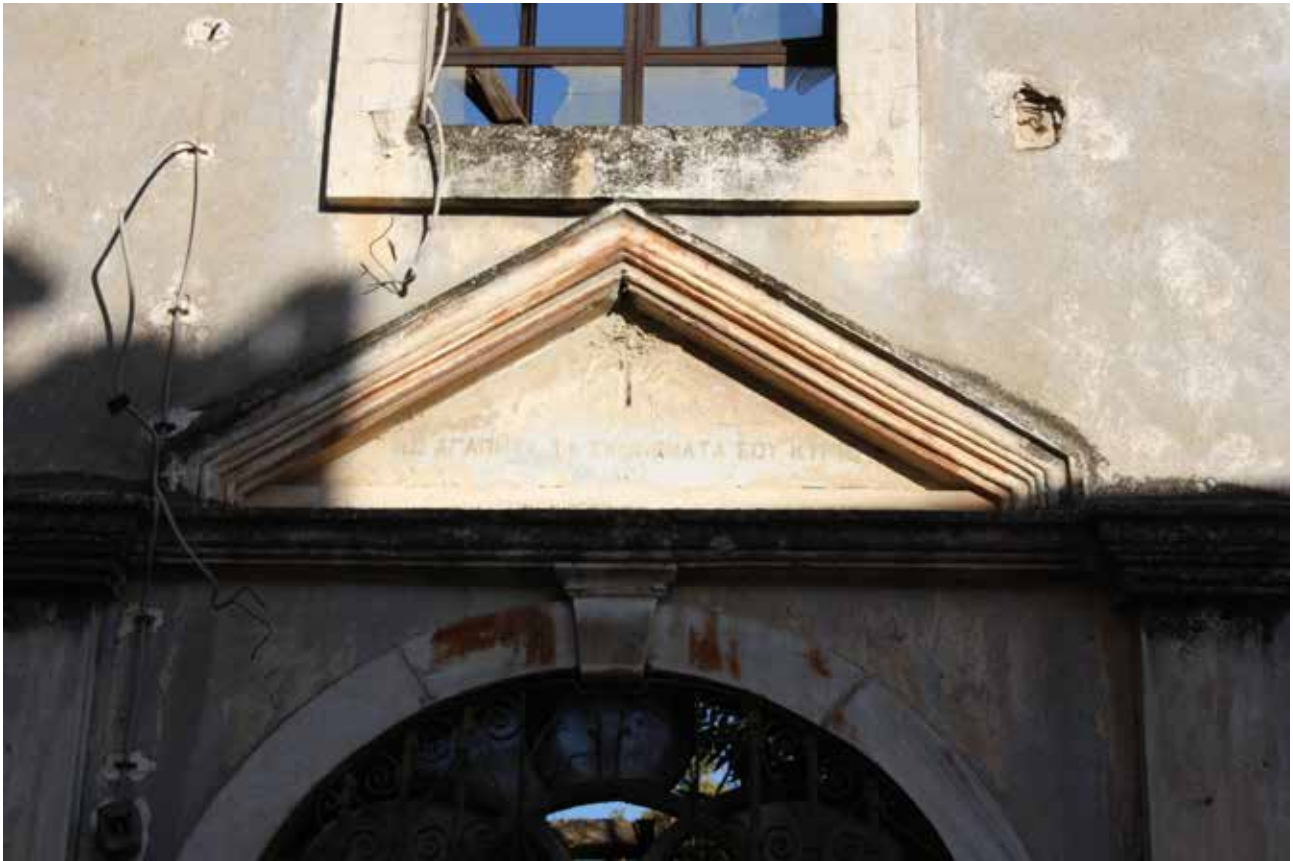
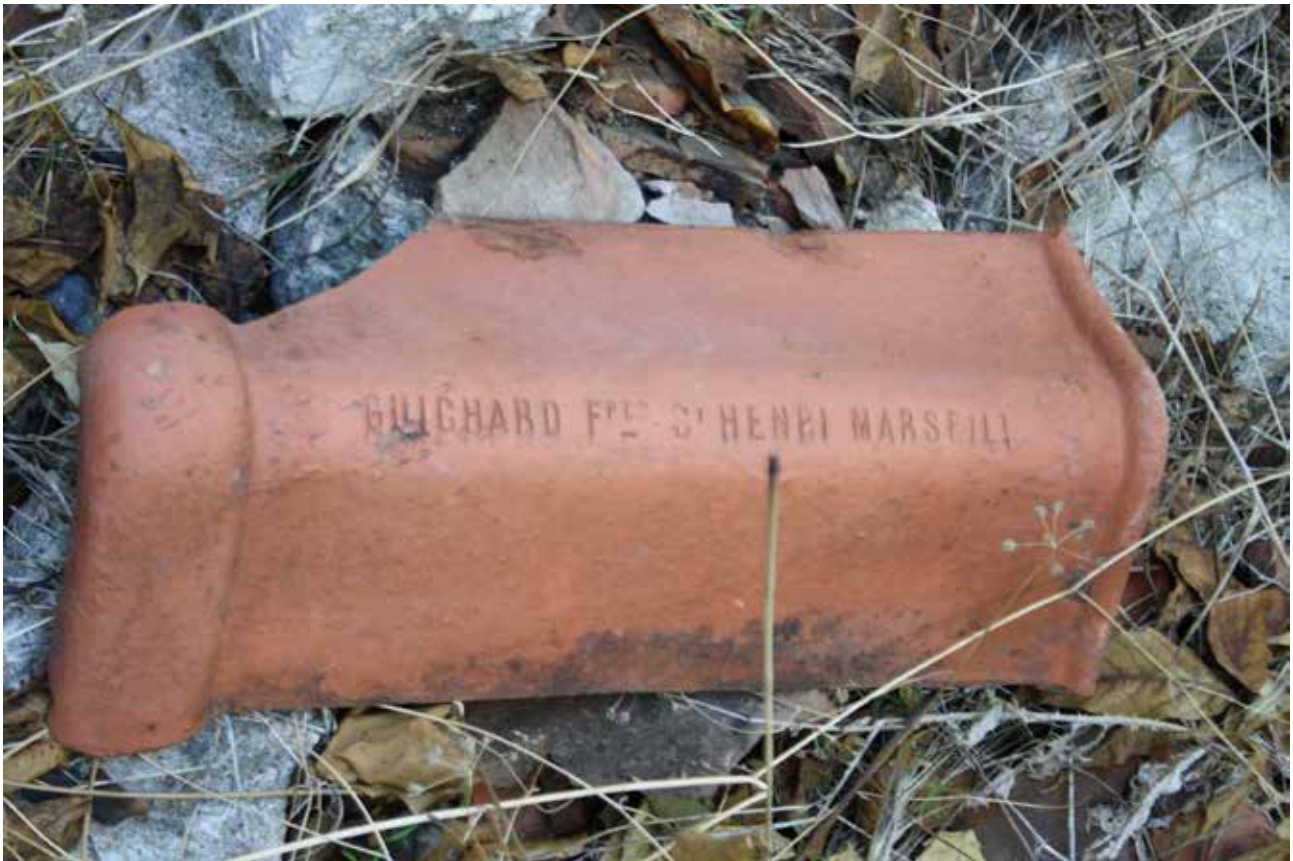
*Church of Saint Apostolos
Mudanya county, Aydınpınar village*

The church is currently in ruins. Not having been used for a long period, the structure has been left defenseless against the forces of nature due to lack of maintenance. The structure, which has suffered severe damage, has had additions including a minbar and walls in the narthex. Traces of its use as a mosque are discernible (calligraphy in the apse, etc), yet there is no trace of the bell tower of the church. As there is no barrier preventing entry, many valuable parts of the structure have been stolen (its ambon, etc.). The upper section of the narthex has not survived and the interior is filled with broken and collapsed remains as well as rubble. As the roof of the naos is completely lost, the remains of roof and ceiling are found within the structure, covered by plants and trees.

The plaster on nearly all of the façades has been lost, with the walls unprotected against all types of environmental factors. Plaster and surface loss is observed in the upper levels due to being exposed to open air. A large portion of the southern façade is current lacking any plaster. Plaster has flaked off the parapet walls and especially in the northern corner, leading to deterioration in the bricks in the parapet. The decorative plates on the parapet have been partly destroyed. There is fragmentation and loss in the capstone molding. Plaster, mortar and parts of the surface have disintegrated at the parapet and eave level of the eastern façade. The brick-cover of the apse has survived, in spite of dense plant cover.

The wooden window fittings on the upper level on the northern and southern walls have nearly been completely destroyed. Those that have survived on the western façade are stained due to dampness and rotting. Non-original wooden frames were installed in the openings of the central nave on the gallery level. The iron bars in the windows are corroding.

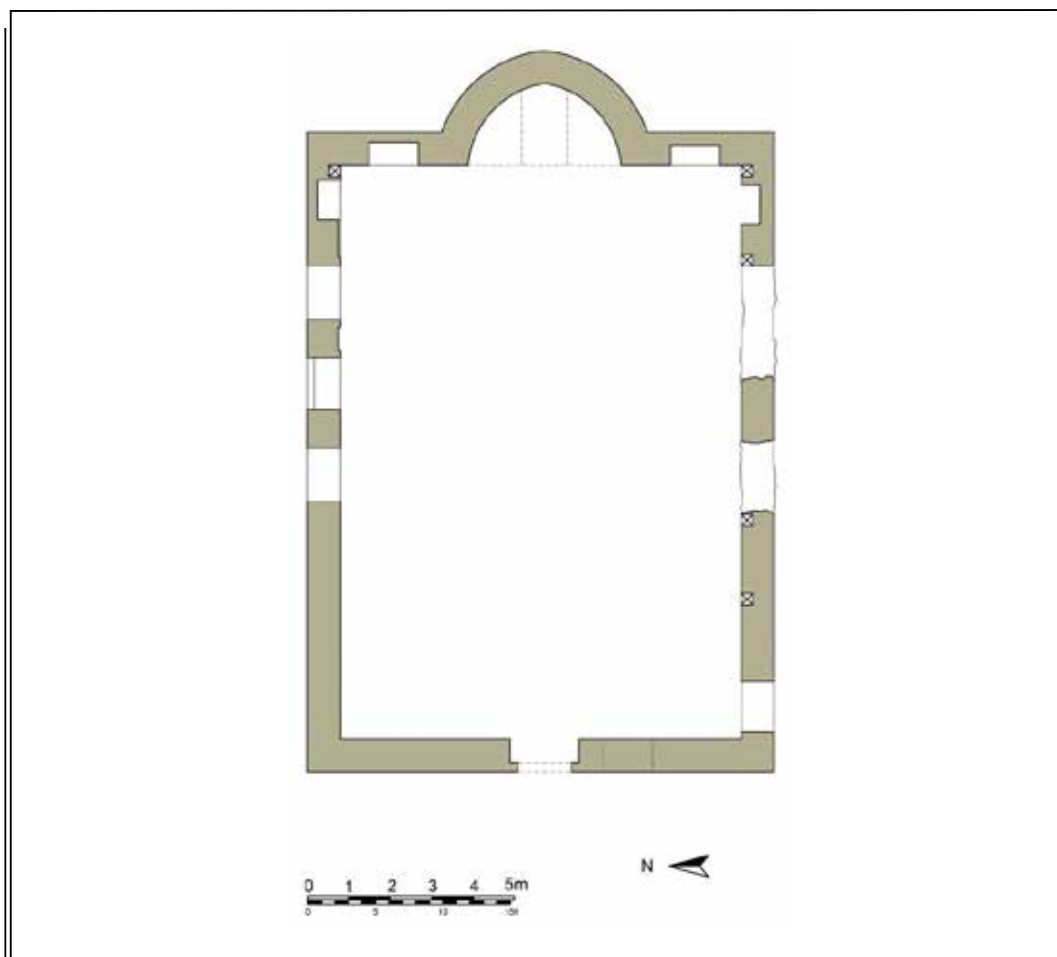
*Church of Saint George
Karacabey county, Çamlıca neighborhood*

The Church of Saint George in Çamlıca village has been abandoned and left to fall into ruin, along with other old houses in the village. The roof of the building has collapsed with the interior partially filled up. The main walls have cracked and partially collapsed. The structure is becoming more ruined each and every day due to both natural factors and vandalism. Nearly all the plaster has fallen off, with advanced disintegration of all building fabric. The wood in the southern wall is in relatively better condition, while there are only empty cavities in the other walls. The eastern façade is adjacent to a private lot and cannot be seen by visitors. North of the apse, the owners of this private lot have built an oven on the upper level, with a toilet on the lower level. The damaged sections of the southern façade negatively affect the stability of the structure, and this poses a threat to people using the lower channel and roads, in the case of its collapse.

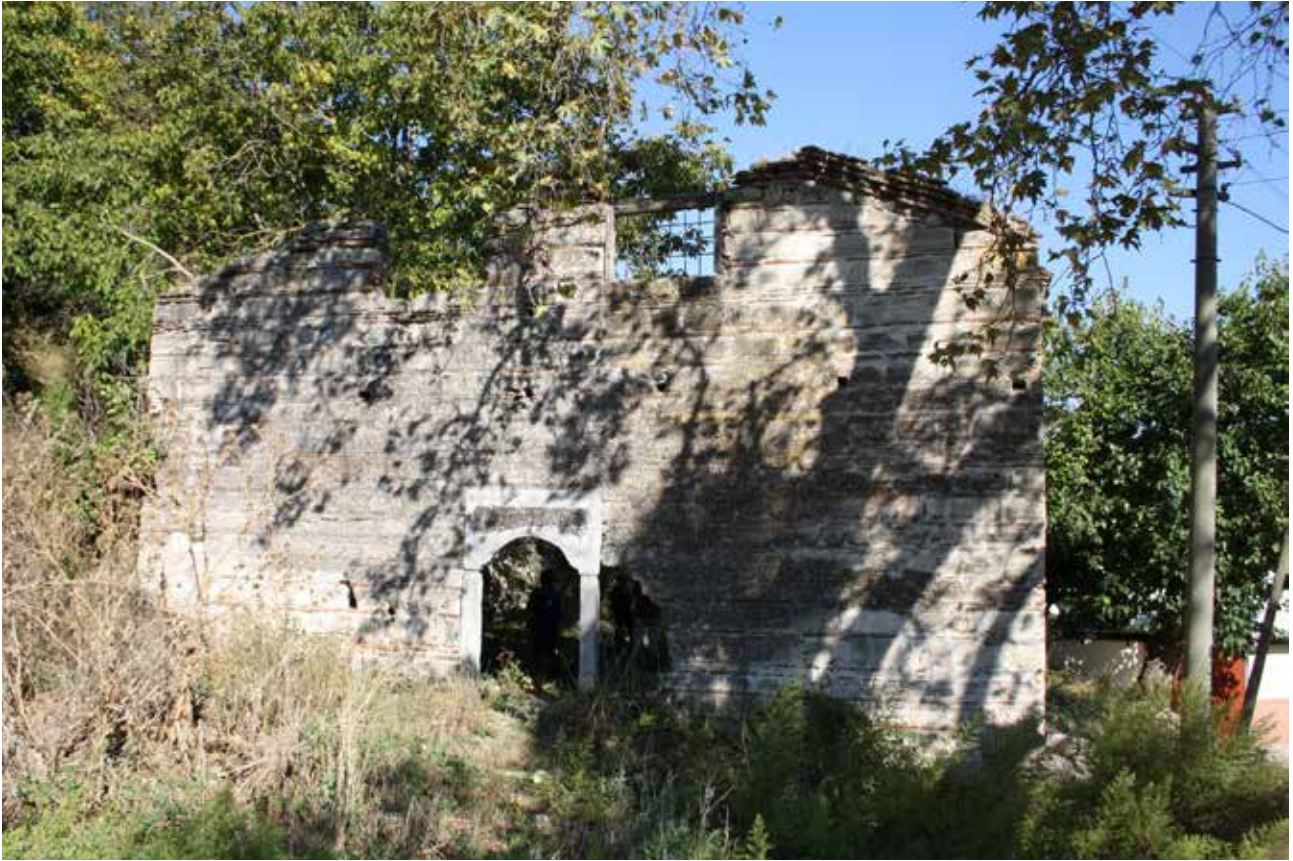
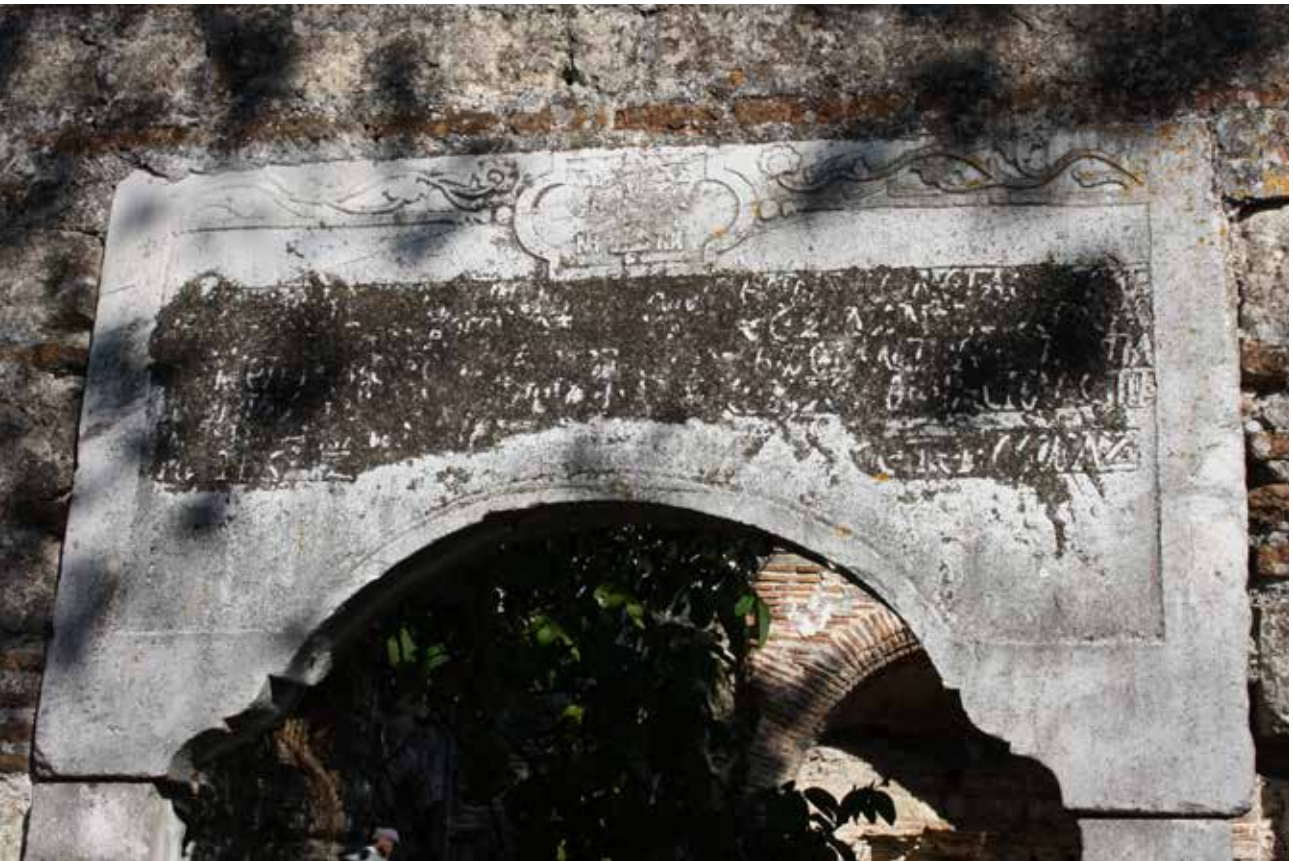
Though there are traces of frescos in the apse and niches, no details may be discerned. It is understood that the interior was plastered with profiled moldings adding movement to the windows and doors. Rounded arches and pediments above the windows are brick-laid. The windows had jambs, lintels and sills of cut stone with, knotted iron grills. These features are clearly visible in two windows on the northern façade.

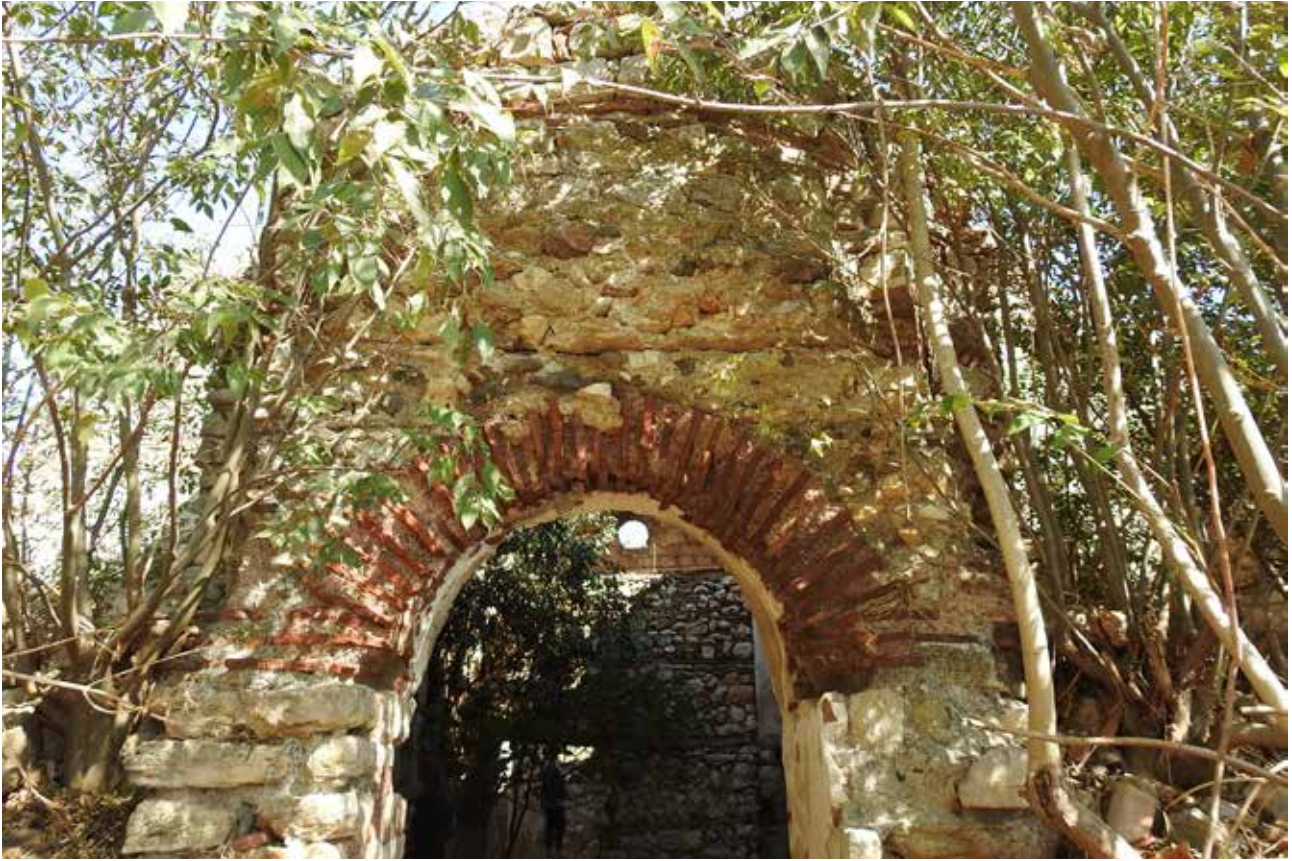
found. In the 20th century an additional floor with wooden support was added within the northern arm of the cross. The floor is covered with rubble, soil and collapsed material. The roofs of the corner rooms and narthex and a large portion of the walls have collapsed. The dome has collapsed; however, the semi-domes above the apses are still standing.

There are pits dug by treasure hunters in the floor. A large portion of the mortar has fallen off the walls, and has caused structural weakening. The layout is mostly discernible, but accessing certain areas is impossible due to destruction and plants growing in the interior. After the structure is excavated as necessary, the characteristics of the interior will be revealed more clearly. Its location on a privately-owned island makes access very difficult.

As previously stated, the different quality marble samples encountered in the monastery indicate it was an important place in its day. Furthermore, Mango (1979, 333) has stated that the eastern and western apse design in this Byzantine church make it a rare example of this type of structure. As a result, the structure has very special importance in terms of architectural heritage. It must be taken under protection immediately, cleared out and cleaned up, with all additions removed and the structure restored. Studies conducted should include the whole monastery complex and not just the church. Considering the cultural identity and history of Gölyazı village, under which the island is registered, the work to be conducted here may be related to other restoration works in the village. It may thus be made part of a holistic restoration project that shall reveal its past ethnic and religious structure. In recent

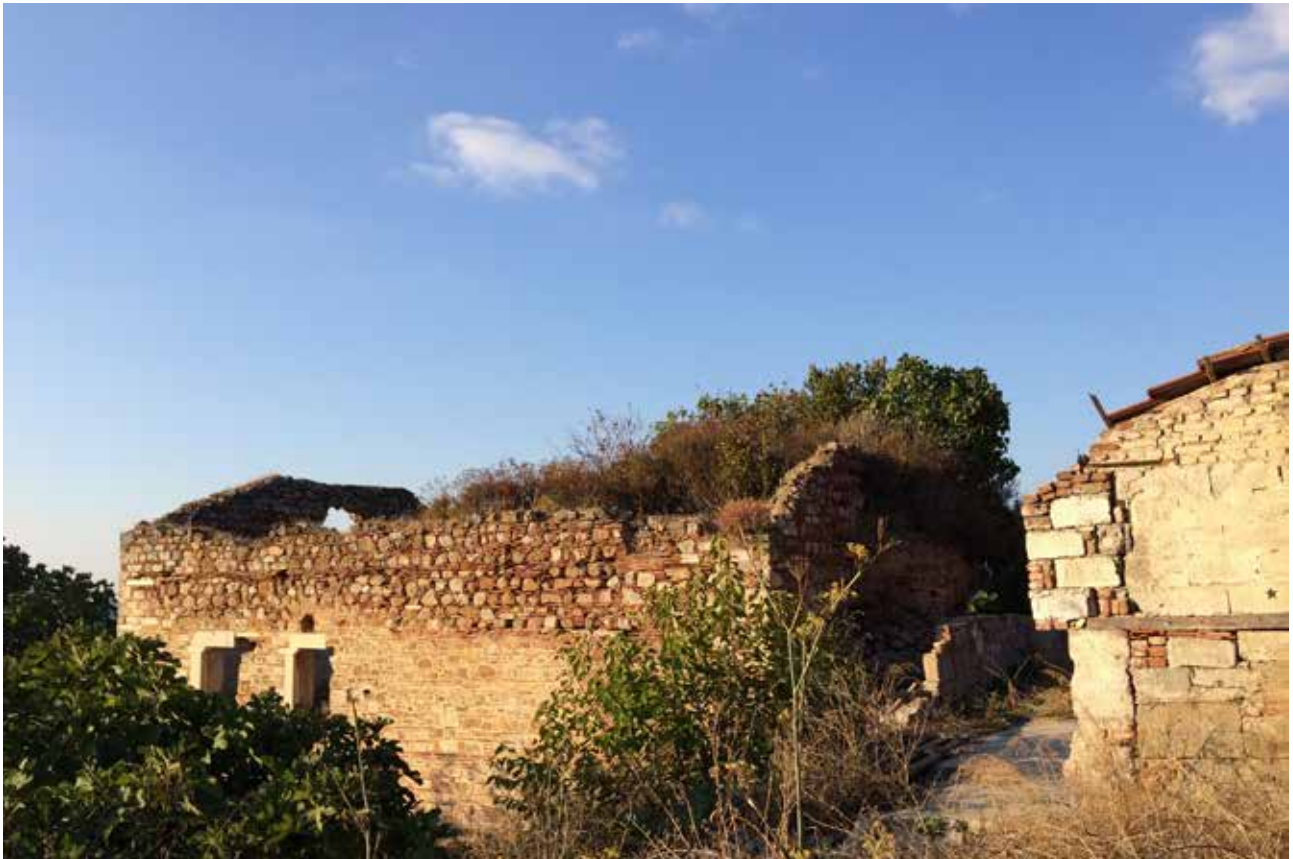
cross-in-square plan that is still discernible. There are only traces of a narthex on the western outer wall and the room accessed through the northern wall is no longer present. The roof of the church is gone, and the interior is filled with soil. A fig tree is growing in the northern wall causing damage. Apart from the central window in the apse, all the windows have been bricked up. Some of the wooden beams in the walls are rotting and decaying. The brick arch of the window above the door in the western wall is broken. Some of the interior moldings in the east have broken and fallen off.

There is abrasion of stone and brick material, and the mortar has lost its binding ability. The mortar is completely missing from the upper levels of the walls. Due to natural forces and illegal excavations, the architectural characteristics of the structure are being rapidly destroyed.

Tirilye was an important religious center in the Byzantine period, housing the Monastery of Saint Ioannes Theologos Pelekitis. One of the serious topics of discussion regarding Byzantine architecture is the origin of the Greek cross-in-square plan and its first application. This monastery church is important as it may shed light on this issue. The monastery is important enough to merit monographic research (Pekak, 1995, 296). The church is rapidly decaying and its architectural fabric requires emergency preservation measures. Natural forces, along with vandalism and the use of the monastery area as a stable, have caused destruction. Understanding the structures around the church requires Archaeological excavation. Existing architectural projects of the site must be updated and work begun on the church, along with the placement of direction and information panels in the area.

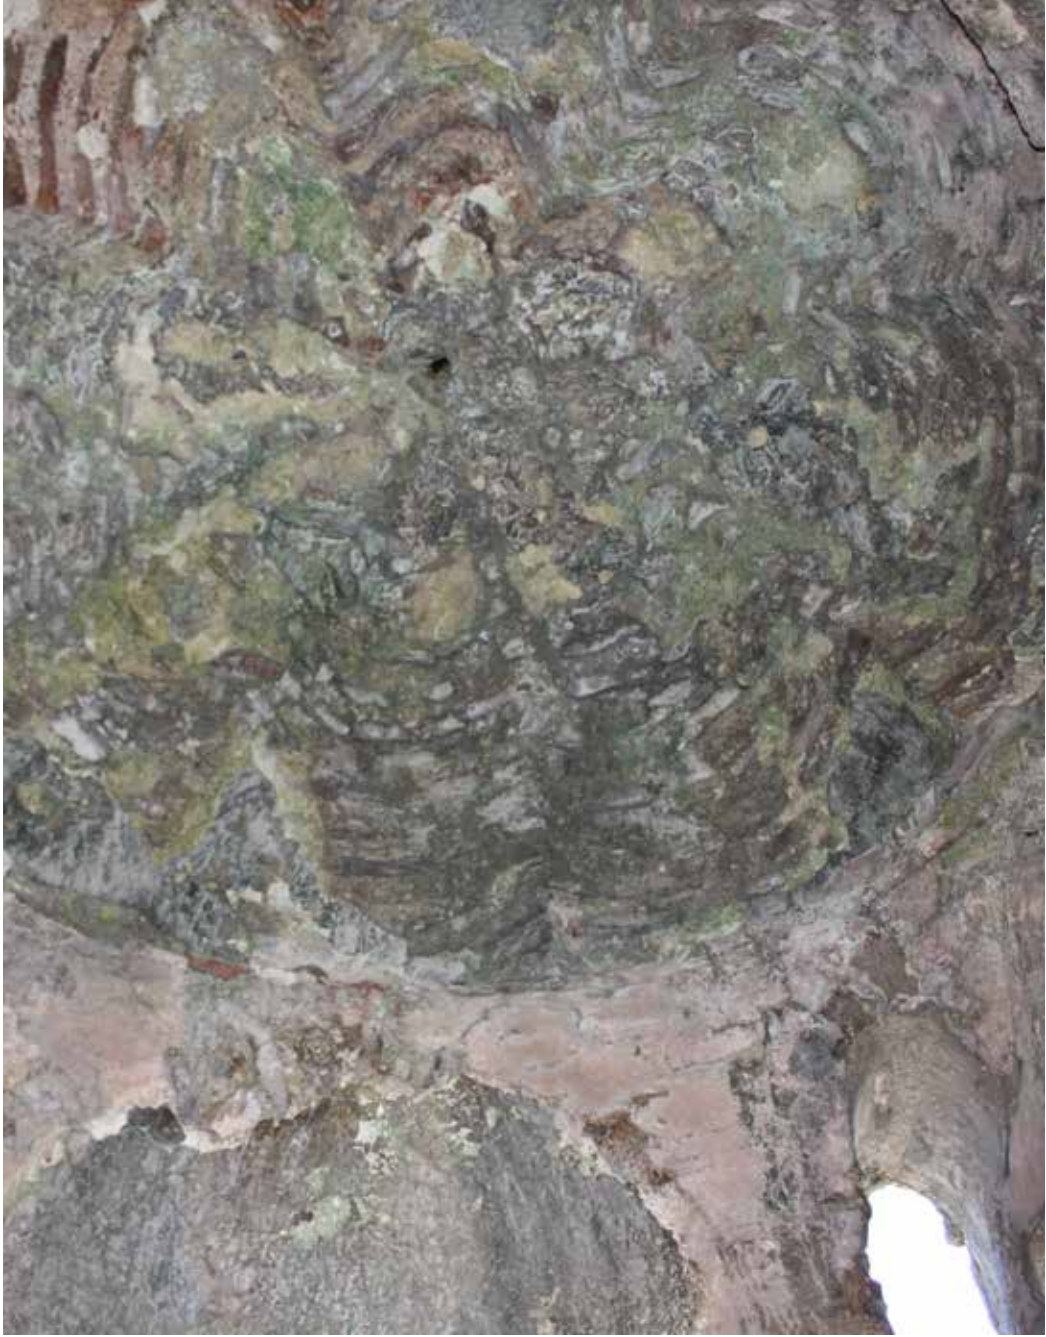
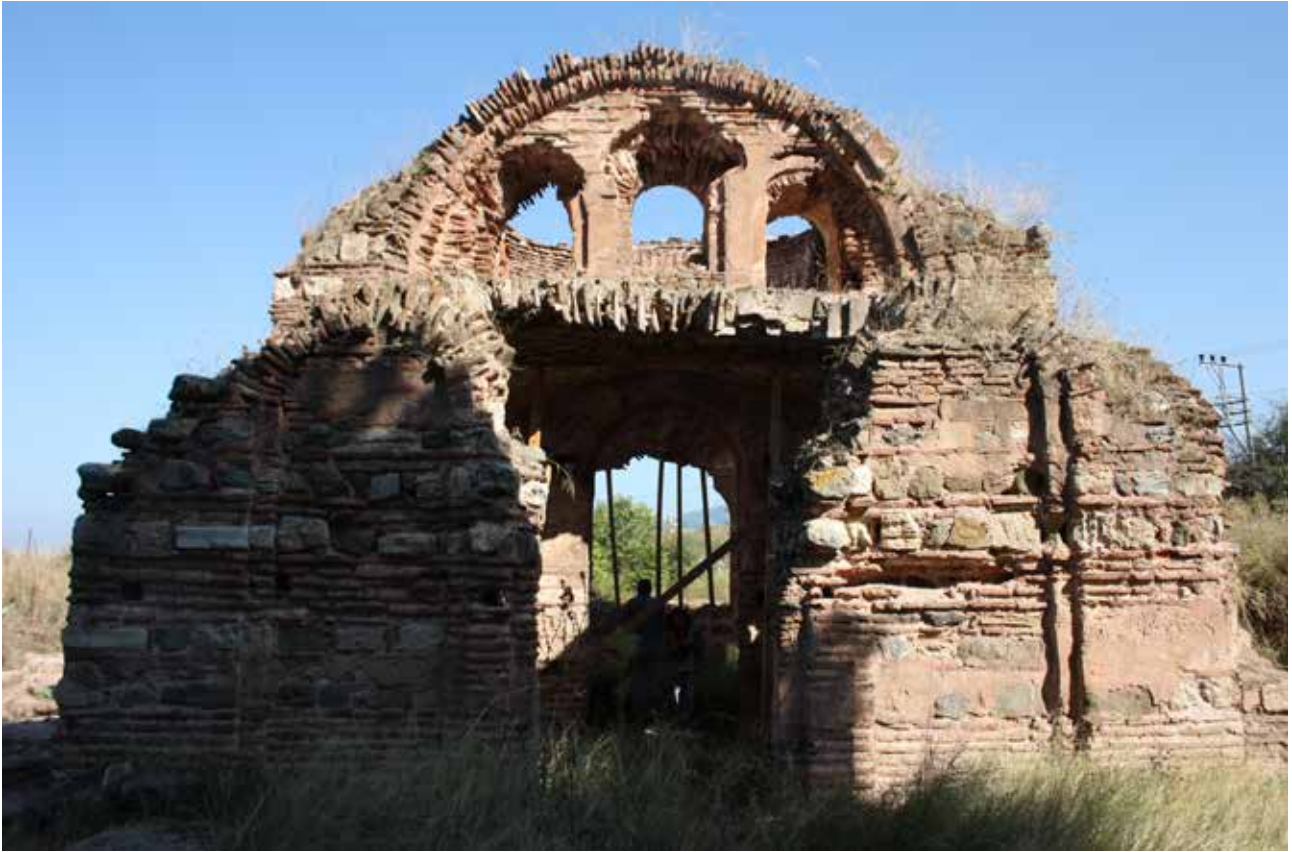
*Church of Saint Averkios
Gemlik county, Kurşunlu neighborhood, Çatal locale*

The church and structures belonging to the monastery are bounded by the Gemlik-Mudanya road to the south, by the Marmara Sea to the north, by residential structures and gardens to the west and by a lot containing a variety of inappropriate structures to the east. Currently not in use, the structure and remains of the monastery complex are surrounded by a fence. It is known that the whole structure was covered in frescos in 1956 (Mango, 1968, 172); however, currently very little of this is left. Many of the remains documented by Mango's photographs in 1968 no longer exist. An examination in 2010 revealed that the roof of the narthex was about to collapse. In 2015 the Ministry of Culture completed partial repairs to the structure, with excavations in areas belonging to the monastery; however the original brick material from the collapsed section of narthex has been taken away from the site. The dome of the building has not survived, with part of the vault covering the narthex also destroyed. There is surface and material loss in many parts of the structure. The fill between the rubble stone used later on to close off the window openings has deteriorated in various places. There is dense plant cover on the vaults, pendentives and wall surfaces.

Restoration work carried out in 2015 included completing the reinforcement of ruined sections in the structure. However, no precautions were taken to prevent the collapse of the dome of the apse, which has no load-bearing system remaining and only insufficient pillars placed for support. There are also no precautions taken regarding insulation or water drainage in the structure, considering the central dome and roof covering are lost. The vaults, domes, wall sections, and interior of the structure are open to all types of precipitation and damage. If precautionary measures are not taken soon, factors such as the separation of certain parts, the loss of material, etc. along with the extensive plant cover will cause severe damage in a short time period. Additionally, the remains revealed by excavation efforts must be protected from rain, and water drainage must be ensured. The

structural remains and ground pits are open and unprotected. As a result, it is necessary to immediately build a temporary cover for the remains of the monastery to be protected from rain. After a comprehensive restitution and restoration project to prevent future damage the lost parts of the structure may be rebuilt and the building used as a museum. The inappropriately-used eastern lot should be expropriated for public use, and may be made part of the museum. The Monastery of Saint Averkios and catholicon, which is an important assemblage of Byzantine structures, must be opened to visitors in order to contribute to the promotion of the region as well as Turkey, allowing this cultural heritage to be passed on to future generations.
