Kayseri
Adana
Izmir
Elazığ
Niğde
Bursa

Assessment Report of Architectural Cultural Heritage

April 2018

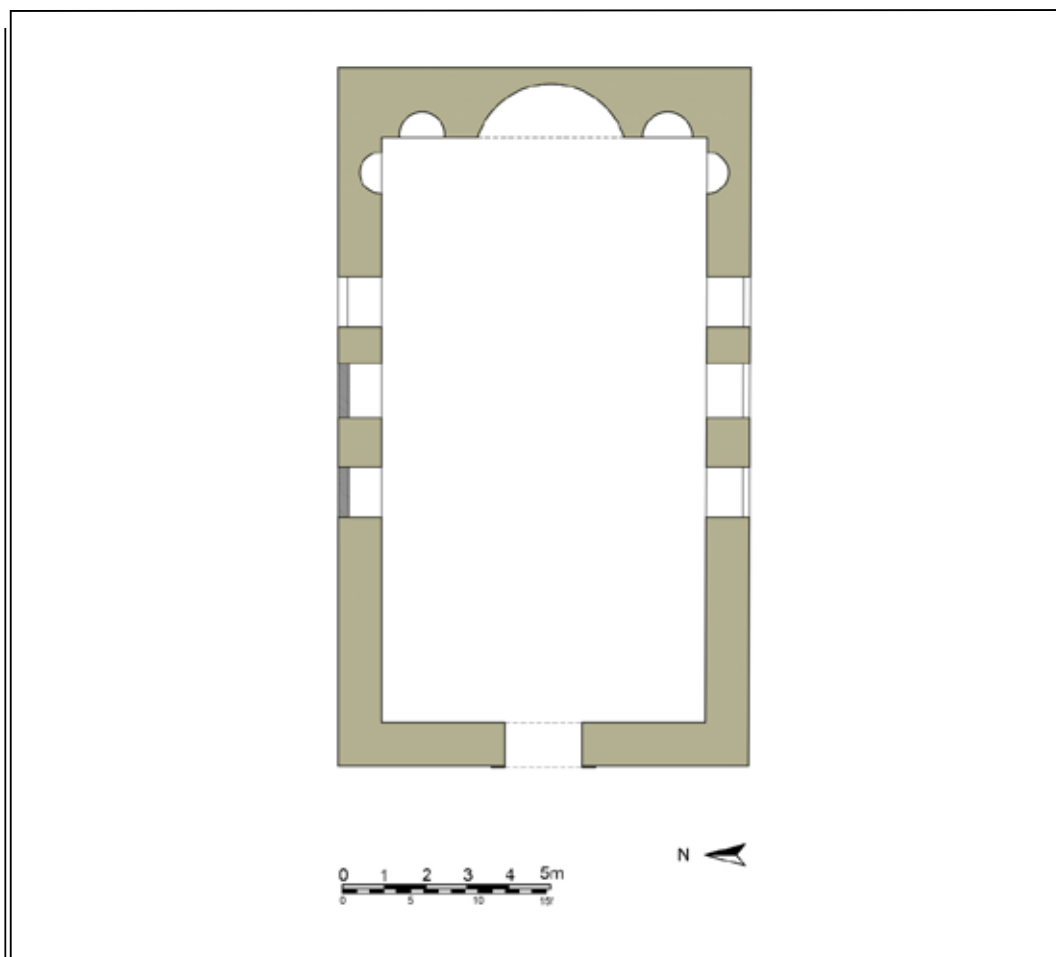
The entrance door of the church was filled in and closed off, with the marble jamb broken and very little of it remaining. On the southern side of the original door, the wall was broken to create a later entrance. The apse projection was completely demolished, with the opening filled in with rubble stone and space for a door and two windows left open in this fill. Currently the brick arch of the apse is observed from the eastern external façade. Mortar pointing using inappropriate material has been attempted the eastern and southern façades.

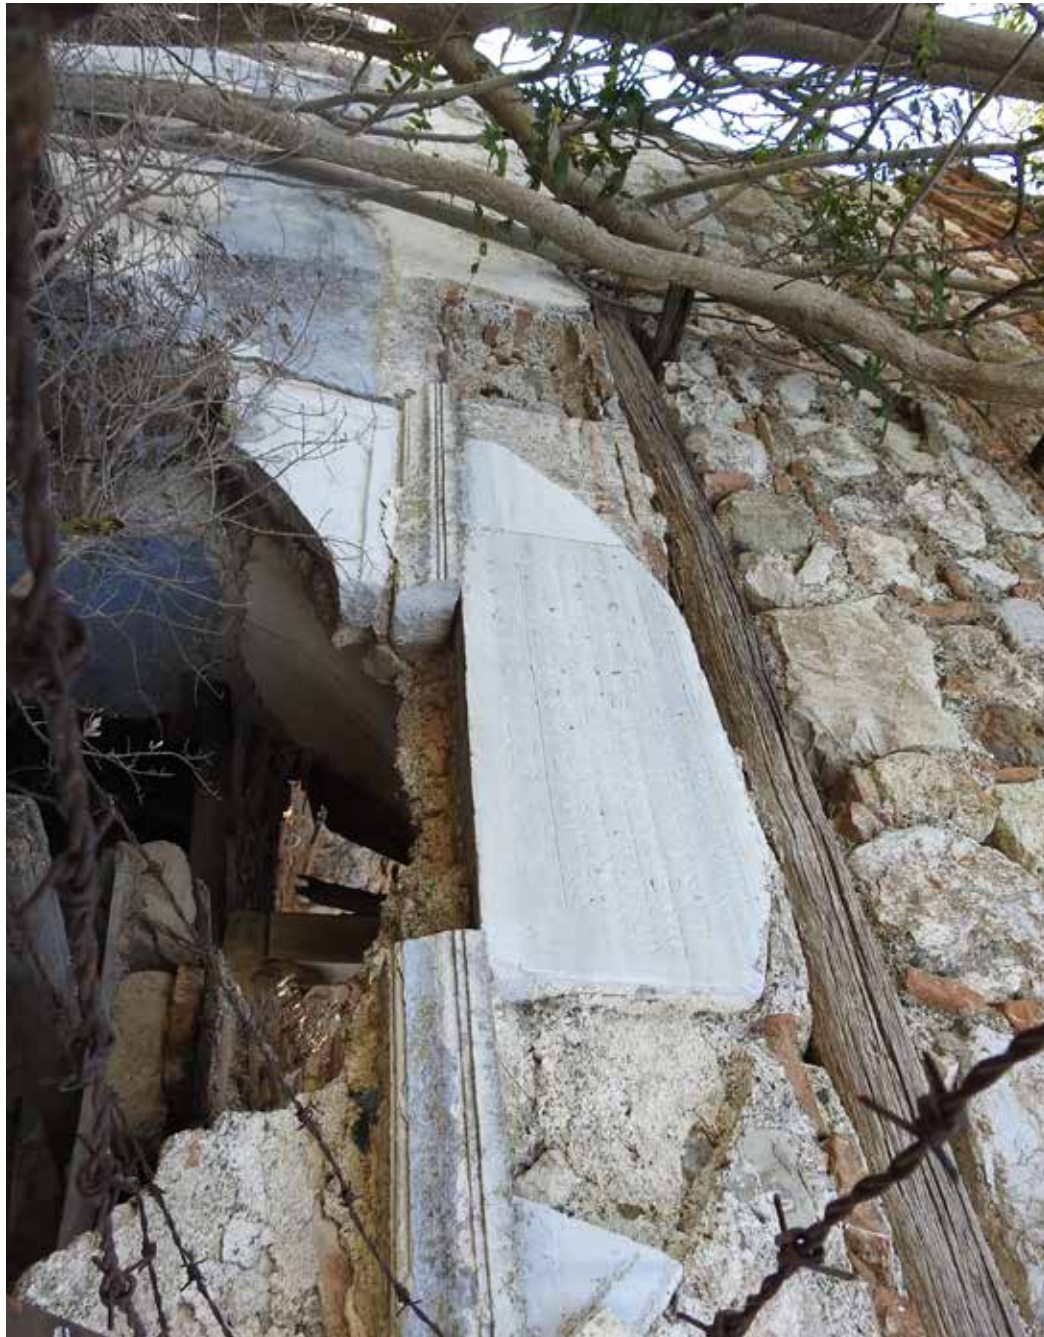
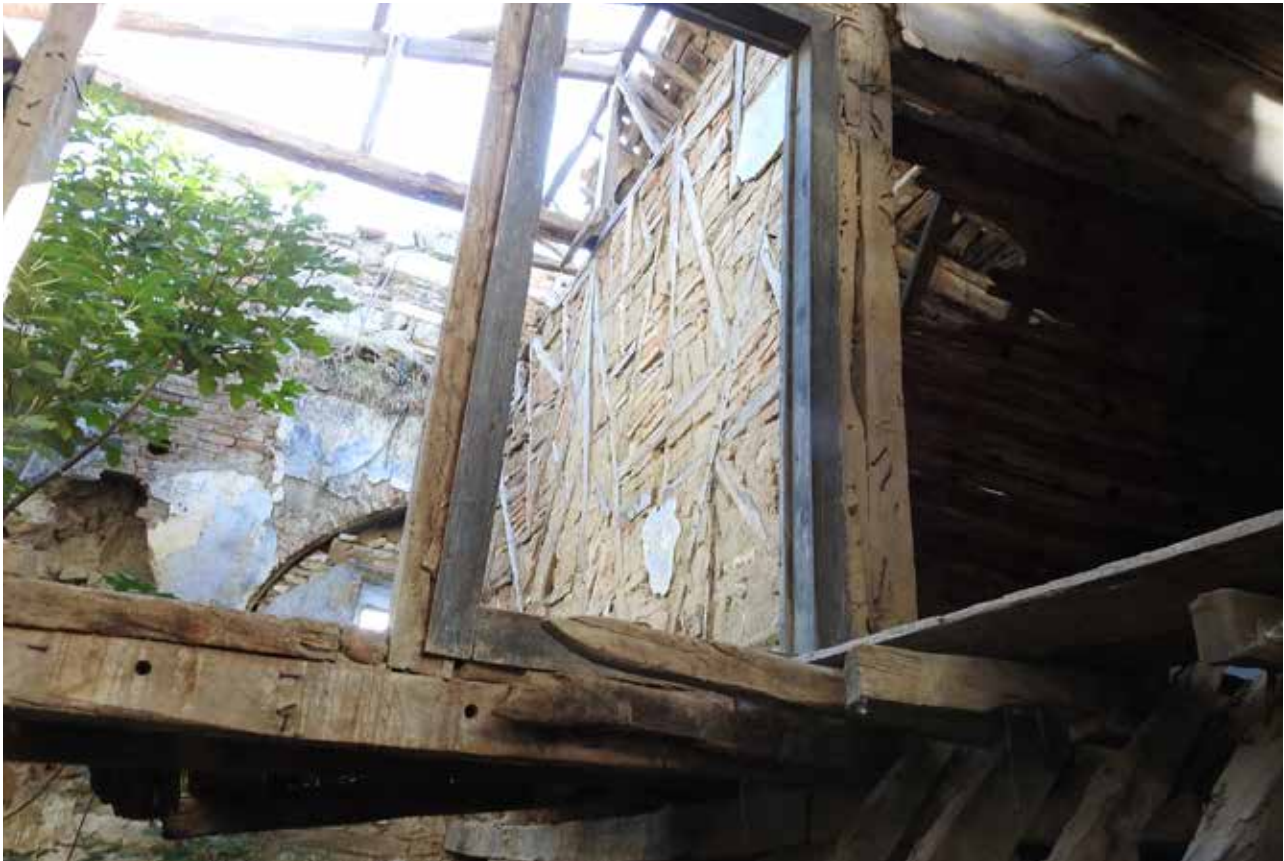
*Church of Archistratigos Michael
Karacabey county, Uluabat village*

More than half of the roof of the church as well as the later interior additions has collapsed, with all of these now filling the floor. Deep pits dug by treasure hunters are also visible. Fig trees are growing in the interior damaging the foundations. Due to precipitation, the plaster is flaking, surface erosion is observed and moss grows due to dampness.

is open to vandalism. Illegal excavations within the building with the aim of finding treasure have caused destruction to the flooring. The greatest danger to the building at the moment is the risk of increased destruction due to natural causes or human depredation. Snow and rain entering through damaged portions of the roof have increased the dampness problem within, causing damage to structural material. The structure is in the process of collapsing and, as all of its architectural elements are open to the effects of the wind and rain, its rate of destruction is rapidly increasing. The church has no information panel and no visitors other than those who already know about it. Environmental as well as human factors endangering the structure should be brought under control with entrance from the doors

and windows prevented and roof repairs made using material and techniques appropriate to the original. Additionally, all later additions and sections in the structure should be cleaned and cleared out, and the walls repaired and reinforced. The foundations of the apse should be determined by excavations to the east of the structure, to obtain information about its original shape. The apse may be rebuilt on condition that appropriate material and methods are used.

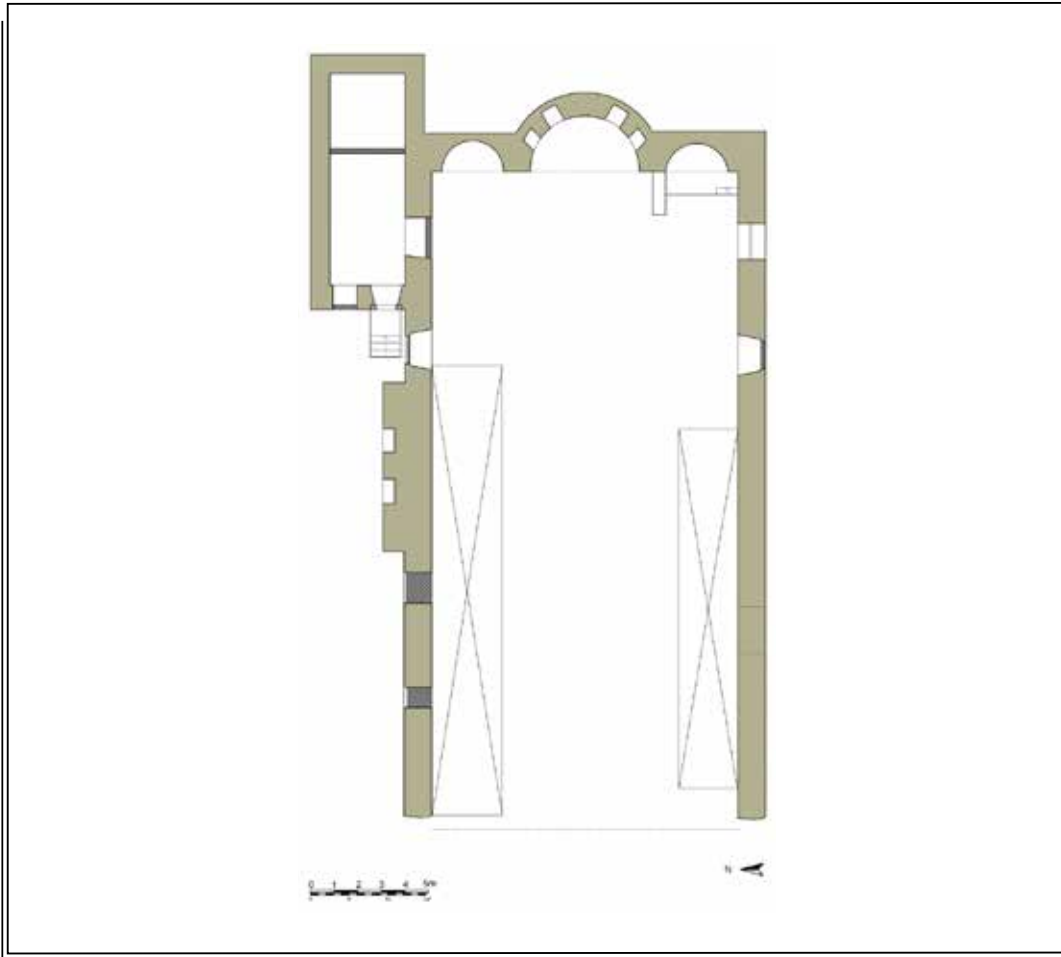
The plan is discernible and the spatial characteristics distinguishable. Apart from the eastern wall, the door and window openings and iron grills in the windows, the original characteristics have been destroyed. The western wall is completely gone. The arched window in the northern wall has been partially bricked up, and two windows with projecting stone jambs closed off and broken. The southern wall cannot

be accessed at present due to other constructions. The door allowing access to the main church from the southern wall of the chapel is closed off. There is plant cover on the remaining walls. The mortar has disintegrated and efflorescence is observed on the wall surfaces. The structure is in bad condition with later annexes and collapsed sections.

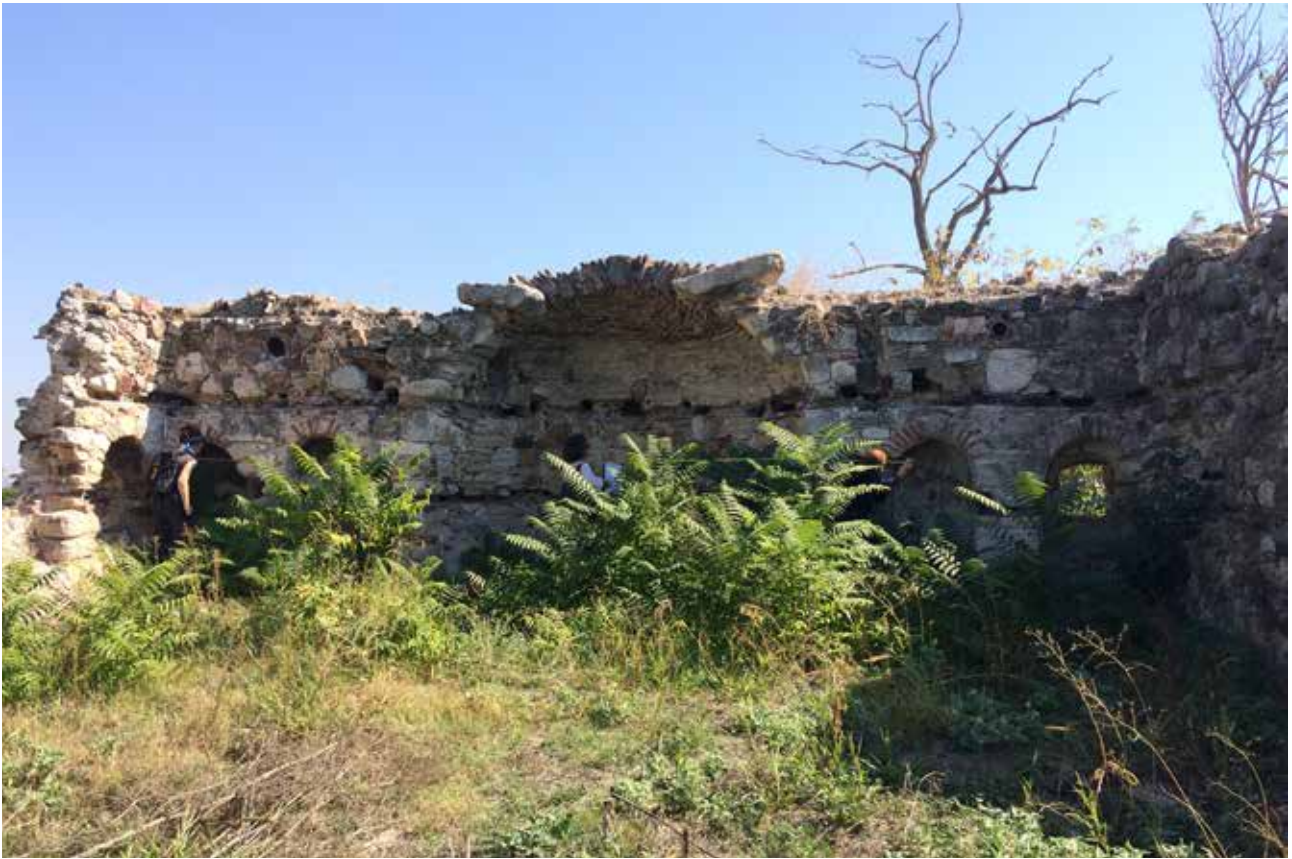
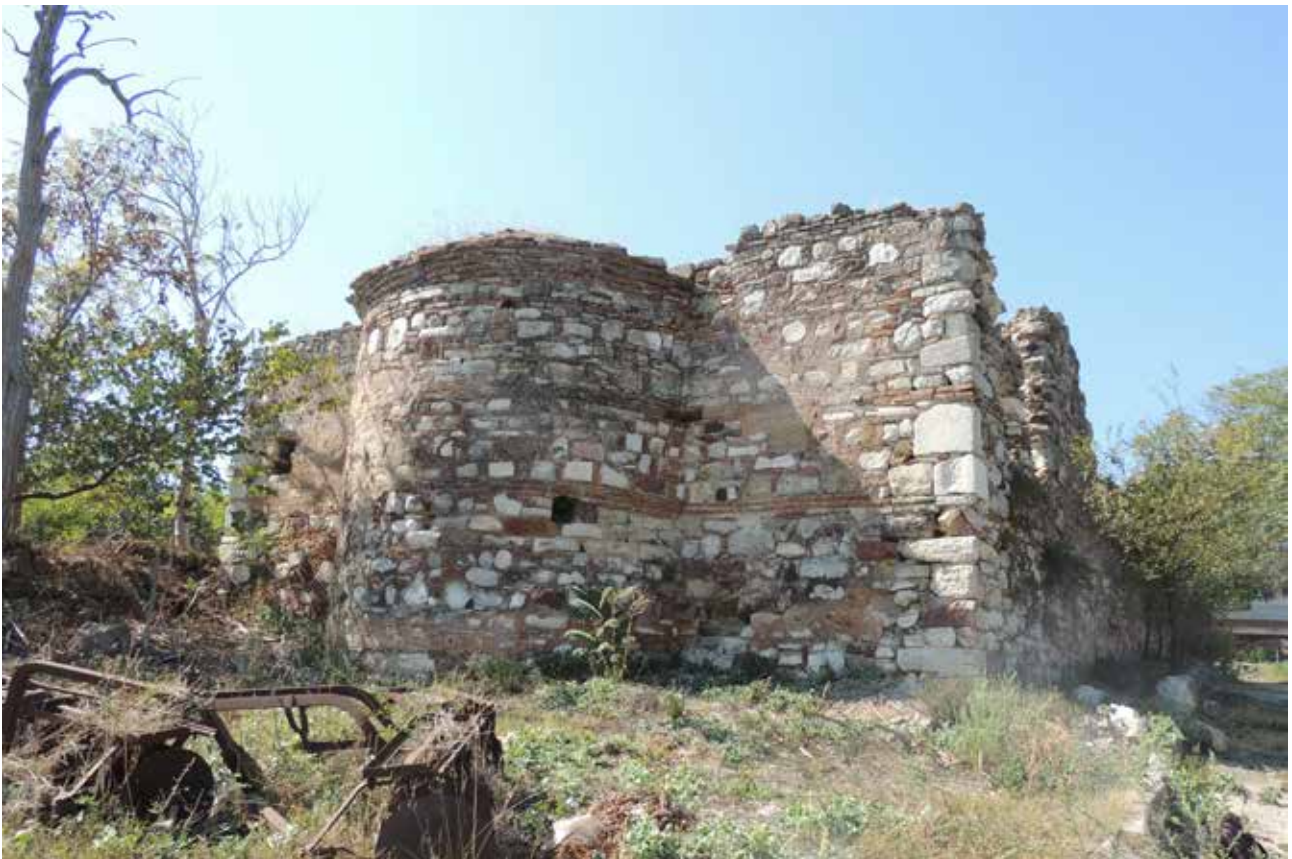
The external walls of the church (especially the northeastern and northwestern façades) have large-scale material loss. Different column pieces are scattered around the ground. The ground also

contains pits dug by treasure hunters. The large scale of the destruction that has taken place in the structure and the lack of any inscription make it difficult to determine the age of the building. It is completely open to human and natural depredation, and its structural integrity is in danger.

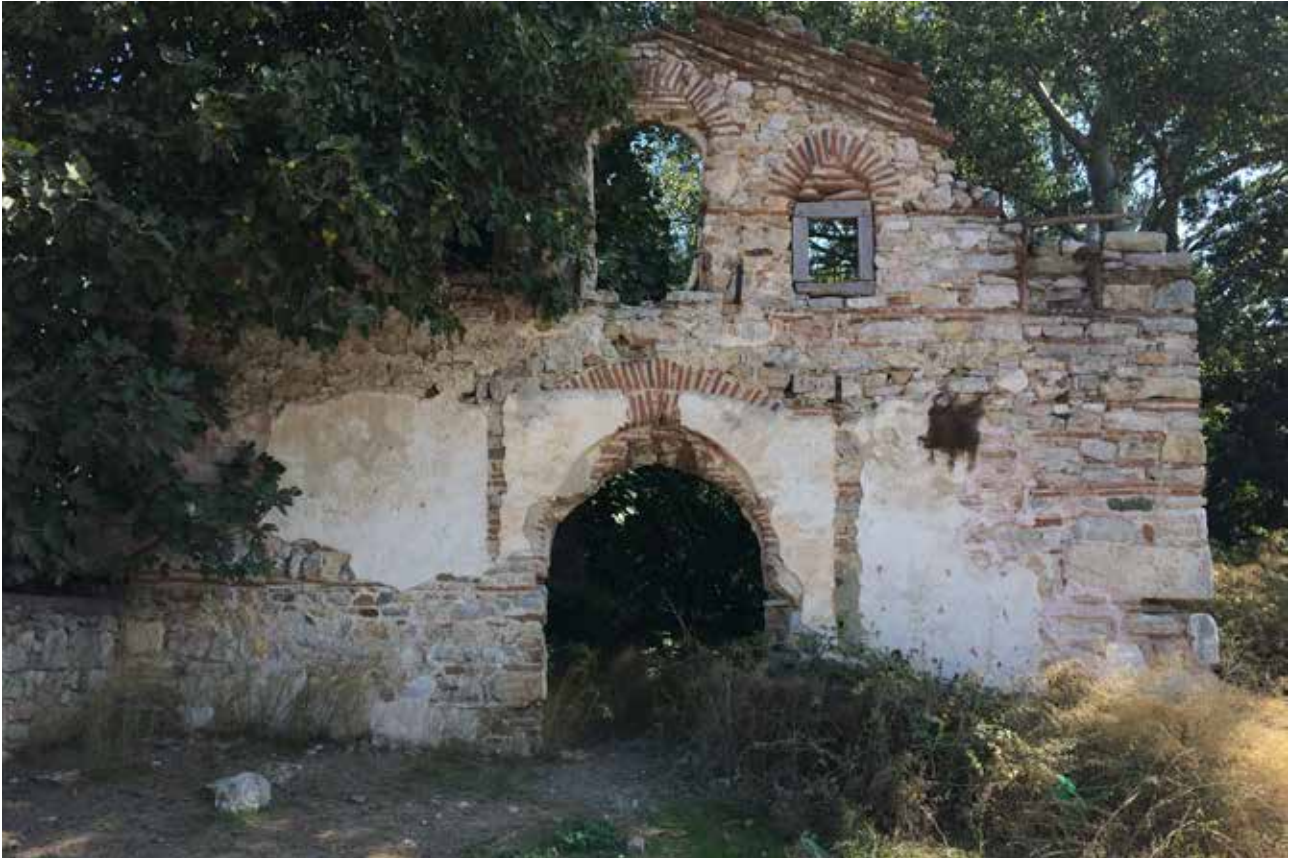
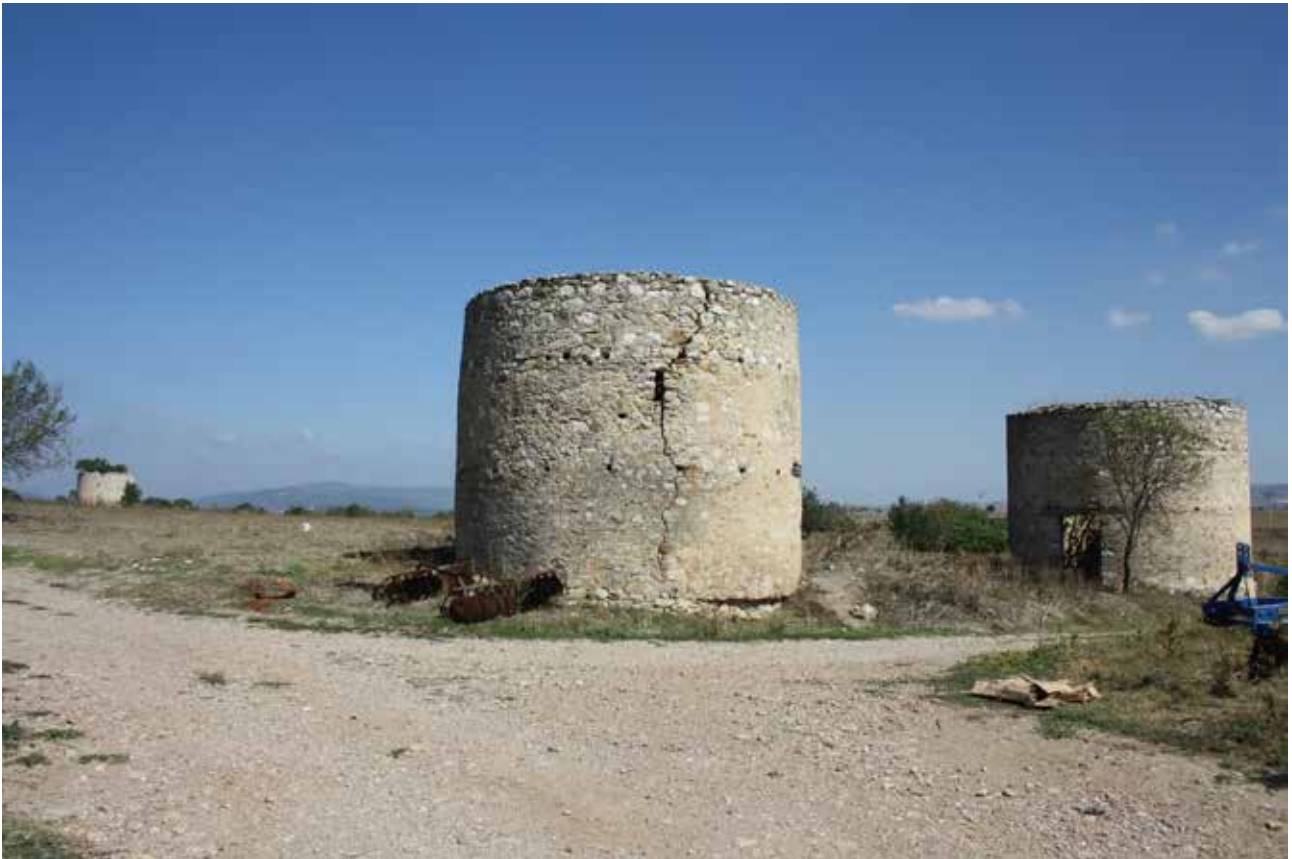
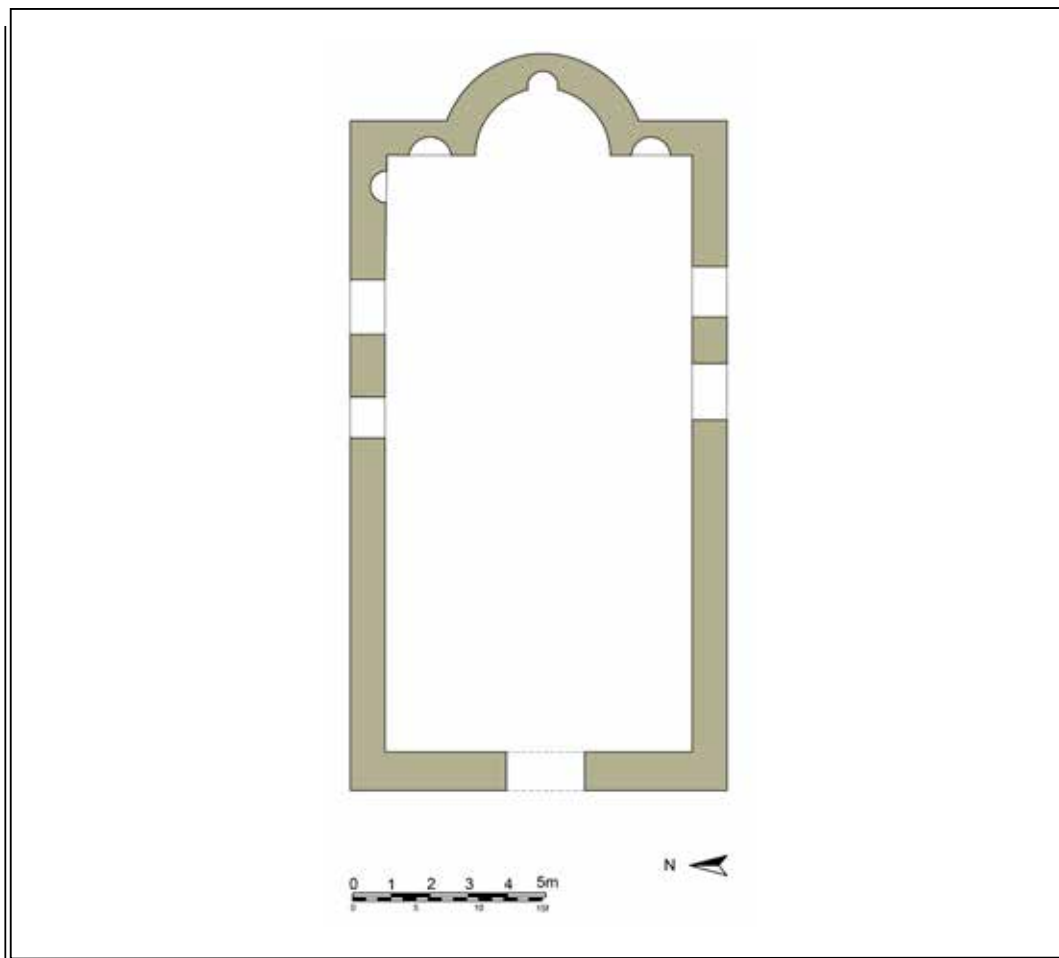
The brick semi-dome above the apse in the east has mostly collapsed. As the roof has not survived, the walls have also begun to collapse. The mortar is mainly lost. In addition to dense plant cover within and around the building, it has been used as a rubbish dump by villagers and is a danger to public health.

The neglect and ruin observed in the church is also visible in the three windmills nearly 300 m northwest of the structure. Internal and environmental cleaning of both the church and windmills as well as an excavation in order to clarify some of the architectural features of the church must be undertaken. The stabilization of

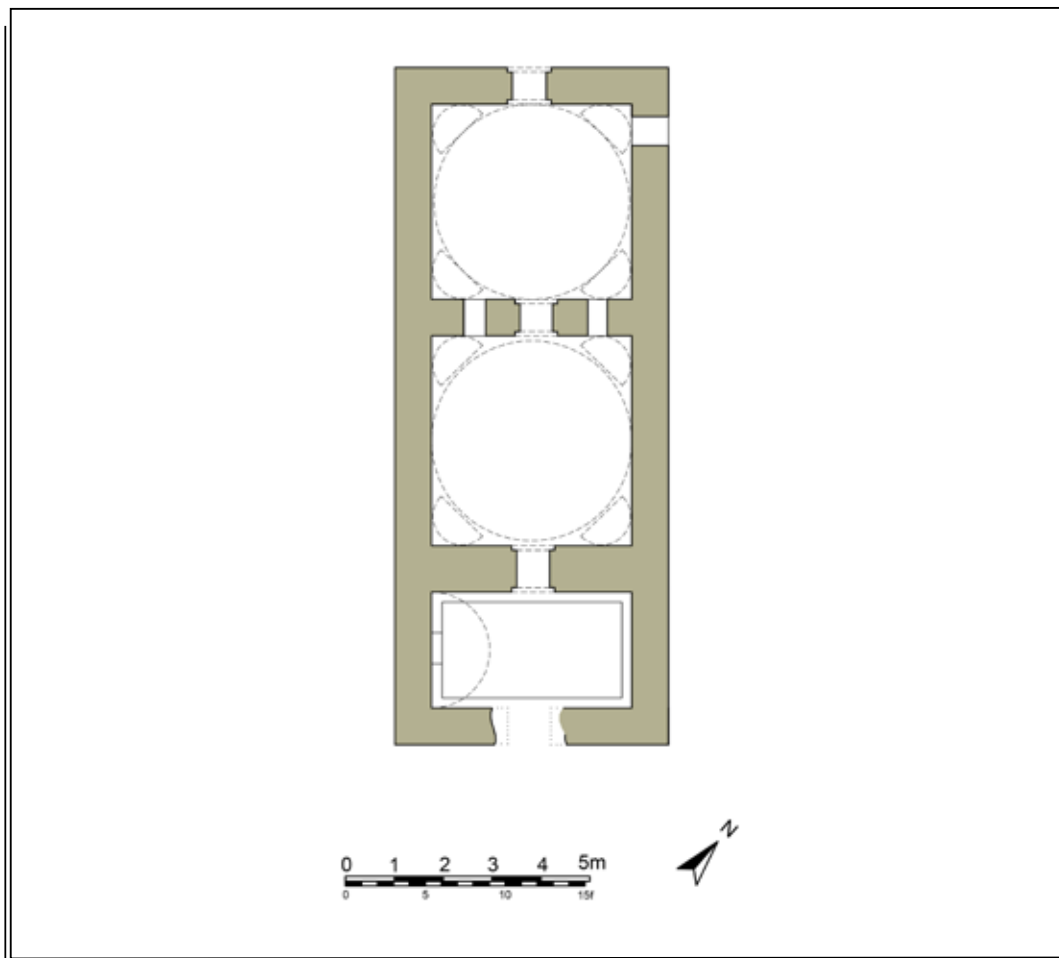
Currently in ruins, the structure is abandoned. There is no door at present, with increasing destruction due to cracks in the southeastern façade and collapse of the roof leaving the structure open to the forces of nature and human destruction. The internal space has damp marks, as well as biological and physical damage. Plaster has fallen off, with further

material loss in various places. The structure is close to a main road and access is easy. There are no information or directional signs relating to the structure. The building is significant, being the only Armenian structure in the village, and its location it provides a significant opportunity for enjoying the view.

and clearing out the soil cover currently burying the northeastern façade, will render all of the façades visible. Additionally, the structure must be preserved and an information panel put in place. In this manner, a restoration project must be developed considering the building along with its surroundings to give it a new function.

The greatest current danger is that the structure is open to natural and human destruction. Structurally in good condition, it is neglected and abandoned. Cleaning the close surroundings, removing later additions (the filling on the floor/the wall on the external façade), eliminating the plant cover on the structure

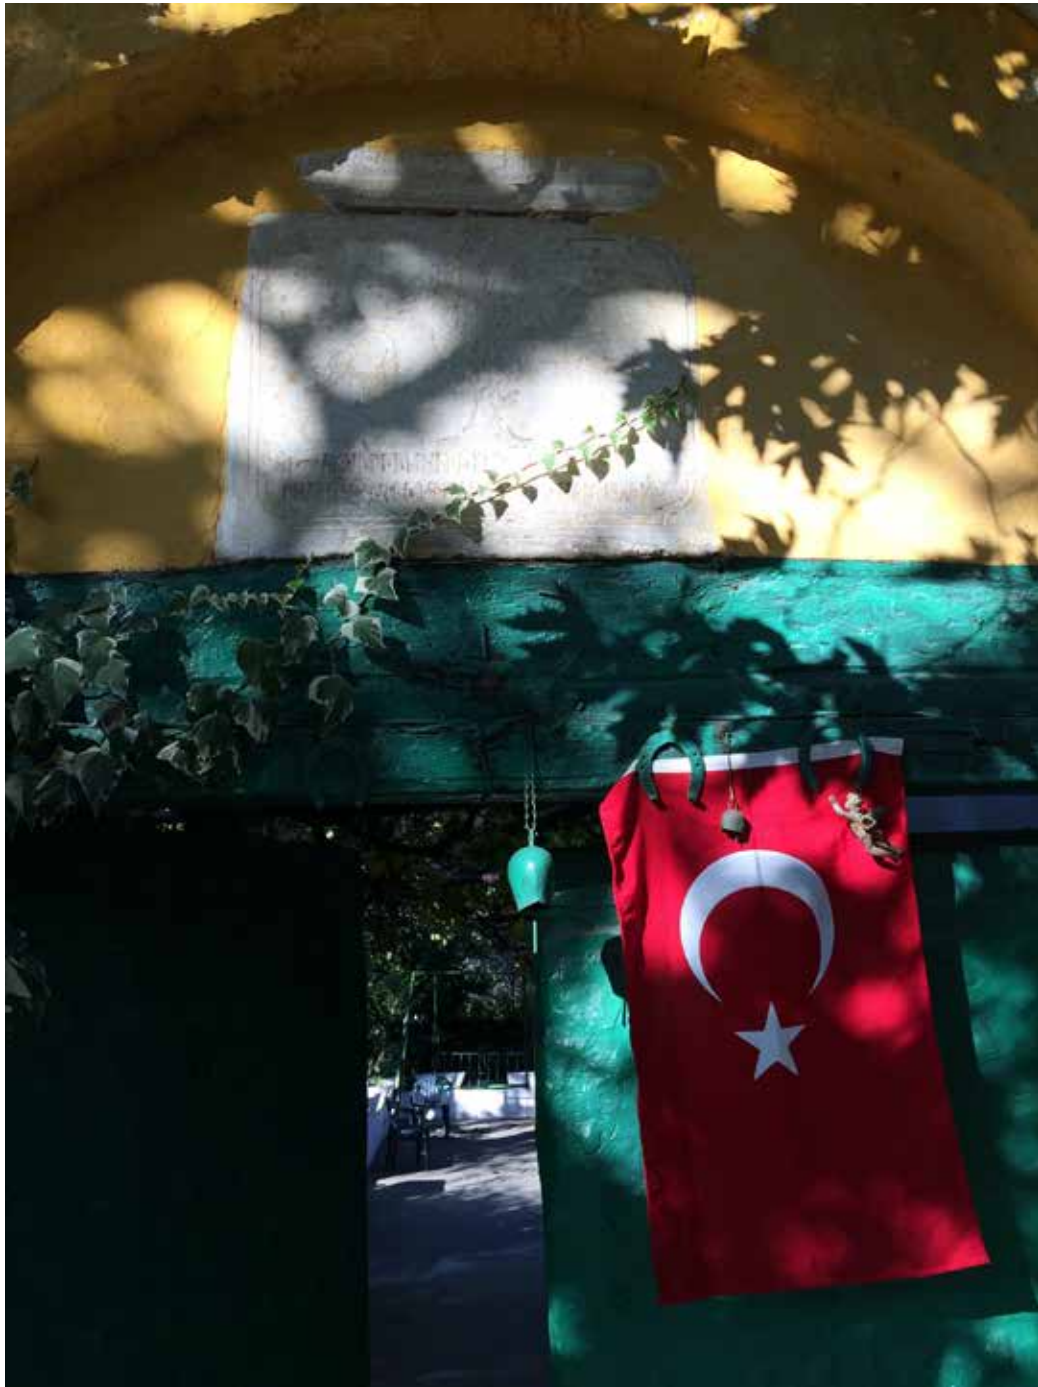
*Medikion Monastery
Mudanya county, Tiriye town*

The monastery itself has not survived to the present; instead the “Aşlar Farm” has been built in its place. Currently, only the wall on both sides of the wooden double door entrance in the west and two inscriptions from the pediment above the door’s arch remains. Photographs taken in 1973 show that the walls and door were not painted. Currently the wall is painted yellow while the door is green. Ivy is growing on the wall. The paint is flaking off, as it is not compatible with the original wall texture.

The wall has no capstone, so rainwater enters it causing damage. At the same time, there are pieces of historical columns lying in the farm garden. On one wall within the farm there is a Turkish-English information panel prepared by the municipality containing many spelling mistakes and missing information.

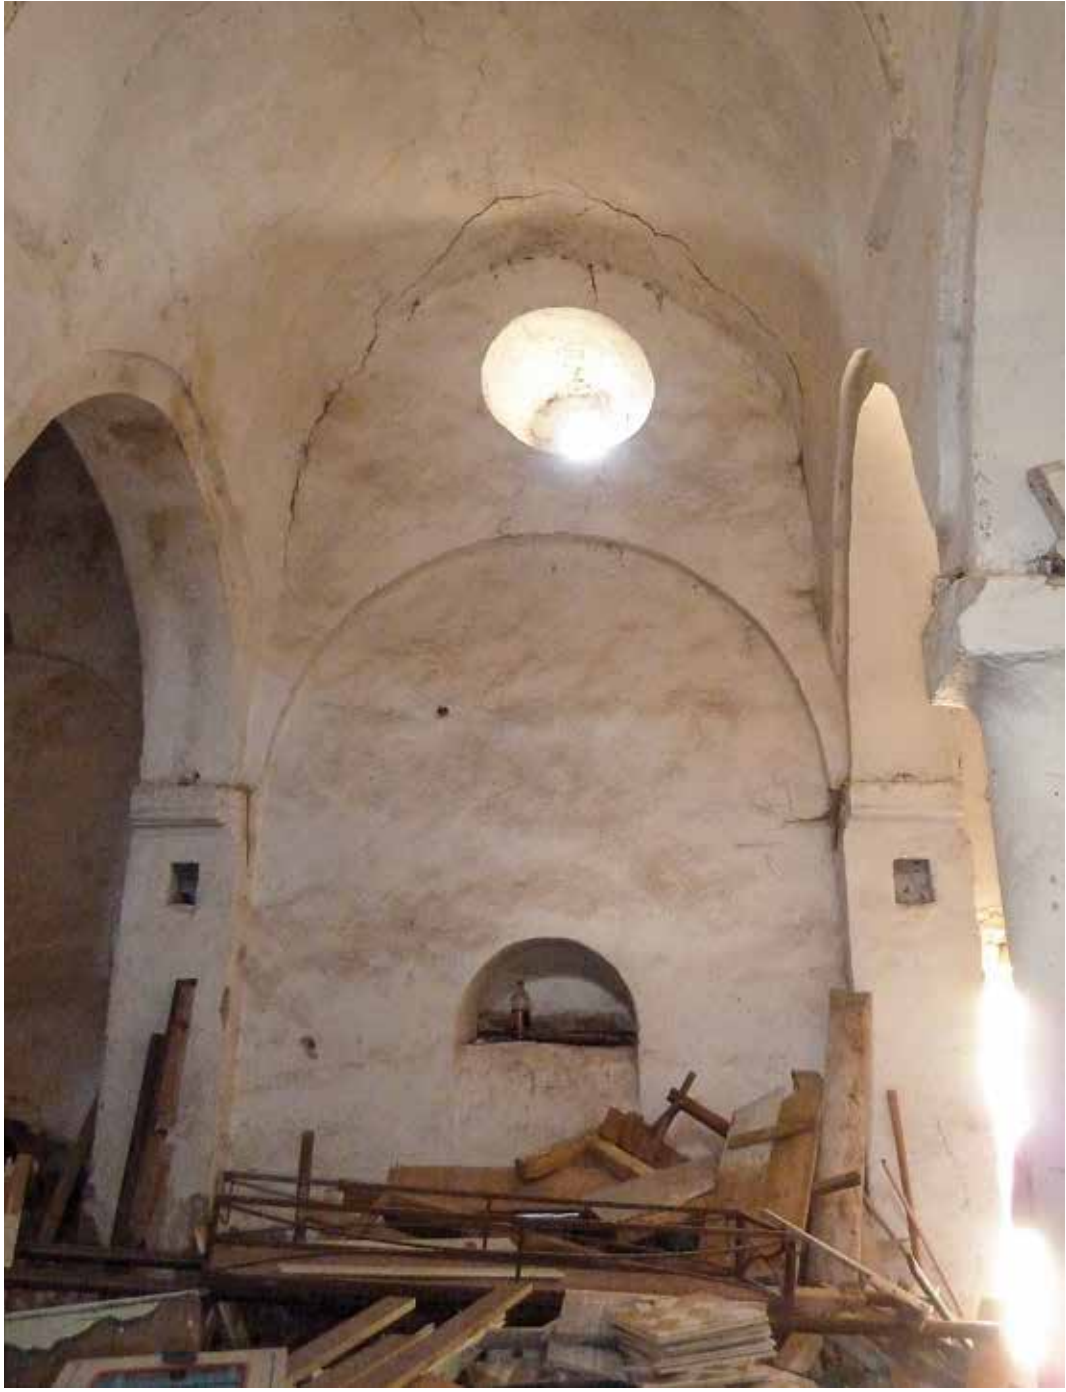
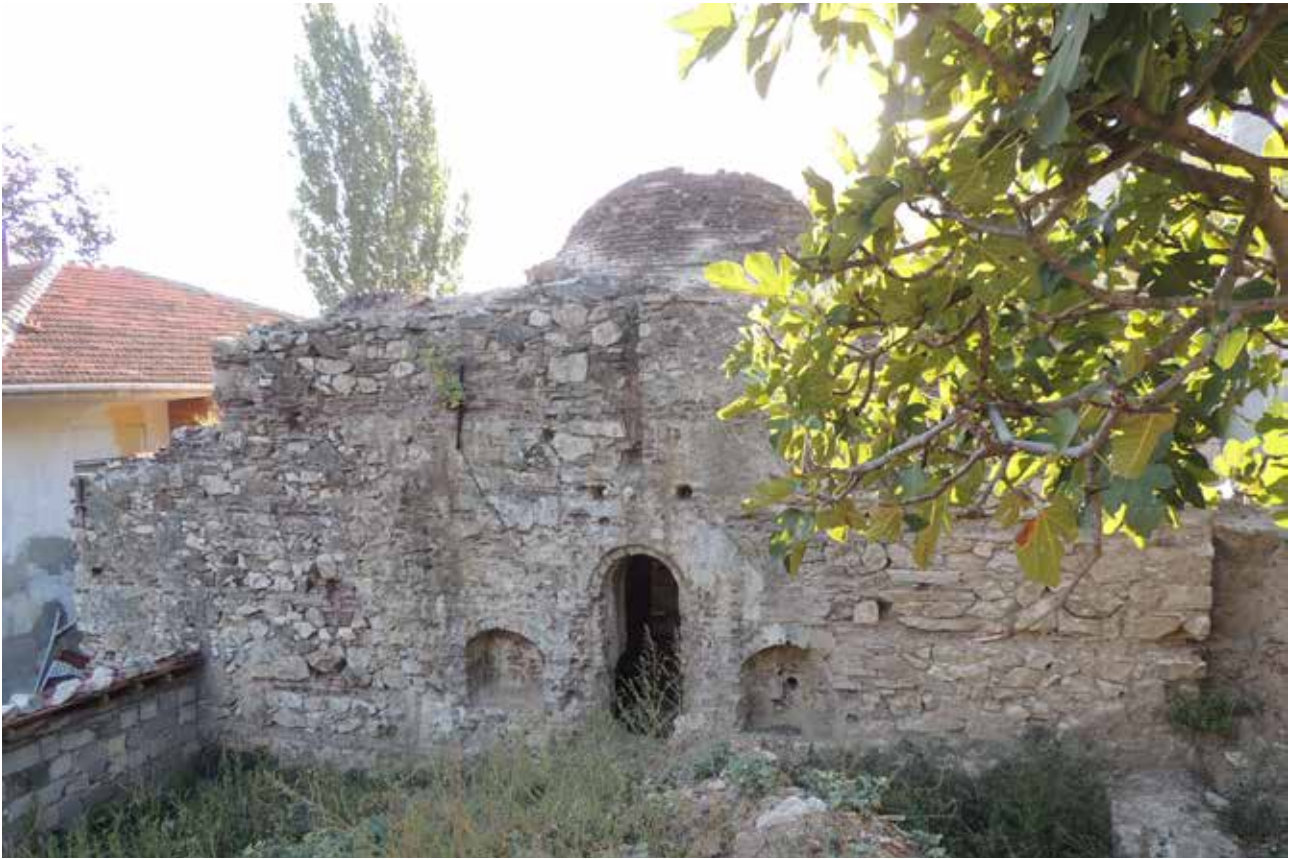
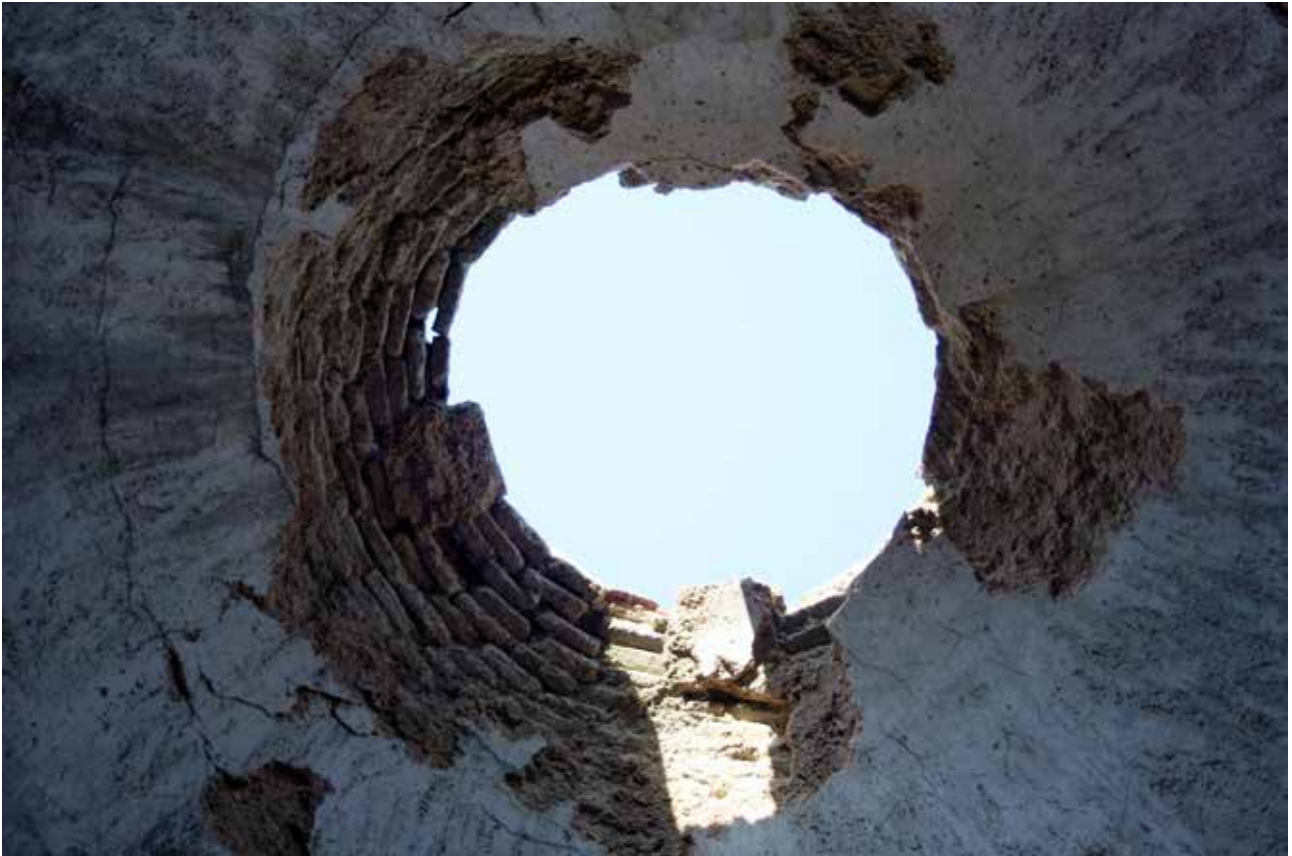
*The Public Bath
Gemlik county, Şahinyurdu village*

Currently, a large portion of the northern façade is buried under soil due to a rise in the road level. The remaining section east of the structure is filled with soil and the floor of the structure is not visible. The structure is in a seriously ruined and neglected state. There is no trace of the changing room and warm sections apart from their foundation walls. The area where these sections were probably located is buried under

soil. The roof of the hot section and secluded cells has partly collapsed. As a result, it is open to destruction by the forces of nature. There is severe disintegration and material loss in the walls and floor due to human depredation. Because of such vandalism, the clay pipes within the walls and the fittings originally underground are open and visible. There is material loss due to vandalism in the walls and floor of the water depot and furnace sections. The annex structure made of concrete blocks situated in the neighboring lot, adjoining onto the eastern façade of the hamam prevents the whole of the façade from being observed. The entire structure is unprotected, increasing the damage suffered due to animal and human activity.

The greatest danger at present is that the structure is completely vulnerable to human and natural depredation. If the surroundings of the building are excavated, traces of the sections predicted to be part of the original plan may be revealed. The structure is significant because it represents a unique example of a certain layout. It must be cleaned, preserved and an information panel put in place. Apart from the hamam, the village contains the remains of an Armenian church. Thus all measures taken must be considered as a whole. After restoration, the hamam could be repurposed and opened to the use of the village population or preserved as it is for tourism.
