## ELAZIĞ SITE ASSESSMENT VISIT

Dates: May 28-June 3, 2016

# KHULEVANK MONASTERY CHURCH OF SAINT GEORGE | SURP KEVORK

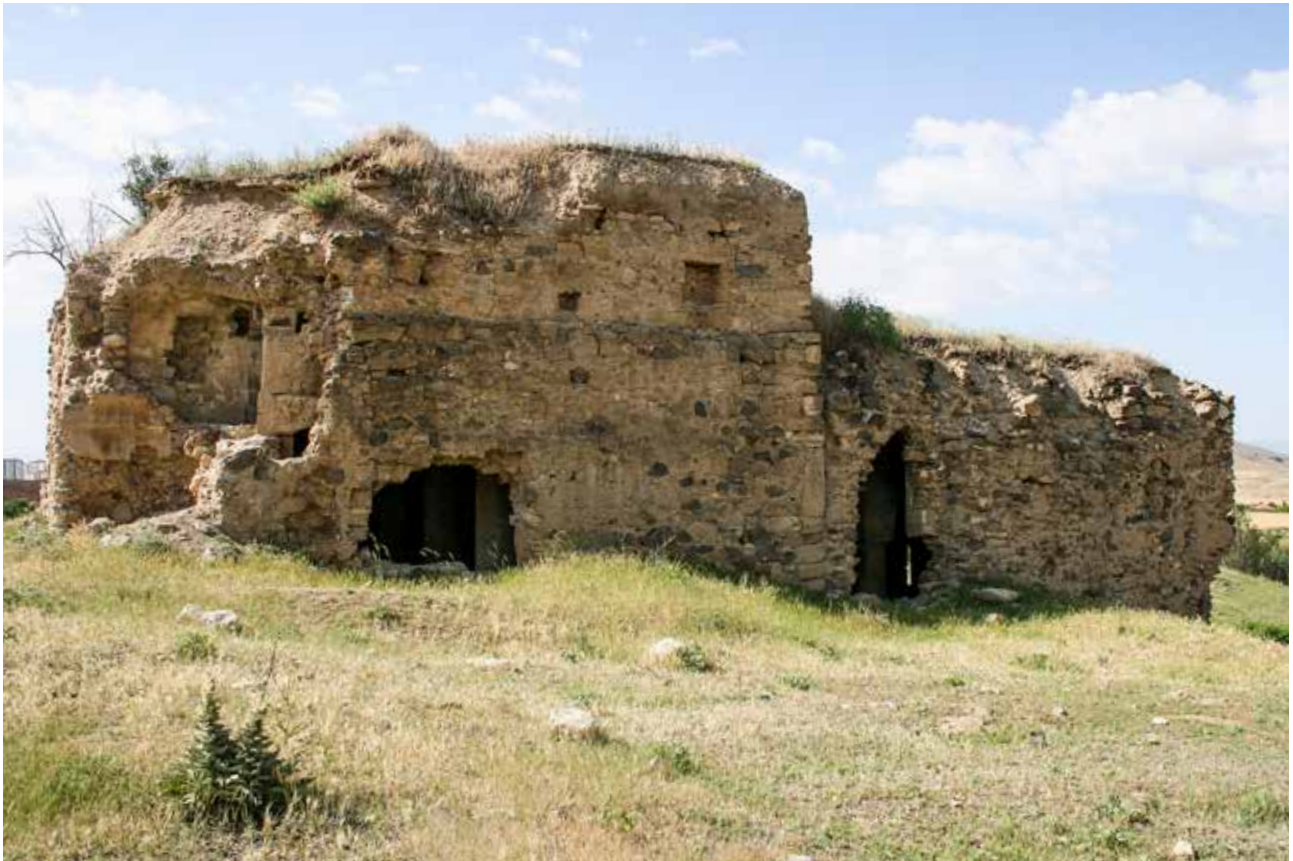
The first section in the church is formed of the apse and two columns in the center with an east-west axis arch; while in an eastern direction there is a nave section with a spherical dome rising above a square drum with corner pendentives. In the side naves of the main church, there are traces of stairs for access to a gallery floor, suggesting it had two floors. Additionally, there is an access to the sepulcher. The second section includes a doorway in the south façade allowing access to the building and a jamatun section with four supporting columns.

The jamatun has a rectangular plan with a construction technique, the same as the church. The masonry walls of the church are rubble limestone joined with mortar. The internal surface of the wall is covered with thick lime plaster.

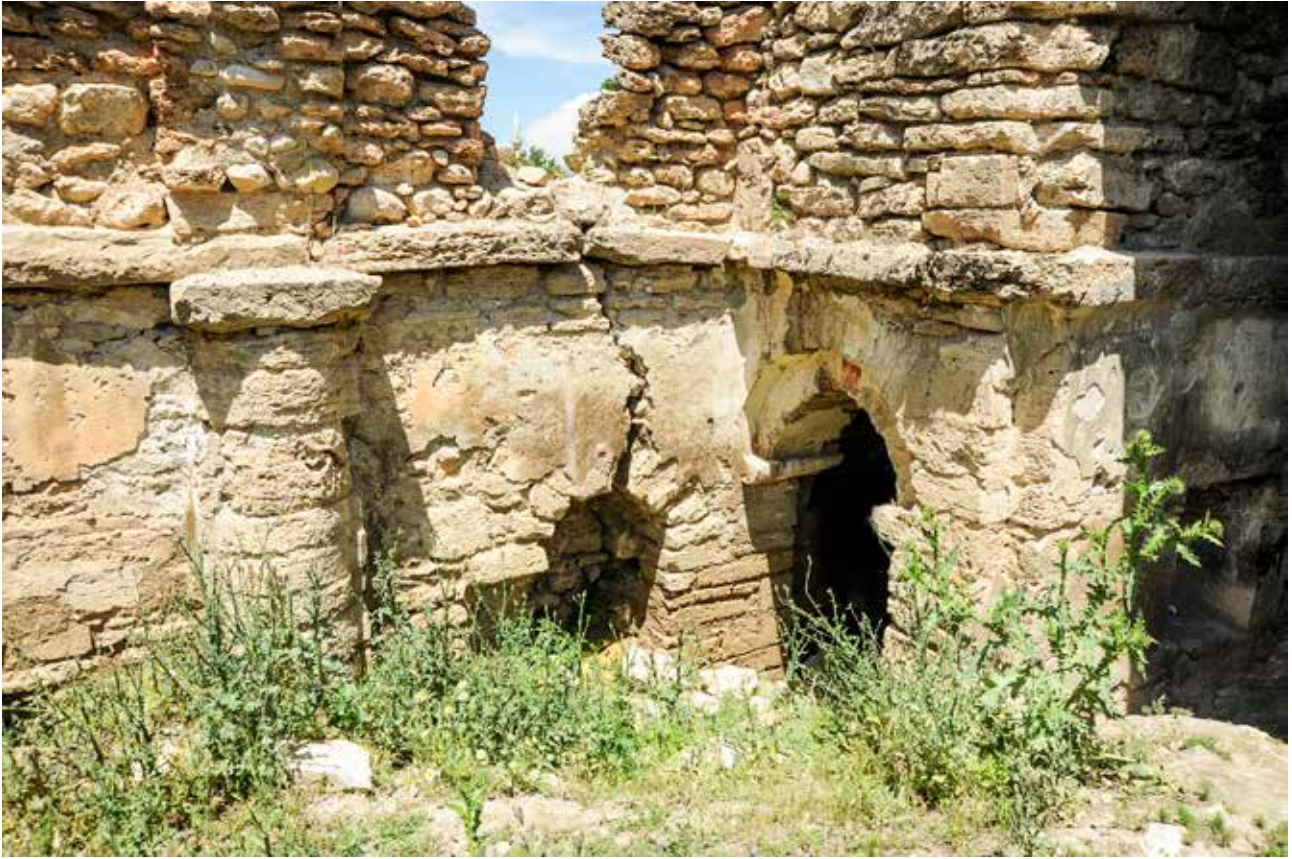
The masonry walls are made of fine-cut stone. There is a domed apse in the center of the east wall. There are two niches in the interior of the apse with widths of about 70 cm and depths of 44 cm. On both sides of the apse are lateral cells, rectangular in shape and covered with vaults. Entrance to the cells from the main area is through arched openings. On the north side above the arched entrance there are traces of red paint. There are windows in the two outer walls of both cells. On both the north and south walls

of the main area, there are two engaged columns in circular shape. The column height is about 1.70 m above the columns are beveled capitals with triangular-shaped lower corners. Above the capital level, there is a projecting profile which continues around all the walls, with the vault, covering the main space, beginning from this springing line. Above the windows on the upper level in the west wall are monolithic stone lintels. The lower level windows on either side of the door are arched. Plastered sections are encountered on all walls.

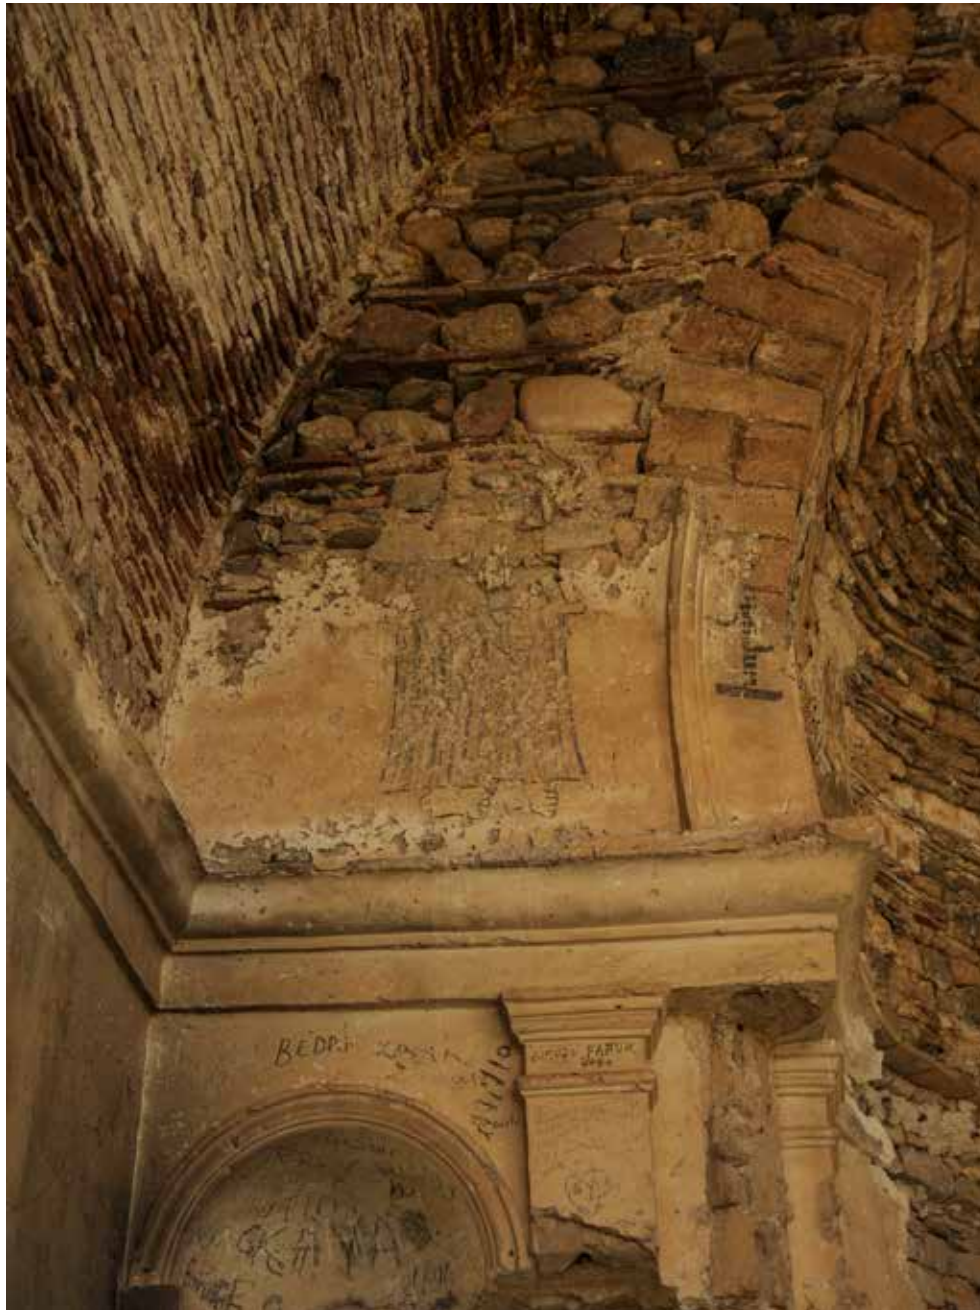
*Church of Saint Gregory the Illuminator  
Palu county, Aşağı Palu neighborhood*

walls. The walls carrying the dome and arches and the supports were stone, with domes and arches made of brick. From the beginning of the arch, along the outer wall of the building there is a stone profiled molding. There are pieces of plaster observed on the inner and outer façades. The main section with square plan was topped with a dome. The drum of the dome with octagonal form is present, however the dome is demolished. On each side of the drum, there are windows with rounded arches. Transition to the dome was provided by pendentives. The dome sat on four arched supports. The deep and externally projecting apse was covered with a semi-dome with a vault in front. There are moldings, profiles and arched niches in the interior. Today there are very few visible frescos, but according to the description on the registration form prepared in 1986 the apse arch contained a frieze, which is nonexistent today. Close to the vault there was a two-winged angel, with the Virgin Mary in the right lower corner

of the arch and Archangel Gabriel on the left and Jesus Christ portrayed in the half dome of the apse but it is completely destroyed. In the center of the vault in front of the apse, the sun was portrayed. In the intervals between the windows on the dome drum, there were saints portrayed and the four authors of the New Testament are observed on pendentives. There are traces of plaster on the external walls

though only a little. There are tie-rods in the west and east arches. The roof has been destroyed. The main walls are largely demolished. The baptism chapel adjacent to the apse and projecting externally has unique properties. On the north and south walls there are three windows with semi-circular arches at the upper level. The west façade wall is completely demolished, with wall traces extending in both directions.

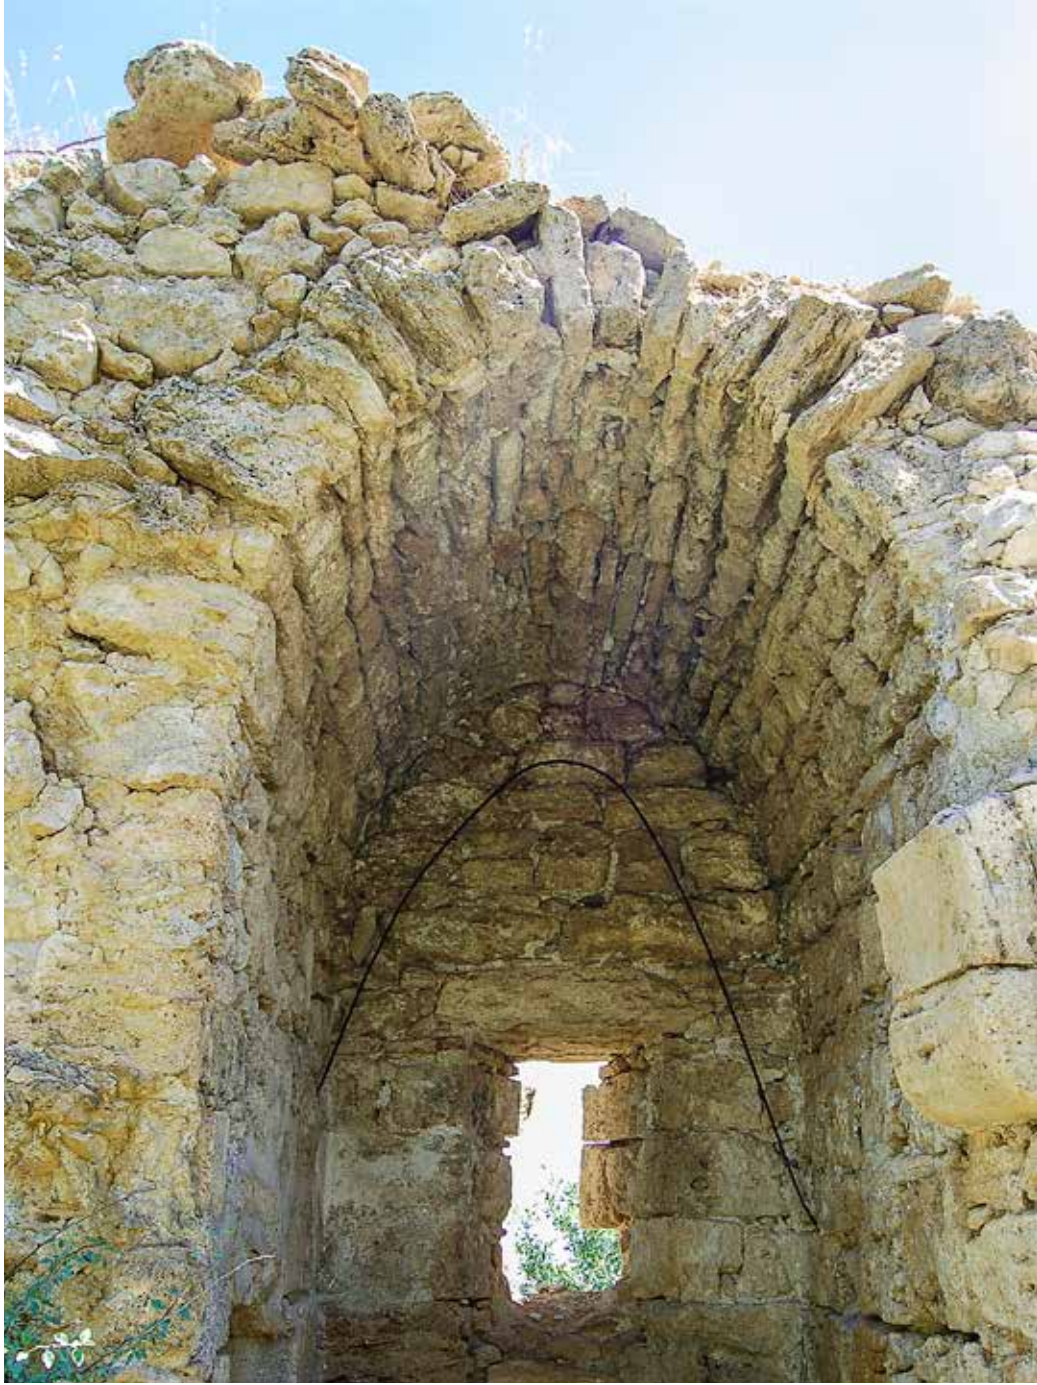
*Monastery of the Holy Mother of God  
Kovanclar county, Ekinözü village*

The walls of the monastery are constructed of rubble stone and enclose a sloped area of 45.60x 30.40 m. There are no traces of plaster on the walls.

The entrance doorway, with wooden door jambs, is situated at the eastern end of the south wall. In addition to the entrance, this wall also contains two windows. The wall was constructed on rocky ground and supported by buttresses.

The walled settlement contains a church near the east wall with dimensions of 9.15x13.07 m. The church has a square plan with three apses. Unlike the monastery wall, which is of rubble stone and not plastered, the church was built of cut stone and spolia stones, with plaster observed in the interior.

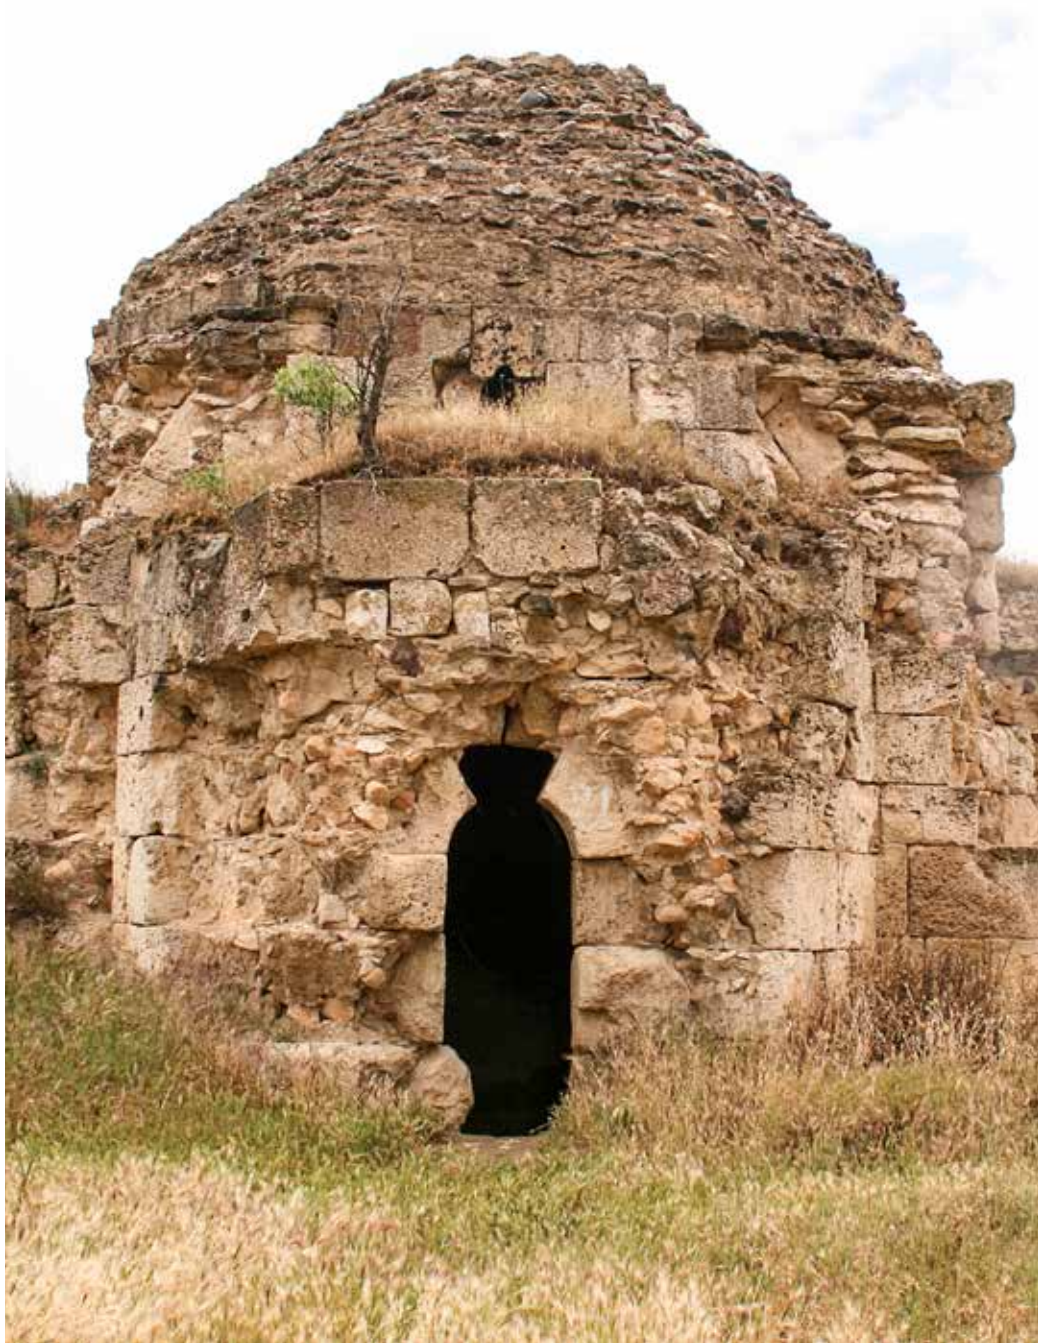
*Church of the Holy Mother of God  
Elazığ Central county, Yalmız village, Venk neighborhood*

The structure comprises of two main sections, the jamatun and the church, and a secondary space adjacent to the south façade. The entrance to the structure is from the jamatun, with a stone-arched door on the southwest. The jamatun comprises three sections (naves) with four cylindrical columns with truncated pyramid shaped impostes and bases, linked to the walls with arches. Here the wall stones have plain cross motifs, polygonal niches and a baptismal font. In the east wall, there are two cell areas to the right and left (bell tower/sacristy/treasury). The ceiling of the central area has a barrel vault with lantern, with vaults covering the surrounding space. From here, a vaulted entrance leads to the main tetraconch planned church. The nave in the east of the church has

traces of steps on the floor, indicating an altar (horan). The main structure has a high dome above a square space formed by arches in the center, while the surrounding areas are covered with semi-domes. The internal dimensions of the church are 3.85x4.19 m. The jamatun is 6.65x6.90 m.

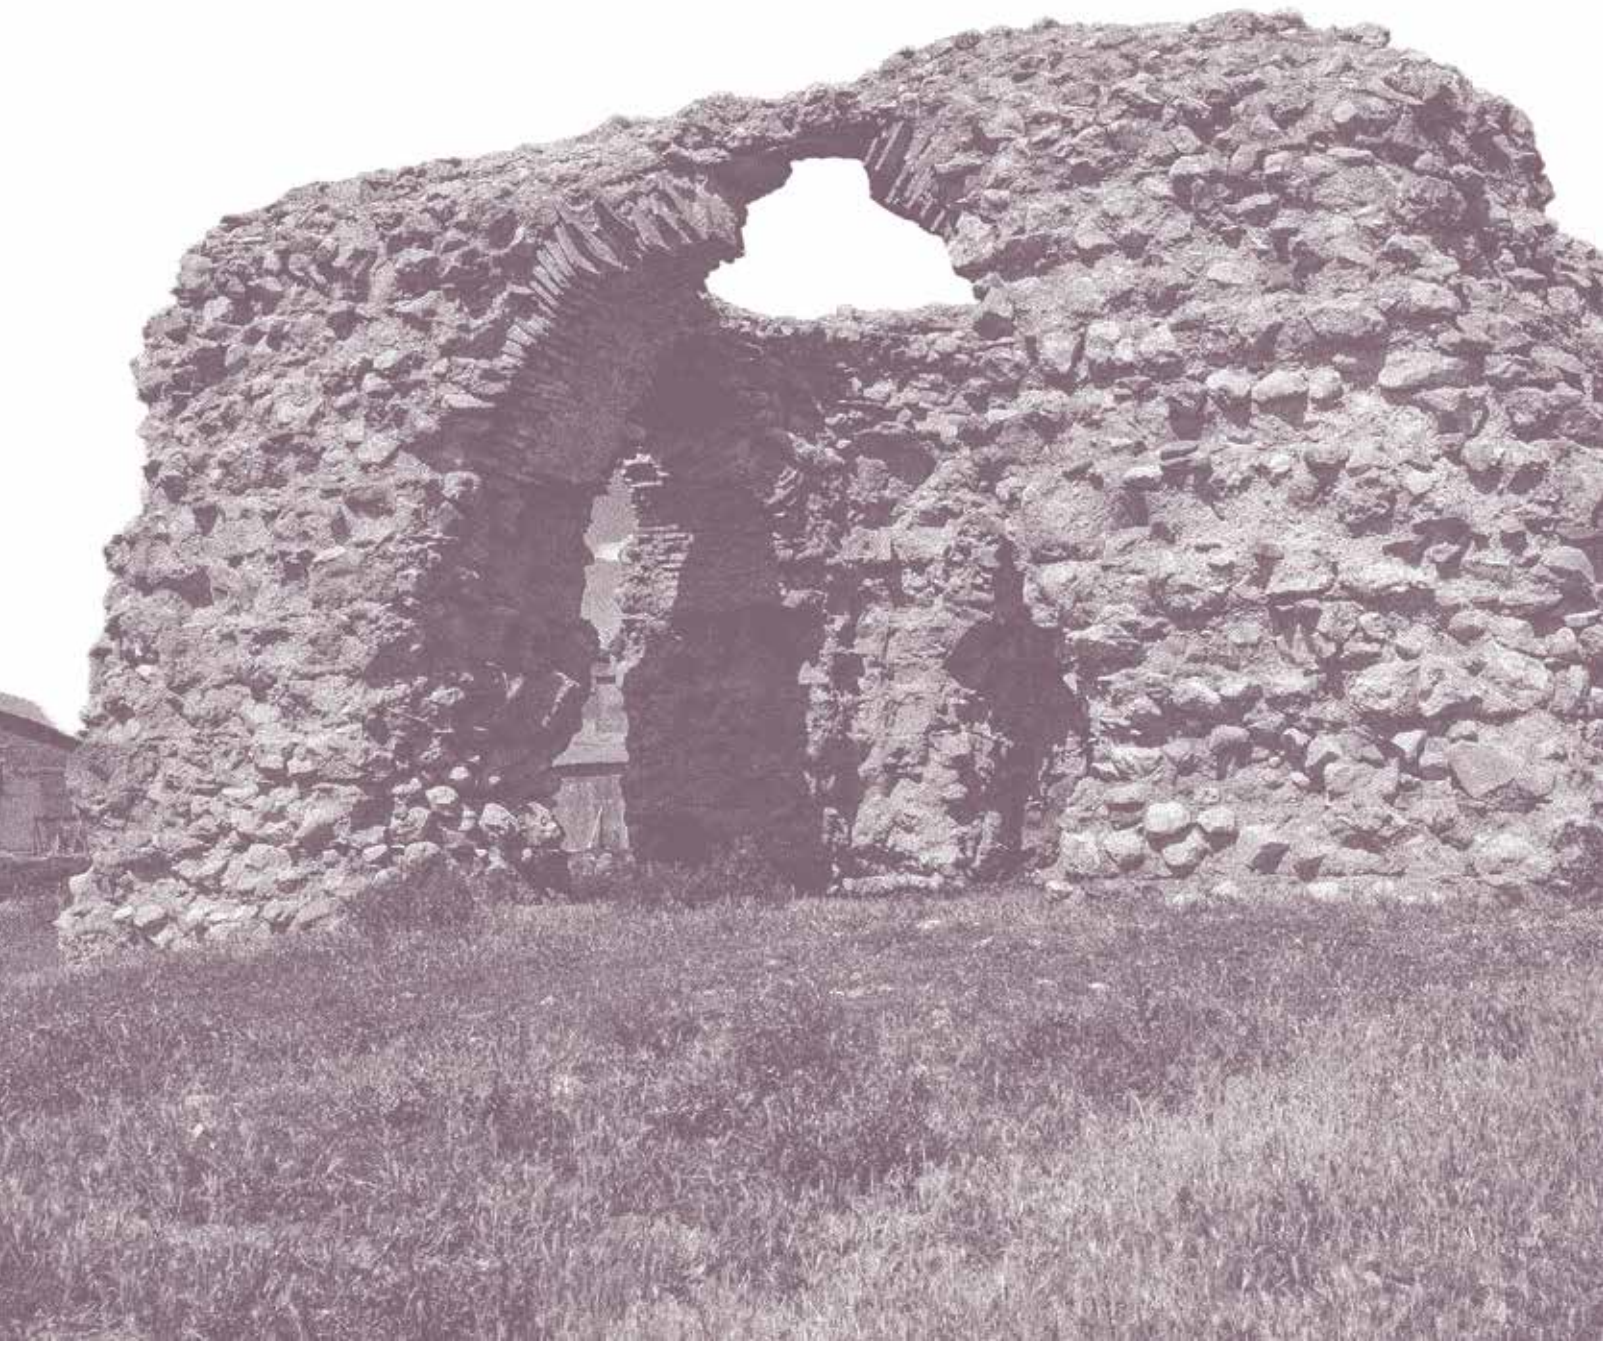
The only preserved parts are the rubble core of four heavy supports, the transition to the dome and the apse. It is difficult to understand whether the church had other spaces or chambers. Huge pillars under the dome no longer have their facing stone, and the remaining rubble gives us minimum information on the shapes and the architectural spaces or layout. Some protrusions of the rubble core imply the former existence of thin walls between the pillars,

except on the eastern side where the altar space was joined with the domed square space. Therefore, it could be possible that the simple plan of the church consisted of four large pillars and a domed superstructure (5.5×5.2 m) and the apse. The overall dimensions of the church are 13.50×10.40 m. Low semi-circular arched arms, arranged within the pillar's thickness, indicate a cross-plan. This kind of plan was unusual for Armenian architecture, but is well known in middle-Byzantine architecture; with or without galleries and additional rooms. The same architectural qualities are present in the Koimesis Church at Nikaea/Iznik (8th century (?), rebuilt after 1065), the Church of Kurşunlu in Bythina, the church near Yenişehir gate of Nikaea/Iznik, in the Church of Chora Monastery in Constantinople/Istanbul, etc. Beside the first example, all others date to the 12th or early 13th century.

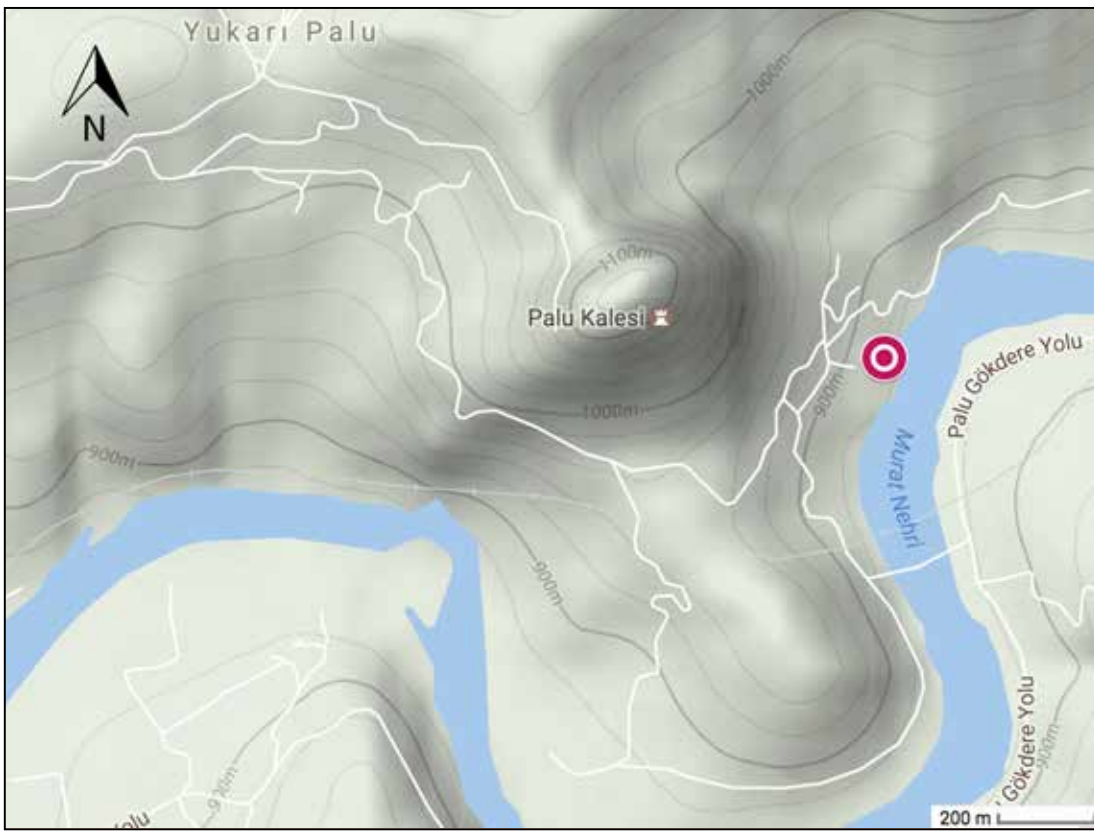
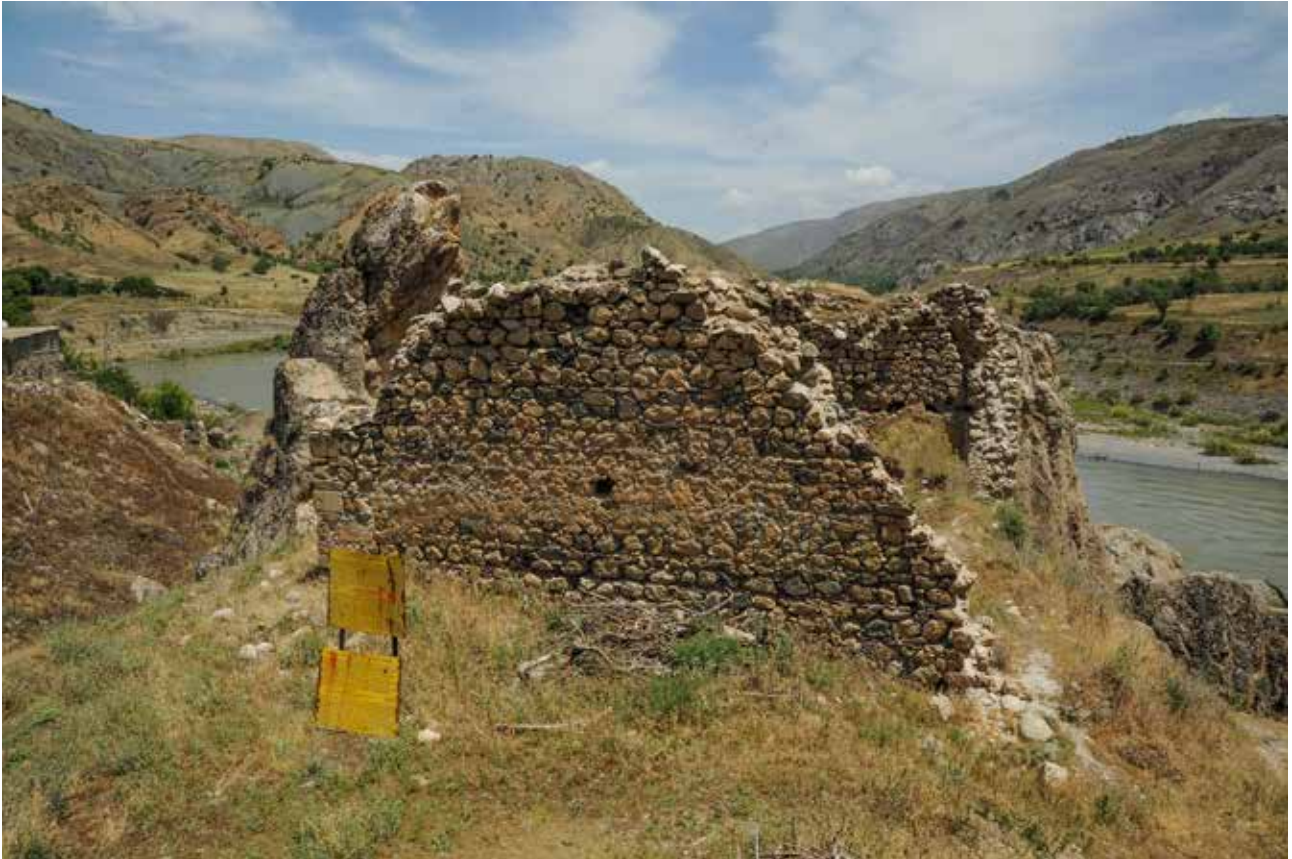
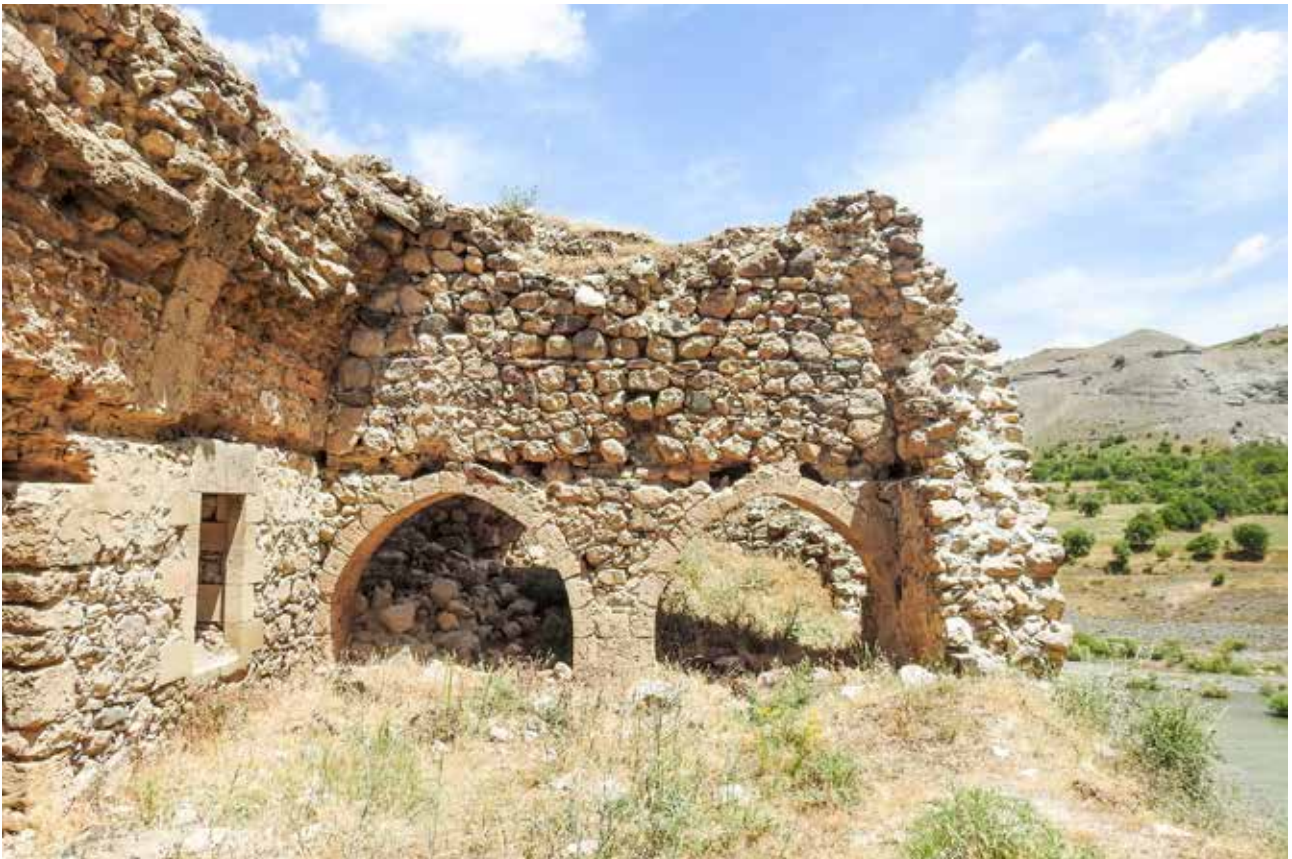
North of Kindik rocks, on a hill overlooking Murat river, between huge rock masses, the Kindik Church has an east-west orientation. It was originally a vaulted masonry stone structure consisting of a single space rectangular with dimensions of 11.0x16.0 m, that is currently collapsed. Later, parallel to the building along the north wall, another space was added and it is thought to have been used as a mosque. Due to its location, there is a high possibility that it might have been a monastery structure. There is no surviving apse of the church. The arched entrance in the later space suggests a wooden cantilever over wood or stone columns, though there is no definite evidence of this.

The internal and external areas have similar construction techniques. The two arches carrying the barrel vault (of which only the initial section in the walls remain), were built of cut stone. In the north wall, traces of the vault are visible. There are two cut stone, wide arched openings in the east wall. From these openings one enters the narrow area to the east of the structure, which is covered with a barrel vault with north-south orientation.

In the north, the entrance wall contains a door with flat lintel and two windows on either side. The end sections of the walls projecting north in the east and west of this section were built of cut stone, and the roof was vaulted.

The east and west walls of the semi-open area in front of the structure are partially destroyed, and the vault totally collapsed. In the interior, the south wall and west wall are largely demolished. All walls have significant degrees of collapse and material loss, with cavities in stones and structural fractures in the walls. The entire floor is covered with rubble.

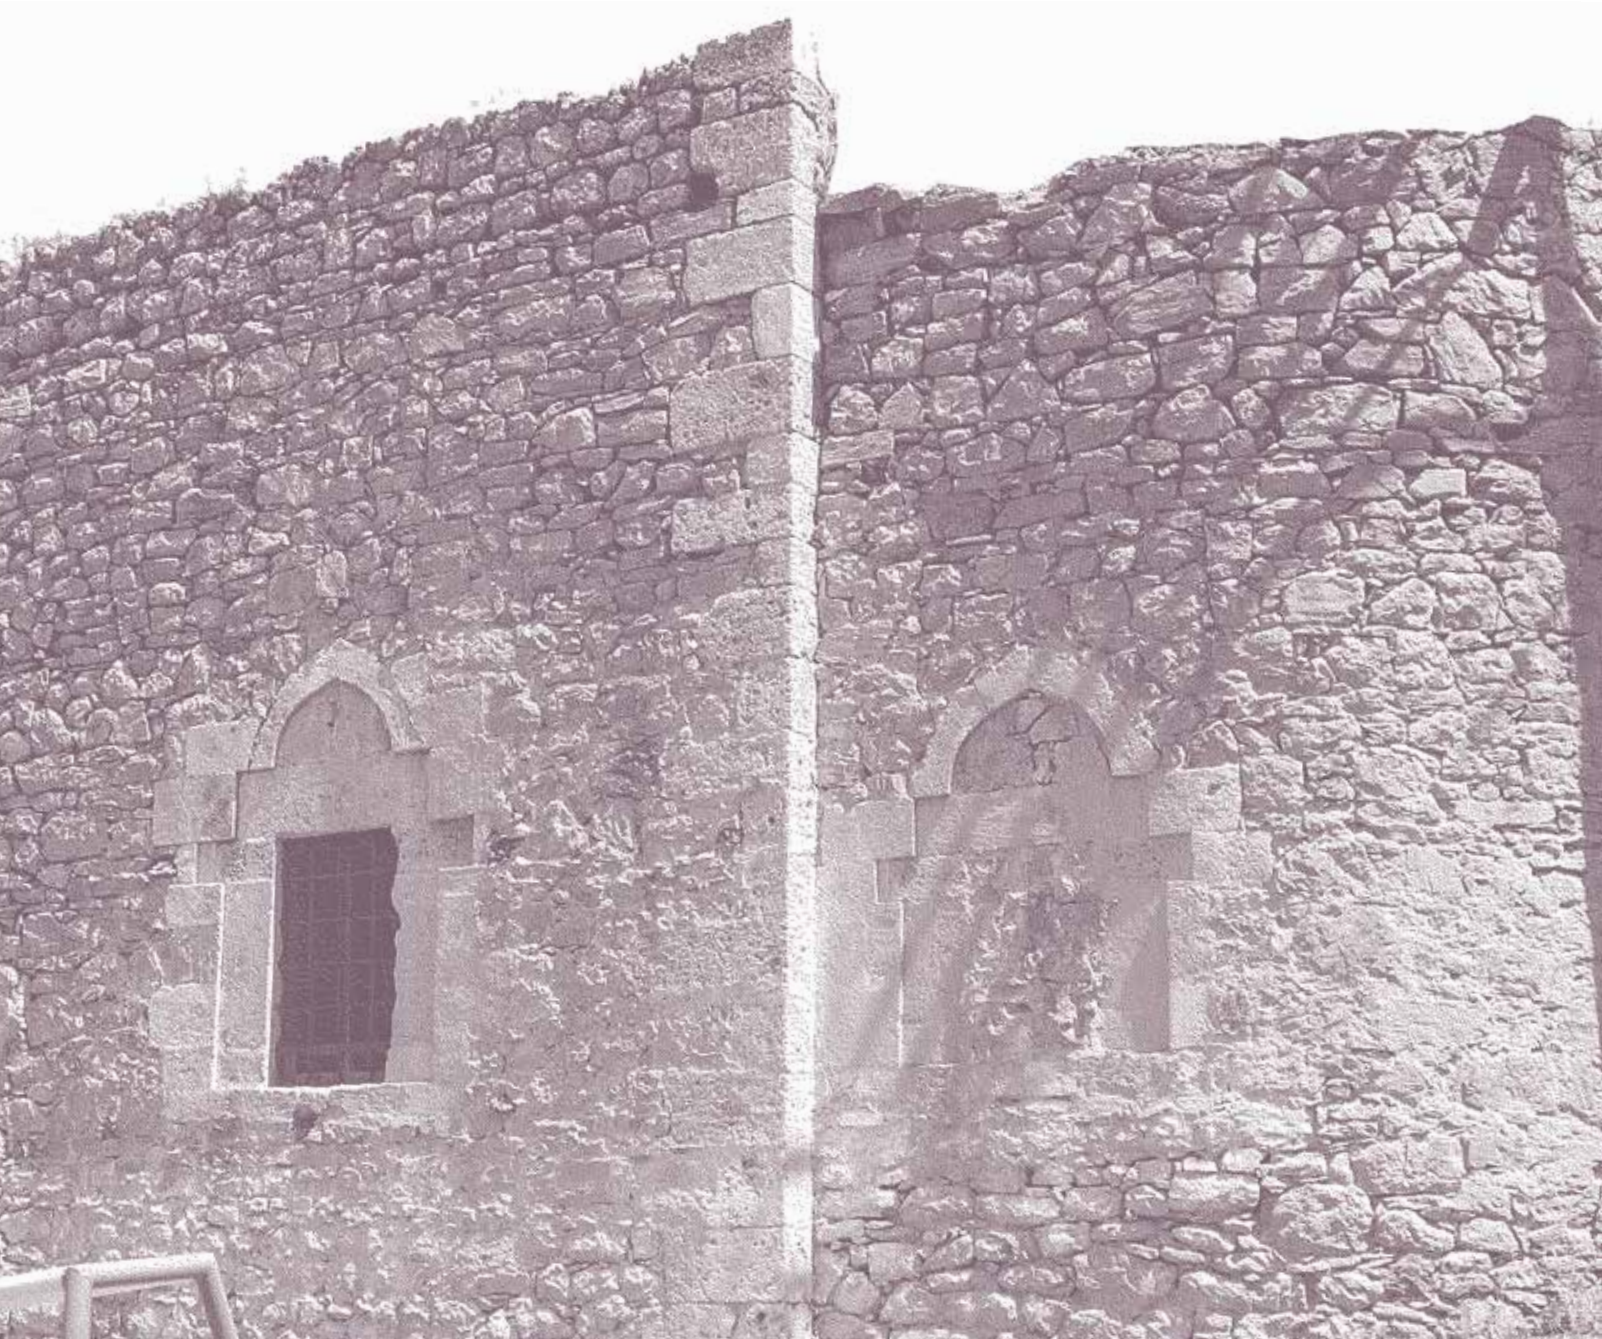
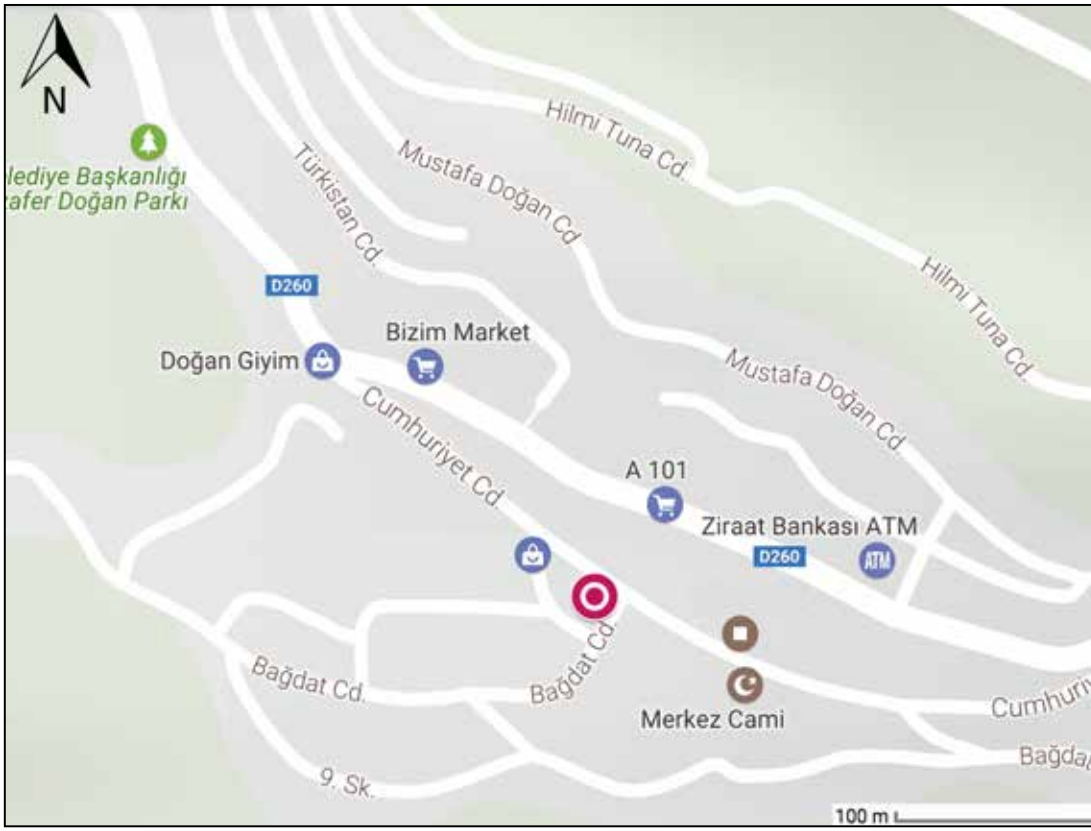
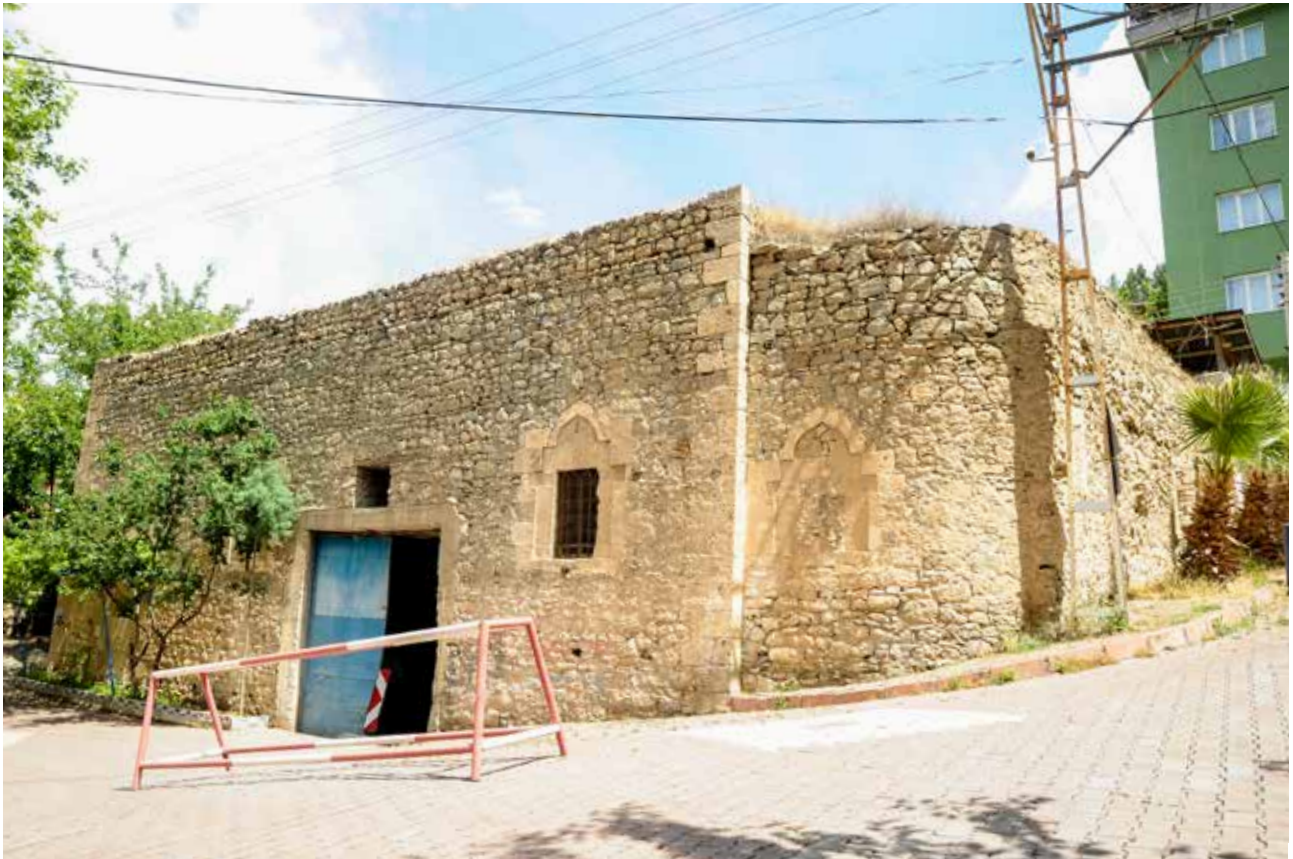
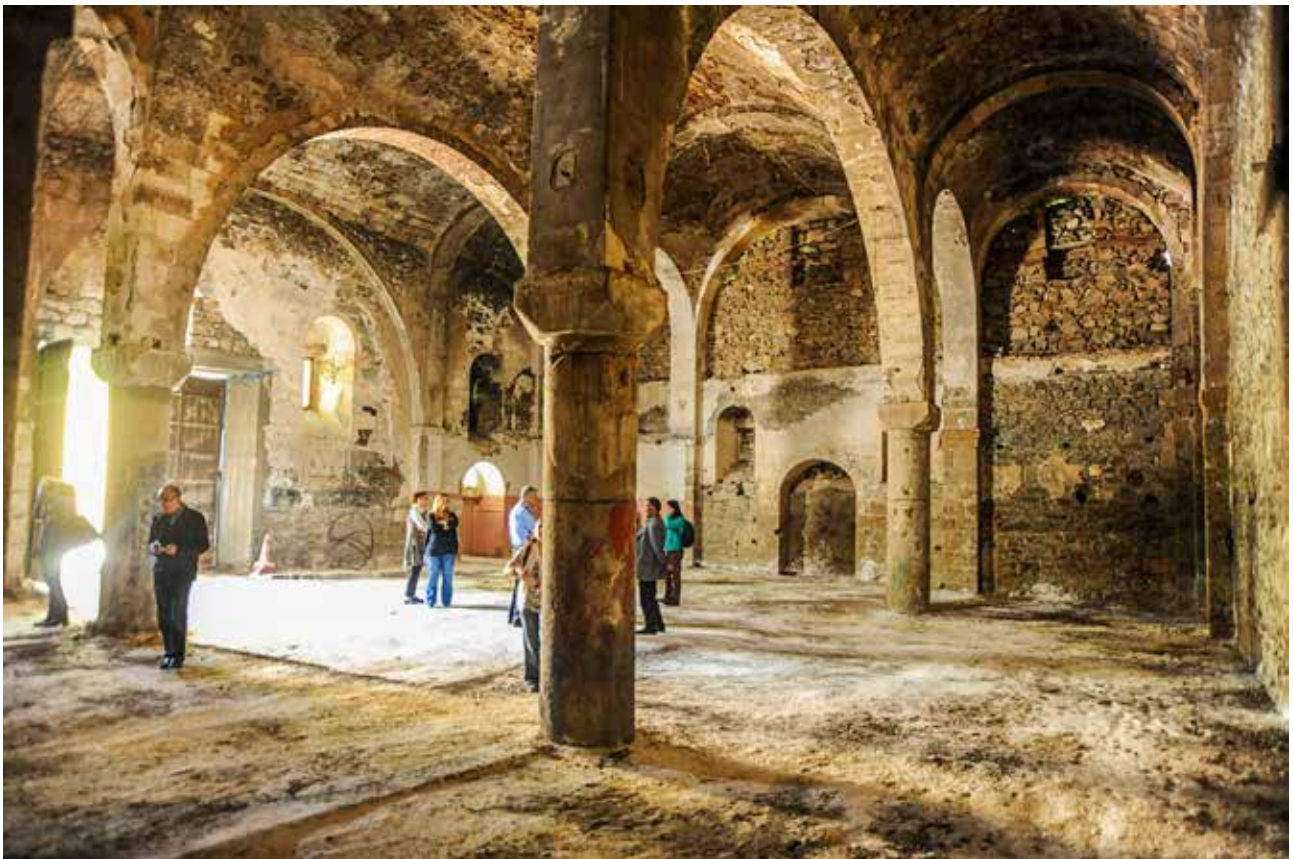
The church has a rectangular plan with dimensions of approximately 14.5x20.0 m. There are three naves separated by four 35 cm diameter stone columns and three apses. The width of the central apse and the nave is nearly 9.0 m and is higher than the nearly 3.6 m wide side naves. The central apse is covered with a semi-dome, while the side aisles have barrel vaults. The internal width of the original entrance was 1.8 m. The height of

the structure is nearly 8,5 m. The keystone of the arches linking the columns is nearly 7 m high. On the exterior, the southern apse is circular, while the other apses have flat walls. The walls are of masonry rubble stone; with windows, doorframes, voussoirs and corners made of fine-cut stone. The arches above the windows are slightly pointed.

The roof was earth-covered. On the east façade, there is a gable roof with a stone eave. In the northwest, there is a waterspout and stone eaves. The exterior walls are unplastered masonry, while the interior is plastered, with traces of extremely degraded frescos. The columns separating the naves in the center of the spaces are comprised of two cylindrical blocks of stone, with plain impost capitals. The arches connecting the columns were constructed to project outside the vault. Similarly the projections of the arch supports are visible in the walls.

The church is located in the center of Keban, within the market area near the municipality building. There is a row of shops adjoining its north wall. The main entrance door and west windows on the west façade are below the current road level and have been closed. A disproportionately large, 3,5 m wide door was opened in the south wall of the structure for access in later periods. The original ground level is not fully observed due to interventions to the floor level.

There is severe material degradation linked to damp in the whole structure. There is efflorescence, due the cement-based plaster used in repairs. The frescos have been destroyed, with very few remaining traces. The roof is covered with plants.
