## ELAZIĞ SITE ASSESSMENT VISIT

Dates: May 28-June 3, 2016

# KHULEVANK MONASTERY CHURCH OF SAINT GEORGE | SURP KEVORK

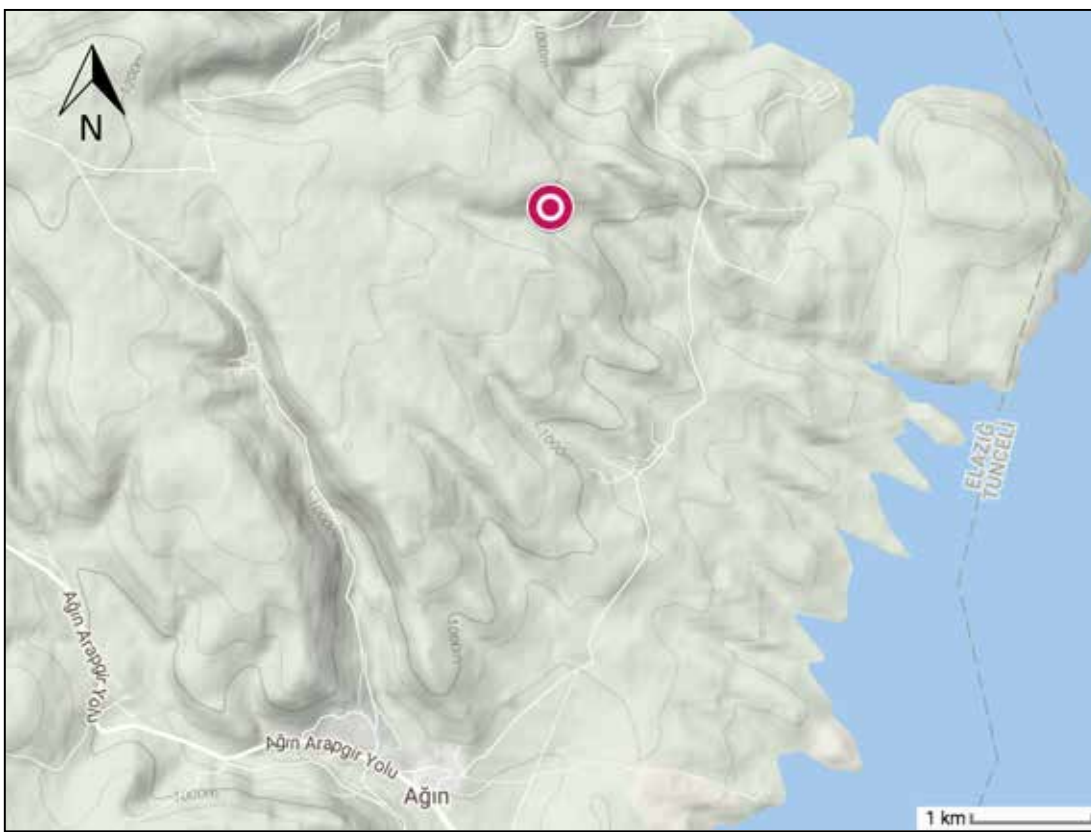
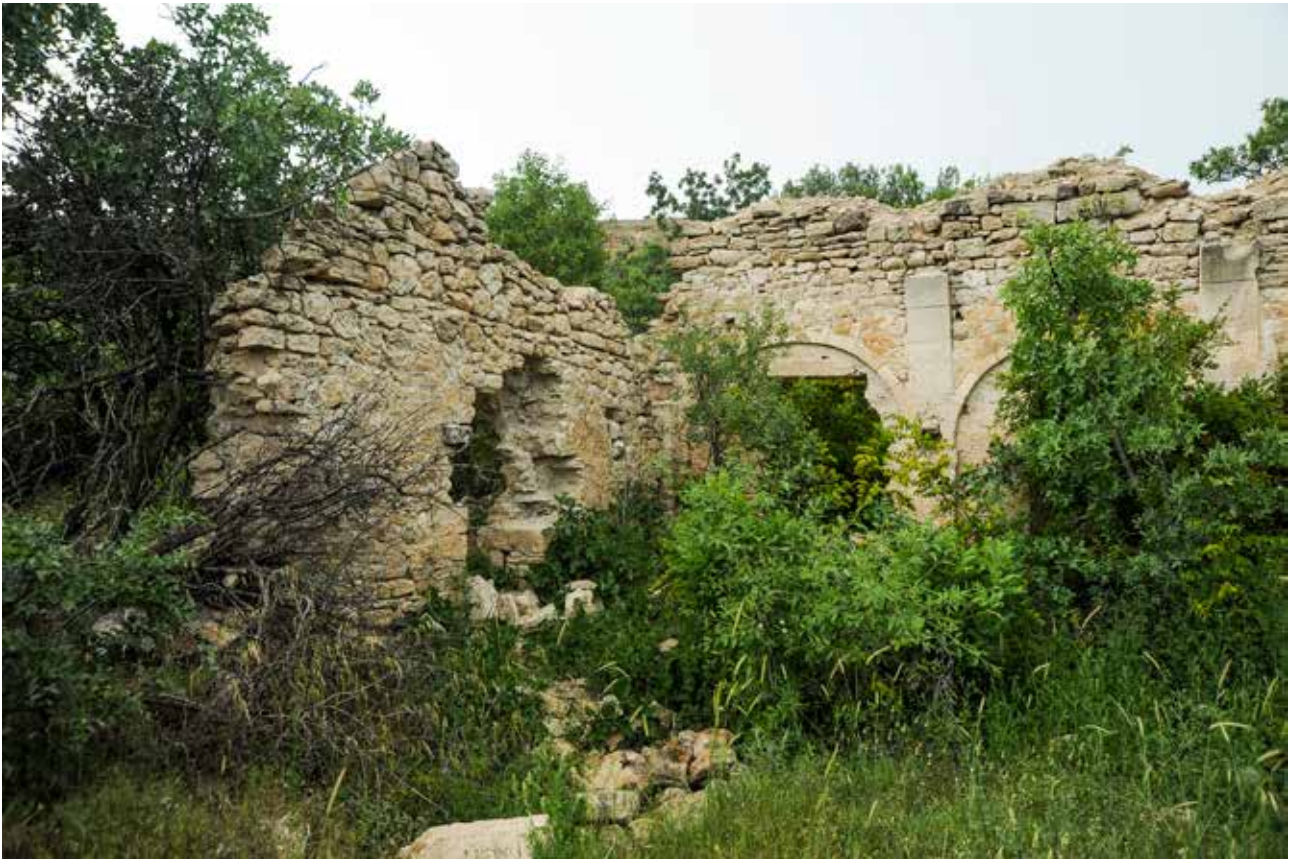
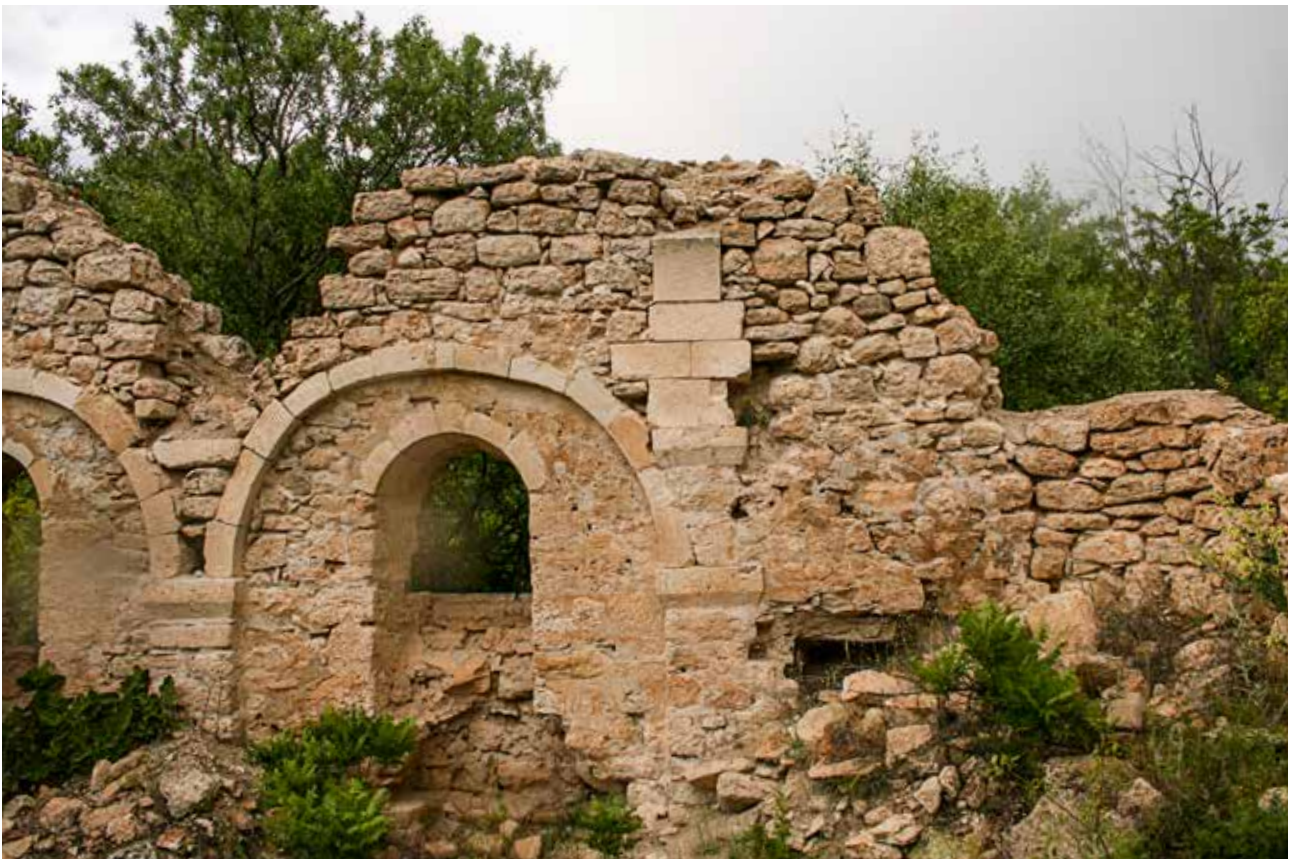
The church has two entrances, which are partly preserved, one in the axis of the western façade and the other in the western section of the northern wall. Large arched windows existed in the other sections of the same wall and probably in the southern wall. There is no information on windows in the western wall and in the apses.

The church was built with traditional Armenian construction techniques. All engaged columns, arches and architectural elements are constructed from fine-cut blocks of light ochre sandstone. All other constructions, including the vault, are made with rough-cut stones, which is typical for provincial architectural traditions.

Only the northern wall is preserved up to the beginning of the vault. The western wall and the apses are partly preserved, and the trajectory of the southern wall could be traced underneath the ground. To the north of the monument, one can see graves that have been excavated by treasure hunters. The building is open to external factors of damage.

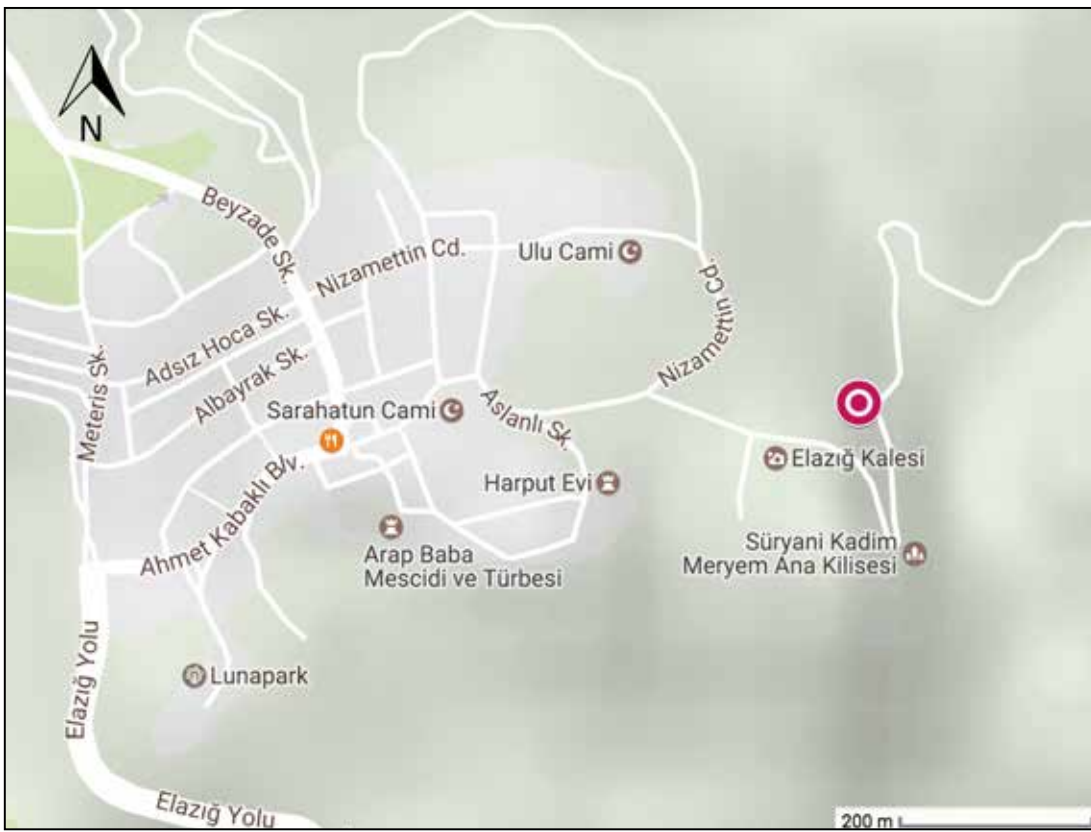
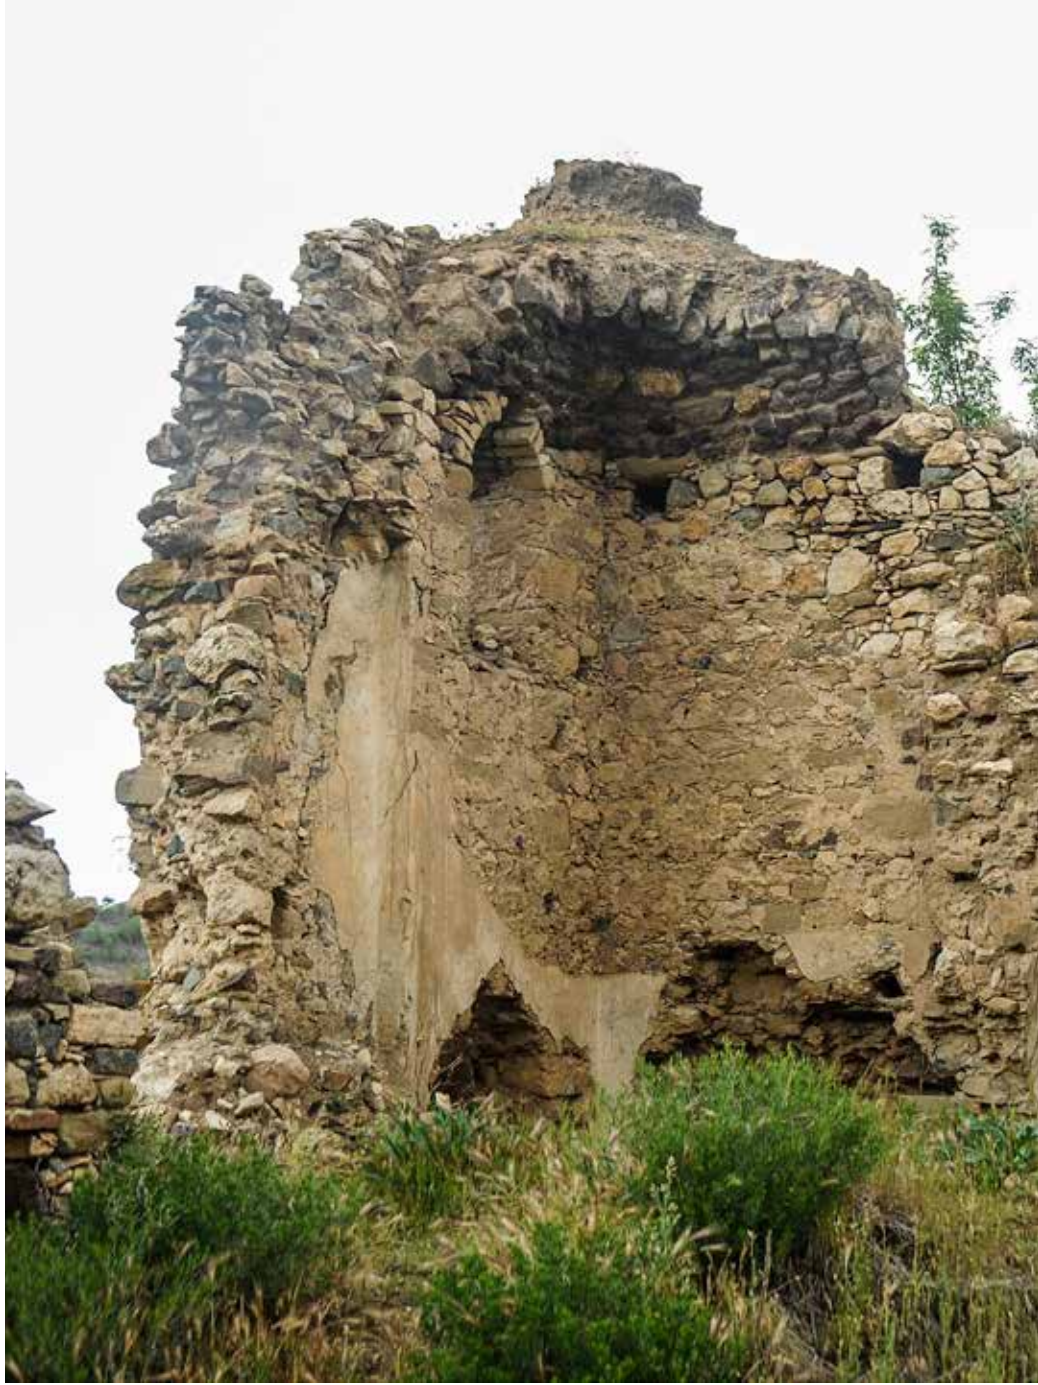
*Church of Saint John the Baptist  
Elazığ Central county, Harput neighborhood*

The exterior length of the east wall is 18 m, while the remaining section of the north wall is nearly 11 m long, with traces on the ground continuing to 15 m. The wall thickness in the lateral cells (north and south walls) is 90 cm, while it is 70 cm in other sections. In the east wall of the side cells, there is a niche, with one window in the outer walls of nearly 90 cm width. Windows with the same dimensions are repeated at the upper level. Of the three apses in the east wall, the central apse measures nearly 3.94 m, with the north apse 2.53 m and the south apse 2.90 m. On the two side walls

of the structure, there are two arched openings of nearly 1.10 m width. In the exterior sections of the two side walls, there are two buttresses with dimensions of 50x90 cm. The west wall of the structure is completely demolished and it is necessary to conduct research excavations to determine how far the north and south walls extend toward the west.

The walls are masonry rubble stone, with fine-cut stone corners. The roof is completely lost; however, there are traces of a dome over the apses. The voussoirs are of cut stone. There are pieces of plaster on the internal walls.

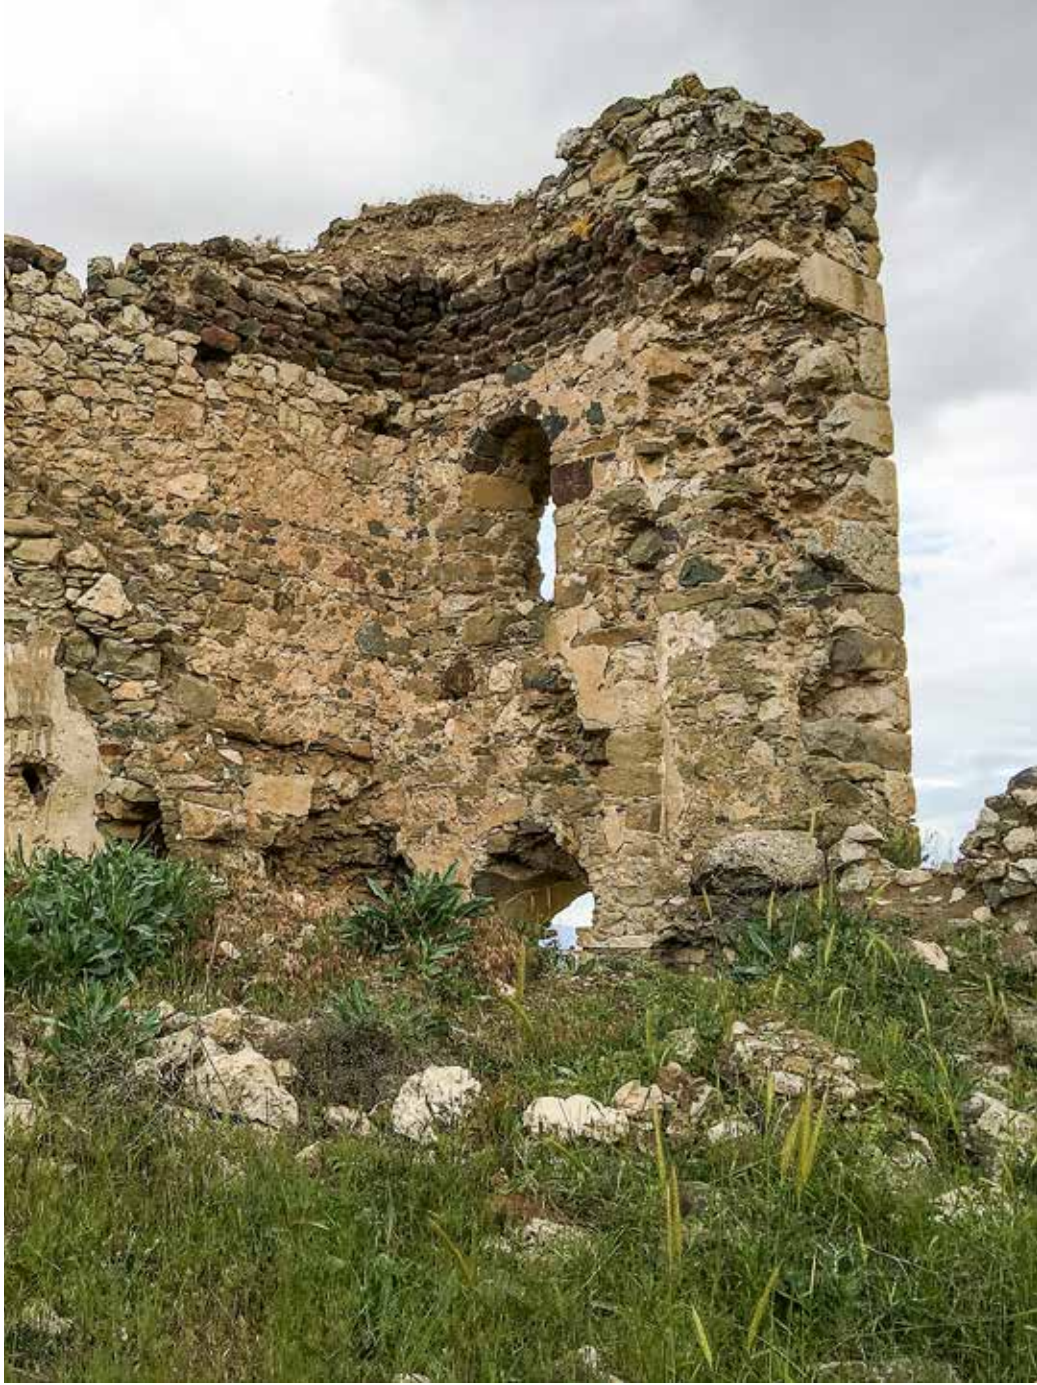
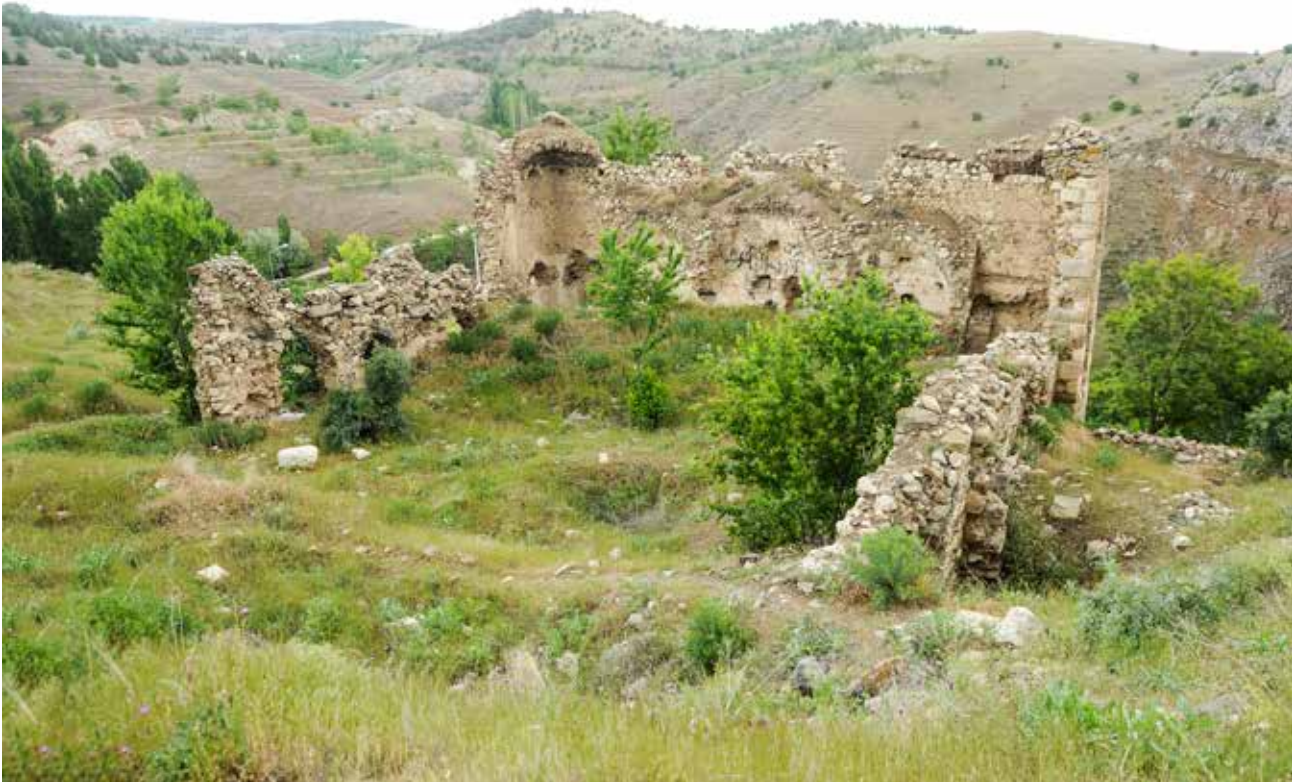
*Church of Saint John the Baptist  
Elazığ Central county, Harput neighborhood*

The north and south walls are partially standing, while the east wall is completely preserved apart from its upper section. There is no visible information about the end of the north and south walls and their upper levels. The roof is completely demolished, apart from some stone rows indicating the beginning of a dome roof partially observed in the lateral cell walls and central apse. The architectural layout is not fully visible.

Nearly the whole of the structure has large amounts of material loss and degradation. Although the east wall and lateral cells are still intact, severe degradation is observed in their masonry walls. The material loss in the north and south walls is slightly more advanced compared to the east wall.

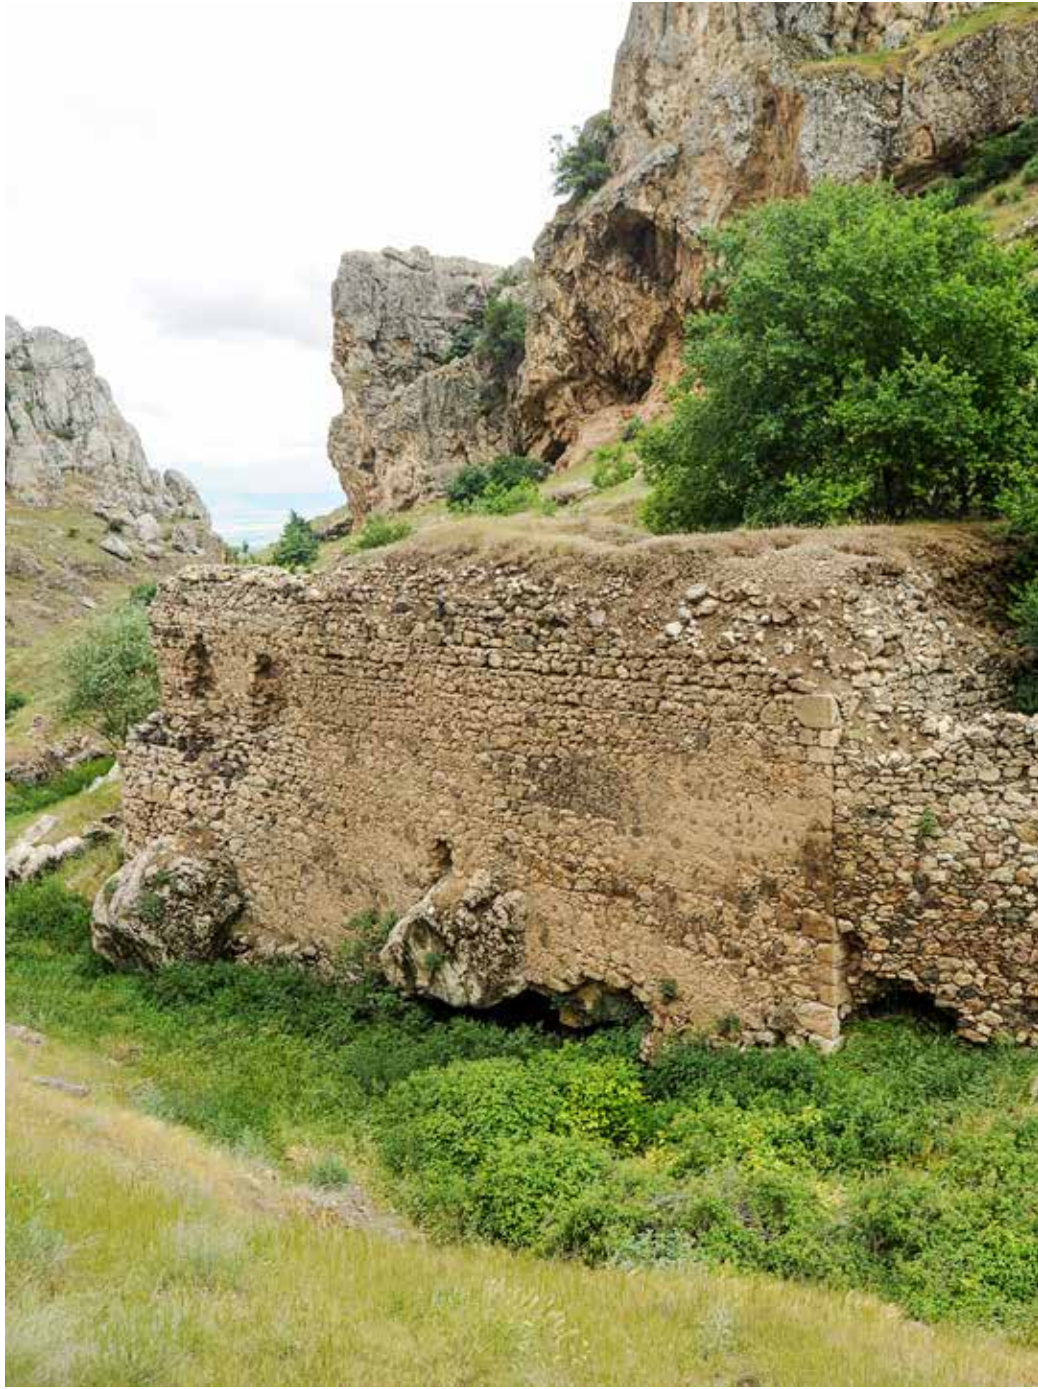
*The Public Bath  
Elazığ Central county, Harput neighborhood*

The structure is located east of the old settlement area of Harput. The section of the structure still standing and accessible is nearly 20x10 m. Considering the section still visible above and below the ground, it is understood that the structure has a large layout. The structure built of rubble stone above the rocky ground has a

rectangular plan. As it sat on a sloped area and due to level differences, part of the structure is buried under soil. As the walls are demolished, the layout is not fully understood but it comprises of a classic public baths (hamam), with three sections.

The northwest wall, which is the only visible portion of the plan, is nearly 6.0 m long and with two arched windows of nearly 1m wide. The wall depth is approximately 70 cm.

The plan is degraded and undecipherable. The roof is completely collapsed. As the structure is partly underground, all spaces have not been identified. Nearly all of the structure has serious loss in its fabric. The northwest wall is relatively sturdy, yet its upper and front sections are completely demolished.

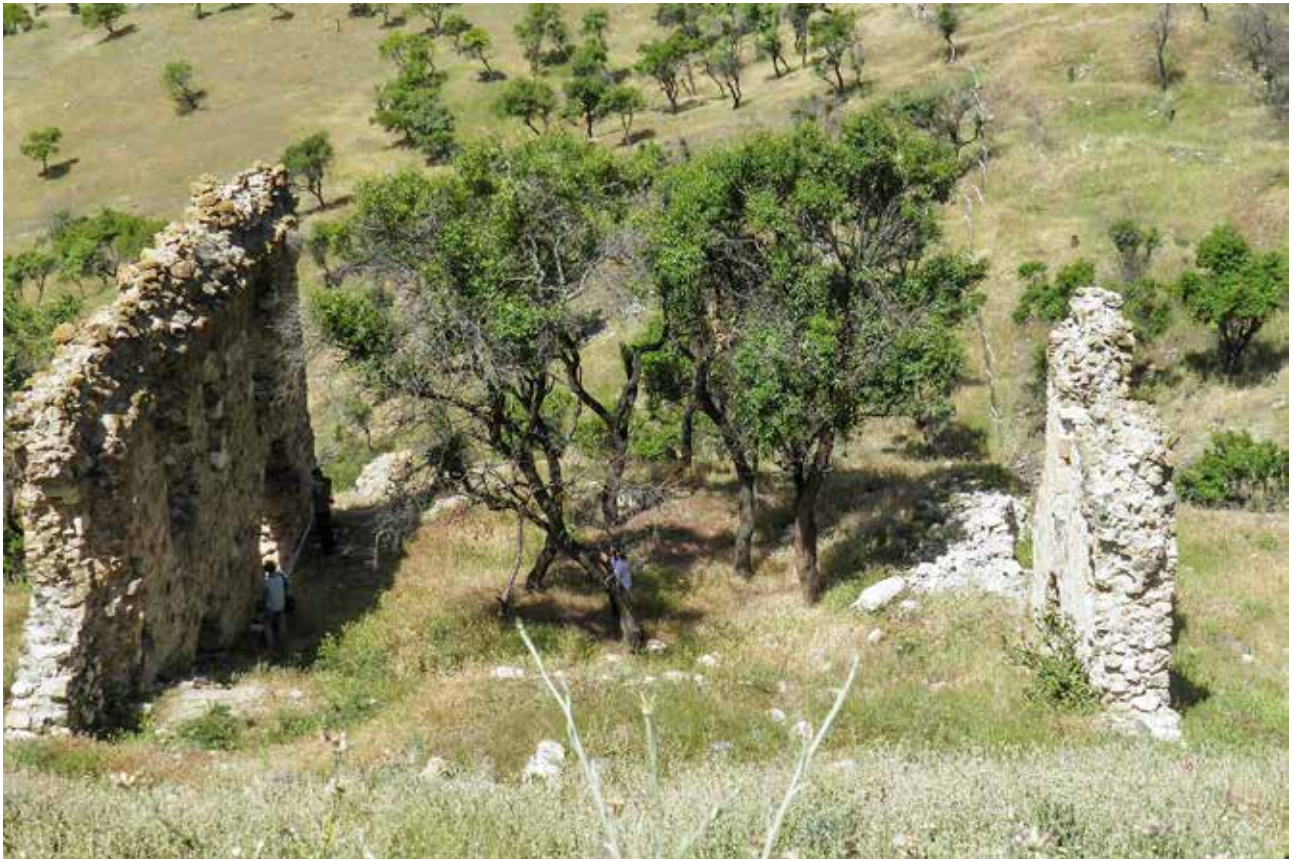
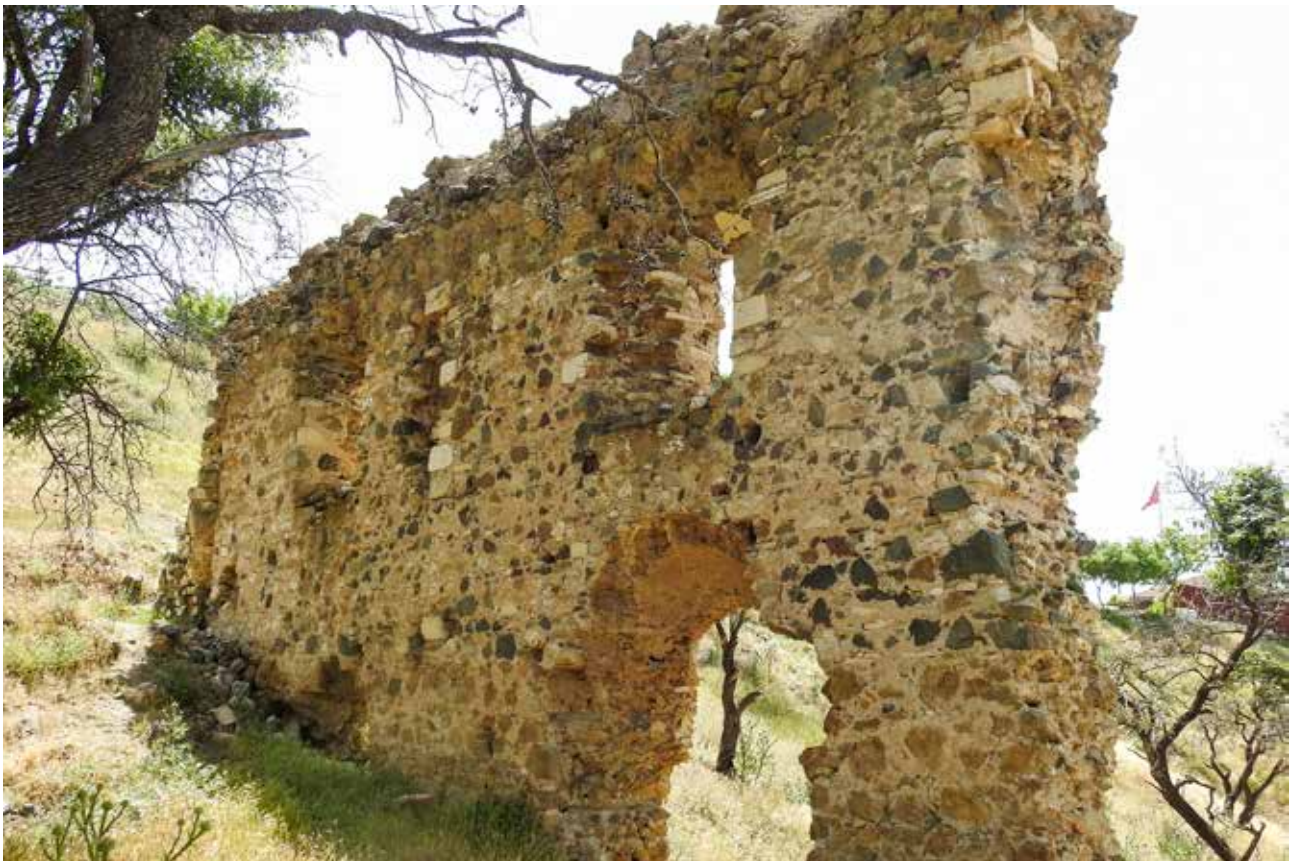
The remaining walls of the structure indicate a rectangular-plan church. The partially standing north and south walls are rubble stone masonry. The foundation traces of the east wall are visible. The north wall has an arched opening at the lower level, while there is an arched window on the upper level. On the south wall, there are two arched openings at the lower level, while there are three arched windows at the upper level. It is not possible to describe the roof covering of the building as it is completely destroyed. There are no foundation traces of the west wall.

The church is currently close to a settlement area, west of the main road, on sloped ground at a level below the road. A very small portion of the walls remains standing and the north wall is proportionally more demolished than the south wall. There is material loss and severe corrosion in the walls.

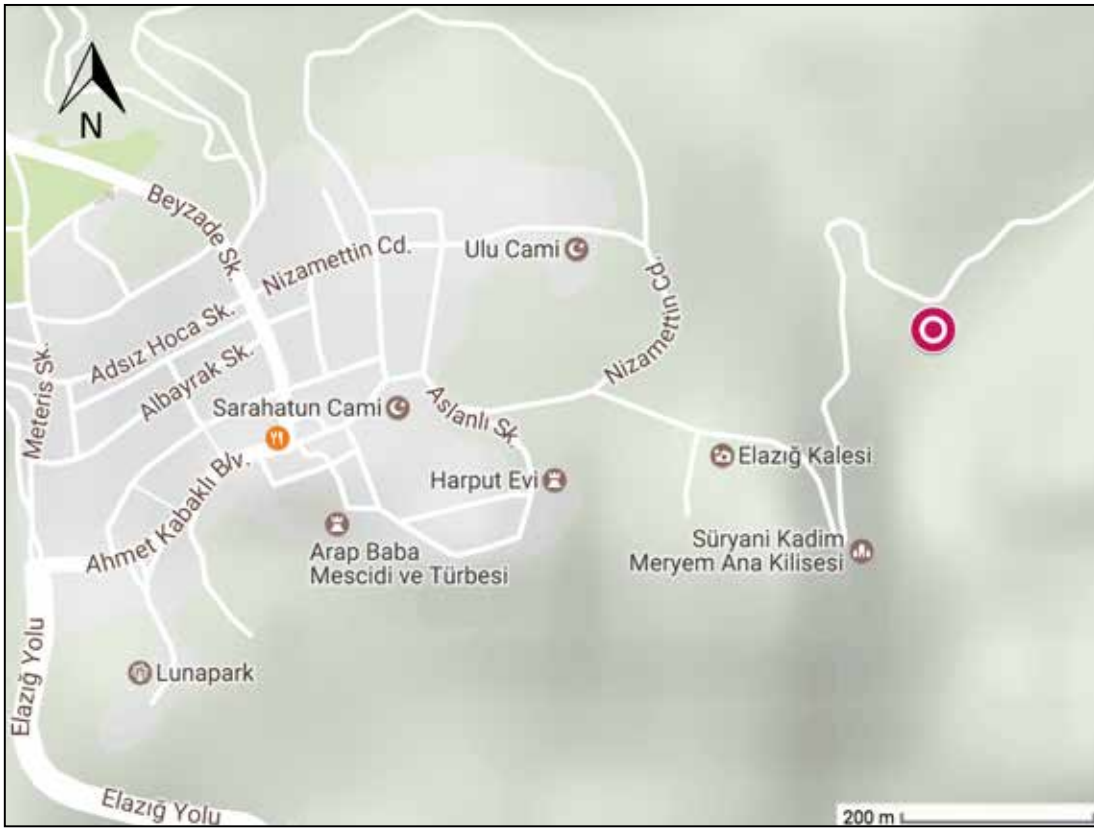
Constructed in the east of the old settlement area of Harput, at a point commanding the entire valley with a view of the castle, the section of the structure still standing has dimensions of 2.2x4.7 meters.

The structure is a single domed, single space and single storey chapel. The northeast wall has preserved its integrity, whereas the measurable internal width of the structure is about 5.30 m. The partially standing northwest wall is nearly 2 m long; while there is a nearly 1.90 m section of the southeast wall remaining with a thickness of nearly 1m. As the walls have collapsed, there are no traces of a mihrab or apse projection which would be present in a masjid or a chapel.

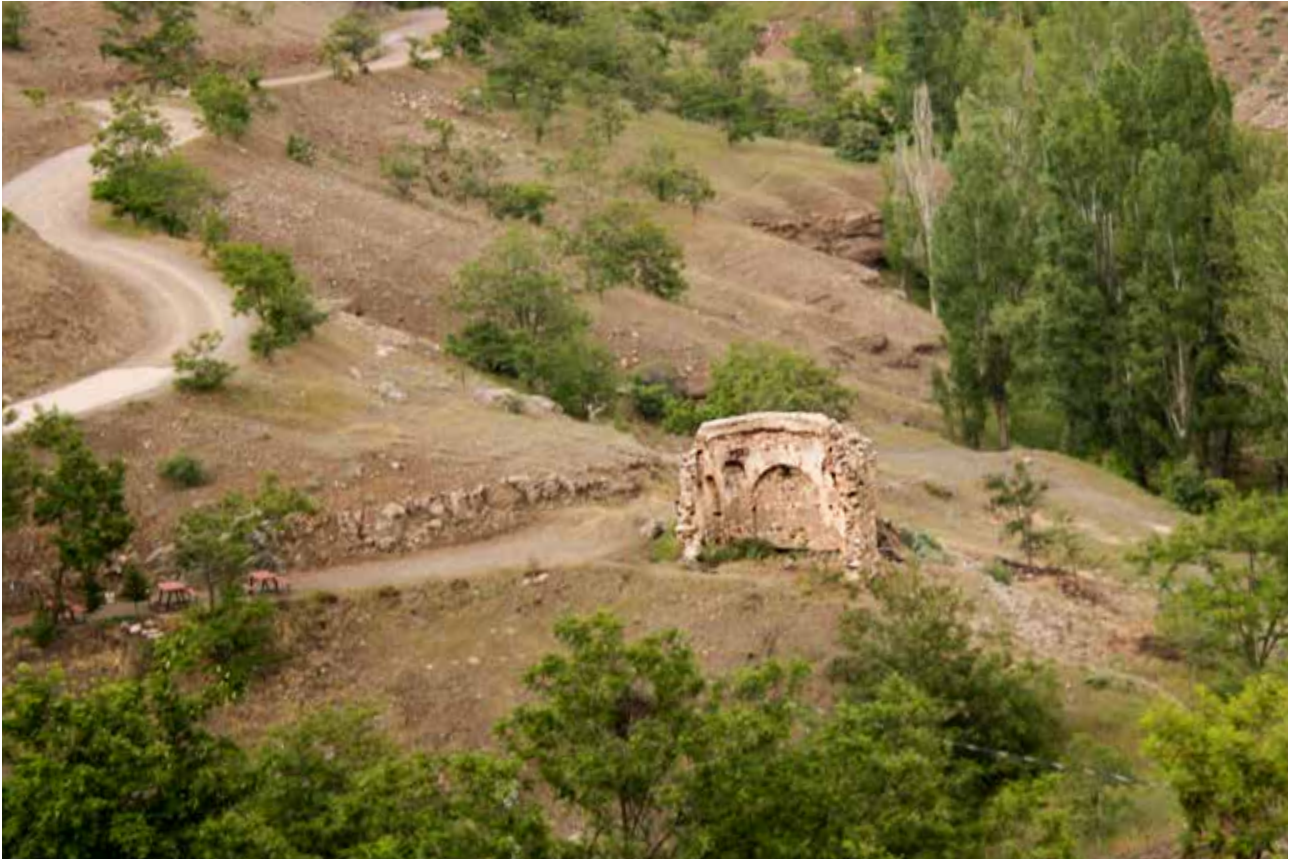
In the interior, the lower sections of the walls were built of cut stone masonry, with brick used for the walls above the arches, squinches and the dome. There are arched squinches as transition elements between the upper portion of the corners of the walls and the dome. The original interior of the structure was plastered, with no traces of plaster on the exterior. In the northwest and northeast façades on the central axis of the walls, immediately below the arches carrying the domes, there is a single small arched window. The stone walls continue until halfway up the

window, with the upper half of the walls made of brick. The arches are all of brick, sitting on brick projections from the wall. Very little is preserved of the drum of the brick dome and of the area above the drum. The dome sits on a drum that projects approximately 10 cm from the wall. The support columns of the arches (the anta) on three façades, project nearly 30 cm with widths of nearly 90-100 cm. The section where the wall meets the ground is visible. The sections closest to the ground of the northwest wall, which is relatively intact, cannot be seen without excavations. The height of the springer of the arch on the northeast wall is 3.21 m from ground level. The lower section of the projection that the arch sits on is 1.70 m high with profiled projection.

The north, east and south walls of the structure are partially standing; while the west wall is completely demolished. The upper section of the dome above the remaining walls is almost demolished, with only a few rows of brick remaining.

There is a large proportion of material loss in the entire structure especially at the base of the walls. Erosion, structural fractures in load-bearing elements, vertical structural fractures in the keystones of arches, window and corner buttresses are observed. Only three walls are partially standing and the roof is completely collapsed, leaving it open to more severe collapse. There is serious material loss linked to dampness in the lower 5-6 rows of stone masonry near the

ground. The six rows of stone in the center are preserved along with mortar. The upper 5-6 rows of stone have preserved their material integrity despite rain and weather conditions, but mortar is lost. There are vertical fractures in the keystone sections of the load-bearing arches and window arches. All walls contain structural fractures. On the three façades of the partially preserved interior walls, plaster is observed.
