# **Production from Destruction: Change of Value of Recycled Decoration. The Roman Villa of Aiano – Torraccia di Chiusi (San Gimignano, Siena – Italy)\***

**Marco Cavalieri – Antonia Fumo – Sara Lenzi – Gloriana Pace**

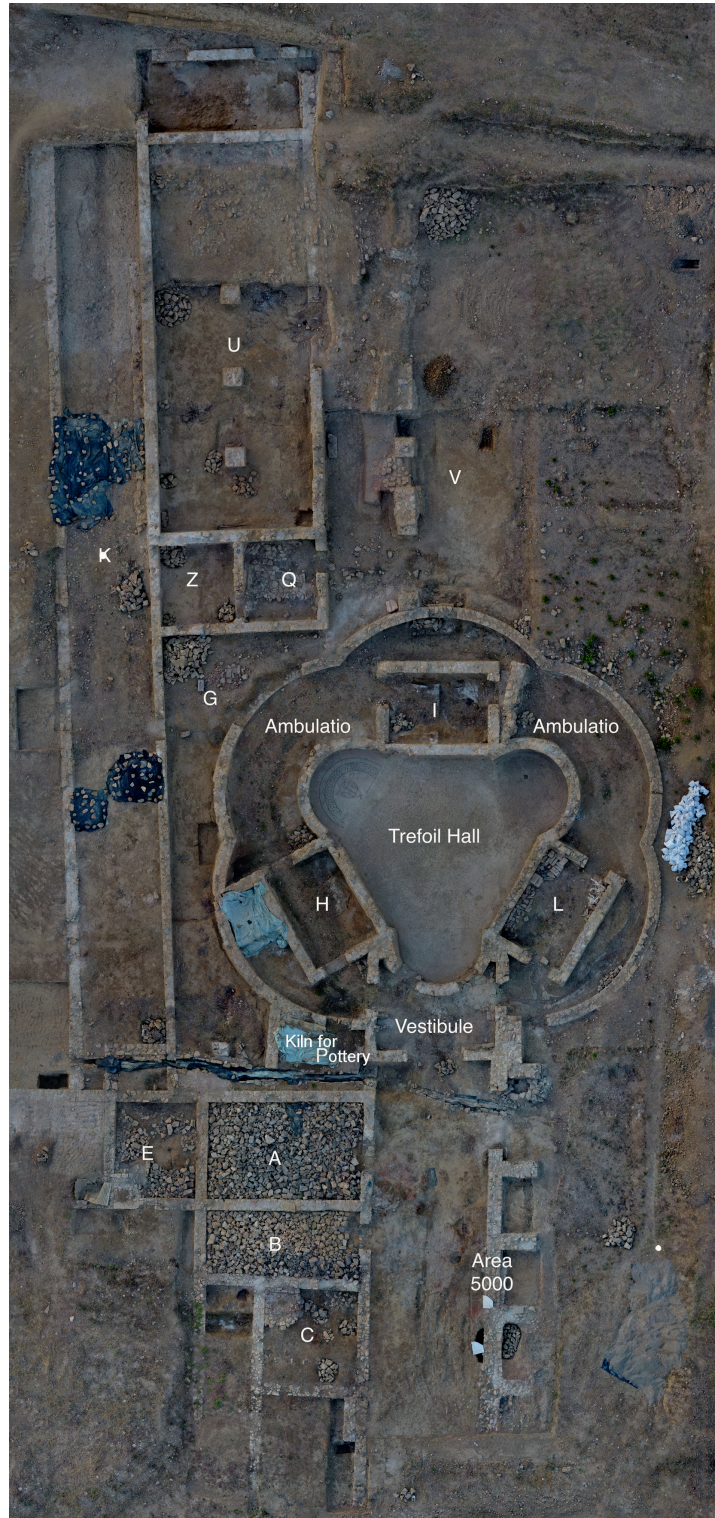
Fig. 2: The excavated area of the villa (2005–2017).

The site has been excavated since 2005 by a Belgian-Italian team led by Marco Cavalieri (*Université catholique de Louvain*). About 3,000 m<sup>2</sup> of the settlement has been excavated (fig. 2), but various archaeological surveys<sup>3</sup> estimate a surface of about 10,000 m<sup>2</sup>.<sup>4</sup>

<sup>40</sup> The 2017 and 2018 campaigns involved the excavation of the two new sections. They lie in the northern part of room K. The first one is visible in fig. 2.

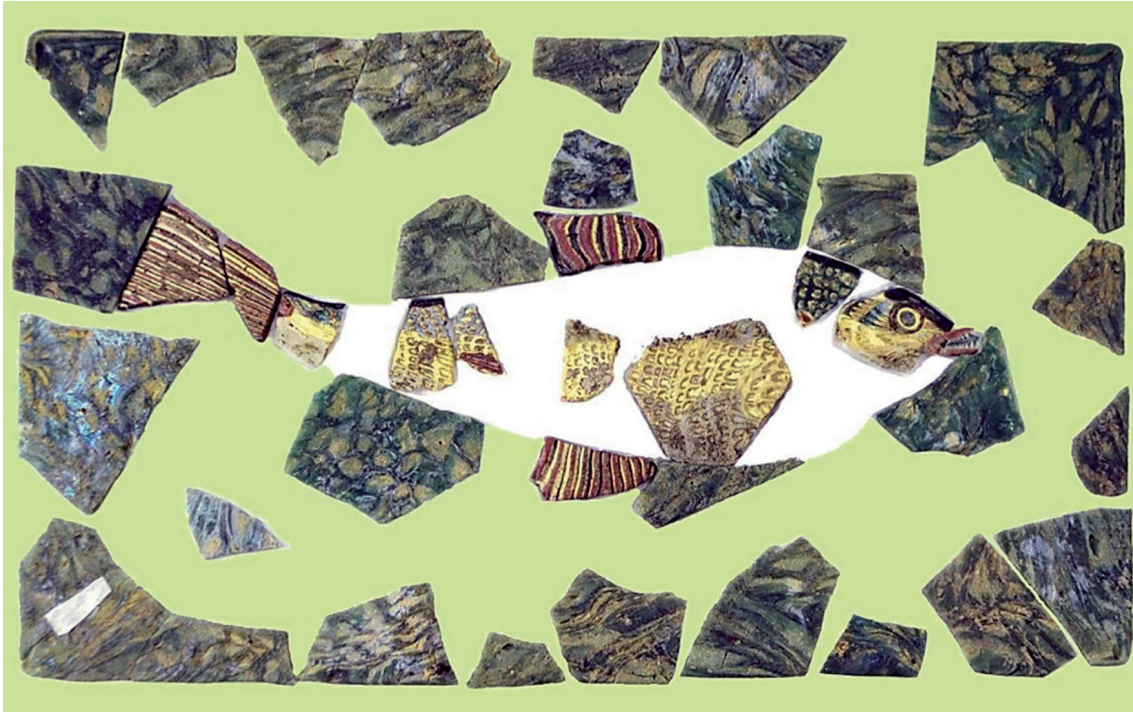
Fig. 3: Examples of glass *sectilia* with representation of sea fish.

Restorers in Palazzo Spinelli Group, Florence, are recomposing the glass *sectilia*.<sup>10</sup> They originally formed panels with representation of sea fish, such as breams, gilthead and morays, in framed groups of three or four (fig. 3).

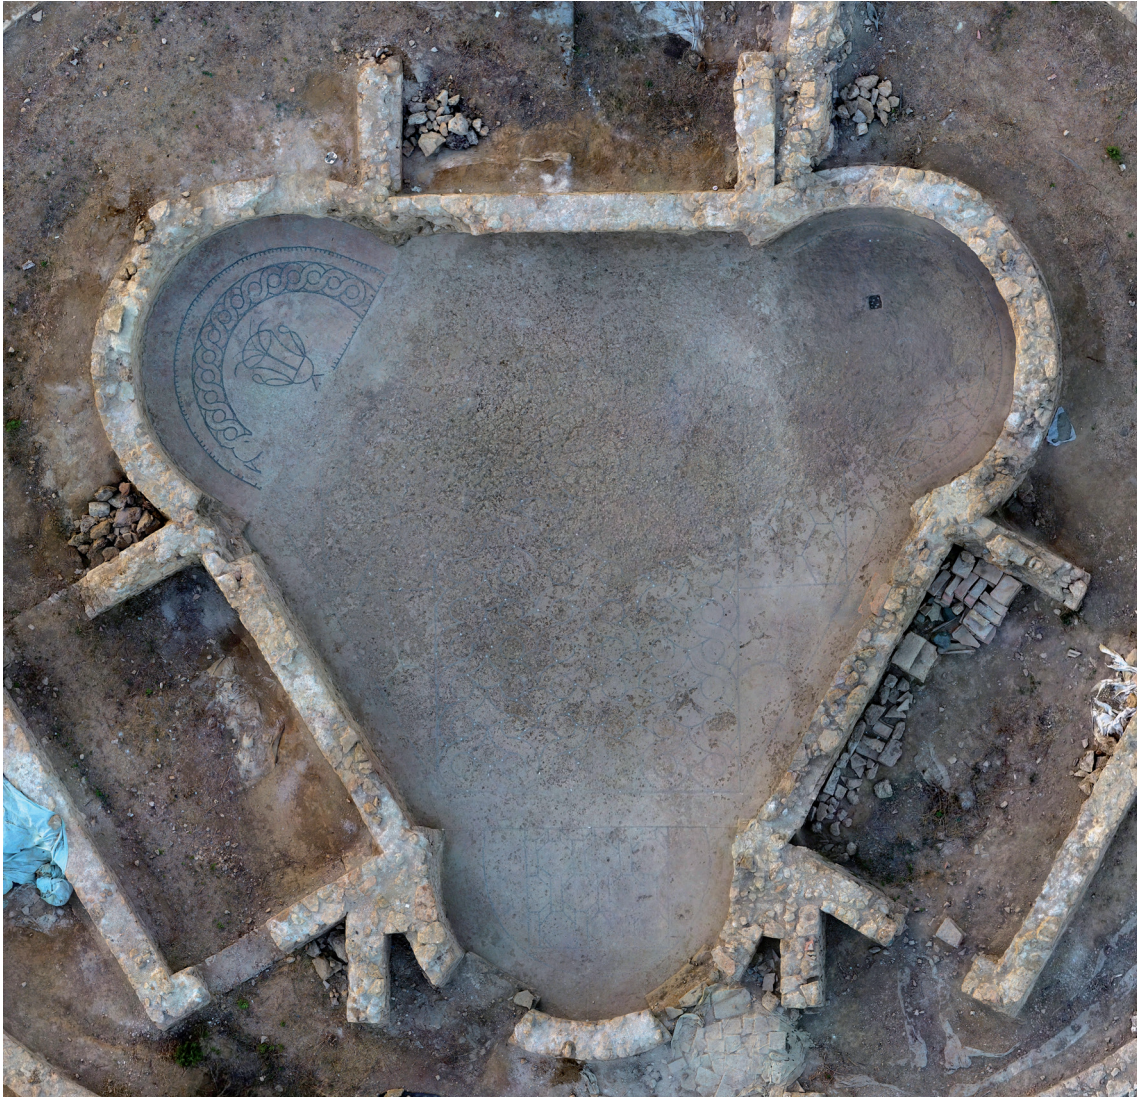
Fig. 4: Remains of the floor in the trefoil hall.

Only the late 4<sup>th</sup>–early 5<sup>th</sup> century floor of the central hall (trefoil hall) still remains *in situ* (fig. 4). This was made of *opus caementicium*, and mosaic details in geometrical and figurative patterns decorated the floor,<sup>16</sup> that was built after the refurbishment of the previous six-foil hall into a trefoil hall.

The central room must have had a taller ceiling: the collapsed roof found in this room must have been arched and in *opus latericium*.

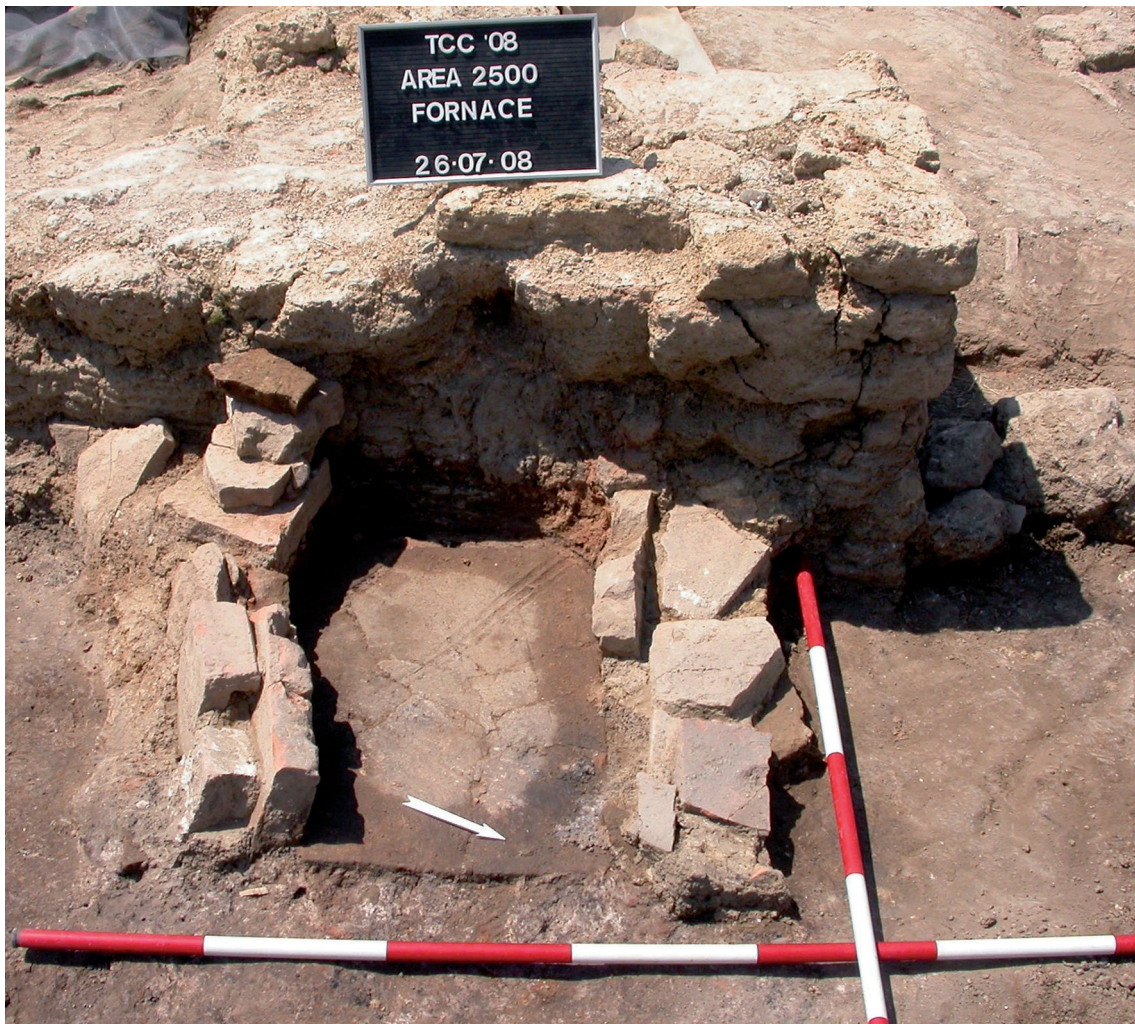
Fig. 5: Small glass fusing kiln in the “Vestibule room”.

The “vestibule” room contained a small glass-fusing kiln (fig. 5):<sup>23</sup> the glass workshop of Aiano probably specialized in recycling glassware from the Roman villa, with the aim of producing small ornaments.<sup>24</sup> This practice of collecting and reprocessing glass shards reduced production costs: it required fewer raw materials and lower temperatures.<sup>25</sup>

The second hypothesis regards the recycling of glass: our glass kiln (in the vestibule) is very similar in size<sup>46</sup> and shape to the two small worktops.<sup>47</sup> However, clear traces of a covering – clay mixed with snail shells – were found for the glass kiln in the vestibule, but this was not the case for the room K worktops. Moreover, in room K we did not find any proof of glass working in the nearby worktops, such as traces of waste materials, glass fusion, or water supply.<sup>48</sup>

<sup>48</sup> In the kiln of the vestibule were found some drops of glass, as well as channels and pits for water.

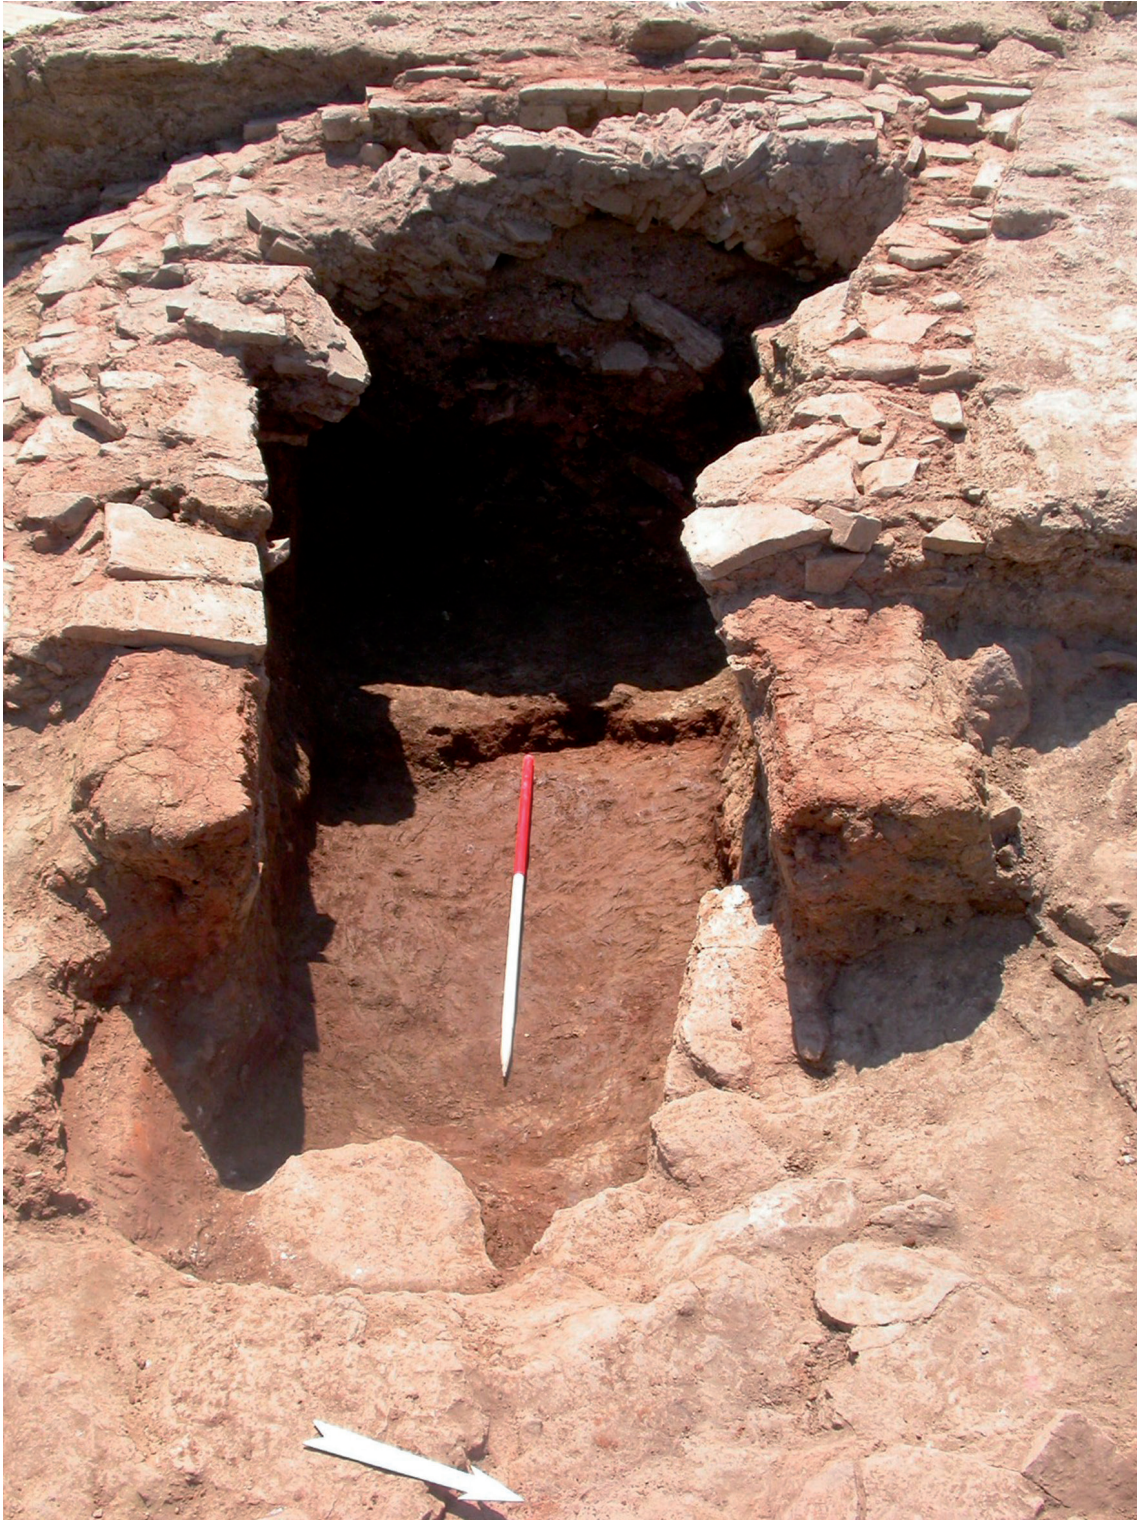
Fig. 6: Kiln.

Another room hosted a kiln (fig. 6), very similar in shape to type II/B *Cuomo di Caprio*, which could be adjusted to bake different items, such as clay for building materials, vessels, and ordinary ware.<sup>32</sup> Again, no waste materials were found.

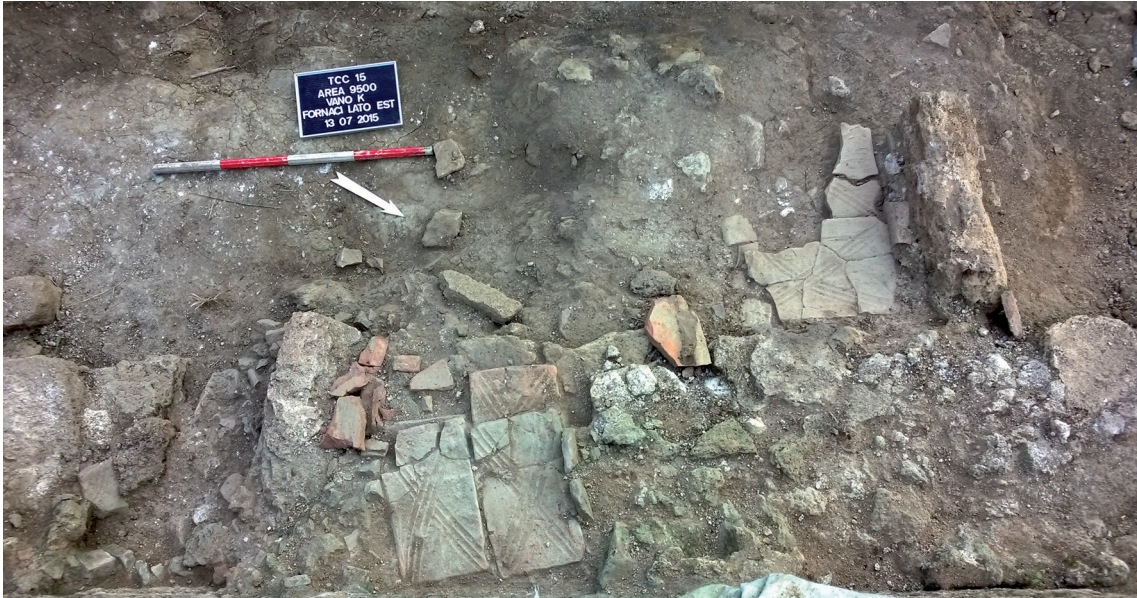
Fig. 7: Worktops in room K (eastern side).

Even more problematic is the so-called room K.<sup>38</sup> This is a long rectangular room with the remains of furnaces/cooking surfaces along two opposite side walls (figs. 7 and 8). All the kilns have clear burning and erosion marks on the back walls, and many of them are located at different heights, which means that the railings of the nearby kilns were reused or destroyed. This suggests that they did not work – or they were not closed – all at the same time.<sup>39</sup>

On the eastern side, there are three worktops, partially or totally destroyed: two of them were carved in an artificial plain surface, which is recognizable only in correspondence with the worktops.<sup>41</sup> The northern and southern part of room K did not possess any traces of this artificial structure.

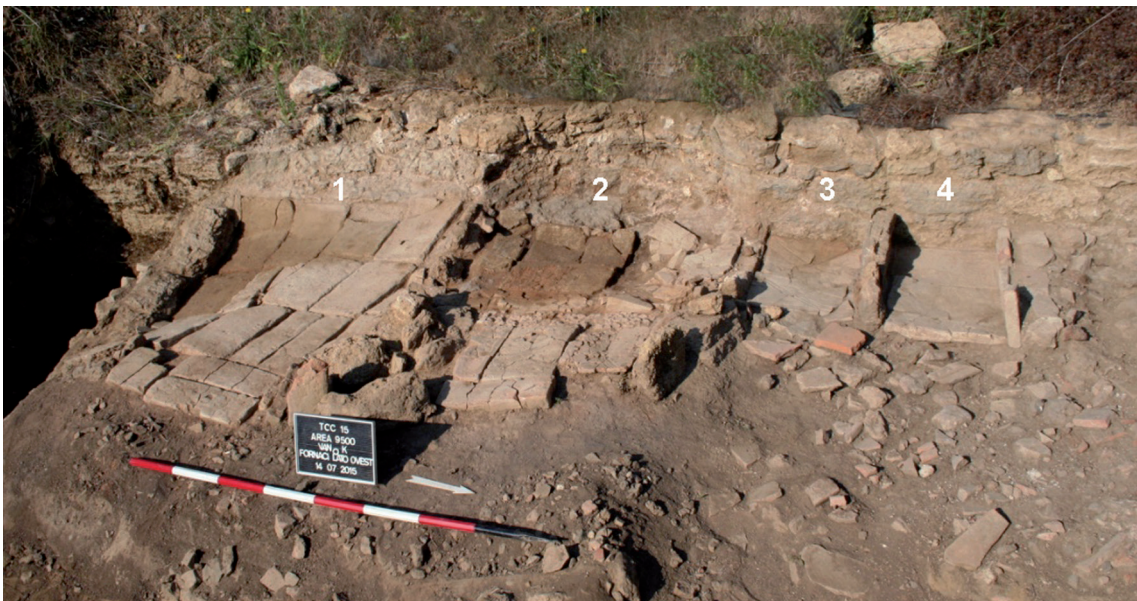
Fig. 8: Worktops in room K (western side).

Almost four worktops lie in the western part of the room: two of them are big (158 × 114 cm and 141 × 111 cm respectively) and traces of fire were recognizable on the eroded wall behind them. The other two are smaller (53 × 40 cm and 71 × 43 cm respectively). The wall behind them is also burned, but not eroded. The worktops were made with reused bricks, sometimes with parallel lines that cross the center of the brick itself (smaller kilns), but sometimes with no lines on their surface (bigger kilns). The worktops did not have any trace of ashes, with the exception of the thin layer covering the worktop number 3.<sup>42</sup>
