Studies of the Early Christian Basilica of Christ of Jerusalem on the island of Kalymnos, Greece, through Terrestrial Laser Scanning

Keywords: *Laser scanning—point cloud—GPS—Kalymnos—basilica*

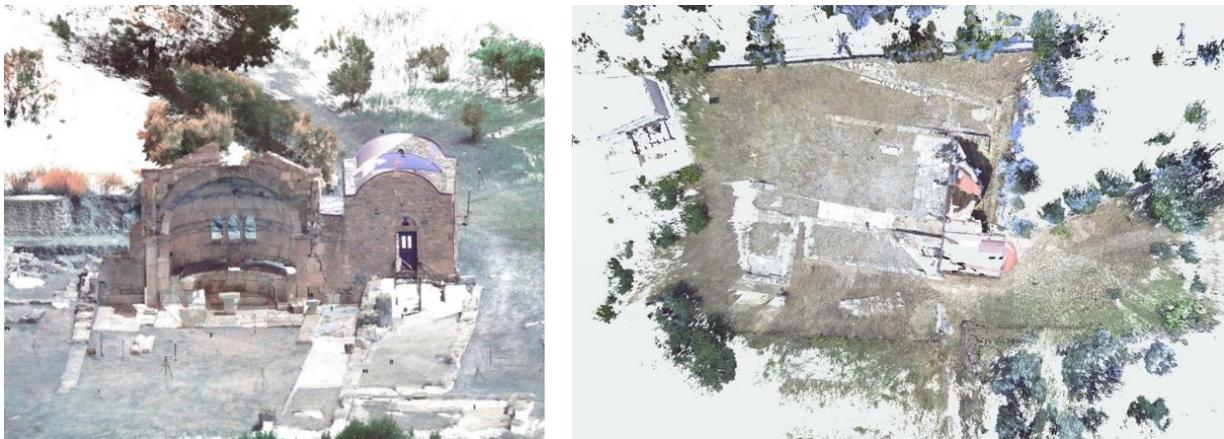
Fig. 1 and Fig. 2. Aerial and angle view of point cloud of basilica of Christ of Jerusalem and Chapel of Ypakoui (© Peter Dare)

Processing raw data to create orthophotos and fly-throughs is time consuming (orthoimages and the flythrough completed for a site in Abdera required 346 hours of processing 10,000 images), while equipment malfunctions during the scanning and analysis processes can result in delays and the loss of many hours of work. All processed data was lost in the fall of 2017, but work has resumed on reprocessing the raw data. Fig. 1, Fig. 2 and Fig. 3 show images of the site created from the point cloud.

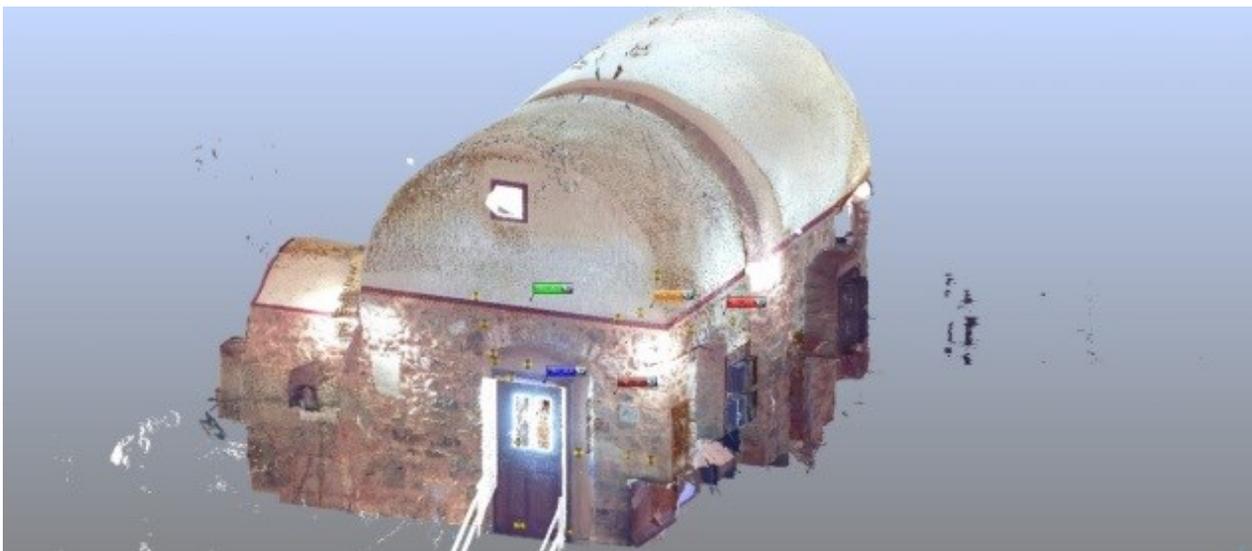
Fig. 3. Point cloud of exterior view of Chapel of Ypakoui (© Peter Dare)
